Your Ref: Aston Martin DB11 Cabriolet  
(chassis number SCFRLFCW4KGM08224)

26 October 2021

Our Ref : CI/TP21010906/D

**INSPECTION REPORT OF AN UNREGISTERED ASTON MARTIN DB11  
CABRIOLET MOTOR CAR WITH CHASSIS NUMBER  
SCFRLFCW4KGM08224**

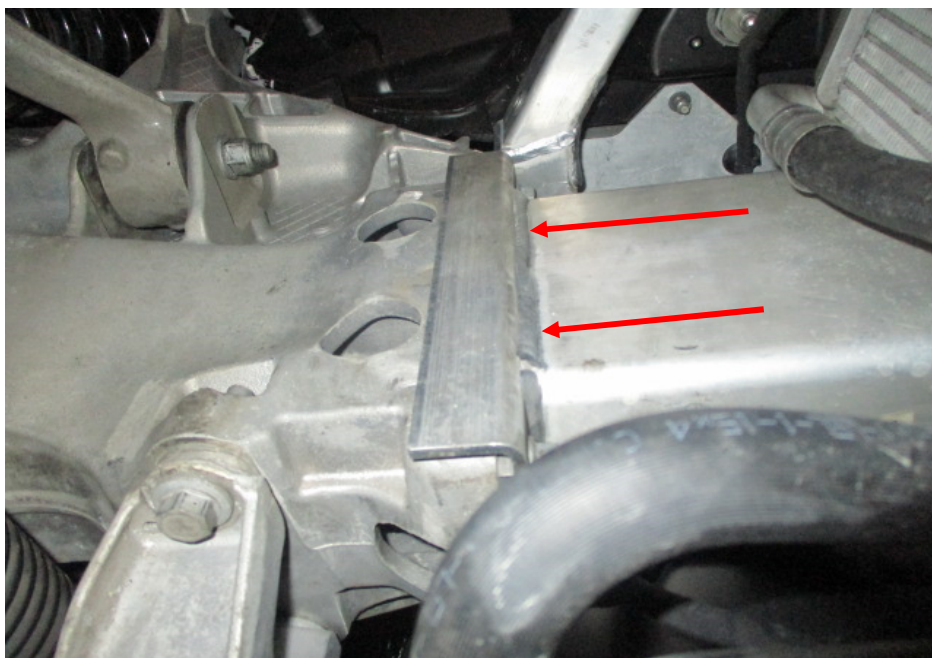
**Photo 32** shows the chassis/structural body at the underside front right of the Motor Car. The original factory sealant (arrowed) at the joints along the chassis/structural body was observed to be untouched. In general, I had found no work was carried out on the chassis/structural body of the Motor Car. The chassis/structural body of the Motor Car was originally fitted.

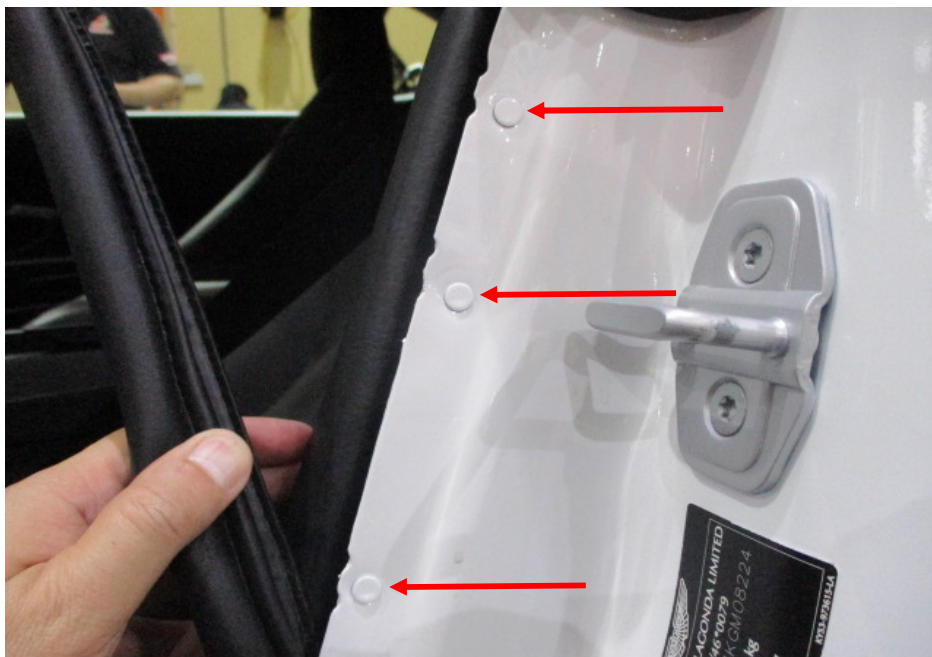
**Photo 33** shows the left side rear body panel of the Motor Car. I did not find any weld marks other than original spot weld marks (arrowed) on the left side rear body panel of the Motor Car which, indicates that there was no re-welding works carried out. In general, I had found all the non-detachable body panels of the Motor Car to be originally fitted at the time of my inspection.

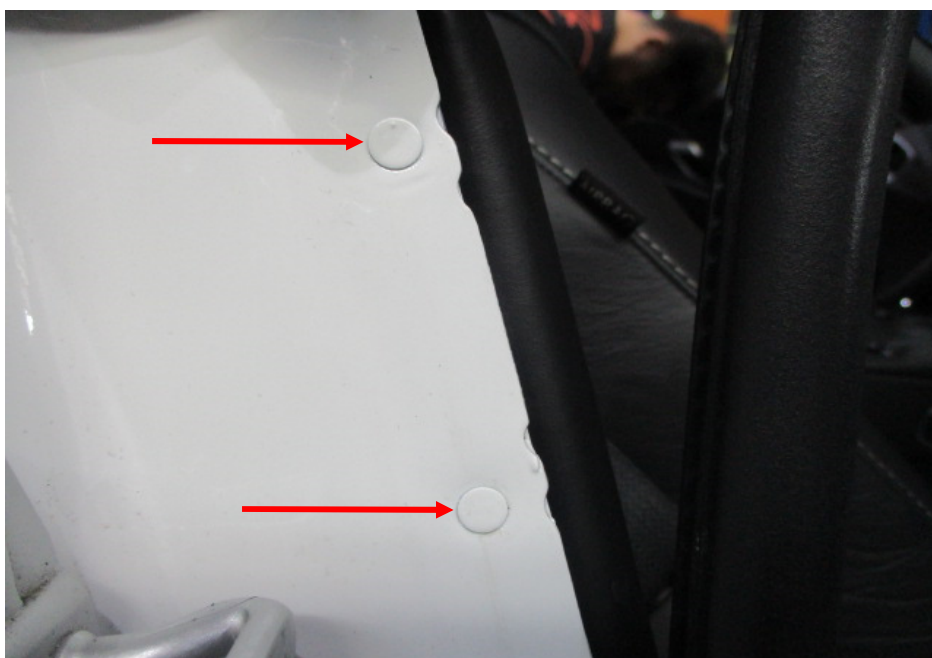
**Photo 34** shows the right side rear body panel of the Motor Car. I did not find any weld marks other than original spot weld marks (arrowed) on the right side rear body panel of the Motor Car which, indicates that there was no re-welding works carried out. In general, I had found all the non-detachable body panels of the Motor Car to be originally fitted at the time of my inspection.

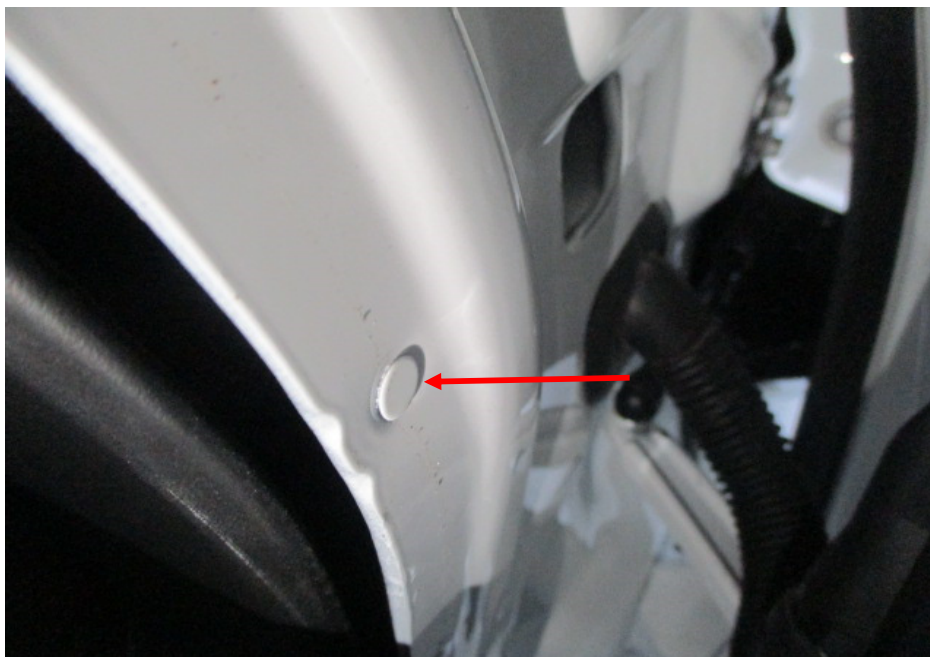
**Photo 35** shows the right side "A" pillar of the Motor Car. I did not find any weld marks other than original spot weld marks (arrowed) on the right side "A" pillar of the Motor Car which, indicates that there was no re-welding works carried out. In general, I had found all the non-detachable body panels of the Motor Car to be originally fitted at the time of my inspection.
