Your Ref : SNM21D206107/C02
Our Ref : CC6/CTI21010908/N

**AUTOMOBILE TECHNICAL INVESTIGATION REPORT OF ACCIDENT
INVOLVING SJG 53S AND PC 4047J ON 12 OCTOBER 2021**

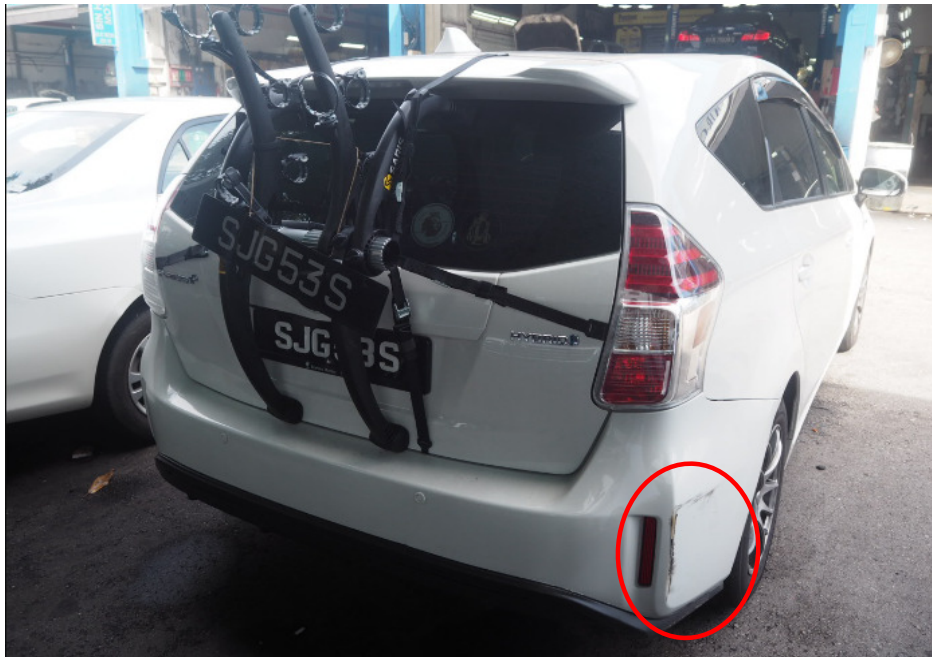
7. From our examination of the photographs taken during the Pre- Repair Survey conducted by LKK Auto Consultants Pte. Ltd. about 3 weeks after the accident, we note that the Toyota had sustained an impact onto its rear right portion. The damages were mainly observed to be at or around the rear bumper.

Photo 1 shows the general view of the right rear portion of the Toyota at the time of the Pre- Repair Survey conducted by LKK Auto Consultants Pte. Ltd. which was taken about 3 weeks after the accident. The damage to the Toyota was observed to be confined to the rear bumper (circled).

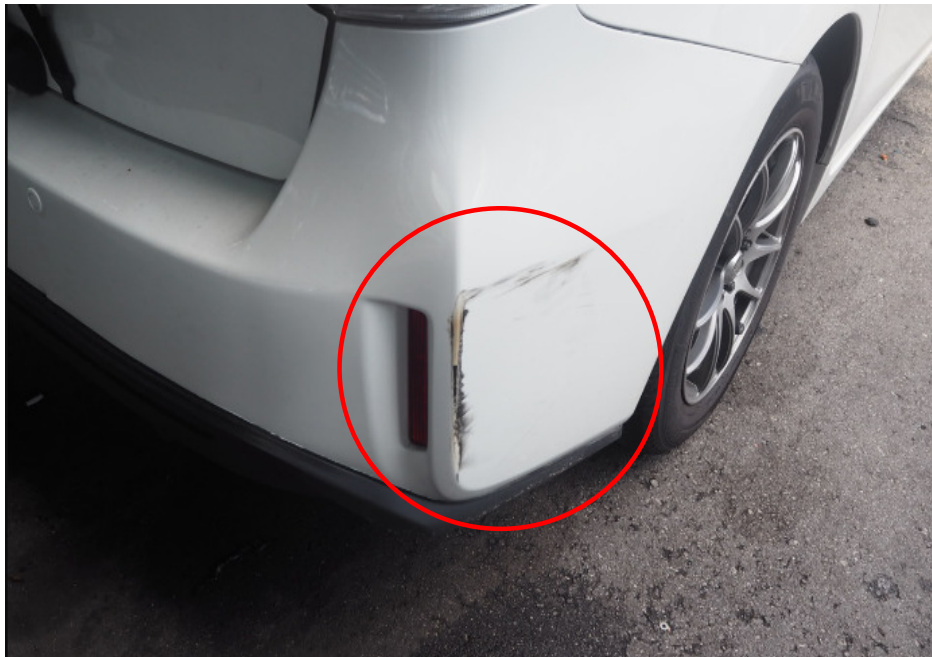
Photo 2 shows the damage observed on the right portion of the rear bumper of the Toyota (circled).

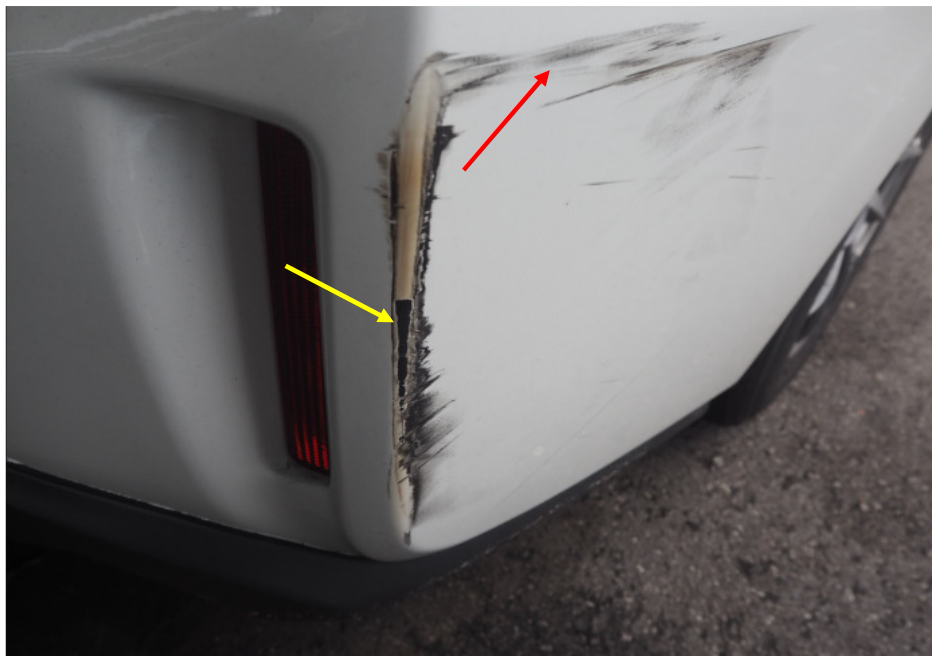
8. We observed paint graze marks and black marks found on the lower right portion of the rear bumper of the Toyota. We also noted the rear bumper was dislodged at the right corner edge. See photos 1 - 7 below.

Photo 3 shows a closer view of the paint graze marks (yellow arrow) and black marks (red arrow) found on the lower right portion of the rear bumper of the Toyota.

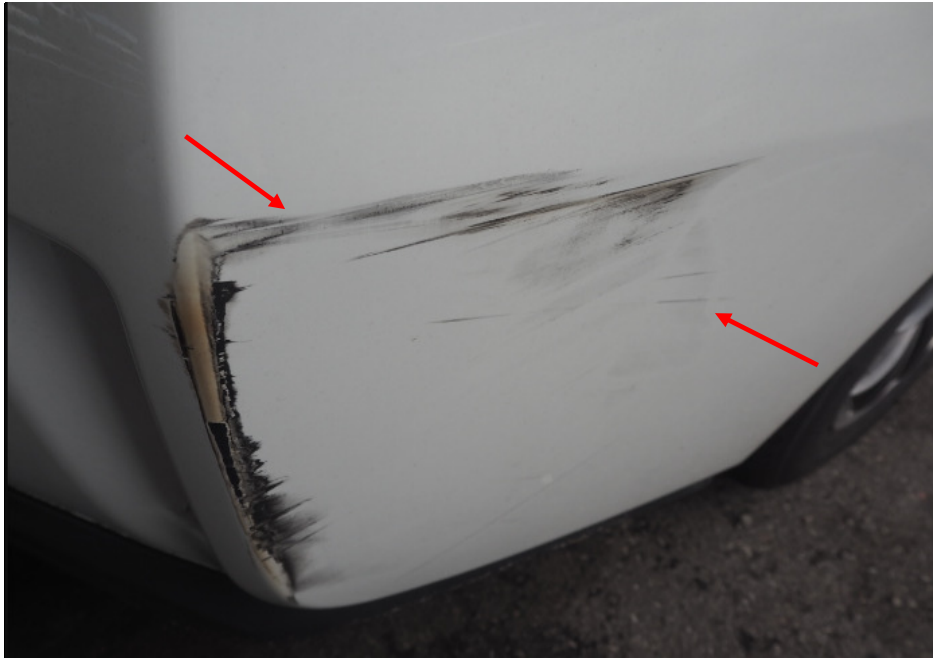
Photo 4 shows a close up view of the black marks found on the lower right portion of the rear bumper of the Toyota (arrowed).

20. The left front wheel rim and tyre is the most protruded part of the Hiace hence as the Hiace was abruptly proceeding straight on the 1st lane beside the Toyota, the left front wheel rim and tyre grazed the right rear portion of the Toyota. The pattern of the black marks seen on the right rear portion of the Toyota corresponds to tyre rubbing marks which was caused by the left front tyre of the Hiace which came into contact with the Toyota while the Hiace was abruptly proceeding straight.

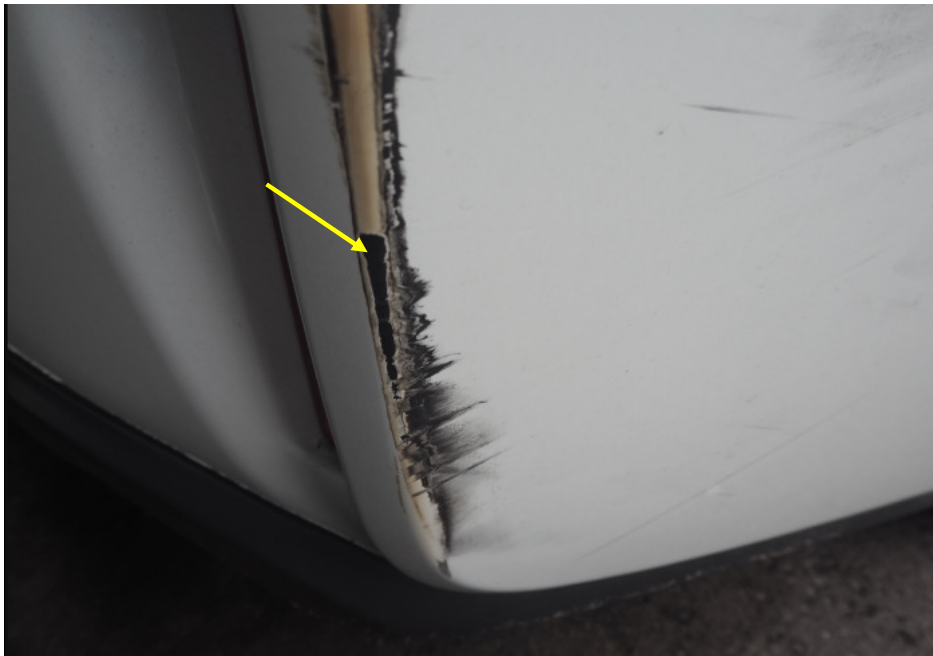
Photo 5 shows a close up view of the paint graze marks found on the lower right portion of the rear bumper of the Toyota (arrowed).

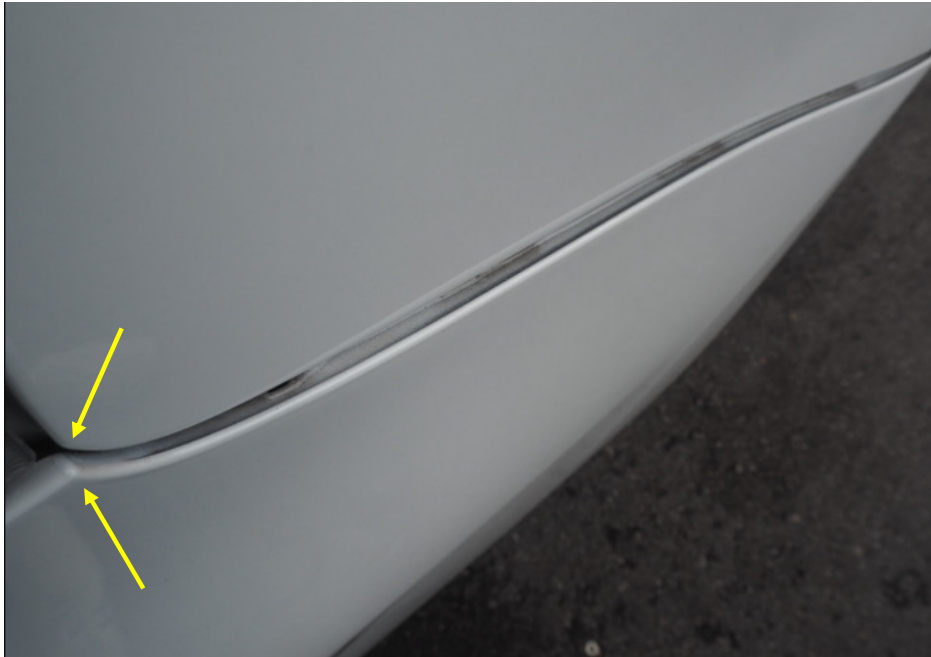
Photo 6 shows the right corner edge of the rear bumper of the Toyota. We observed that the rear bumper was dislodged at the right corner edge (arrowed).

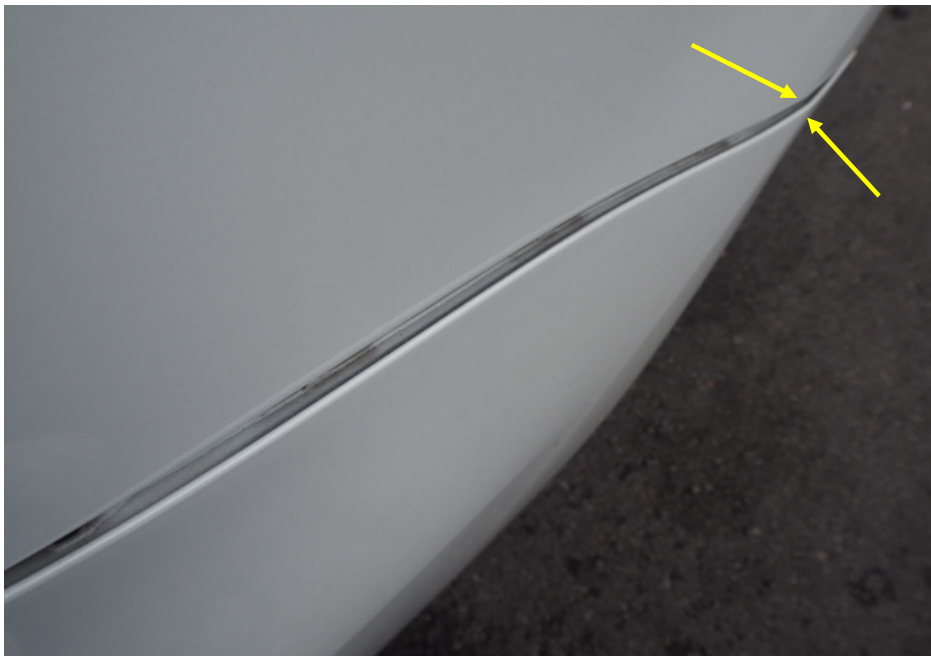
Photo 7 shows a close up view of the right corner edge of the rear bumper of the Toyota. We observed that the rear bumper was dislodged at the right corner edge (arrowed).

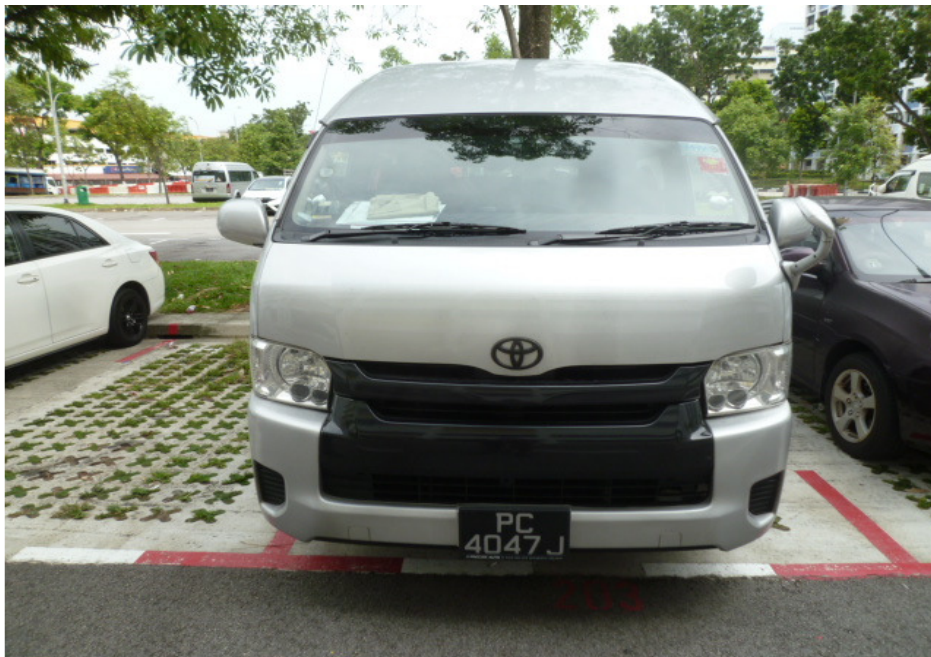
Photo 8 shows the general view of the frontal portion of the Hiace at the time of our physical inspection.

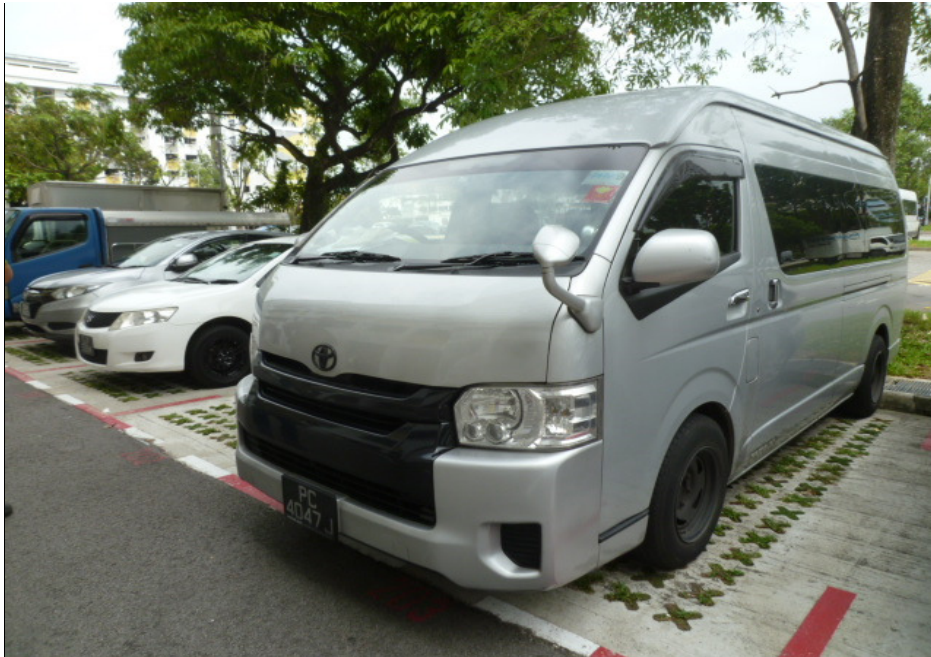
Photo 9 shows the general view of the left frontal portion of the Hiace at the time of our physical inspection. Its left frontal portion was observed to have no visible impact damage.

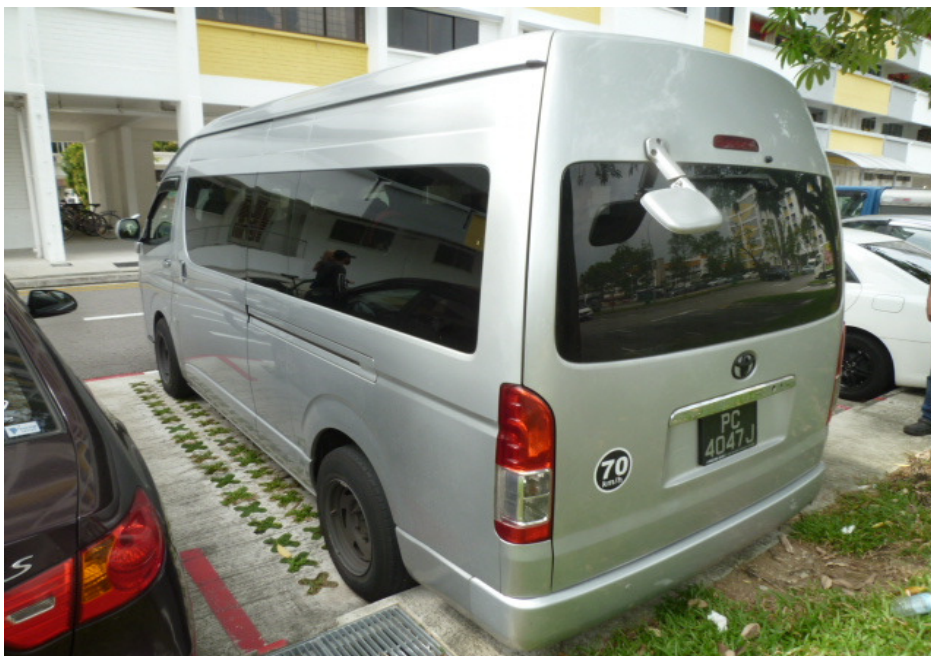
Photo 10 shows the general view of the left rear portion of the Hiace at the time of our physical inspection. Its left rear portion was observed to have no visible impact damage.

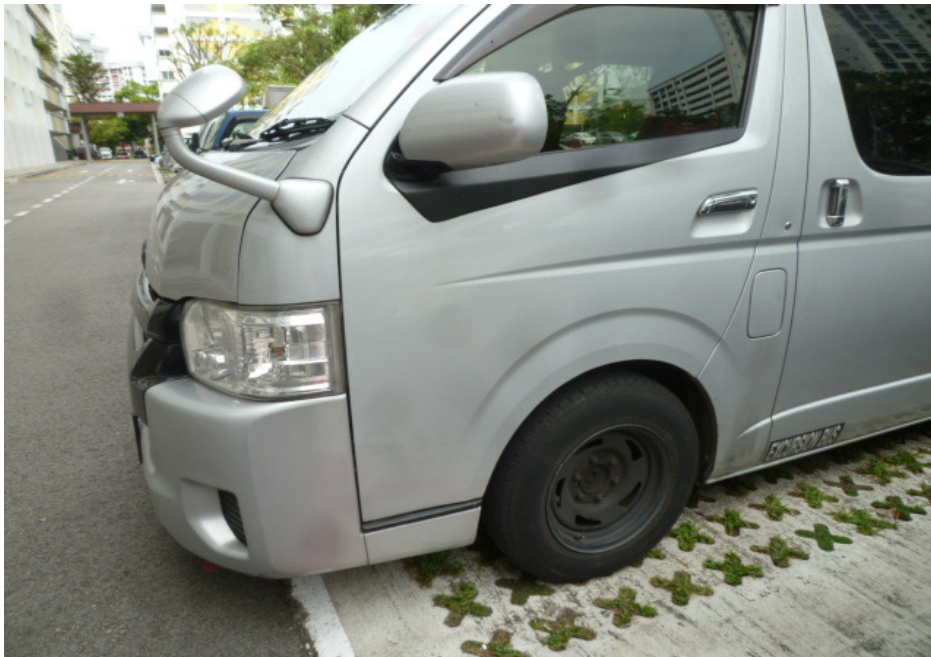
Photo 11 shows a closer view of the left frontal portion of the Hiace at the time of our physical inspection. There were no cracks or dents observed.

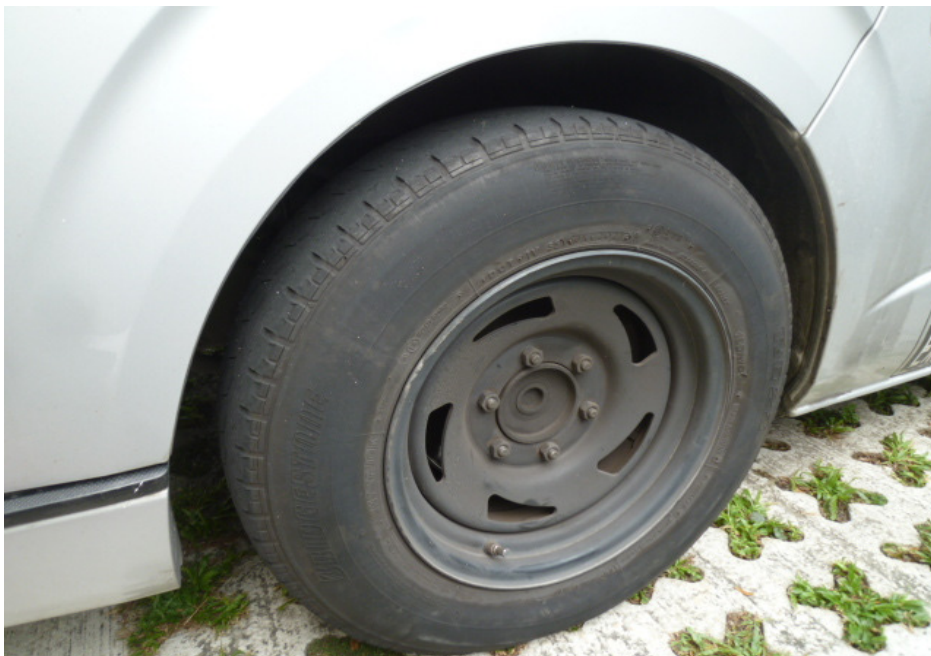
Photo 12 shows a close up view of the left frontal portion of the Hiace at the time of our physical inspection. There were no paint graze marks observed.

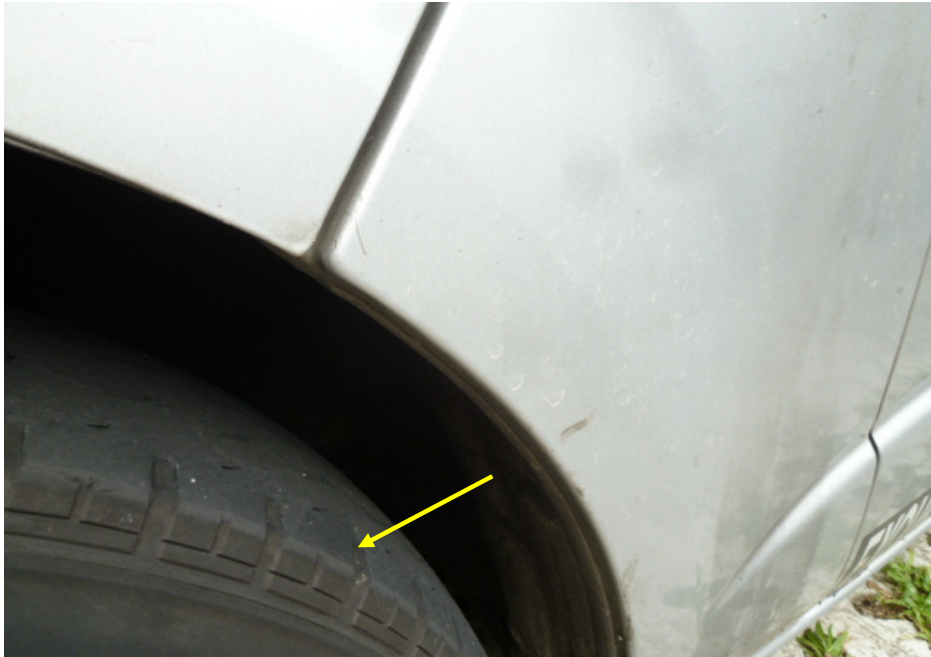
Photo 13 shows a close up view of the left front tyre of the Hiace at the time of our physical inspection. We observed that the left front tyre was observed to have protruded out from the body of the Hiace (arrowed).

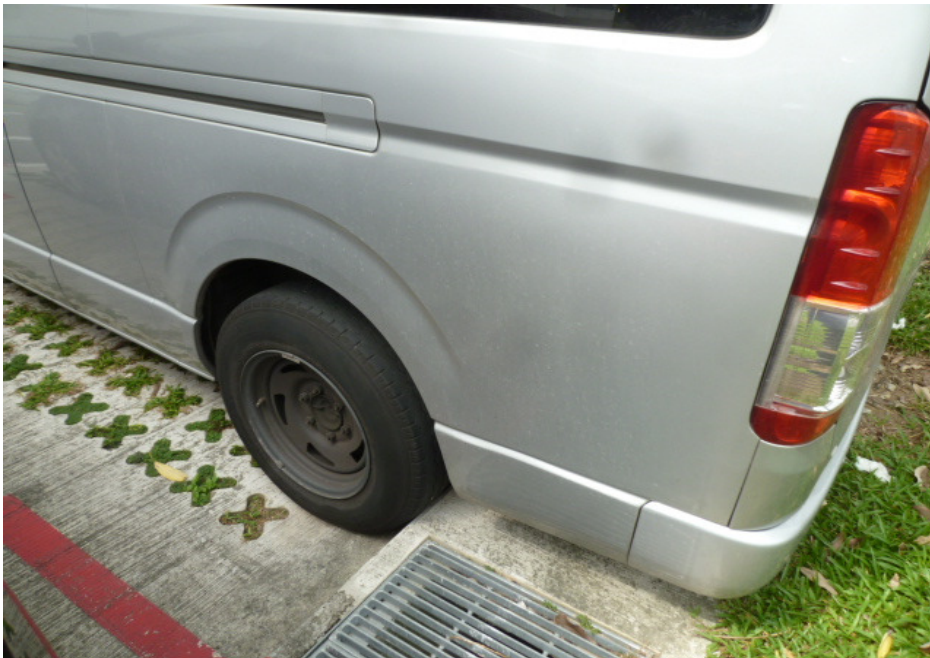
Photo 14 shows a closer view of the left rear portion of the Hiace at the time of our physical inspection. There were no cracks or dents observed.

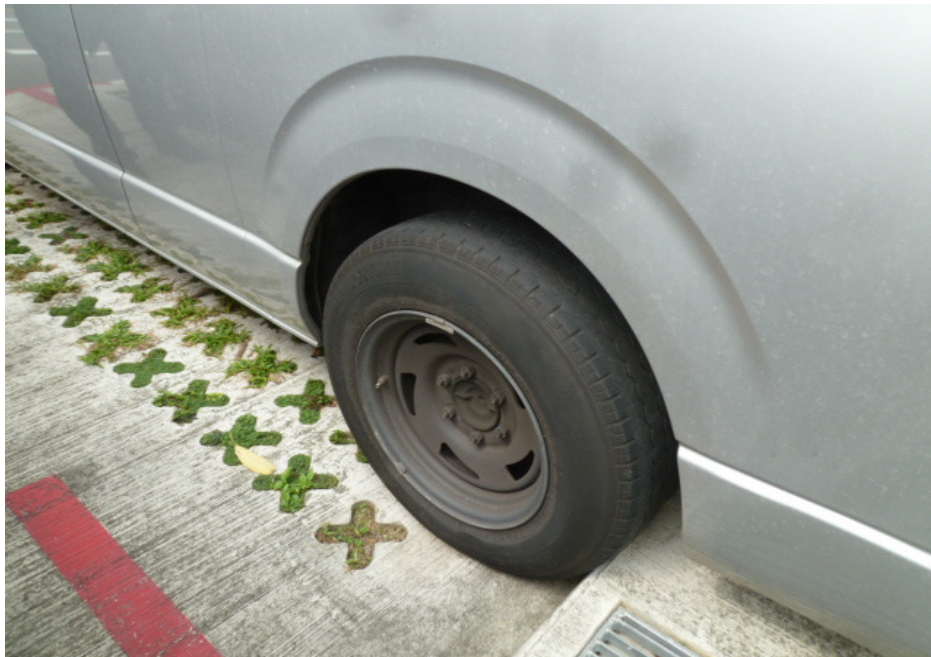
Photo 15 shows a close up view of the left rear portion of the Hiace at the time of our physical inspection. There were no paint graze marks observed.

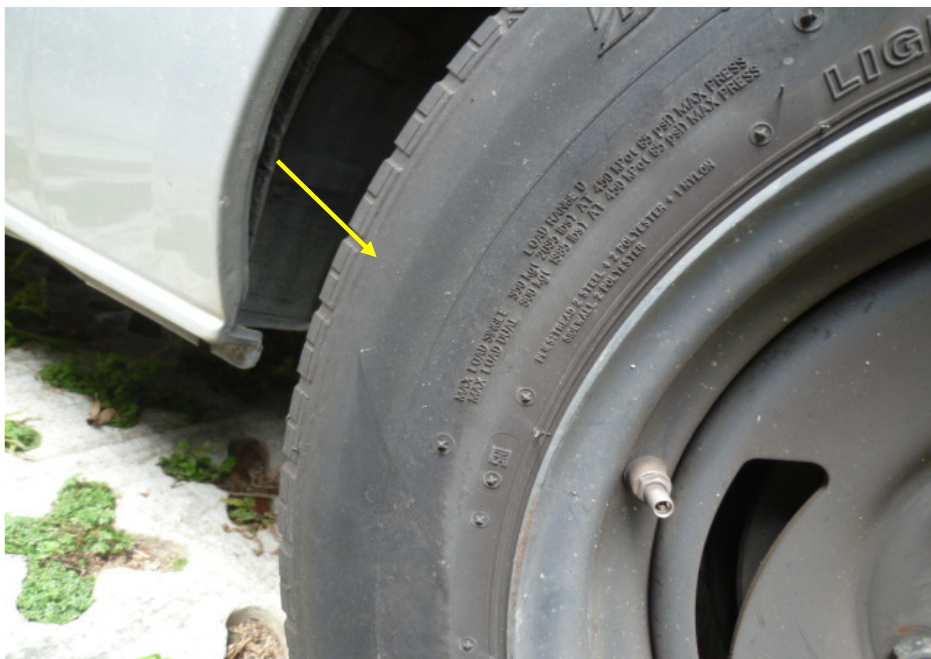
Photo 16 shows a close up view of the left front tyre of the Hiace at the time of our physical inspection. We observed that the left front tyre was observed to have protruded out from the body of the Hiace (arrowed).

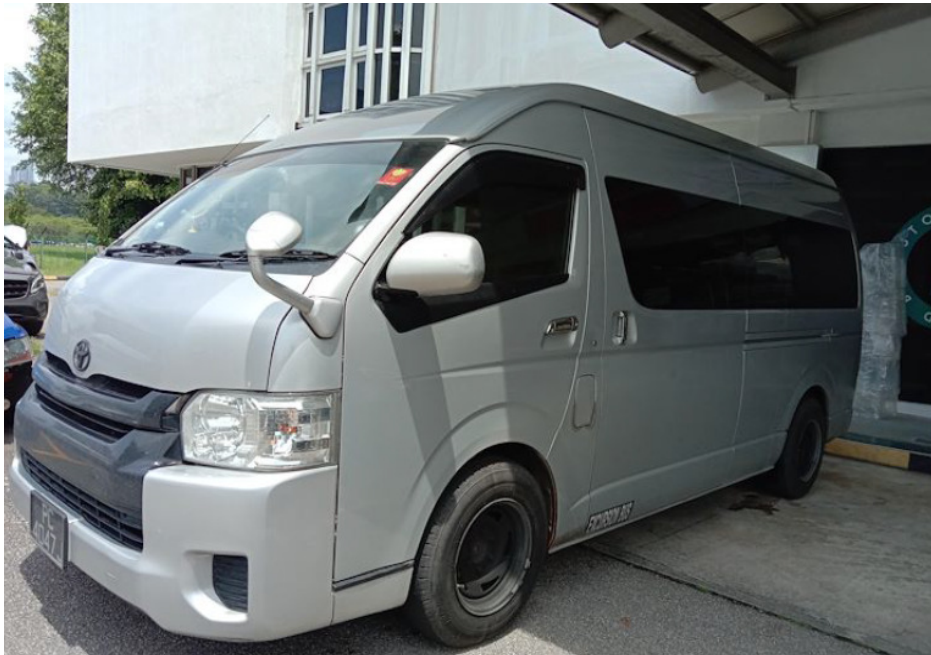
12. Our examination of the photographs showing the Hiace at the time of its accident reporting on 30 October 2021 had also revealed no visible damage to its left portion. See photo 17 below.

Photo 17 shows the general view of the left portion of the Hiace at the time of its accident reporting. Its left portion was observed to have no impact damage.

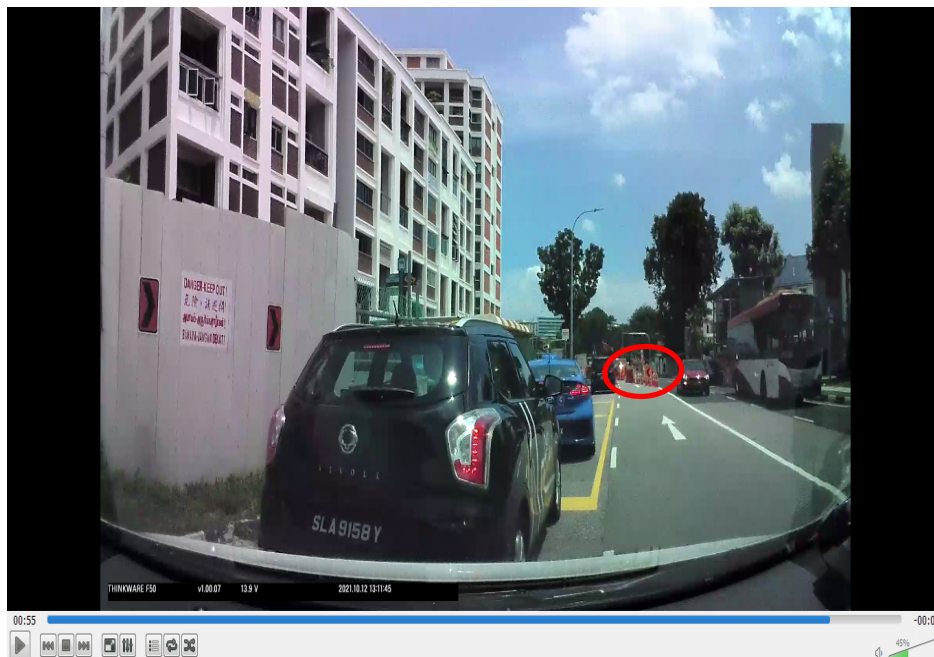
Screenshot 1 of the video recording from the video recording device that was mounted onto the front windscreen of the Toyota shows the Toyota waiting to switch from lane 1 to lane 2 due to road works ahead (circled) at the 55 second mark.

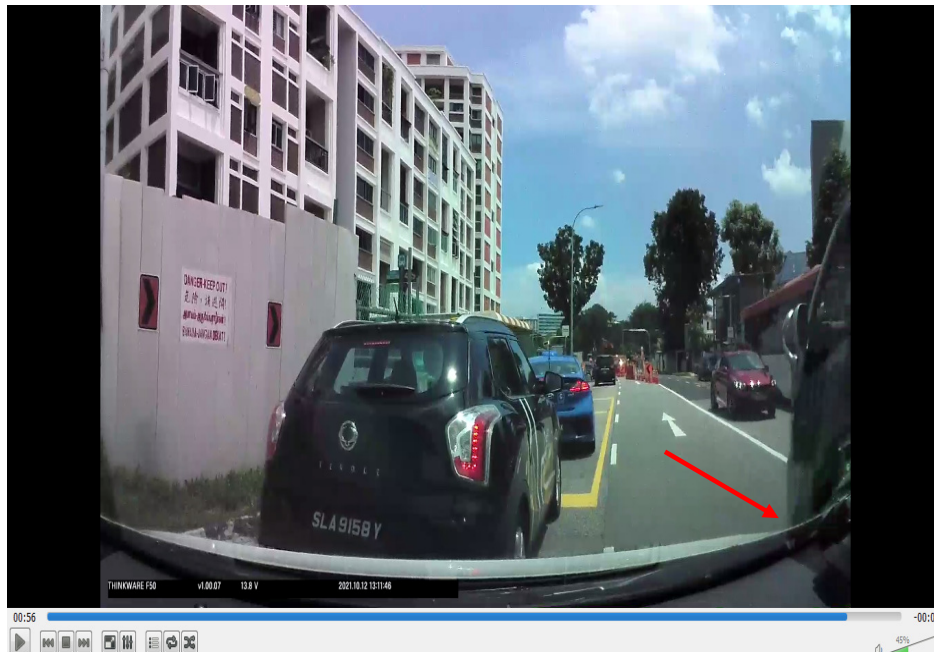
15. See screenshot 1 and 2 below showing the 56 and 57 second mark of the video recording where the Hiace can be seen abruptly proceeding straight. However one would have to view the recording to see this slight movement.

Screenshot 2 shows at the 56 second mark of the video recording, we had noted a slight movement (jerk like movement) of the Toyota. This was after the Hiace had abruptly proceeded straight on the 1st lane beside the Toyota (arrowed). The capturing of this slight movement is a sign that there was jerk like movement to the Toyota itself. Ultimately, indicating that there was contact between the left portion of the Hiace and the right rear portion of the Toyota.

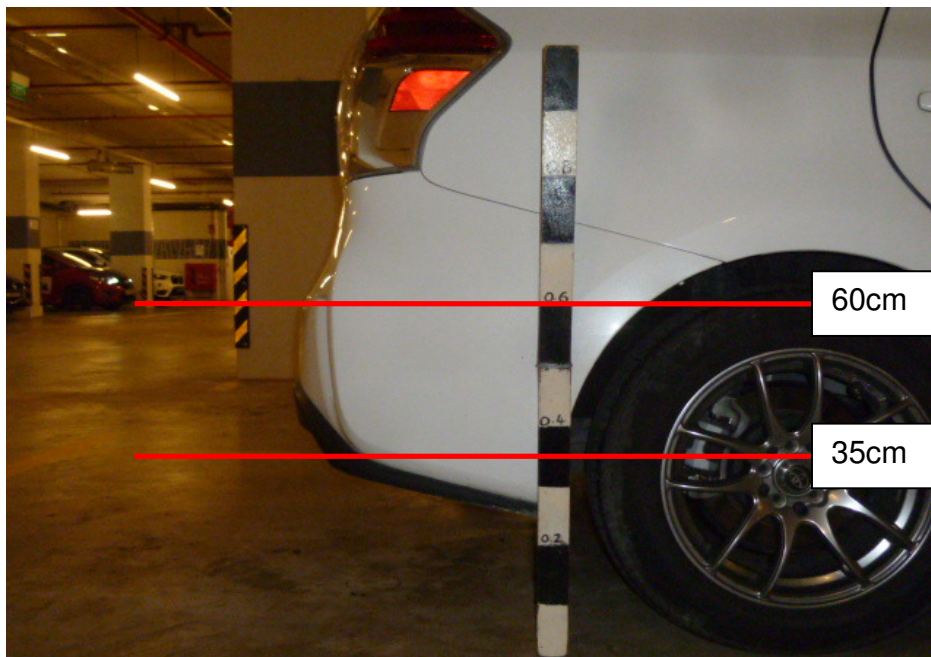
Photo 18 shows the height measurement being conducted on the right rear portion of the Toyota. The paint graze and black marks on the right rear portion of the Toyota were between the height ranges of 35cm to 60cm above ground level.

- a) The paint graze and black marks on the right rear portion of the Toyota were between the height ranges of 35cm to 60cm above ground level;
- b) the body part between the height ranges of 35cm to 60cm above ground level was the left front wheel rim and tyre of the Hiace;
- c) the height measurements appear to support the findings of possible contact between the right rear portion of the Toyota and the front left portion of the Hiace. The point of contact to the right rear portion of the Toyota would have been from the left front wheel rim and tyre of the Hiace given that this was the most protruded body part at the left frontal portion of the Hiace and also the height above ground level had corresponded to the height above ground level of the paint graze and black marks found on the right rear portion of the Toyota.

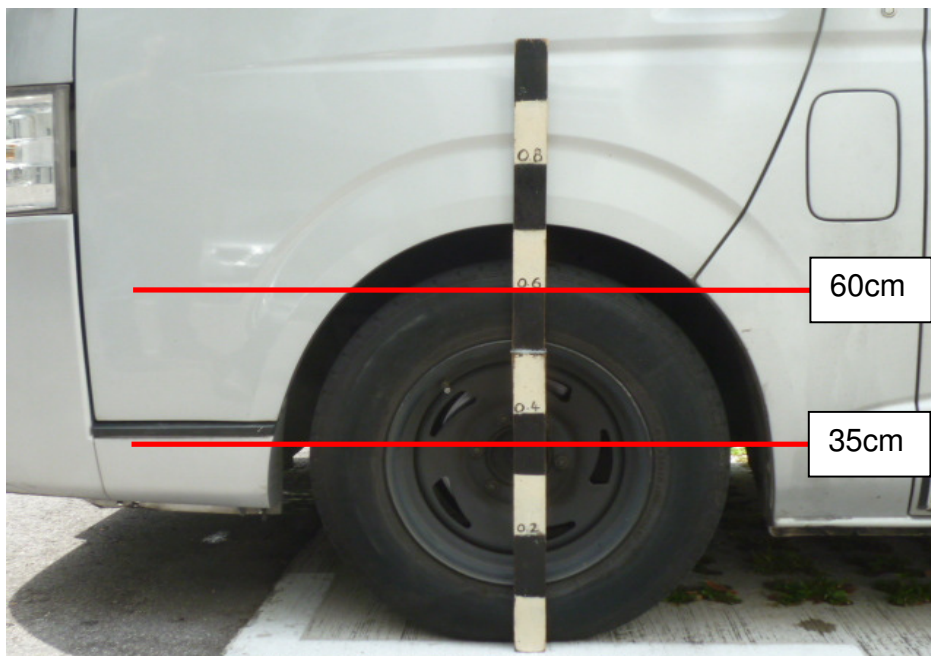
Photo 19 shows height measurement being conducted on the left frontal portion of the Hiace. The body part between the height ranges of 35cm to 60cm above ground level was the left front wheel rim and tyre of the Hiace.
