Your Ref: Mercedes Benz GLC 43  
(chassis number WDC2539642F521545)  
Our Ref : CI/TP21010995/D

27 October 2021

**INSPECTION REPORT OF AN UNREGISTERED MERCEDES BENZ GLC 43  
MOTOR CAR WITH CHASSIS NUMBER WDC2539642F521545**

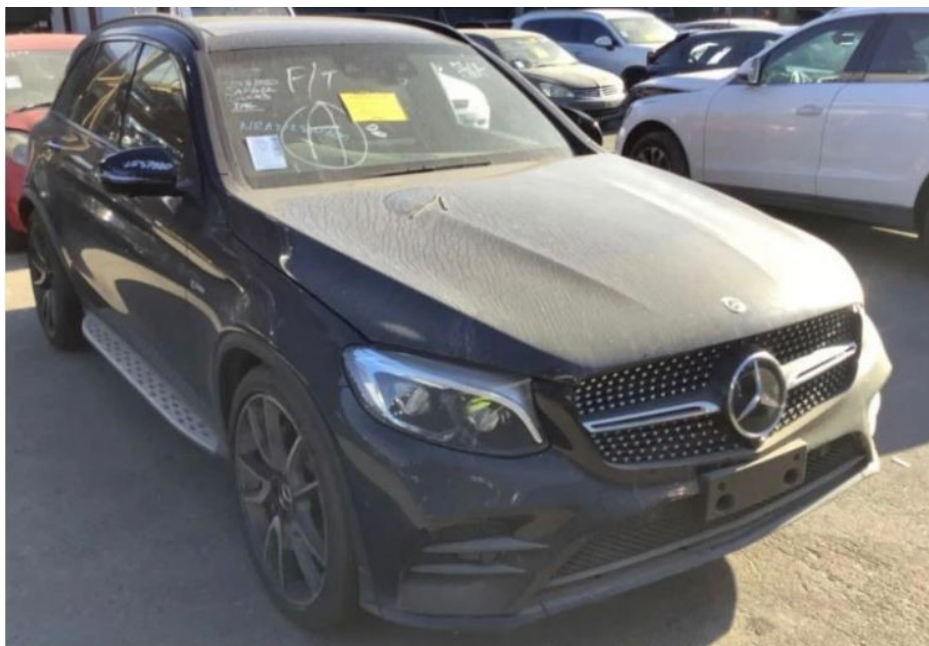
**Photo 1** shows the front right body of the Motor Car prior to any repairs being carried out (photograph provided to me). No physical damage was observed to the Motor Car except for the front left passenger door window, which was observed to be shattered. The airbags of the Motor Car were not deployed.

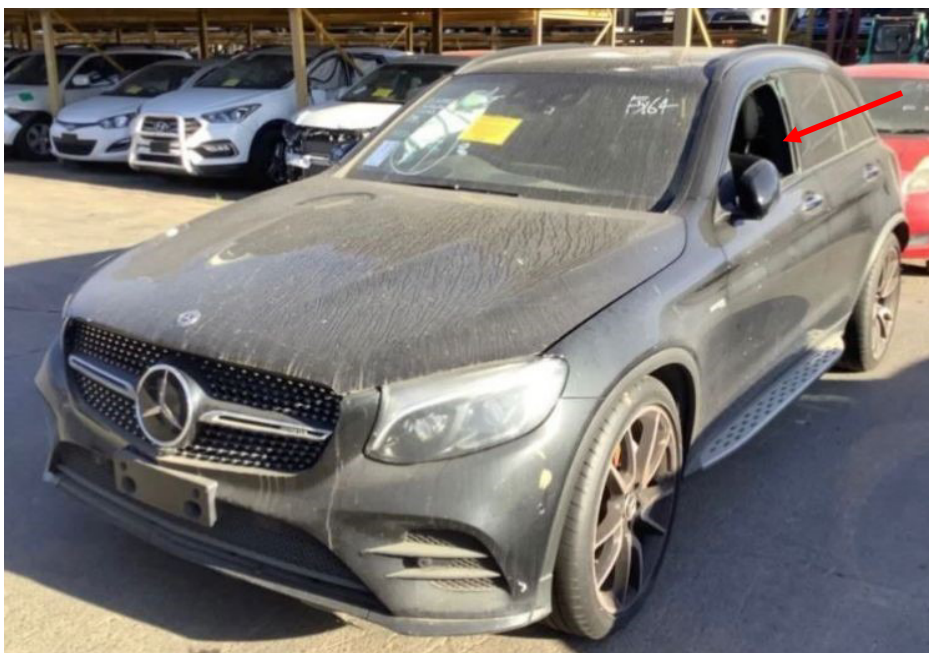
**Photo 2** shows the front left body of the Motor Car prior to any repairs being carried out (photograph provided to me). No physical damage was observed to the Motor Car except for the front left passenger door window (arrowed), which was observed to be shattered.

22. The front left passenger door window of the Motor Car was visually examined, and it was noted that the repair/restoration works carried out (refer photograph 2 & 3 above) were reasonably adequate and in order.

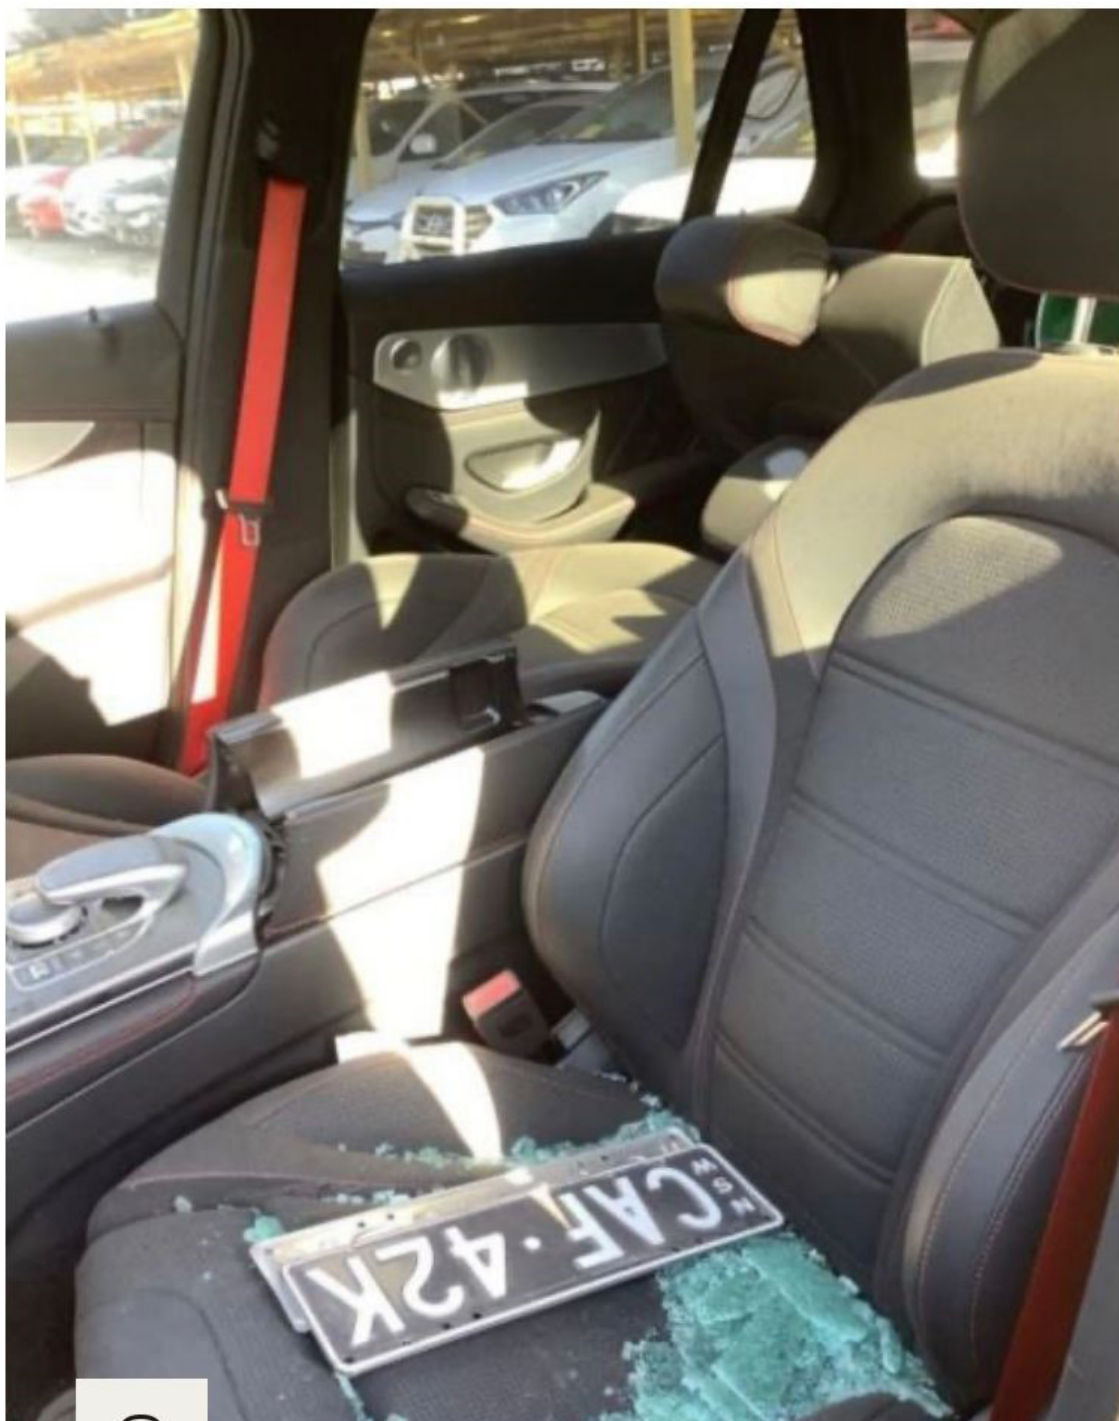
**Photo 3** shows the interior compartment of the Motor Car prior to any repairs being carried out (photograph provided to me). The interior compartment was observed to be without any physical damage. The airbags of the Motor Car were not deployed as seen from the photographs that were provided to me. Broken glass fragments from the shattered front left passenger door window can be seen on the front left passenger seat of the Motor Car.

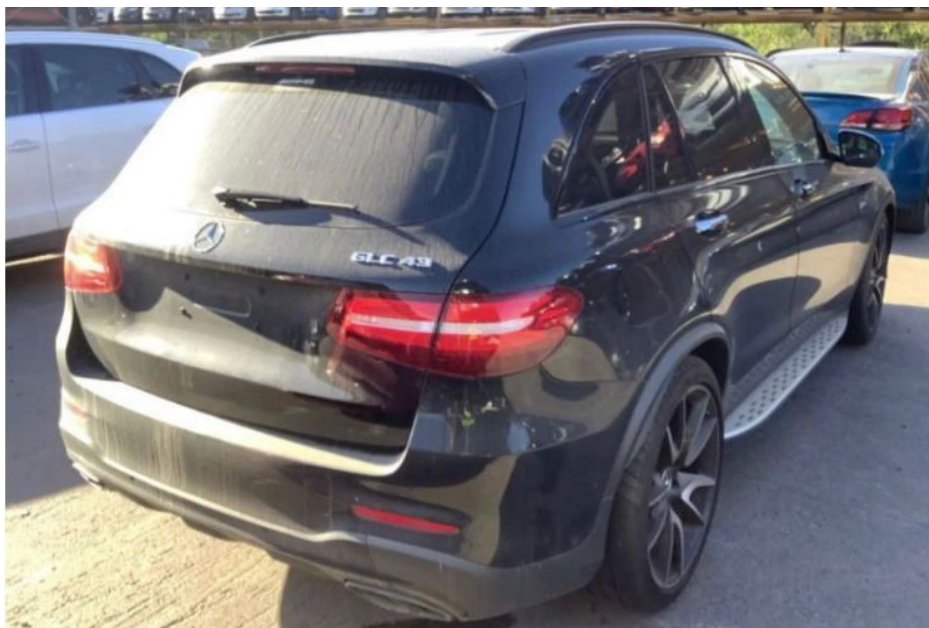
**Photo 4** shows the rear right body of the Motor Car prior to any repairs being carried out (photograph provided to me). No physical damage was observed to the Motor Car except for the front left passenger door window, which was observed to be shattered.

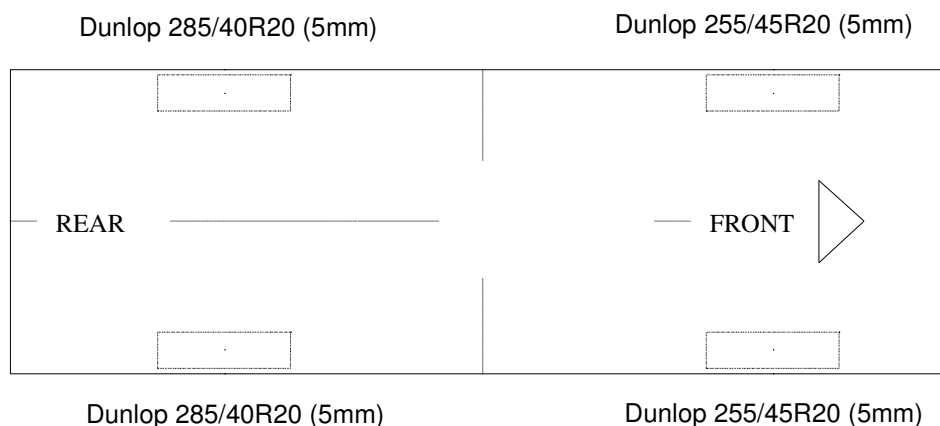
8. It was fitted with 20inch sport wheel rims that were wrapped with tyres that were observed to be of serviceable condition. The tyres were also sufficiently inflated for vehicular operation. The tyre brand, tyre size and approximate remaining tread depth of the 4 tyres of the Motor Car were recorded as follows: -

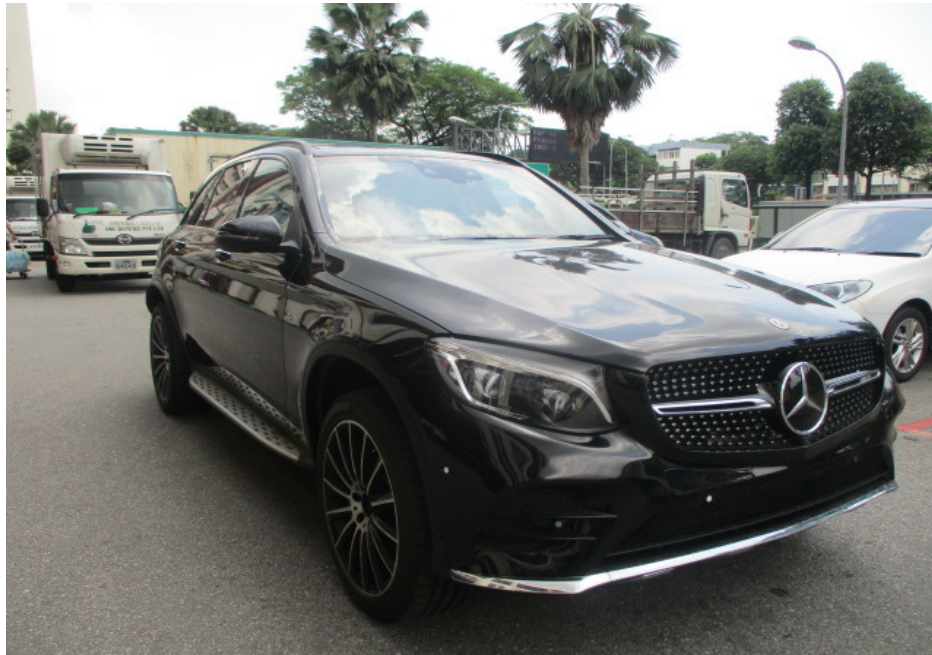
**Photo 5** shows a general view of the front right body of the Motor Car at the time of my inspection. The Motor Car was observed to be in a relatively good general condition with no loose exterior fittings observed. The mileage of the Motor Car recorded at the time of my inspection was 16,253km.

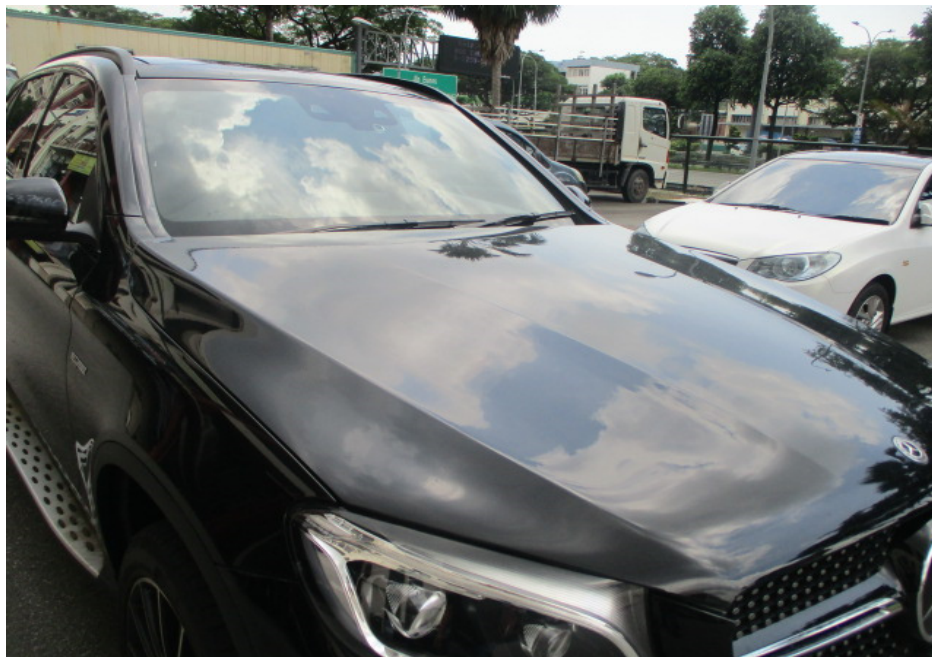
**Photo 6** shows a closer view of the Motor Car's front bonnet, front windscreen and front right headlamp. In general, the Motor Car was observed to be in a relatively good general condition with no loose exterior fittings observed.

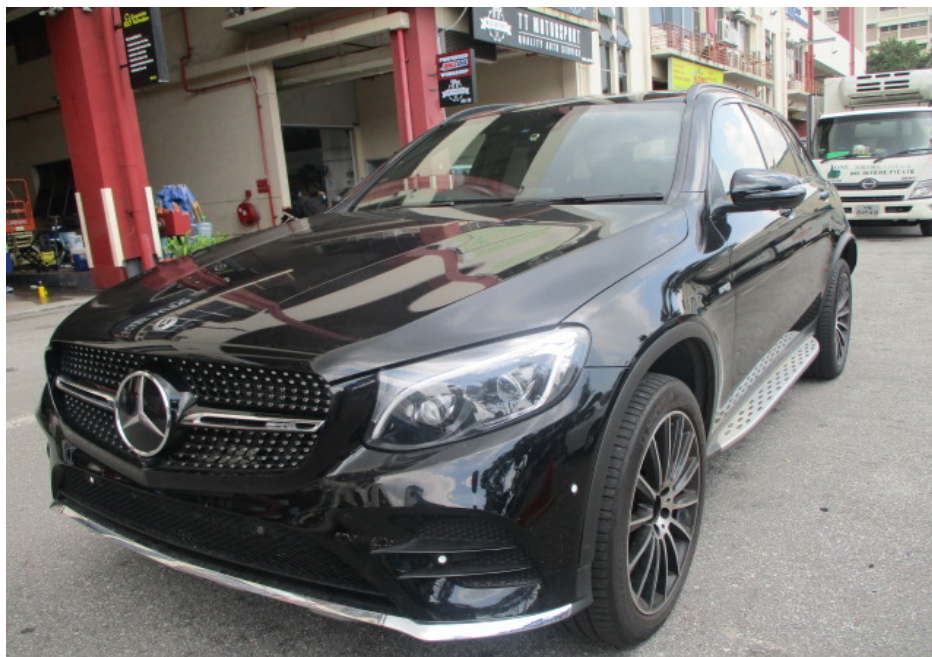
**Photo 7** shows a general view of the front left body of the Motor Car at the time of my inspection. The Motor Car was observed to be in a relatively good general condition with no loose exterior fittings observed. The mileage of the Motor Car recorded at the time of my inspection was 16,253km.

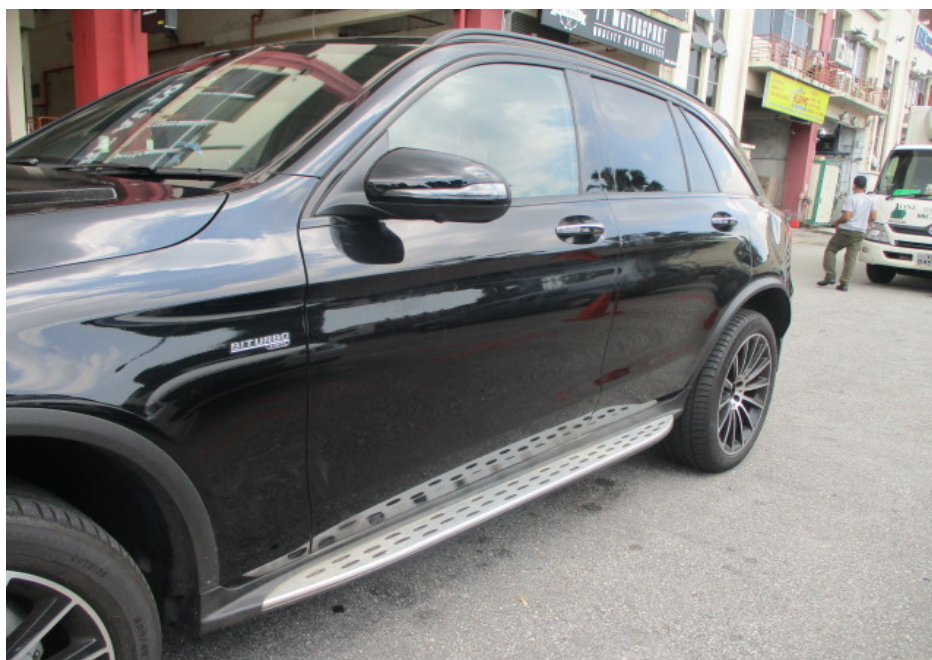
**Photo 8** shows the Motor Car's front left fender, front left passenger door, front left passenger door window and rear left passenger door. The shattered front left passenger door window was observed to be replaced. The repair/restoration works carried out (refer to photograph 2 & 3 above) was reasonably adequate and in order.

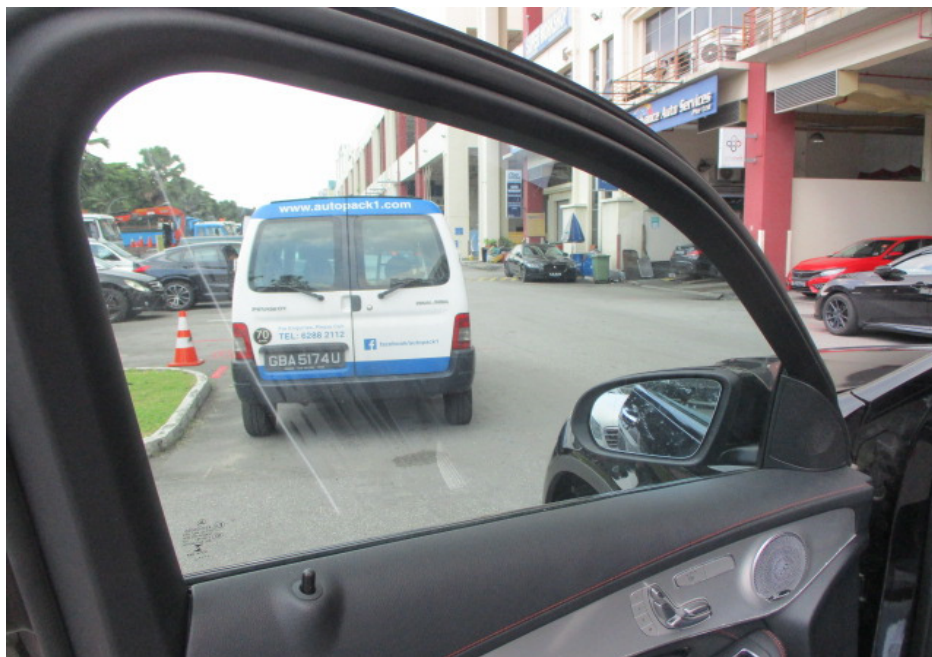
**Photo 9** shows a closer view of the Motor Car's front left passenger door window. The shattered front left passenger door window was observed to be replaced. The repair/restoration works carried out (refer to photograph 2 & 3 above) was reasonably adequate and in order.

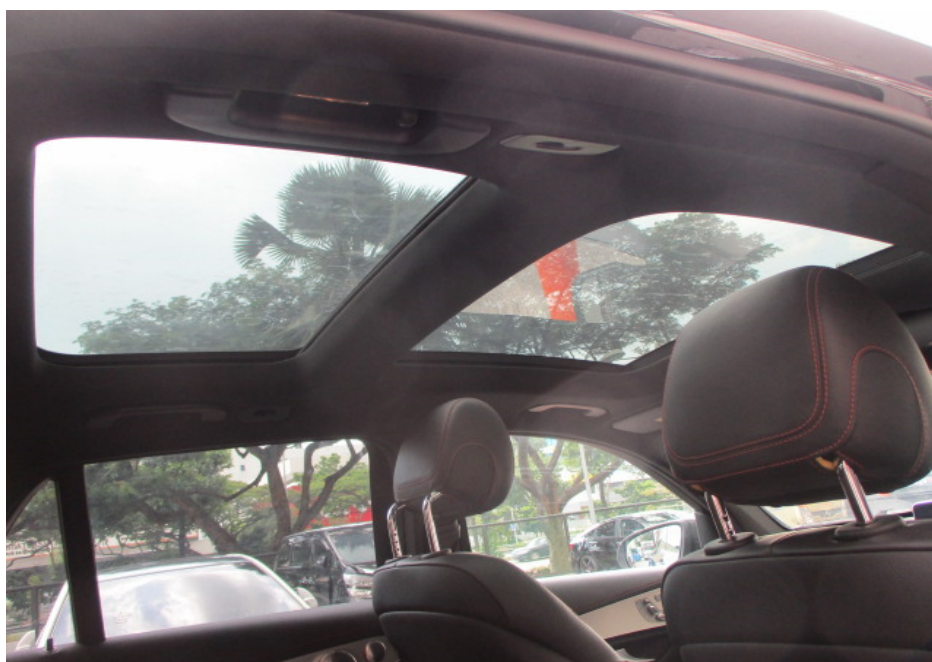
**Photo 10** shows a general view of the Motor Car's panoramic sunroof. In general, the Motor Car was observed to be in a relatively good general condition with no loose exterior fittings observed.

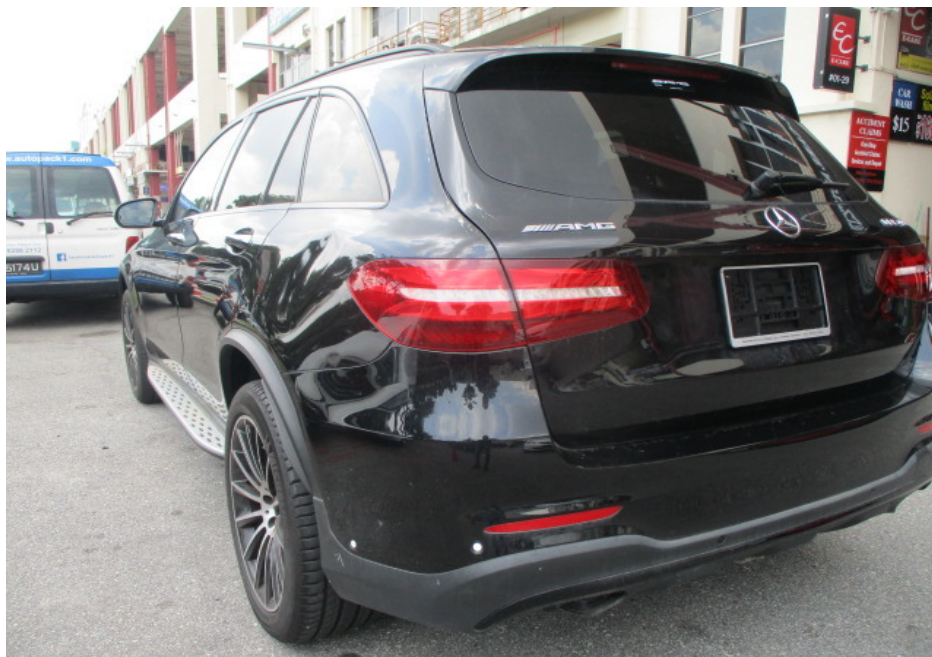
**Photo 11** shows a general view of the rear left body of the Motor Car at the time of my inspection. The Motor Car was observed to be in a relatively good general condition with no loose exterior fittings observed. The mileage of the Motor Car recorded at the time of my inspection was 16,253km.

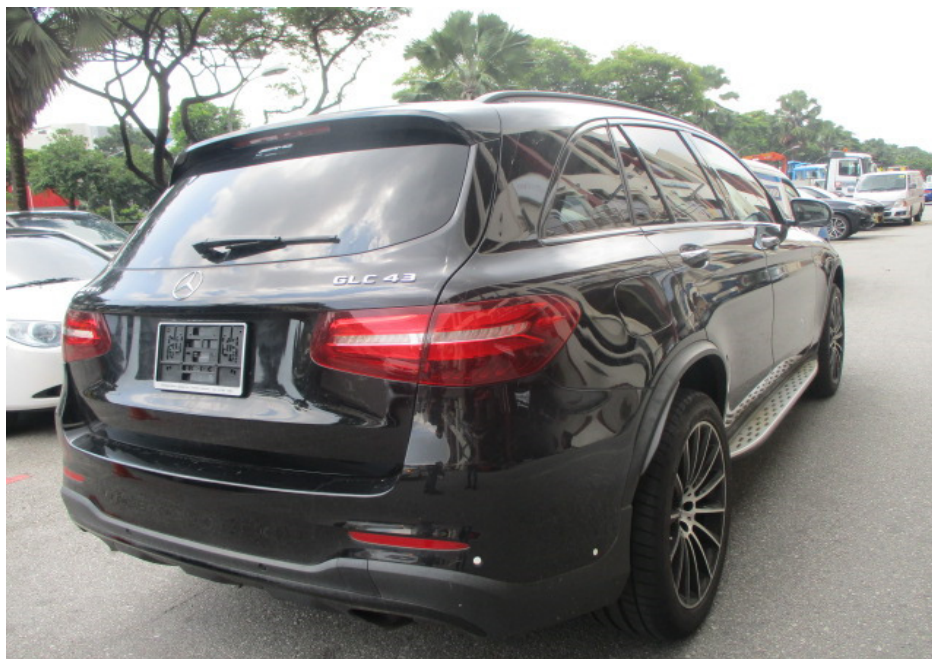
**Photo 12** shows a general view of the rear right body of the Motor Car at the time of my inspection. The Motor Car was observed to be in a relatively good general condition with no loose exterior fittings observed. The mileage of the Motor Car recorded at the time of my inspection was 16,253km.

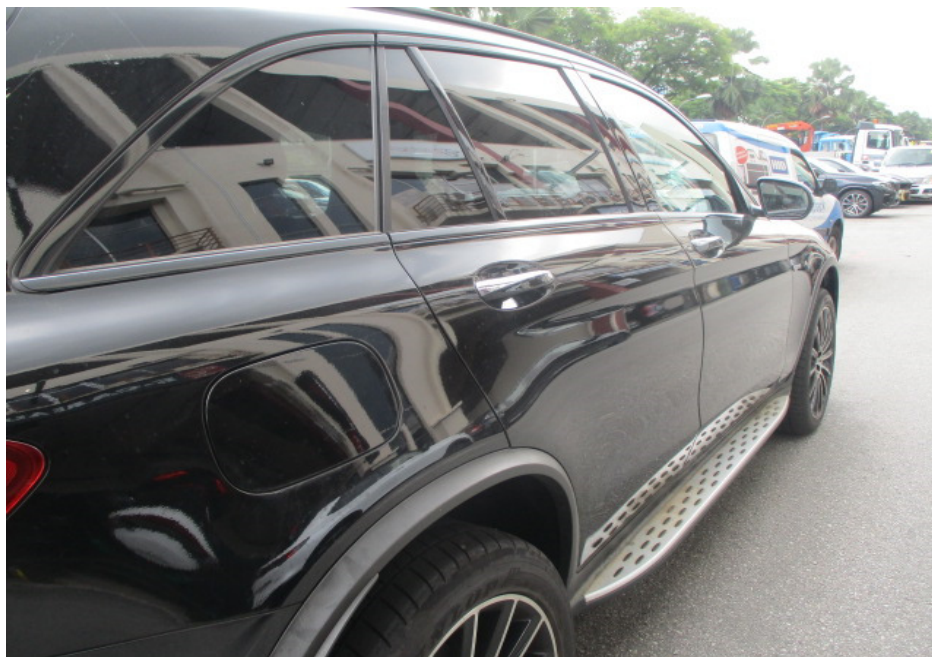
**Photo 13** shows a closer view of the Motor Car's rear right fender and rear right passenger door. In general, the Motor Car was observed to be in a relatively good general condition with no loose exterior fittings observed.

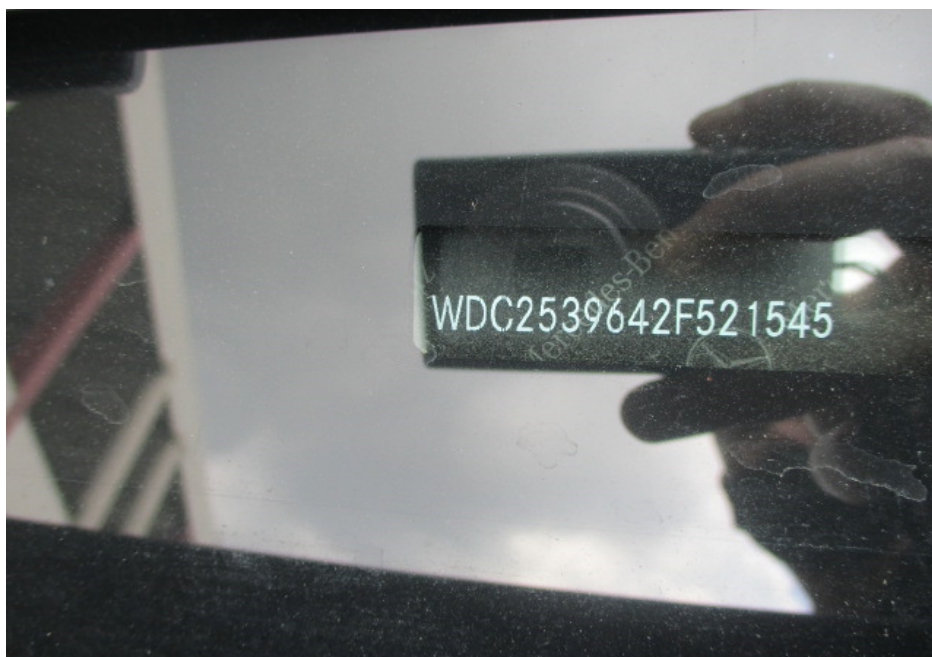
**Photo 14** shows the chassis number of the Motor Car. The chassis number recorded was WDC2539642F521545.

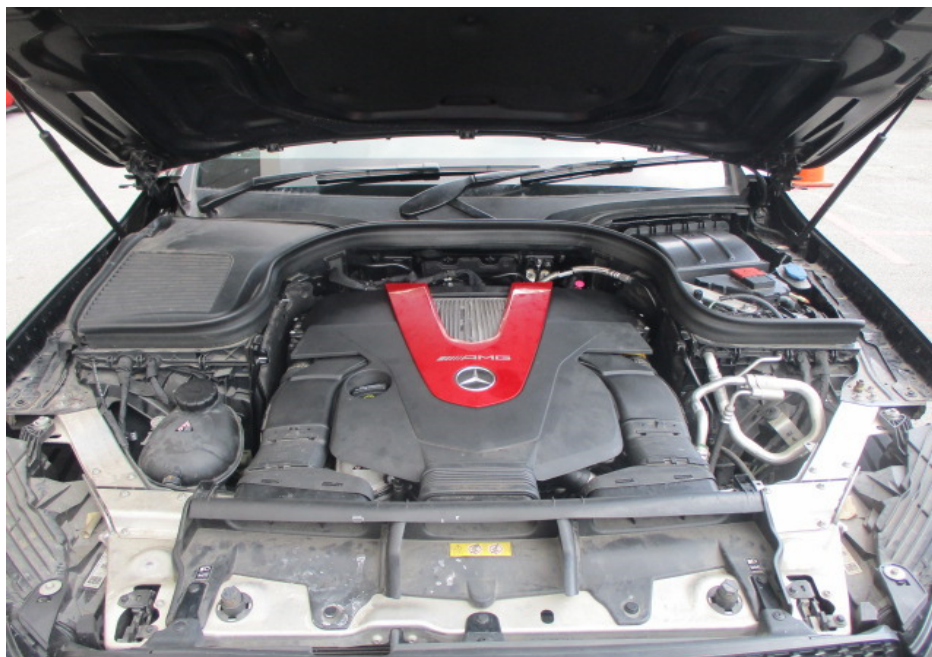
**Photo 15** shows a general view of the engine compartment of the Motor Car at the time of my inspection. The various parts and components inside the engine compartment were all observed to be intact and properly fitted. There was also no sign(s) or indication(s) of fluid leak and/or fluid stain found inside the engine compartment.

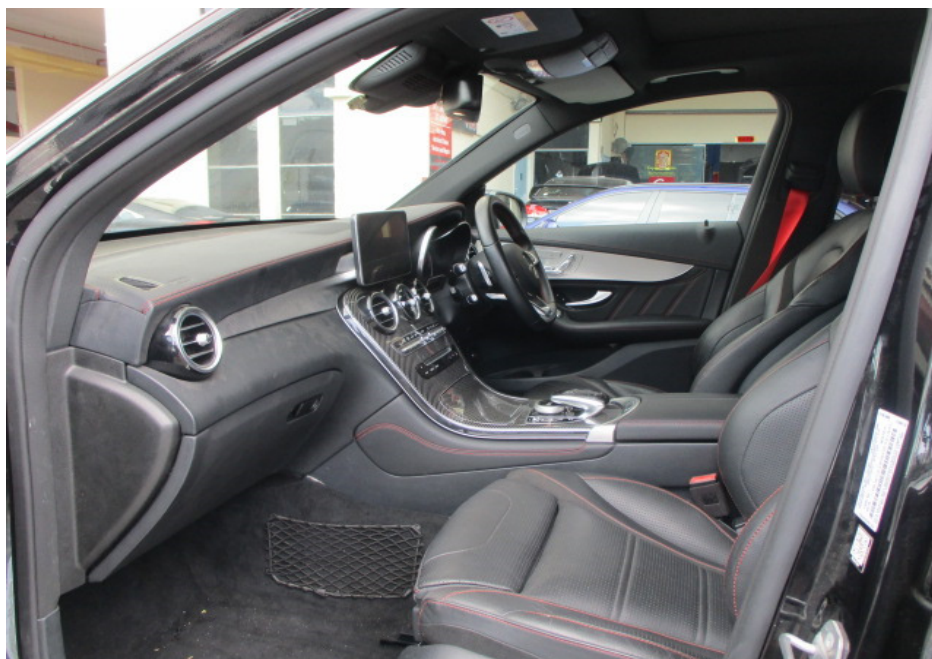
**Photo 16** shows the interior compartment of the Motor Car at the time of my inspection. The various parts and components, trims, carpet and upholstery inside the interior compartment were all observed to be intact and properly fitted.

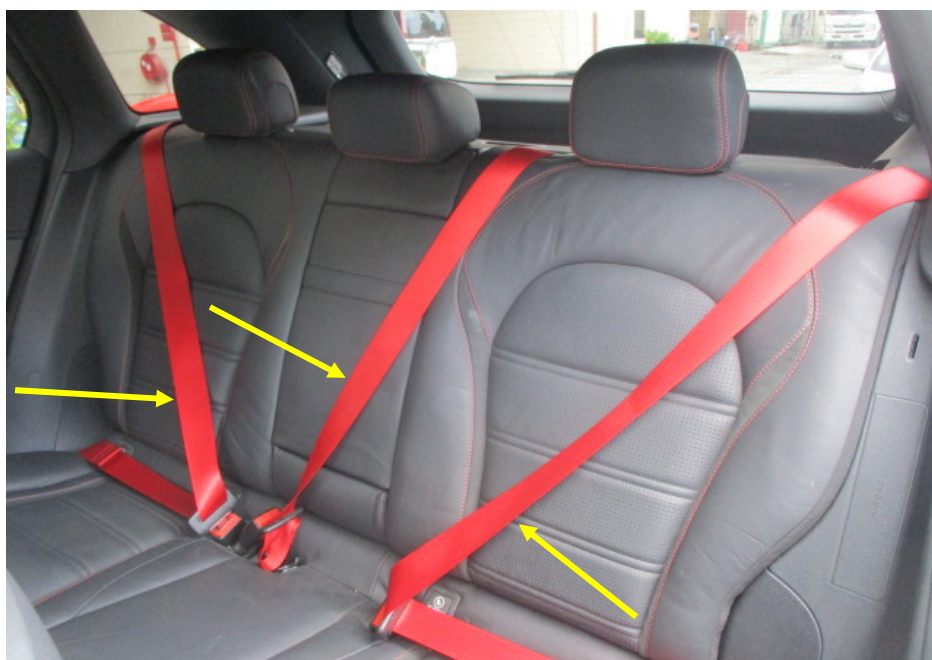
**Photo 17** shows the rear seats of the Motor Car. All the seats of the Motor Car were secured via seat rails to the floorboard. They were also fitted with a retractable seat belt reel and a pre-tensioner. The seat belts (arrowed) were tested and were able to be fastened into the respective pre-tensions that were fitted on the side of each individual seat.

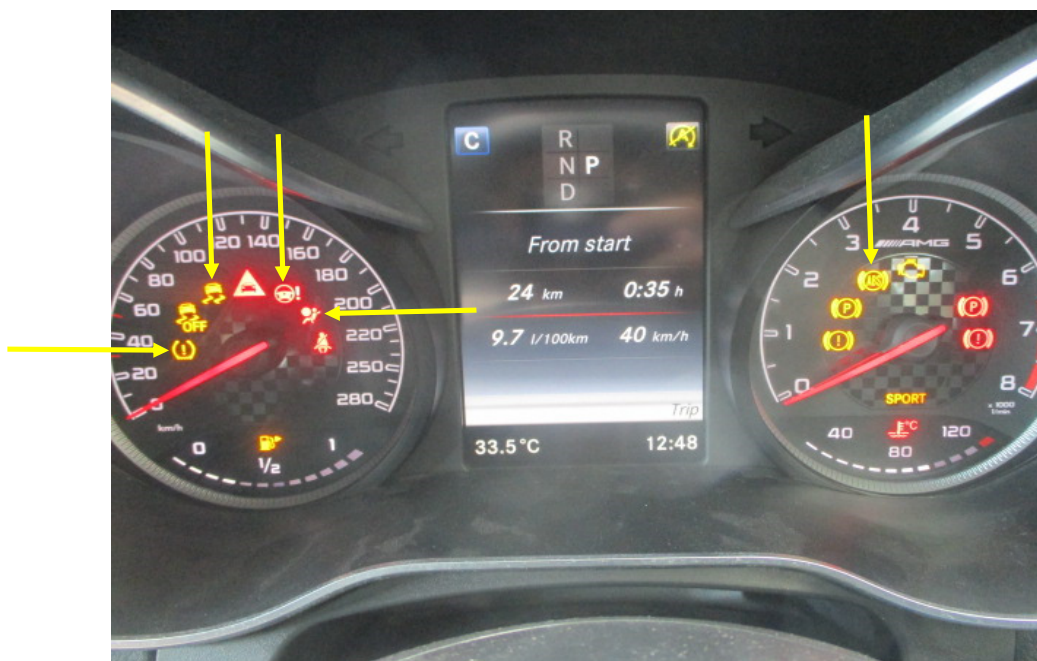
**Photo 18** shows the warning lights for the various electronic safety features appearing on the instrument panel of the Motor Car during its self-test when the engine is cranked, in particular the ABS, SRS, EPS, TPM and TCS lights (arrowed).

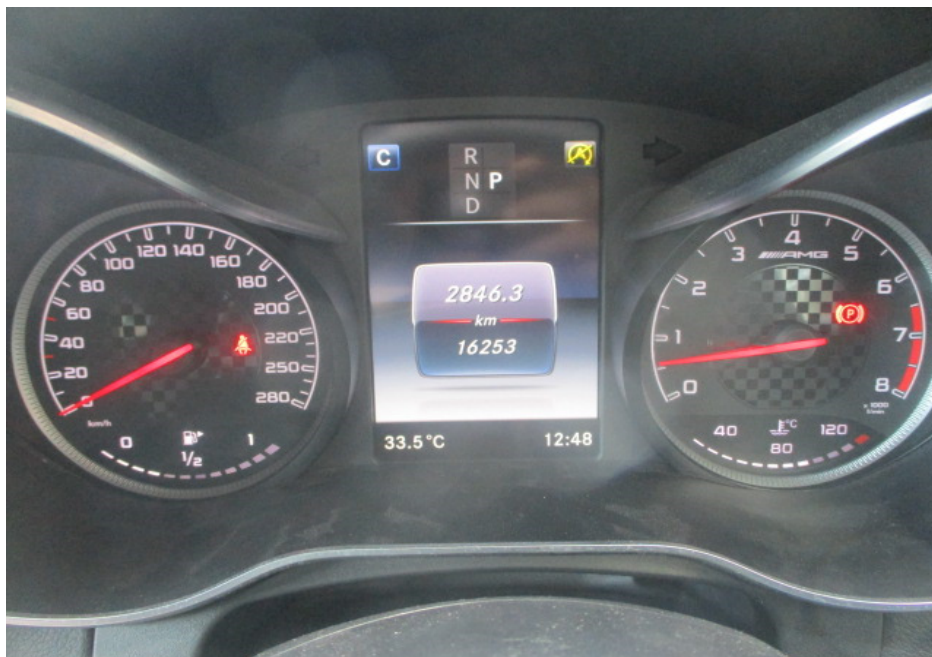
**Photo 19** shows the respective warning lights no longer illuminated, indicating that there is no fault detected to the ABS, SRS, EPS, TPM and TCS systems of the Motor Car during the self-test. These electronic systems were hence in working condition at the time of my inspection.

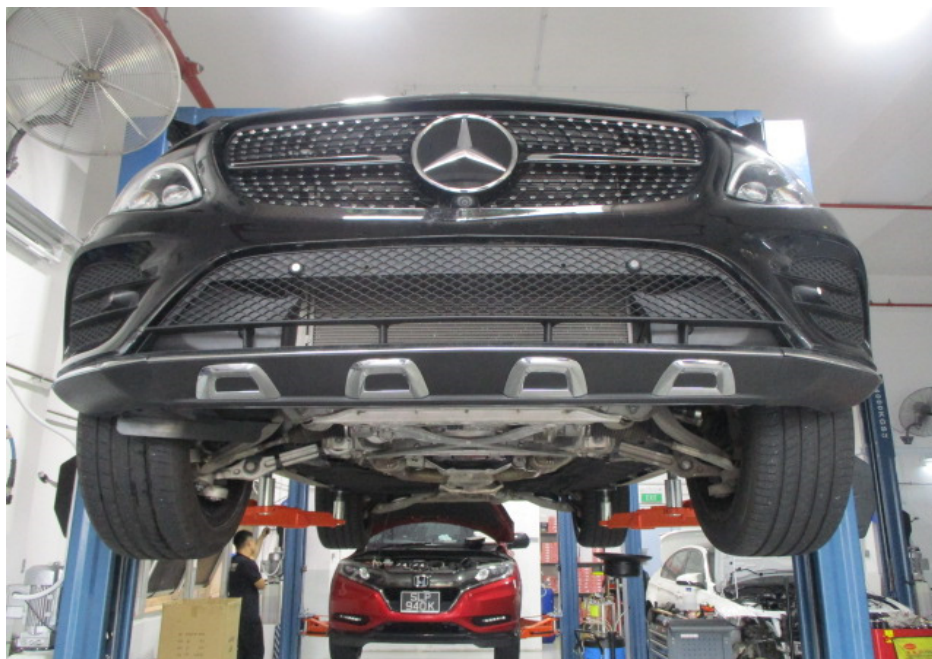
**Photo 20** shows the Motor Car hoisted up for checks on its undercarriage. There was no sign(s) or indication(s) of fluid leakage and/or fluid stain(s) on the underside of the Motor Car. The undercarriage components of the Motor Car were also all observed to be intact and secured in an appropriate manner.

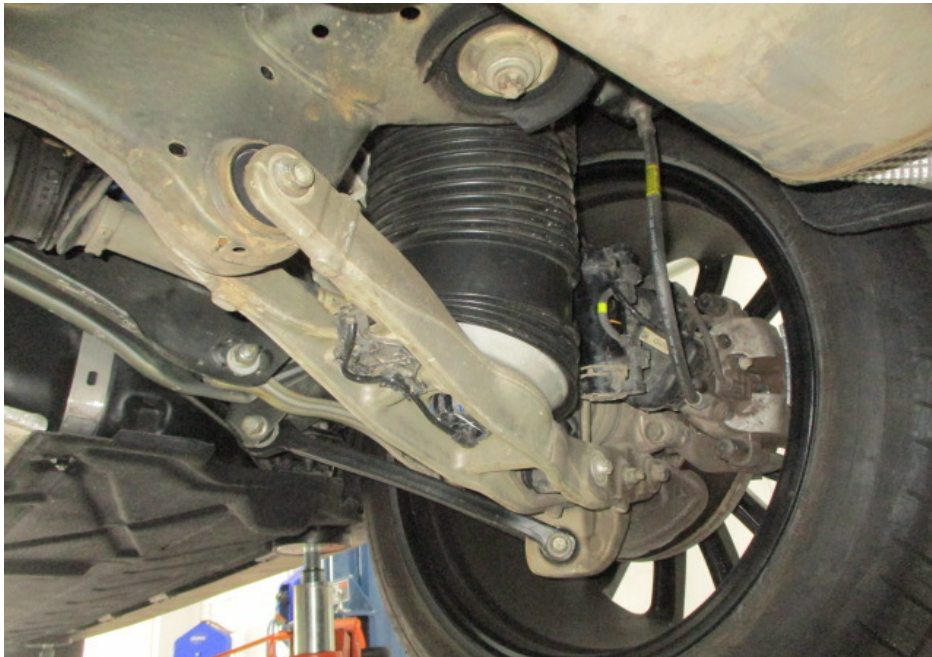
**Photo 21** shows a general view of the control arms and linkages at the rear right wheel of the Motor Car. I did not observe any fluid leak and/or fluid stain on the underside of the Motor Car. All the Motor Car's undercarriage components were observed to be intact and secured in an appropriate manner.

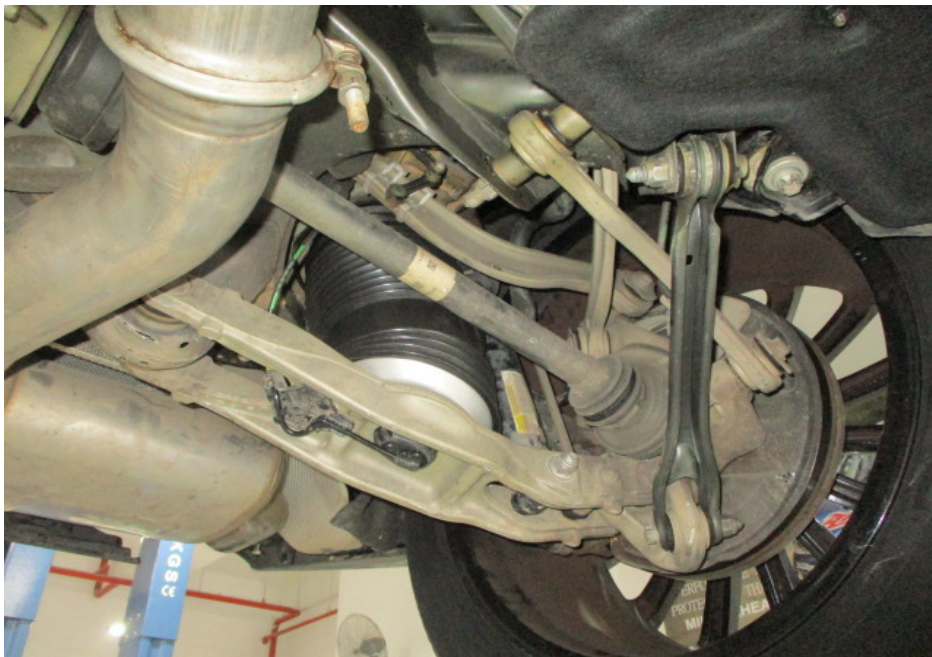
**Photo 22** shows a general view of the control arms and linkages at the rear left wheel of the Motor Car. I did not observe any fluid leak and/or fluid stain on the underside of the Motor Car. All the Motor Car's undercarriage components were observed to be intact and secured in an appropriate manner.

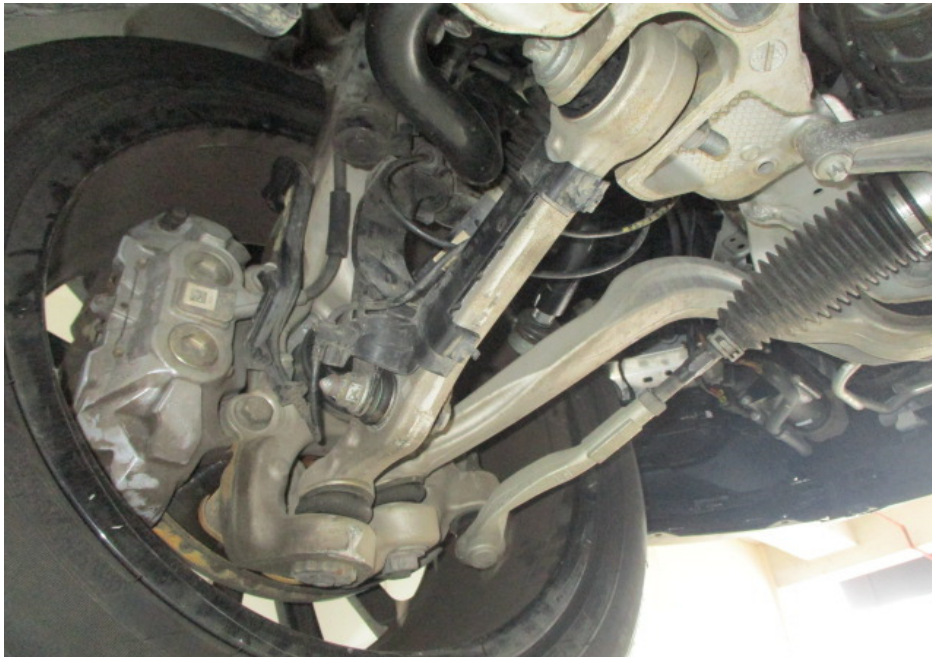
**Photo 23** shows the various undercarriage components at the front left wheel of the Motor Car. The mechanical components, control arms and linkages were all found to be intact and secured in an appropriate manner.

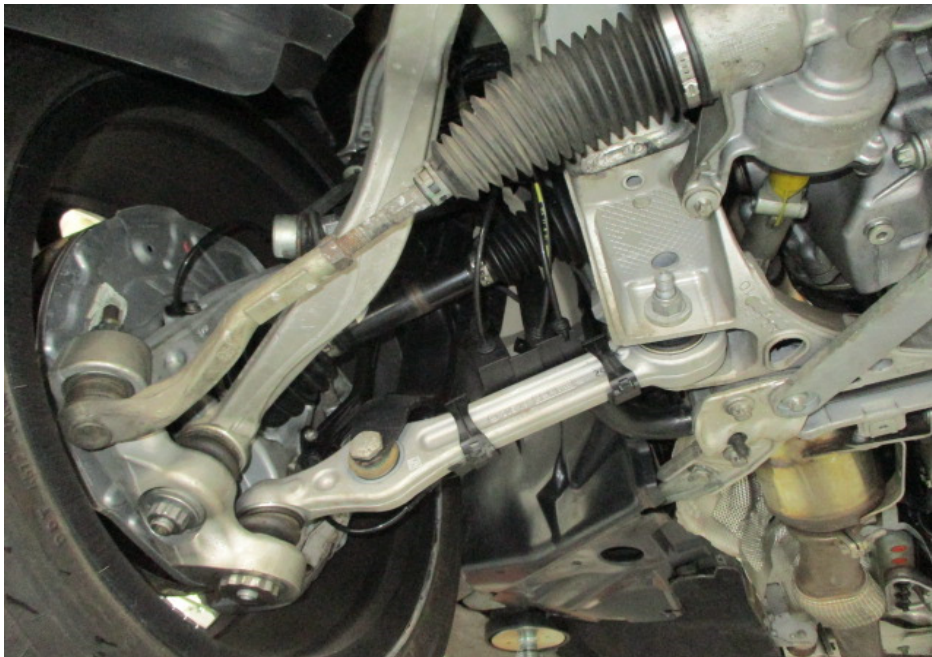
**Photo 24** shows the various undercarriage components at the front right wheel of the Motor Car. The mechanical components, control arms and linkages were all found to be intact and secured in an appropriate manner. I also did not observe any fluid leak and/or fluid stain on the underside of the Motor Car.

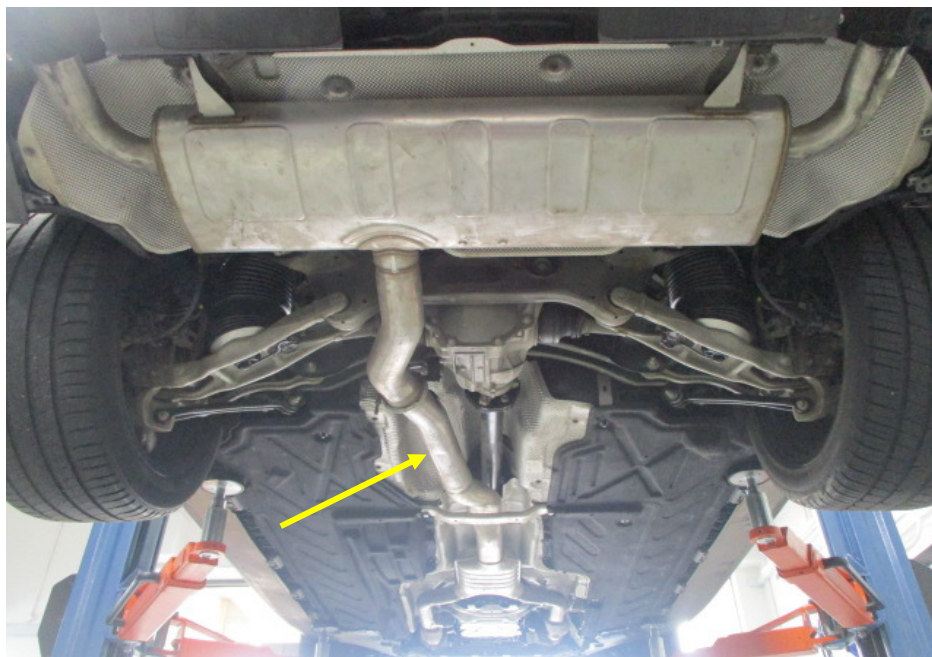
**Photo 25** shows the rear section of the Motor Car's exhaust system. My examination of the Motor Car's exhaust system revealed no sign(s) or indication(s) of any cut or weld marks along its exhaust pipes (arrowed), on its centre resonator boxes, on its rear muffler and on its catalytic converters.

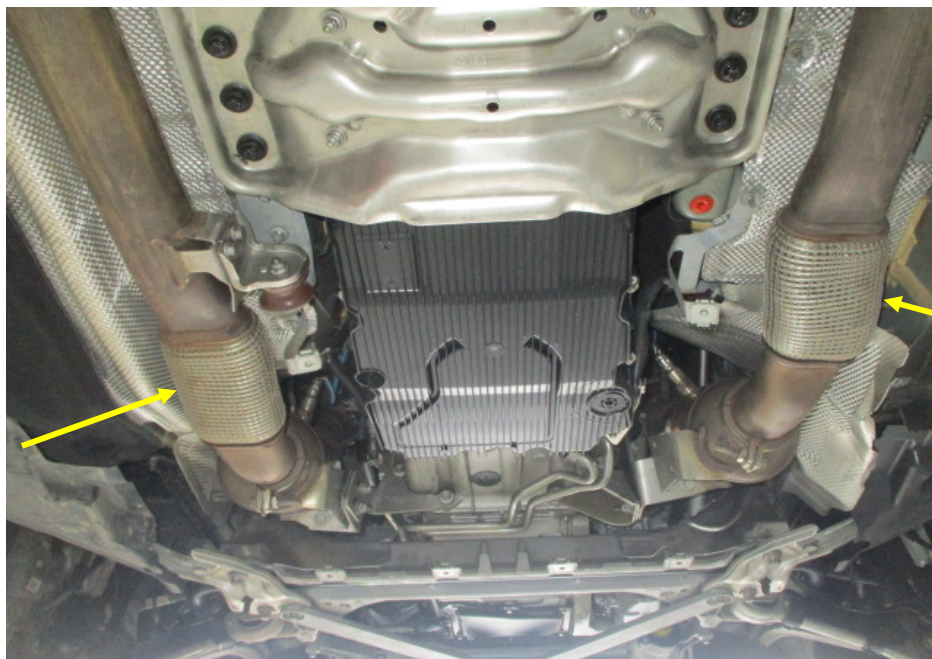
**Photo 26** shows the front section of the Motor Car's exhaust system. My examination of the Motor Car's exhaust system revealed no sign(s) or indication(s) of any cut or weld marks along its exhaust pipes, on its centre resonator boxes, on its rear muffler and on its catalytic converters (arrowed).

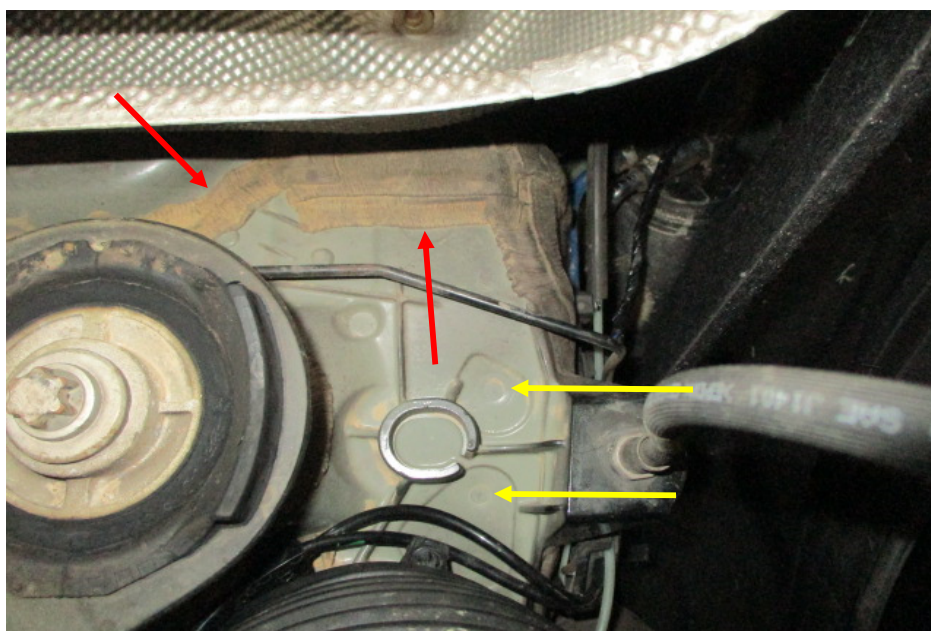
**Photo 27** shows the chassis/structural body at the underside rear right of the Motor Car. I did not find any weld marks other than original spot weld marks (yellow arrow) on the chassis/structural body of the Motor Car. The original factory sealant (red arrow) at the joints along the chassis/structural body was untouched, indicating no work was done on the chassis/structural body of the Motor Car and that the chassis/structural body was originally fitted.

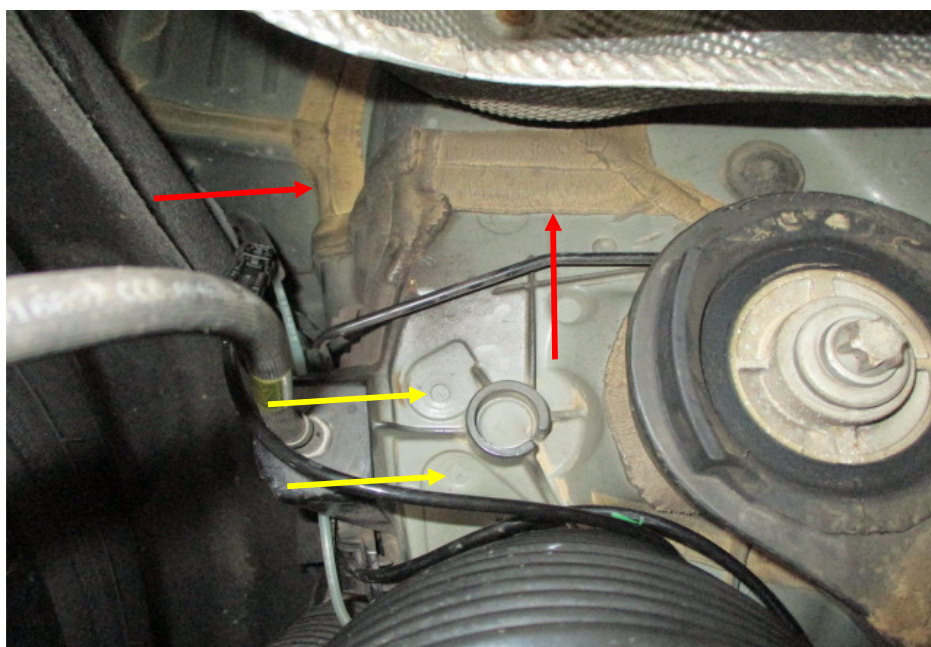
**Photo 28** shows the chassis/structural body at the underside rear left of the Motor Car. I did not find any weld marks other than original spot weld marks (yellow arrow) on the chassis/structural body of the Motor Car. The original factory sealant (red arrow) at the joints along the chassis/structural body was untouched, indicating no work was done on the chassis/structural body of the Motor Car and that the chassis/structural body was originally fitted.

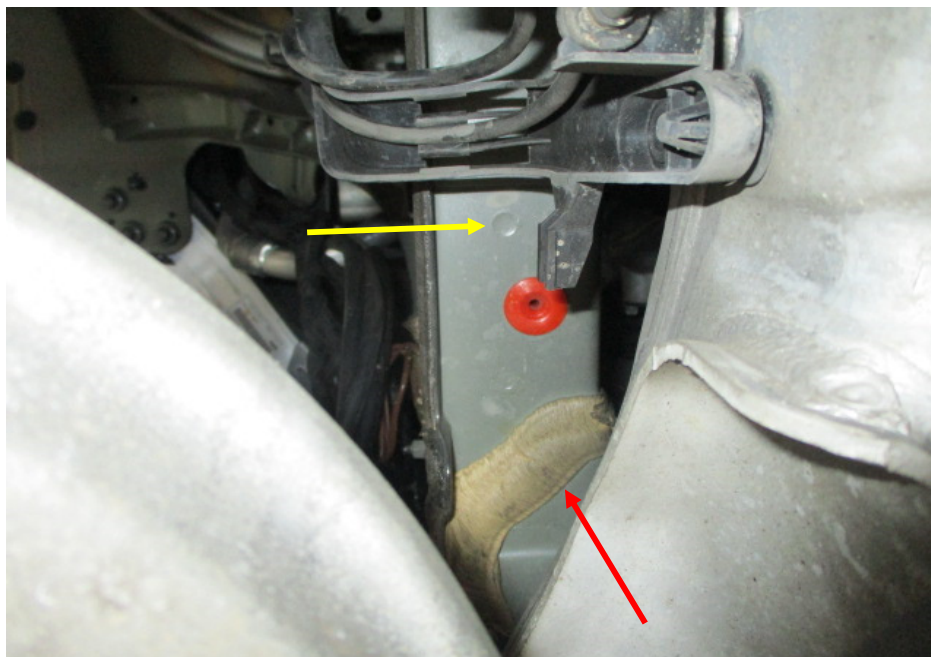
**Photo 29** shows the chassis/structural body at the underside front left of the Motor Car. I did not find any weld marks other than original spot weld marks (yellow arrow) on the chassis/structural body of the Motor Car. The original factory sealant (red arrow) at the joints along the chassis/structural body was untouched, indicating no work was done on the chassis/structural body of the Motor Car and that the chassis/structural body was originally fitted.

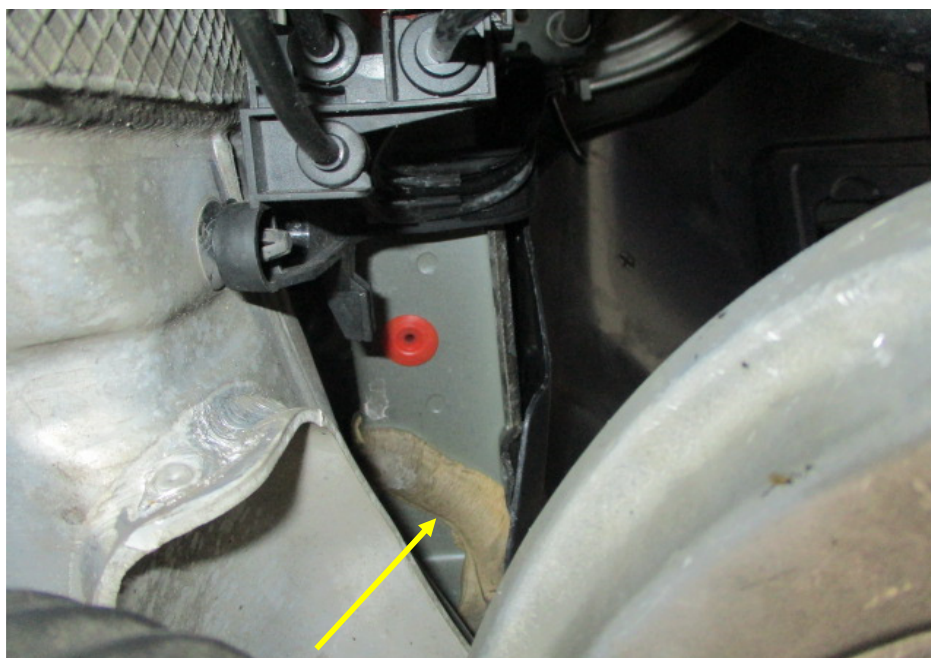
**Photo 30** shows the chassis/structural body at the underside front right of the Motor Car. The original factory sealant (arrowed) at the joints along the chassis/structural body was observed to be untouched. In general, I had found no work was carried out on the chassis/structural body of the Motor Car. The chassis/structural body of the Motor Car was originally fitted.
