Your Ref: Mercedes Benz GLC 43  
(chassis number WDC2539642F521545)  
Our Ref : CI/TP21010995/D

27 October 2021

**INSPECTION REPORT OF AN UNREGISTERED MERCEDES BENZ GLC 43  
MOTOR CAR WITH CHASSIS NUMBER WDC2539642F521545**

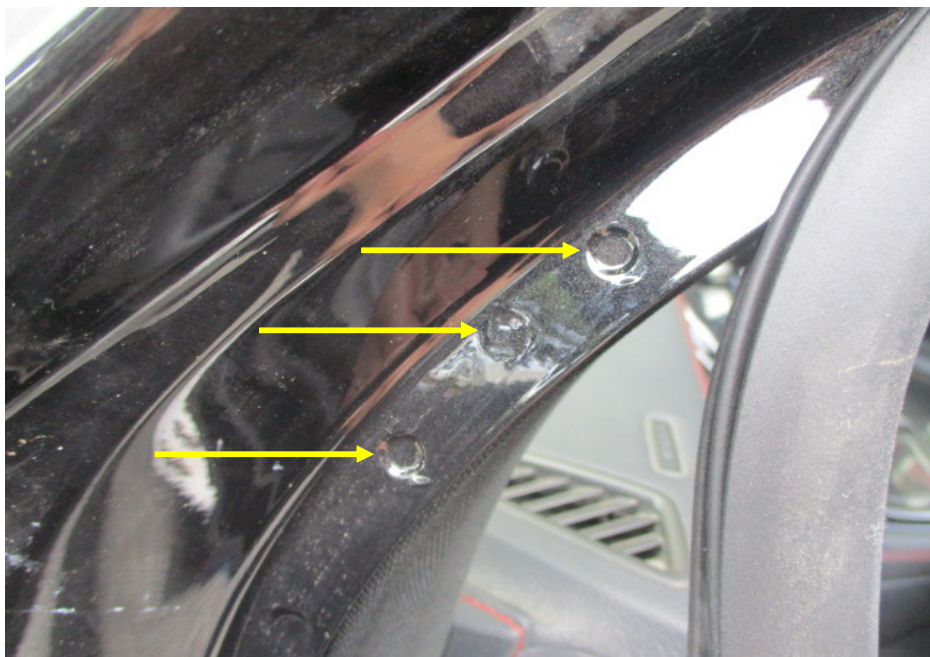
**Photo 31** shows the left side "A" pillar of the Motor Car. I did not find any weld marks other than original spot weld marks (arrowed) on the left side "A" pillar of the Motor Car which, indicates that there was no re-welding works carried out. In general, I had found all the non-detachable body panels of the Motor Car to be originally fitted at the time of my inspection.

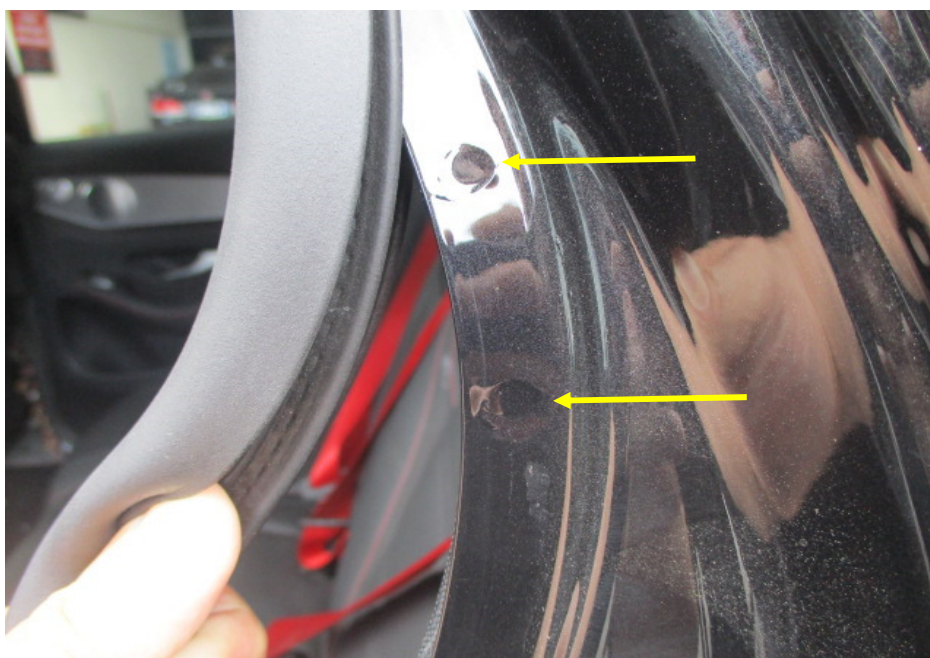
**Photo 32** shows the left side "C" pillar of the Motor Car. I did not find any weld marks other than original spot weld marks (arrowed) on the left side "C" pillar of the Motor Car which, indicates that there was no re-welding works carried out. In general, I had found all the non-detachable body panels of the Motor Car to be originally fitted at the time of my inspection.

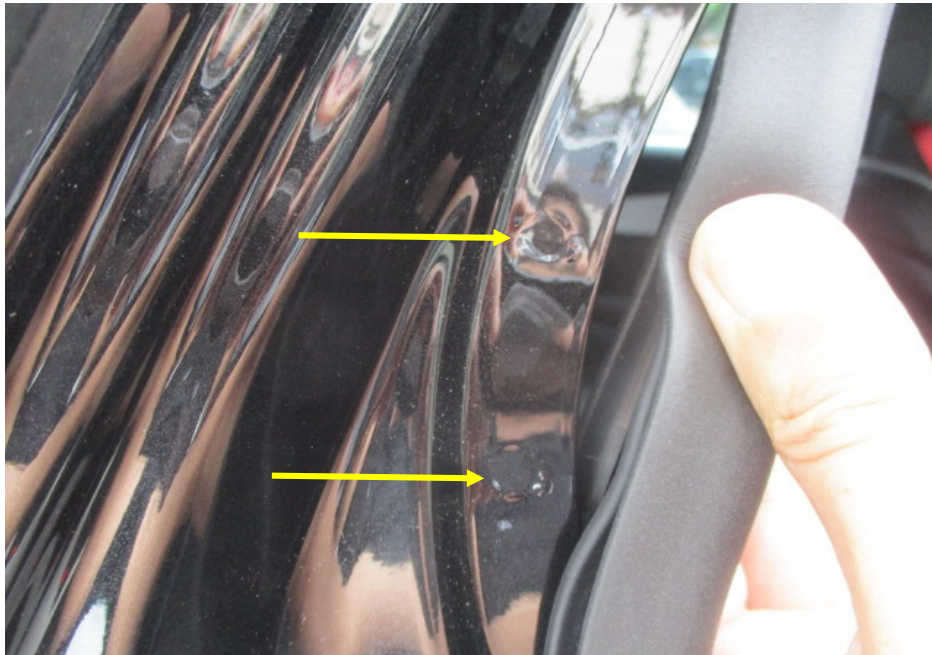
**Photo 33** shows the right side "C" pillar of the Motor Car. I did not find any weld marks other than original spot weld marks (arrowed) on the right side "C" pillar of the Motor Car which, indicates that there was no re-welding works carried out. In general, I had found all the non-detachable body panels of the Motor Car to be originally fitted at the time of my inspection.
