### REFERENCES

| Third party vehicle | : SLK5282U | Date of Accident | : 2/9/2020 |

| Model / Make | : Honda Odyssey | Pre-accident damage | : NIL |

## DESCRIPTION OF DAMAGE

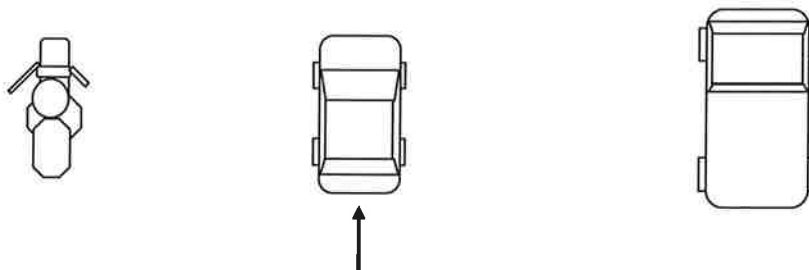
At the time of inspection, this vehicle sustained damages to the **Rear portion**.

Rear bumper, tailgate, rear both fender, rear end panel, spare tyre panel dented. Taillamp broken, rear windscreen shattered

We have not authorised repair. Under normal circumstances, estimated **18** working days are required to repair the vehicle.
