**TECHNICAL INVESTIGATION REPORT OF WARRANTY CLAIM INVOLVING
THE INSURED VEHICLE SMW 6664U ON 21th OCTOBER 2021**

Vehicle Registration No.	: SMW 6664U
Make / Model	: TOYOTA RAIZE 1.0 XS CVT
Chassis No	: A200A0021400
Year of Registration	: DEC 2020
Mileage	: 24,533KM

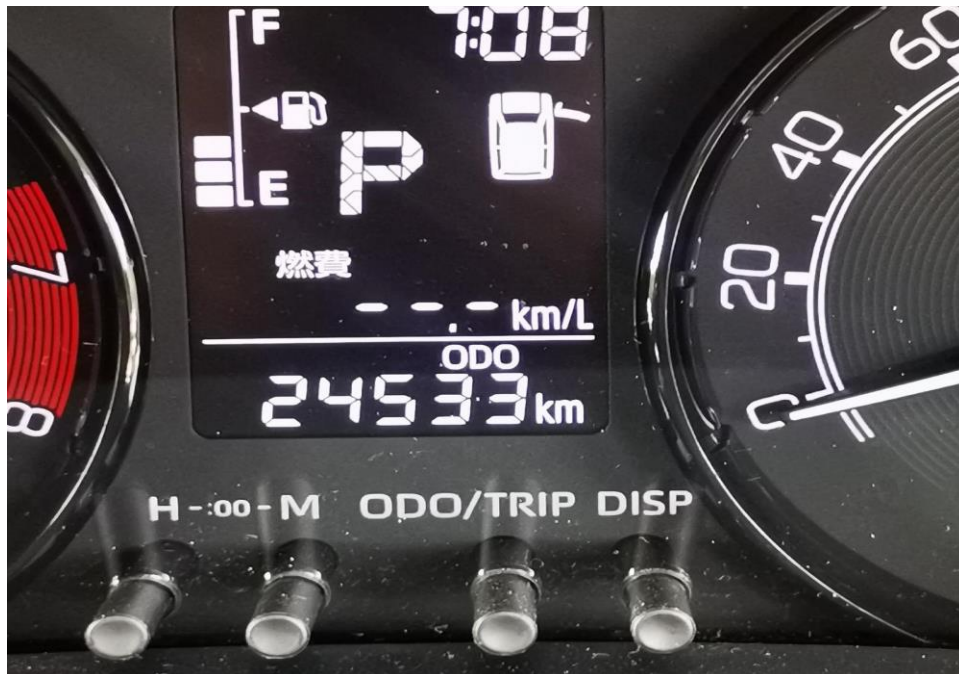
Photo 1 shows the mileage of the Insured Vehicle recorded at the time inspection at 24,533KM

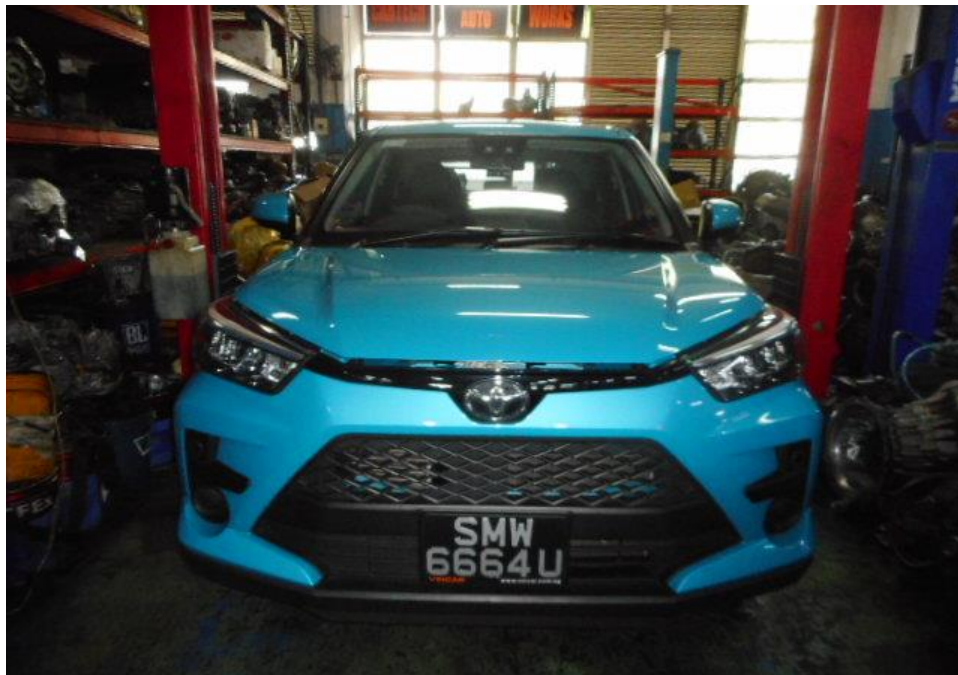
Photo 2 shows the general view of the front portion of the Insured Vehicle at the time of our inspection. The Insured Vehicle is observed to be unaffected by any signs of accident.

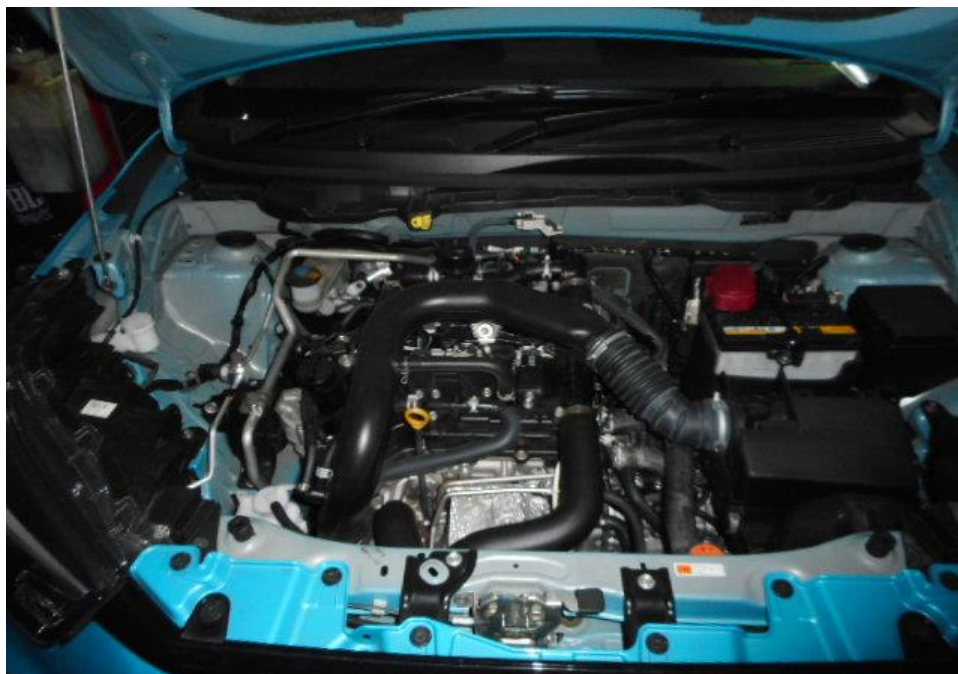
Photo 3 shows the general view of the engine portion of the Insured Vehicle at the time of our inspection. The engine compartment is observed to be unaffected by any signs of accident.

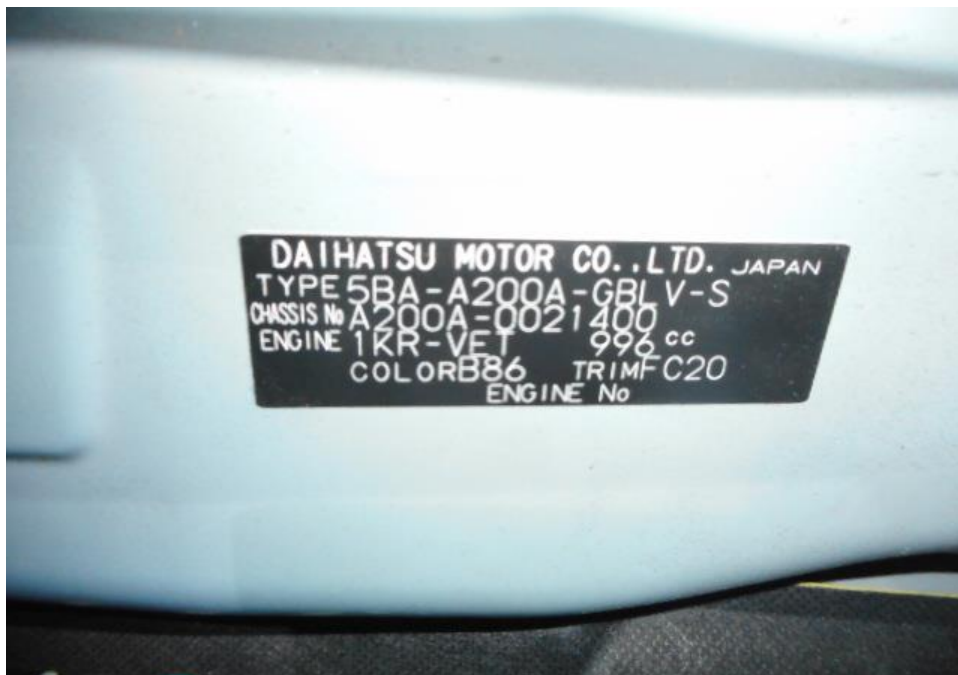
Photo 4 shows the chassis number of the Insured Vehicle at the time of our inspection.

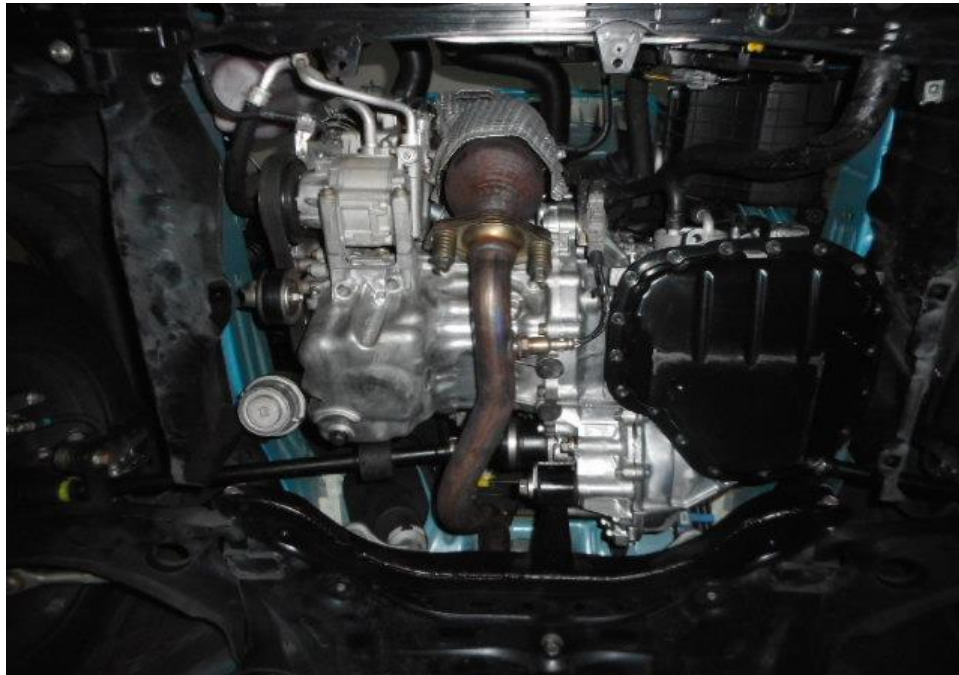
Photo 5 shows the general view of the engine underside portion of the Insured Vehicle at the time of our inspection. The engine underside compartment is observed to be unaffected and by any signs of accident.

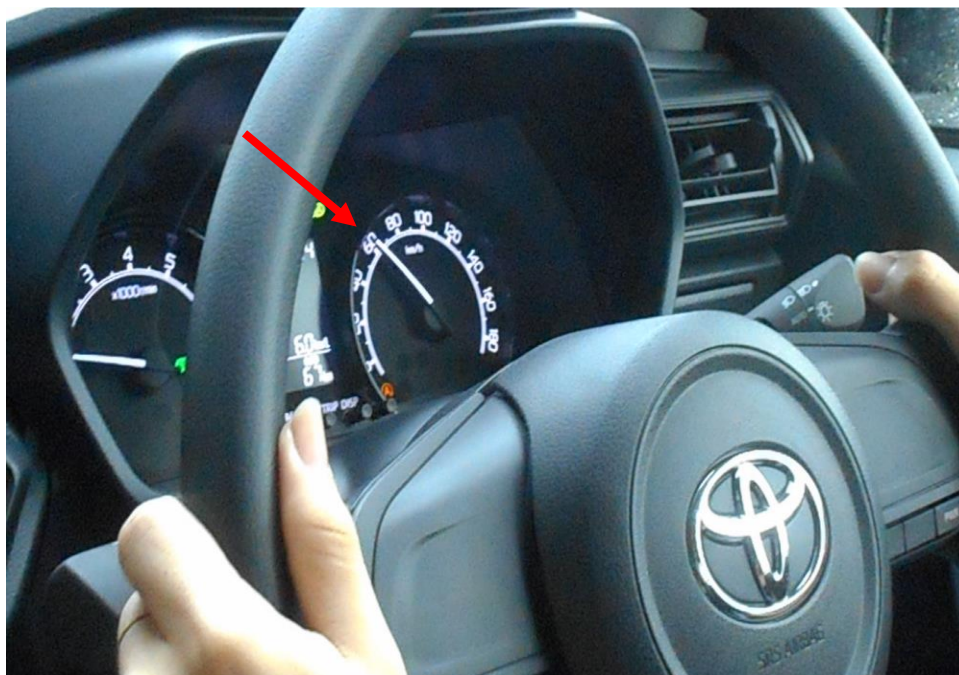
5. The complaint on the Insured Vehicle was noted be to Whistling noise from gearbox above 60kmph and there a recommendation by the workshop to replace the CVT automatic transmission unit. The vehicle was observed to be unaffected by any signs of accident.
6. Prior to our inspection, the workshop had informed us that they had already conducted replacements of the components in the CVT transmission unit. However, the issue was still present during our inspection of the Insured Vehicle See photos 1 – 8 below.

Photo 6 shows the conducted test drive of the Insured Vehicle at the time of our inspection. The said whistling noise was heard at moving speed of 60km/h (arrowed) above.

8. We did not find any evidence which had suggested that the cause of abnormalities to the Insured Vehicle was due to poor maintenance and/or recurring problem.
9. The recommendation to replace the CVT transmission unit is justifiable as all the relevant checks has been conducted.

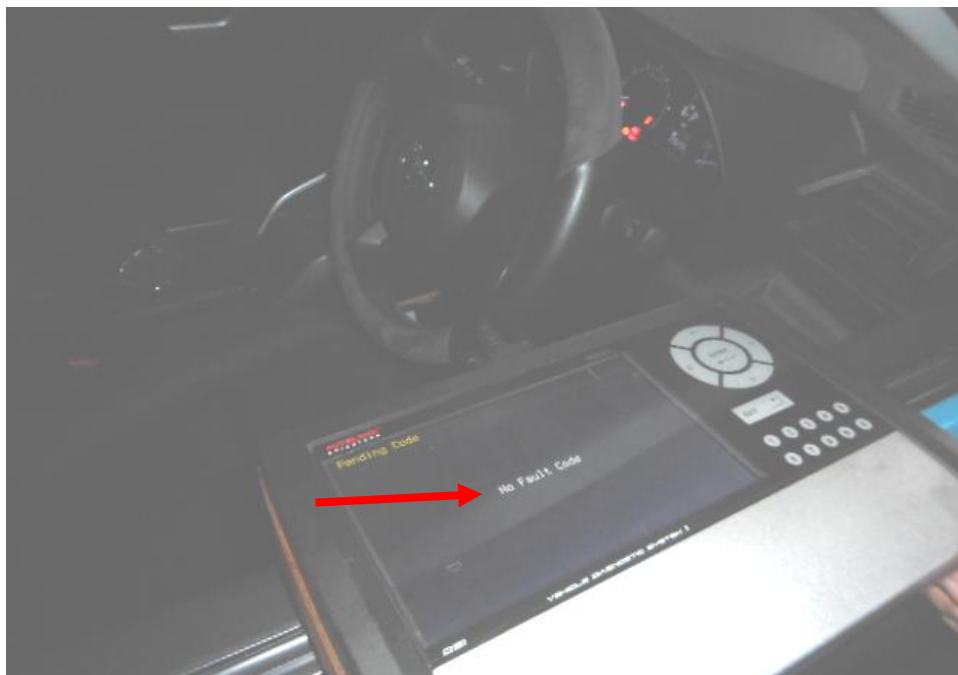
Photo 7 shows the conducted ECU diagnosis of the Insured Vehicle at the time of our inspection. There was no electronic error on the Insured Vehicle (arrowed).
