Your Ref: TP/IP/41065/2021  
Our Ref : CI/TPD21011271/P

**General Investigation Team**

**MECHANICAL INSPECTION REPORT OF MOTOR TAXI SH 7598D**

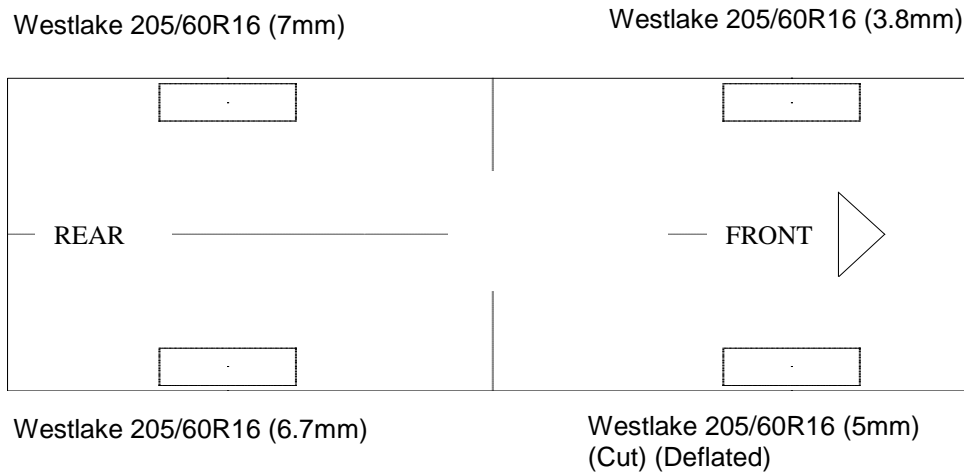
6. The condition of the Motor Taxi's front right tyre was observed to be cut and deflated as a result of the accident. However, the other 3 tyres was observed to be in serviceable condition. I did not find any tear, cut or burst mark(s) on the outer and the inner sidewalls as well as across the tread of the 3 tyres. The 3 tyres were also observed to be sufficiently inflated for vehicular operation. The tyre brand, tyre size and remaining tread depth of the 4 tyres were recorded as follows:-

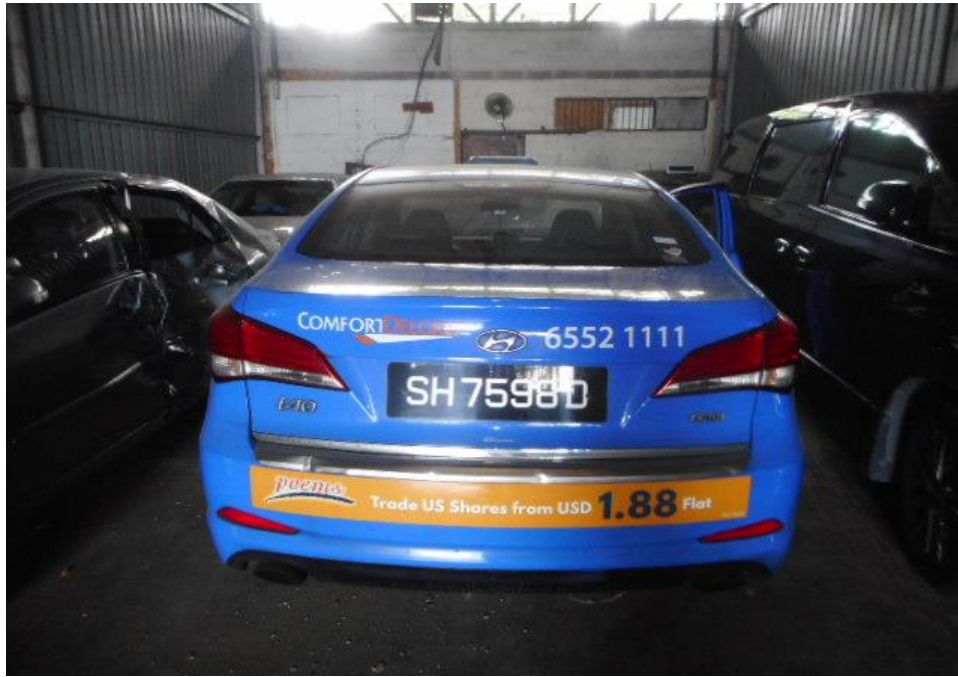
**Photo 1** shows the general view of the Motor Taxi's rear body at the time of my inspection. The rear portion of the Motor Taxi was observed to have been unaffected by the accident.

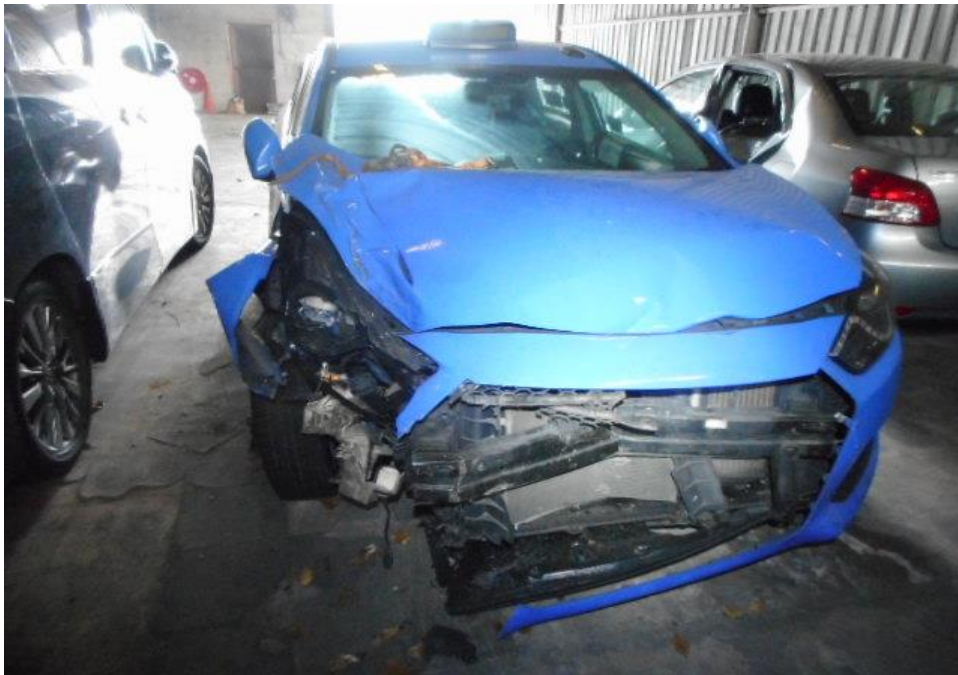
4. The mileage of the Motor Taxi was not recorded as the access to the battery to jumpstart the Motor Taxi was block due to the result of the accident.
5. The Motor Taxi was observed to have sustained damage at its front portion. Its front bonnet, front bumper, front reinforcement panel, front right headlamp and front right fender were amongst the body parts that were damaged as a result of the accident. The Supplemental Restraint System (SRS) was activated as a result of the accident.

**Photo 2** shows a general view of the Motor Taxi's front body at the time of my inspection. The Motor Taxi was observed to have sustained damage at its front portion. Its front bonnet, front bumper, front reinforcement panel, front right headlamp and front right fender were amongst the body parts that were damaged as a result of the accident. The Supplemental Restraint System (SRS) was activated as a result of the accident.

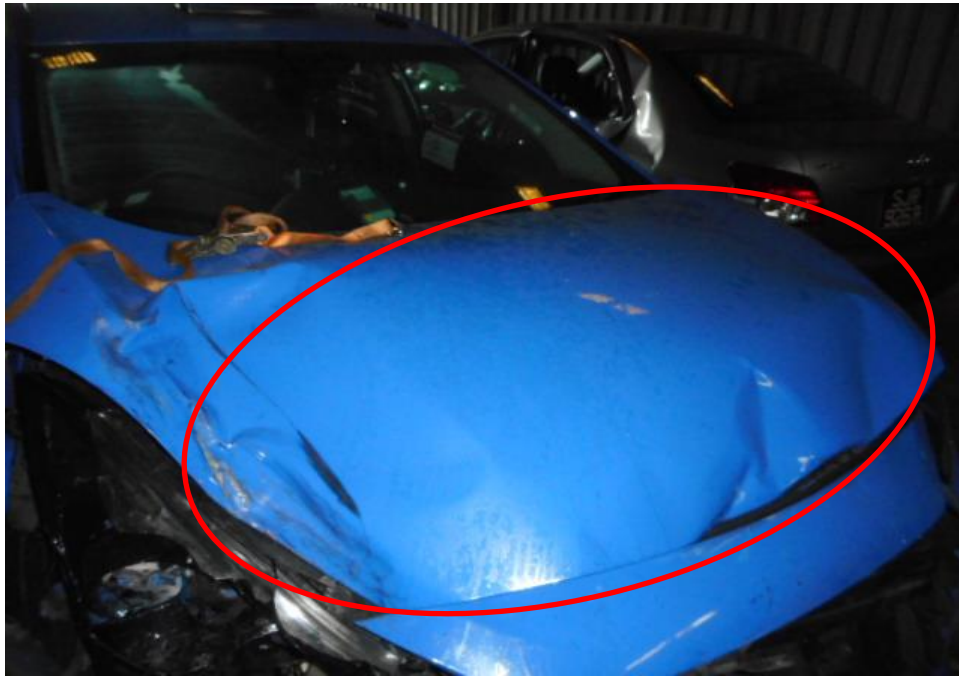
**Photo 3** shows the close up view of the Motor Taxi's front body at the time of my inspection. The Motor Taxi was observed to have sustained damage at its front portion. Its front bonnet (circled) were amongst the body parts that were damaged as a result of the accident.

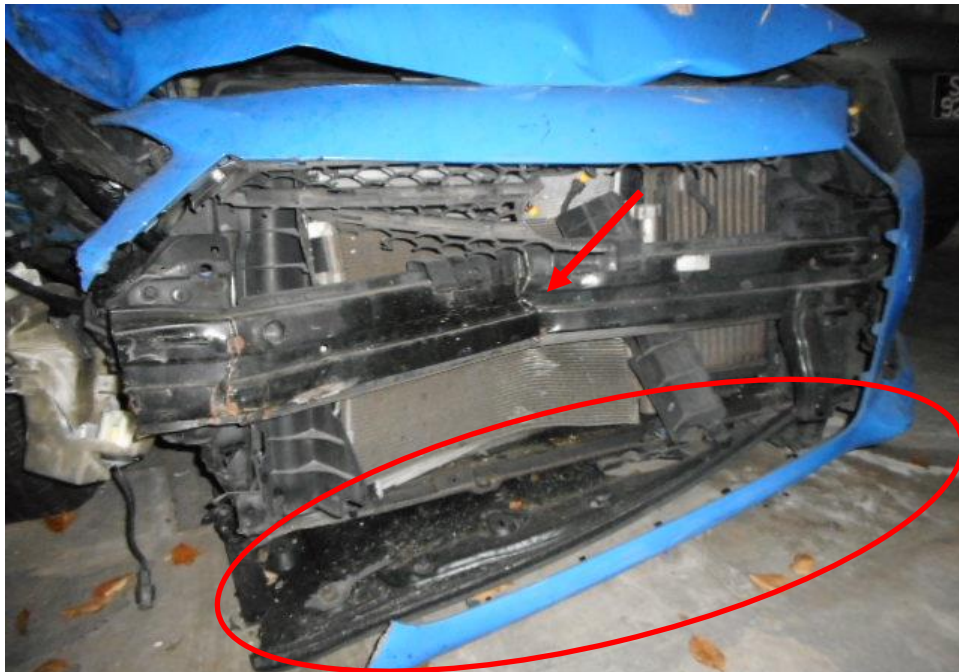
**Photo 4** shows the close up view of the Motor Taxi's front body at the time of my inspection. The Motor Taxi was observed to have sustained damage at its front portion. Its front bumper (circled) and front reinforcement panel (arrowed) were amongst the body parts that were damaged as a result of the accident.

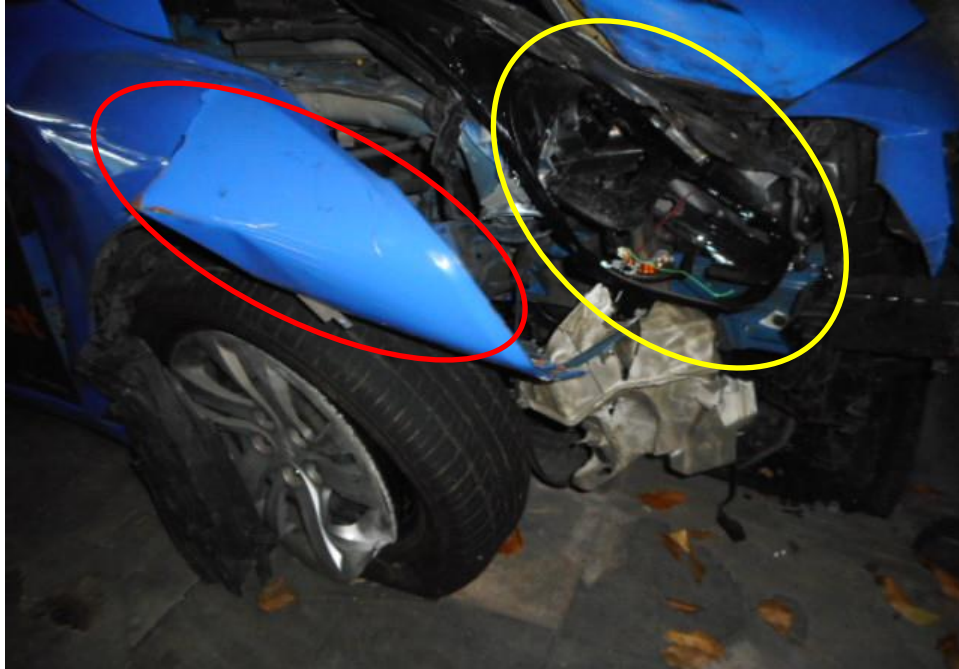
**Photo 5** shows the close up view of the Motor Taxi's front body at the time of my inspection. The Motor Taxi was observed to have sustained damage at its front portion. Its front right fender (red circle) and front left headlamp (yellow circle) were amongst the body parts that were damaged as a result of the accident.

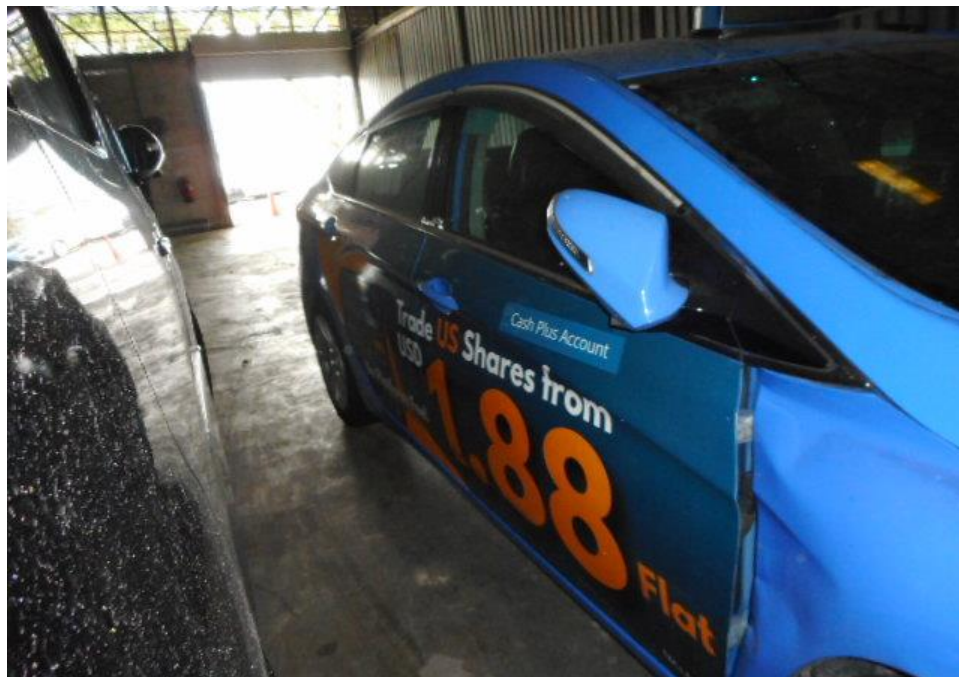
**Photo 6** shows the general view of the Motor Taxi's right body at the time of my inspection. The right portion of the Motor Taxi was observed to have been unaffected by the accident.

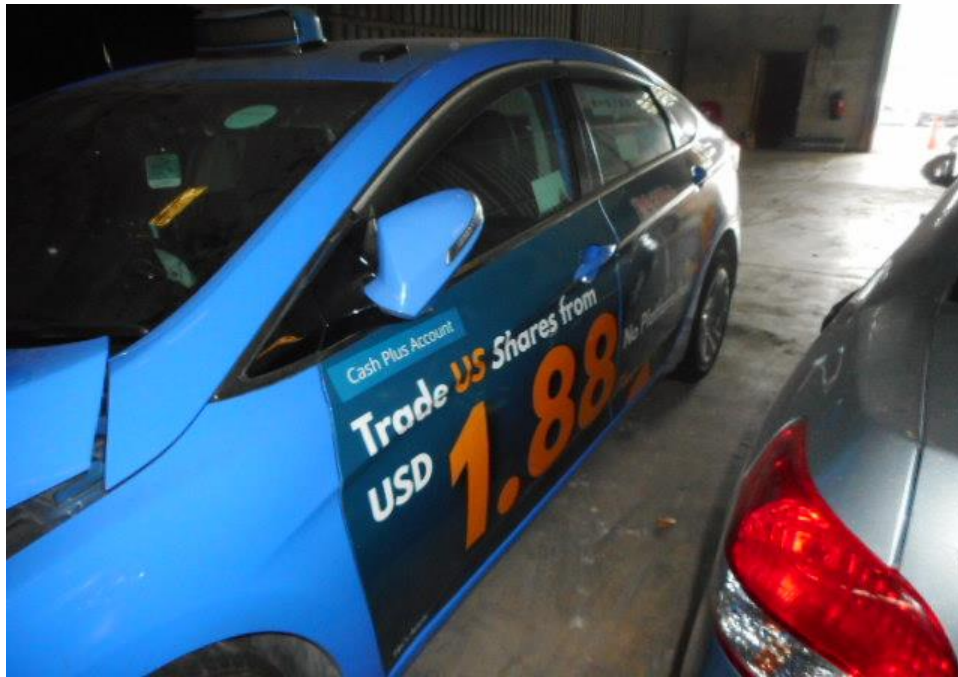
**Photo 7** shows a general view of the Motor Taxi's left body at the time of my inspection. The left portion of the Motor Taxi was observed to have been unaffected by the accident.

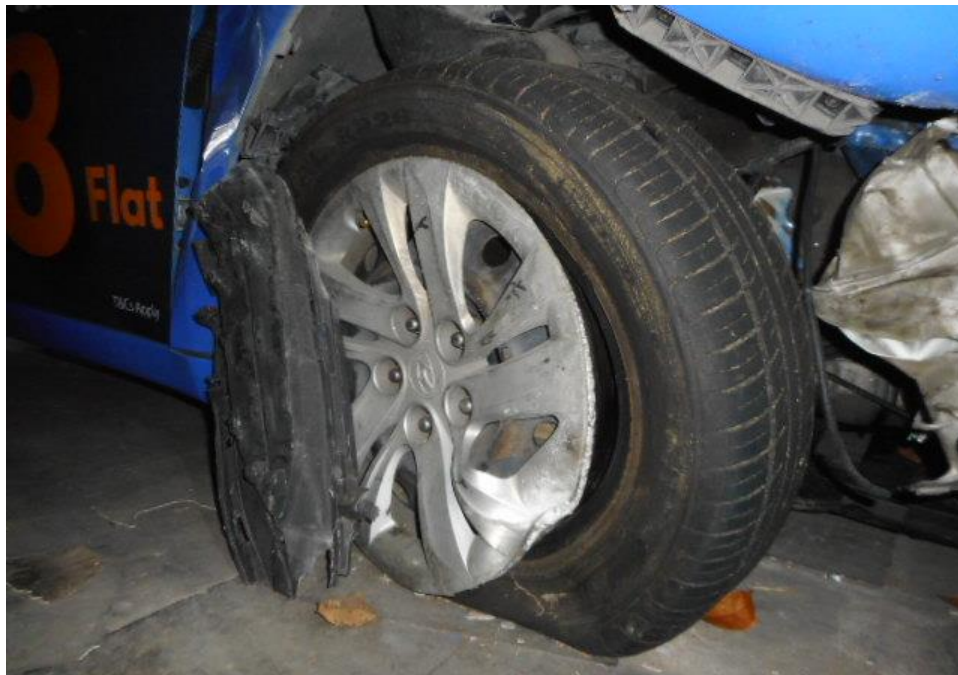
7. The front right tyre and rims was observed to be damaged as a result of the accident. However the other 3 tyres were observed to be wrapped around standard steel wheel rims that were found to be damage as a result of the accident. See photo 1 – 13 below.

**Photo 8** shows the condition of the front right tyre of the Motor Taxi, which was observed to be unserviceable condition with remaining tread depth of approximately 5mm. The tyre was observed with cut mark(s) on the inner sidewalls and there was damage observed on the wheel rims as a result of the accident.

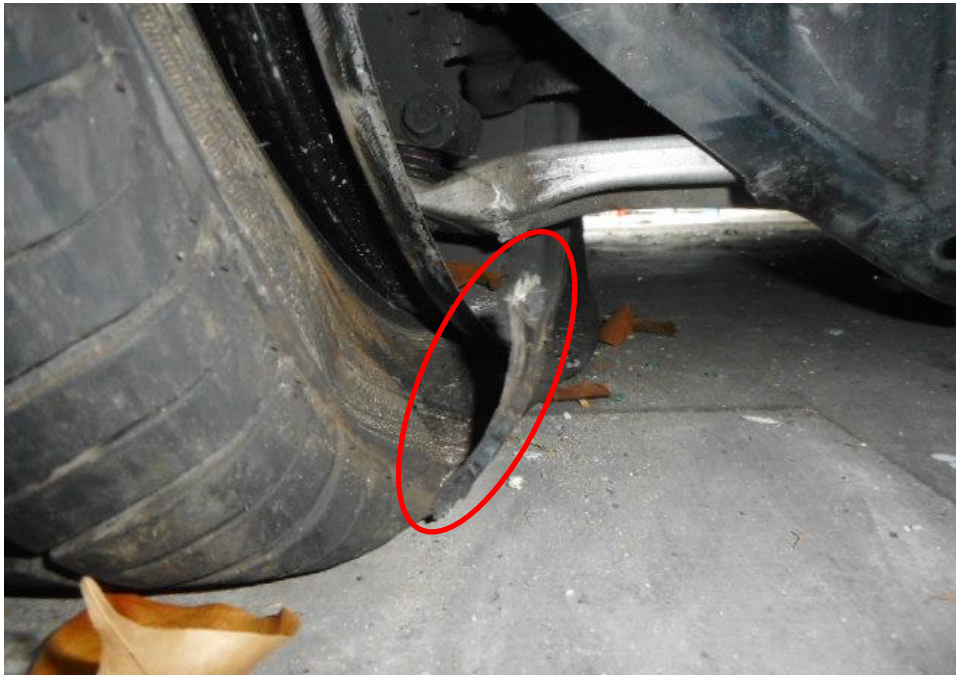
**Photo 9** shows the close up view of the condition of the front right tyre of the Motor Taxi, which was observed to be unserviceable condition. The tyre was observed with cut mark(s) on the inner sidewalls and there was damage observed on the wheel rims (circled) as a result of the accident.

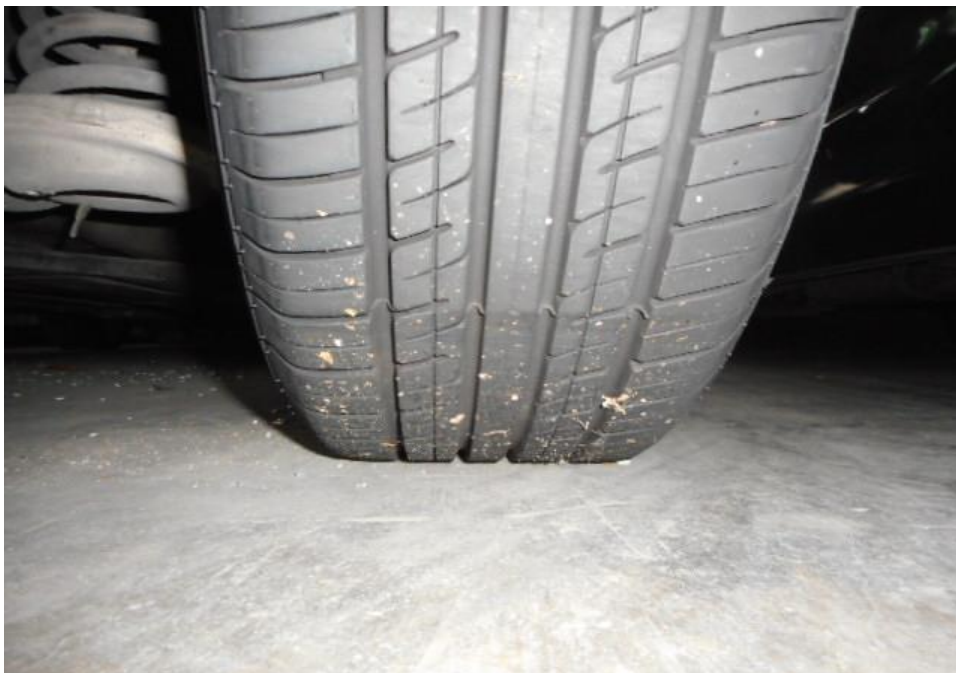
**Photo 10** shows the condition of the rear right tyre of the Motor Taxi, which was observed to be in serviceable condition with remaining tread depth of approximately 6.7mm. The tyre was also observed to be sufficiently inflated for vehicular operation with no tear, cut or burst mark(s).

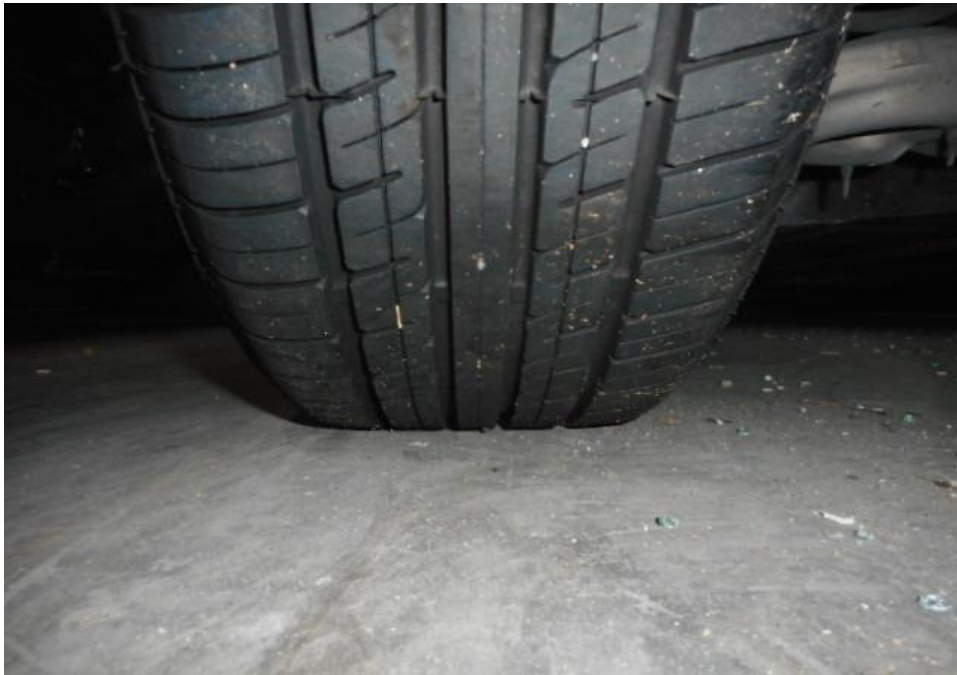
**Photo 11** shows the condition of the rear left tyre of the Motor Taxi, which was observed to be in serviceable condition with remaining tread depth of approximately 7mm. The tyre was also observed to be sufficiently inflated for vehicular operation with no tear, cut or burst mark(s).

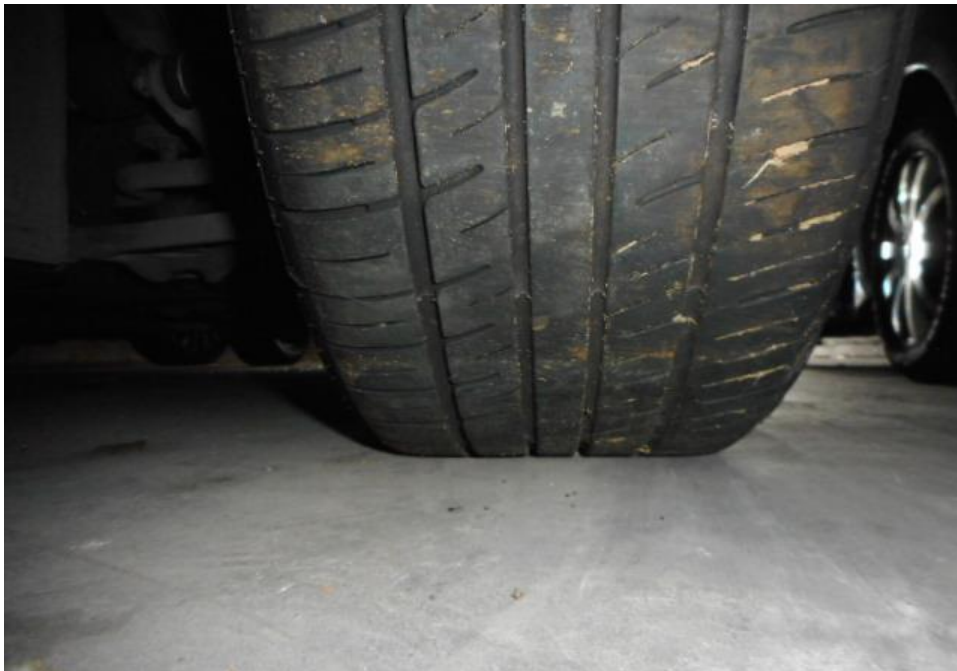
**Photo 12** shows the condition of the front left tyre of the Motor Taxi, which was observed to be in serviceable condition with remaining tread depth of approximately 3.8mm. The tyre was also observed to be sufficiently inflated for vehicular operation with no tear, cut or burst mark(s).

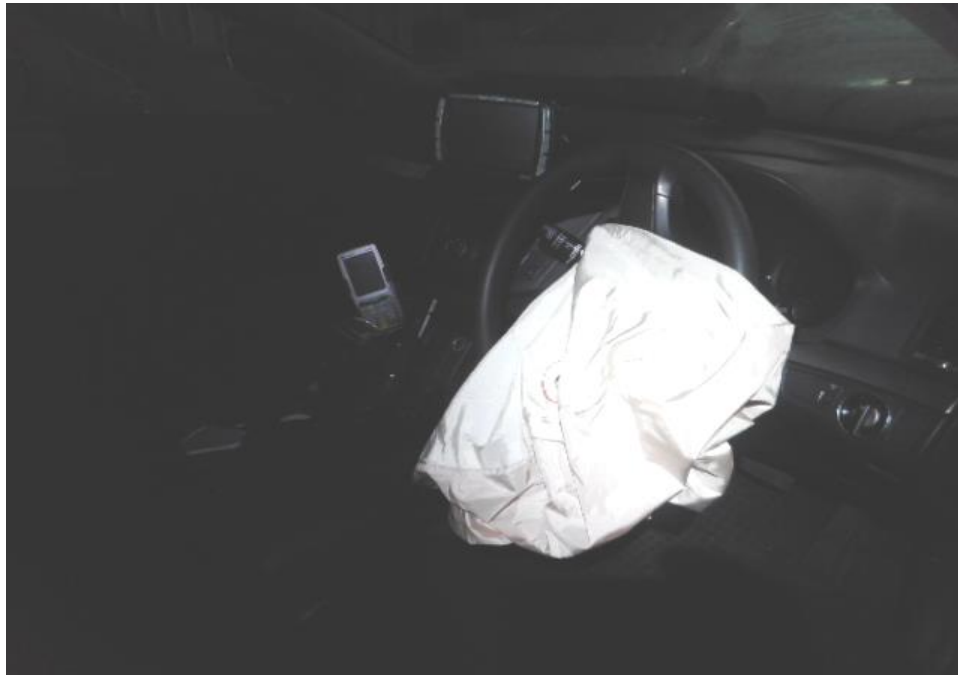
**Photo 13** shows the deployment of the Supplemental Restraint System (SRS) airbag in the Motor Taxi as a result of the accident.

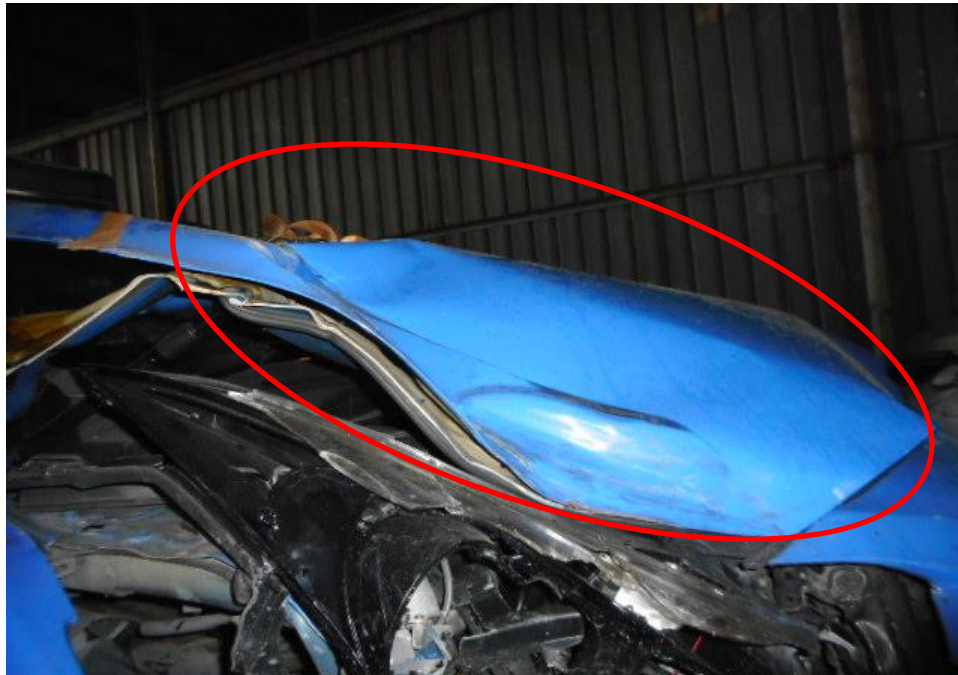
8. We were unable to raise the front bonnet of the Motor Taxi to conduct the examination of the Motor Taxi's engine compartment because the damage caused by the accident had resulted in the damages to the lock mechanism of the bonnet and the structure of the engine compartment. (unable to open)  
See photo 14 below.

**Photo 14** shows a close up view of the damaged front bonnet lock mechanism and the structure of the engine compartment of the Motor Taxi at the time of my inspection resulting it unable to open a result of the accident. (circled) (Unable to open)

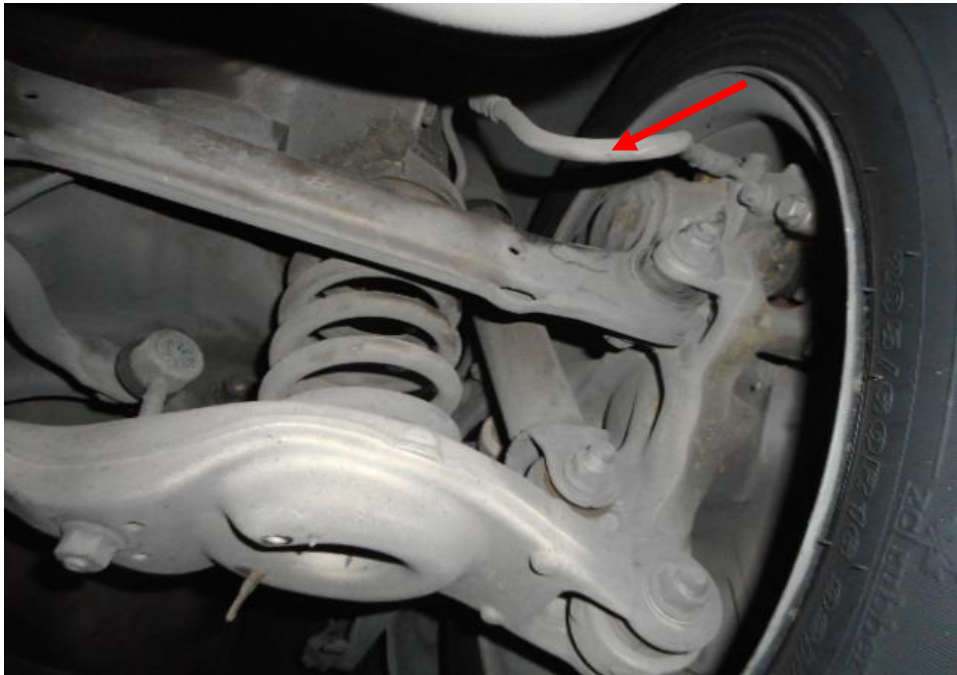
**Photo 15** shows the brake hose/pipe (arrowed) at the rear right wheel of the Motor Taxi. No leakage of brake fluid was observed. Visual examination of the various components of the braking system like the drum brake, brake booster, brake pedal etc. had revealed all to be intact and without visible damage.

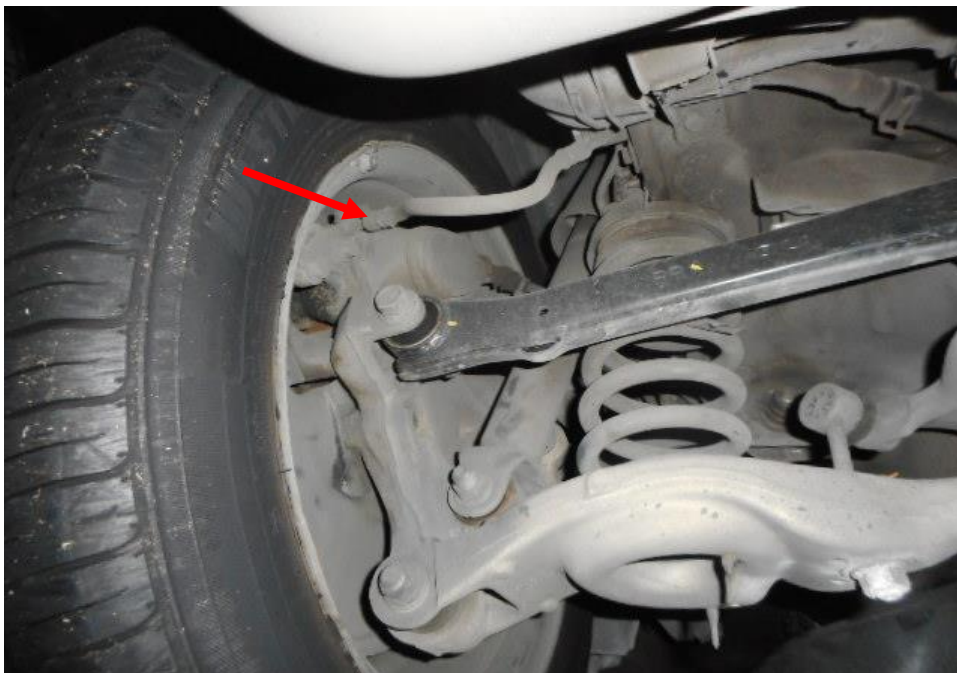
**Photo 16** shows the brake hose/pipe (arrowed) at the rear left wheel of the Motor Taxi. I did not observe any leakage of brake fluid at the time of my inspection of the Motor Taxi. The undercarriage components of the Motor Taxi were also all found to be intact and without any visible damage.

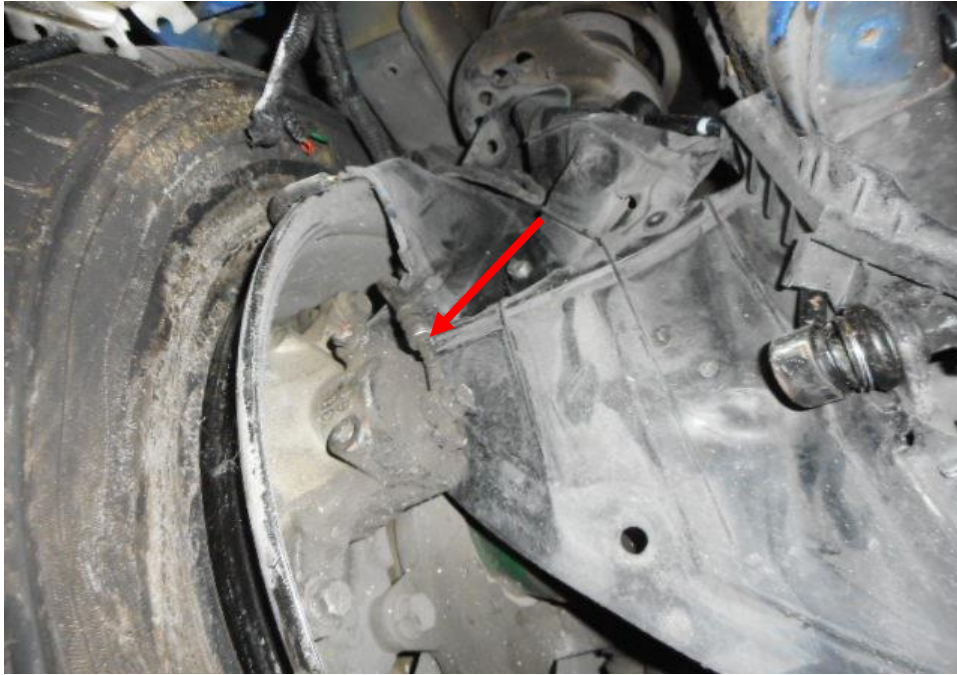
**Photo 17** shows the brake hose/pipe (arrowed) at the front right wheel of the Motor Taxi. I did not observe any leakage of brake fluid at the time of my inspection of the Motor Taxi. The undercarriage components of the Motor Taxi were also all found to be intact and without any visible damage.

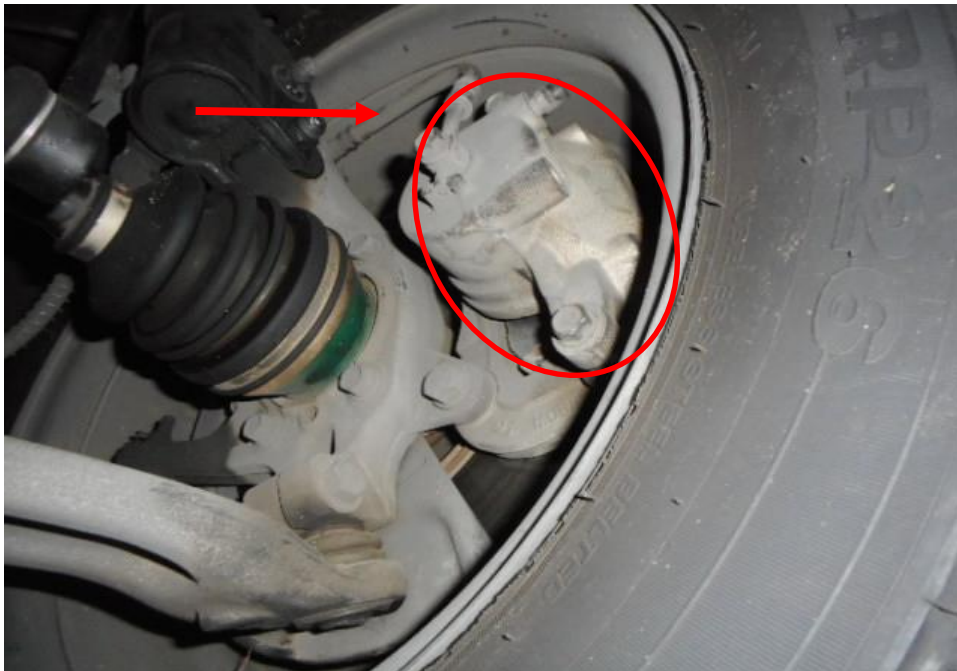
**Photo 18** shows the brake hose/pipe (arrowed) at the front left wheel of the Motor Taxi. No leakage of brake fluid was observed. Visual examination of the various components of the braking system like the brake caliper (circled), brake booster, brake pedal etc had revealed all to be intact and without visible damage.

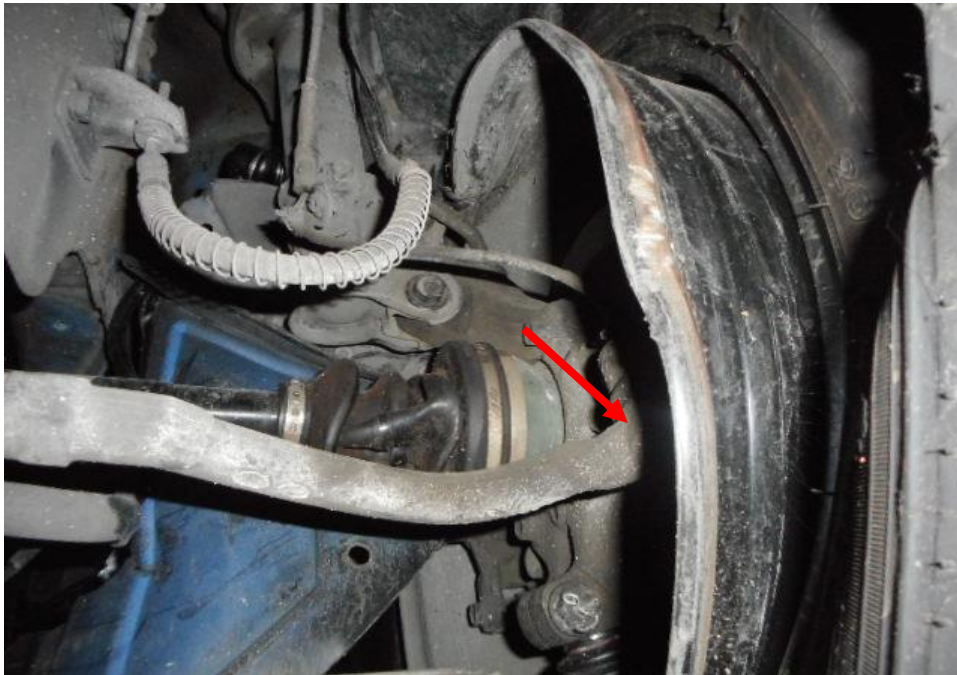
**Photo 19** shows the various undercarriage components at the front right wheel of the Motor Taxi, in particular the steering tie rod (red arrow). The various steering components were all found to be intact. There was also no sign of fluid stain observed on the various undercarriage components at the front right wheel of the Motor Taxi.

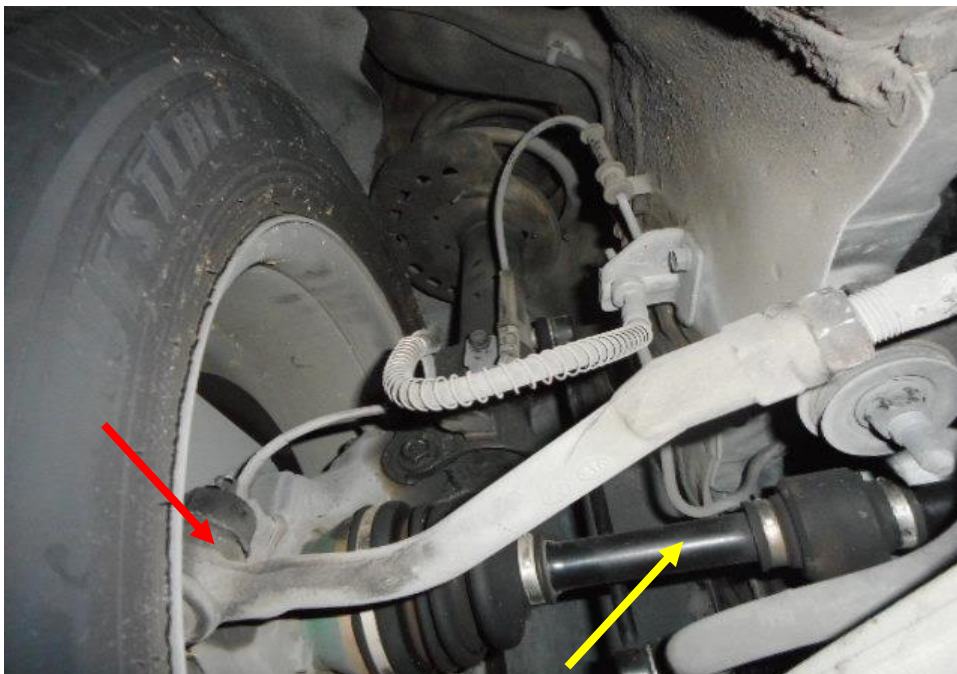
**Photo 20** shows the various undercarriage components at the front left wheel of the Motor Taxi, in particular the steering tie rod (red arrow) and driveshaft (yellow arrow). The various steering components were all found to be intact. There was also no sign of fluid stain observed on the various undercarriage components at the front right wheel of the Motor Taxi.

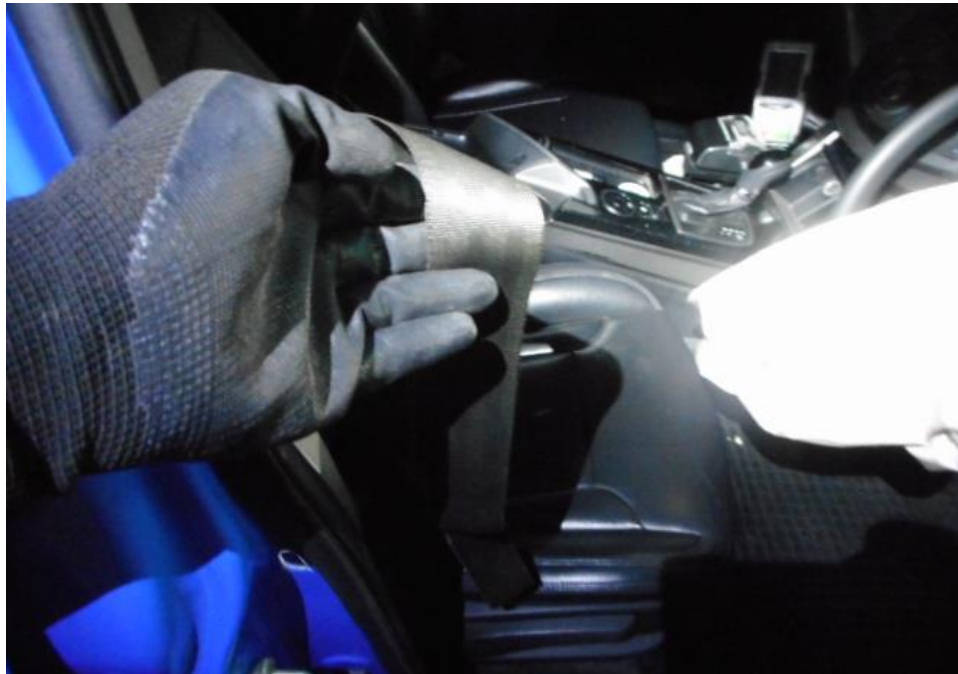
12. The front right seat belt of the "Motor Taxi" was worn and the left seat belt was not worn at the material time of accident as the respective pre-tensioners that were fitted at the side of each seat was activated upon the material time. See photo 21 and 22 below.

**Photo 21** shows that the seat belt on the right seat was worn at the material time of accident as the safety pre-tensioners was activated at the moment of impact and caused the seat belt to be locked into the last position.

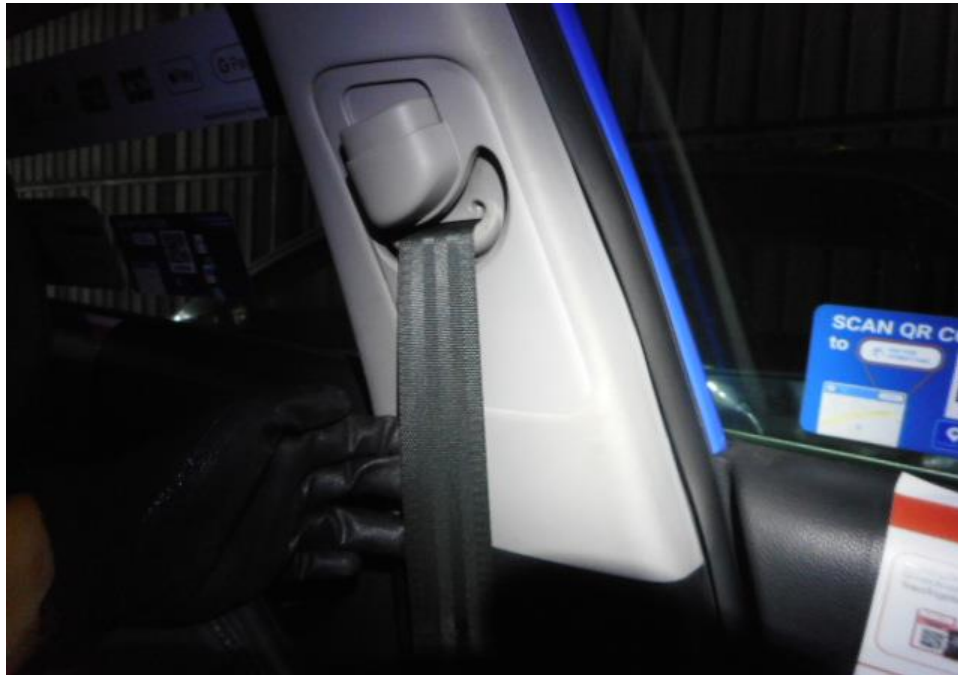
**Photo 22** shows that the seat belt on the left seat was not worn at the material time of accident as the safety pre-tensioners was activated at the moment of impact and caused the seat belt to be locked into the last position.
