Your Ref: TP/IP/43533/2021
Our Ref : CI/TPD21011272/P

10th November 2021

MECHANICAL INSPECTION REPORT OF MOTOR CAR SMR 1861B

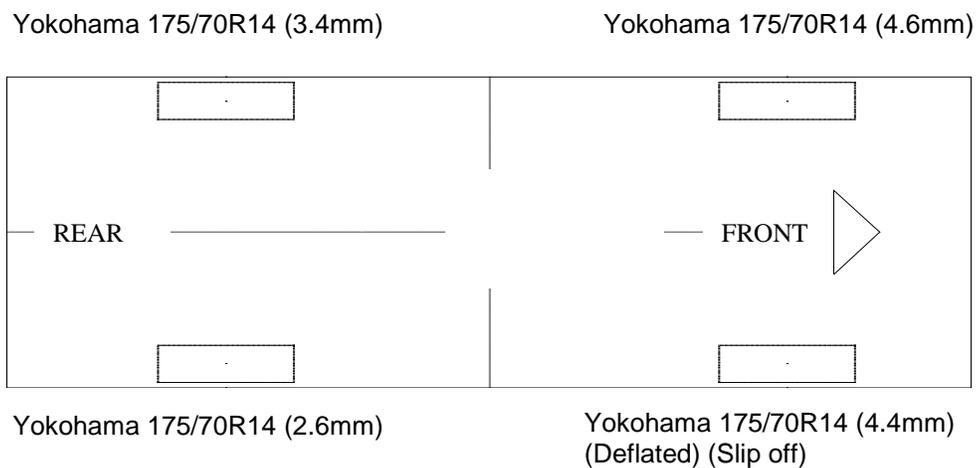
6. The condition of the Motor Car's front right tyre was observed to be in damaged as a result of the accident. However, the other 3 tyres was observed to be in serviceable condition. I did not find any tear, cut or burst mark(s) on the outer and the inner sidewalls as well as across the tread of the 3 tyres. The 3 tyres were also observed to be sufficiently inflated for vehicular operation. The tyre brand, tyre size and remaining tread depth of the 4 tyres were recorded as follows:-

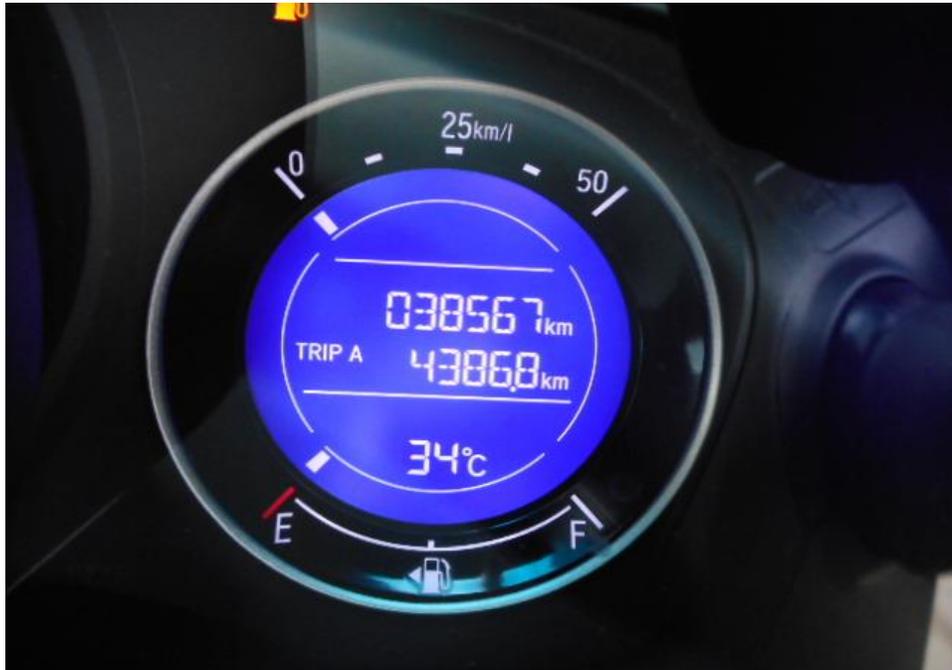
Photo 1 shows the mileage of the Motor Car at the time of my inspection. The mileage observed was 38,567km.

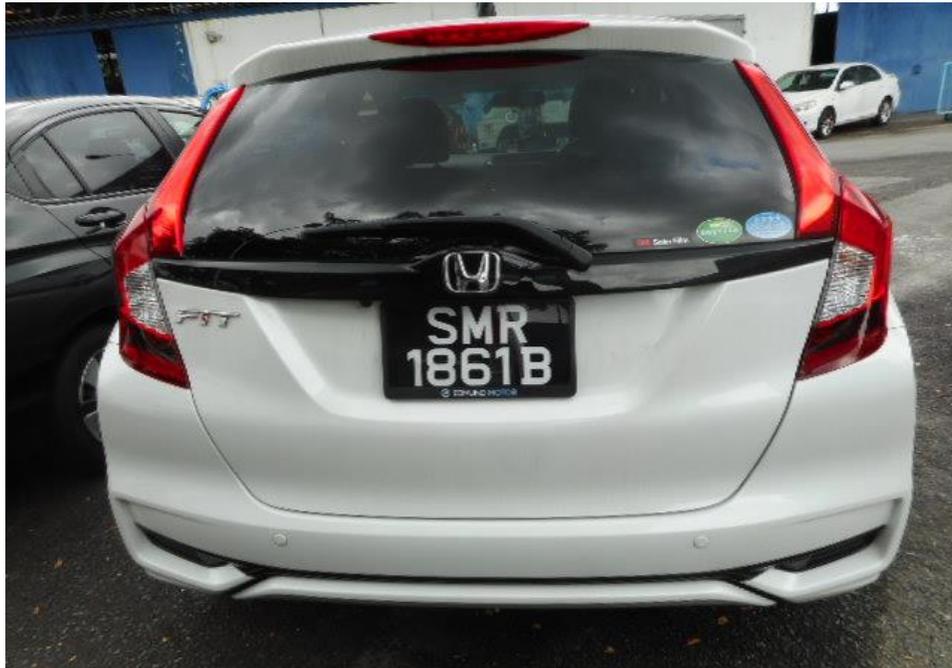
Photo 2 shows the general view of the Motor Car's rear body at the time of my inspection. The rear portion of the Motor Car was observed to have been unaffected by the accident.

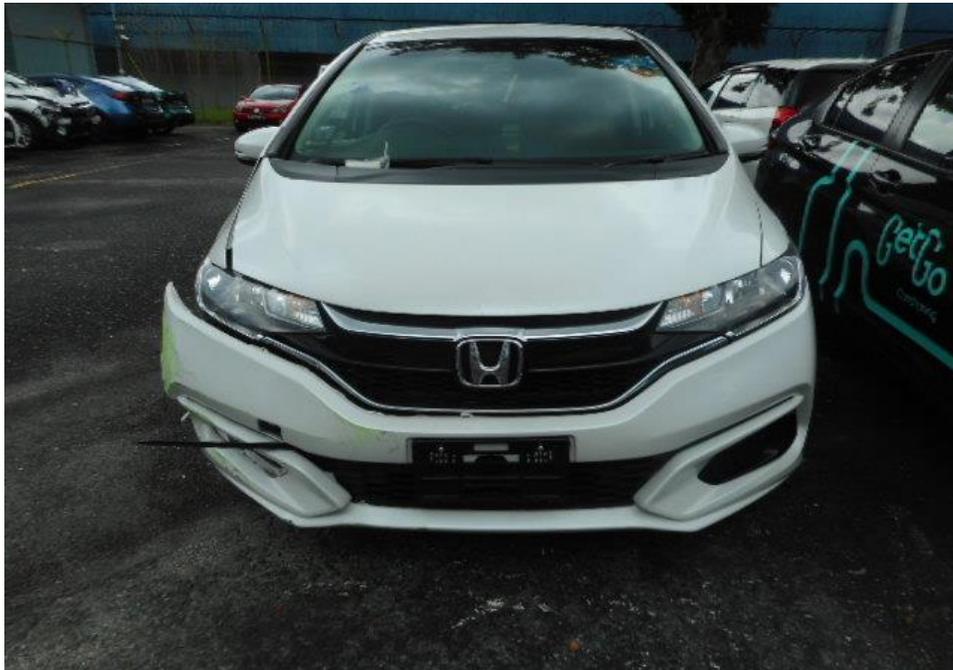
4. The mileage of the Motor Car at the time of my inspection was 38,567km.
5. The Motor Car was observed to have sustained damage at its front portion. Its front bumper and front right fender were amongst the body parts that were damaged as a result of the accident.

Photo 3 shows a general view of the Motor Car's front body at the time of my inspection. The Motor Car was observed to have sustained damage at its front portion. Its front bumper and front right fender were amongst the body parts that were damaged as a result of the accident.

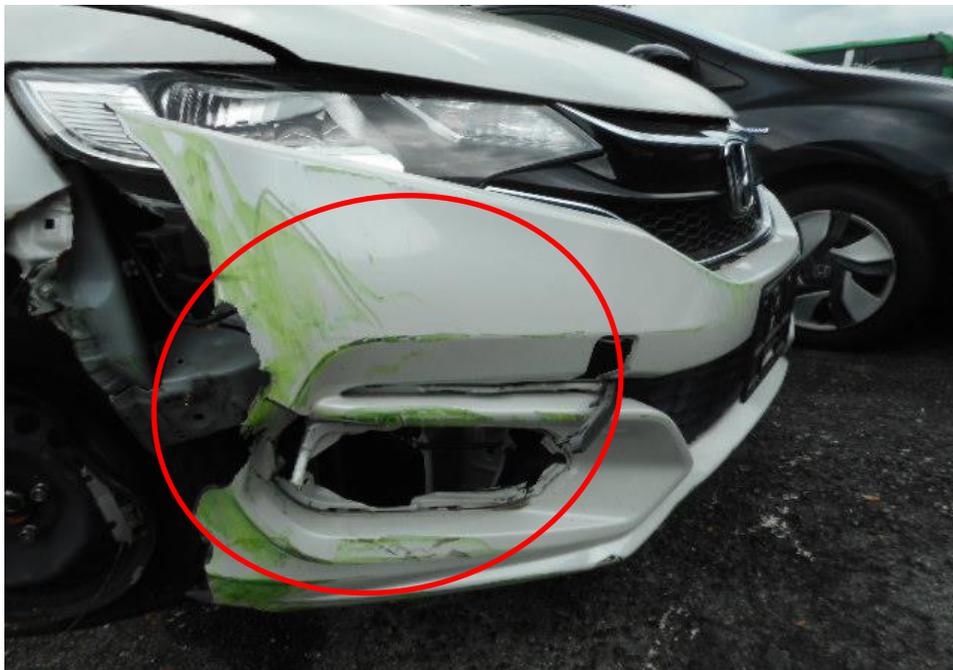
Photo 4 shows the close up view of the Motor Car's front body at the time of my inspection. The Motor Car was observed to have sustained damage at its front portion. Its front bumper (circled) were amongst the body parts that were damaged as a result of the accident.

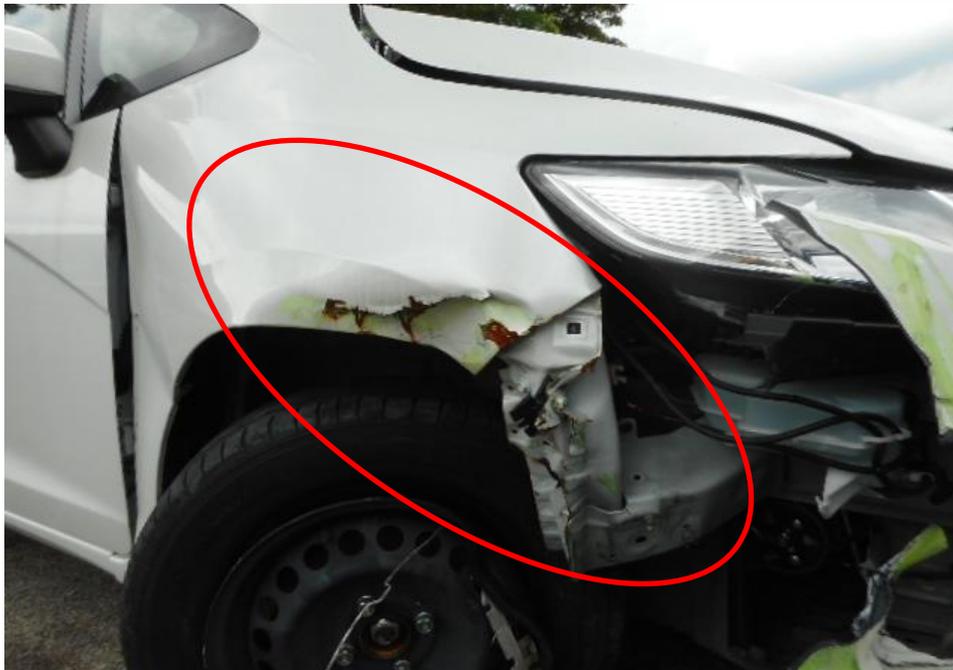
Photo 5 shows the close up view of the Motor Car's front body at the time of my inspection. The Motor Car was observed to have sustained damage at its front portion. Its front right fender (circled) were amongst the body parts that were damaged as a result of the accident.

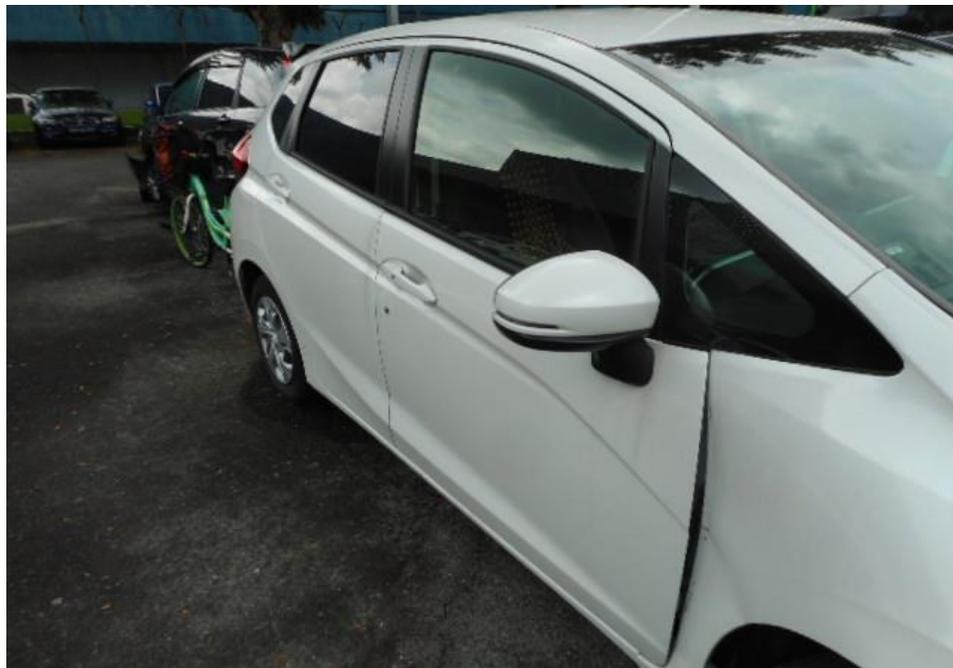
Photo 6 shows a general view of the Motor Car's left body at the time of my inspection. The right portion of the Motor Car was observed to have been unaffected by the accident.

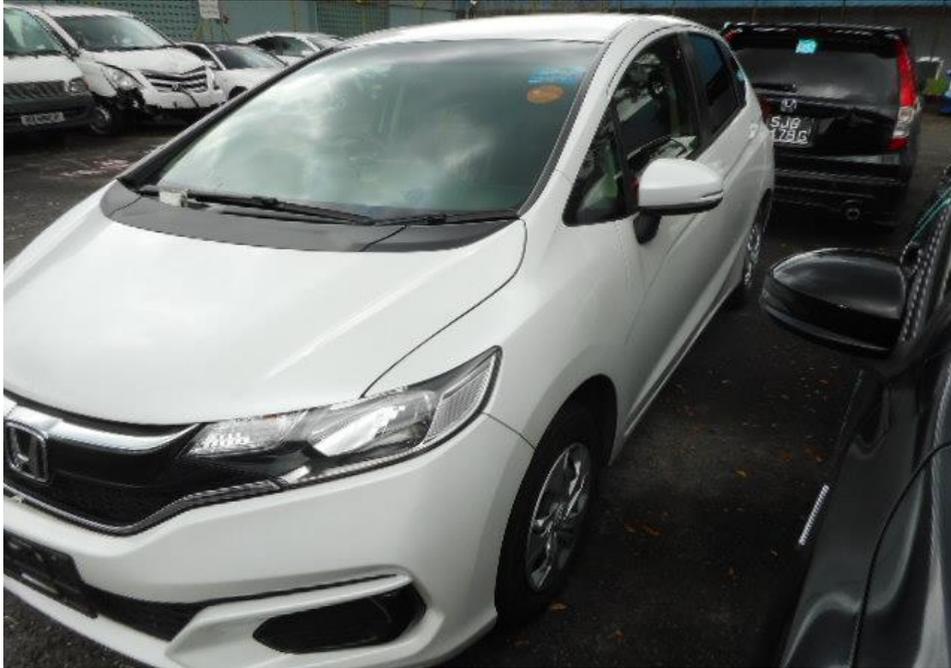
Photo 7 shows a general view of the Motor Car's left body at the time of my inspection. The left portion of the Motor Car was observed to have been unaffected by the accident.

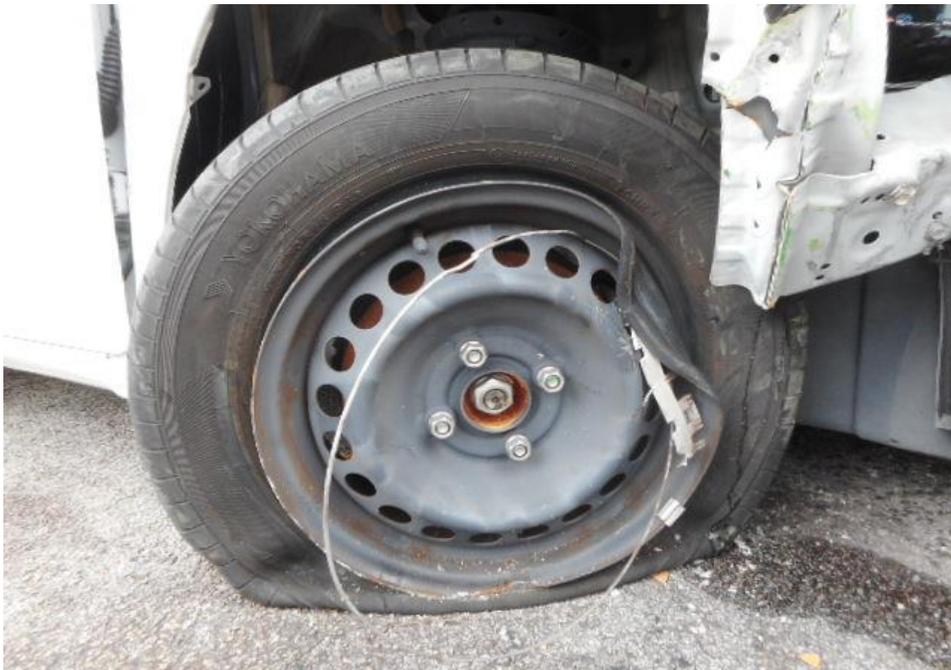
7. The front right tyre and rims was observed to be deflated and slipped off as a result of the accident. However the other 3 tyres were observed to be wrapped around standard alloy wheel rims that were found to be damage as a result of the accident. See photo 1 – 12 below.

Photo 8 shows the condition of the front right tyre of the Motor Car, which was observed to be unserviceable condition with remaining tread depth of approximately 4.4mm. The tyre was observed to be deflated and slipped off the wheel rim as a result of the accident.

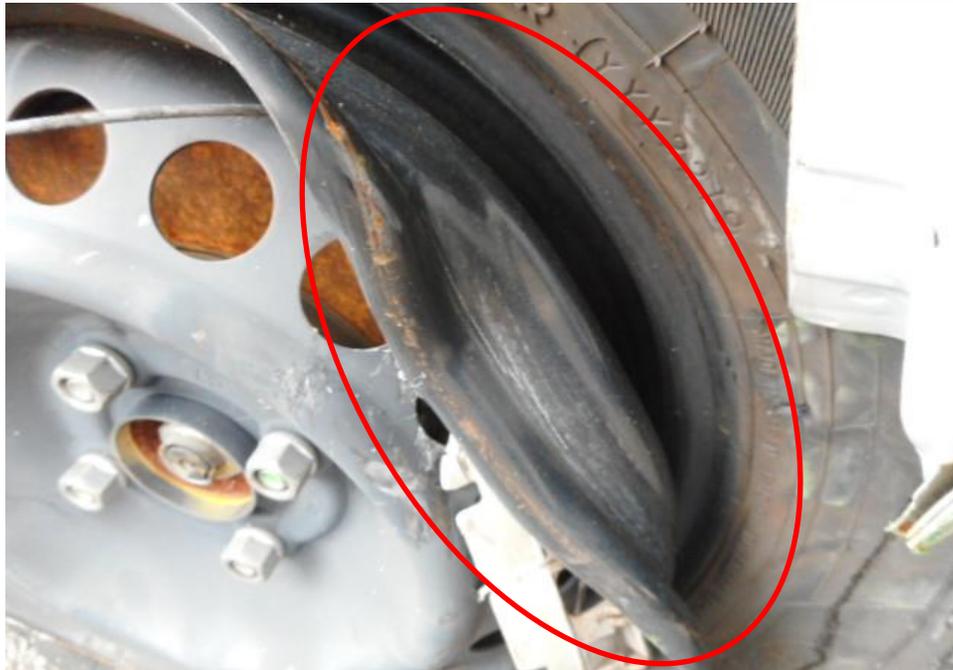
Photo 9 shows the close up view of the condition of the front right tyre of the Motor Car, which was observed to be unserviceable condition. The tyre was observed to be deflated and slip off as there was damage observed on the wheel rims (circled) as a result of the accident.

19. The front right tyre and wheel rim of the Motor Car were found to be damaged as a result of the accident. However, the other 3 tyres were found to be serviceable condition as I did not find any tear, cut or burst mark(s) on the outer and the inner sidewalls as well as across the tread of the 3 tyres. The 4 tyres were also observed with remaining tread depth of approximately 2.6mm to 4.6mm.

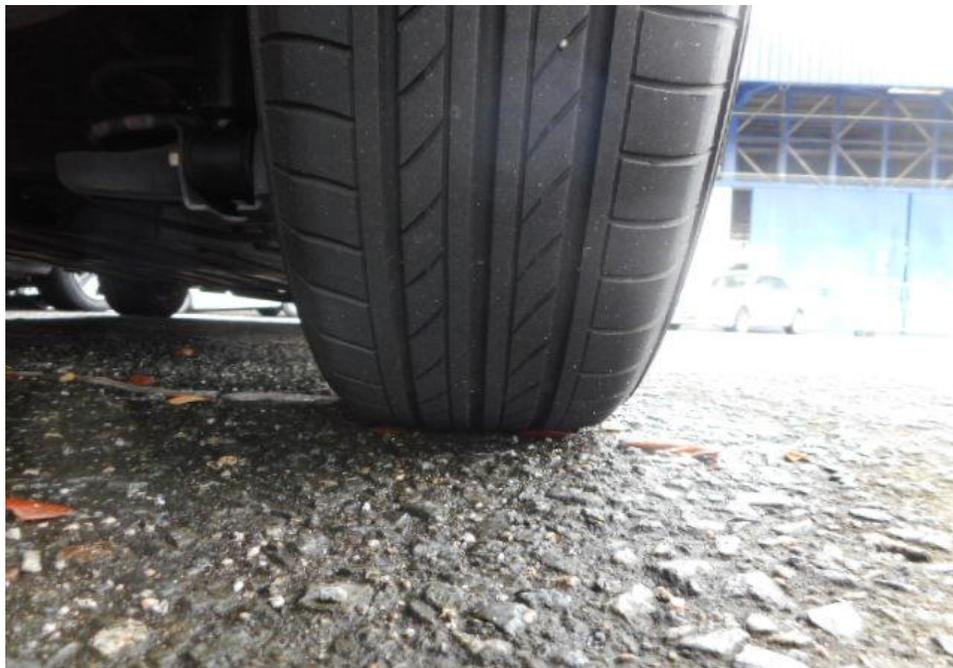
Photo 10 shows the condition of the rear right tyre of the Motor Car, which was observed to be in serviceable condition with remaining tread depth of approximately 2.6mm. The tyre was also observed to be sufficiently inflated for vehicular operation with no tear, cut or burst mark(s).

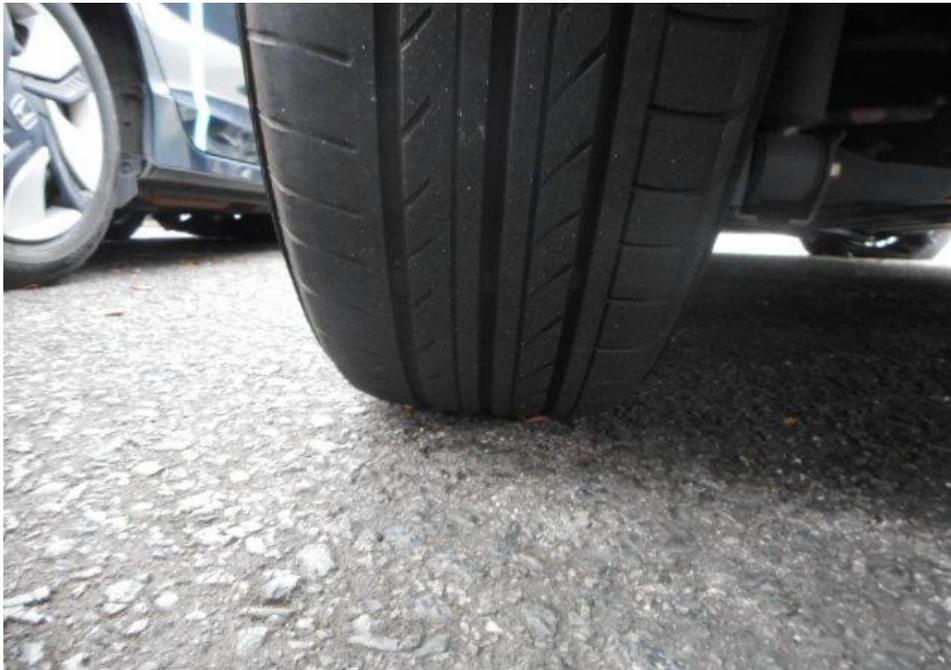
Photo 11 shows the condition of the rear left tyre of the Motor Car, which was observed to be in serviceable condition with remaining tread depth of approximately 3.8mm. The tyre was also observed to be sufficiently inflated for vehicular operation with no tear, cut or burst mark(s).

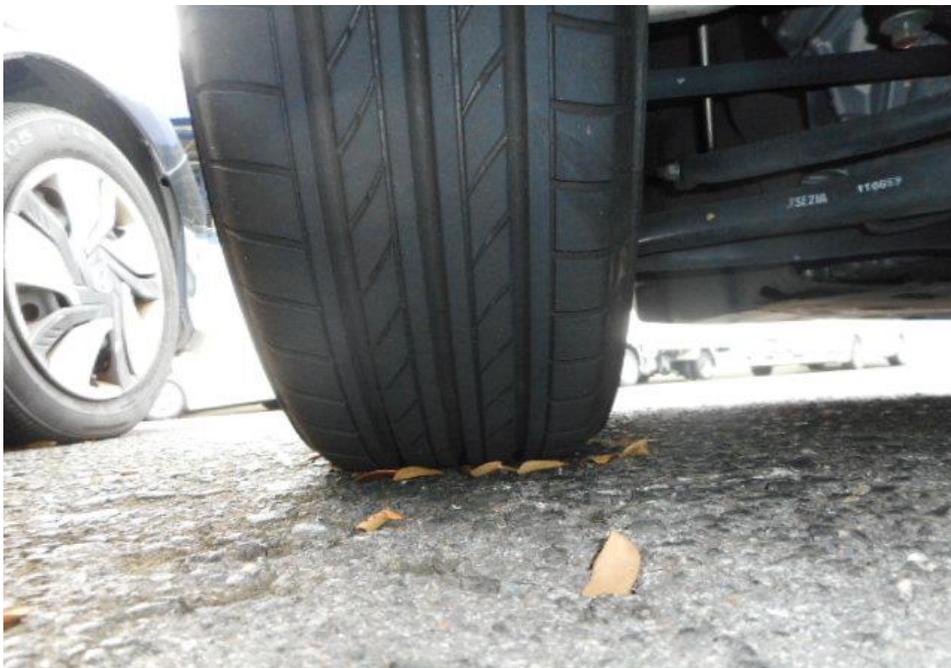
Photo 12 shows the condition of the front left tyre of the Motor Car, which was observed to be in serviceable condition with remaining tread depth of approximately 4.6mm. The tyre was also observed to be sufficiently inflated for vehicular operation with no tear, cut or burst mark(s).

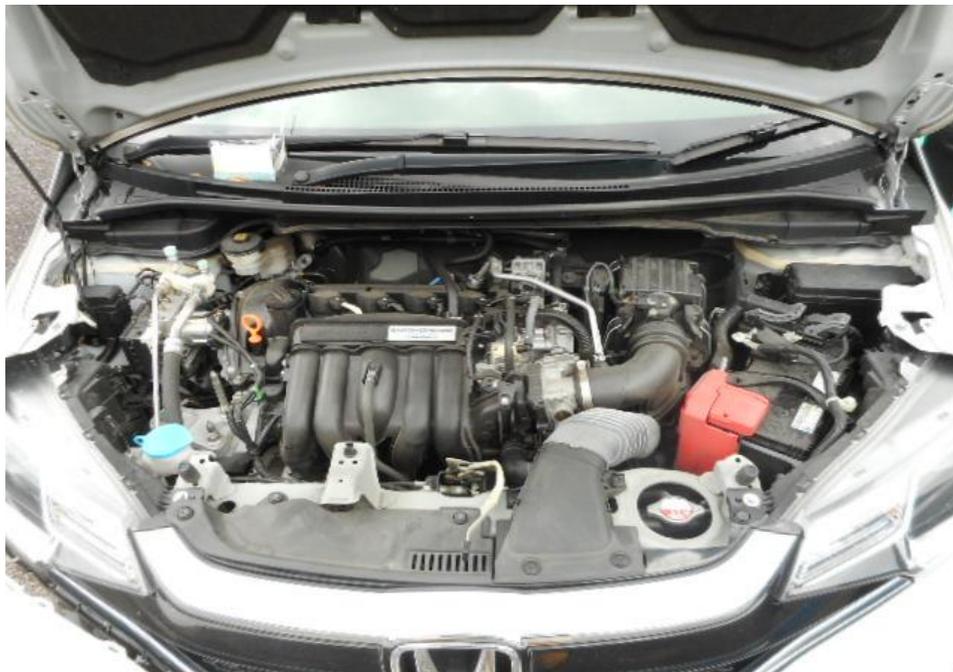
8. Upon examination of the engine compartment of the Motor Car, I had observed all the parts and components inside the engine compartment to be intact and unaffected by the accident. The brake fluid, engine oil and engine coolant were all found to be of sufficient level for operating purposes. Visually, there was also no contamination found to these fluids.

10. Further examination of the engine compartment revealed no sign(s) or indication(s) of fluid leakage and/or fluid stain within the engine compartment of the Motor Car.

Photo 13 shows a general view of the Motor Car's engine compartment. The various parts and components inside the engine compartment were unaffected by the accident. There was also no sign(s) or indication(s) of fluid leakage and/or fluid stain within the engine compartment.

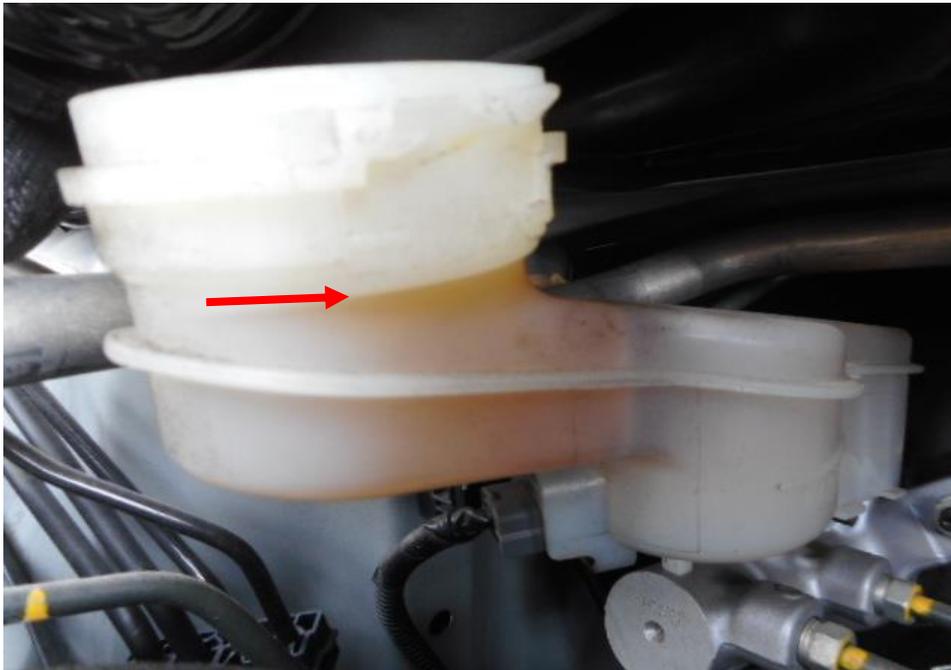
Photo 14 shows the brake fluid reservoir of the Motor Car at the time of my inspection. The brake fluid was observed to be of sufficient level (arrowed) and without any visible contamination.

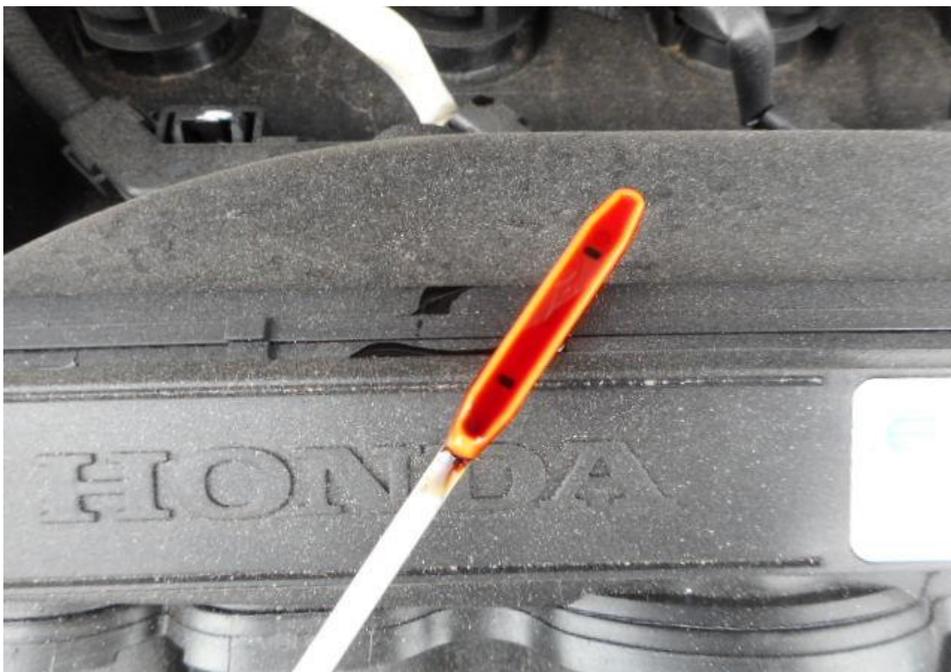
Photo 15 shows the engine oil dip stick of the Motor Car at the time of my inspection. The engine oil was observed to be of sufficient level and without any visible contamination.

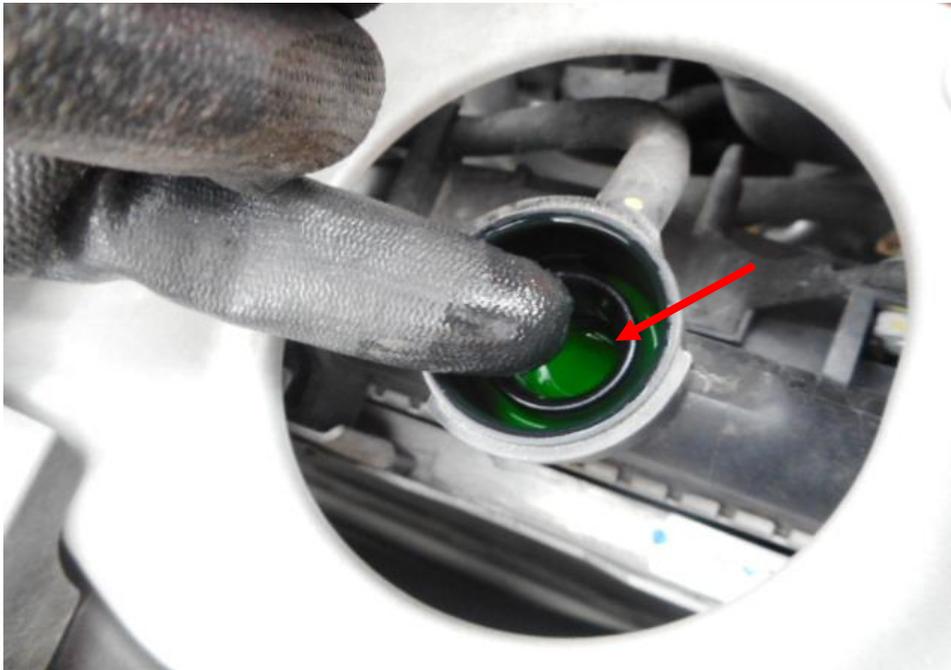
Photo 16 shows checks being carried out to the engine coolant of the Motor Car at the time of my inspection. The engine coolant was observed to be of sufficient level (arrowed) and without any visible contamination.

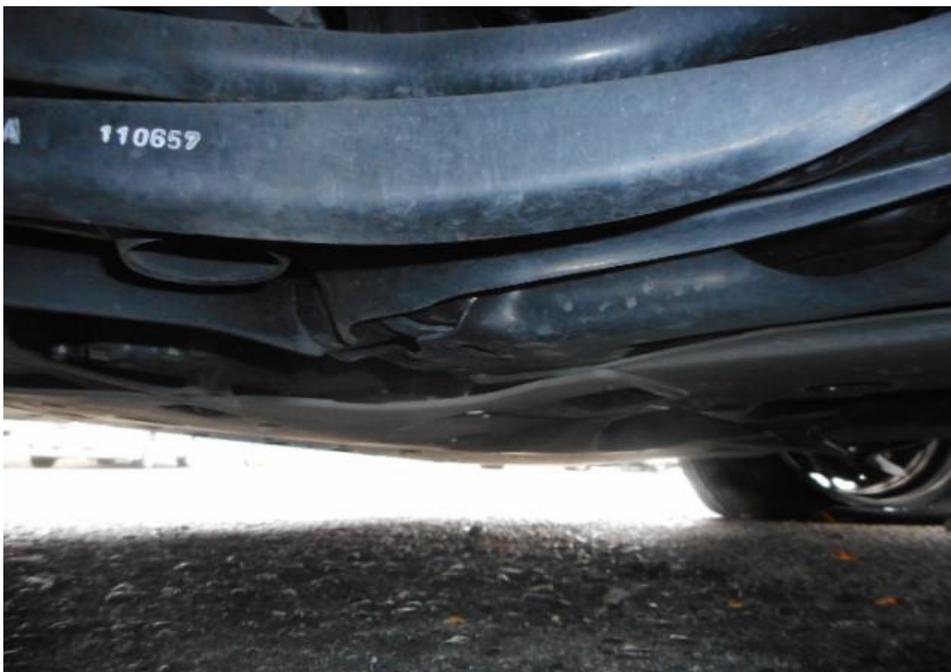
11. My subsequent checks on the underside of the Motor Car also revealed no sign(s) or indication(s) of fluid leak and/or fluid stain(s). Visually, the various undercarriage components of the Motor Car were all observed to be intact and without any visible damage. See photo 13 – 17 below.

Photo 17 shows the undercarriage of the Motor Car, at the area where the engine housing and transmission housing are located. I did not find any sign(s) or indication(s) of fluid leak and/or fluid stain(s) on the underside of the Motor Car.

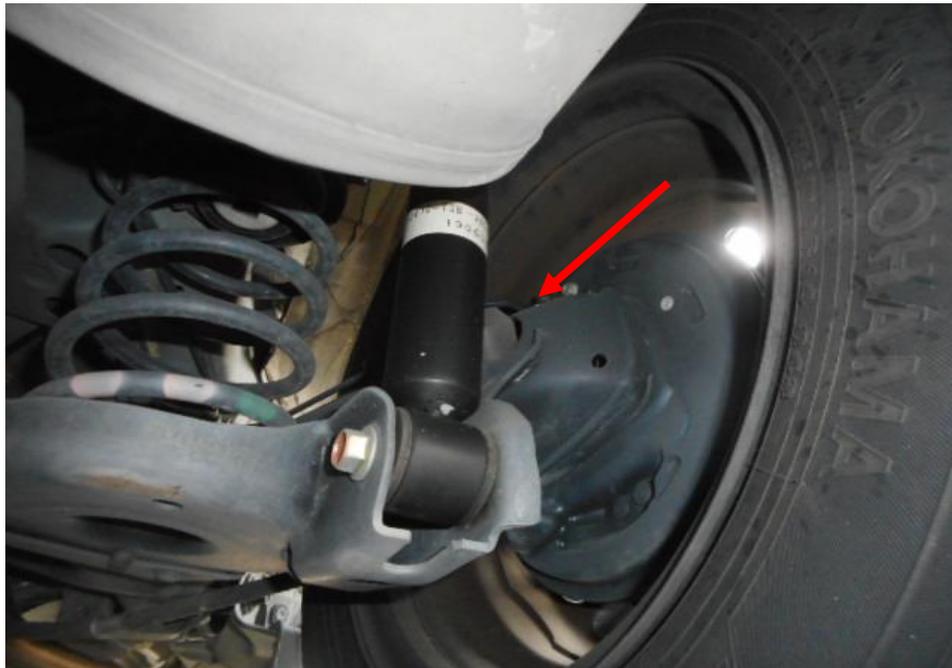
12. Static brake tests conducted on the Motor Car revealed no abnormality. The brake booster had responded well to the various tests conducted. There was also no abnormal movement of the brake pedal when it was depressed. In general, the static brake tests had suggested that there was no internal leakage of pressure/vacuum in the braking system of the Motor Car. The braking system of the Motor Car was likely to be in serviceable condition at the material time. This was taking into consideration that the brake fluid was of sufficient level, and also that there was no sign(s) of brake fluid leakage along the brake hoses and brake pipes.

Photo 18 shows the brake hose/pipe (arrowed) at the rear right wheel of the Motor Car. No leakage of brake fluid was observed. Visual examination of the various components of the braking system like the drum brake, brake booster, brake pedal etc. had revealed all to be intact and without visible damage.

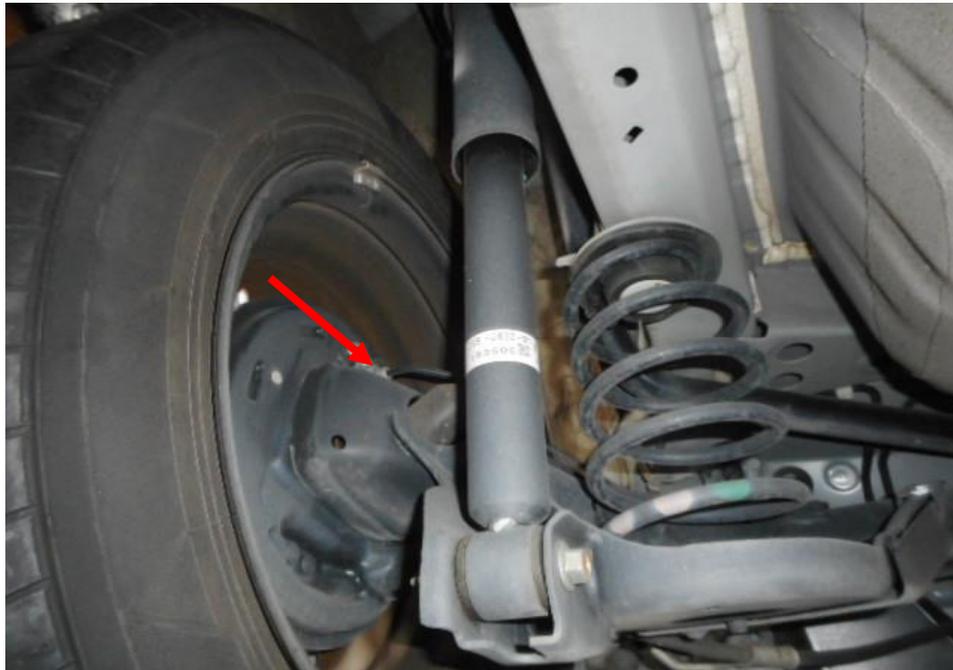
Photo 19 shows the brake hose/pipe (arrowed) at the rear left wheel of the Motor Car. I did not observe any leakage of brake fluid at the time of my inspection of the Motor Car. Static tests of the Motor Car's braking system had indicated that there was no internal leakage of pressure/vacuum. The undercarriage components of the Motor Car were also all found to be intact and without any visible damage.

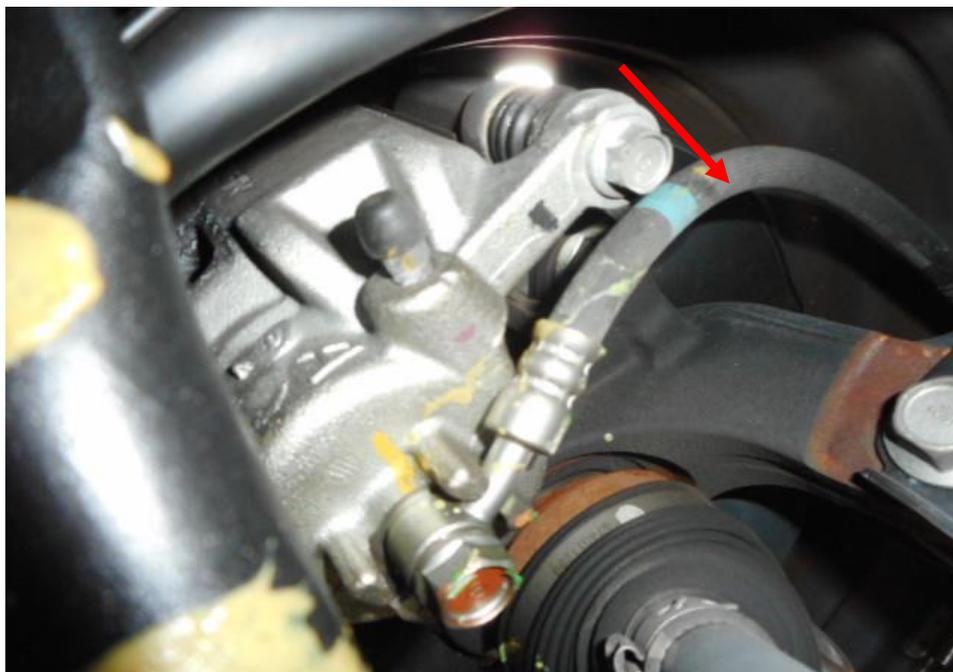
Photo 20 shows the brake hose/pipe (arrowed) at the front right wheel of the Motor Car. I did not observe any leakage of brake fluid at the time of my inspection of the Motor Car. Static tests of the Motor Car's braking system had indicated that there was no internal leakage of pressure/vacuum. The undercarriage components of the Motor Car were also all found to be intact and without any visible damage.

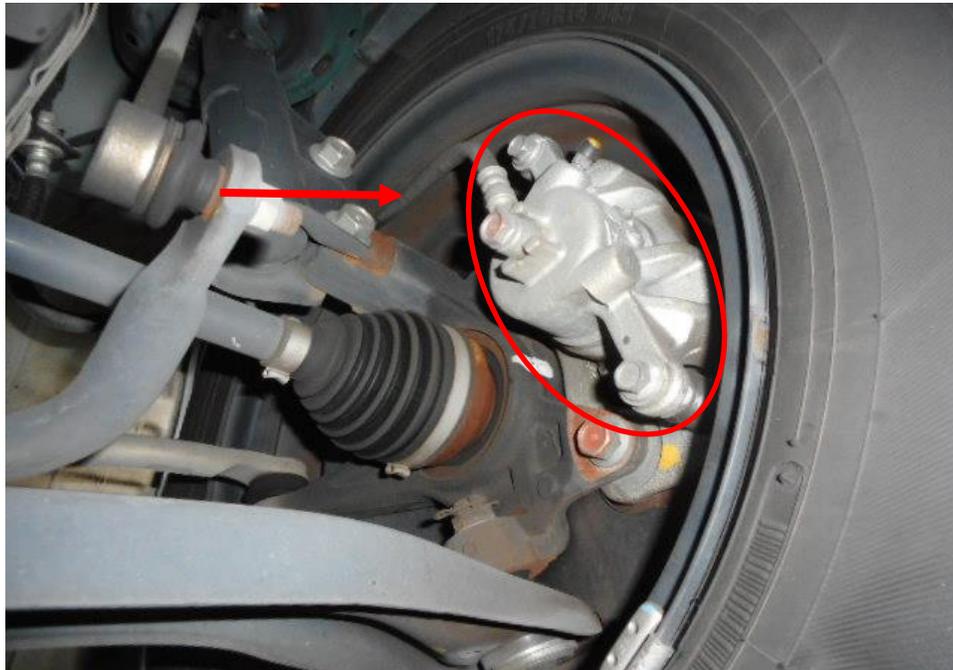
Photo 21 shows the brake hose/pipe (arrowed) at the front left wheel of the Motor Car. No leakage of brake fluid was observed. Visual examination of the various components of the braking system like the brake caliper (circled), brake booster, brake pedal etc had revealed all to be intact and without visible damage.

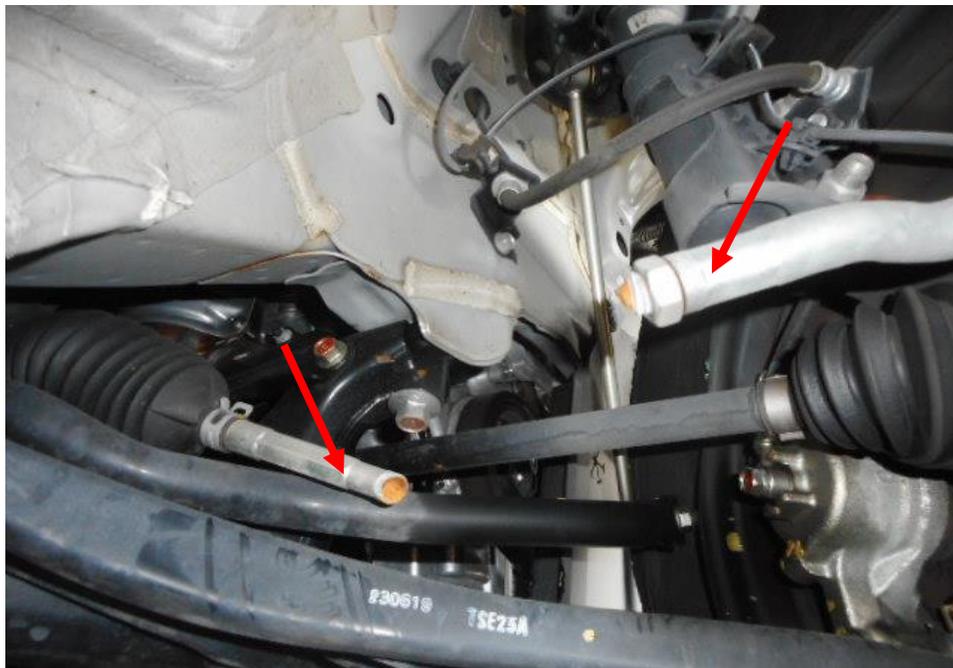
13. Static test on the steering system of the Motor Car was conducted and revealed abnormality as we observed that the front right tie rod was broken as a result of the accident. However, my visual examination of the other various steering components which had included the steering rack and pinion, the left tie rod ends and ball joints revealed that these components were all generally in good condition. See photo 18 - 23 below.

Photo 22 shows the various undercarriage components at the front right wheel of the Motor Car, in particular the steering tie rod (arrowed). The various steering components were all found to be broken as a result of the accident.

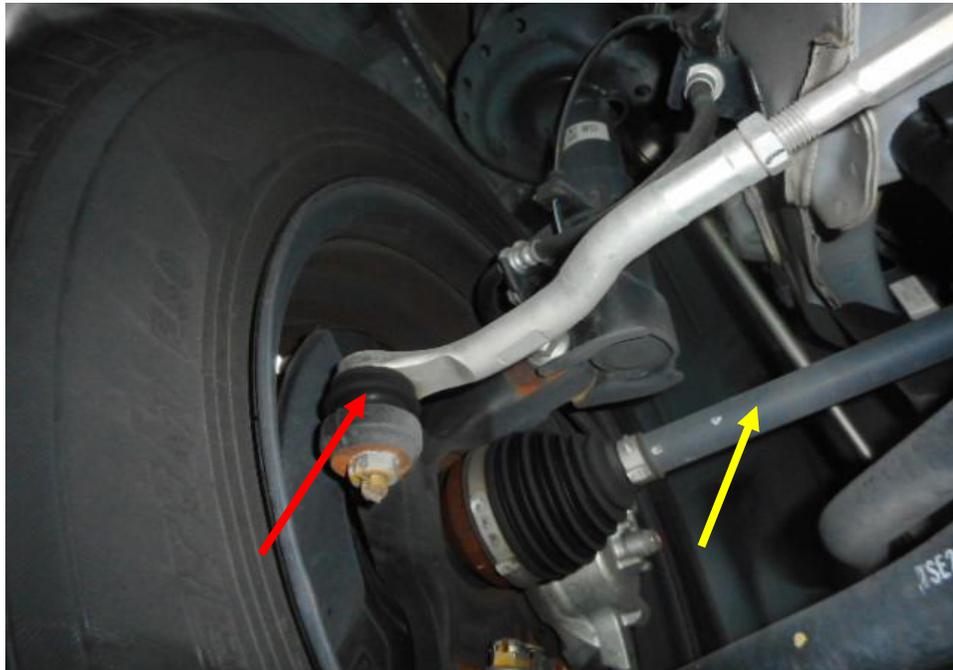
Photo 23 shows the various undercarriage components at the front left wheel of the Motor Car, in particular the steering tie rod (red arrow) and driveshaft (yellow arrow). The various steering components were all found to be intact, suggesting that the steering system of the Motor Car was likely to be in serviceable condition at the material time of accident. There was also no sign of fluid stain observed on the various undercarriage components at the front right wheel of the Motor Car.

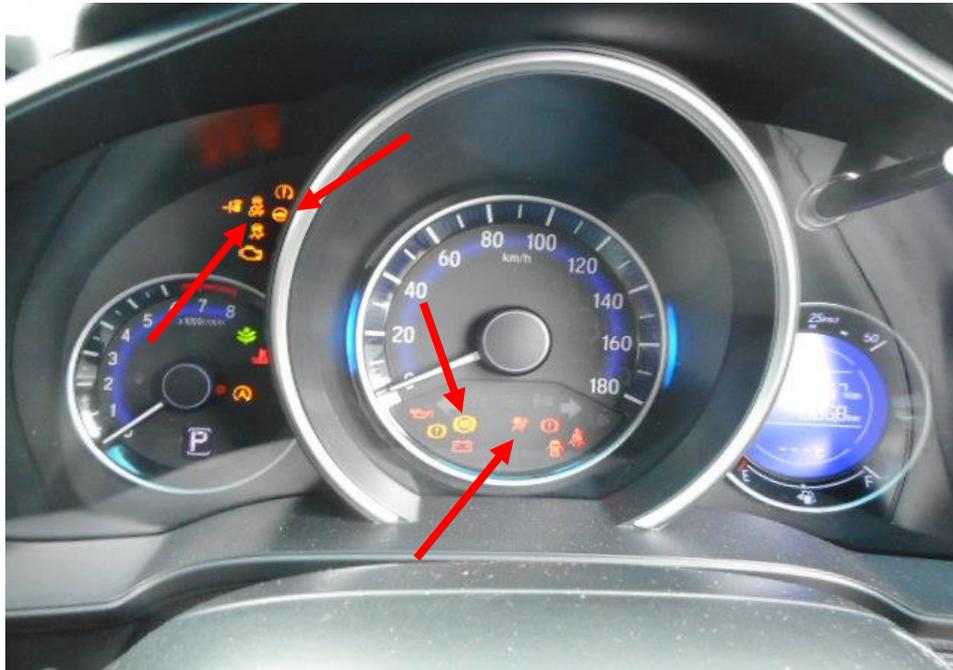
14. The Motor Car's automatic self-test of the functionality of its electronic operating systems like the Anti-Lock Brake System (ABS), Electrical Power Steering (EPS) and Traction Control System (TCS) during cranking of the engine had indicated that the system were in working condition and without abnormality. This can be established from the warning lights disappearing from the instrument panel after the self-test. However, the Supplemental Restraint System (SRS) remained illuminated up due to the activation of the front right seat belt tensioner as a result of the accident. See photo 24 & 25 below.

Photo 24 shows the warning light for Anti-Lock Brake System (ABS), Supplemental Restraint System (SRS) (arrowed) appearing on the instrument panel of the Motor Car during the self-test of its various electronic operating systems when its engine was cranked.

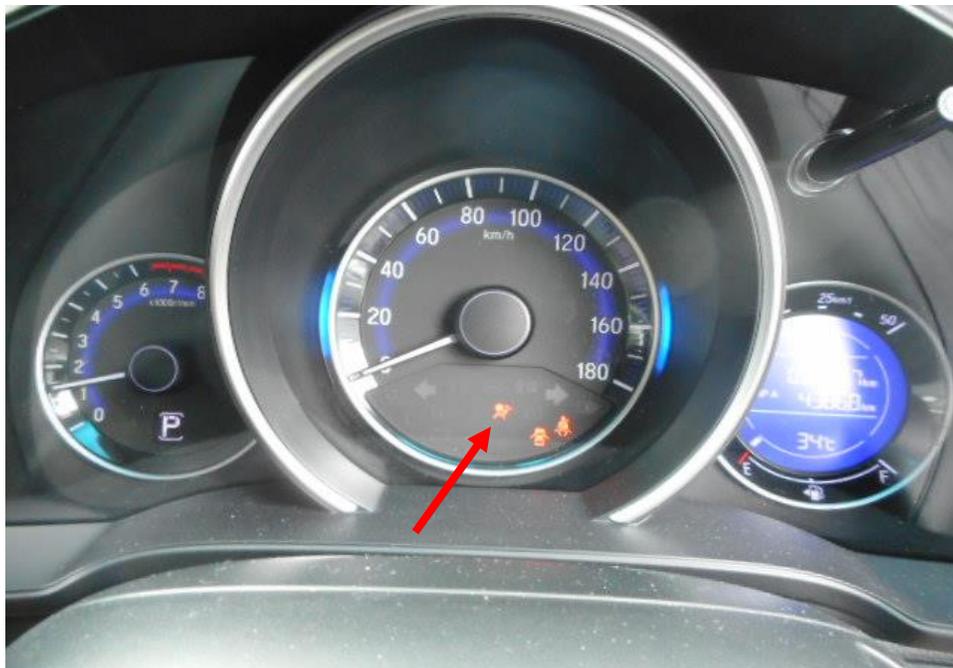
Photo 25 shows only the Supplemental Restraint System (SRS) warning lights (arrowed) remained illuminated on the instrument panel of the Motor Car after the engine was cranked due to the activation of the front right seat belt tensioner. However, the other electronic operation system did not, this would suggest that there was no abnormality to the electronic operating system of the Motor Car, like the ABS, EPS, TCS and etc.

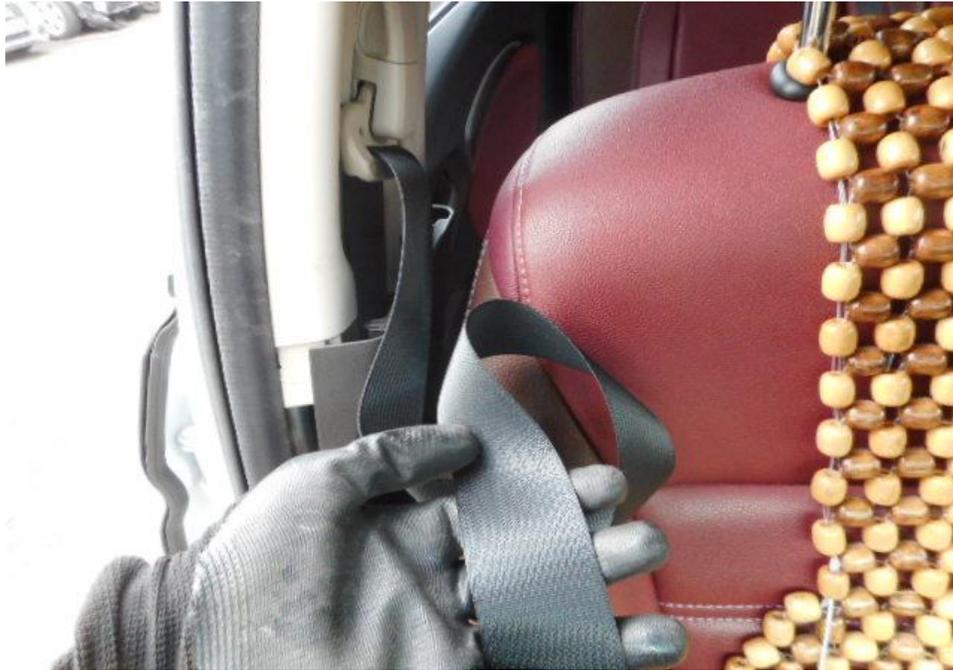
15. The front right seat belt of the “Motor Car” was worn at the material time of accident as the respective pre-tensioners that were fitted at the side of the seat was activated upon the material time. See photo 26 below.

Photo 26 shows that the seat belt on the right seat was worn at the material time of accident as the safety pre-tensioners was activated at the moment of impact and caused the seat belt to be locked into the last position.
