Your Ref: TP/IP/47769/2021  
Our Ref : CI/TPD21011274/P

17<sup>th</sup> November 2021

**MECHANICAL INSPECTION REPORT OF MOTOR VAN GBG 6849T**

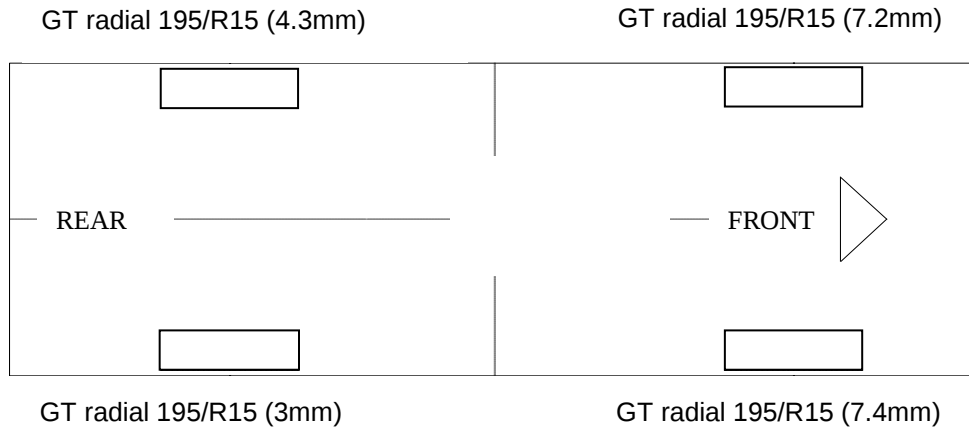
6. The 4 tyres of the Motor Van were observed to be in serviceable condition and sufficiently inflated for vehicular operation. I did not find any tear, cut or burst mark(s) on the outer and the inner sidewalls as well as across the tread of the 4 tyres. The tyre brand, tyre size and remaining tread depth of the 4 tyres of the Motor Van were recorded as follows:-

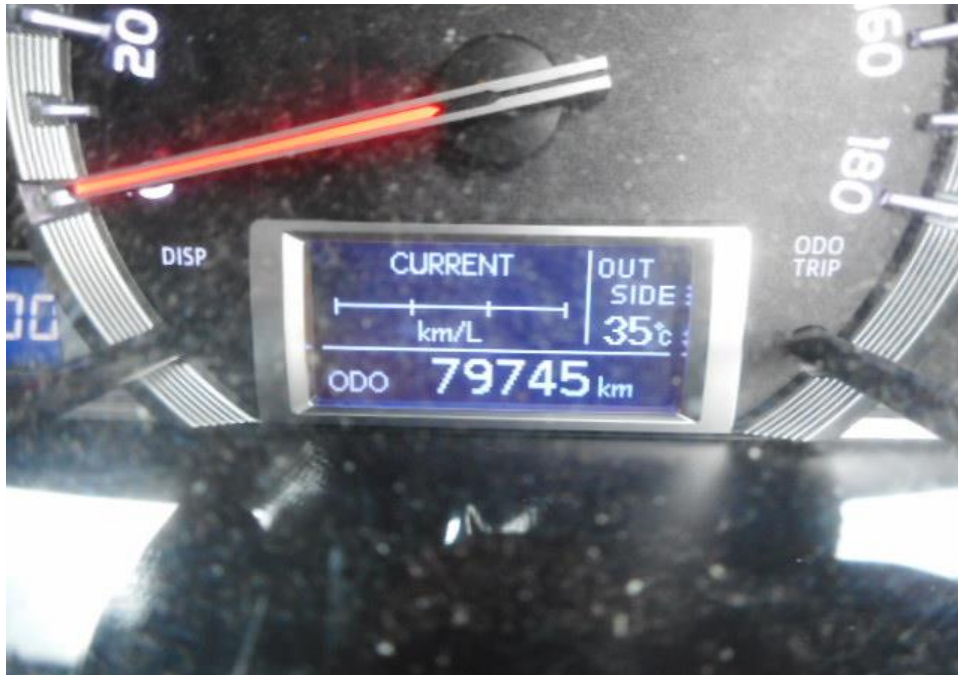
**Photo 1** shows a general view of the instrument cluster of the Motor Van at the time of my inspection. The mileage of the Motor Van was 79,745km

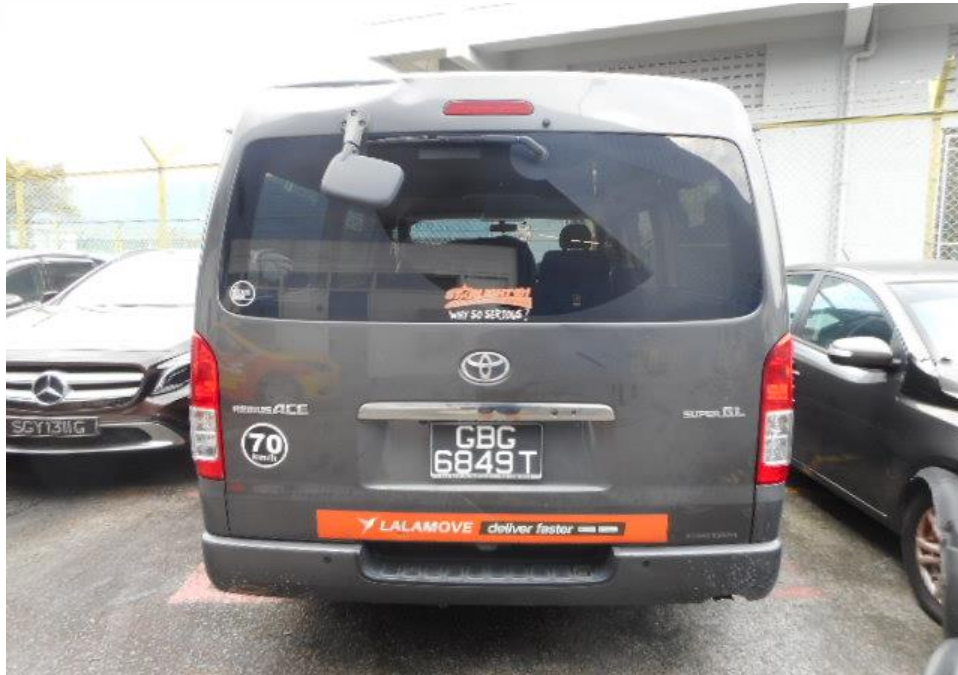
**Photo 2** shows a general view of the rear body of the Motor Van at the time of my inspection. The Motor Van was observed to be intact and unaffected by the accident.

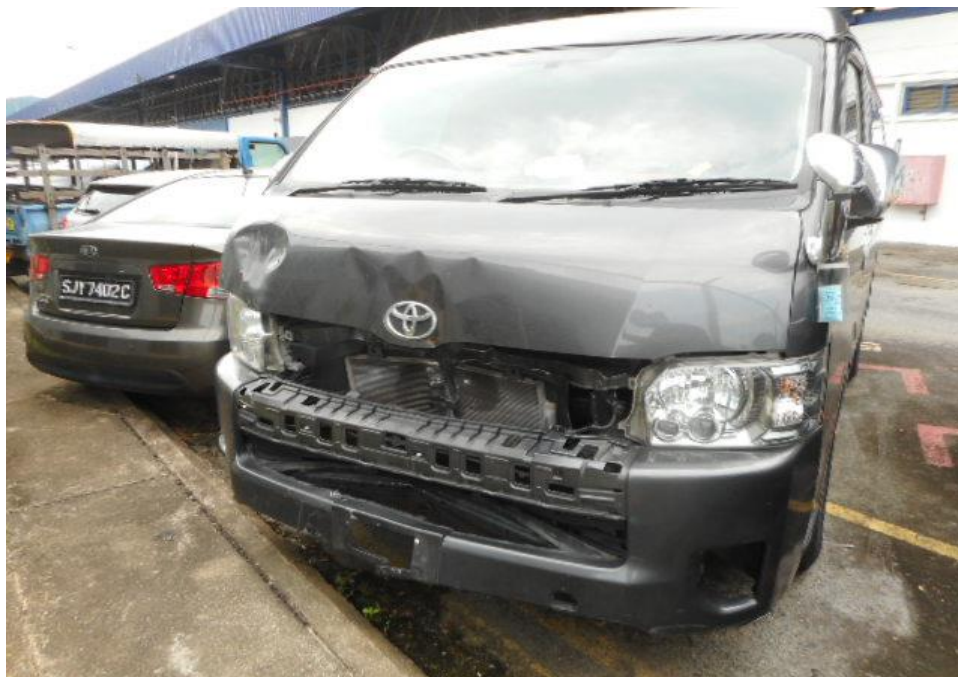
4. The mileage of the Motor Van at the time of my inspection was 79,745km.
5. The Motor Van appeared to have sustained damage at its frontal portion. Its front body panel, front bumper, front bumper reinforcement and its engine radiator were also damaged at the time of my inspection.

**Photo 3** shows a general view of the Motor Van's frontal portion at the time of my inspection. It appeared to have sustained damage at its frontal portion. Its front body panel, front bumper, front bumper reinforcement and its engine radiator were also damage at the time of my inspection.

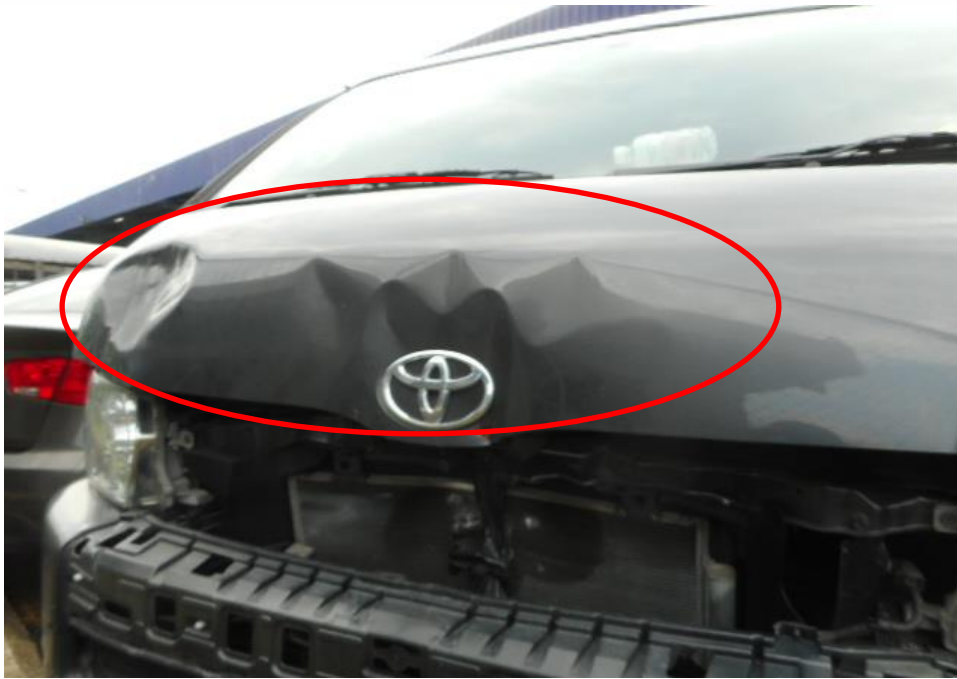
**Photo 4** shows a close up view of the Motor Van's frontal portion at the time of my inspection. It appeared to have sustained damage at its frontal portion. Its front body panel (circled) was damage at the time of my inspection as a result of the accident.

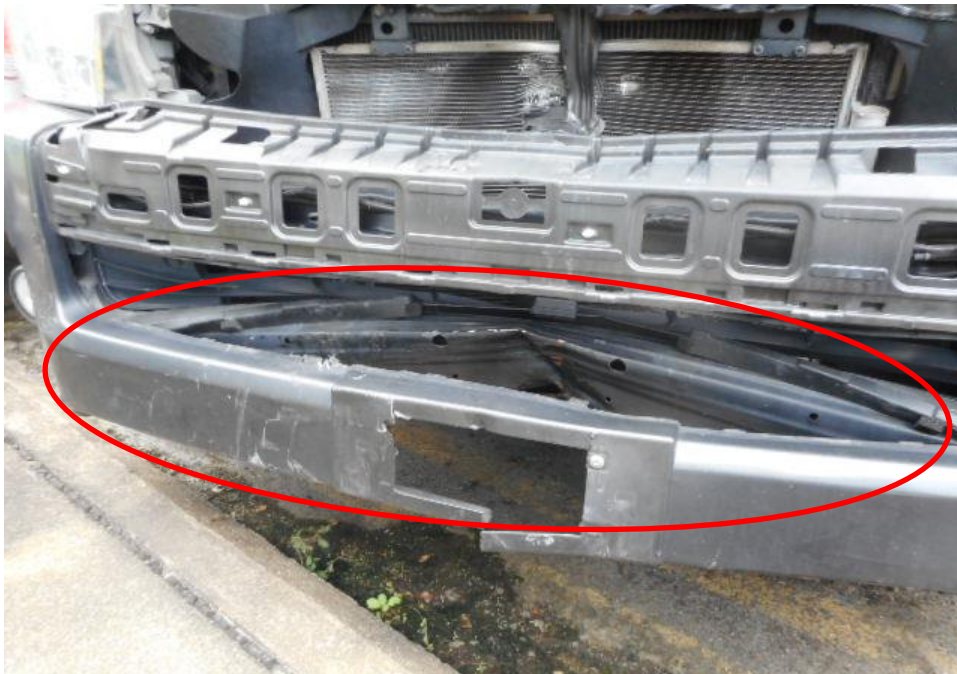
**Photo 5** shows a close up view of the Motor Van's frontal portion at the time of my inspection. It appeared to have sustained damage at its frontal portion. Its front bumper and front bumper reinforcement (circled) was damage at the time of my inspection as a result of the accident.

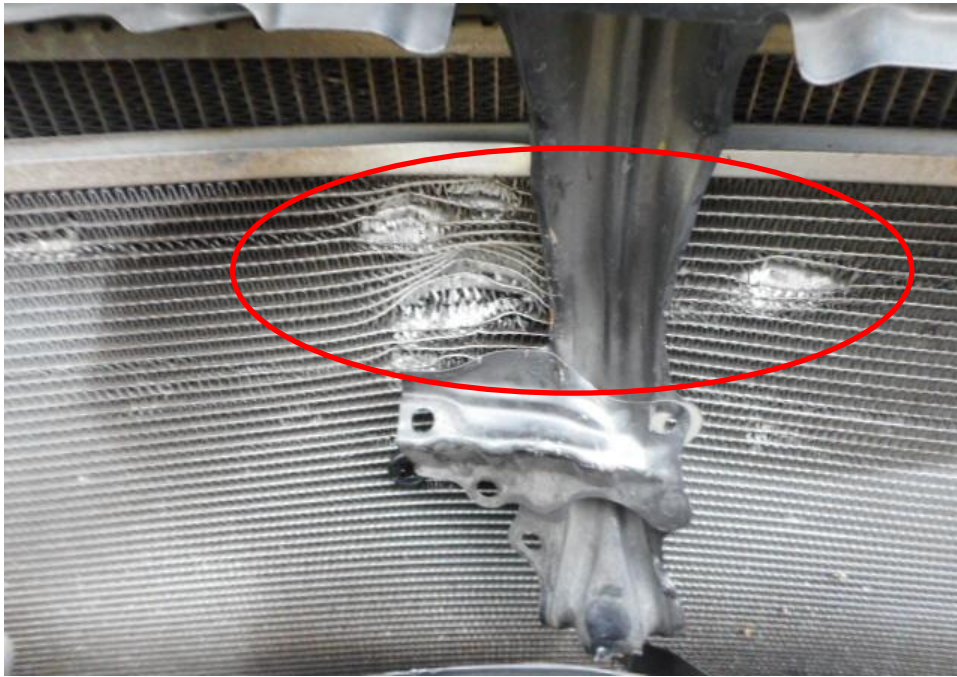
**Photo 6** shows a close up view of the Motor Van's frontal portion at the time of my inspection. It appeared to have sustained damage at its frontal portion. Its engine radiator (circled) was damage at the time of my inspection as a result of the accident.

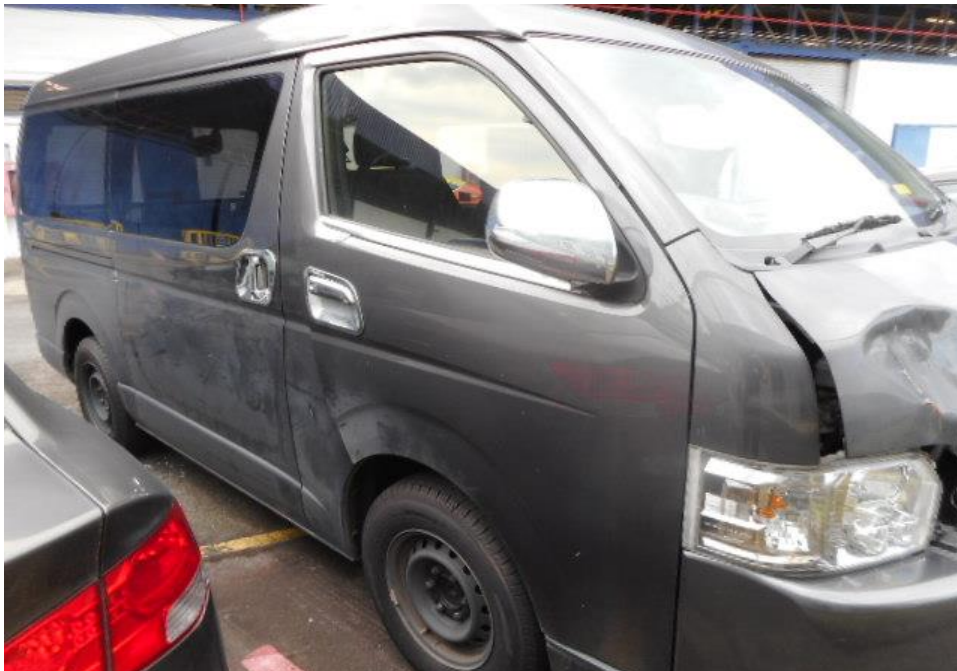
**Photo 7** shows a general view of the right body of the Motor Van at the time of my inspection. The Motor Van was observed to be intact and unaffected by the accident.

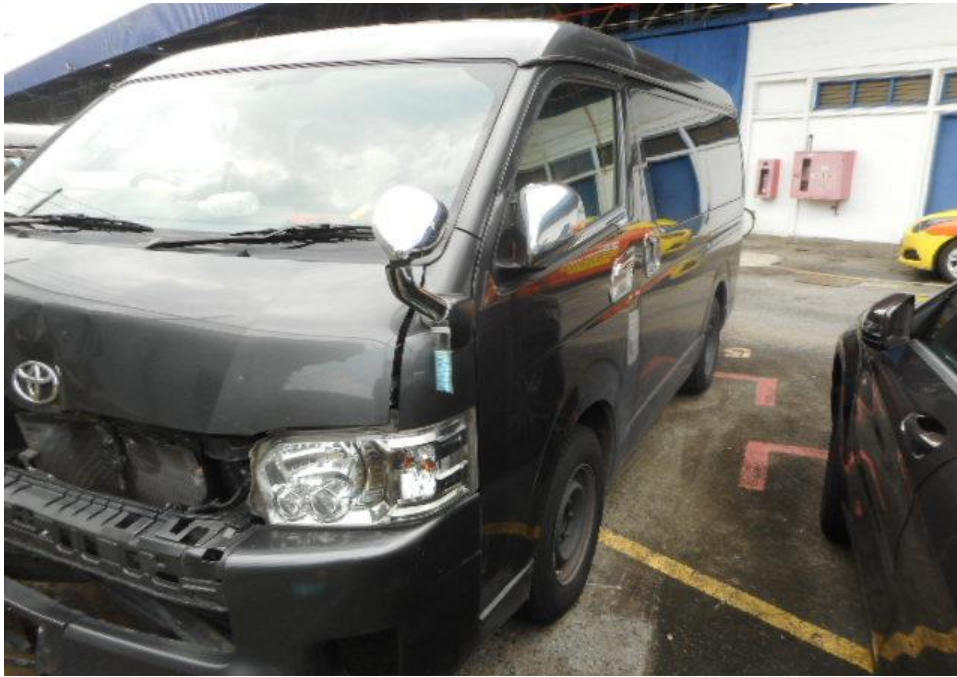
**Photo 8** shows a general view of the left body of the Motor Van at the time of my inspection. The Motor Van was observed to be intact and unaffected by the accident.

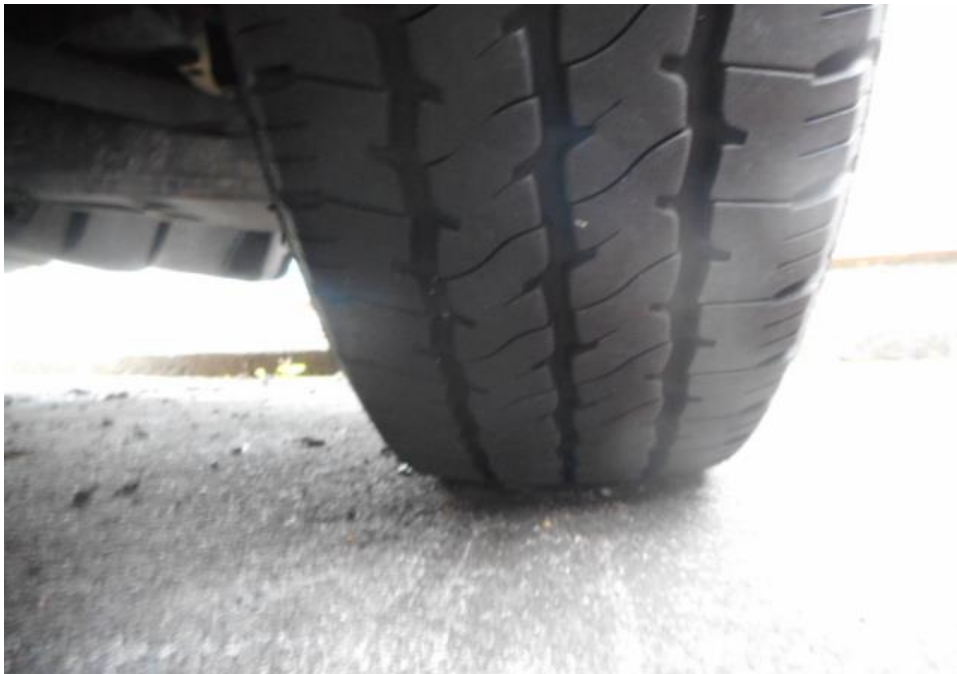
**Photo 9** shows the condition of the front right tyre of the Motor Van, which was observed to be in serviceable condition with remaining tread depth of approximately 7.4mm. The tyre, which was wrapped around standard steel wheel rim, was also observed to be sufficiently inflated for vehicular operation. There was no tear, cut or burst mark(s) on the outer and the inner sidewalls as well as across the tread of the 4 tyres that were fitted on the Motor Van.

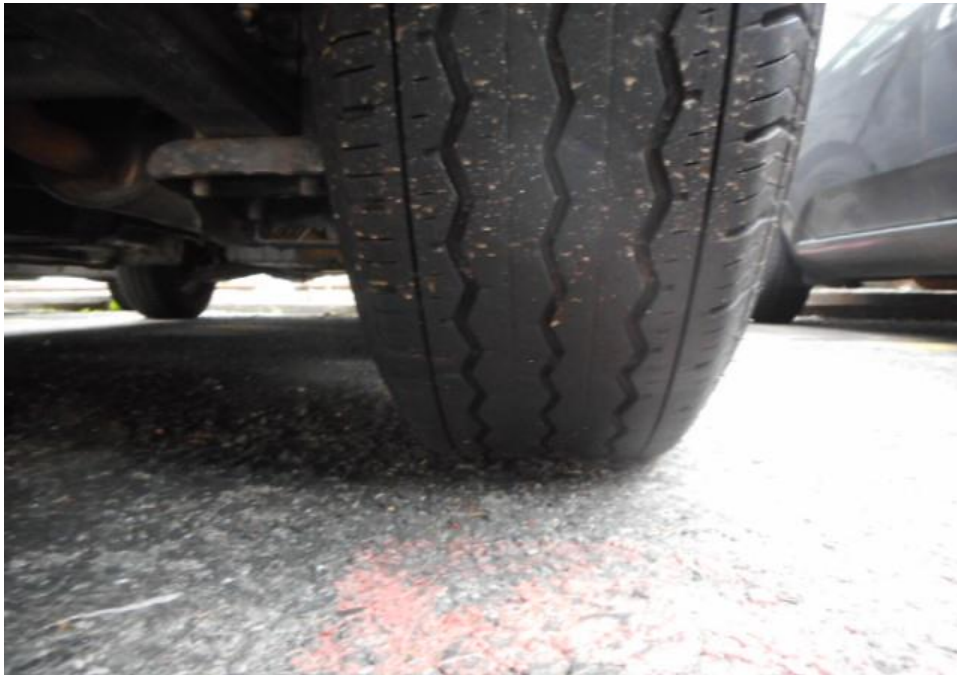
**Photo 10** shows the condition of the rear right tyre of the Motor Van, which was observed to be in serviceable condition with remaining tread depth of approximately 3mm. The tyre, which was wrapped around standard steel wheel rim, it was observed to be sufficiently inflated for vehicular operation.

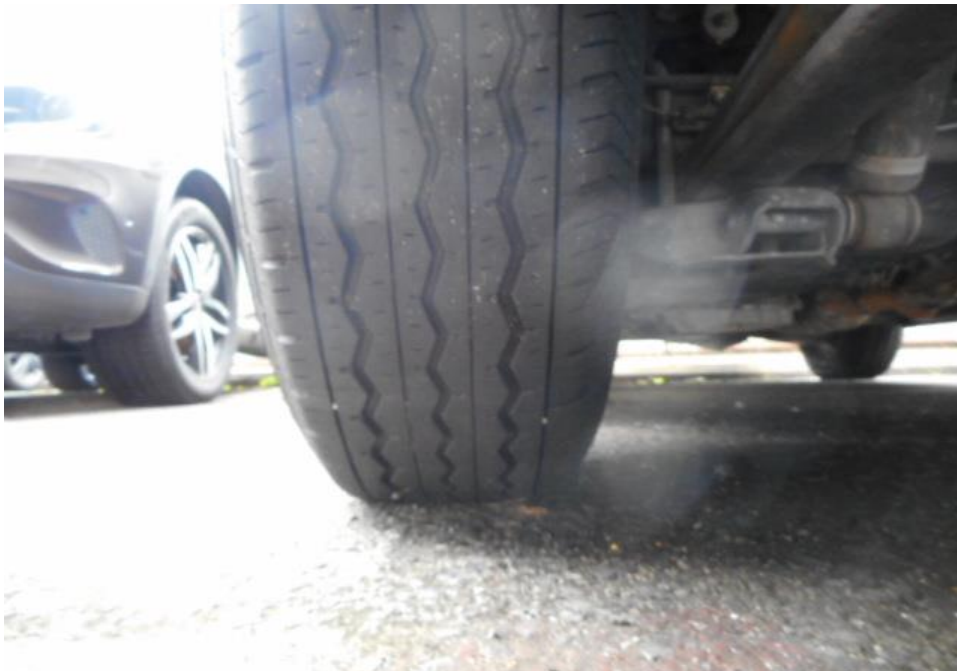
**Photo 11** shows the condition of the rear left tyres of the Motor Van, which was observed to be in serviceable condition with remaining tread depth of approximately 4.3mm. The tyres, which were wrapped around standard steel wheel rim, were also observed to be sufficiently inflated for vehicular operation. There was also no damage found on all 4 steel wheel rims of the Motor Van.

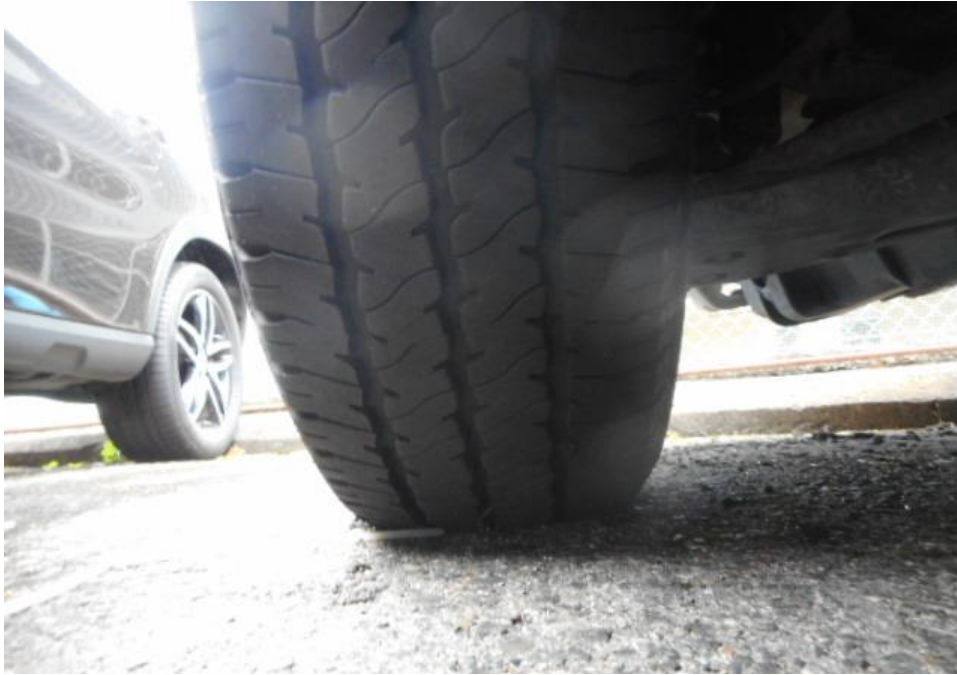
**Photo 12** shows the condition of the rear right tyres of the Motor Van, which were observed to be in serviceable condition with remaining, tread depth of approximately 7.2mm. There was also no tear, cut or burst mark(s) on the outer and the inner sidewalls as well as across the tread of the 4 tyres that were fitted on the Motor Van.

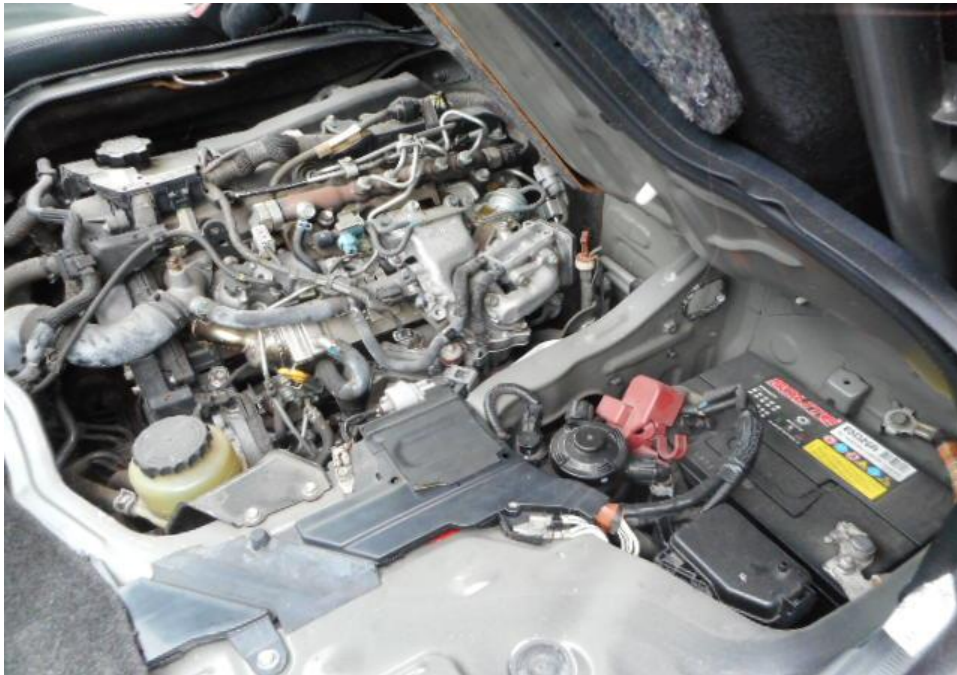
8. Upon examination of the Motor Van's engine compartment, I had observed the engine radiator and its engine coolant reservoir to be damaged by the accident. However, all the other parts and components inside the engine compartment to be intact and unaffected by the accident. The engine coolant was observed to be insufficient due to the damage to the engine radiator and its engine coolant reservoir that had caused the leakage of the coolant. The brake fluid and engine oil were all found to be of sufficient level for operating purposes. Visually, there was also no contamination found to these fluids.

**Photo 13** shows a general view of the Motor Van's engine compartment, which was accessed by lifting the front cabin of the Motor Van. I had observed the engine radiator and its engine coolant reservoir to be damaged by the accident. However, the other various parts and components inside the engine compartment were unaffected by the accident. There was also no sign(s) or indication(s) of fresh fluid leakage and/or fluid stain within the engine compartment.

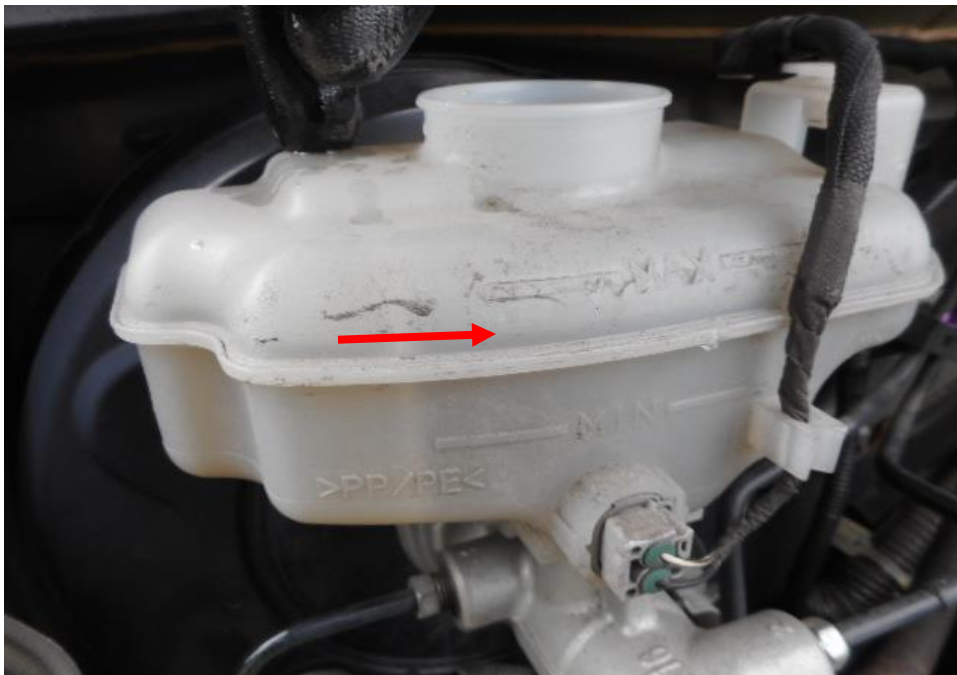
**Photo 14** shows the brake fluid reservoir of the Motor Van at the time of my inspection. The brake fluid was observed to be of sufficient level (arrowed) and without any visible contamination.

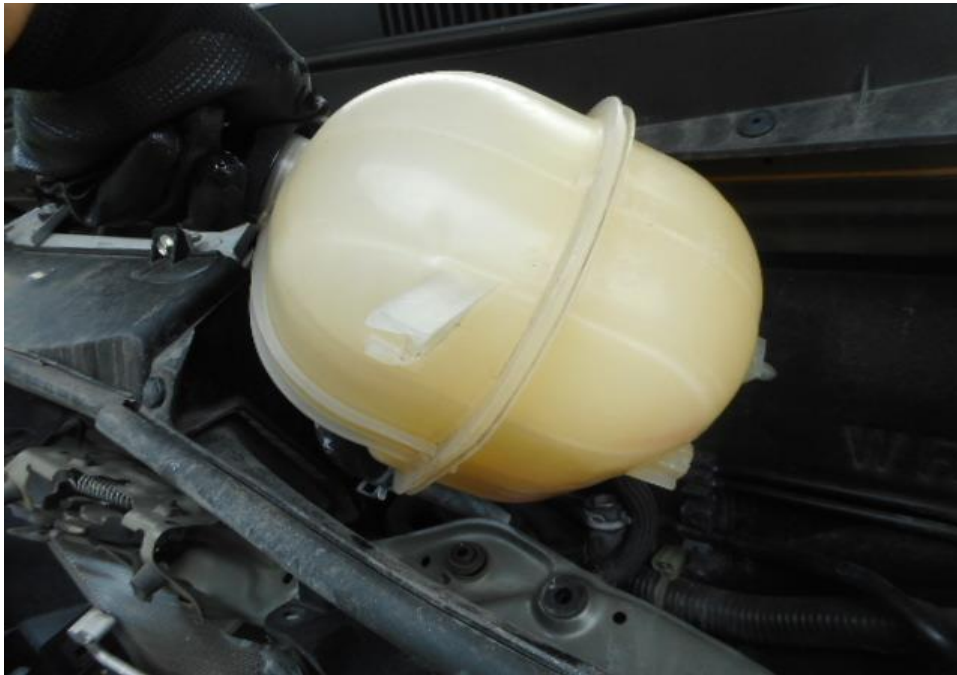
**Photo 15** shows the engine coolant reservoir of the Motor Van at the time of my inspection. The engine coolant was observed to be of insufficient as the coolant reservoir was damaged as a result of the accident.

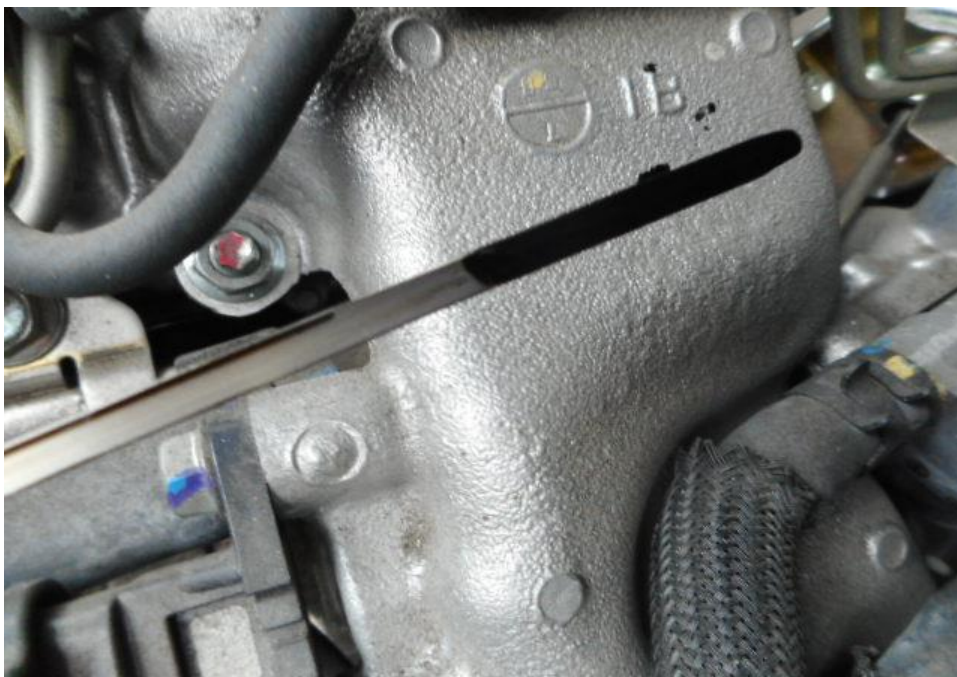
**Photo 16** shows the engine oil dip stick of the Motor Van at the time of my inspection. The engine oil was observed to be of sufficient level and without any visible contamination.

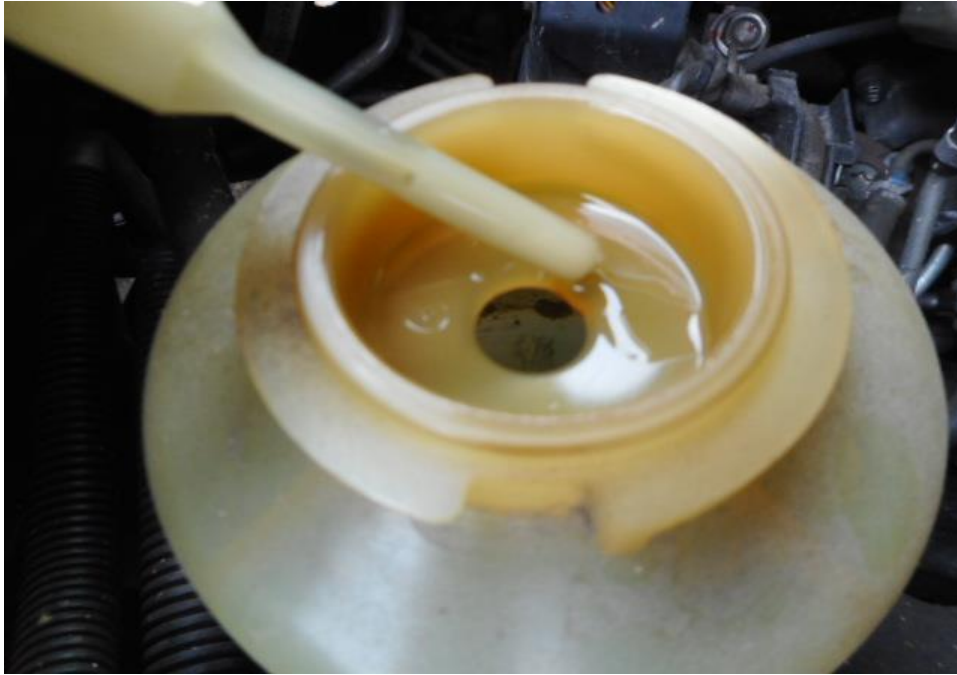
**Photo 17** shows the power steering fluid reservoir of the Motor Van at the time of my inspection. The power steering fluid was observed to be of sufficient level and without any visible contamination.

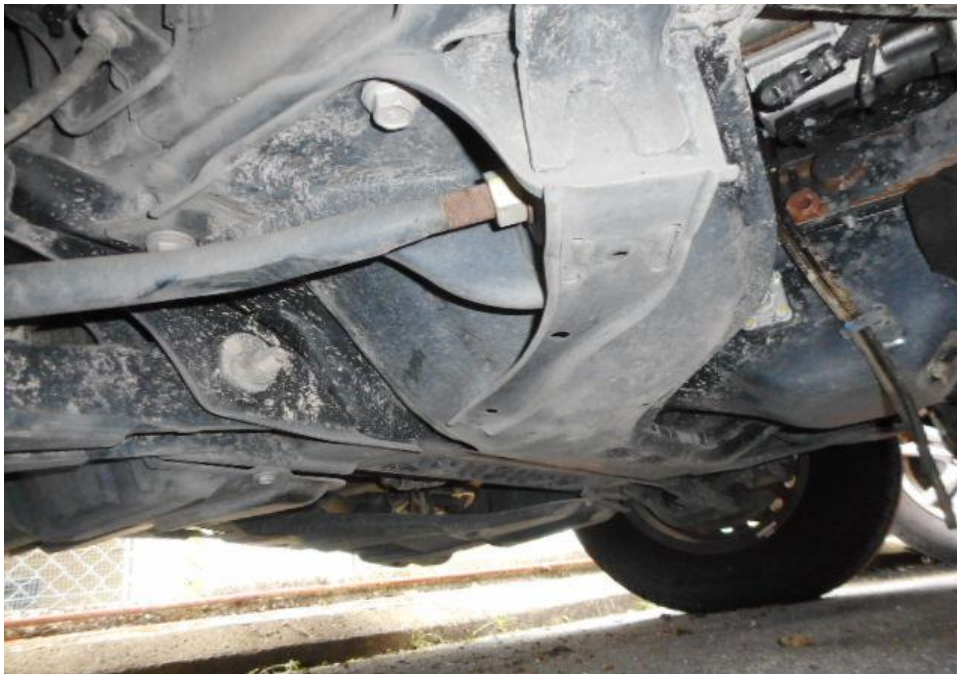
**Photo 18** shows the undercarriage of the Motor Van, at the area where the engine housing and transmission housing are located. . I did not find any sign(s) or indication(s) of fluid leak and/or fluid stain(s) on the underside of the Motor Van.

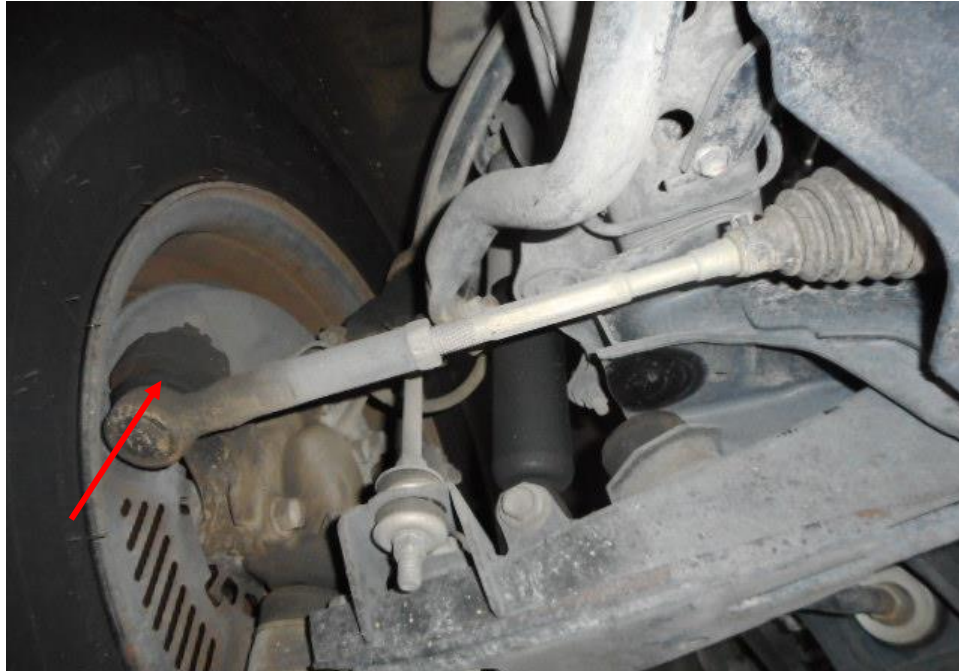
**Photo 19** shows the various undercarriage components at the front right wheel of the Motor Van, in particular the steering tie rod end (arrowed). The various steering components were all found to be intact, suggesting that the steering system of the Motor Van was likely to be in serviceable condition at the material time of accident. There was also no sign of fluid stain(s) observed on the various undercarriage components.

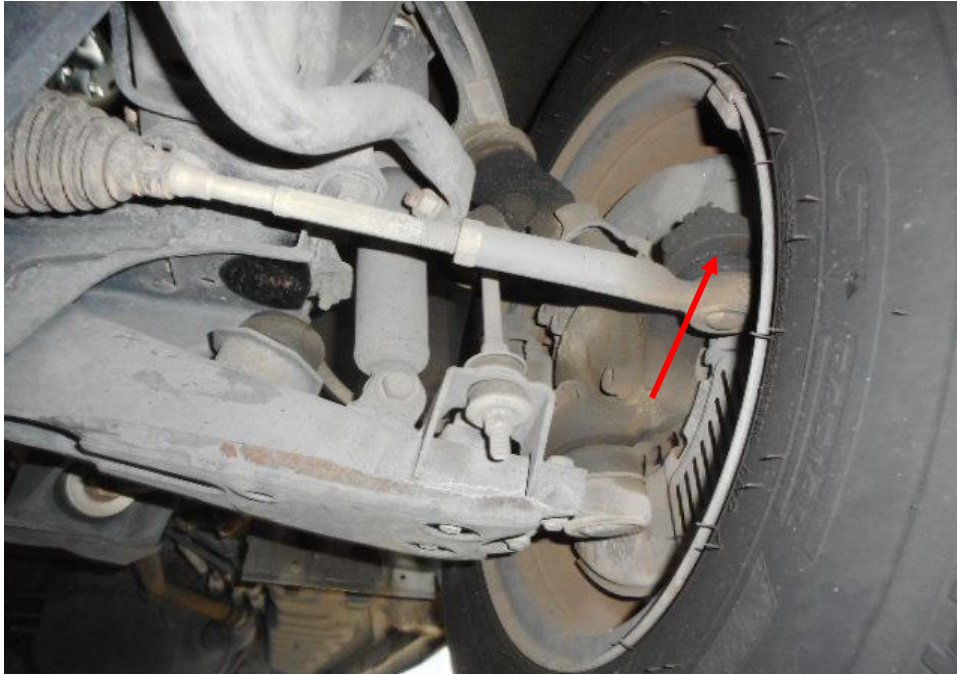
**Photo 20** shows the various undercarriage components at the front left wheel of the Motor Van, in particular the steering tie rod end (arrowed). The various undercarriage components of the Motor Van were all found to be intact without any visible damage. There was also no sign of fluid stain(s) observed on the various undercarriage components.

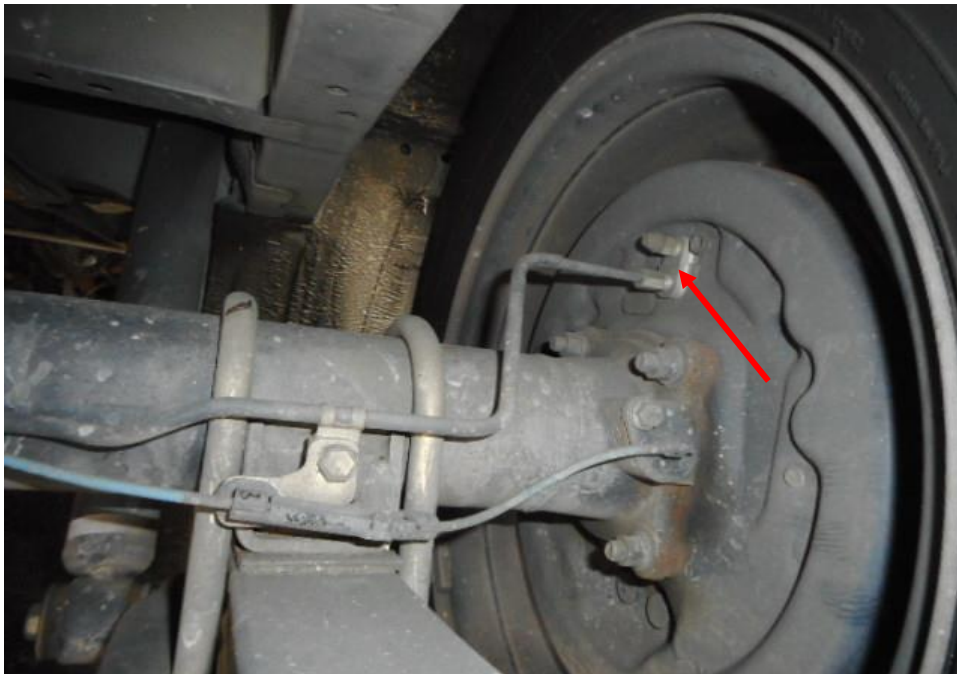
**Photo 21** shows the brake pipe (arrowed) at the rear right wheel of the Motor Van. I did not observe any leakage of brake fluid at the time of my inspection of the Motor Van. My static tests of the Motor Van's braking system, along with my visual examination of the various mechanical components in the braking system, had indicated that there was no internal leakage of pressure/vacuum. Hence the braking system of the Motor Van was likely to be in serviceable condition at the material time of accident.

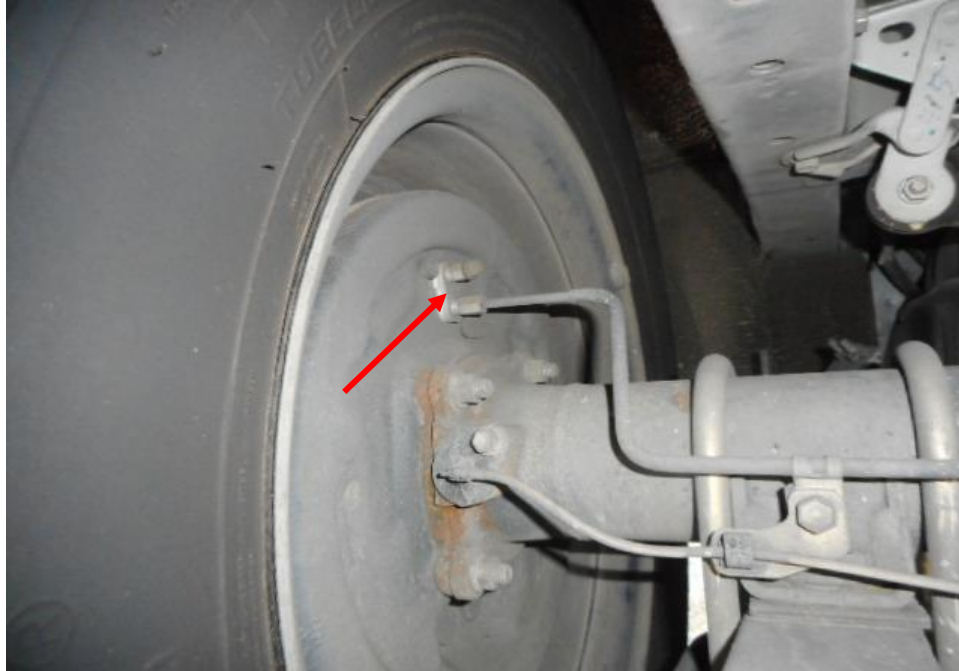
**Photo 22** shows the brake pipe (arrowed) at the rear left wheel of the Motor Van. I did not observe any leakage of brake fluid at the time of my inspection of the Motor Van. My static tests of the Motor Van's braking system, along with my visual examination of the various mechanical components in the braking system had indicated that there was no internal leakage of pressure/vacuum. Hence the braking system of the Motor Van was likely to be in serviceable condition at the material time of accident.

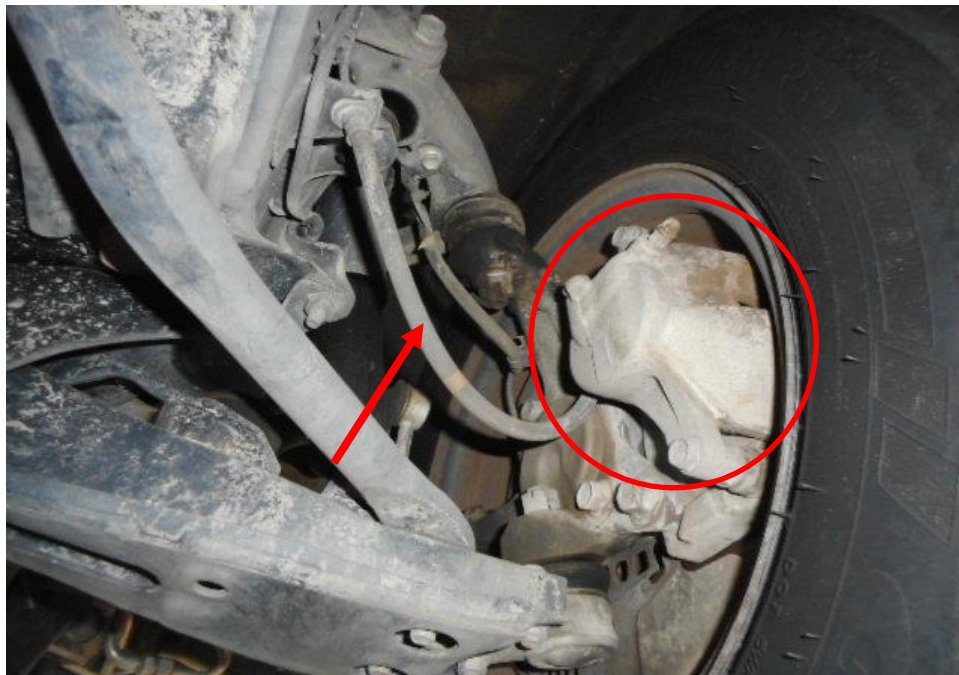
**Photo 23** shows the brake hose/pipe (arrowed) at the front right wheel of the Motor Van. No leakage of brake fluid was observed. Visual examination of the various components of the braking system like the brake caliper (circled), brake booster, brake pedal etc had revealed all to be intact and without visible damage at the time of accident. There was also no sign of fluid stain(s) observed on the various undercarriage components.

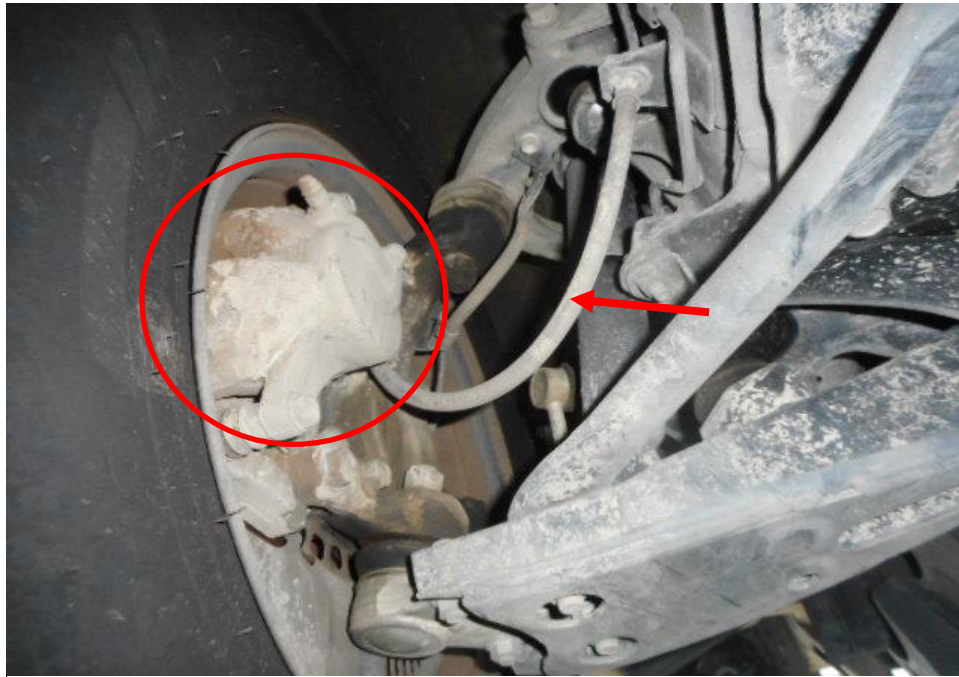
**Photo 24** shows the brake hose/pipe (arrowed) at the front left wheel of the Motor Van. No leakage of brake fluid was observed. Visual examination of the various components of the braking system like the brake caliper (circled), brake booster, brake pedal etc had revealed all to be intact and without visible damage at the time of accident. There was also no sign of fluid stain(s) observed on the various undercarriage components.

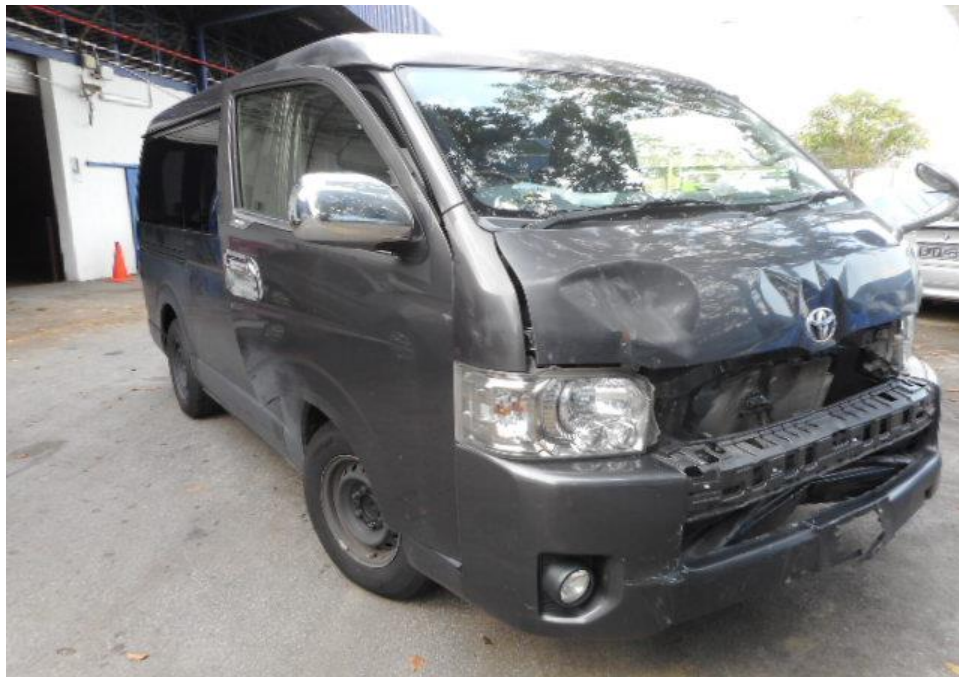
**Photo 25** shows the front right wheel of the Motor Van turned to its full left. During my steering system test, I did not experience any abnormal free play and/or resistance when I had turned the steering wheel towards full left and full right. This would suggest that the steering system of the Motor Van was likely to be in serviceable condition at the material time of accident.

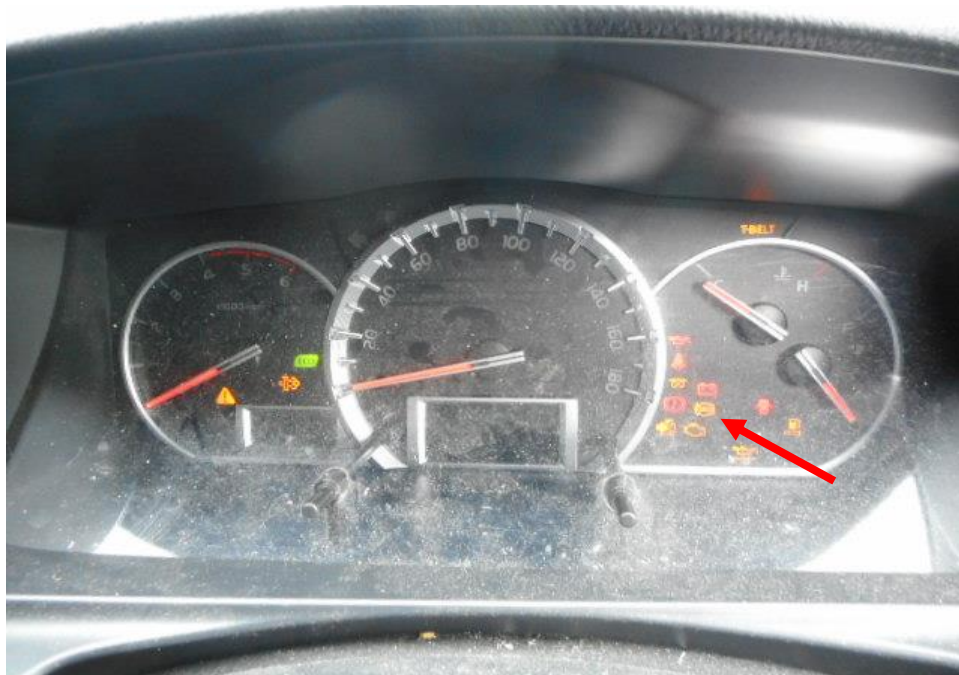
**Photo 26** shows the warning light for Anti-Lock Brake System (ABS) (arrowed) appearing on the instrument panel of the Motor Van during the self-test of its various electronic operating systems when its engine was cranked.

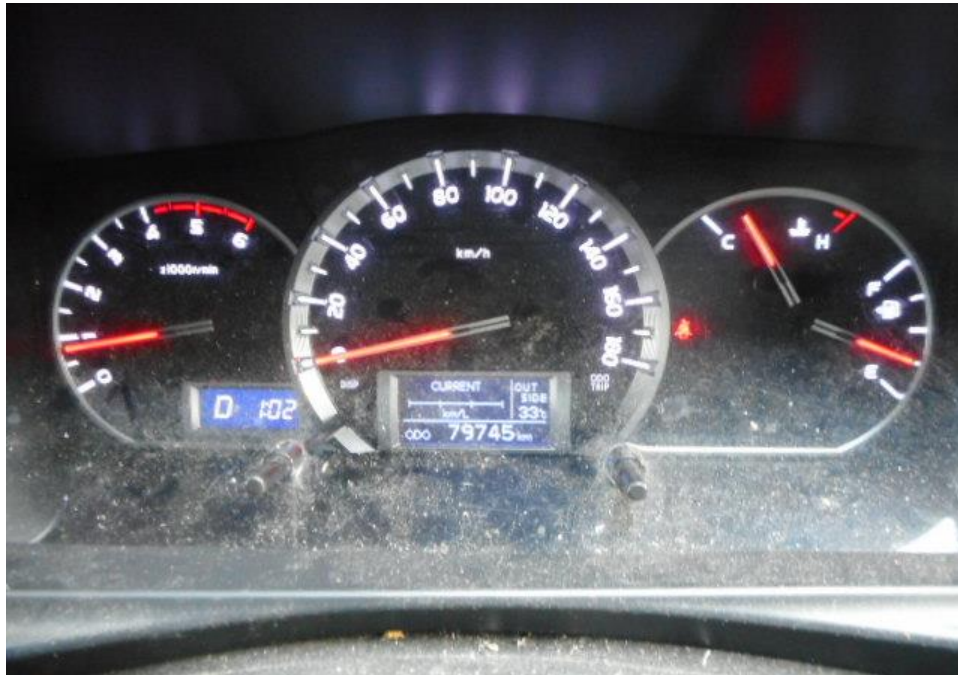
**Photo 27** shows no warning lights illuminated on the instrument panel of the Motor Van after the engine was cranked. This would suggest that there was no abnormality to the electronic operating system of the Motor Van, like the ABS and etc.
