Your Ref: TP/IP/48709/2021  
Our Ref : CI/TPD21011276/P

**Fatal Accident Investigation Team**

**MECHANICAL INSPECTION REPORT OF MOTOR LORRY, XD 568Z**

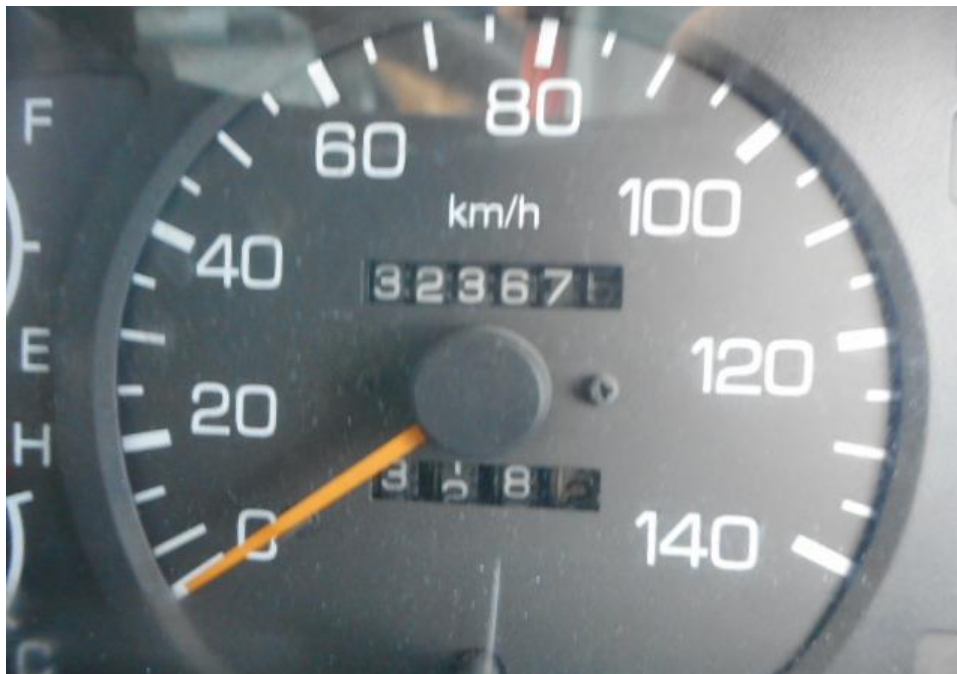
4. The mileage of the Motor Lorry at the time of my inspection was 323,675km.
5. The Motor Lorry was observed to sustained damage at its rear portion. Its rear left brake lamp and rear body panel were damage at the time of my inspection as a result of the accident.

**Photo 1** shows a general view of the instrument cluster of the Motor Lorry at the time of my inspection. The mileage of the Motor Lorry was 323,675km

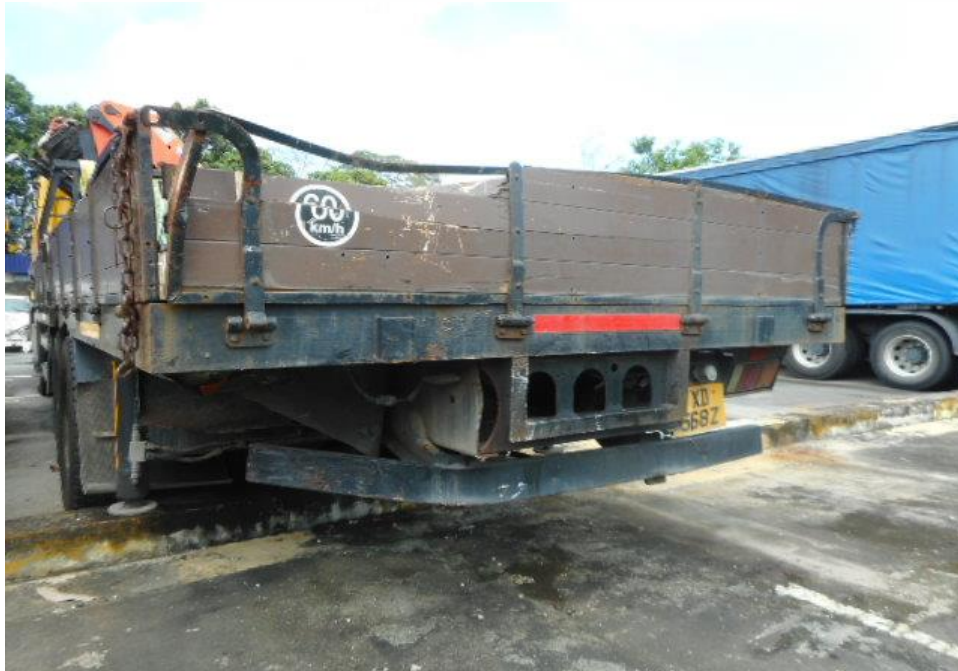
**Photo 2** shows a general view of the Motor Lorry's rear body at the time of my inspection. The Motor Lorry was observed to sustained damage at its rear portion. Its rear left brake lamp and rear body panel were damage at the time of my inspection as a result of the accident.

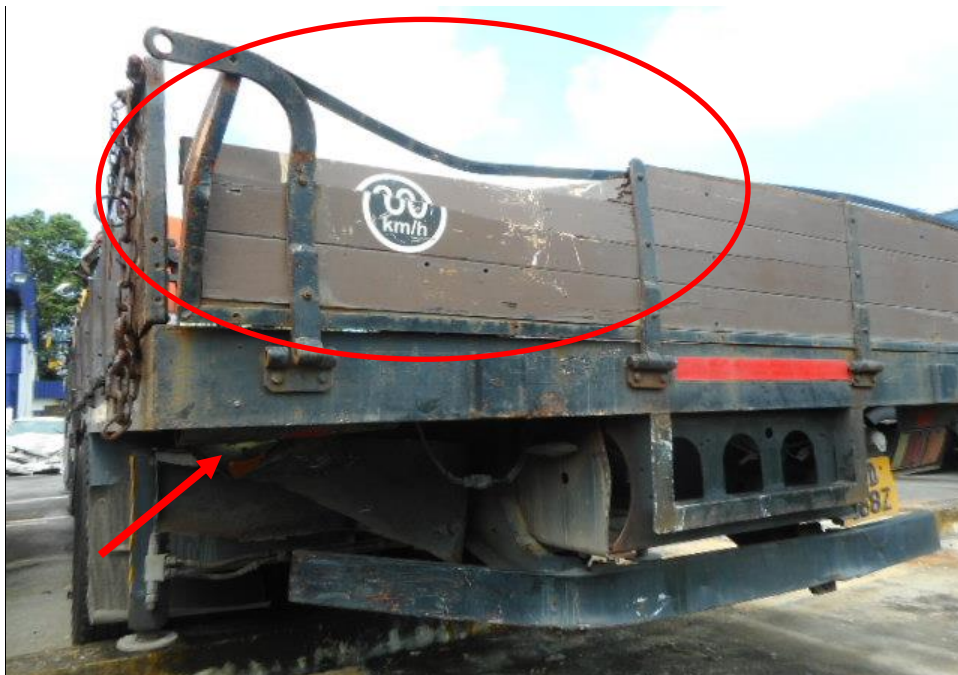
**Photo 3** shows a close up view of the Motor Lorry's rear body at the time of my inspection. The Motor Lorry was observed to sustained damage at its rear portion. Its rear right brake lamp (arrowed) and rear body panel (circled) were damage at the time of my inspection as a result of the accident.

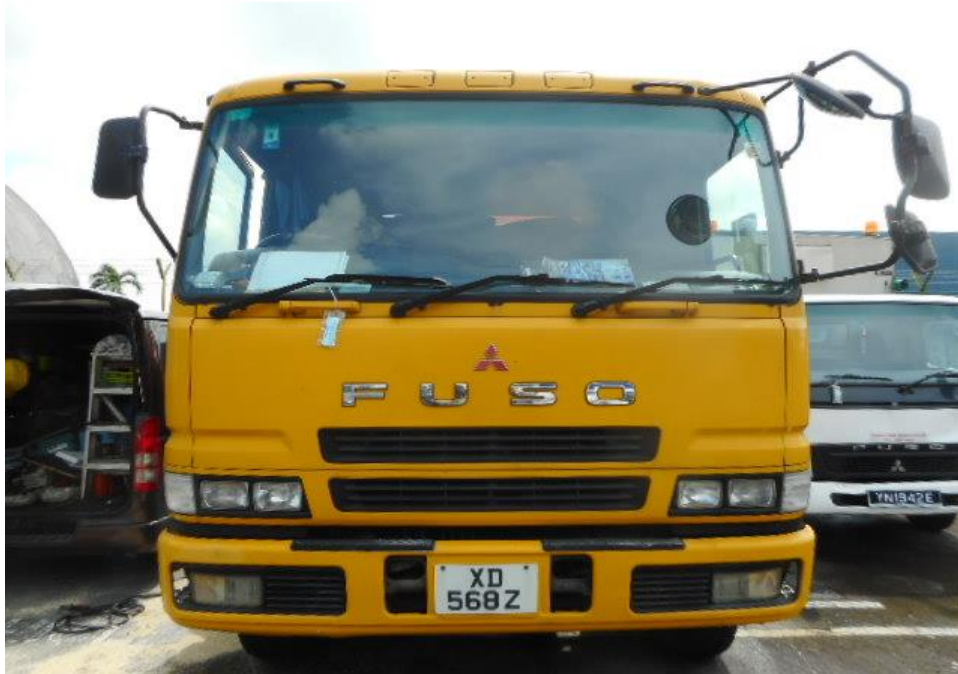
**Photo 4** shows a general view of the front body of the Motor Lorry at the time of my inspection. The Motor Lorry was observed to be intact and unaffected by the accident.

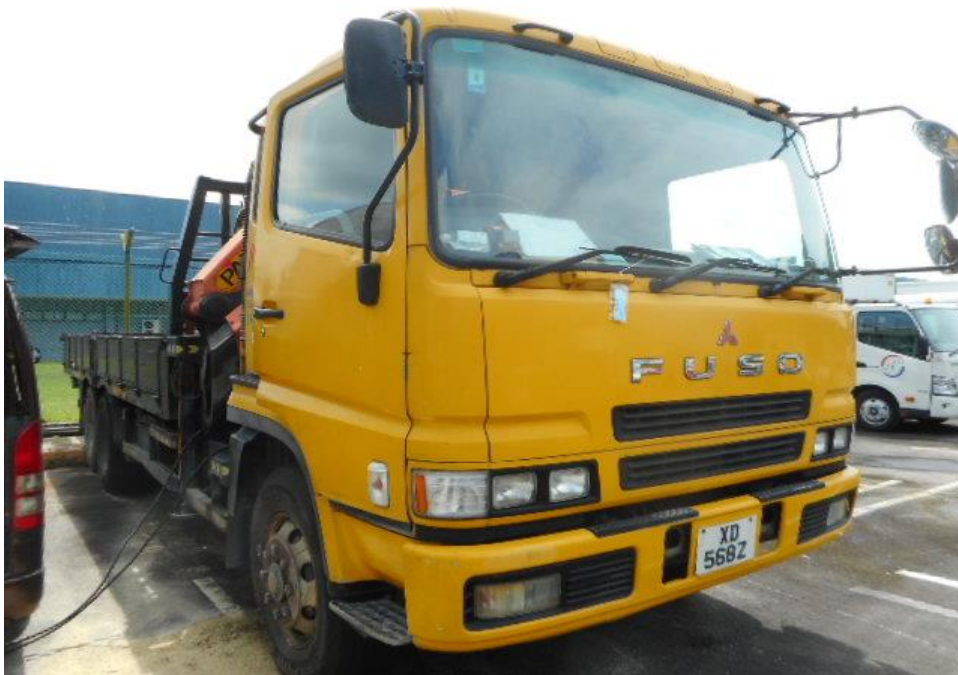
**Photo 5** shows a general view of the right body of the Motor Lorry at the time of my inspection. The Motor Lorry was observed to be intact and unaffected by the accident.

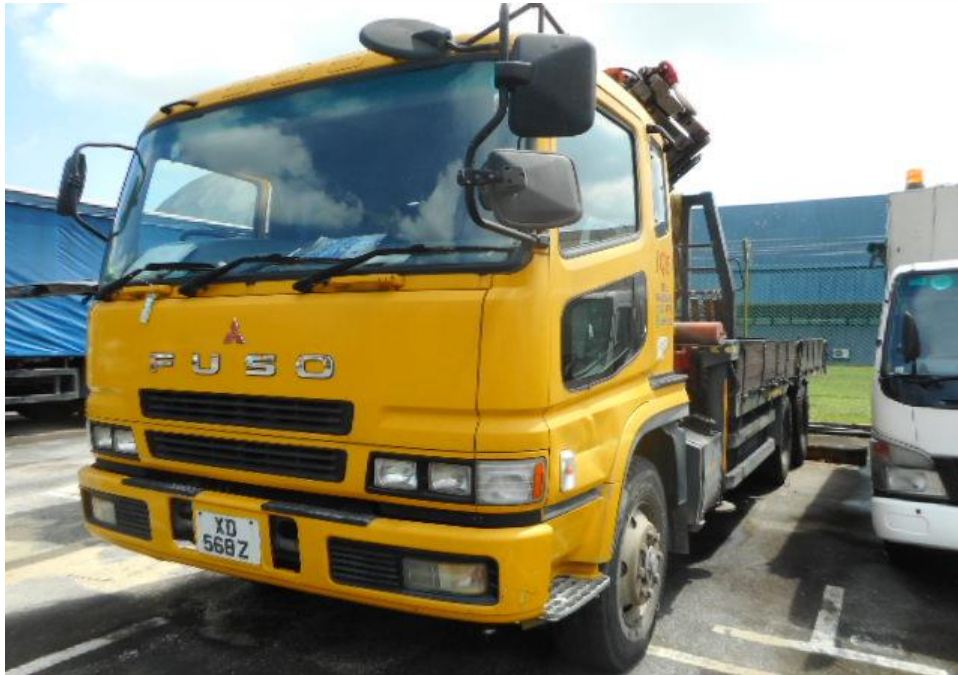
**Photo 6** shows a general view of the left body of the Motor Lorry at the time of my inspection. The Motor Lorry was observed to be intact and unaffected by the accident.

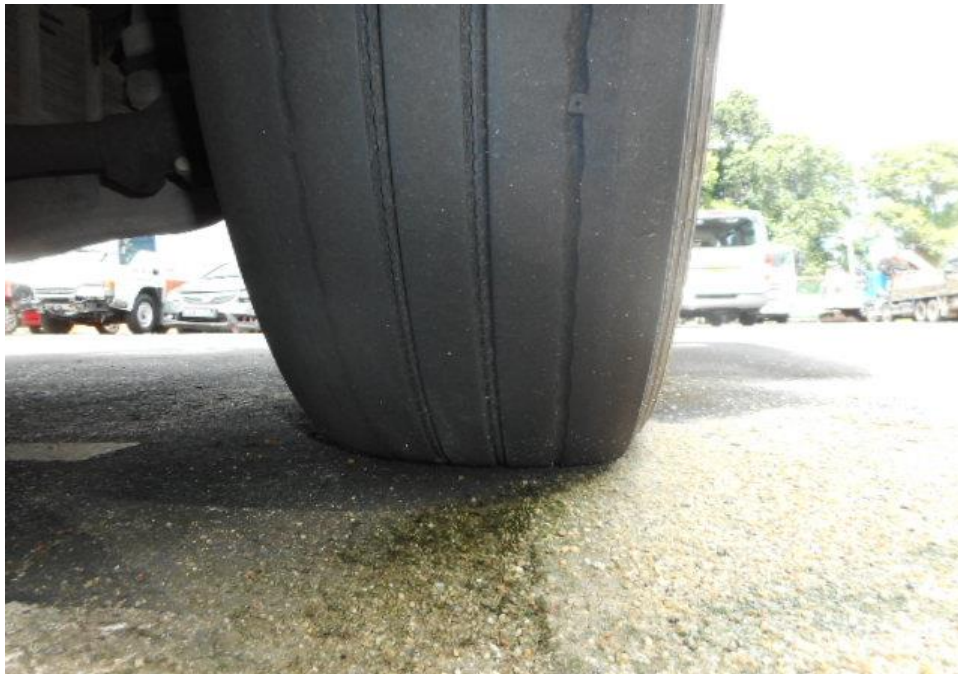
**Photo 7** shows the condition of the front right tyre of the Motor Lorry, which was observed to be in serviceable condition with remaining tread depth of approximately 4.5mm. The tyre, which was wrapped around standard steel wheel rim, was also observed to be sufficiently inflated for vehicular operation. There was no tear, cut or burst mark(s) on the outer and the inner sidewalls as well as across the tread of the 10 tyres that were fitted on the Motor Lorry.

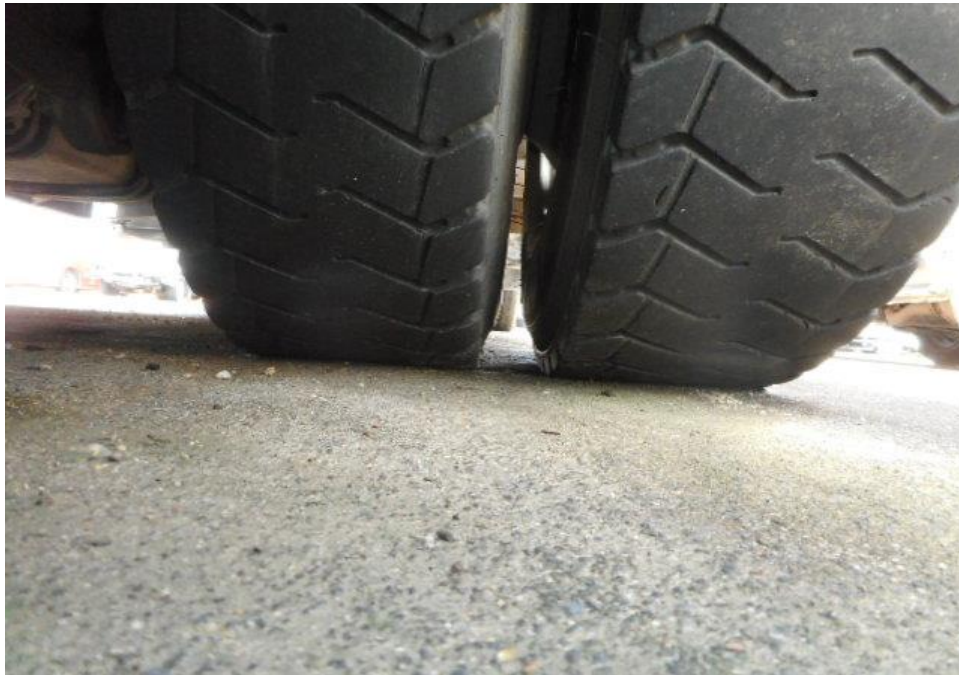
**Photo 8** shows the condition of the rear right tyre of the Motor Lorry, which was observed to be in serviceable condition with remaining tread depth of approximately 4.5mm. The tyre, which was wrapped around standard steel wheel rim, was also observed to be sufficiently inflated for vehicular operation.

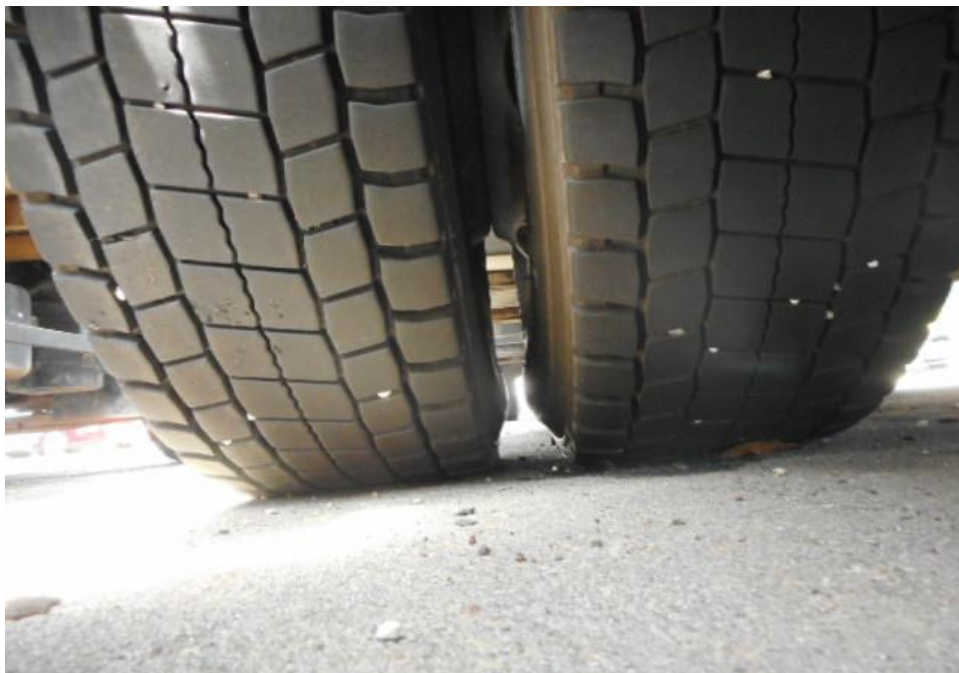
**Photo 9** shows the condition of the rear left tyre of the Motor Lorry, which was observed to be in serviceable condition with remaining tread depth of approximately 3.8mm. The tyre, which was wrapped around standard steel wheel rim, was also observed to be sufficiently inflated for vehicular operation.

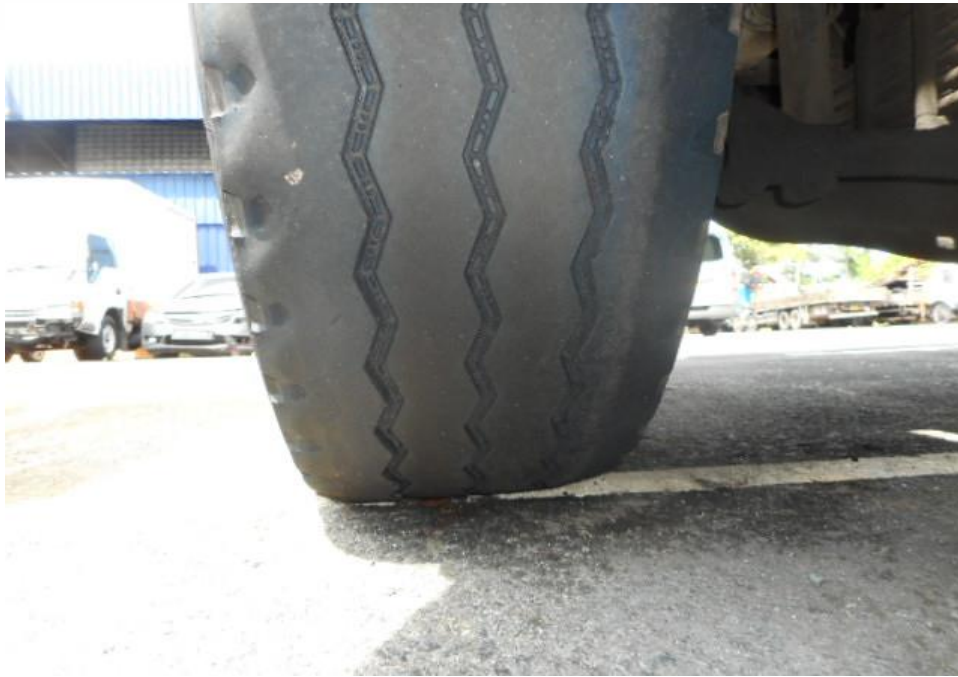
**Photo 10** condition of the front left tyre of the Motor Lorry, which was observed to be in serviceable condition with remaining tread depth of approximately 3mm. The tyre, which was wrapped around standard steel wheel rim, was also observed to be sufficiently inflated for vehicular operation.

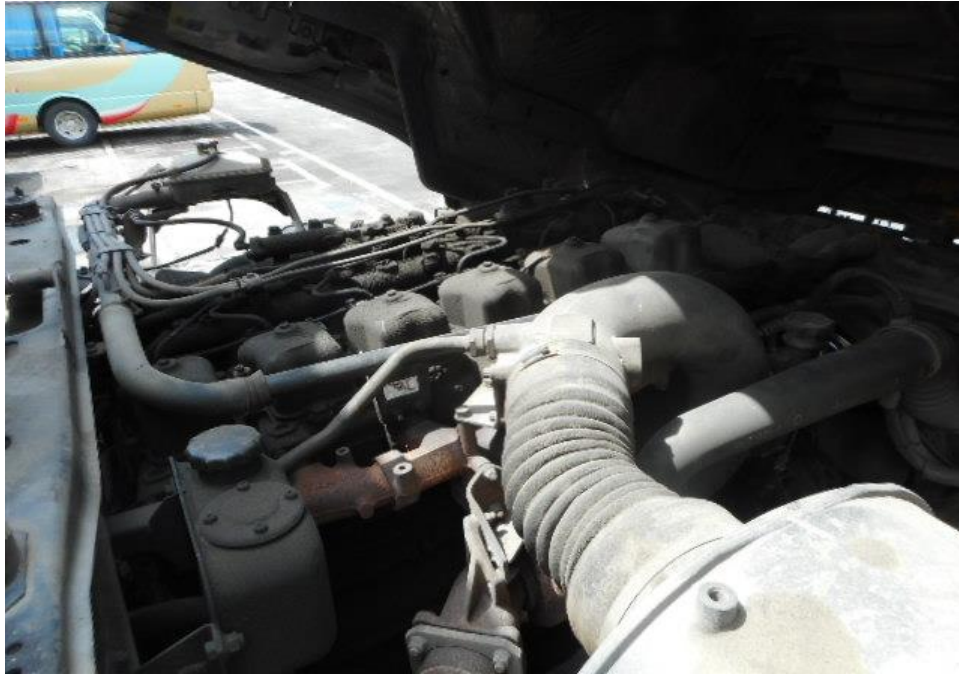
**Photo 11** shows a general view of the Motor Lorry's engine compartment, which was accessed by lifting the front cabin of the Motor Lorry. The various parts and components inside the engine compartment were unaffected by the accident. There was also no sign(s) or indication(s) of fresh fluid leakage and/or fluid stain within the engine compartment

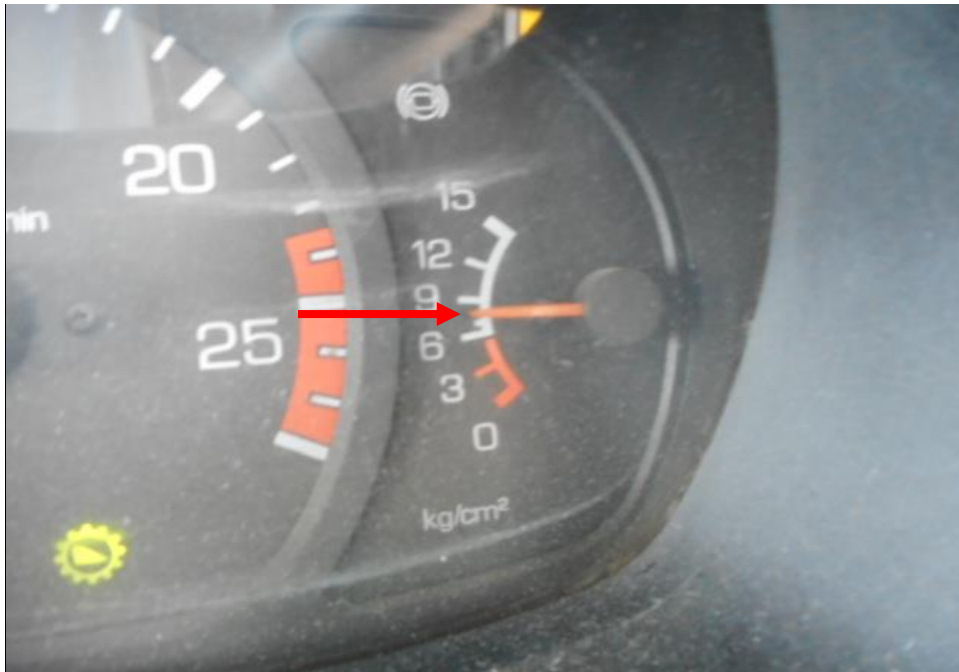
**Photo 12** shows the air in the air brake cylinders of the Prime Mover at the time of my inspection. The air in the cylinder was observed to be of sufficient level & serviceable at the time of the accident.

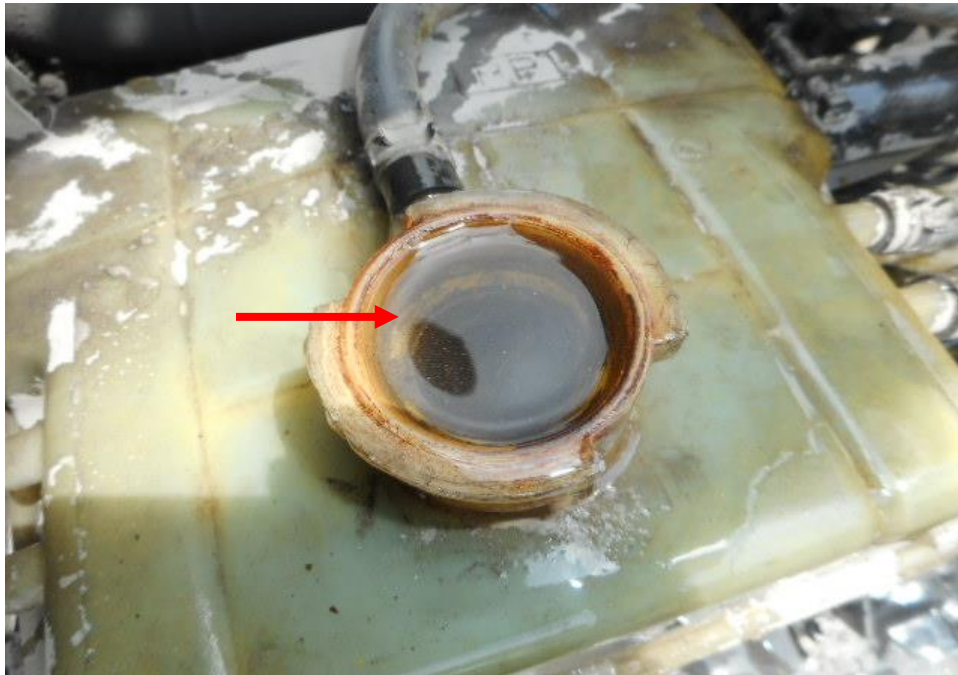
**Photo 13** shows the engine coolant reservoir of the Motor Lorry at the time of my inspection. The engine coolant was observed to be of sufficient level (arrowed) and without any visible contamination.

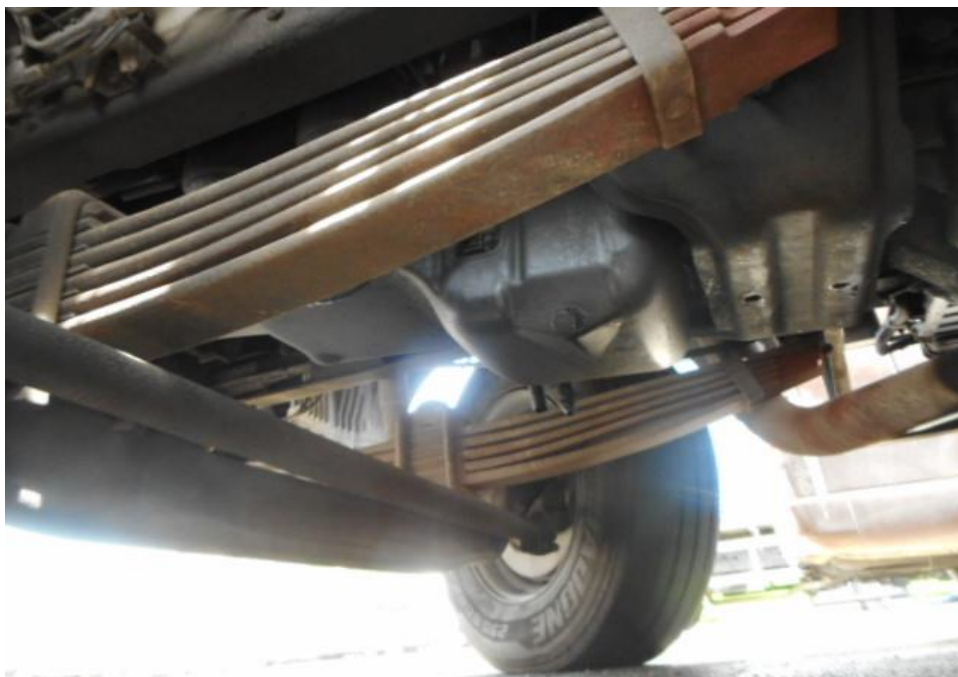
**Photo 16** shows the undercarriage of the Motor Lorry, at the area where the engine housing and transmission housing are located. I did not find any sign(s) or indication(s) of fluid leak and/or fluid stain(s) on the underside of the Motor Lorry.

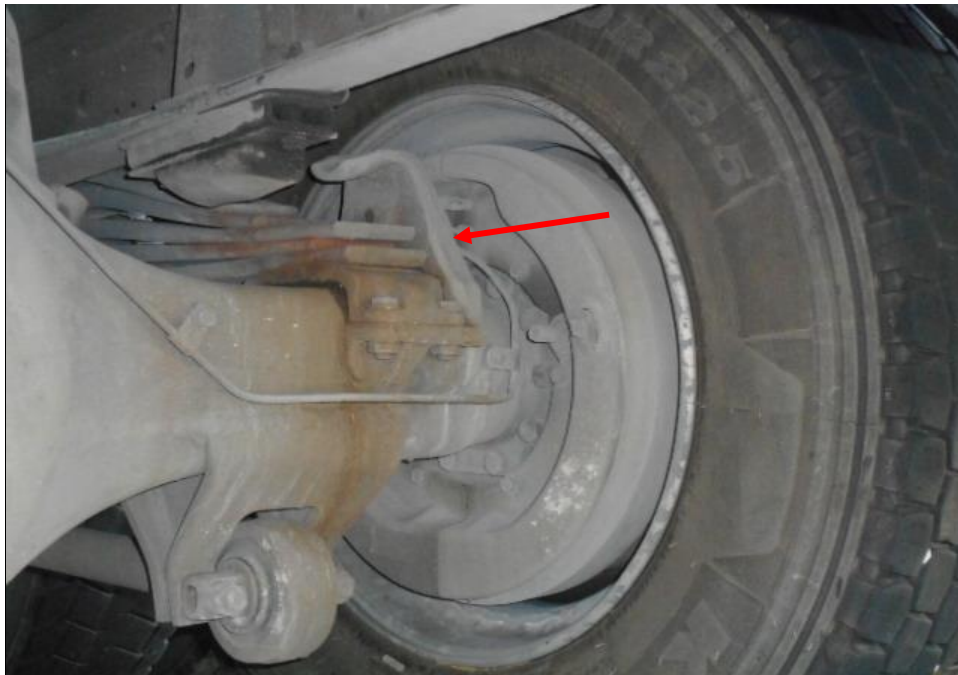
**Photo 17** shows the brake pipe (arrowed) at the rear right wheel of the Motor Lorry. I did not observe any leakage of brake fluid at the time of my inspection of the Motor Lorry. My visual examination of the various mechanical components in the braking system, had indicated that these was no internal leakage of pressure/vacuum and these components were generally in good condition.

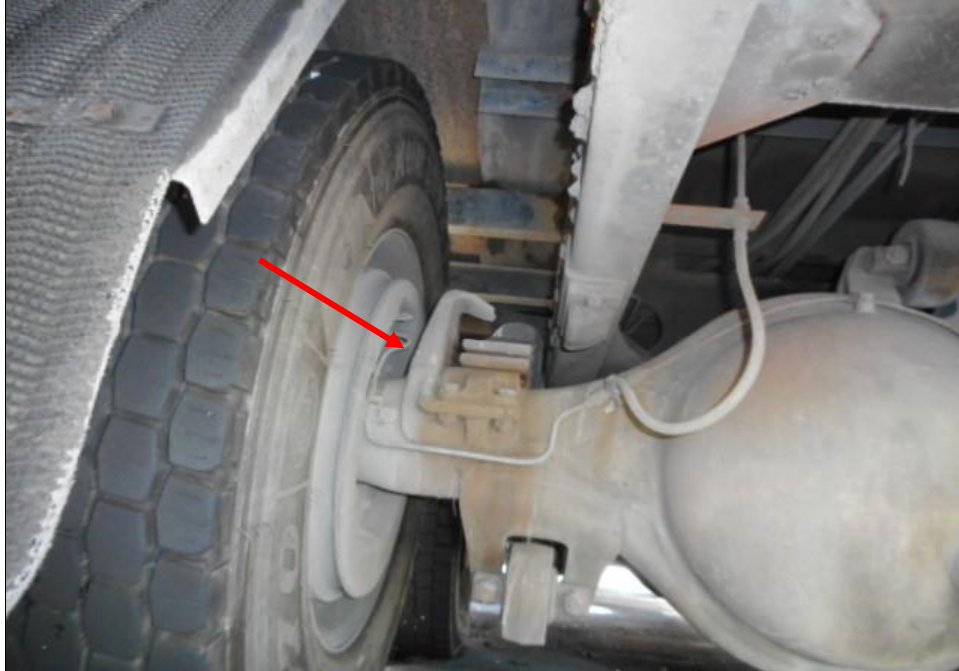
**Photo 18** shows the brake pipe (arrowed) at the rear left wheel of the Motor Lorry. I did not observe any leakage of brake fluid at the time of my inspection of the Motor Lorry. My static tests of the Motor Lorry's braking system, along with my visual examination of the various mechanical components in the braking system, had indicated that there was no internal leakage of pressure/vacuum and these components were generally in good condition.

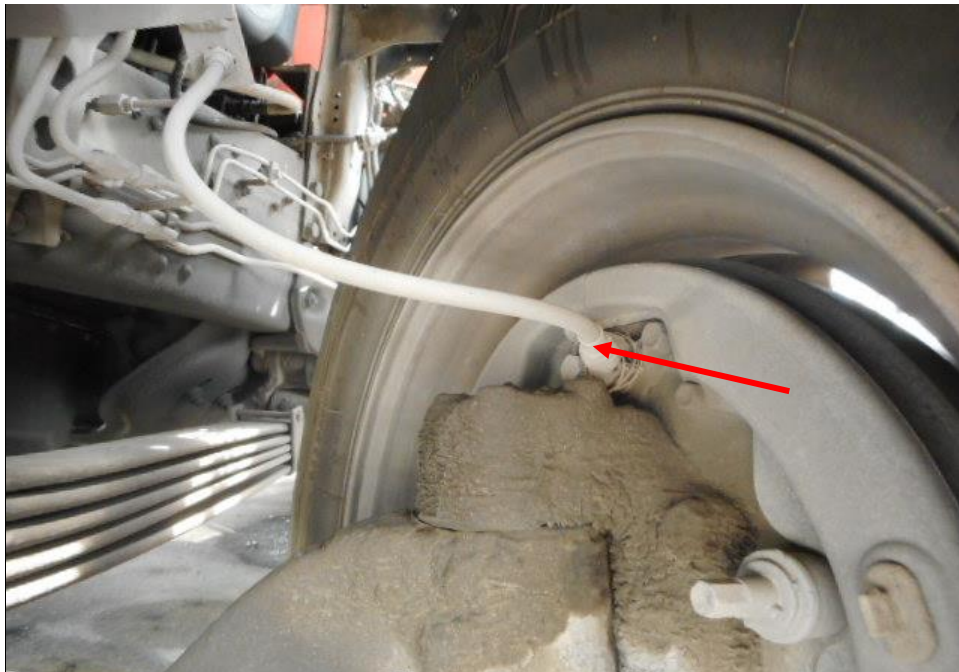
**Photo 19** shows the brake pipe (arrowed) at the front right wheel of the Motor Lorry. I did not observe any leakage of brake fluid at the time of my inspection of the Motor Lorry. My static tests of the Motor Lorry's braking system, along with my visual examination of the various mechanical components in the braking system, had indicated that there was no internal leakage of pressure/vacuum and these components were generally in good condition.

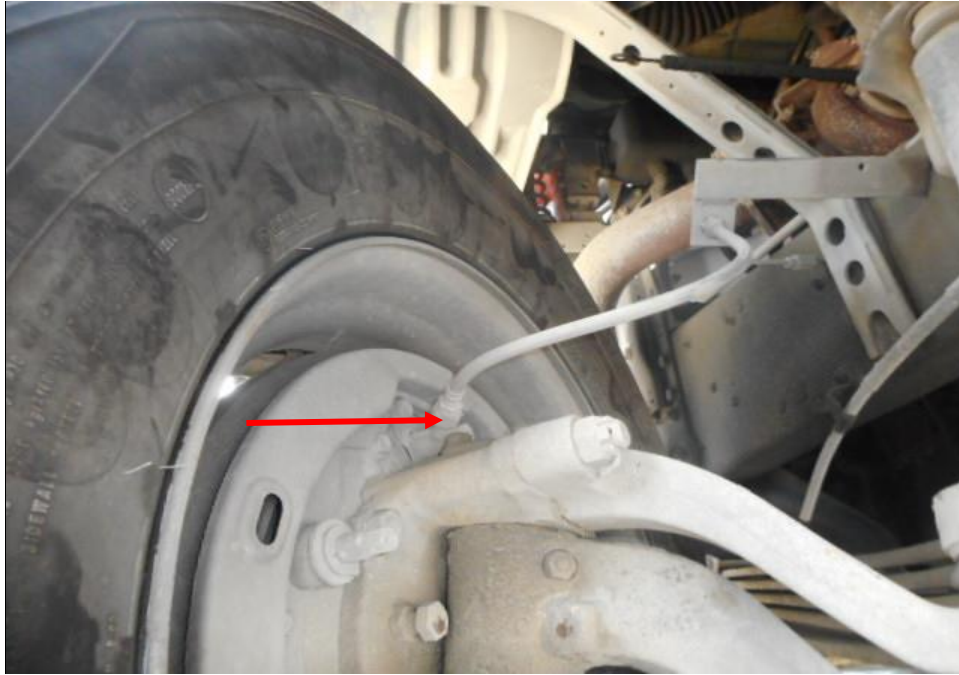
**Photo 20** shows the brake pipe (arrowed) at the front left wheel of the Motor Lorry. I did not observe any leakage of brake fluid at the time of my inspection of the Motor Lorry. My visual examination of the various mechanical components in the braking system had indicated that these was no internal leakage of pressure/vacuum and these components were generally in good condition.

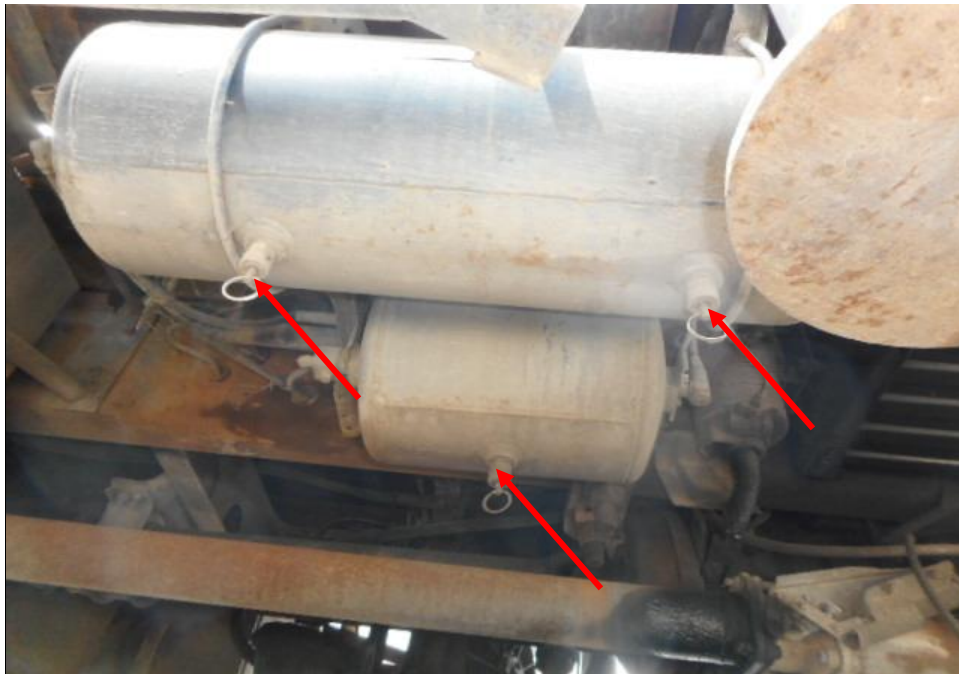
**Photo 21** shows the air brake cylinders (arrowed) at the undercarriage of the Motor Lorry. I did not observe any leakage of air brake fluid at the time of my inspection of the Motor Lorry. My visual examination of the various mechanical components in the braking system had indicated that these was no internal leakage of pressure/vacuum and these components were generally in good condition.

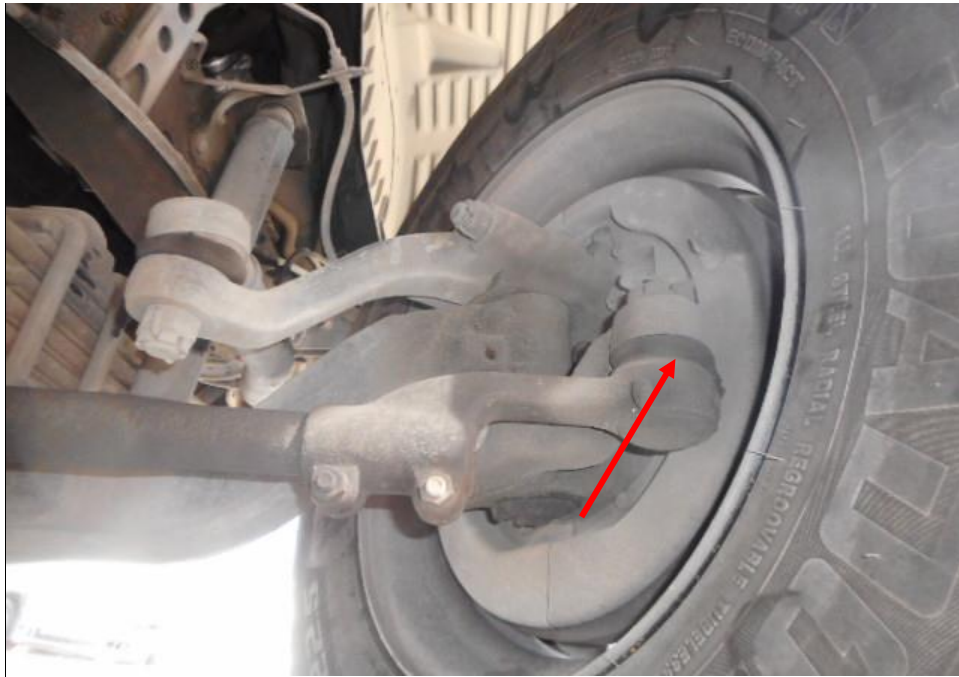
**Photo 22** shows the various undercarriage components at the front right wheel of the Motor Lorry, in particular the steering tie rod end (arrowed). The various steering components were all found to be intact, suggesting that the steering system of the Motor Lorry was likely to be in serviceable condition at the material time of accident. There was also no sign of fluid stain(s) observed on the various undercarriage components.

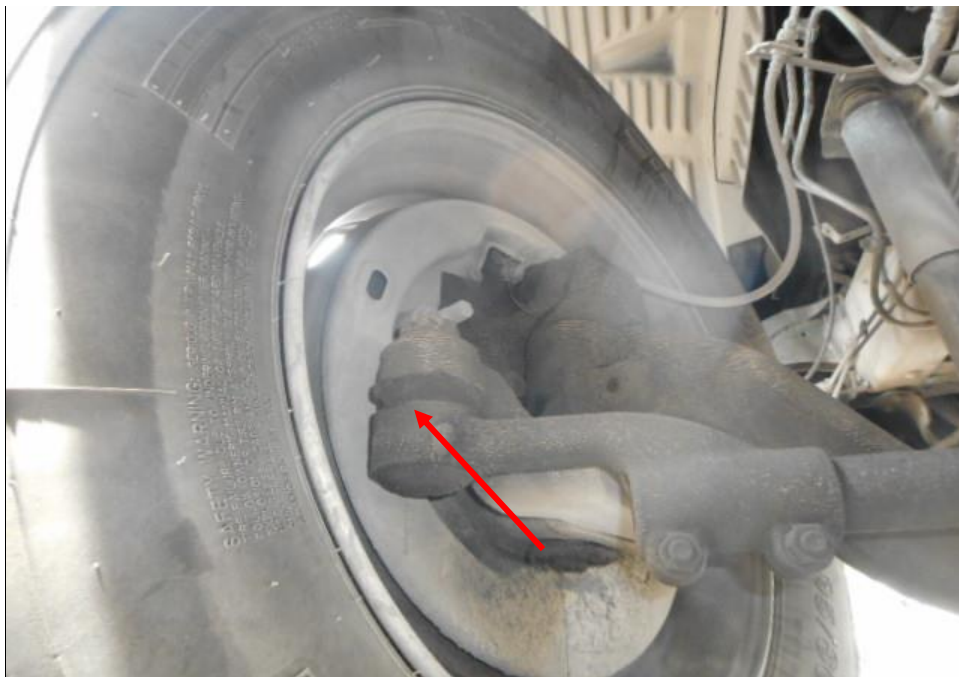
**Photo 23** shows the various undercarriage components at the front left wheel of the Motor Lorry, in particular the steering tie rod end (arrowed). The various undercarriage components of the Motor Lorry were all found to be intact without any visible damage. There was also no sign of fluid stain(s) observed on the various undercarriage components.

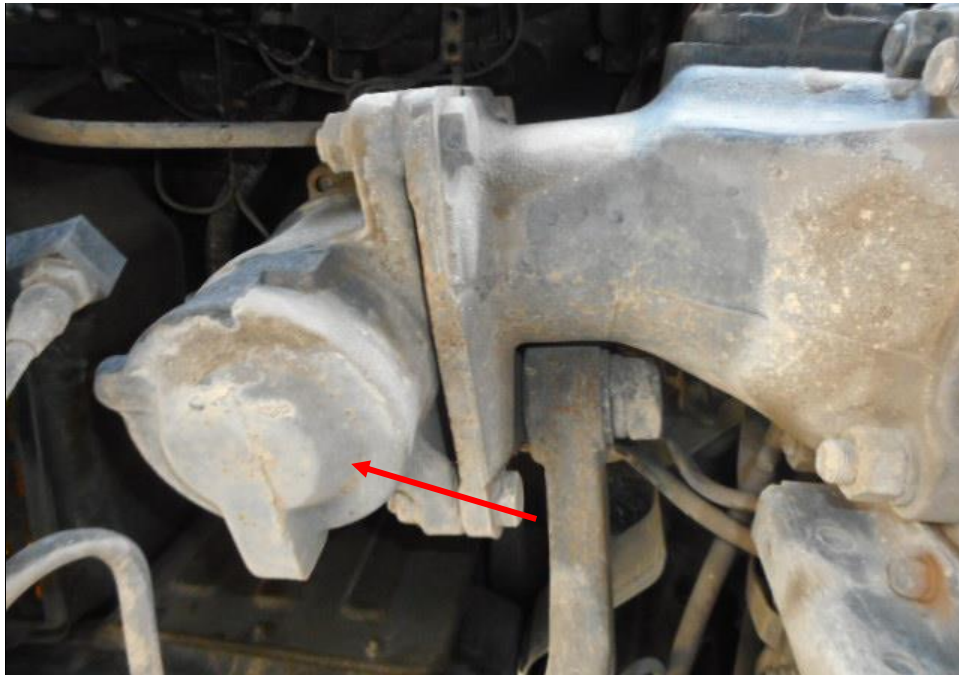
**Photo 24** shows the steering box component (arrowed) at the undercarriage of the Motor Lorry was found to be intact without any visible damage. There was also no sign of fluid stain(s) observed on the various undercarriage components.

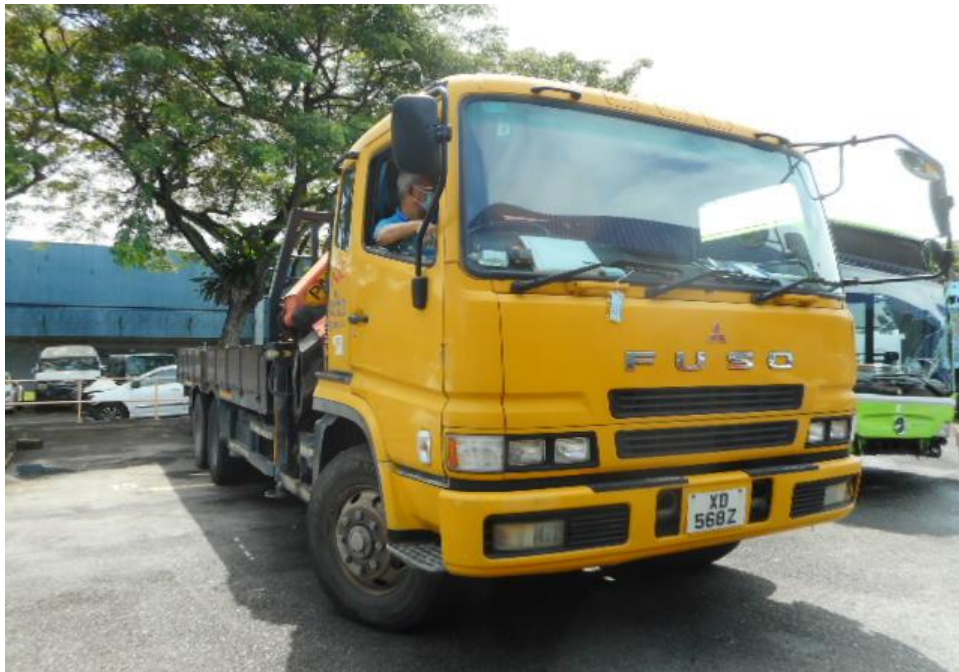
**Photo 25** shows the front right wheel of the Motor Lorry turned to its full left. During my steering system test, I did not experience any abnormal free play and/or resistance when I had turned the steering wheel towards full left and full right. This would suggest that the steering system of the Motor Lorry was likely to be in serviceable condition at the material time of accident.
