Your Ref: TP/IP/47263/2021  
Our Ref : CI/TPD21011277/P

22<sup>nd</sup> November 2021

**MECHANICAL INSPECTION REPORT OF TAXI SHA 8810B**

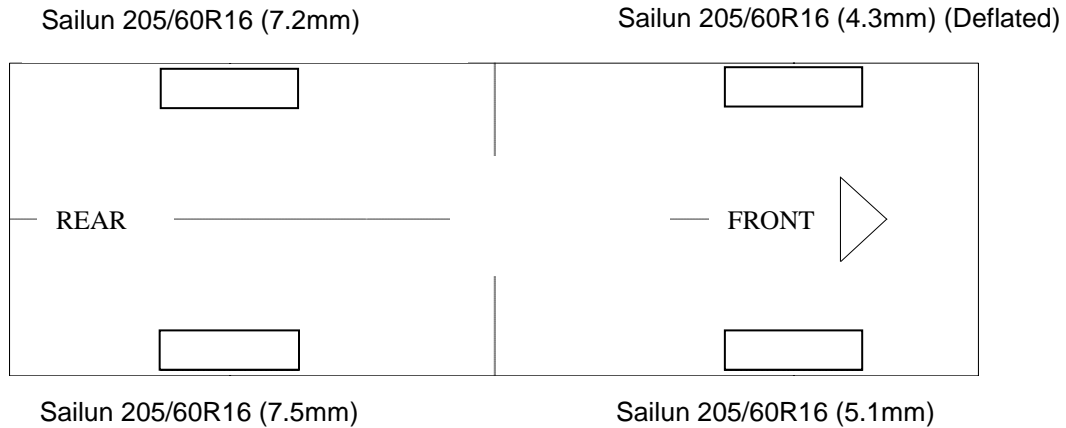
6. The front left tyre was observed to be deflated as a result of the accident. The other 3 tyres of the Taxi were observed to be in serviceable condition and sufficiently inflated for vehicular operation. I did not find any tear, cut or burst mark(s) on the outer and the inner sidewalls as well as across the tread of the 4 tyres. The tyre brand, tyre size and remaining tread depth of the 4 tyres of the Taxi were recorded as follows:-

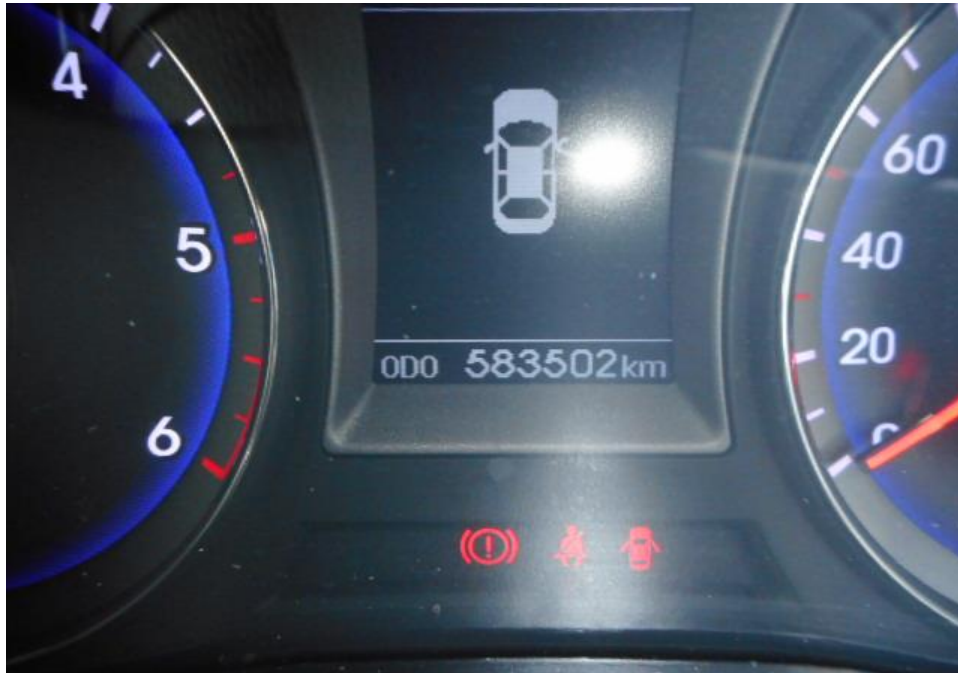
**Photo 1** shows a general view of the instrument cluster of the Taxi at the time of my inspection. The mileage of the Taxi was 583,502 km

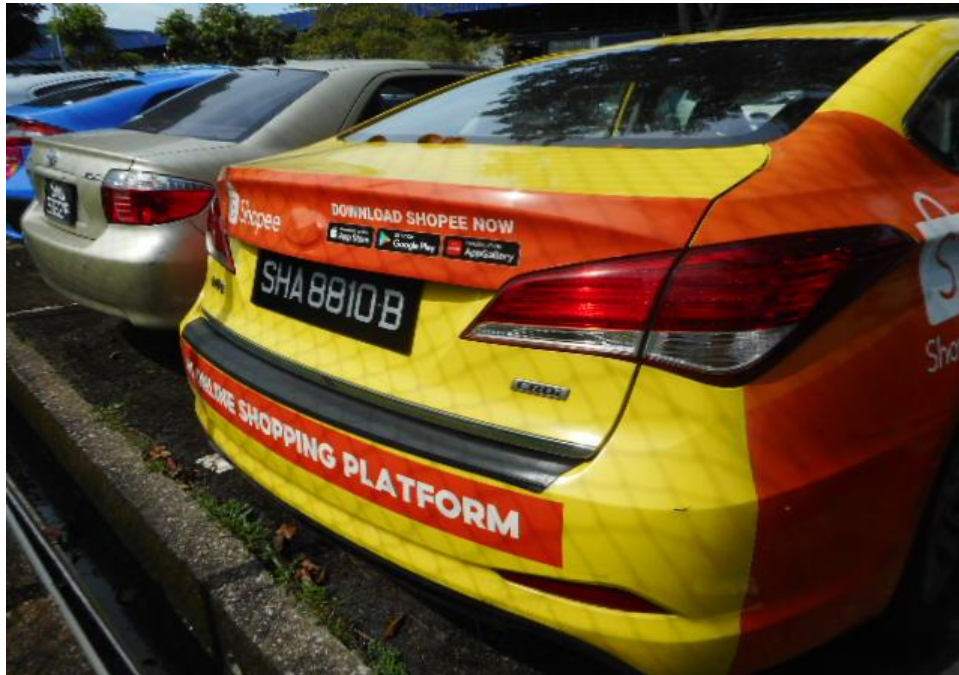
**Photo 2** shows a general view of the Taxi's rear portion at the time of my inspection. The Taxi was observed to be intact and unaffected by the accident.

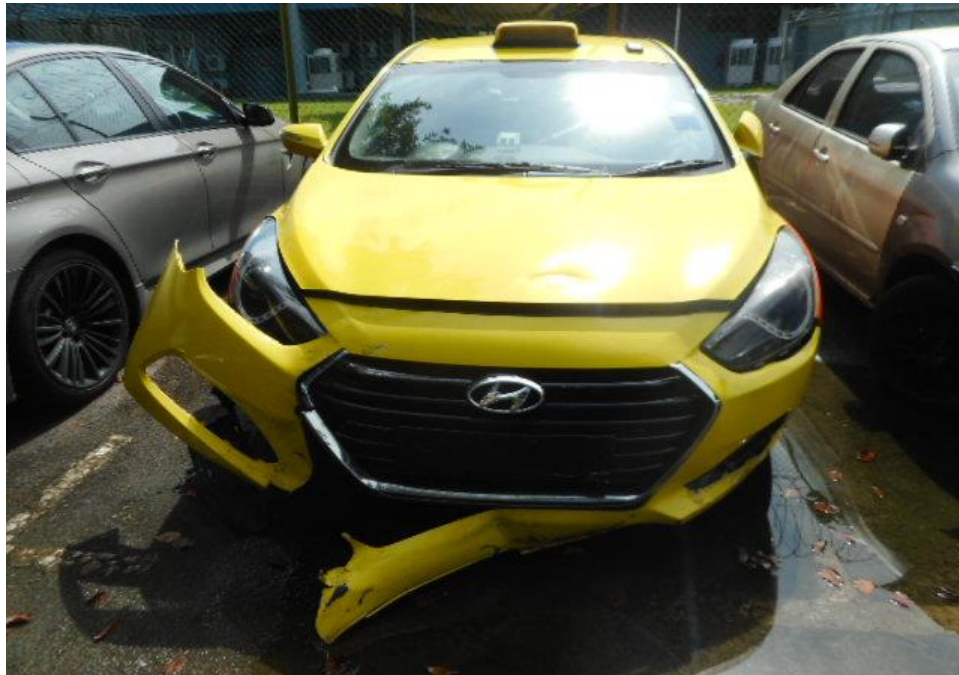
4. The mileage of the Taxi at the time of my inspection was 583,502km.
5. The Taxi was observed to sustained damage at its front portion. Its front bonnet and front bumper were damaged at the time of my inspection as a result of the accident.

**Photo 3** shows a general view of the Taxi's front portion at the time of my inspection. It appeared to have sustained damage at its front portion. Its front bonnet and front bumper were damaged at the time of my inspection as a result of the accident.

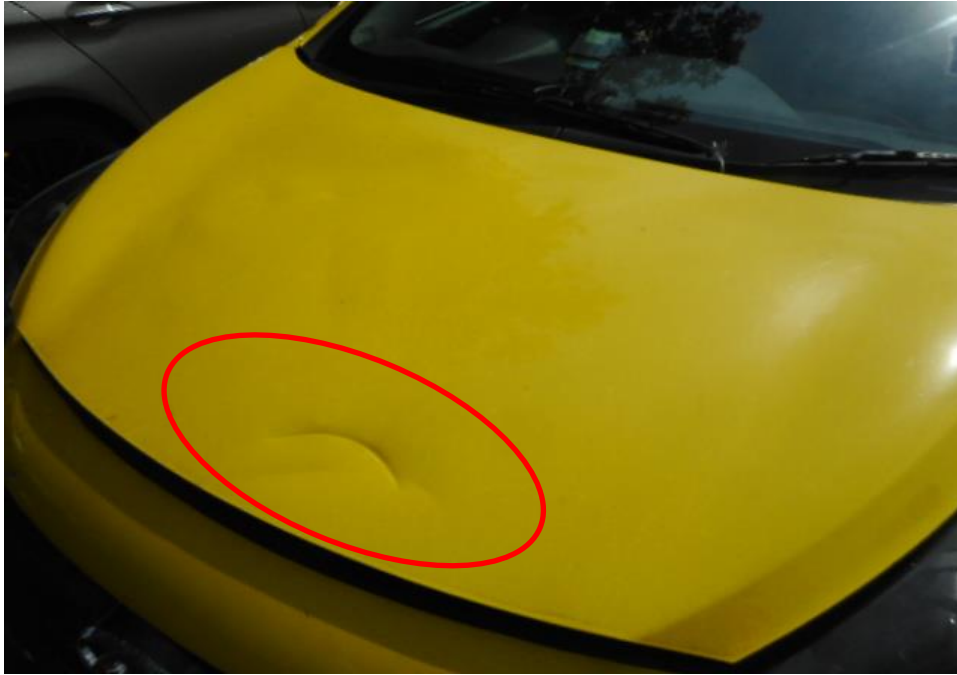
**Photo 4** shows a close up view of the Taxi's front portion at the time of my inspection. It appeared to have sustained damage at its front portion. Its front bonnet (circled) were damaged at the time of my inspection as a result of the accident.

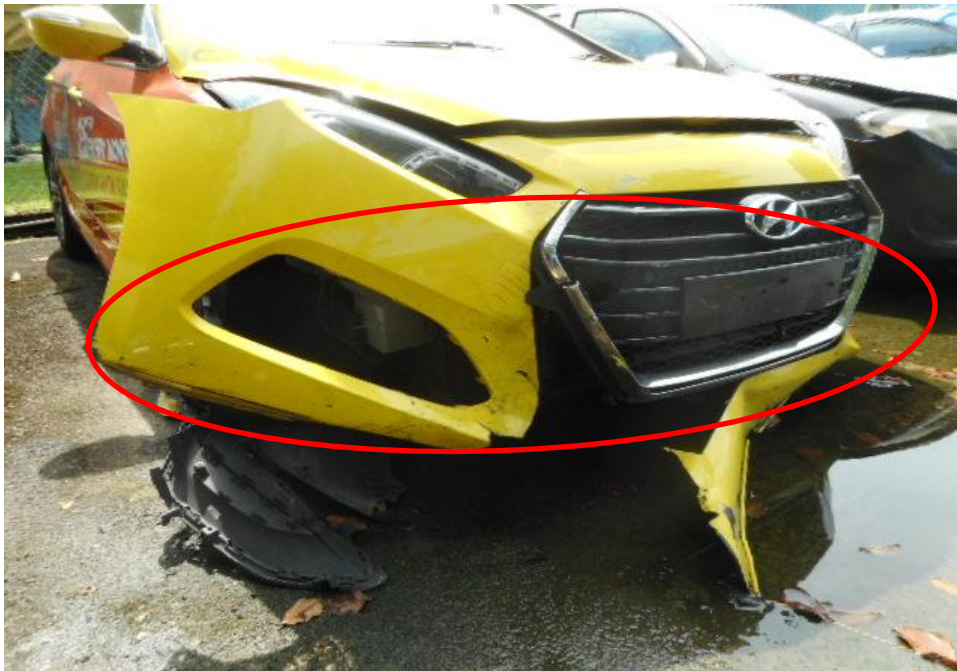
**Photo 5** shows a close up view of the Taxi's front portion at the time of my inspection. It appeared to have sustained damage at its front portion. Its front bumper (circled) were damaged at the time of my inspection as a result of the accident.

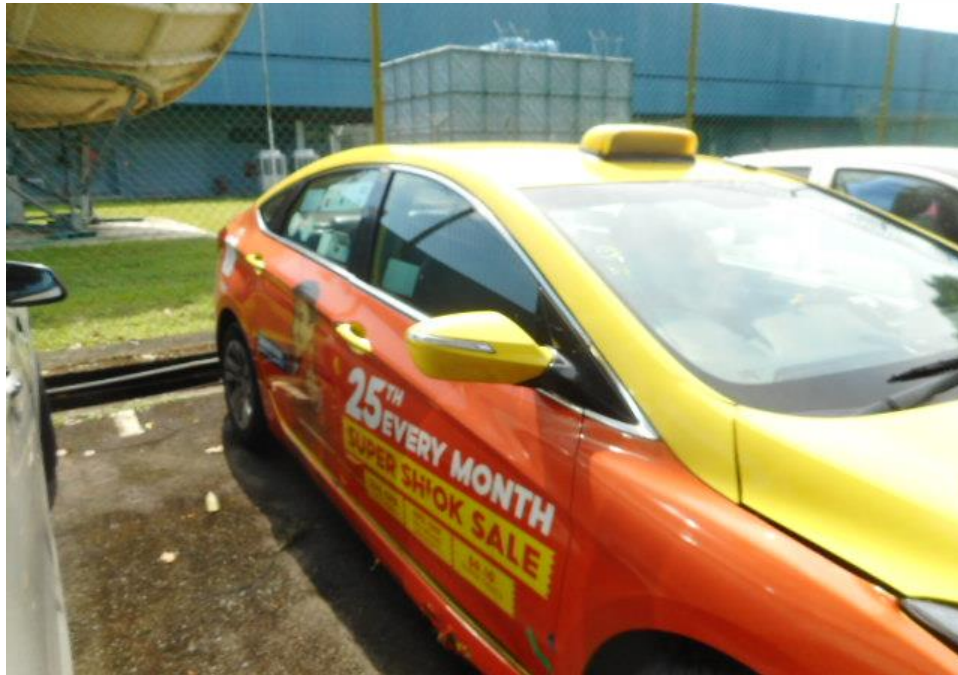
**Photo 6** shows a general view of the right body of the Taxi at the time of my inspection. The Taxi was observed to be intact and unaffected by the accident.

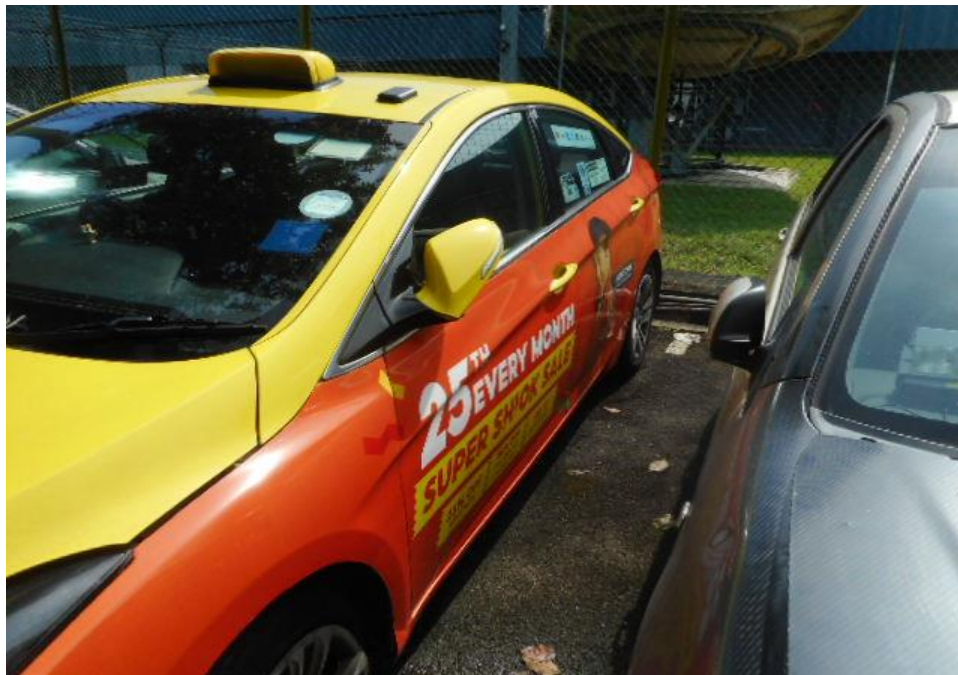
**Photo 7** shows a general view of the left body of the Taxi at the time of my inspection. The Taxi was observed to be intact and unaffected by the accident.

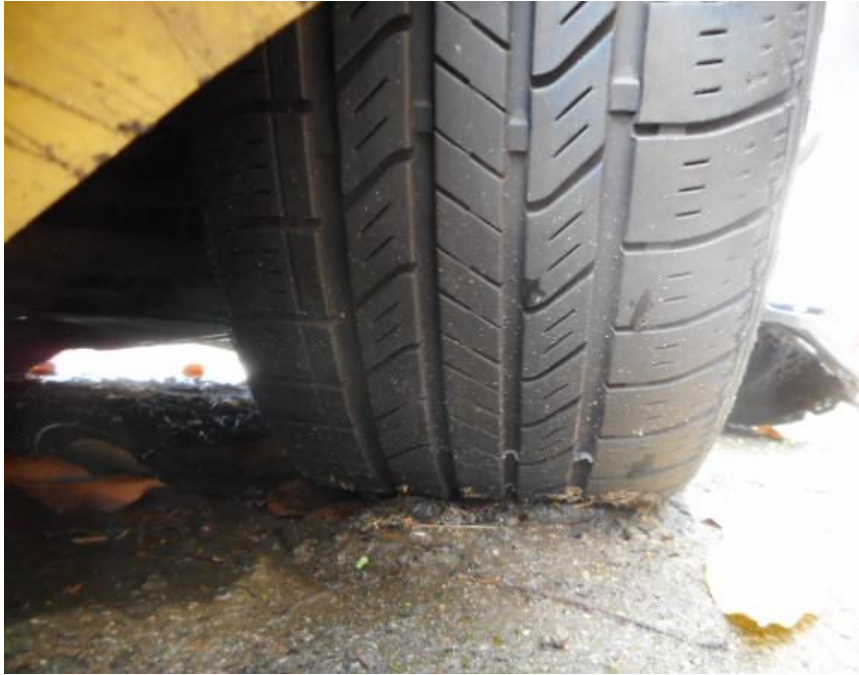
**Photo 8** shows the condition of the front right tyre of the Taxi, which was observed to be in serviceable condition with remaining tread depth of approximately 5.1mm. The tyre, which was wrapped around standard steel wheel rim, was also observed to be sufficiently inflated for vehicular operation. There was no tear, cut or burst mark(s) on the outer and the inner sidewalls as well as across the tread of the 4 tyres that were fitted on the Taxi.

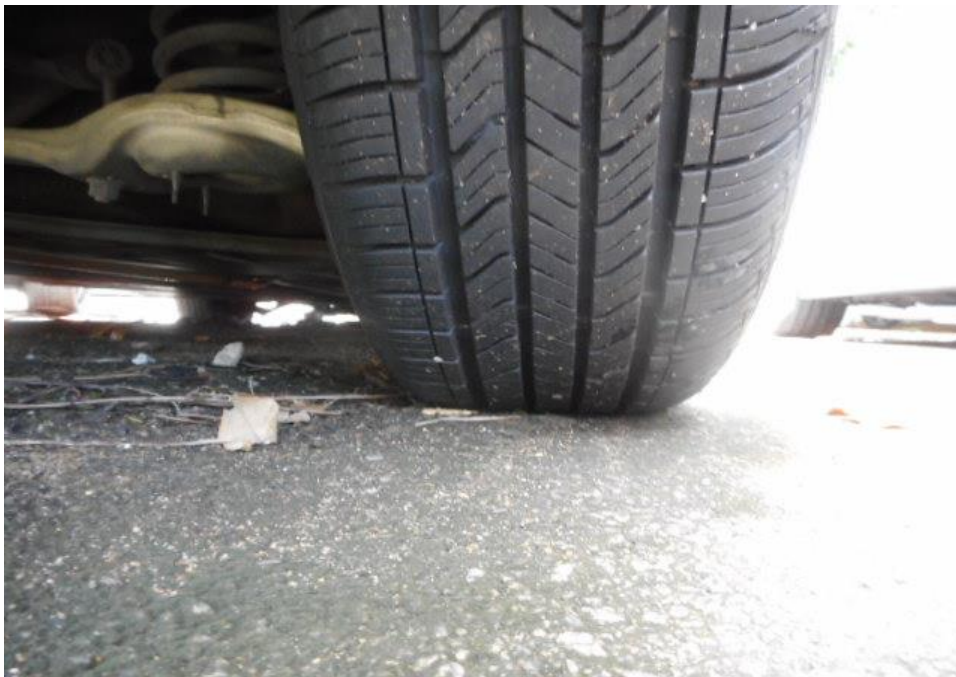
**Photo 9** shows the condition of the rear right tyre of the Taxi, which was observed to be in serviceable condition with remaining tread depth of approximately 7.5mm. The tyre, which was wrapped around standard steel wheel rim, it was observed to be sufficiently inflated for vehicular operation.

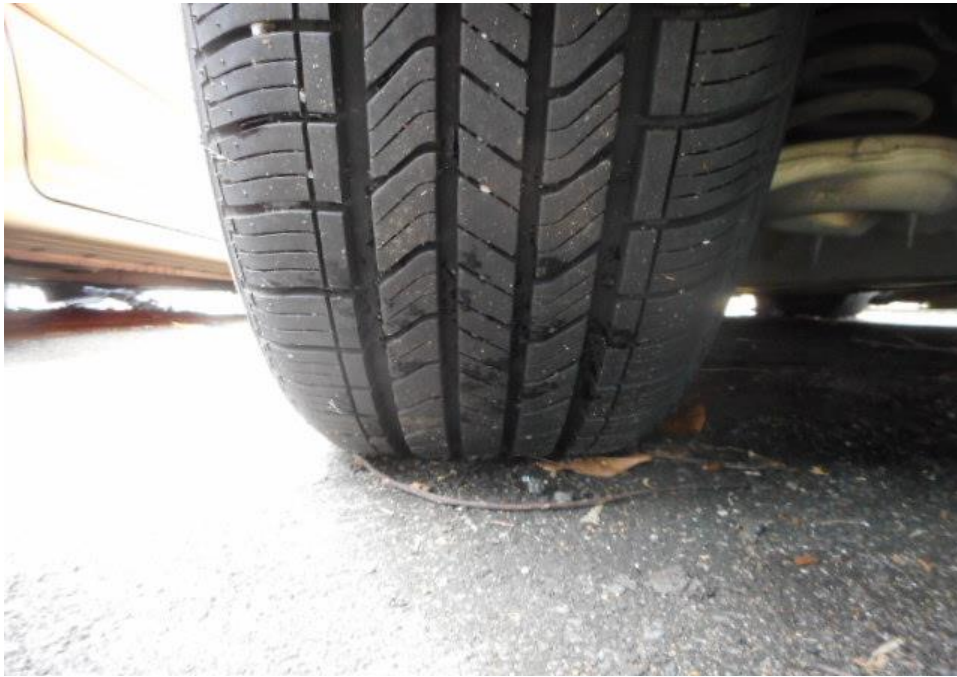
**Photo 10** shows the condition of the rear left tyre of the Taxi, which was observed to be in serviceable condition with remaining tread depth of approximately 7.2mm. The tyres, which were wrapped around standard steel wheel rim, were also observed to be sufficiently inflated for vehicular operation.

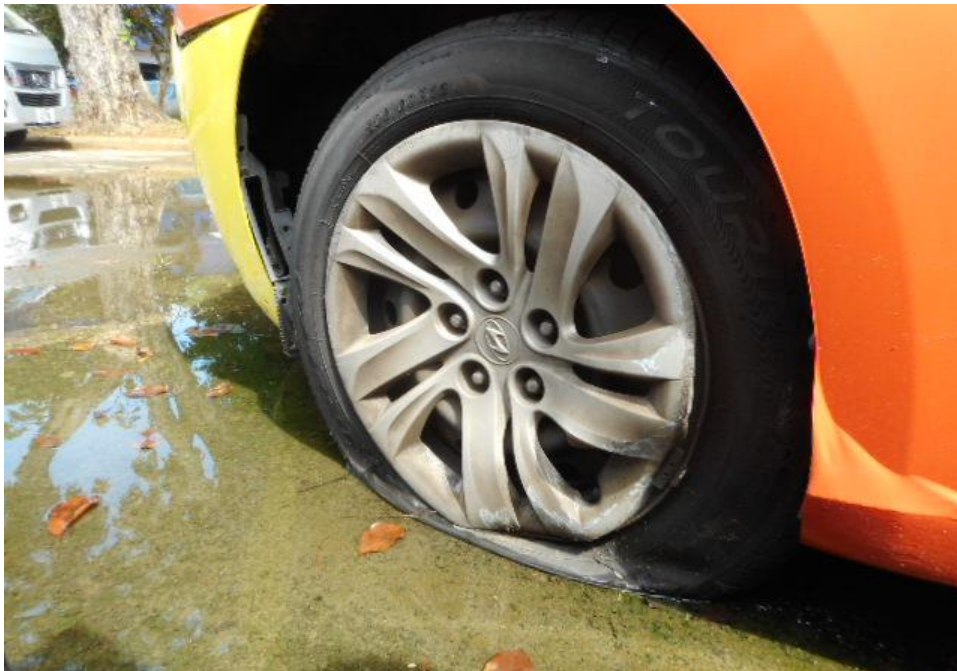
**Photo 11** shows the condition of the front left tyre of the Taxi, which were observed to be in serviceable condition with remaining, tread depth of approximately 4.3mm. There was also no tear, cut or burst mark(s) on the outer and the inner sidewalls as well as across the tread of the 4 tyres that were fitted on the Taxi.

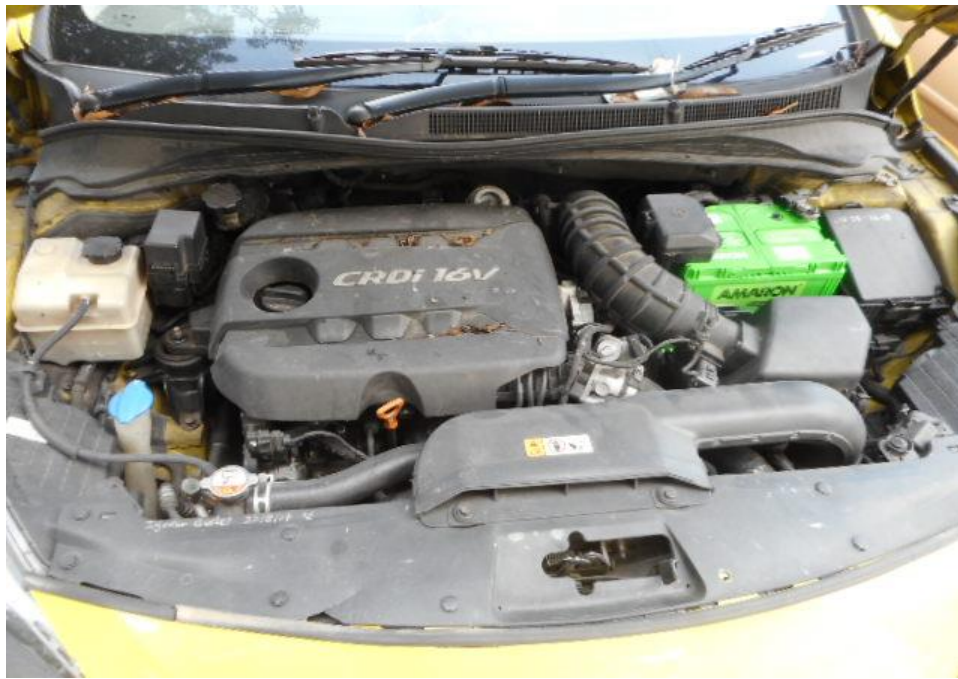
**Photo 12** shows a general view of the Taxi's engine compartment, which was accessed by lifting the front cabin of the Taxi. The various parts and components inside the engine compartment were unaffected by the accident. There was also no sign(s) or indication(s) of fresh fluid leakage and/or fluid stain within the engine compartment

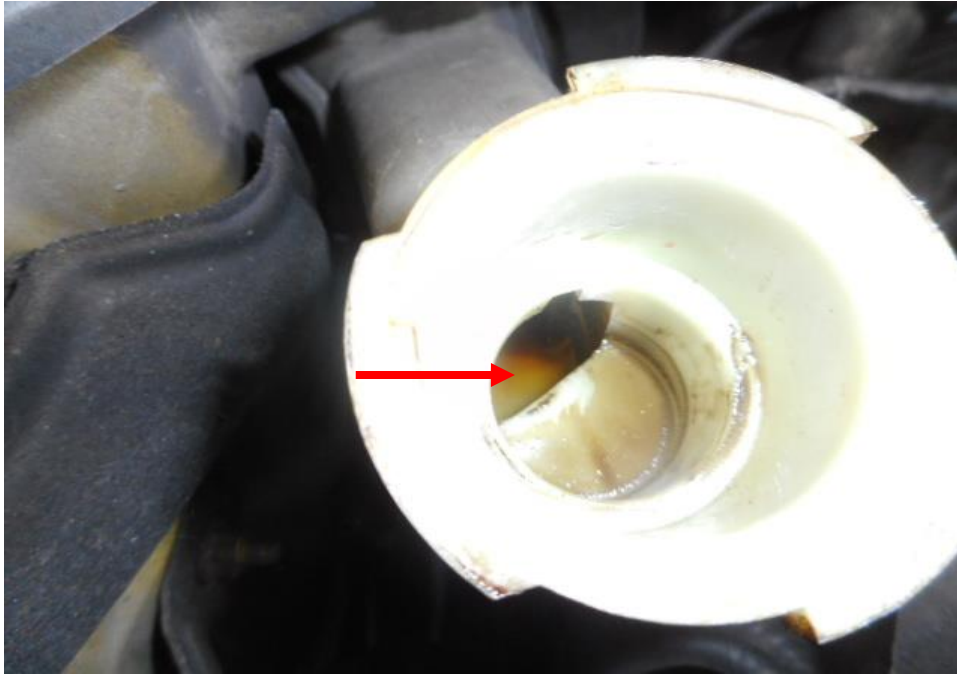
**Photo 13** shows the brake fluid reservoir of the Taxi at the time of my inspection. The brake fluid was observed to be of sufficient level (arrowed) and without any visible contamination.

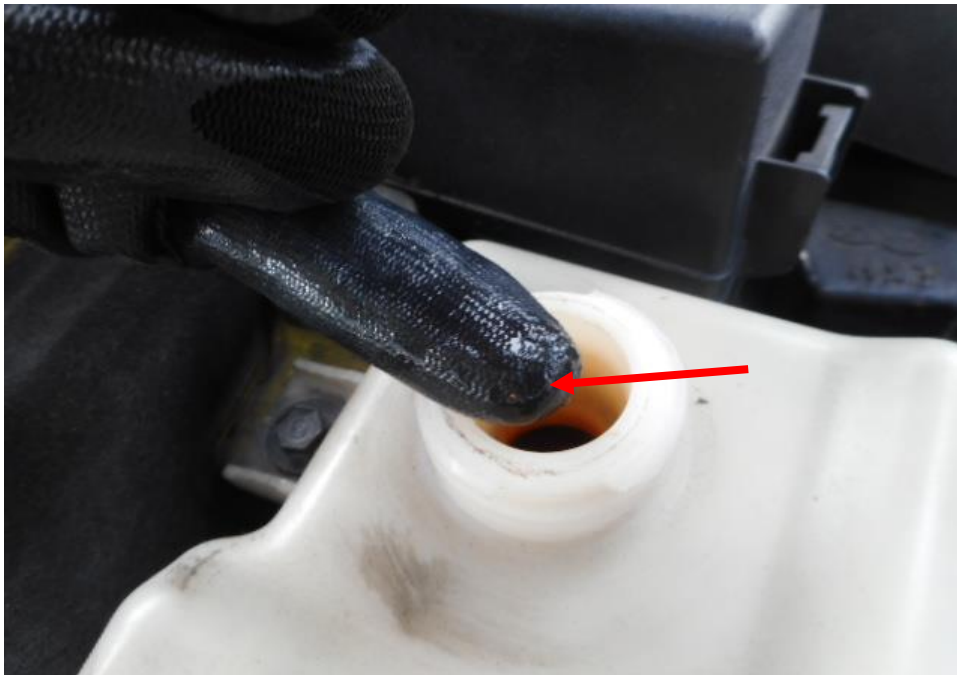
**Photo 14** shows the engine coolant reservoir of the Taxi at the time of my inspection. The engine coolant was observed to be of sufficient level (arrowed) and without any visible contamination.

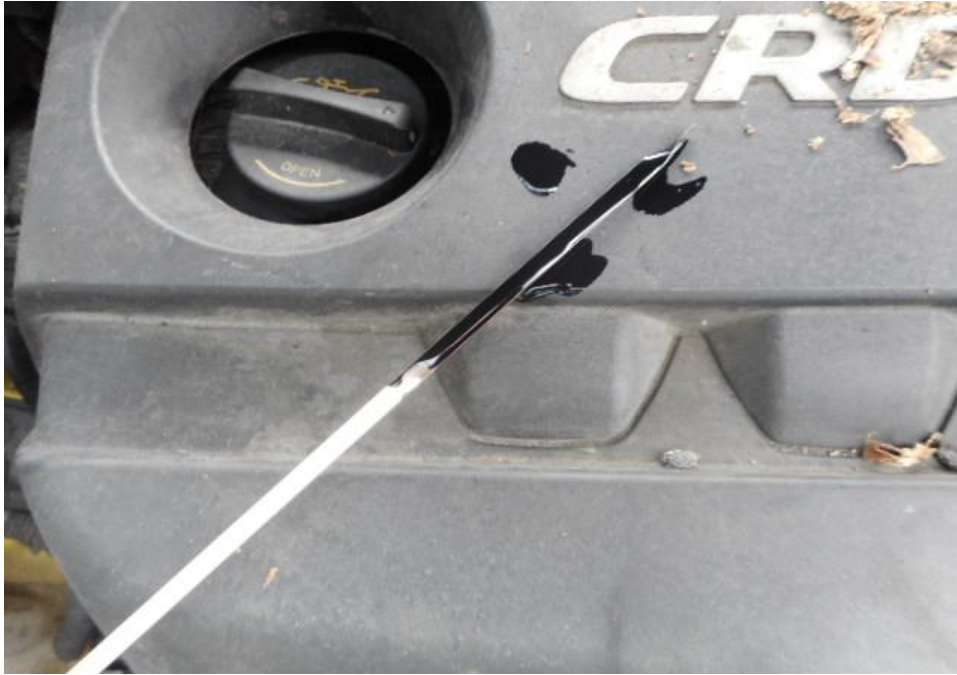
**Photo 15** shows the engine oil dip stick of the Taxi at the time of my inspection. The engine oil was observed to be of sufficient level and without any visible contamination.

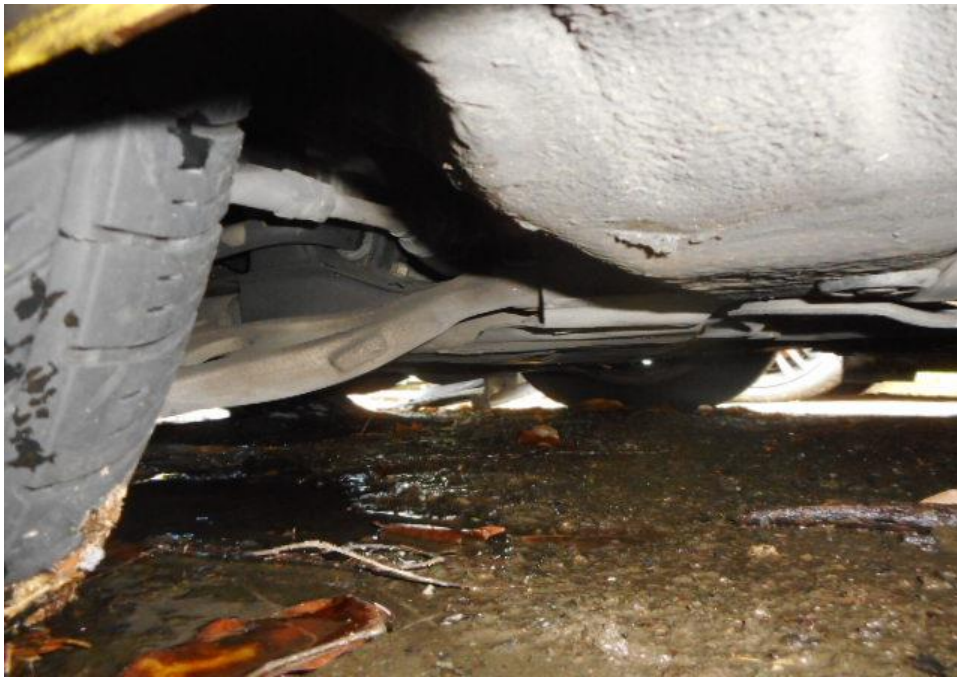
**Photo 16** shows the undercarriage of the Taxi, at the area where the engine housing and transmission housing are located. I did not find any sign(s) or indication(s) of fluid leak and/or fluid stain(s) on the underside of the Taxi.

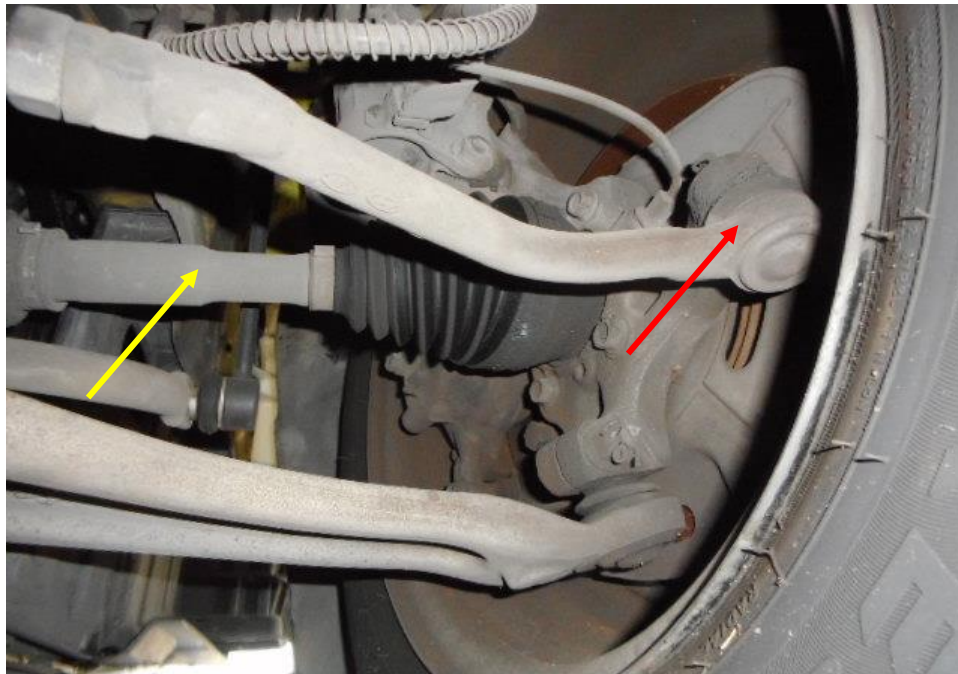
**Photo 17** shows the various undercarriage components at the front right wheel of the Taxi, in particular the steering tie rod end (red arrow) and its driveshaft (yellow arrow). The various steering components were all found to be intact, suggesting that the steering system of the Taxi was likely to be in serviceable condition at the material time of accident. There was also no sign of fluid stain(s) observed on the various undercarriage components.

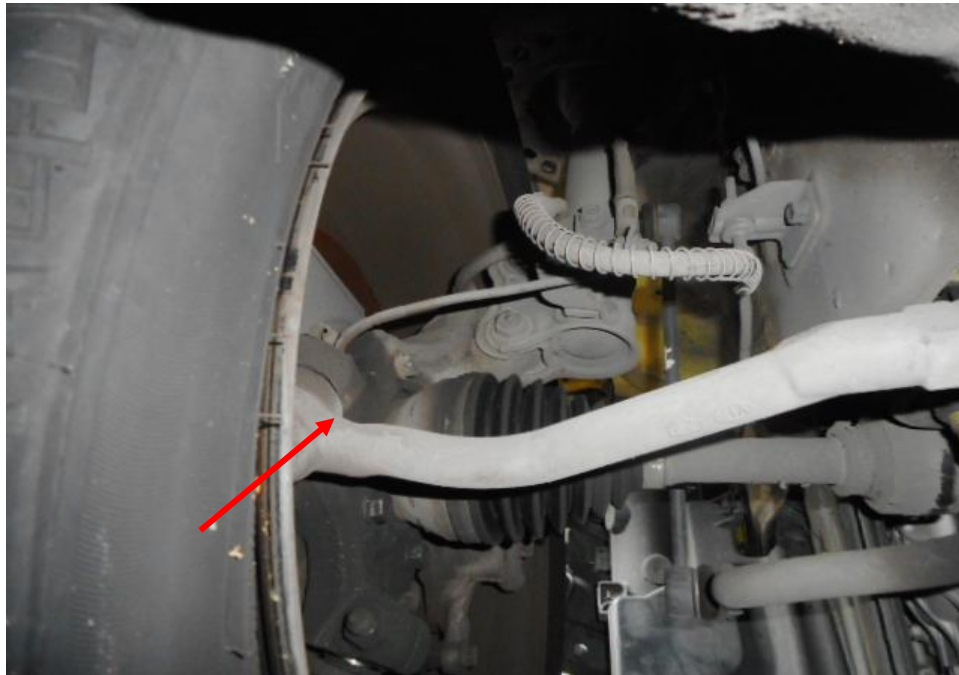
**Photo 18** shows the various undercarriage components at the front left wheel of the Taxi, in particular the steering tie rod end (arrowed). The various undercarriage components of the Taxi were all found to be intact without any visible damage. There was also no sign of fluid stain(s) observed on the various undercarriage components.

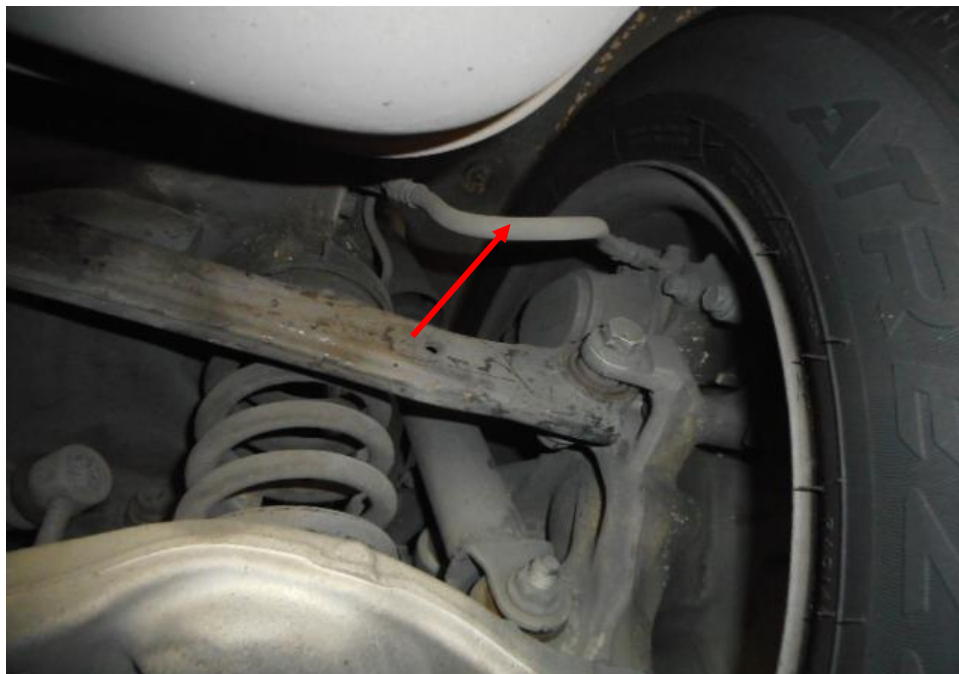
**Photo 19** shows the brake pipe (arrowed) at the rear right wheel of the Taxi. I did not observe any leakage of brake fluid at the time of my inspection of the Taxi. My static tests of the Taxi's braking system, along with my visual examination of the various mechanical components in the braking system, had indicated that there was no internal leakage of pressure/vacuum. Hence the braking system of the Taxi was likely to be in serviceable condition at the material time of accident.

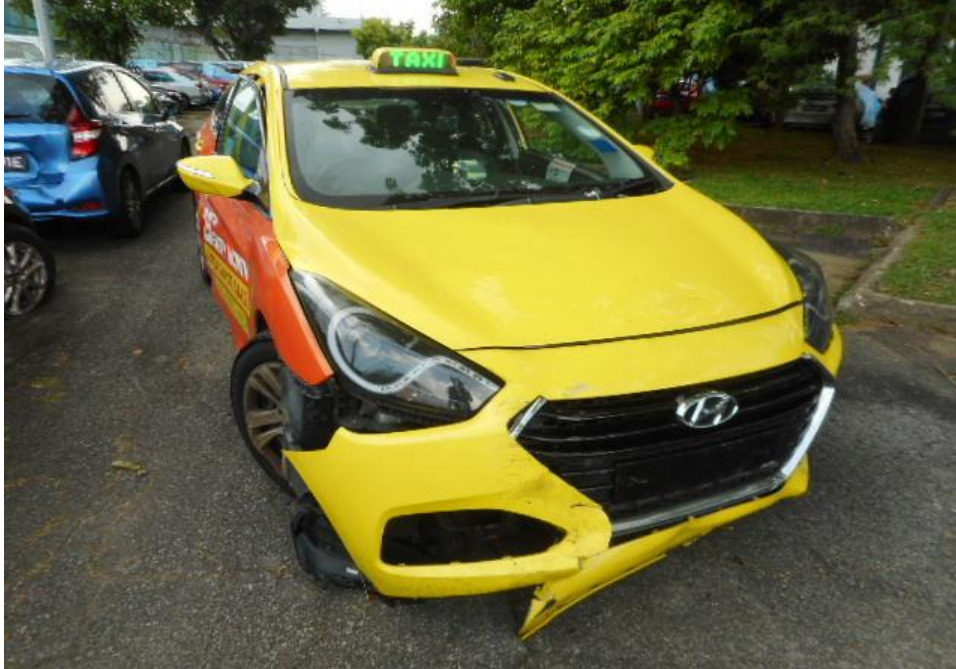
**Photo 20** shows the front right wheel of the Taxi turned to its full left. During my steering system test, I did not experience any abnormal free play and/or resistance when I had turned the steering wheel towards the left and right. This would suggest that the steering system of the Taxi was likely to be in serviceable condition at the material time of accident.

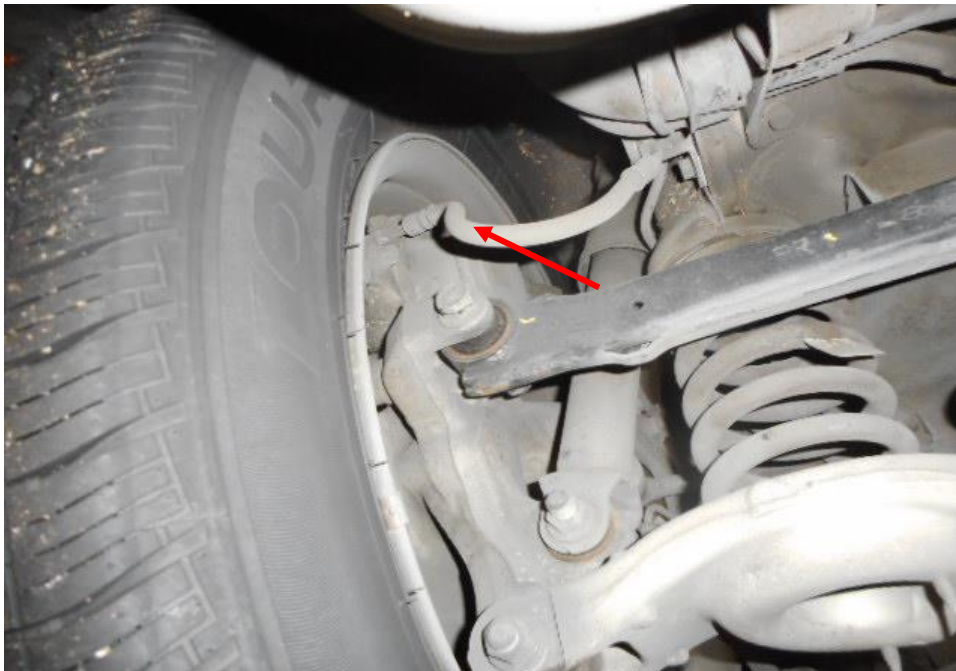
**Photo 21** shows the brake pipe (arrowed) at the rear left wheel of the Taxi. I did not observe any leakage of brake fluid at the time of my inspection of the Taxi. My static tests of the Taxi's braking system, along with my visual examination of the various mechanical components in the braking system had indicated that there was no internal leakage of pressure/vacuum. Hence the braking system of the Taxi was likely to be in serviceable condition at the material time of accident.

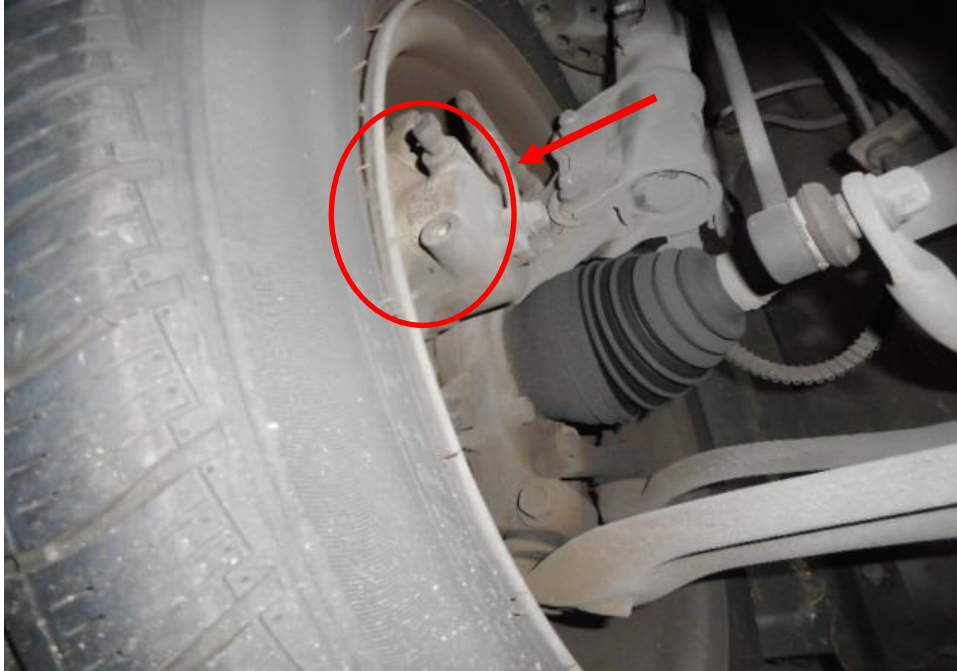
**Photo 22** shows the brake hose/pipe (arrowed) at the front right wheel of the Taxi. No leakage of brake fluid was observed. Visual examination of the various components of the braking system like the brake caliper (circled), brake booster, brake pedal etc had revealed all to be intact and without visible damage at the time of accident. There was also no sign of fluid stain(s) observed on the various undercarriage components.

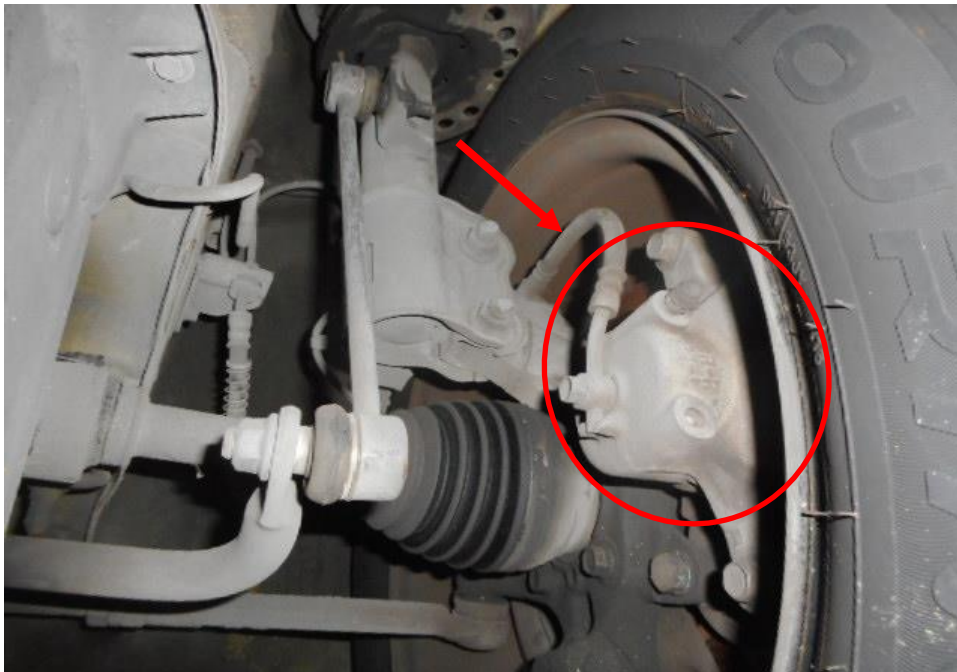
**Photo 23** shows the brake hose/pipe (arrowed) at the front left wheel of the Taxi. No leakage of brake fluid was observed. Visual examination of the various components of the braking system like the brake caliper (circled), brake booster, brake pedal etc had revealed all to be intact and without visible damage at the time of accident. There was also no sign of fluid stain(s) observed on the various undercarriage components.

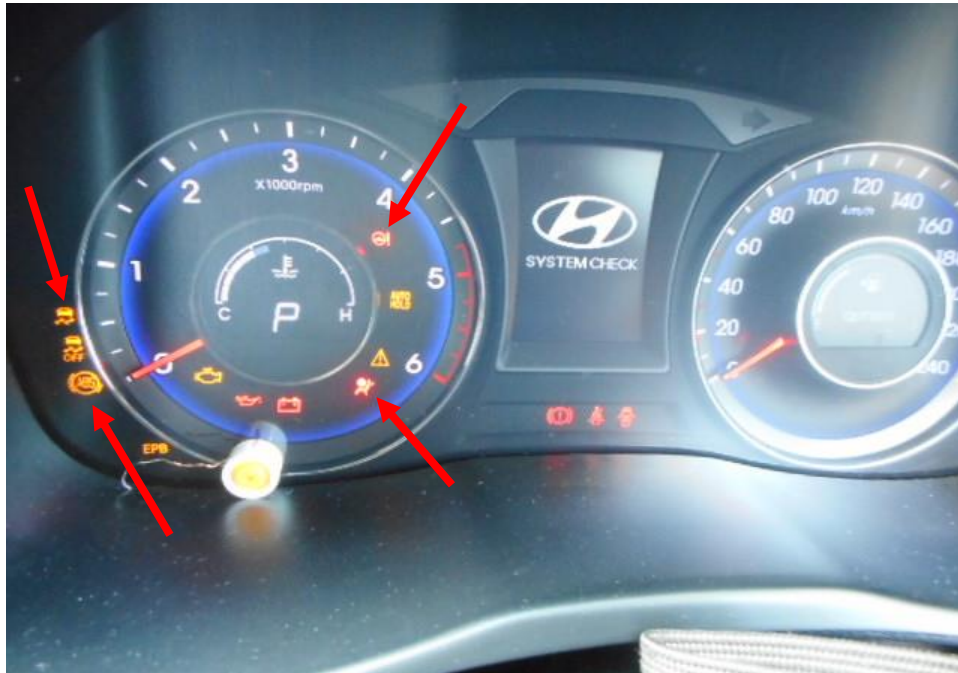
**Photo 24** shows the warning light for Anti-Lock Brake System (ABS) and Power Steering System (EPS), Supplemental Restraint System (SRS) and Traction Control (TC) (arrowed) appearing on the instrument panel of the Taxi during the self-test of its various electronic operating systems when its engine was cranked.

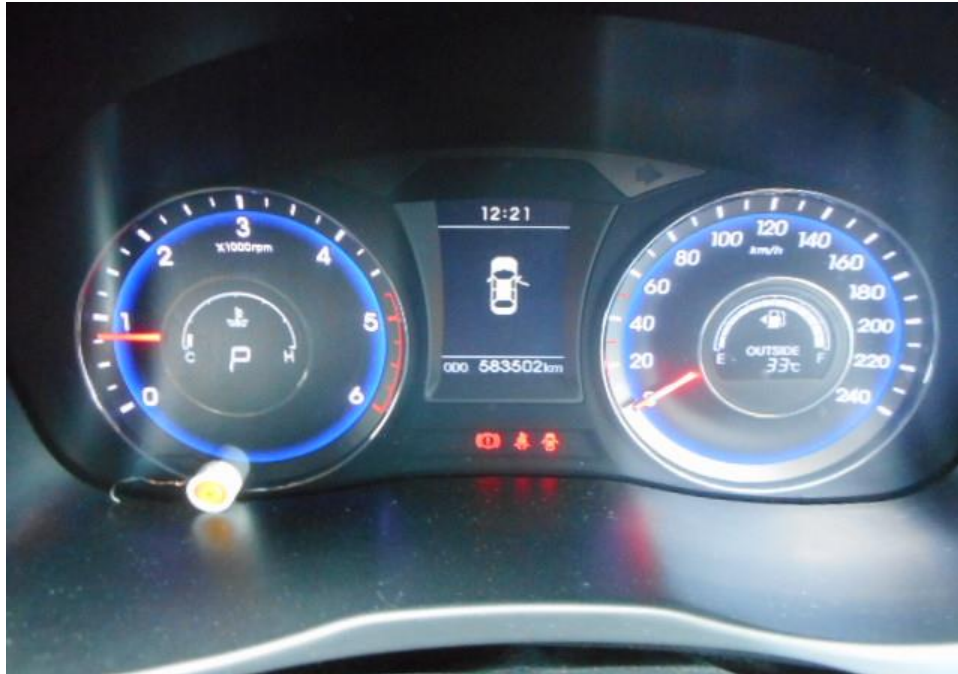
**Photo 25** shows no warning lights illuminated on the instrument panel of the Taxi after the engine was cranked. This would suggest that there was no abnormality to the electronic operating system of the Taxi, like the ABS, EPS, SRS, and TC etc.
