Your Ref: TP/IP/45327/2021
Our Ref : CI/TPD21011279/P

23rd November 2021

MECHANICAL INSPECTION REPORT OF MOTOR CAR SJZ 7606B

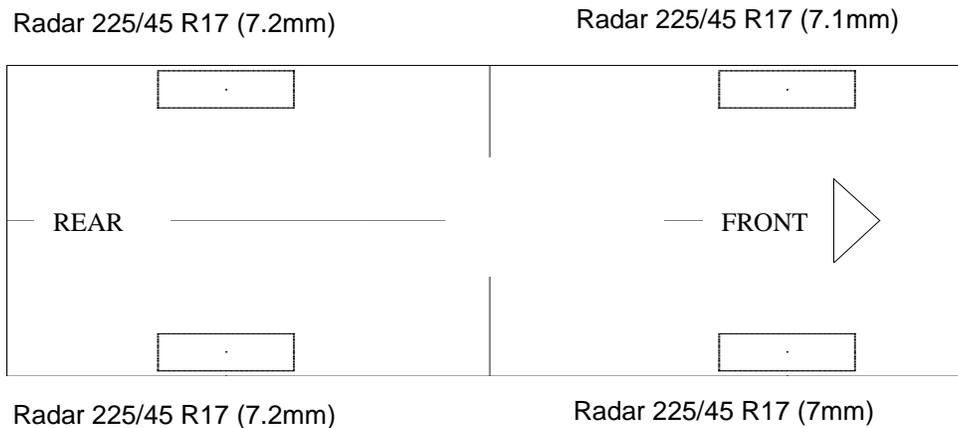
6. The 4 tyres of the Motor Car were observed to be in serviceable condition and sufficiently inflated for vehicular operation. I did not find any tear, cut or burst mark(s) on the outer and the inner sidewalls as well as across the tread of the 4 tyres. The tyre brand, tyre size and remaining tread depth of the 4 tyres of the Motor Car were recorded as follows:-

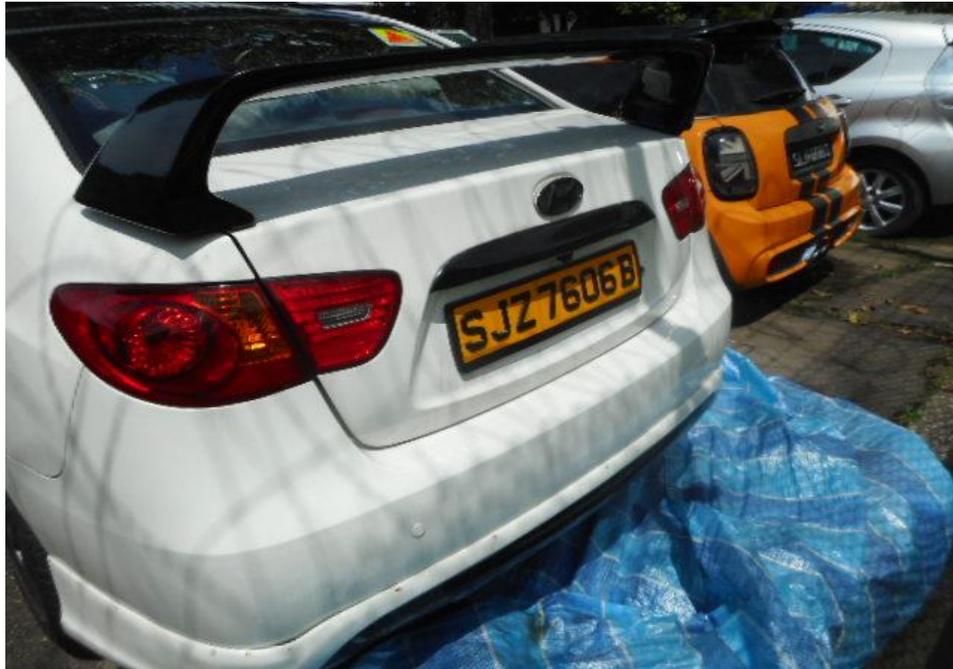
Photo 1 shows a general view of the Motor Car's rear body at the time of my inspection. The rear portion of the Motor Car was observed to have been undamaged by the accident.

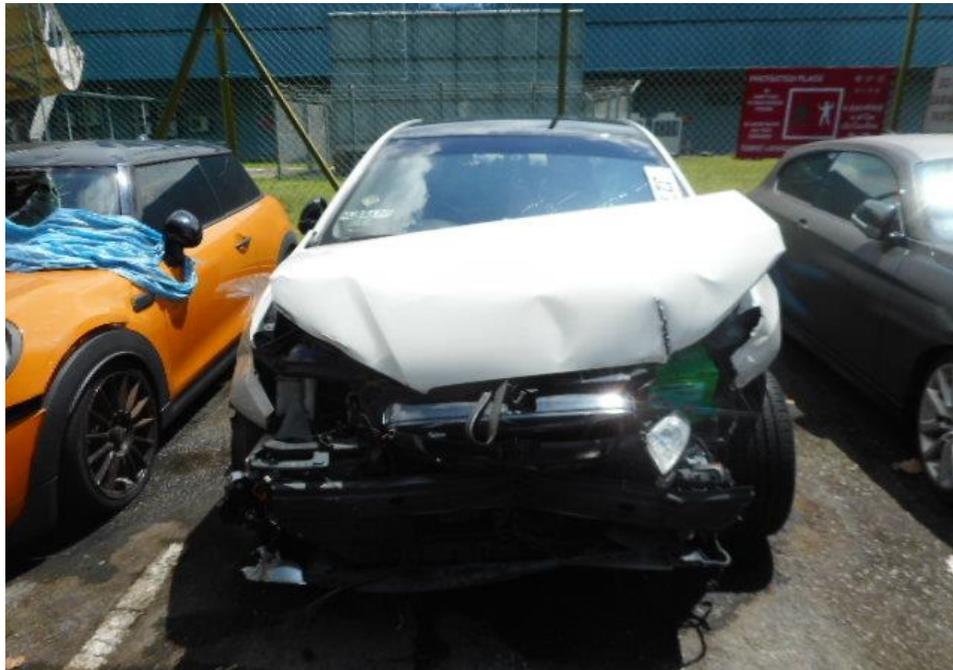
Photo 2 shows a general view of the Motor Car's front body at the time of my inspection. The Motor car was observed to have sustained damage at its front portion. Its front windscreen, front bonnet, both front headlamps, both front fenders, front bumper, was amongst the body parts and various components in the engine compartments were also damaged as a result of the accident.

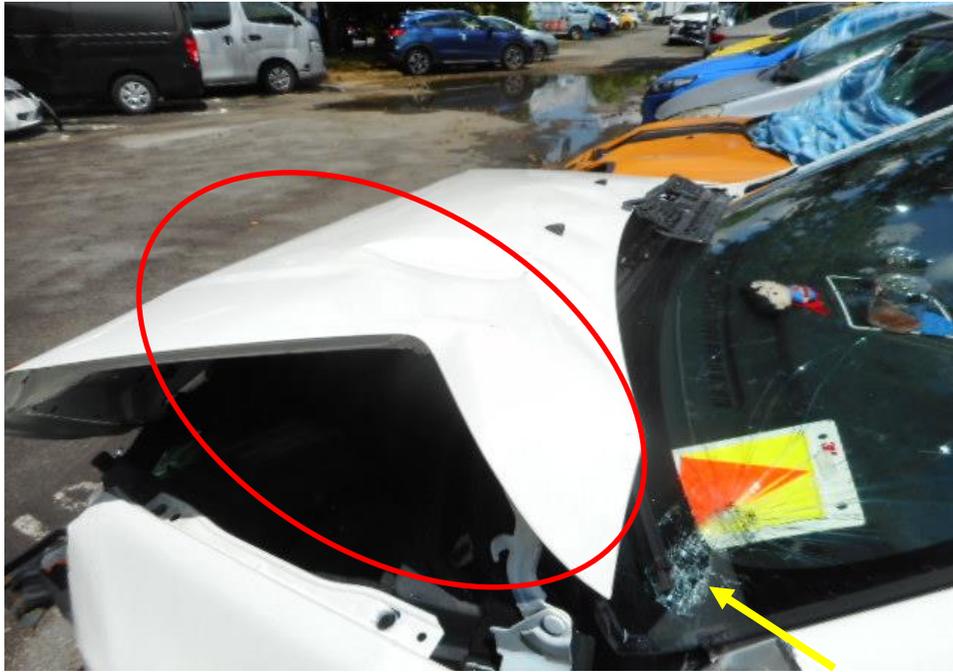
Photo 3 shows the close up view of the Motor Car's front body at the time of my inspection. The Motor car was observed to have sustained damage at its front portion. Its front bonnet (circled) and front windscreen (arrowed) was amongst the body parts and various components in the engine compartments were also damaged as a result of the accident.

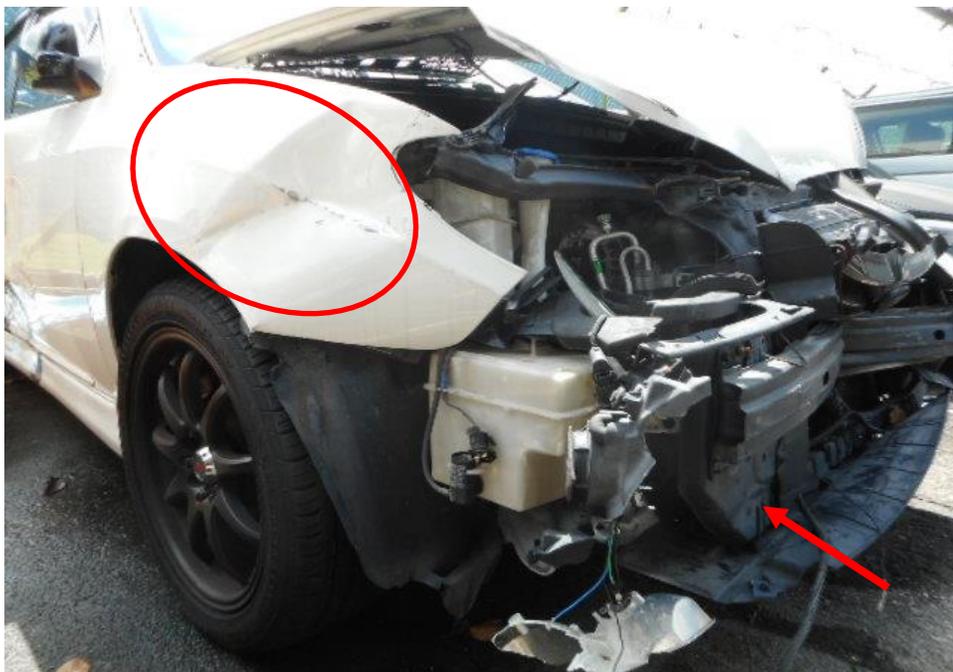
Photo 4 shows the general view of the Motor Car's front body at the time of my inspection. The Motor car was observed to have sustained damage at its front portion. Its front bumper (arrowed) and front right fender (circled) was amongst the body parts and various components in the engine compartments were also damaged as a result of the accident.

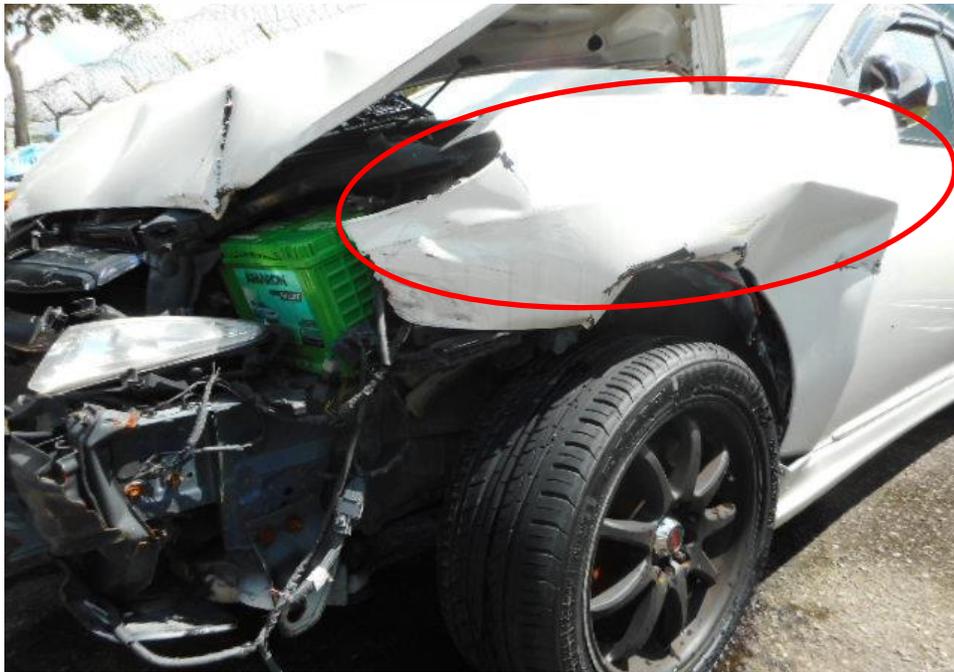
Photo 5 shows the general view of the Motor Car's front body at the time of my inspection. The Motor car was observed to have sustained damage at its front portion. Its front left fender (circled) was amongst the body parts and various components in the engine compartments were also damaged as a result of the accident.

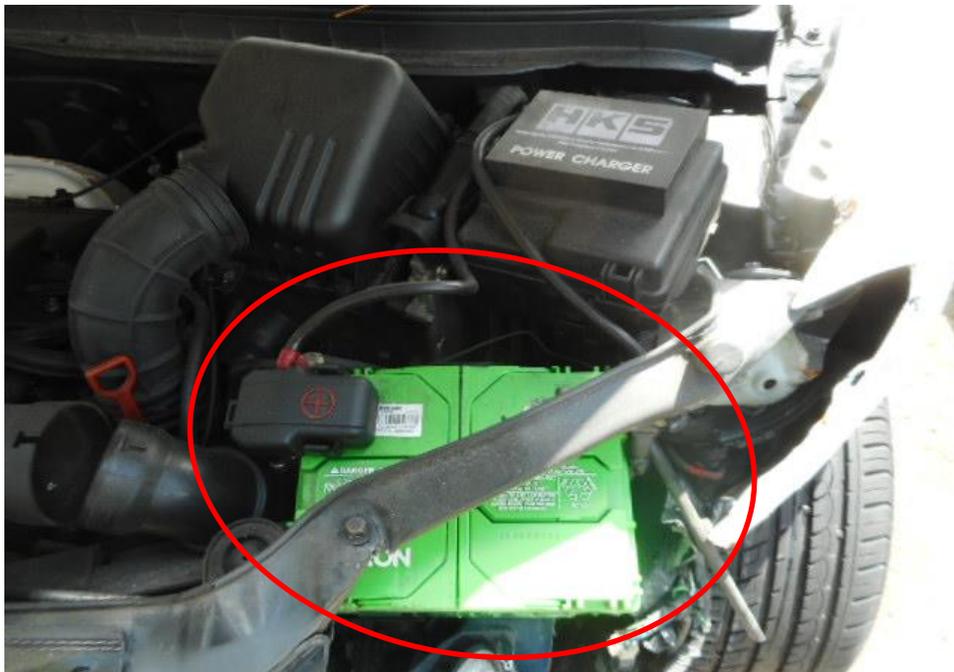
Photo 6 shows the close up view of the Motor Car's front body at the time of my inspection. The Motor car was observed to have sustained damage at its front portion. Its ignition system battery (circled) was amongst the various components in the engine compartments were also damaged as a result of the accident.

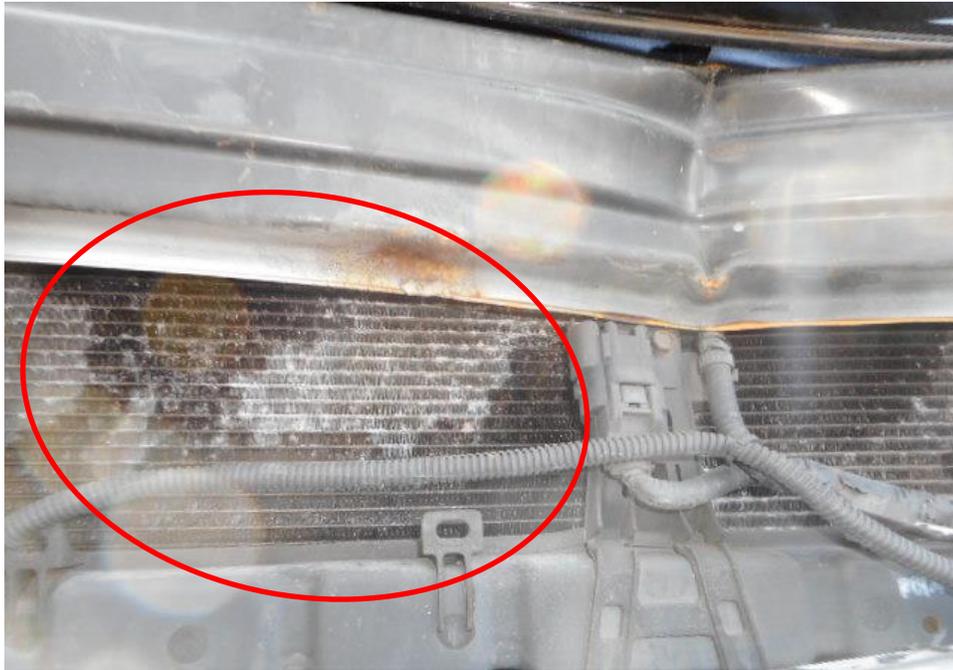
Photo 7 shows the close up view of the Motor Car's front body at the time of my inspection. The Motor car was observed to have sustained damage at its front portion. Its engine radiator (circled) was amongst the various components in the engine compartments were also damaged as a result of the accident.

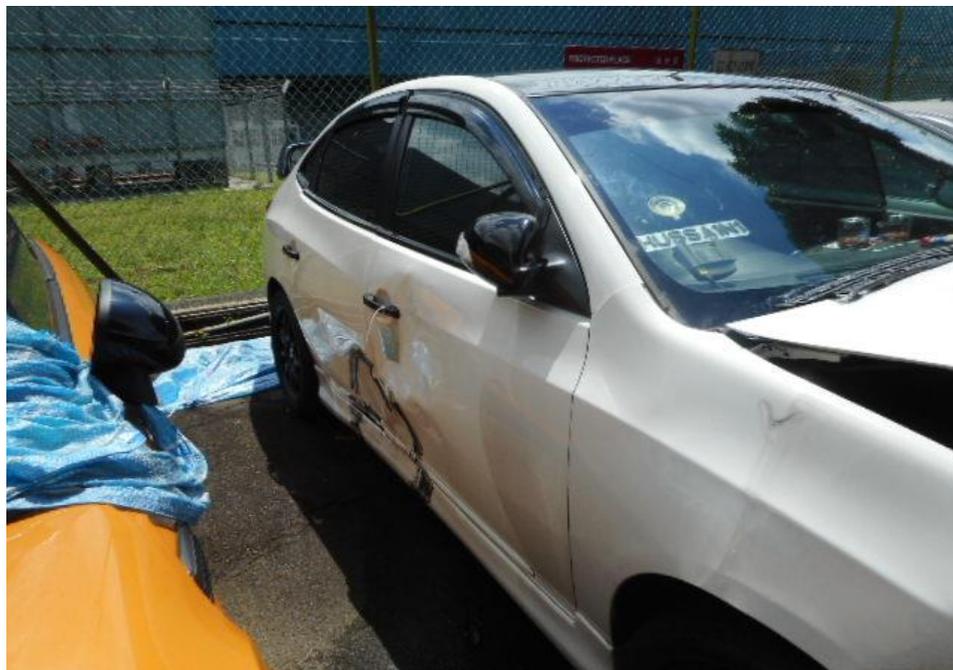
Photo 8 shows a general view of the Motor Car's right body at the time of my inspection. The right portion door panel of the Motor Car was observed to have been damaged by the accident.

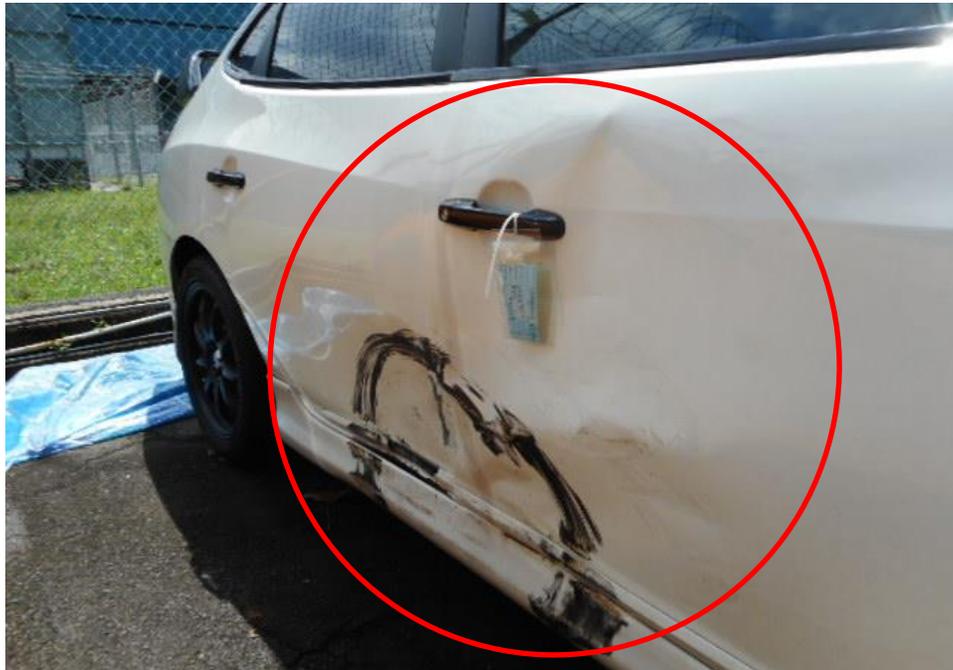
Photo 9 shows a close up view of the Motor Car's right body at the time of my inspection. The right portion door panel (circled) of the Motor Car was observed to have been damaged by the accident.

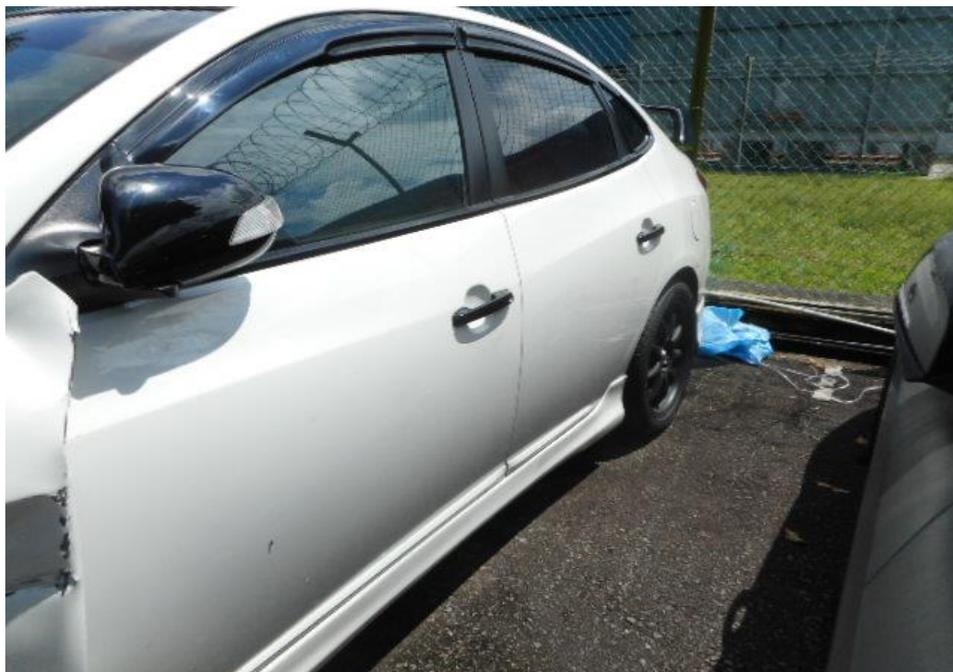
Photo 10 shows a general view of the Motor Car's left body at the time of my inspection. The left portion of the Motor Car was observed to have been undamaged by the accident.

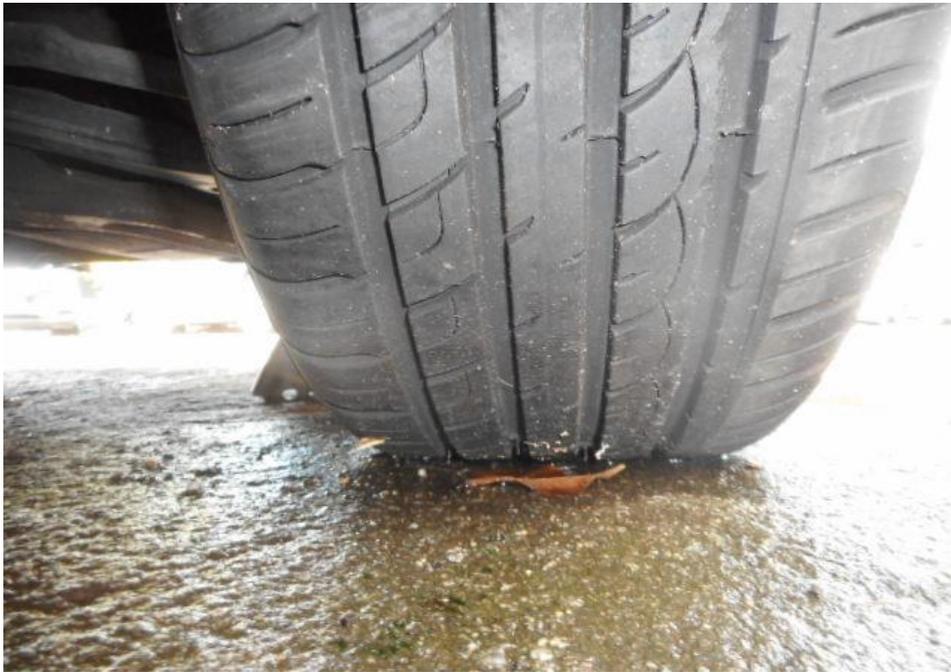
Photo 11 shows the condition of the front right tyre of the Motor Car, which was observed to be in serviceable condition with remaining tread depth of approximately 7mm. The tyre was also observed to be sufficiently inflated for vehicular operation with no tear, cut or burst mark(s).

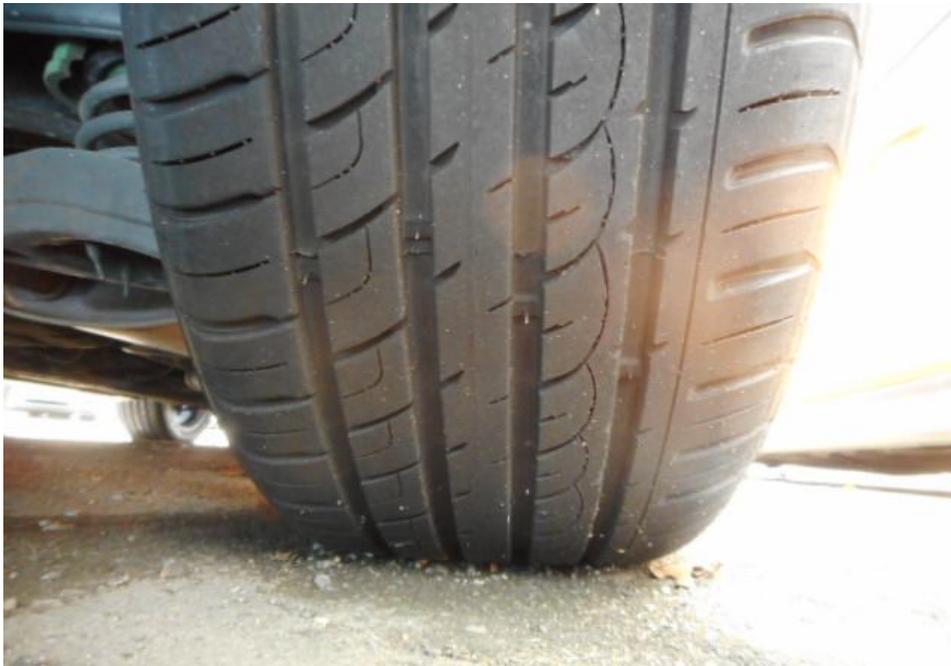
Photo 12 shows the condition of the rear right tyre of the Motor Car, which was observed to be in serviceable condition with remaining tread depth of approximately 7.2mm. The tyre was also observed to be sufficiently inflated for vehicular operation with no tear, cut or burst mark(s).

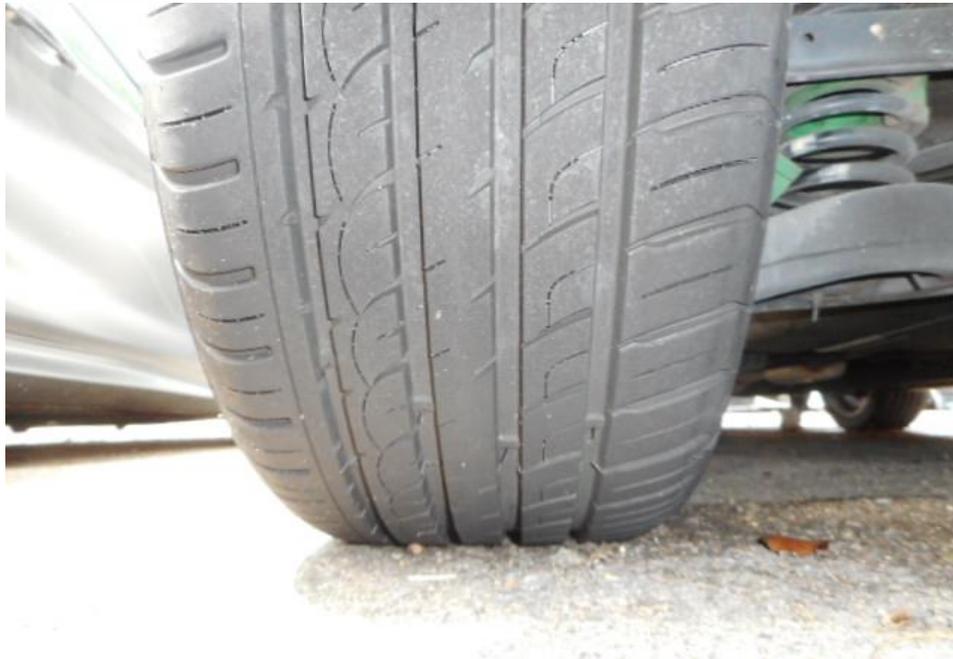
Photo 13 shows the condition of the rear left tyre of the Motor Car, which was observed to be in serviceable condition with remaining tread depth of approximately 7.2mm. The tyre was also observed to be sufficiently inflated for vehicular operation with no tear, cut or burst mark(s).

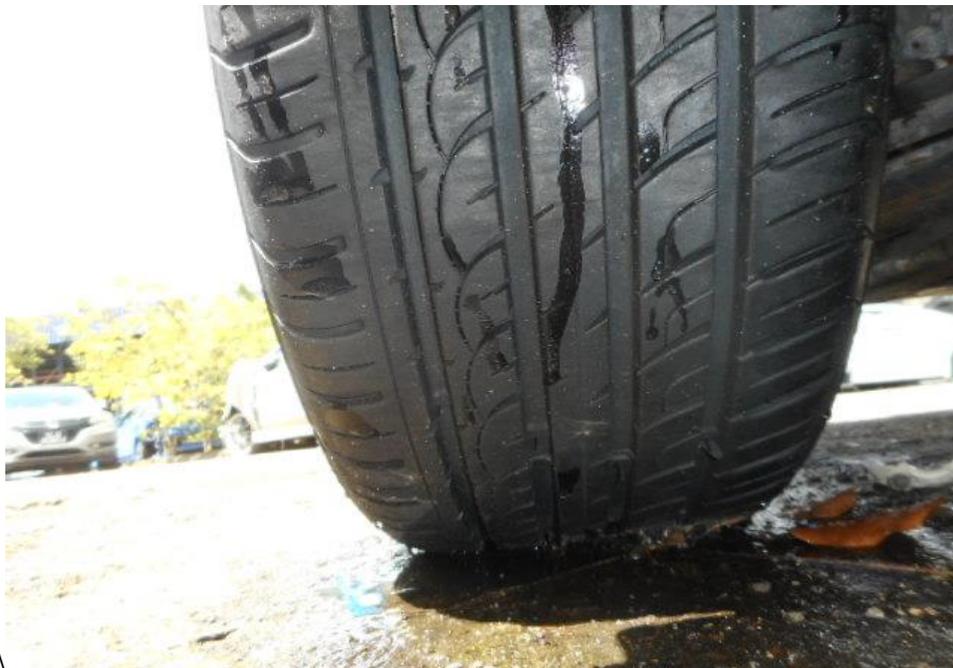
Photo 14 shows the condition of the front left tyre of the Motor Car, which was observed to be in serviceable condition with remaining tread depth of approximately 7.1mm. The tyre was also observed to be sufficiently inflated for vehicular operation with no tear, cut or burst mark(s).

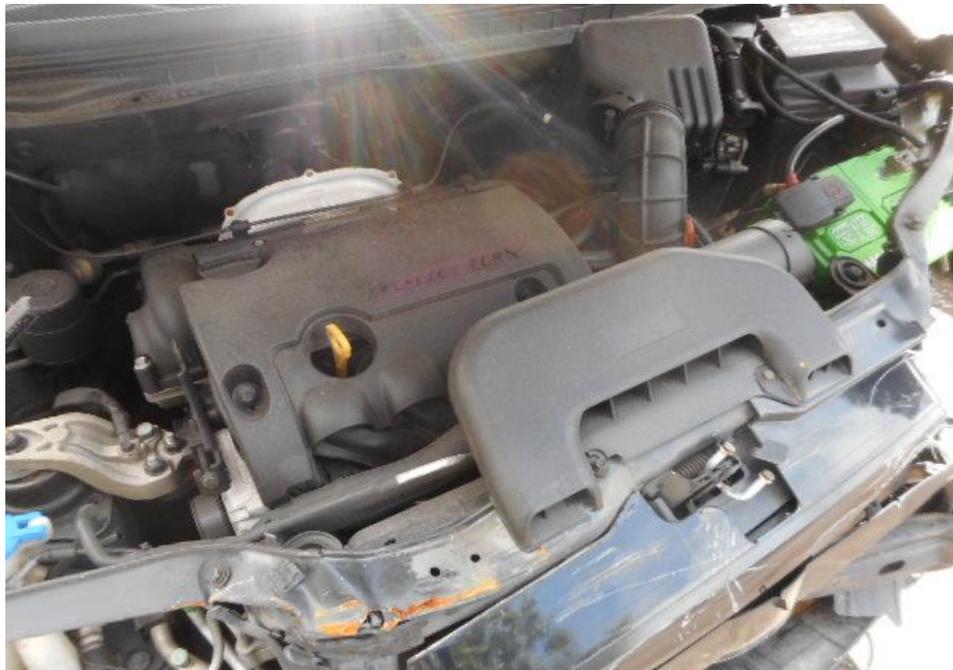
Photo 15 shows a general view of the Motor Car's engine compartment. The various parts and components inside the engine compartment were unaffected by the accident. There was also no sign(s) or indication(s) of fluid leakage and/or fluid stain within the engine compartment.

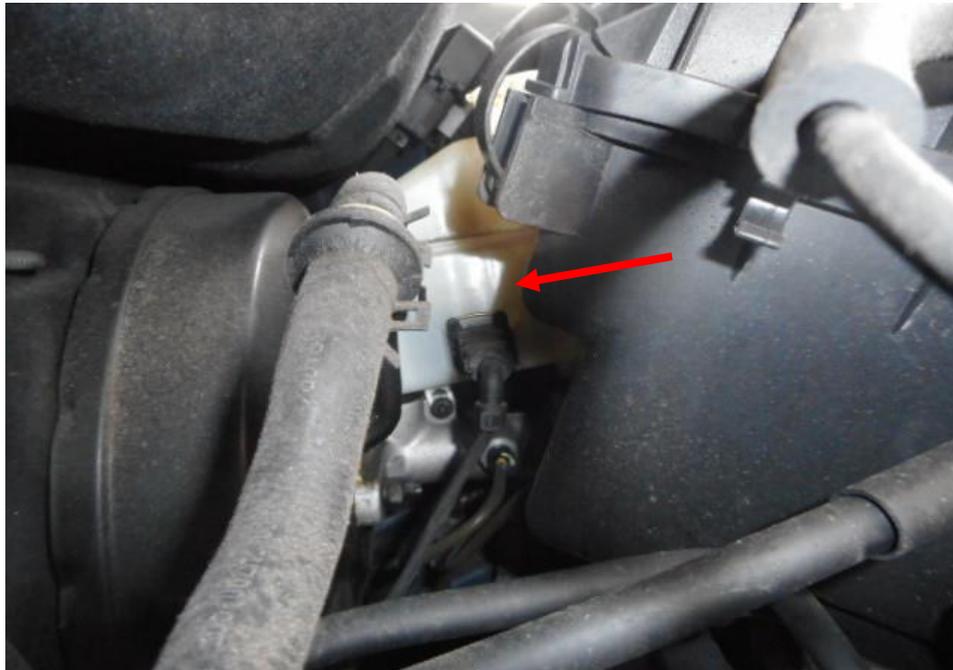
Photo 16 shows the brake fluid reservoir of the Motor Car at the time of my inspection. The brake fluid reservoir was observed to be damaged and the brake fluid was observed to be of insufficient level.

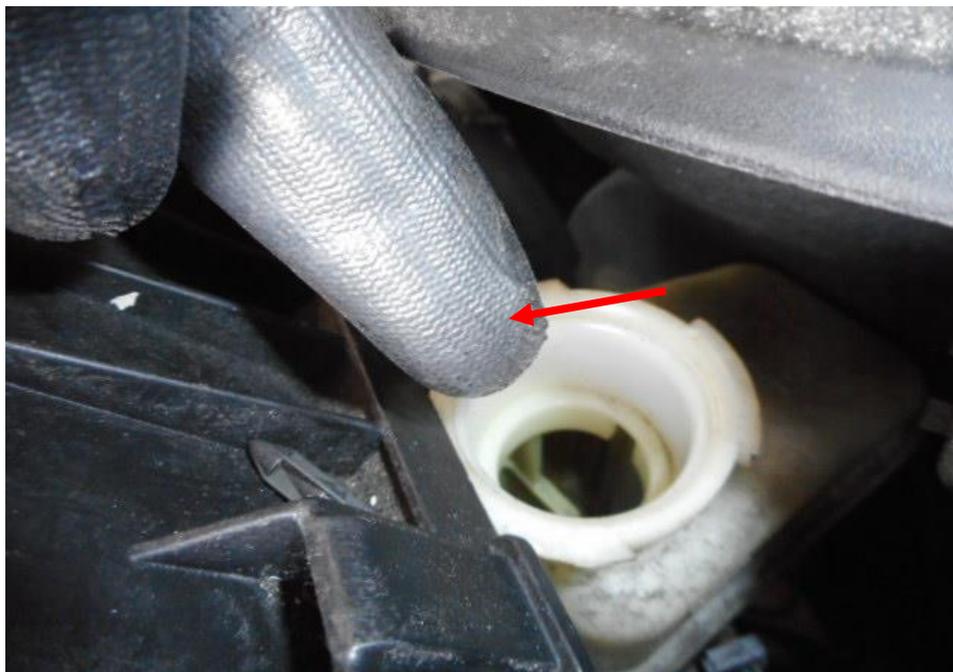
Photo 17 shows the brake fluid reservoir of the Motor Car at the time of my inspection. The brake fluid reservoir was observed to be damaged and the brake fluid was observed to be of insufficient level (arrowed)

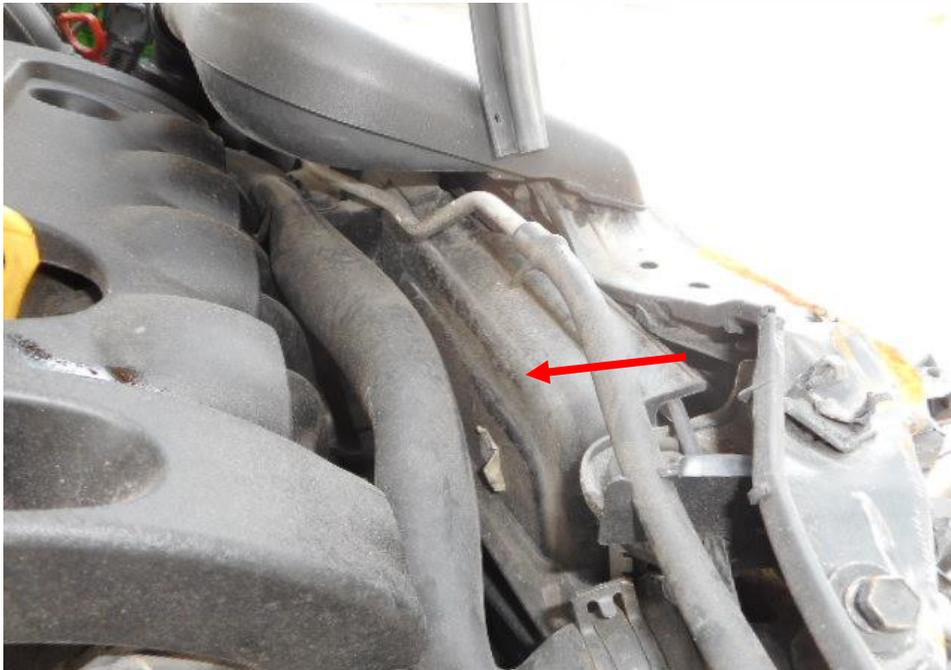
Photo 18 shows checks being carried out to the engine coolant of the Motor Car at the time of my inspection. The engine coolant was unable to be observed as the engine radiator was blocked (arrowed) as the result of the accident.

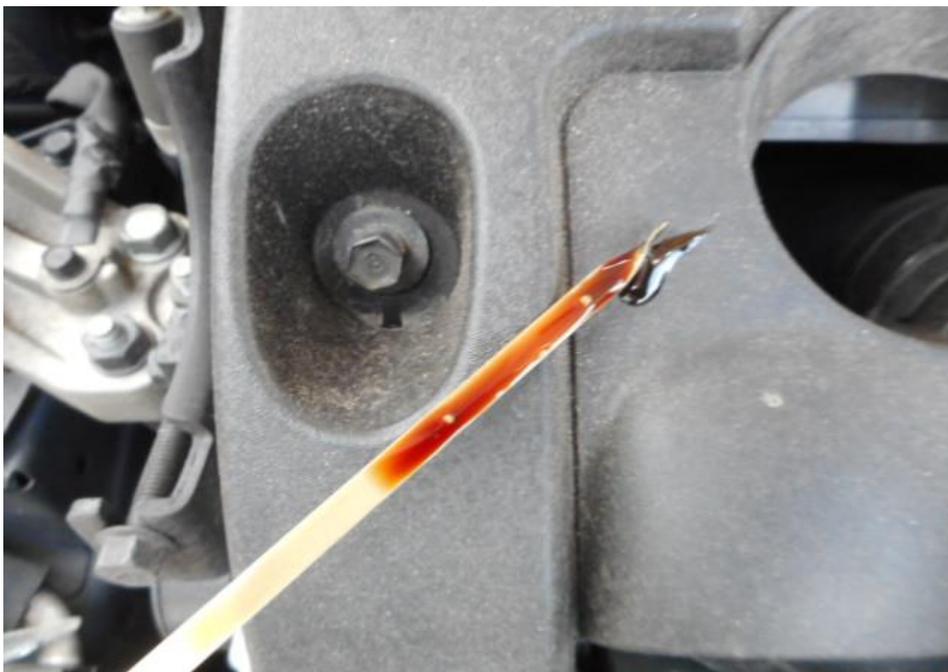
Photo 19 shows the engine oil dip stick of the Motor Car at the time of my inspection. The engine oil was observed to be of sufficient level and without any visible contamination.

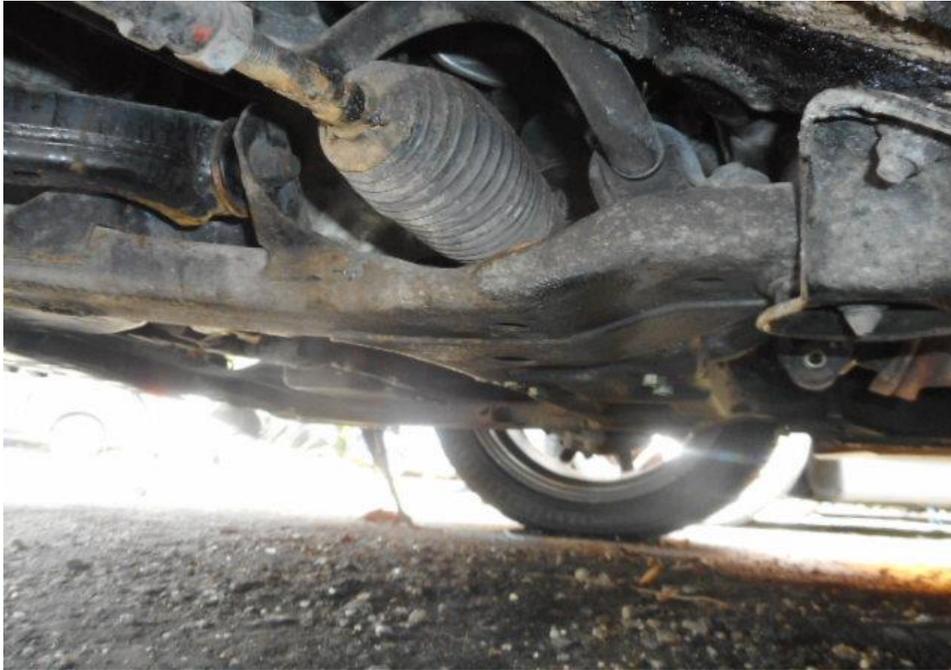
Photo 20 shows the undercarriage of the Motor Car, at the area where the engine housing and transmission housing are located. I did not find any sign(s) or indication(s) of fluid leak and/or fluid stain(s) on the underside of the Motor Car.

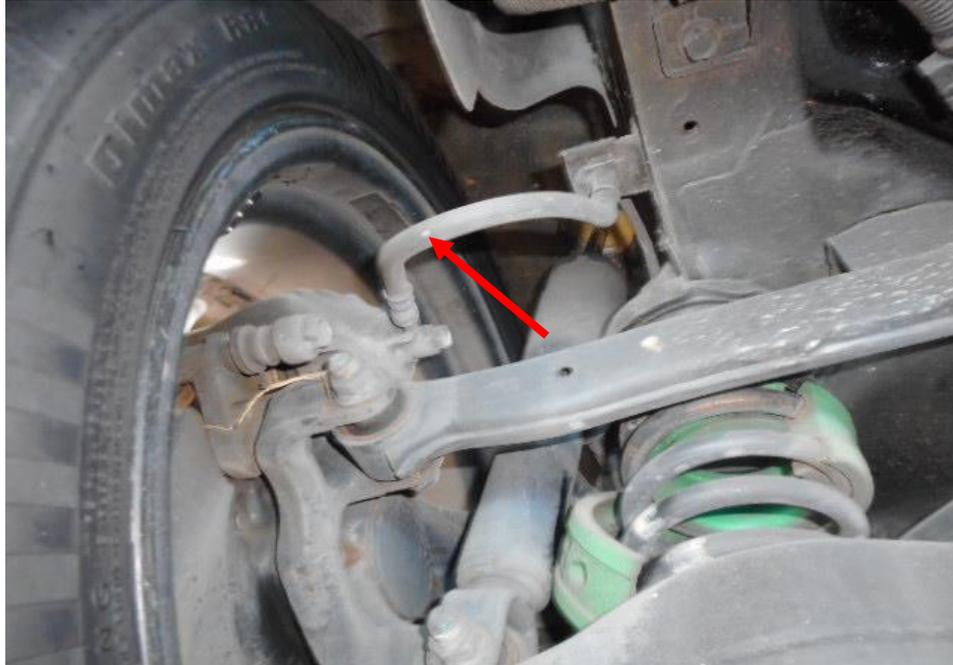
Photo 21 shows the brake hose/pipe (arrowed) at the rear left wheel of the Motor Car. I did not observe any leakage of brake fluid at the time of my inspection of the Motor Car. Static tests of the Motor Car's braking system had indicated that there was no internal leakage of pressure/vacuum. The undercarriage components of the Motor Car were also all found to be intact and without any visible damage.

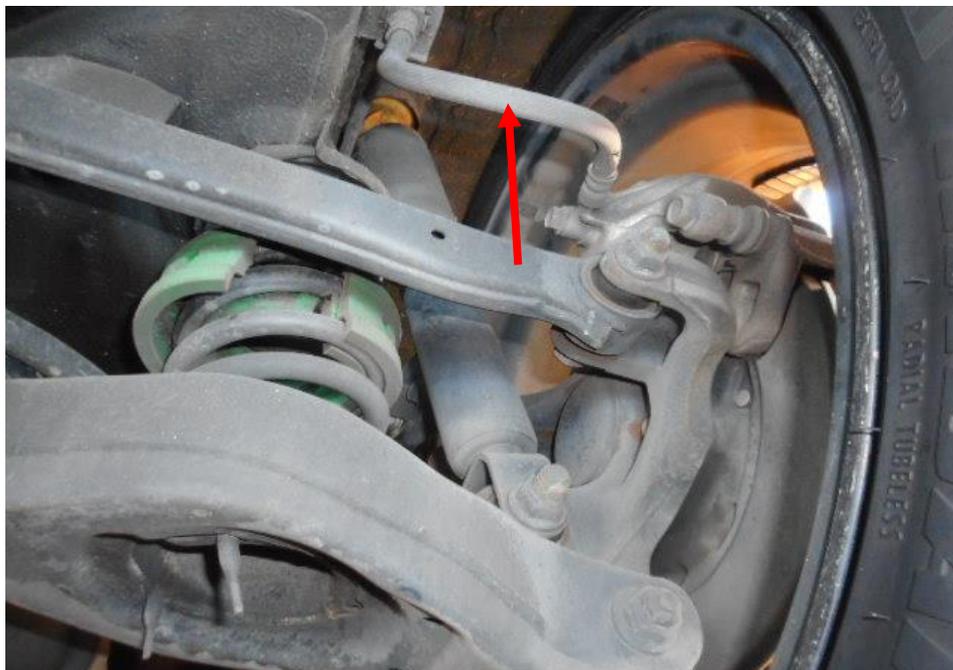
Photo 22 shows the brake hose/pipe (arrowed) at the front right wheel of the Motor Car. I did not observe any leakage of brake fluid at the time of my inspection of the Motor Car. Static tests of the Motor Car's braking system had indicated that there was no internal leakage of pressure/vacuum. The undercarriage components of the Motor Car were also all found to be intact and without any visible damage.

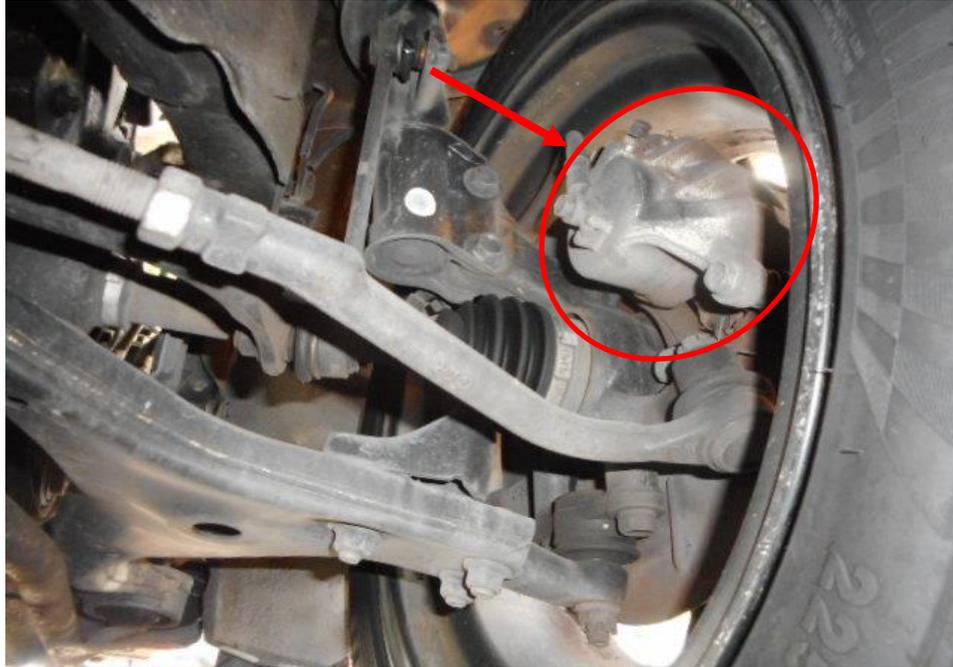
Photo 23 shows the brake hose/pipe (arrowed) at the front right wheel of the Motor Car. No leakage of brake fluid was observed. Visual examination of the various components of the braking system like the brake caliper (circled) brake pedal etc had revealed all to be intact and without visible damage at the time of accident. There was also no sign of fluid stain(s) observed on the various undercarriage components.

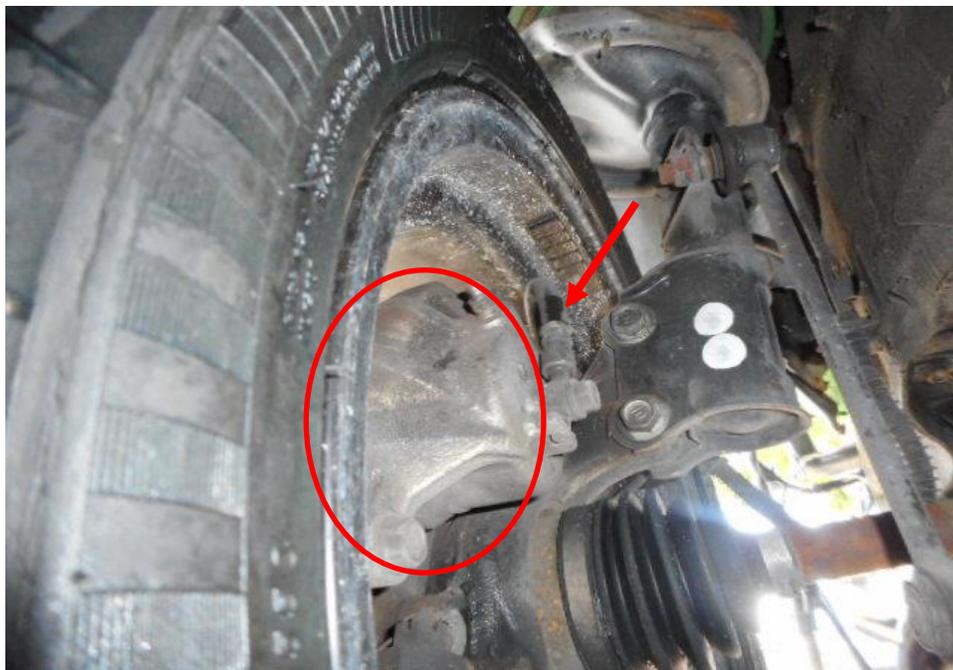
Photo 24 shows the brake hose/pipe (arrowed) at the front left wheel of the Motor Car. No leakage of brake fluid was observed. Visual examination of the various components of the braking system like the brake caliper (circled), brake pedal etc had revealed all to be intact and without visible damage at the time of accident. There was also no sign of fluid stain(s) observed on the various undercarriage components.

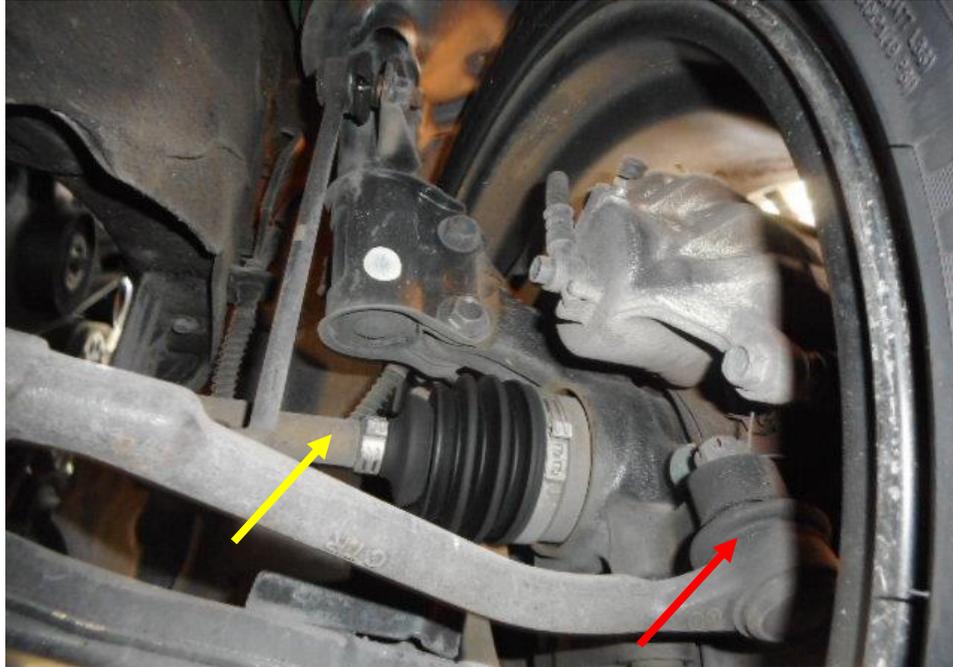
Photo 25 shows the various undercarriage components at the front right wheel of the Motor Car, in particular the steering tie rod end (arrowed) and drive shaft (yellow arrow). The various steering components were all found to be intact, suggesting that the steering system of the Motor Car was likely to be in serviceable condition at the material time of accident. There was also no sign of fluid stain(s) observed on the various undercarriage components.

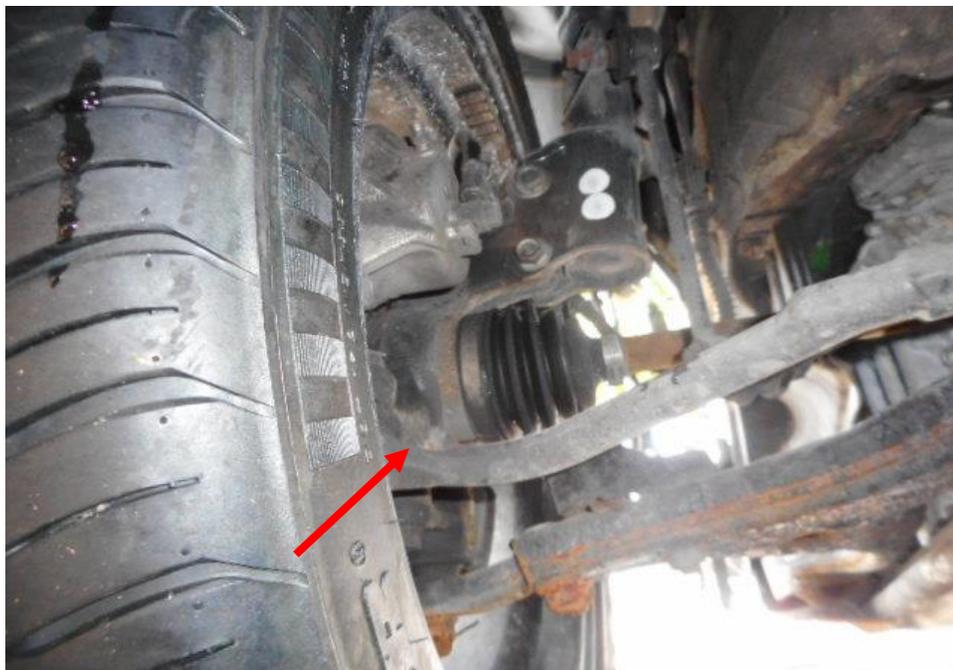
Photo 26 shows the various undercarriage components at the front left wheel of the Motor Car, in particular the steering tie rod end (arrowed). The various steering components were all found to be intact, suggesting that the steering system of the Motor Car was likely to be in serviceable condition at the material time of accident. There was also no sign of fluid stain(s) observed on the various undercarriage components.
