15<sup>th</sup> February 2022

**Fatal Accident Investigation Team**

Traffic Police Department  
Singapore Police Force  
10 Ubi Avenue 3  
Singapore 408865

**MECHANICAL INSPECTION REPORT OF MOTOR CAR SJR 926R**

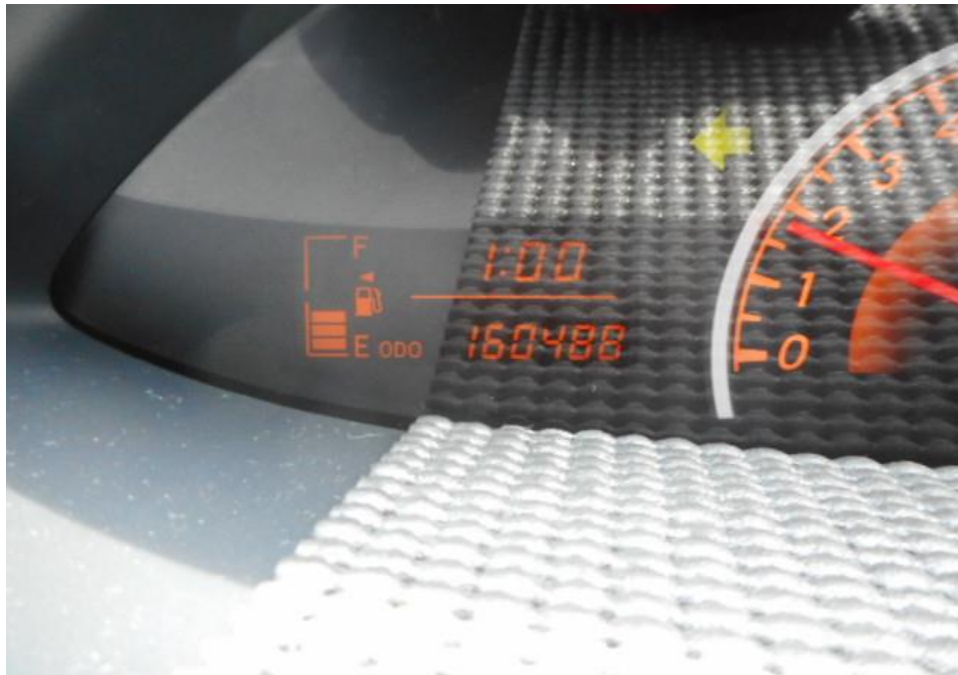
**Photo 1** shows the mileage of the Motor Car at the time of my inspection. The mileage observed was 160,488km.

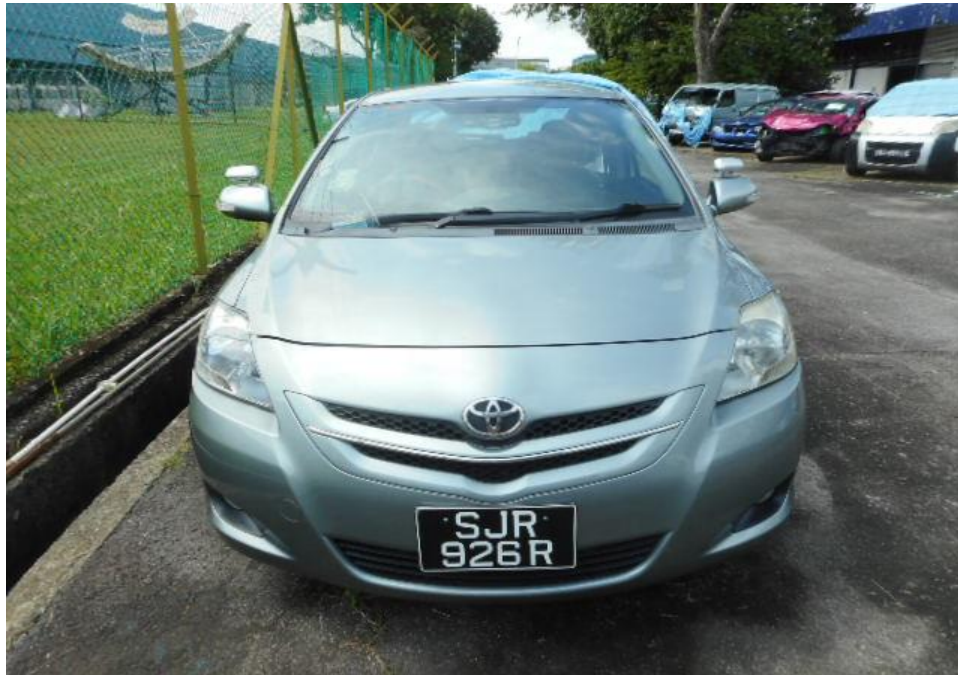
**Photo 2** shows a general view of the Motor Car's front body at the time of my inspection. The Motor Car front was observed to be unaffected by the accident.

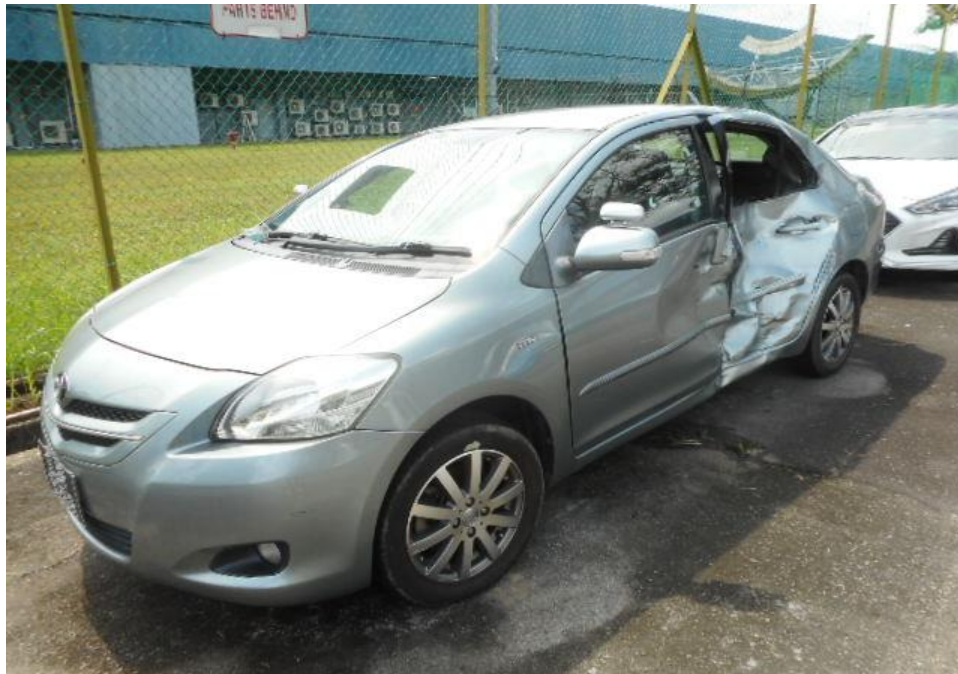
4. The mileage of the Motor Car at the time of my inspection was 160,488km.
5. The Motor Car was observed to have sustained damage at its left portion. Its left front and rear door panel were amongst the body parts that were damaged as a result of the accident.

**Photo 3** shows a general view of the Motor Car's left body at the time of my inspection. The Motor Car was observed to have sustained damage at its left portion. Its left front and rear door panel were amongst the body parts that were damaged as a result of the accident.

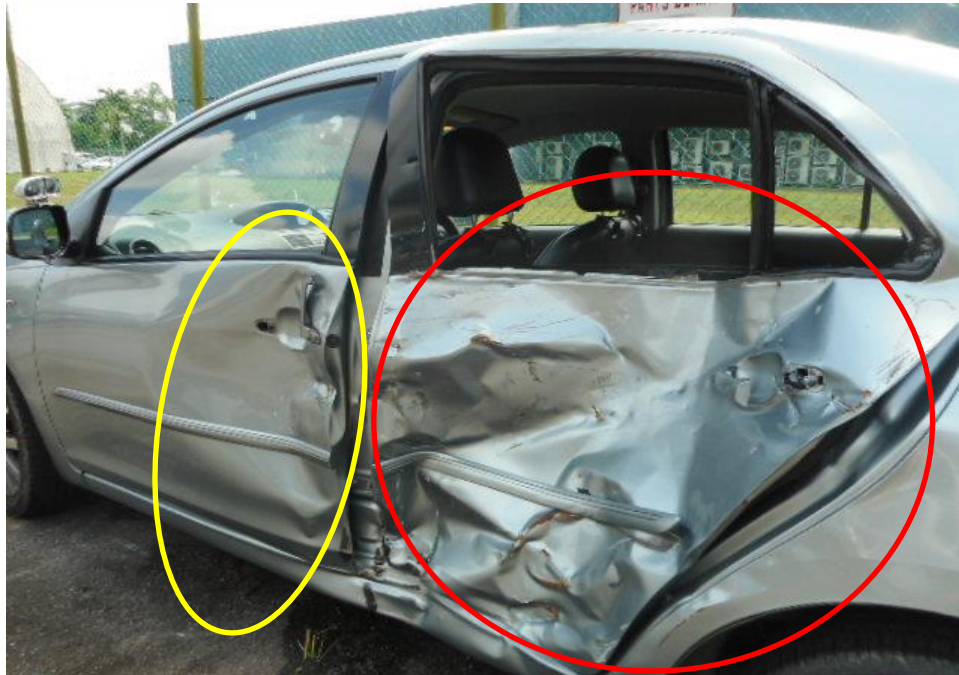
**Photo 4** shows a close up view of the Motor Car's left body at the time of my inspection. The Motor Car was observed to have sustained damage at its left portion. Its left front (yellow circle) and rear door panel (red circle) were amongst the body parts that were damaged as a result of the accident.

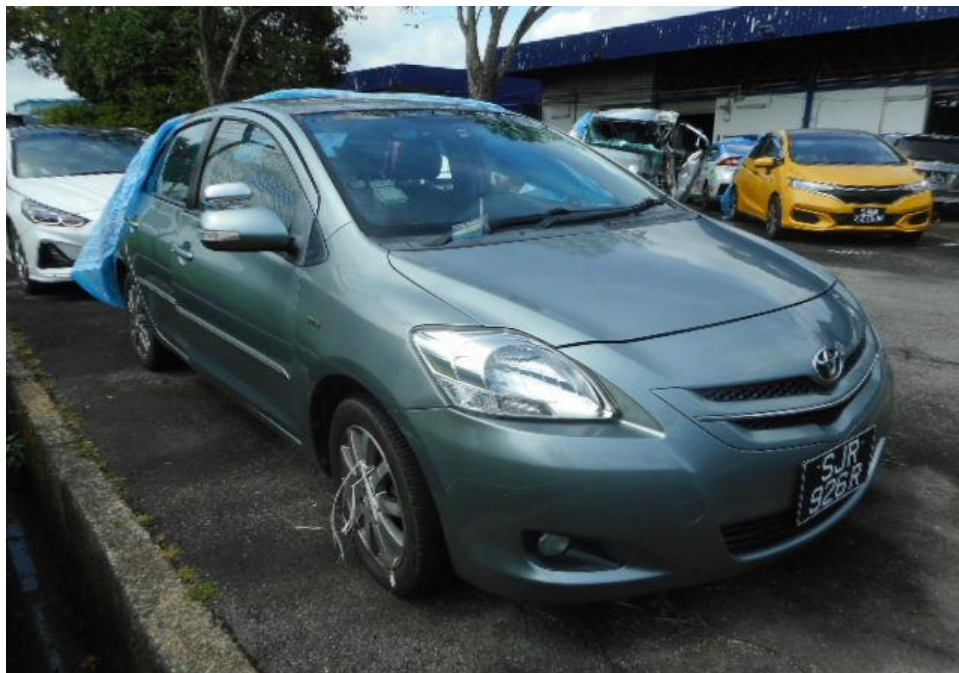
**Photo 5** shows a general view of the Motor Car's right body at the time of my inspection. The right portion of the Motor Car was observed to have been unaffected by the accident.

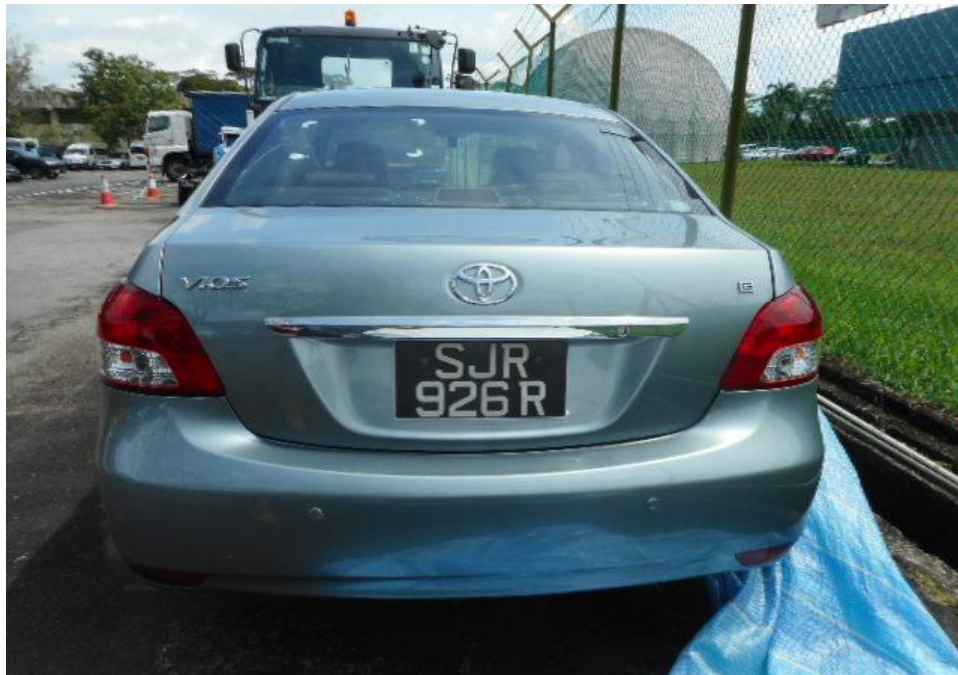
**Photo 6** shows the general view of the Motor Car's rear body at the time of my inspection. The Motor Car rear was observed to be unaffected by the accident.

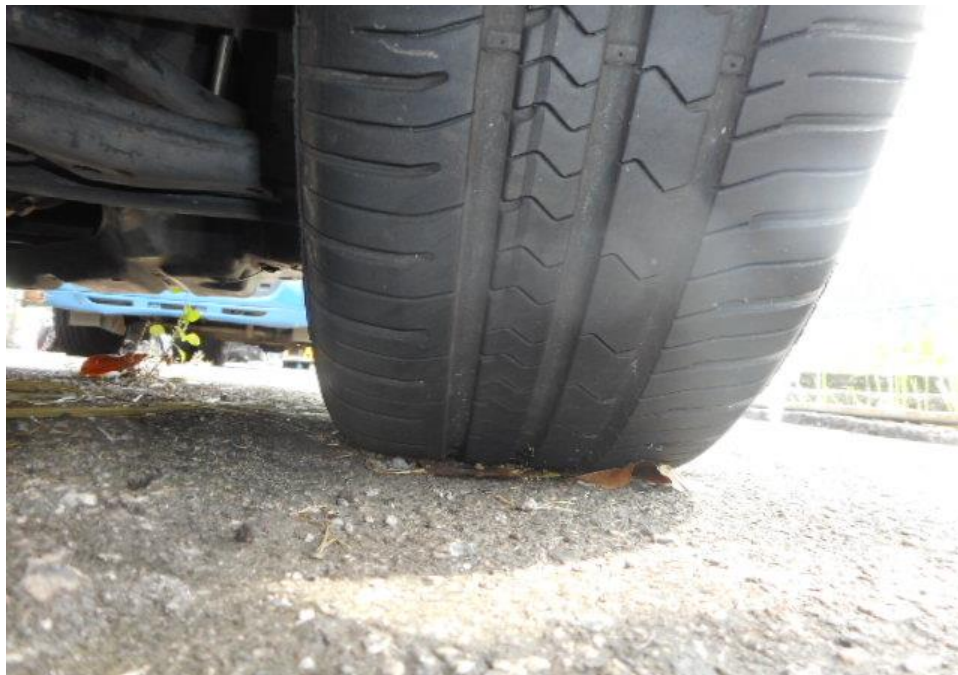
**Photo 7** shows the condition of the front right tyre of the Motor Car, which was observed to be in serviceable condition with remaining tread depth of approximately 6mm. The tyre was sufficiently inflated for vehicular operation with no tear, cut or burst mark(s) on the outer and the inner sidewalls as well as across the tread. The 4 tyres of the Motor Car were wrapped around standard steel wheel rims without any damage.

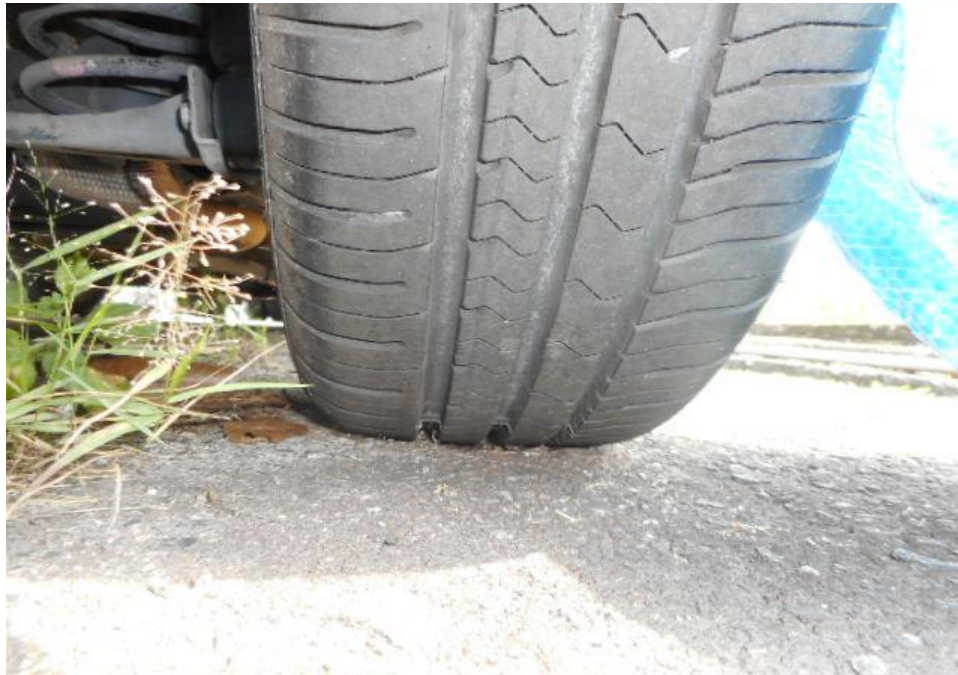
**Photo 8** shows the condition of the rear right tyre of the Motor Car, which was observed to be in serviceable condition with remaining tread depth of approximately 6.7mm. The tyre was also observed to be sufficiently inflated for vehicular operation with no tear, cut or burst mark(s).

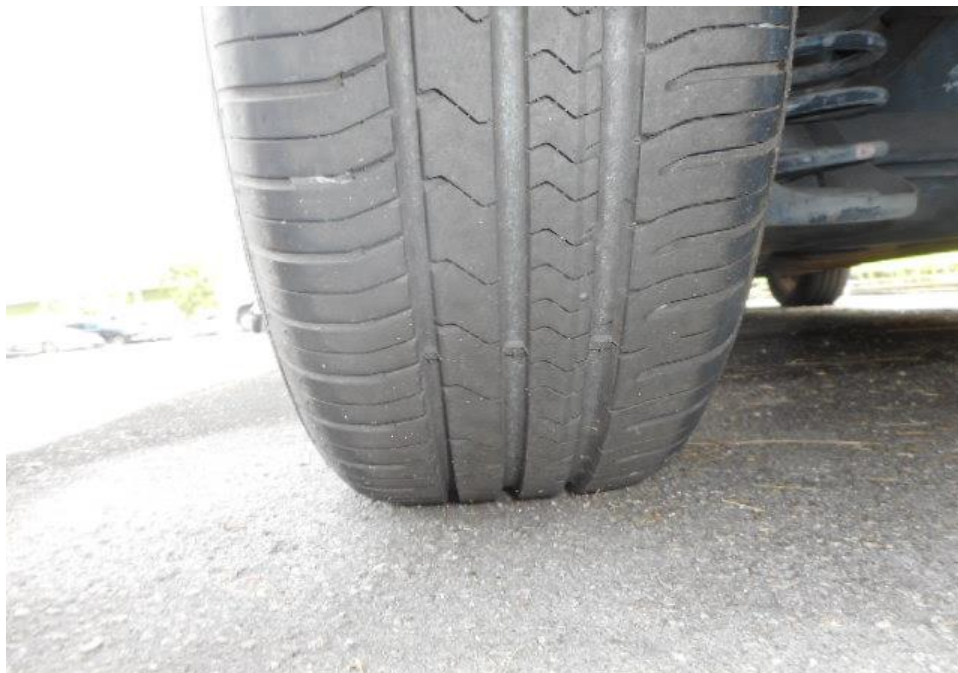
**Photo 9** shows the condition of the rear left tyre of the Motor Car, which was observed to be in serviceable condition with remaining tread depth of approximately 6.7mm. The tyre, which was wrapped around steel wheel rim, was also observed to be sufficiently inflated for vehicular operation. The 4 tyres of the Motor Car were wrapped around standard steel wheel rims.

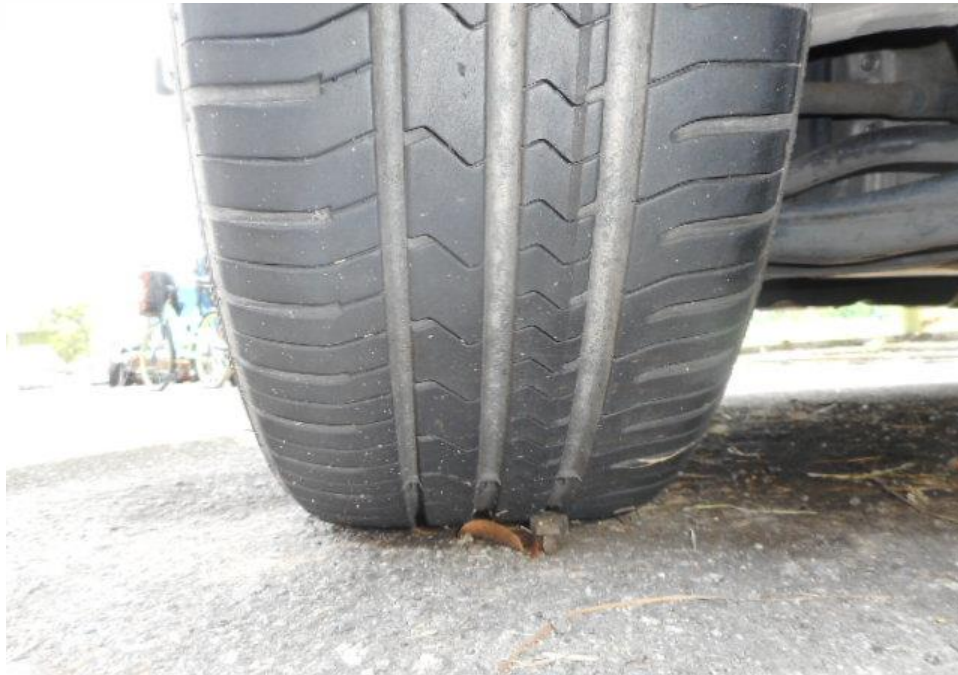
**Photo 10** shows the condition of the front left tyre of the Motor Car, which was observed to be in serviceable condition with remaining tread depth of approximately 5.8mm. There was also no tear, cut or burst mark(s) on the outer and the inner sidewalls as well as across the tread of the Motor Car's 4 tyres.

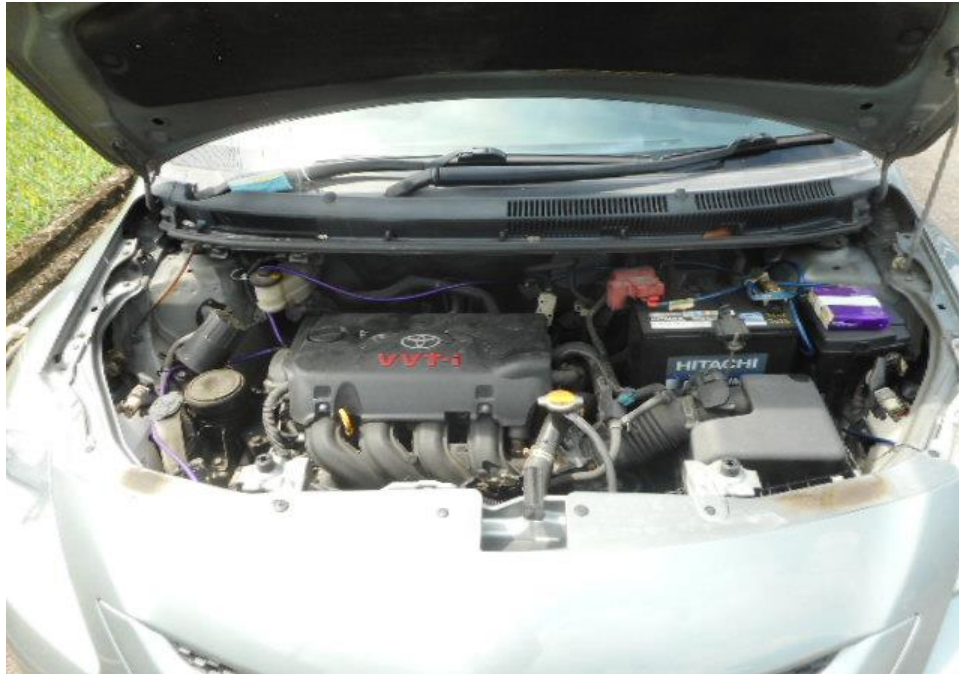
**Photo 11** shows a general view of the Motor Car's engine compartment. The various parts and components inside the engine compartment were unaffected by the accident. There was also no sign(s) or indication(s) of fluid leakage and/or fluid stain within the engine compartment.

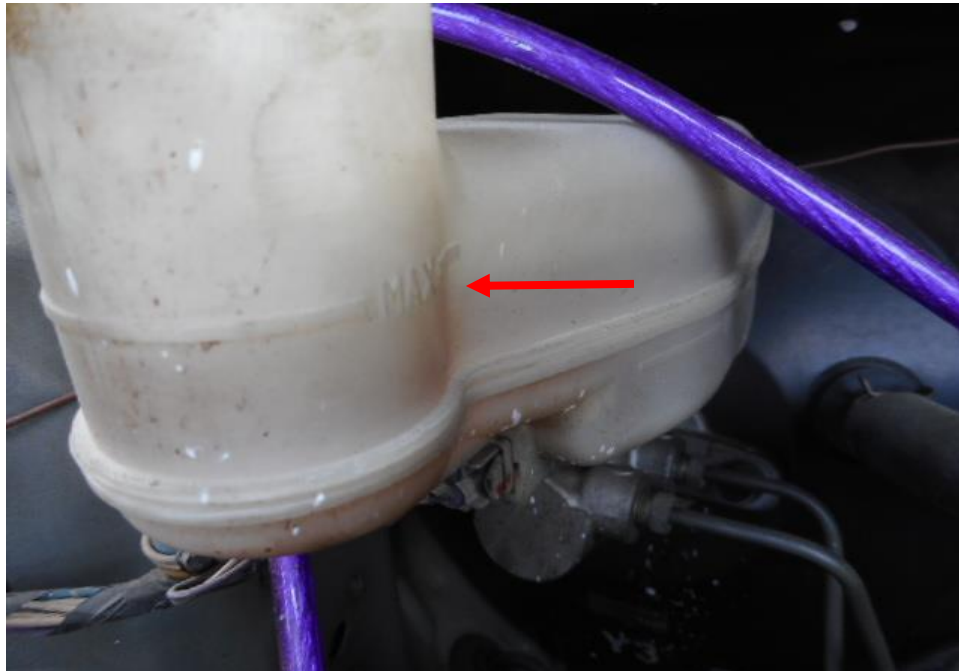
**Photo 12** shows the brake fluid reservoir of the Motor Car at the time of my inspection. The brake fluid was observed to be of sufficient level (arrowed) and without any visible contamination.

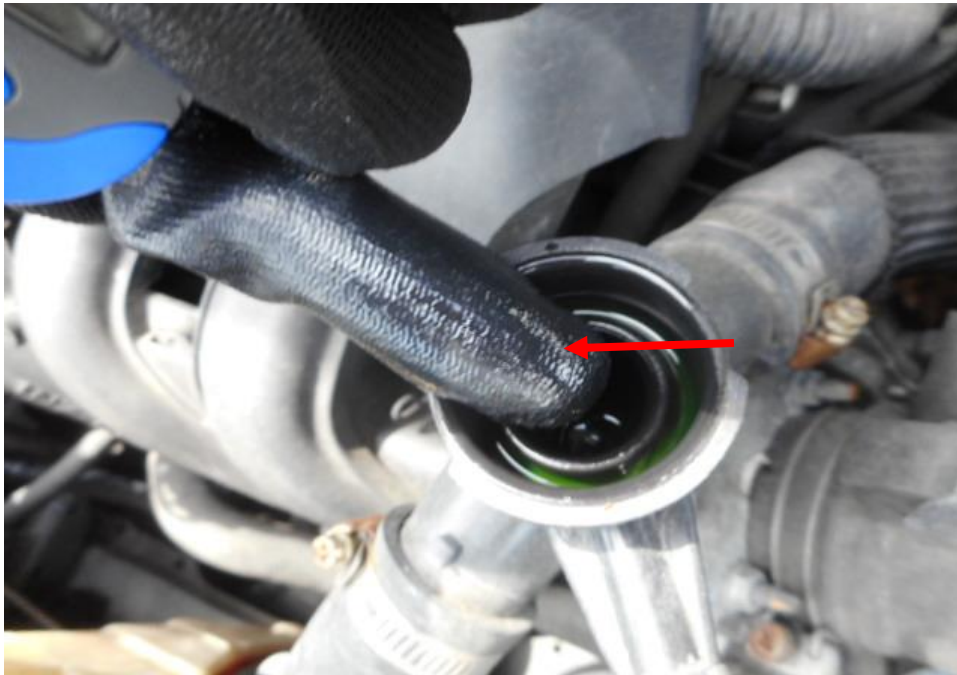
**Photo 13** shows checks being carried out to the engine coolant of the Motor Car at the time of my inspection. The engine coolant was observed to be of sufficient level (arrowed) and without any visible contamination.

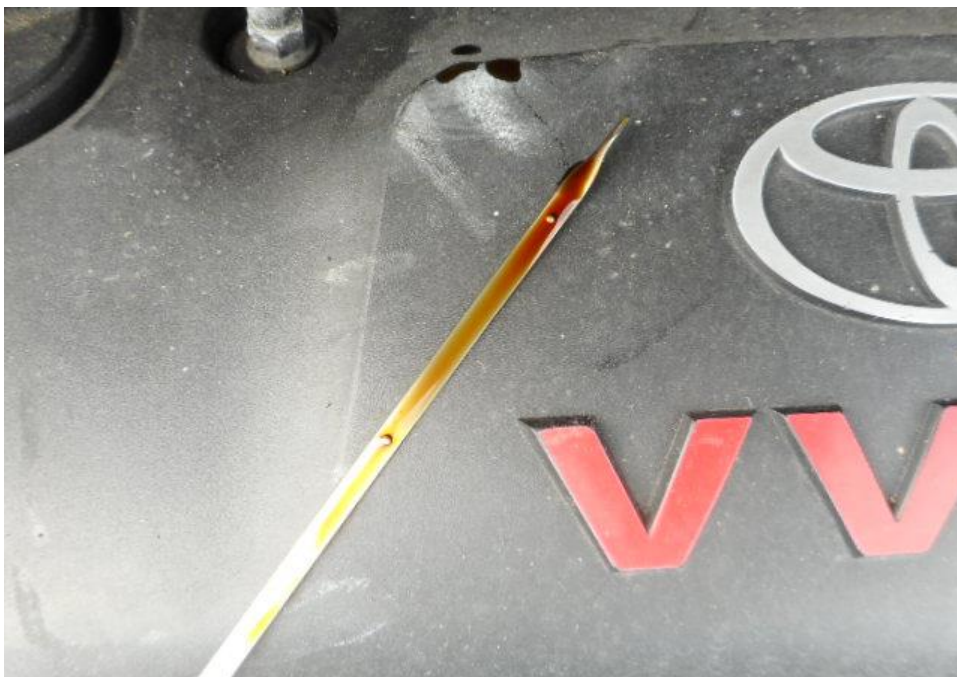
**Photo 14** shows the engine oil dipstick of the Motor Car at the time of my inspection. The engine oil was observed to be of sufficient level and without any visible contamination.

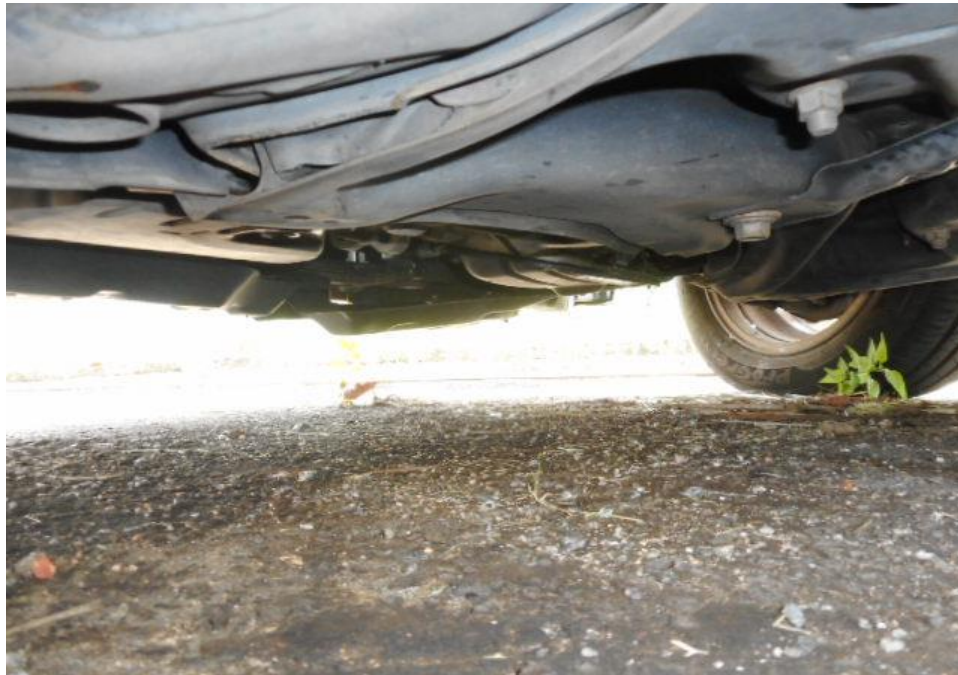
**Photo 15** shows the undercarriage of the Motor Car, at the area where the engine housing and transmission housing are located. I did not find any sign(s) or indication(s) of fluid leak and/or fluid stain(s) on the underside of the Motor Car.

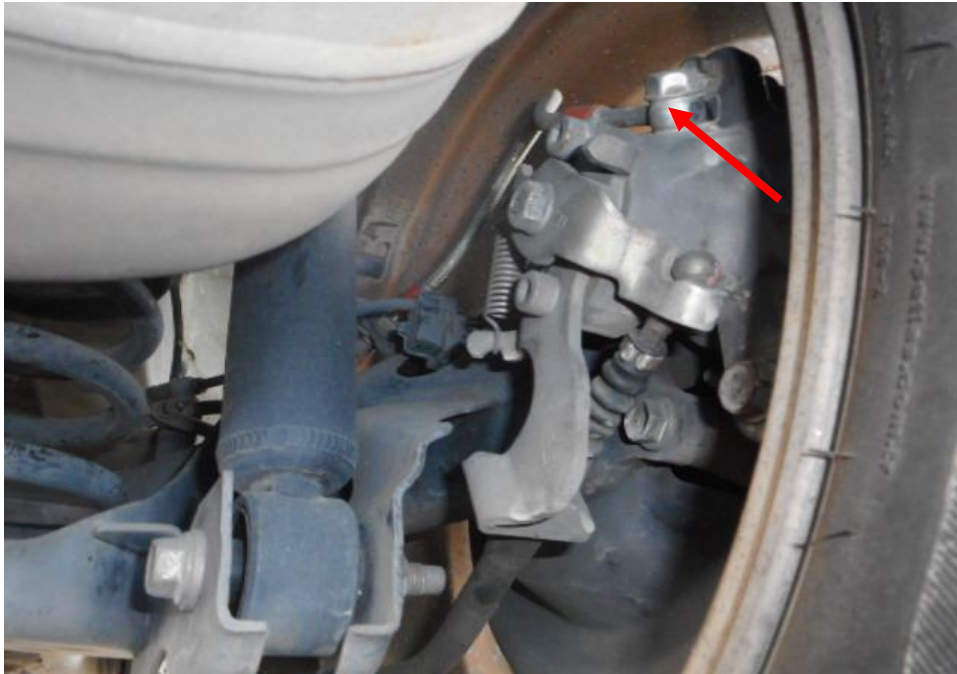
**Photo 16** shows the brake hose/pipe (arrowed) at the rear right wheel of the Motor Car. No leakage of brake fluid was observed. Visual examination of the various components of the braking system like the drum brake, brake booster, brake pedal etc. had revealed all to be intact and without visible damage.

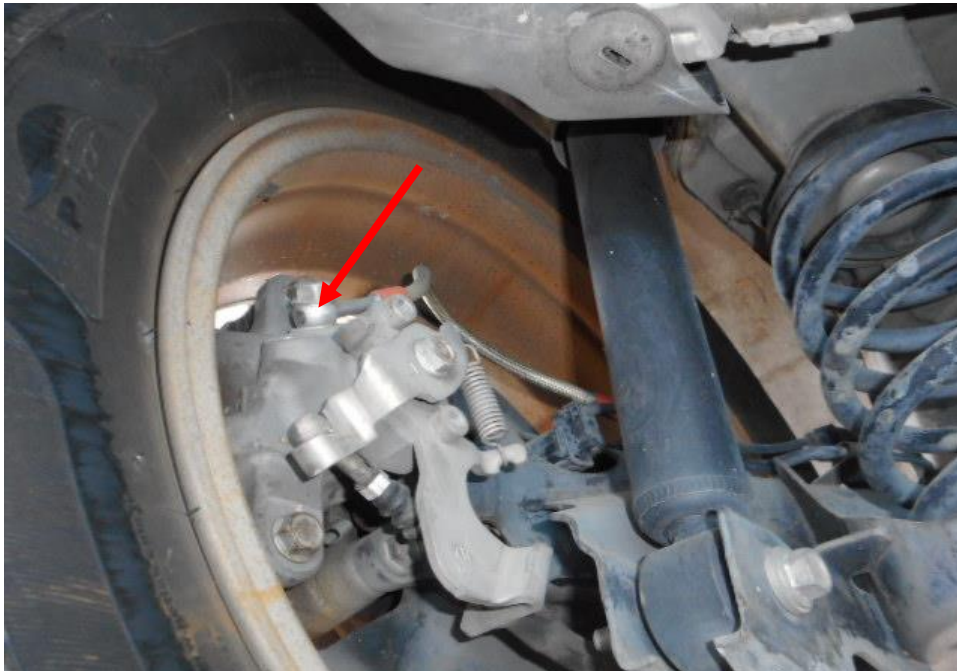
**Photo 17** shows the brake hose/pipe (arrowed) at the rear left wheel of the Motor Car. I did not observe any leakage of brake fluid at the time of my inspection of the Motor Car. Static tests of the Motor Car's braking system had indicated that there was no internal leakage of pressure/vacuum. The undercarriage components of the Motor Car were also all found to be intact and without any visible damage.

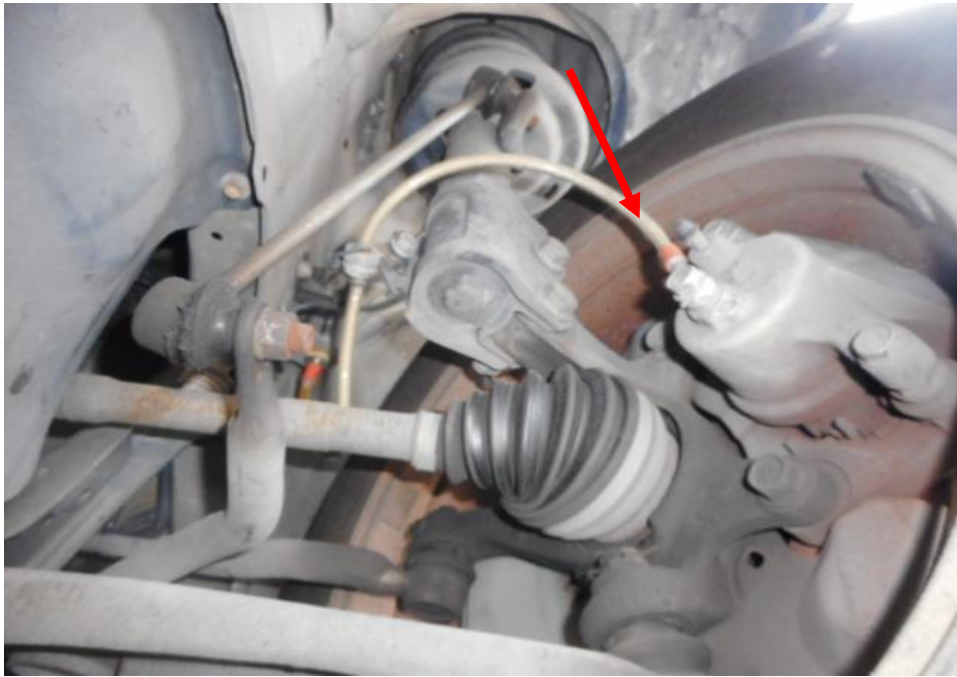
**Photo 18** shows the brake hose/pipe (arrowed) at the front right wheel of the Motor Car. I did not observe any leakage of brake fluid at the time of my inspection of the Motor Car. Static tests of the Motor Car's braking system had indicated that there was no internal leakage of pressure/vacuum. The undercarriage components of the Motor Car were also all found to be intact and without any visible damage.

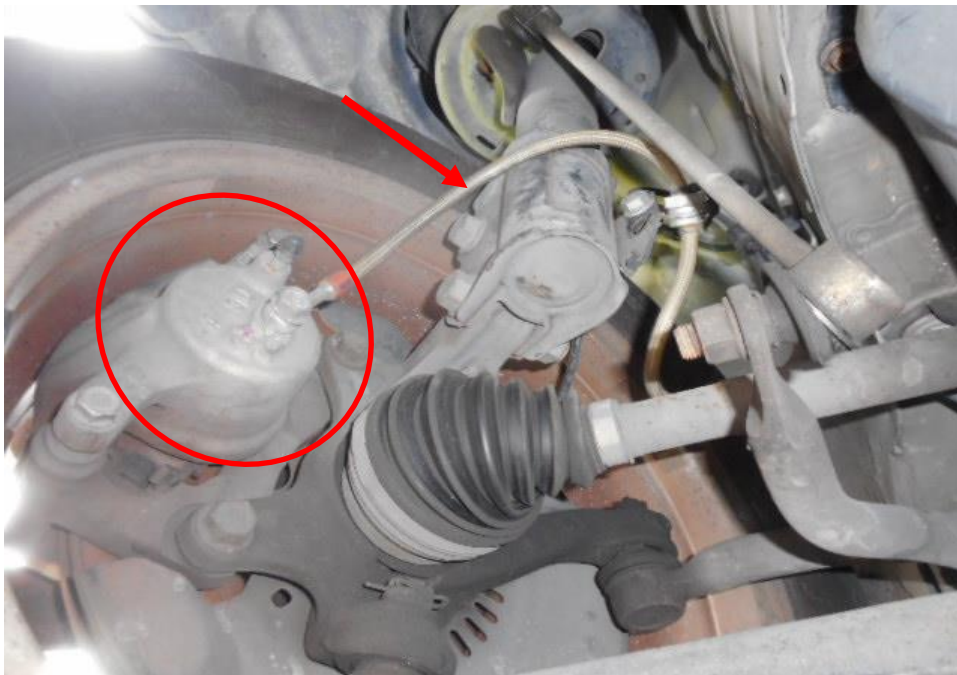
**Photo 19** shows the brake hose/pipe (arrowed) at the front left wheel of the Motor Car. No leakage of brake fluid was observed. Visual examination of the various components of the braking system like the brake caliper (circled), brake booster, brake pedal etc had revealed all to be intact and without visible damage.

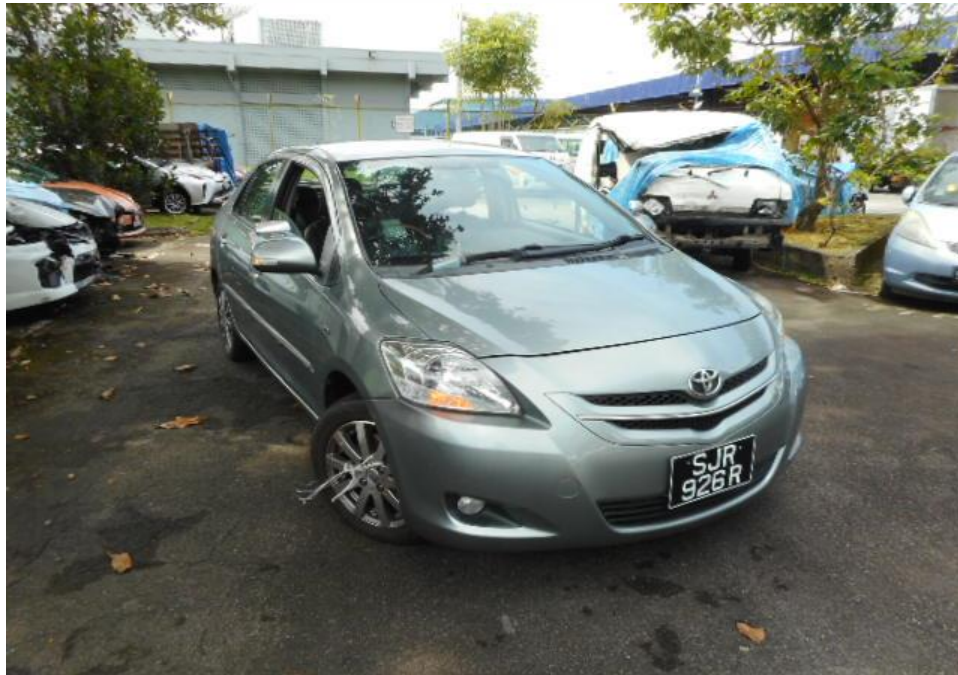
**Photo 20** shows the front right wheel of the Motor Car turned to its full left. During my steering system test, I did not experience any abnormal free play and/or resistance when I had turned the steering wheel towards the left and right. This would suggest that the steering system of the Motor Car was likely to be in serviceable condition at the material time of accident.

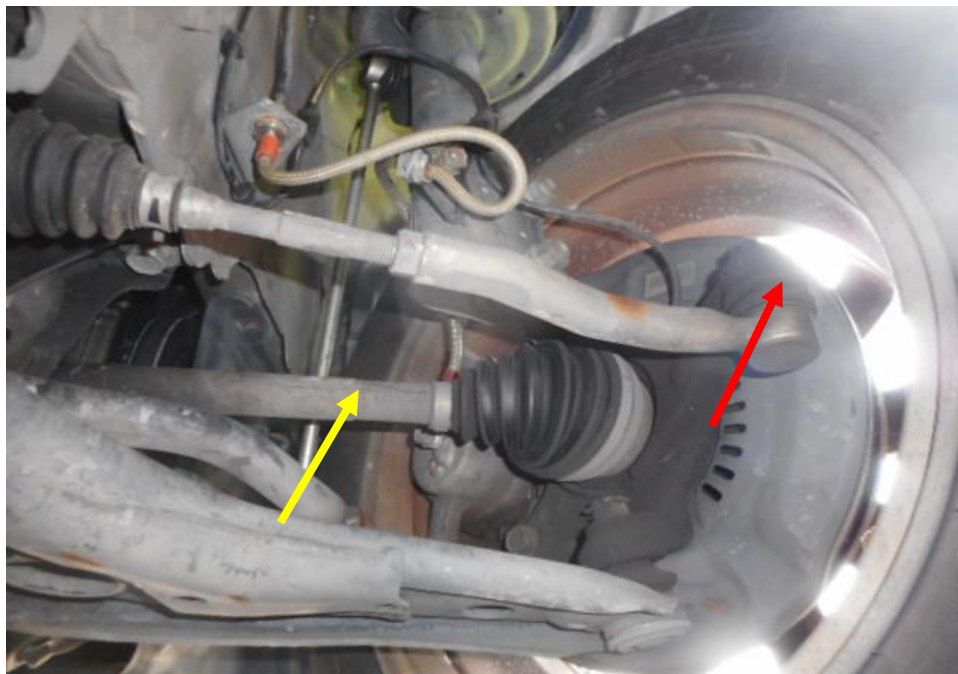
**Photo 21** shows the various undercarriage components at the front right wheel of the Motor Car, in particular the steering tie rod (red arrow) and drive shaft (yellow arrow). The various steering components were all found to be intact, suggesting that the steering system of the Motor Car was likely to be in serviceable condition at the material time of accident. There was also no sign of fluid stain observed on the various undercarriage components at the front right wheel of the Motor Car.

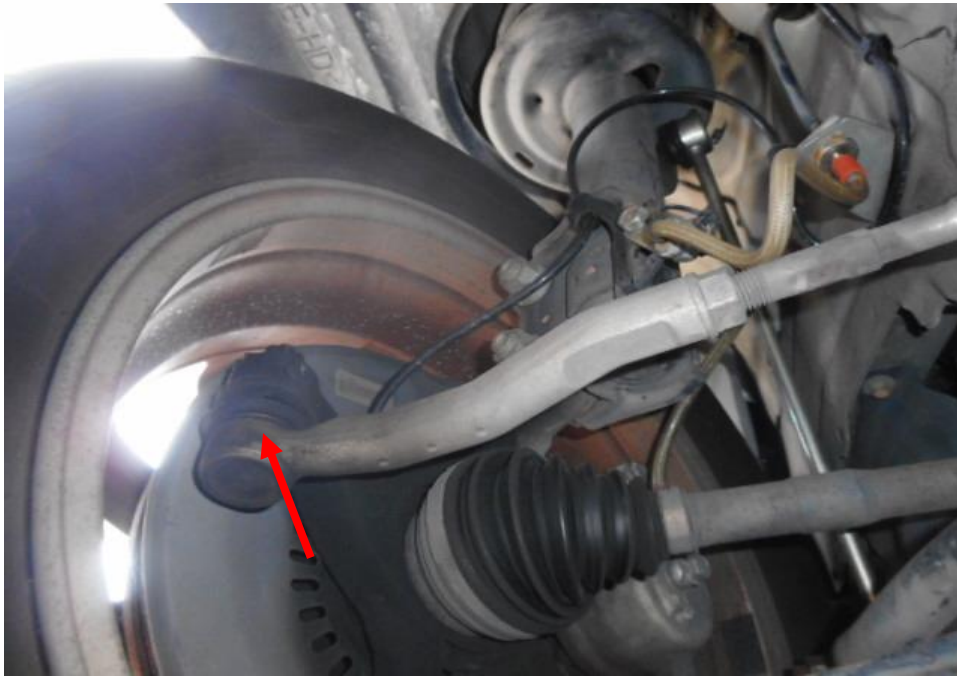
**Photo 22** shows the various undercarriage components at the front left wheel of the Motor Car, which had included the steering tie rod (red arrow). The various undercarriage components of the Motor Car were all found to be intact without any visible damage.

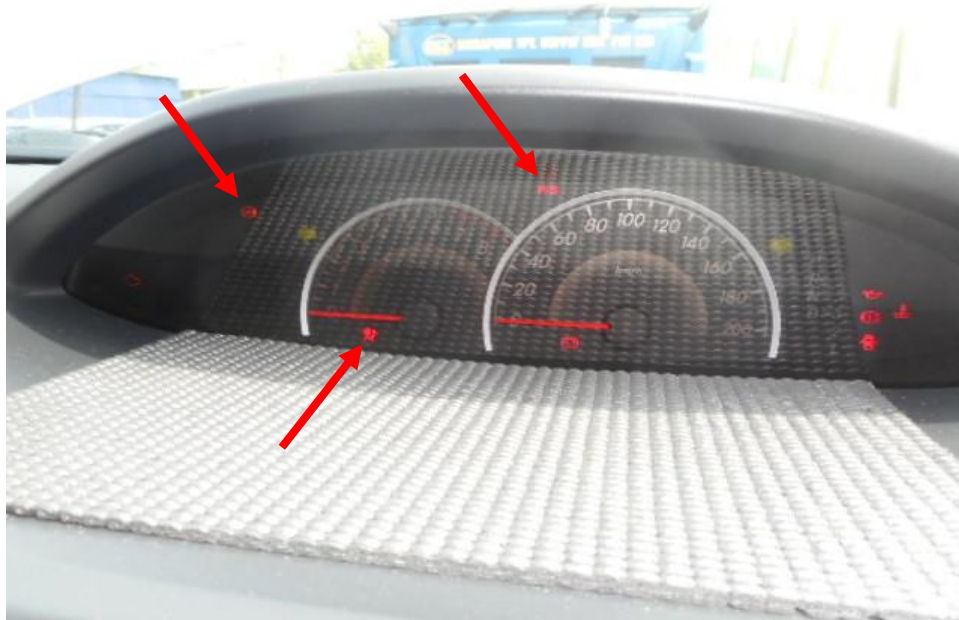
**Photo 23** shows the warning light for Anti-Lock Brake System (ABS), Electric Power Steering System (EPS), and Supplemental Restraint System (SRS) (arrowed) appearing on the instrument panel of the Motor Car during the self-test of its various electronic operating systems when its engine was cranked.

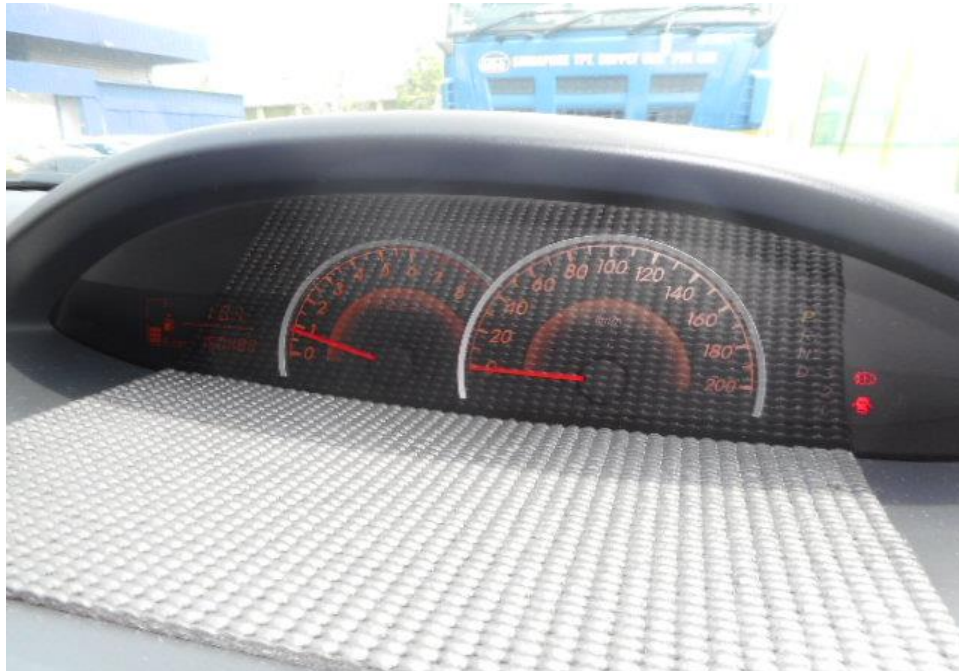
**Photo 24** shows no warning lights illuminated on the instrument panel of the Motor Car after the engine was cranked. This would suggest that there was no abnormality to the electronic operating system of the Motor Car, like the ABS, EPS, and SRS etc.
