Re : Third Party Claim For Vehicle Registration No. SLE909K

VEHICLE INSPECTION REPORT

Our ref. : UAM21.10.10-PT-STP-CSM-SLE909K

Date : 15 Oct 2021

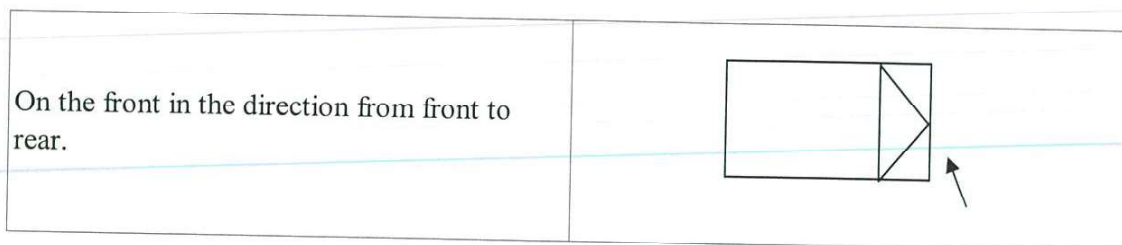
POINT OF IMPACT

The impact of the collision has damaged / affected the front bumper, headlamp, radiator grille, and etc...
