Your Ref: Audi A7  
(chassis number WAUZZZF24KN097295)  
Our Ref : CI/TP21011299/D

05 November 2021

**INSPECTION REPORT OF AN UNREGISTERED AUDI A7 MOTOR CAR WITH CHASSIS NUMBER WAUZZZF24KN097295**

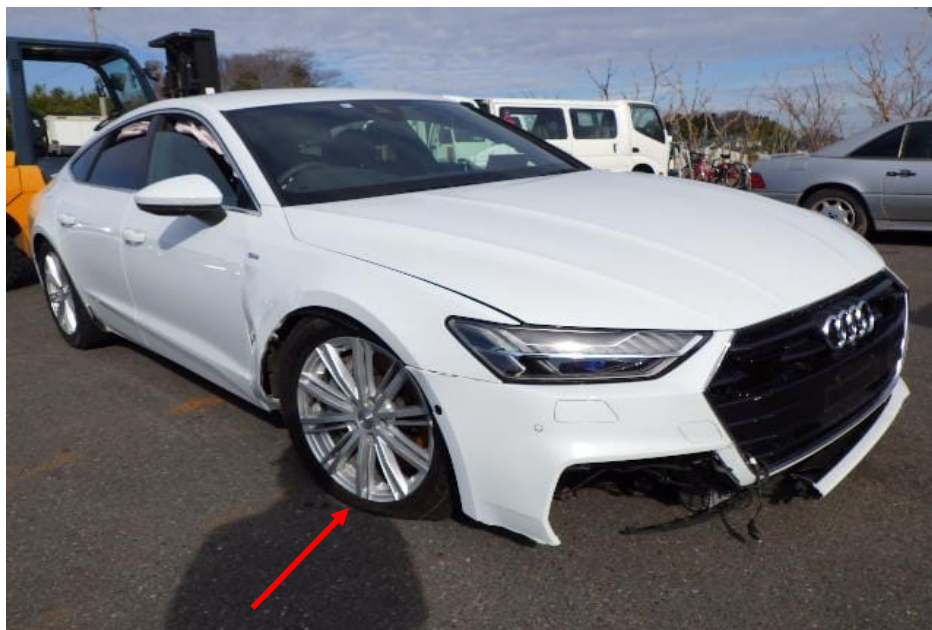
3. The photographs provided to me had showed damage to the front right portion of the Motor Car. The front bumper, front bumper centre lower grille, front bumper right lower grille and garnish, front bumper left lower grille and garnish and front right fender were amongst the body parts that were observed to have been damaged.
4. The orientation of the front right wheel and front left wheel suggest damage to the front right undercarriage parts of the Motor Car. The undercarriage parts that may possible be damage include the front right lower arm, front right steering tie rod and front right shock absorber amongst others.
5. No physical damage was observed to other areas of the Motor Car. The right side curtain airbag, left side curtain airbag, driver airbag and front left passenger airbag were observed to have been deployed. See photo 1 – 5 below.

**Photo 1** shows the front right body of the Motor Car (photograph provided to me). The Motor Car was observed to have sustained damage at its front right portion. Body parts damaged include the front bumper, front bumper right lower grille and garnish and front right fender amongst others. The front right wheel (arrowed) and front left wheel (refer to photograph 3 below) were both orientated in an inward direction, which suggests damage to the Motor Car's front right undercarriage parts.

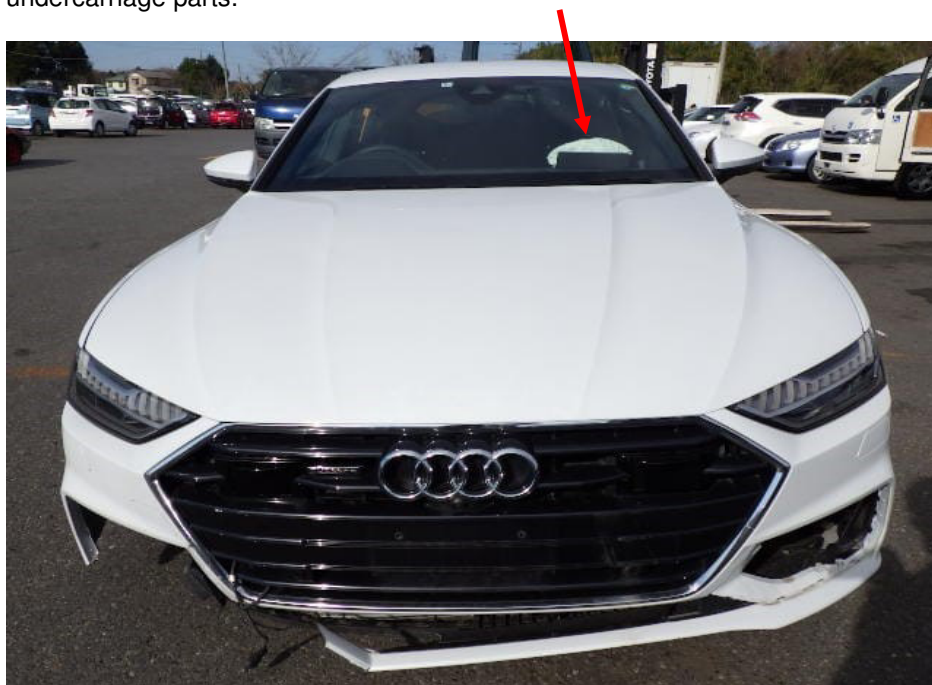
**Photo 2** shows the frontal body of the Motor Car (photograph provided to me). The Motor Car was observed to have sustained damage at its front right portion. Body parts damaged include the front bumper, front bumper centre lower grille, front bumper right lower grille and garnish, front bumper left lower grille and garnish. The front left passenger airbag (arrowed) was deployed.

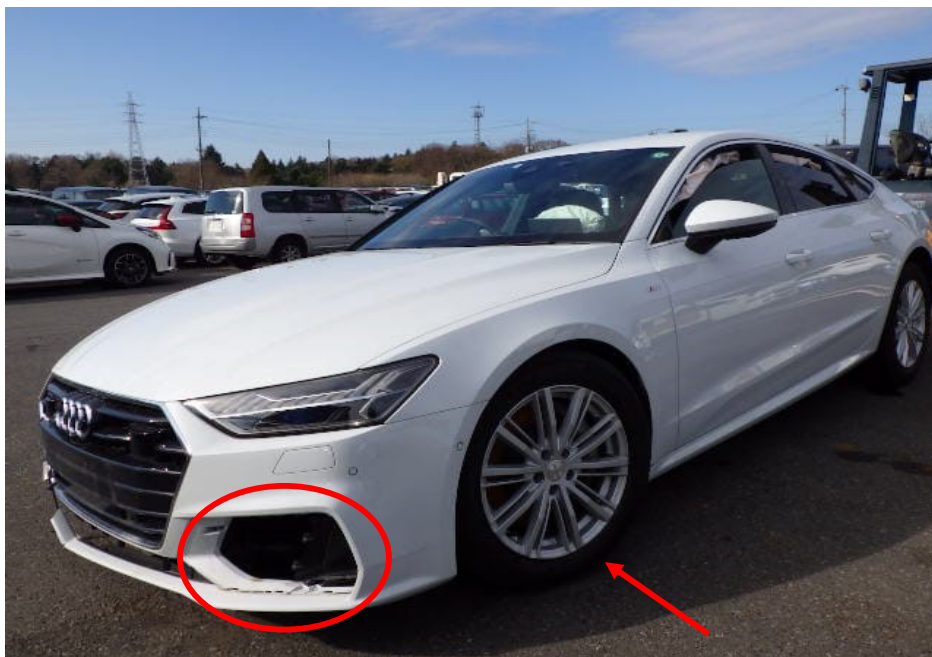
**Photo 3** shows the front left body of the Motor Car (photograph provided to me). The front left portion of the Motor Car was relatively unaffected however I had observed that the front bumper left lower grille and garnish (circled) were dislodged/missing/damaged. The front left wheel (arrowed) and front right wheel (refer to photograph 1 above) were both orientated in an inward direction, which suggests damage to the Motor Car's front right undercarriage parts.

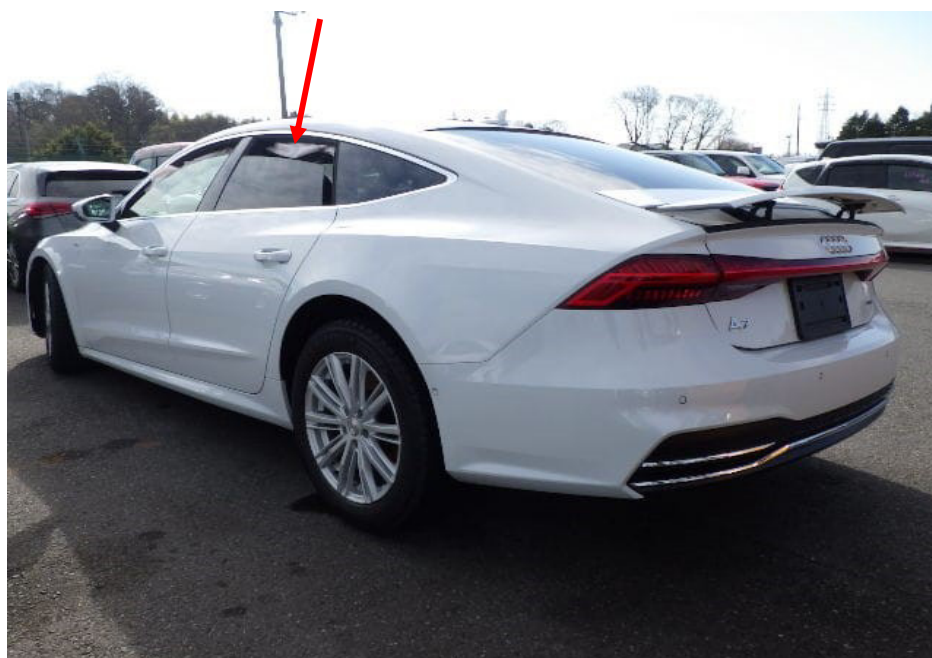
**Photo 4** shows the rear left body of the Motor Car (photograph provided to me). Apart for the front right portion, there was no physical damage seen to other areas of the Motor Car. The left side curtain airbag (arrowed) of the Motor Car was deployed.

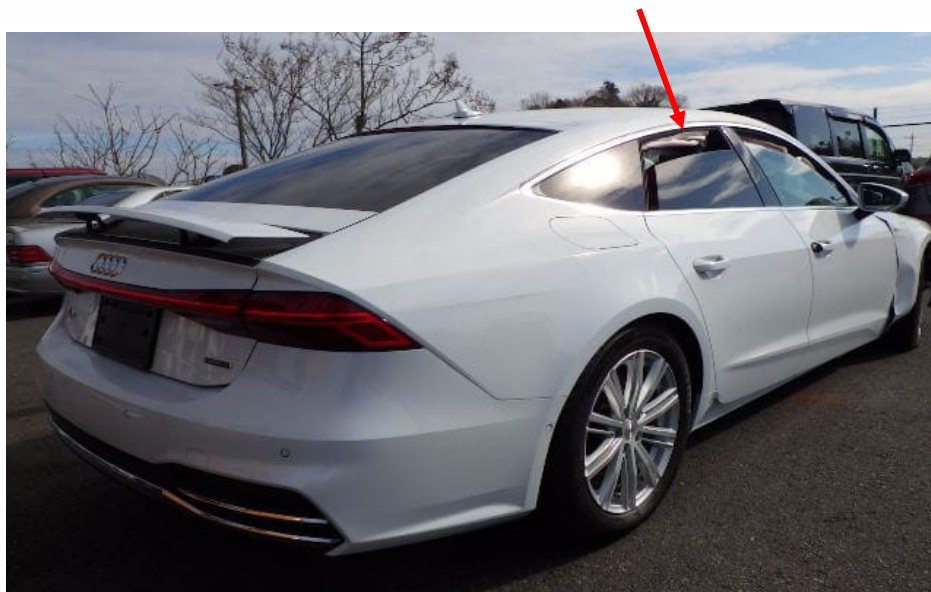
**Photo 5** shows the rear right body of the Motor Car (photograph provided to me). Apart for the front right portion, there was no physical damage seen to other areas of the Motor Car. The right side curtain airbag (arrowed) of the Motor Car was deployed.

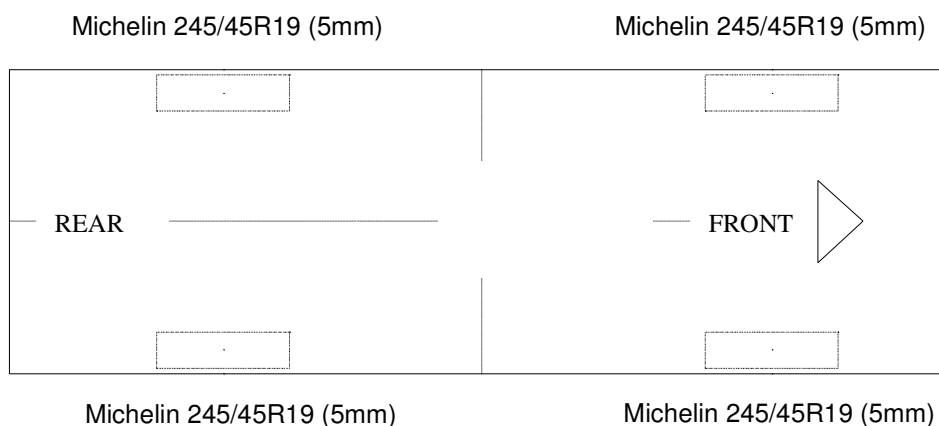
9. It was fitted with 19inch sport wheel rims that were wrapped with tyres that were observed to be of serviceable condition. The tyres were also sufficiently inflated for vehicular operation. The tyre brand, tyre size and approximate remaining tread depth of the 4 tyres of the Motor Car were recorded as follows: -

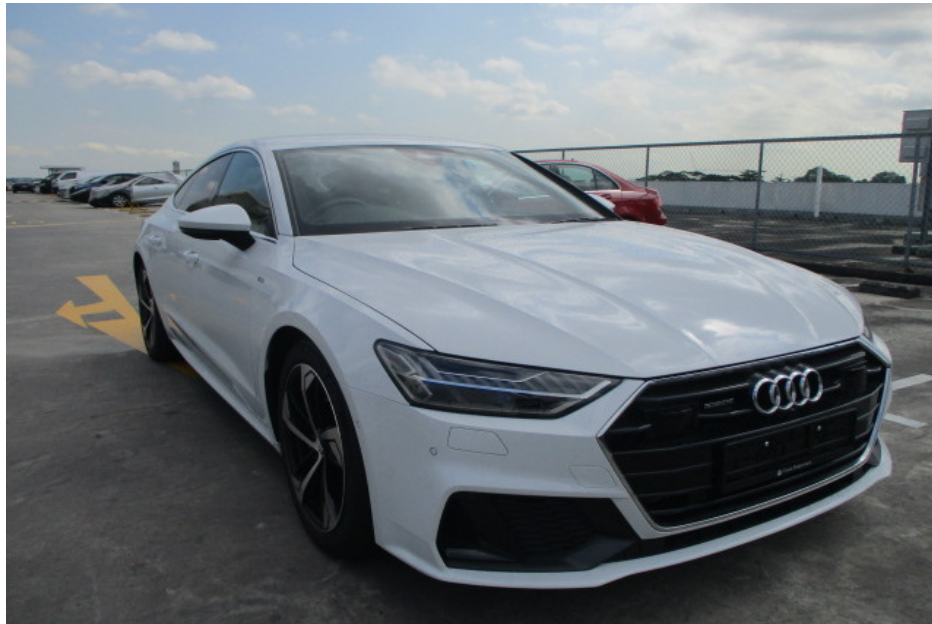
**Photo 6** shows a general view of the front right body of the Motor Car at the time of my inspection. The Motor Car was observed to be in a relatively good general condition with no loose exterior fittings observed. The body parts and undercarriage parts at the front right portion of the Motor Car were visually examined and it was observed that the repair/restoration works carried out to the damaged area of the Motor Car (refer to photograph 1 - 3 above) were reasonably adequate and in order.

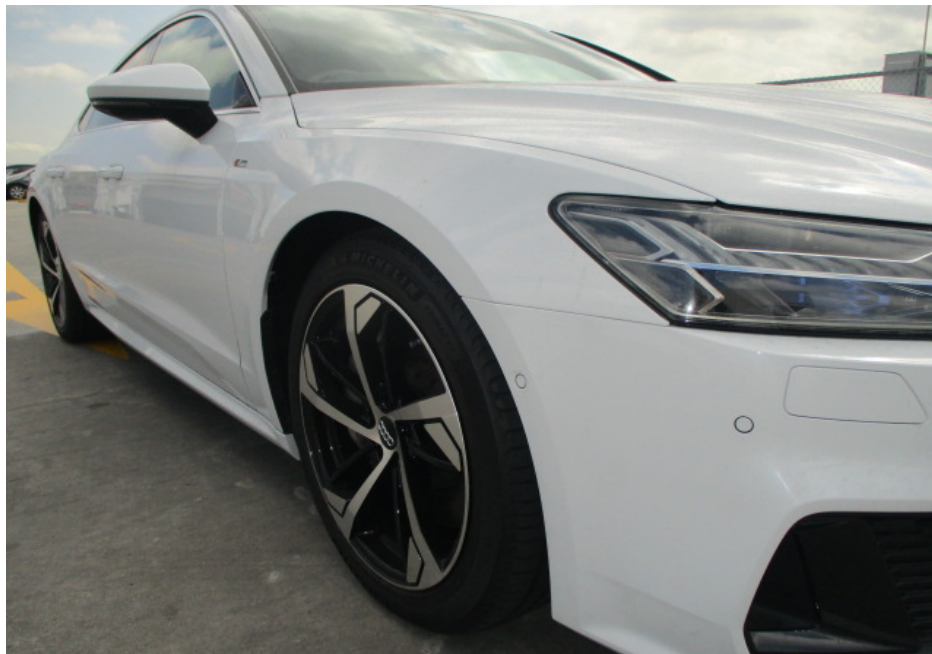
**Photo 7** shows a closer view of the Motor Car's front bumper, front right fender and front right wheel. The body parts and undercarriage parts at the front right portion of the Motor Car were visually examined and it was observed that the repair/restoration works carried out to the damaged area of the Motor Car (refer to photograph 1 - 3 above) were reasonably adequate and in order.

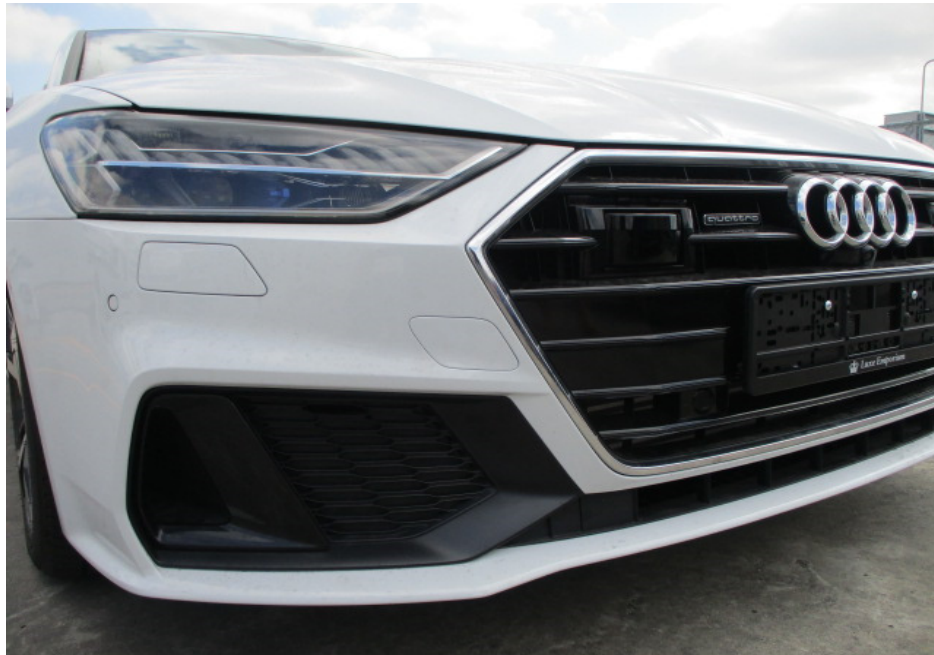
**Photo 8** shows a closer view of the Motor Car's front bumper, front bumper right lower grille and garnish. The body parts at the front right portion of the Motor Car were visually examined and it was observed that the repair/restoration works carried out to the damaged area of the Motor Car (refer to photograph 1 - 3 above) were reasonably adequate and in order.

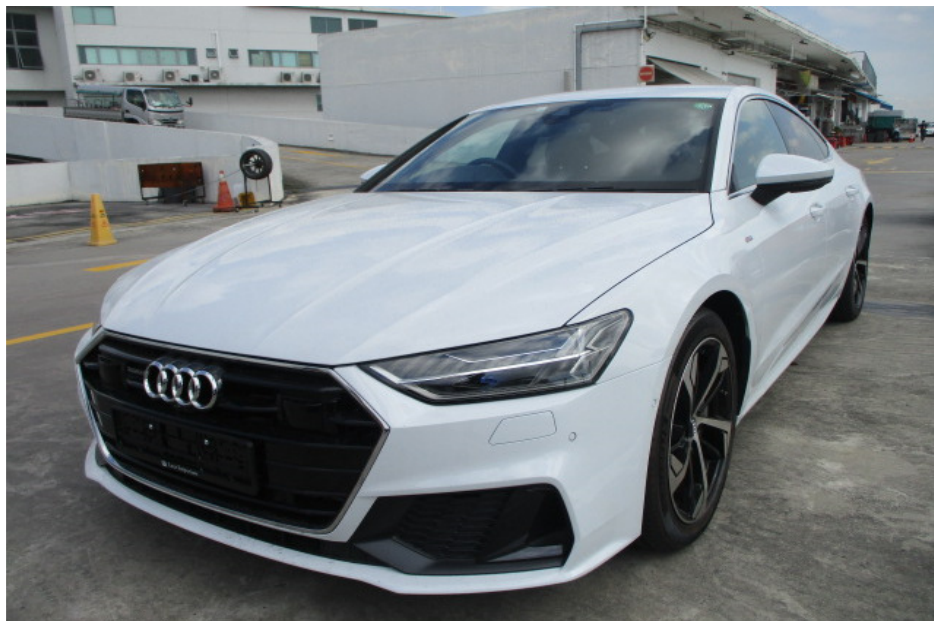
**Photo 9** shows a general view of the front left body of the Motor Car at the time of my inspection. The Motor Car was observed to be in a relatively good general condition with no loose exterior fittings observed. The body parts and undercarriage parts at the front right portion of the Motor Car were visually examined and it was observed that the repair/restoration works carried out to the damaged area of the Motor Car (refer to photograph 1 - 3 above) were reasonably adequate and in order.

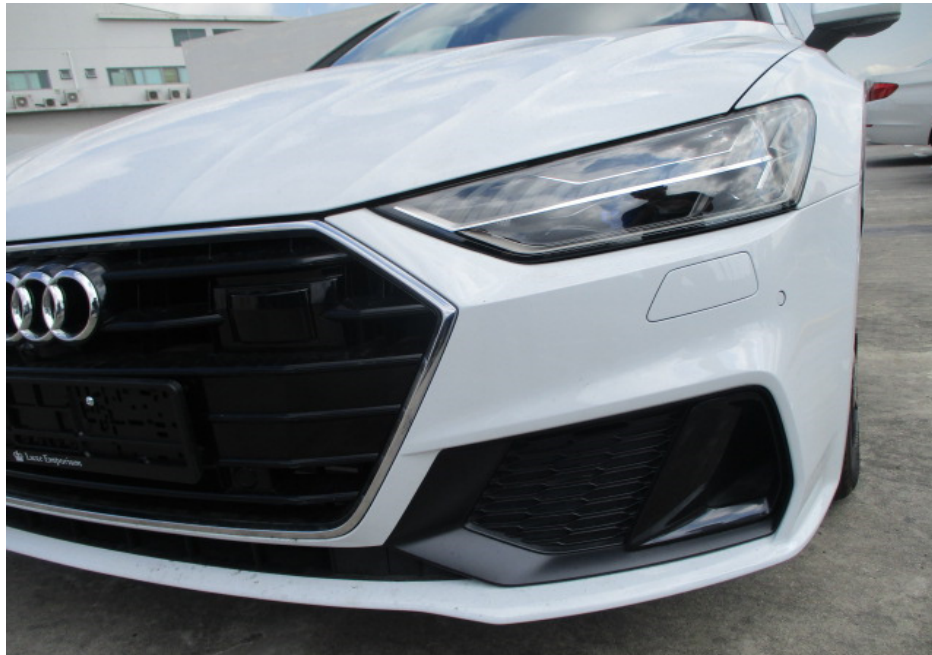
**Photo 10** shows a closer view of the Motor Car's front bumper, front bumper left lower grille and garnish. The body parts at the front right portion of the Motor Car were visually examined and it was observed that the repair/restoration works carried out to the damaged area of the Motor Car (refer to photograph 1 - 3 above) were reasonably adequate and in order.

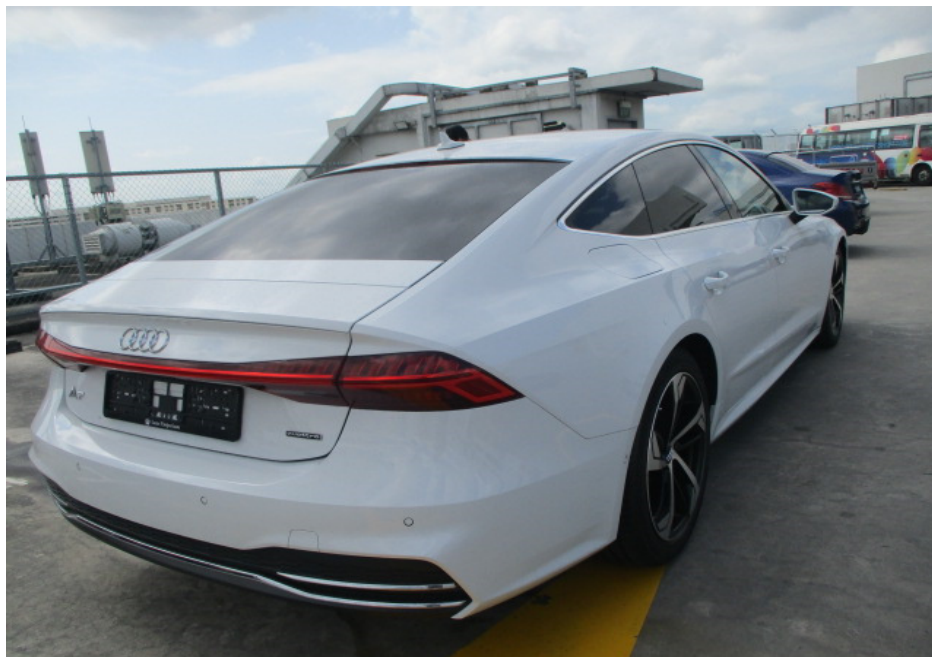
**Photo 11** shows a general view of the rear right body of the Motor Car at the time of my inspection. The Motor Car was observed to be in a relatively good general condition with no loose exterior fittings observed. The mileage of the Motor Car recorded at the time of my inspection was 13,858km.

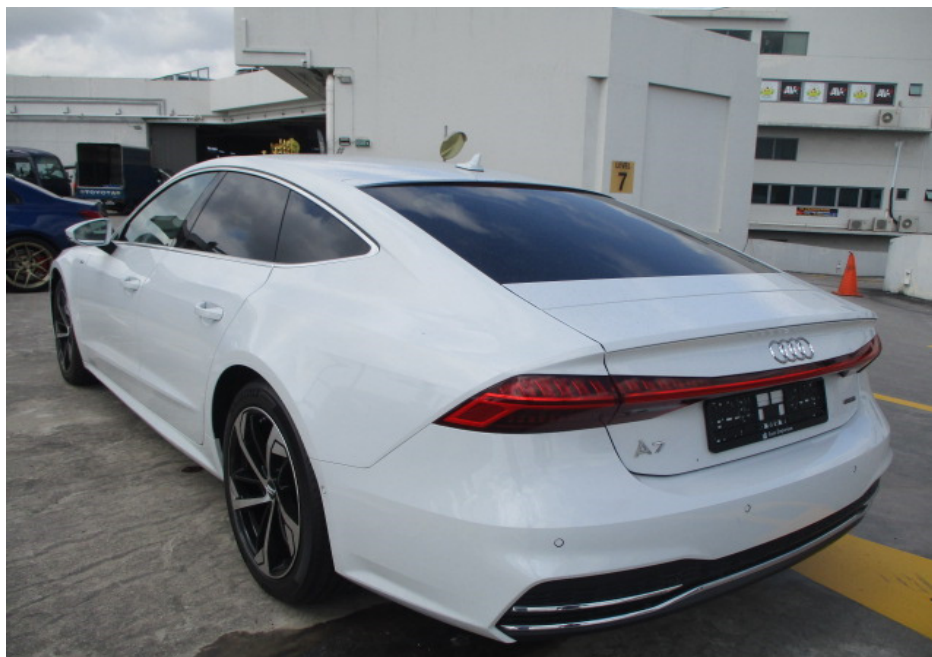
**Photo 12** shows a general view of the rear left body of the Motor Car at the time of my inspection. The Motor Car was observed to be in a relatively good general condition with no loose exterior fittings observed. The mileage of the Motor Car recorded at the time of my inspection was 13,858km.

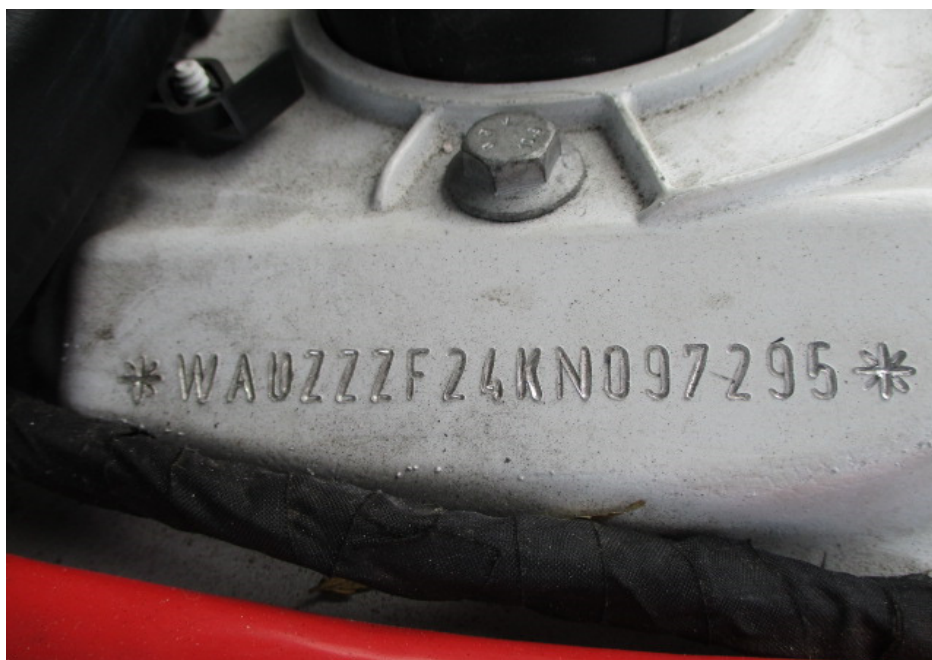
**Photo 13** shows the chassis number of the Motor Car. The chassis number recorded was WUZZZF24KN097295.

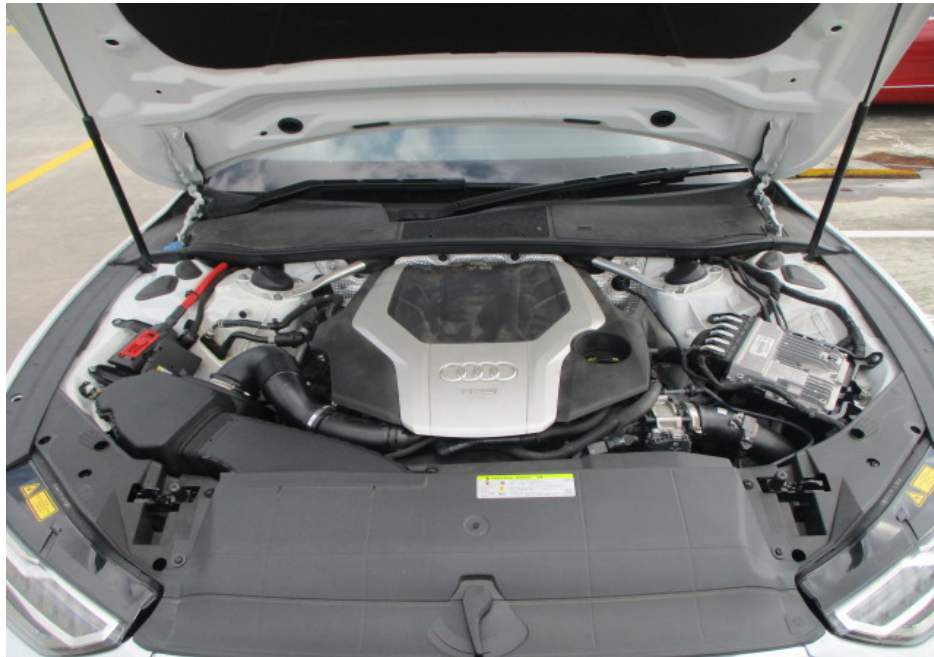
**Photo 14** shows a general view of the engine compartment of the Motor Car at the time of my inspection. The various parts and components inside the engine compartment were all observed to be intact and properly fitted. There was also no sign(s) or indication(s) of fluid leak and/or fluid stain found inside the engine compartment.

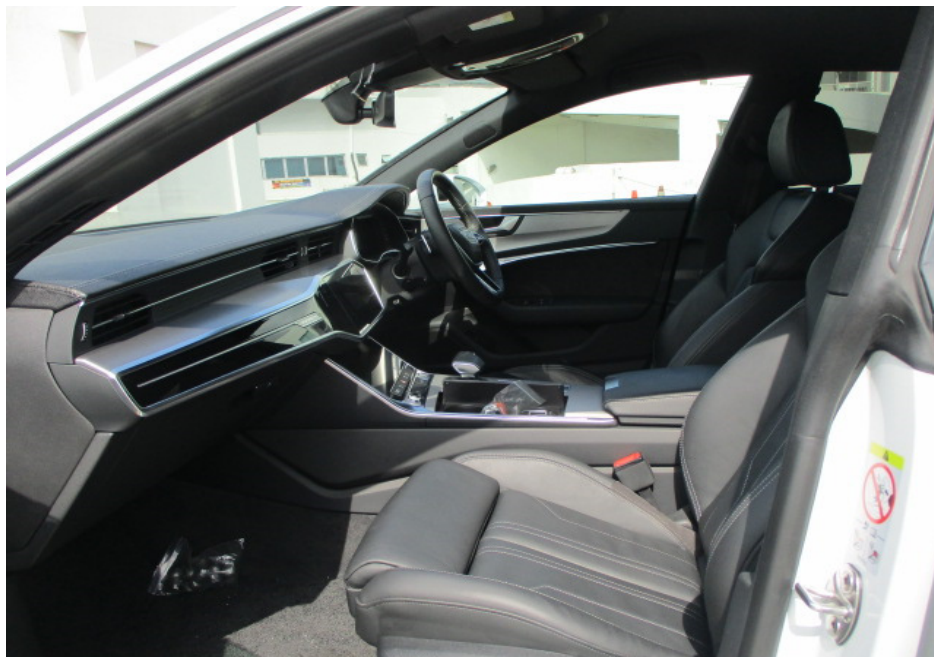
**Photo 15** shows the interior compartment of the Motor Car at the time of my inspection. The various parts and components, trims, carpet and upholstery inside the interior compartment were all observed to be intact and properly fitted.

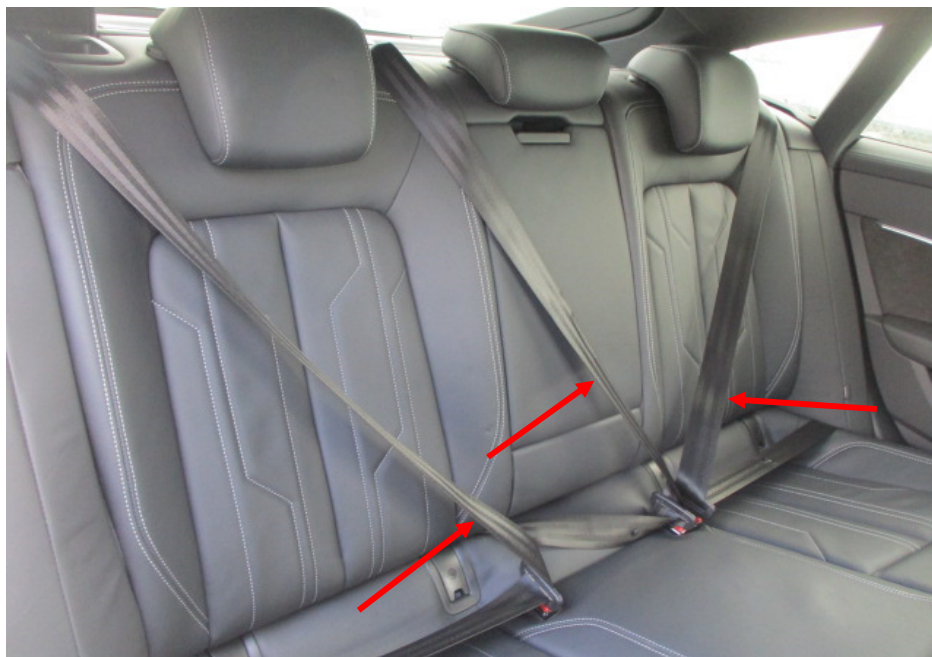
**Photo 16** shows the rear seats of the Motor Car. All the seats of the Motor Car were secured via seat rails to the floorboard. They were also fitted with a retractable seat belt reel and a pre-tensioner. The seat belts (arrowed) were tested and were able to be fastened into the respective pre-tensions that were fitted on the side of each individual seat.

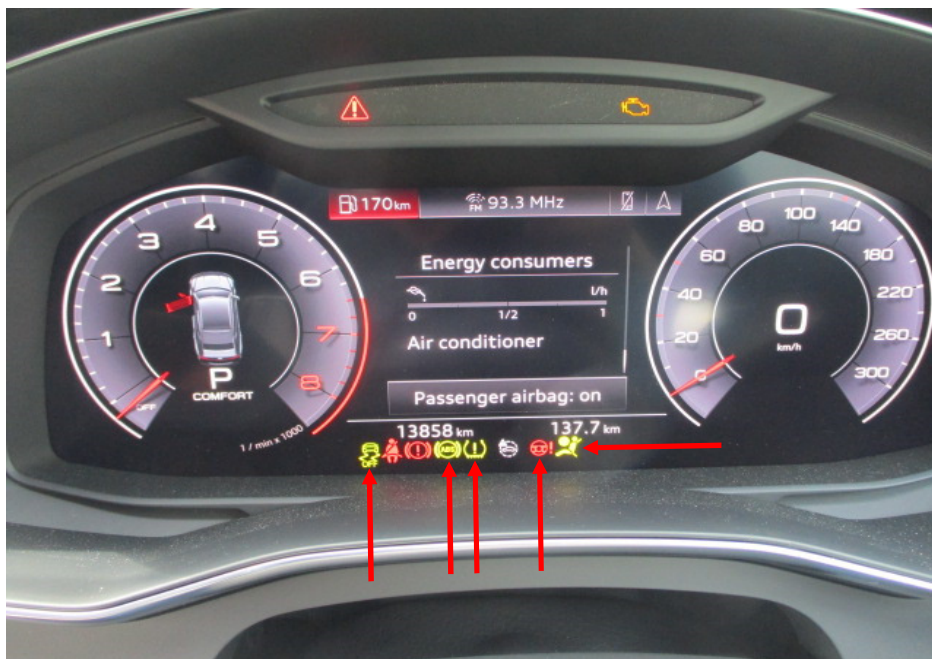
**Photo 17** shows the warning lights for the various electronic safety features appearing on the instrument panel of the Motor Car during its self-test when the engine is cranked, in particular the ABS, SRS, EPS, TPM and ESC lights (arrowed).

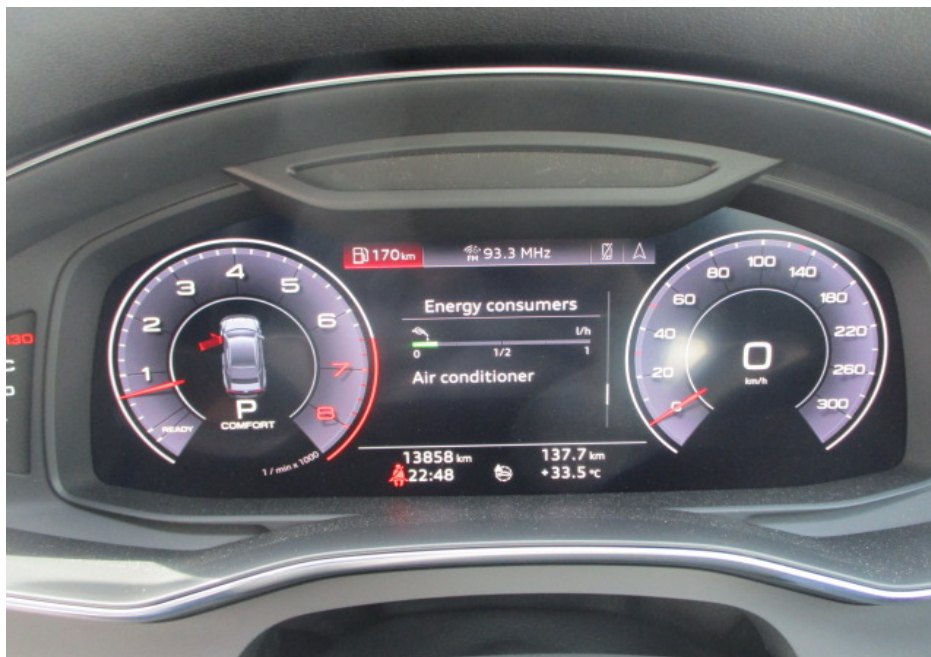
**Photo 18** shows the respective warning lights no longer illuminated, indicating that there is no fault detected to the ABS, SRS, EPS, TPM and ESC systems of the Motor Car during the self-test. These electronic systems were hence in working condition at the time of my inspection.

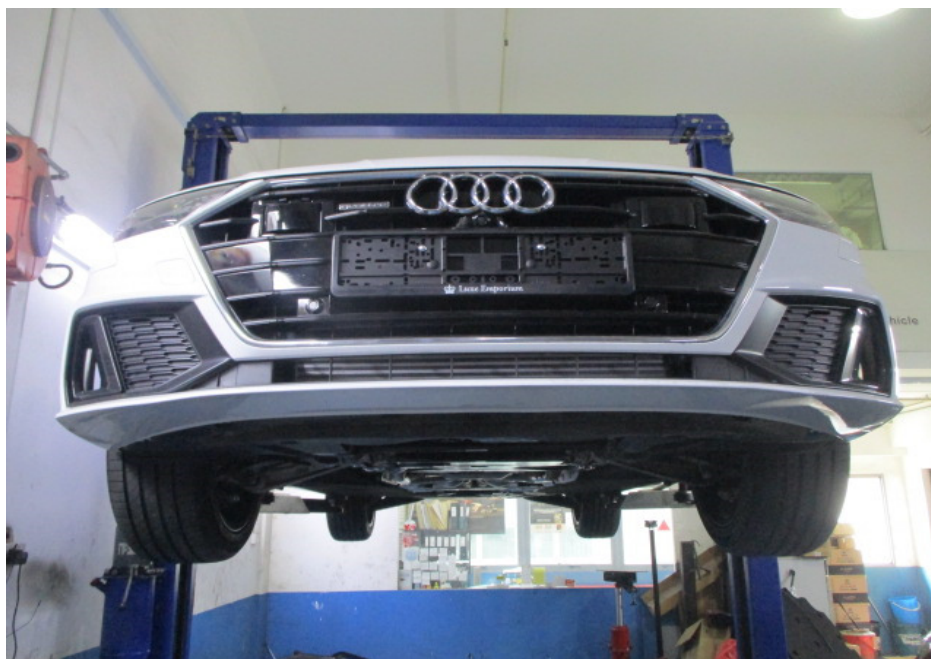
**Photo 19** shows the Motor Car hoisted up for checks on its undercarriage. There was no sign(s) or indication(s) of fluid leakage and/or fluid stain(s) on the underside of the Motor Car. The undercarriage components of the Motor Car were also all observed to be intact and secured in an appropriate manner.

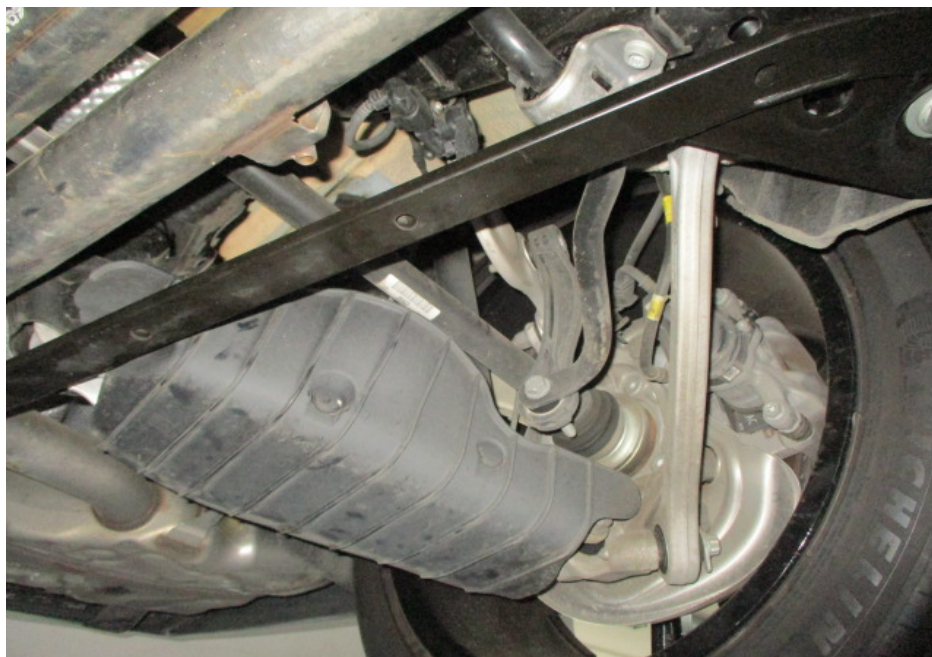
**Photo 20** shows a general view of the control arms and linkages at the rear left wheel of the Motor Car. I did not observe any fluid leak and/or fluid stain on the underside of the Motor Car. All of the Motor Car's undercarriage components were observed to be intact and secured in an appropriate manner.

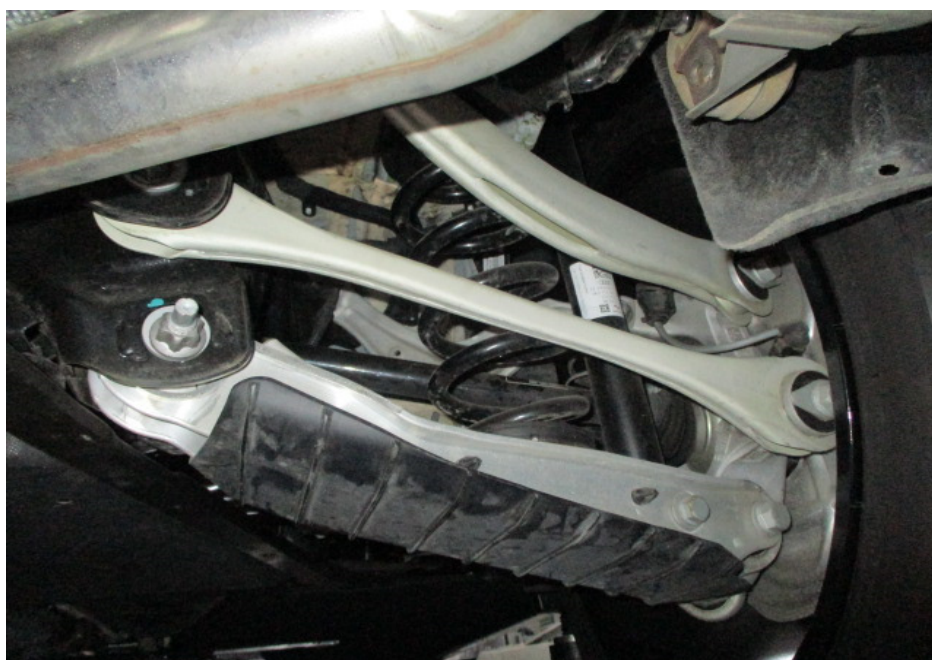
**Photo 21** shows the various undercarriage components at the rear right wheel of the Motor Car. The mechanical components, control arms and linkages were all found to be intact and secured in an appropriate manner.

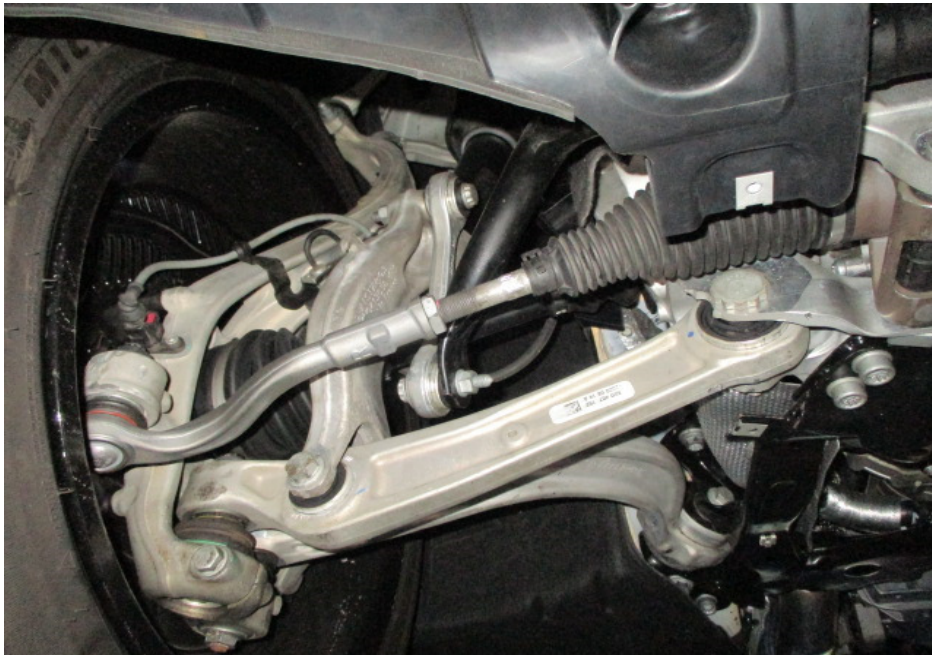
**Photo 22** shows the various undercarriage components at the front right wheel of the Motor Car. The mechanical components, control arms and linkages were all found to be intact and secured in an appropriate manner. The undercarriage parts at the front right portion of the Motor Car were visually examined and it was observed that the repair/restoration works carried out to the damaged area of the Motor Car (refer to photograph 1 - 3 above) were reasonably adequate and in order.

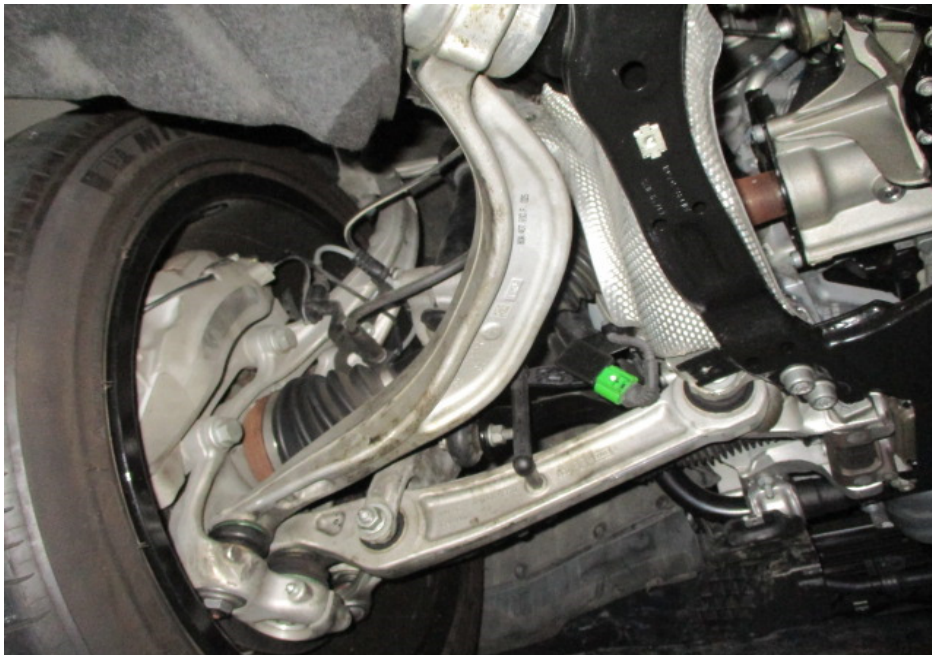
**Photo 23** shows the various undercarriage components at the front left wheel of the Motor Car. The mechanical components, control arms and linkages were all found to be intact and secured in an appropriate manner. I also did not observe any fluid leak and/or fluid stain on the underside of the Motor Car.

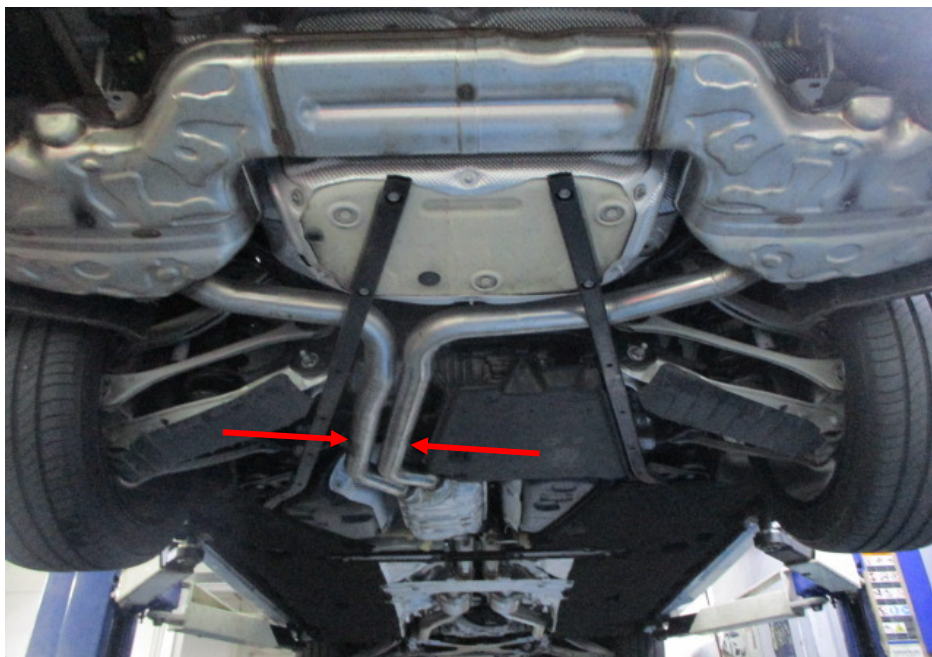
**Photo 24** shows the rear section of the Motor Car's exhaust system. My examination of the Motor Car's exhaust system revealed no sign(s) or indication(s) of any cut or weld marks along its exhaust pipes (arrowed), on its centre resonator boxes, on its rear muffler and on its catalytic converters.

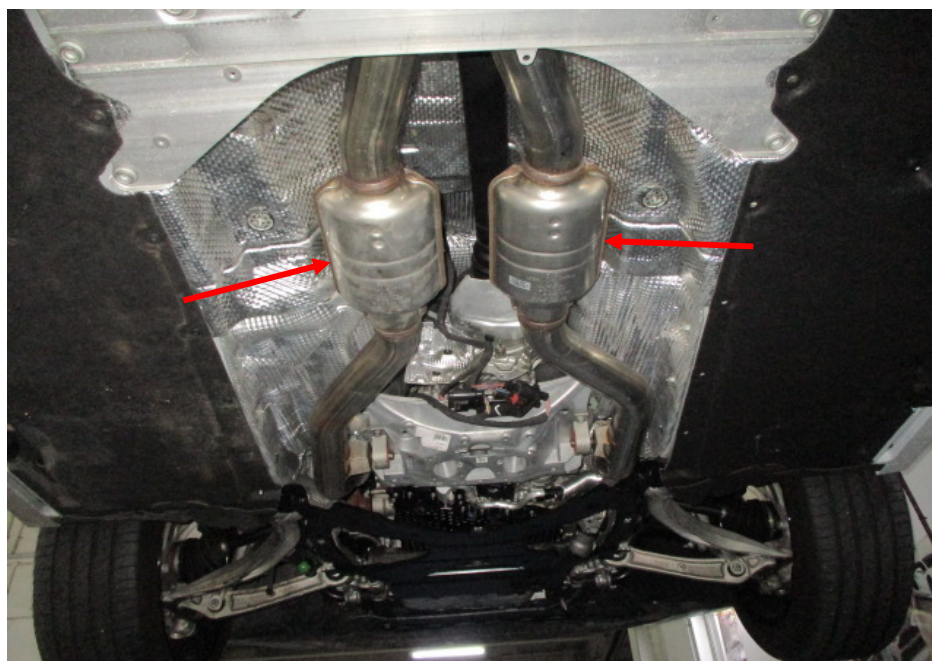
**Photo 25** shows the front section of the Motor Car's exhaust system. My examination of the Motor Car's exhaust system revealed no sign(s) or indication(s) of any cut or weld marks along its exhaust pipes, on its centre resonator boxes (arrowed), on its rear muffler and on its catalytic converters.

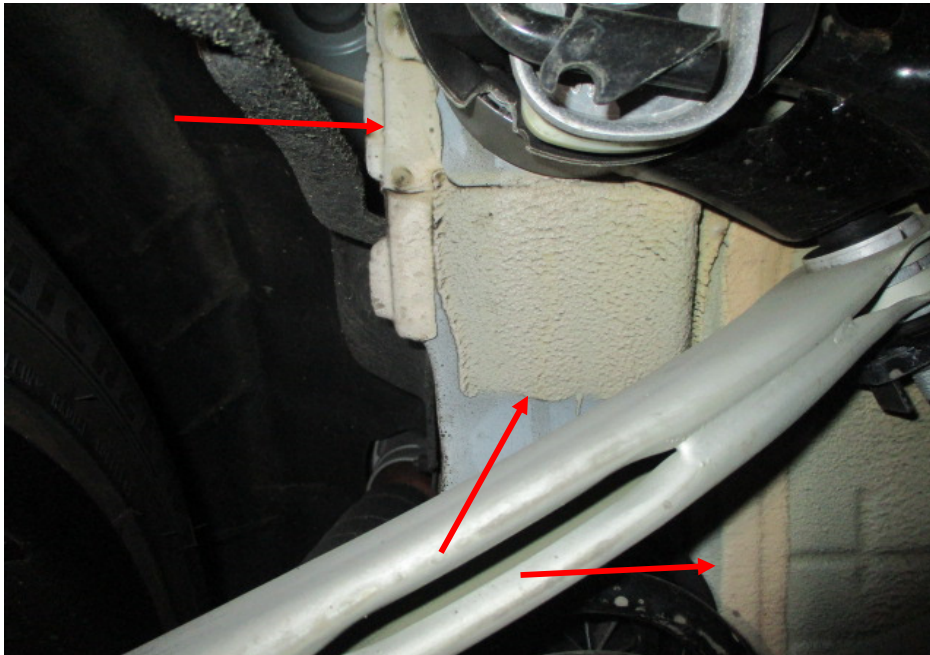
**Photo 26** shows the chassis/structural body at the underside rear left of the Motor Car. I did not find any weld marks other than original spot weld marks on the chassis/structural body of the Motor Car. The original factory sealant (arrowed) at the joints along the chassis/structural body was untouched, indicating no work was done on the chassis/structural body of the Motor Car and that the chassis/structural body was originally fitted.

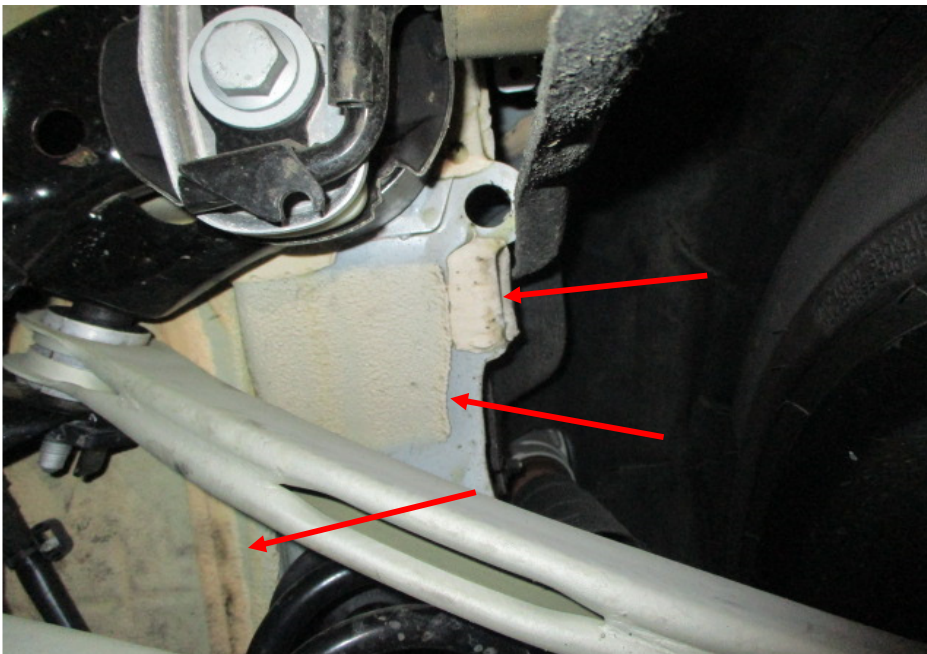
**Photo 27** shows the chassis/structural body at the underside rear right of the Motor Car. The original factory sealant (arrowed) at the joints along the chassis/structural body was observed to be untouched. In general, I had found no work was carried out on the chassis/structural body of the Motor Car. The chassis/structural body of the Motor Car was originally fitted.

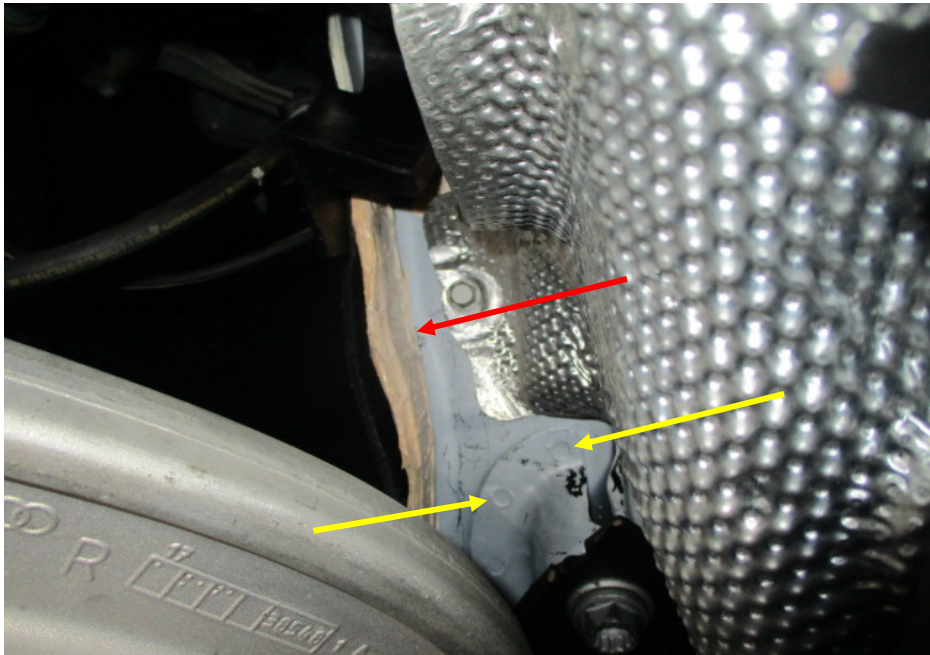
**Photo 28** shows the chassis/structural body at the underside front right of the Motor Car. I did not find any weld marks other than original spot weld marks (yellow arrow) on the chassis/structural body of the Motor Car. The original factory sealant (red arrow) at the joints along the chassis/structural body was untouched, indicating no work was done on the chassis/structural body of the Motor Car and that the chassis/structural body was originally fitted.

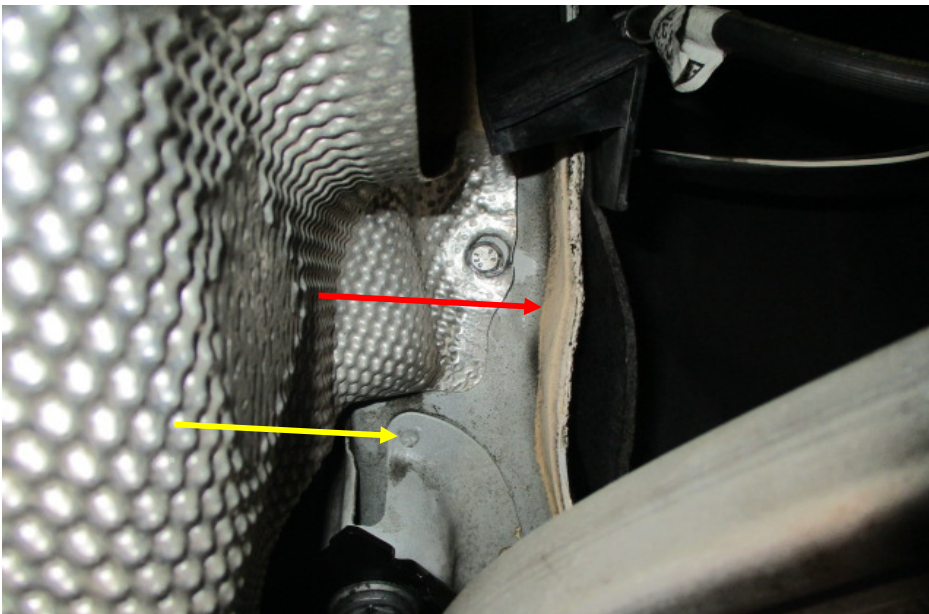
**Photo 29** shows the chassis/structural body at the underside front left of the Motor Car. I did not find any weld marks other than original spot weld marks (yellow arrow) on the chassis/structural body of the Motor Car. The original factory sealant (red arrow) at the joints along the chassis/structural body was untouched, indicating no work was done on the chassis/structural body of the Motor Car and that the chassis/structural body was originally fitted.

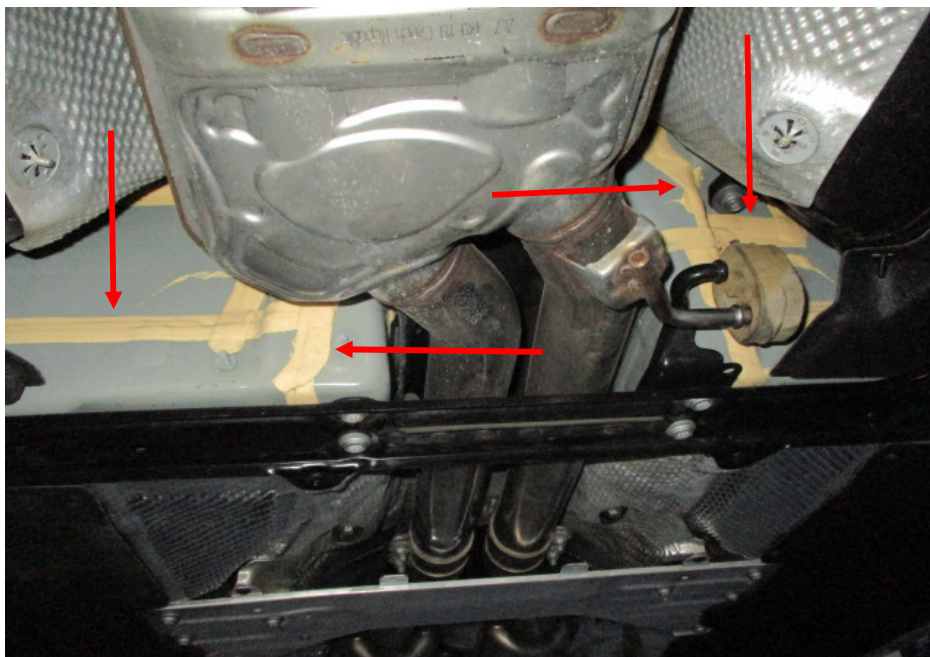
**Photo 30** shows the floorboard at the underside centre of the Motor Car. The original factory sealant (arrowed) at the joints along the floorboard was observed to be untouched. In general, I had found all the non-detachable body panels of the Motor Car to be originally fitted at the time of my inspection
