Your Ref: Maserati Levante  
(chassis number ZN6YU61D00X322950)  
Our Ref : CI/TP21011315/D

**INSPECTION REPORT OF AN UNREGISTERED MASERATI LEVANTE  
MOTOR CAR WITH CHASSIS NUMBER ZN6YU61D00X322950**

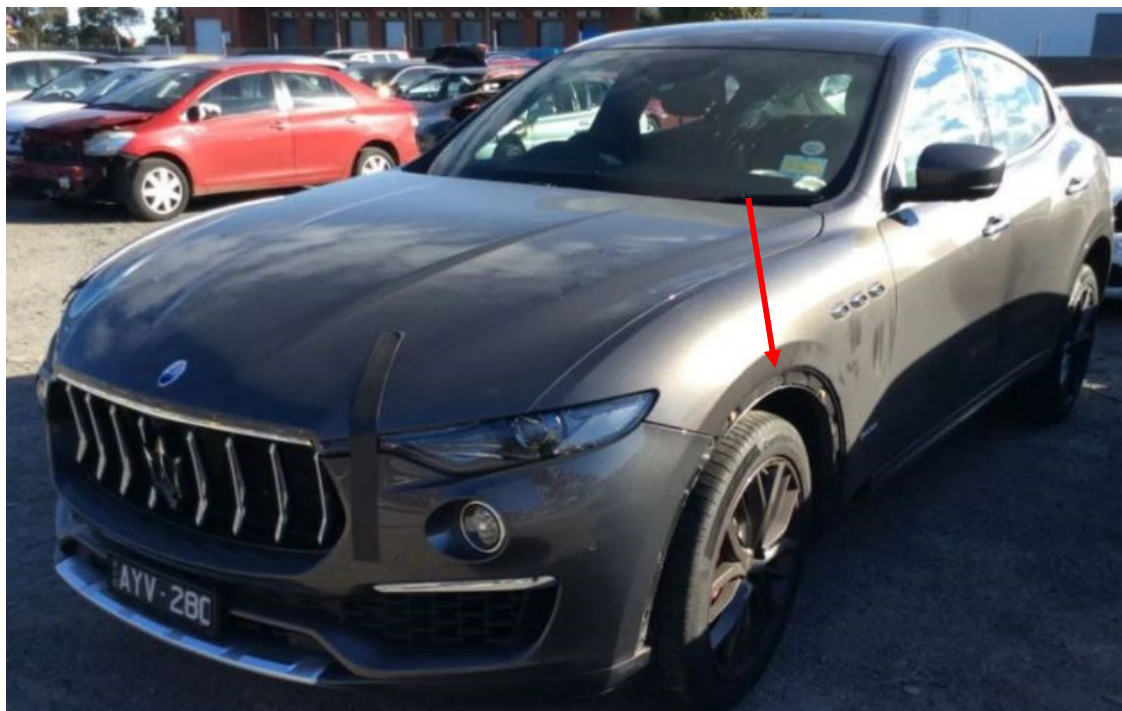
3. I did not observe any physical damage to the exterior body of the Motor Car except for its front left fender wheel arc garnish and front right fender wheel arc garnish, which were both observed to be missing/dislodged/damaged.
4. The front left passenger airbag and driver airbag were deployed as seen from the photographs that were provide to me. See photo 1 – 5 below.

**Photo 1** shows the front left body of the Motor Car (photograph provided to me). The front left fender wheel arc garnish (arrowed) was observed to be missing/dislodged/damaged. Apart for this, there was no physical damage observed to the exterior body of the Motor Car.

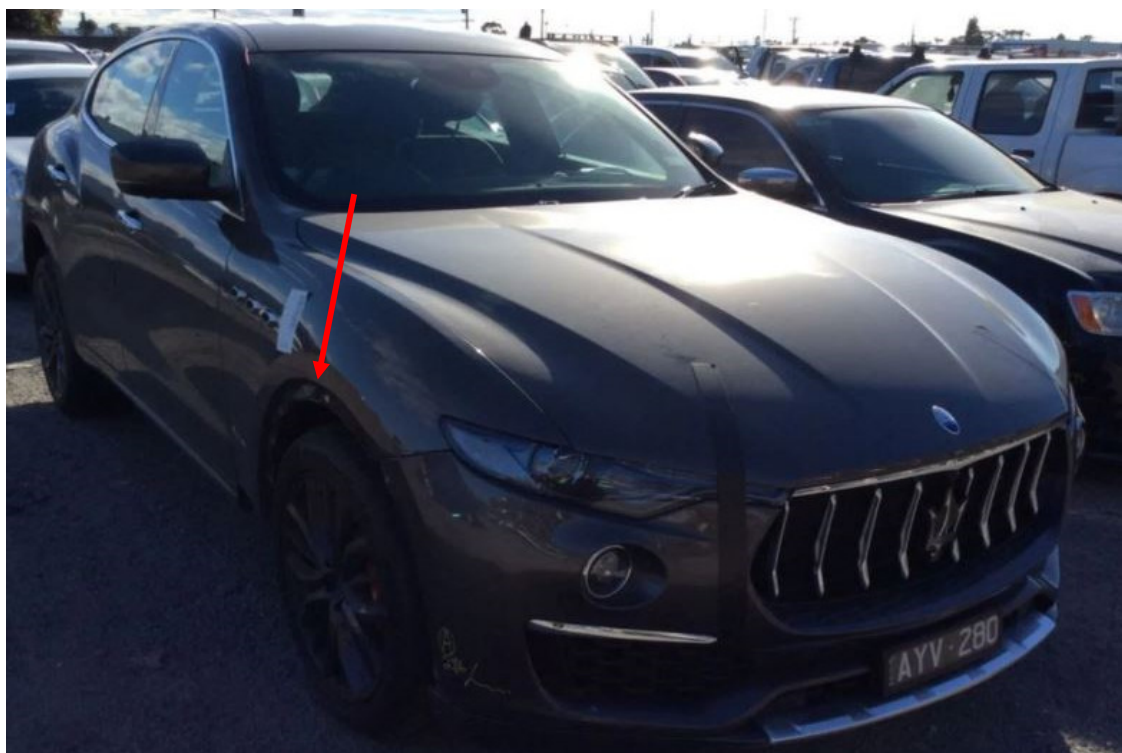
**Photo 2** shows the front right body of the Motor Car (photograph provided to me). The front right fender wheel arc garnish (arrowed) was observed to be missing/dislodged/damaged. Apart for this, there was no physical damage observed to the exterior body of the Motor Car.

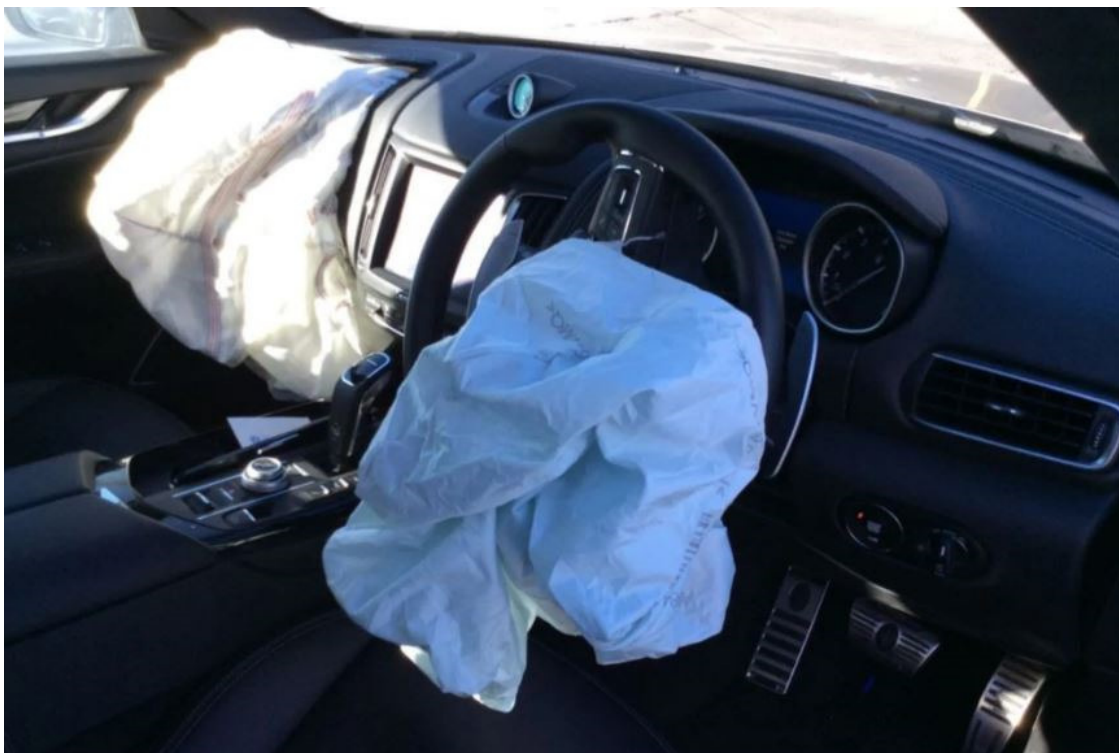
**Photo 3** shows the interior compartment of the Motor Car (photograph provided to me). The driver airbag and front left passenger seat airbag were deployed.

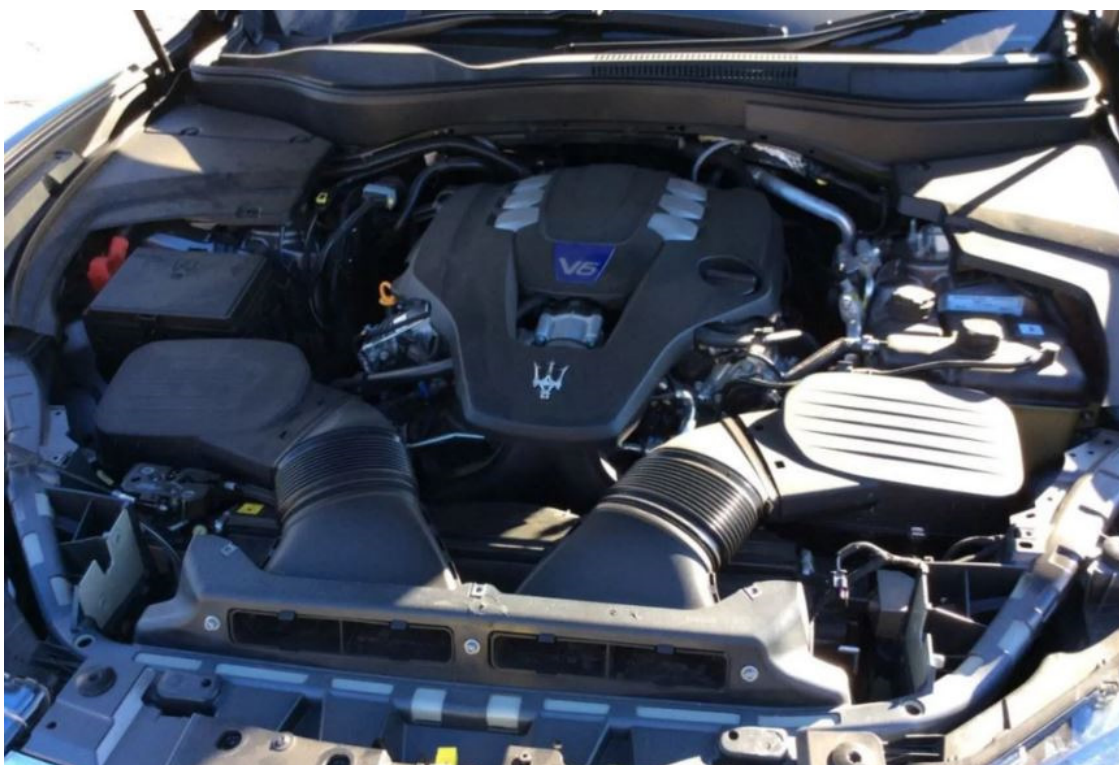
**Photo 4** shows the engine compartment of the Motor Car (photograph provided to me). The various parts and components within the engine compartment were intact and unaffected.

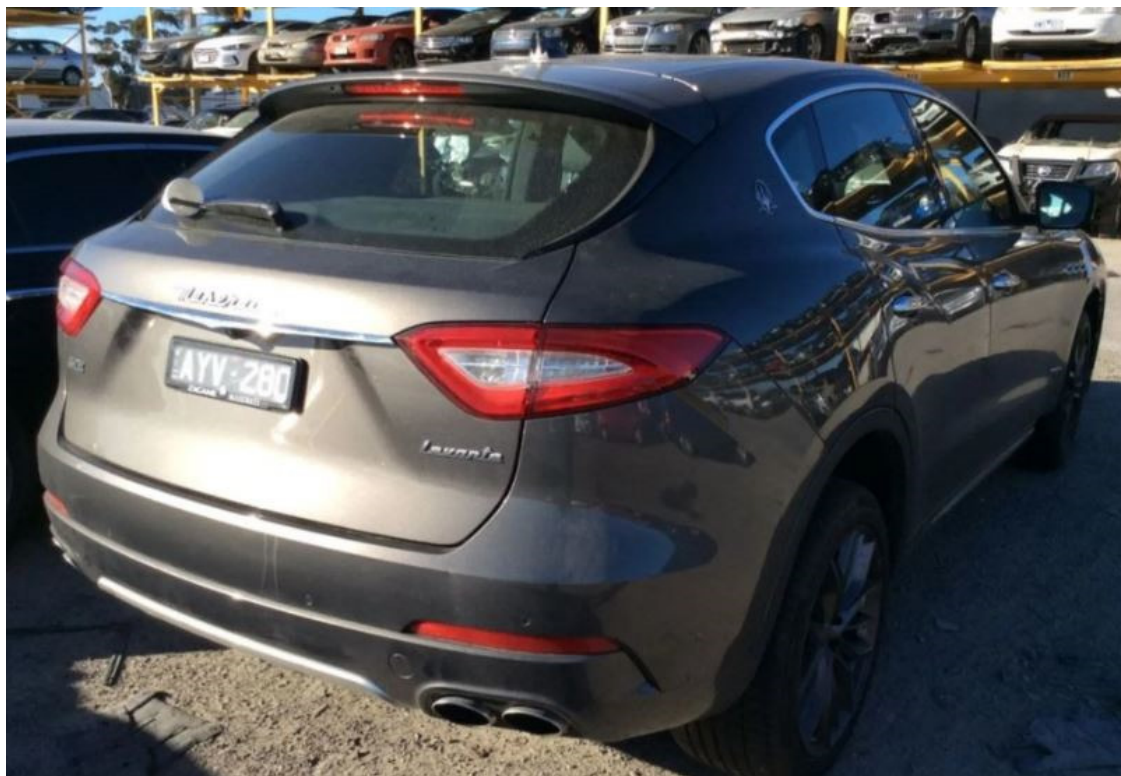
**Photo 5** shows the rear right body of the Motor Car (photograph provided to me). No physical damage was observed to the exterior body at the rear portion of the Motor Car.

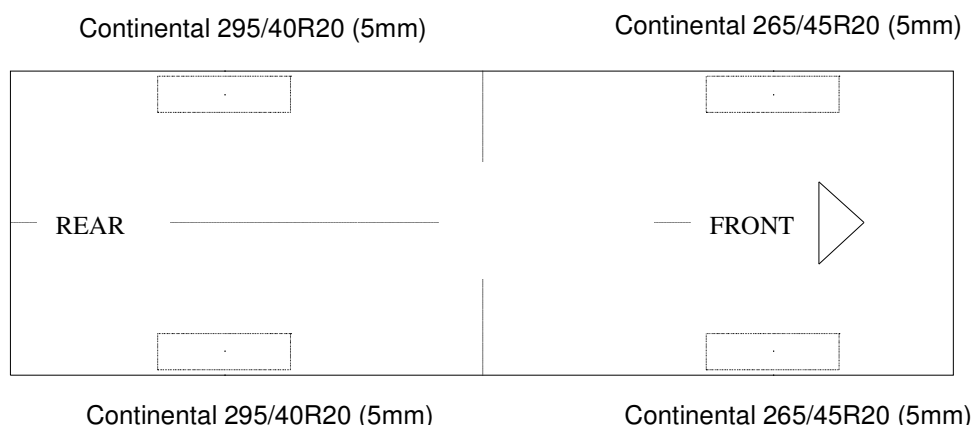
8. It was fitted with 20inch sport wheel rims that were wrapped with tyres that were observed to be of serviceable condition. The tyres were also sufficiently inflated for vehicular operation. The tyre brand, tyre size and approximate remaining tread depth of the 4 tyres of the Motor Car were recorded as follows: -

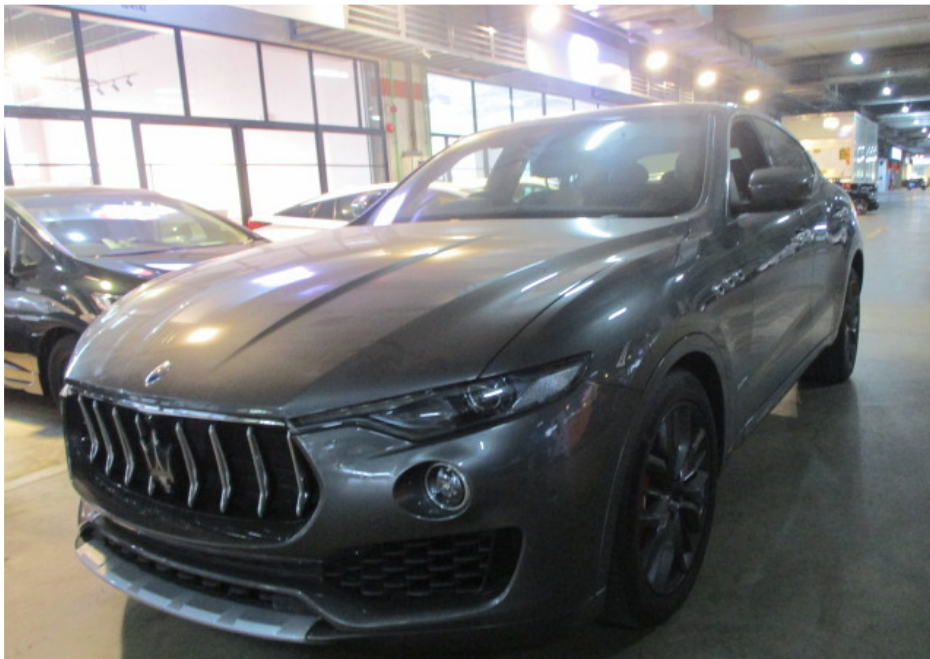
**Photo 6** shows a general view of the front left body of the Motor Car at the time of my inspection. The Motor Car was observed to be in a relatively good general condition with no loose exterior fittings observed. The body parts of the Motor Car were visually examined, and it was noted that the repair/restoration works carried out to the damaged area of the Motor Car (refer to photograph 1 - 3 above) were reasonably adequate and in order.

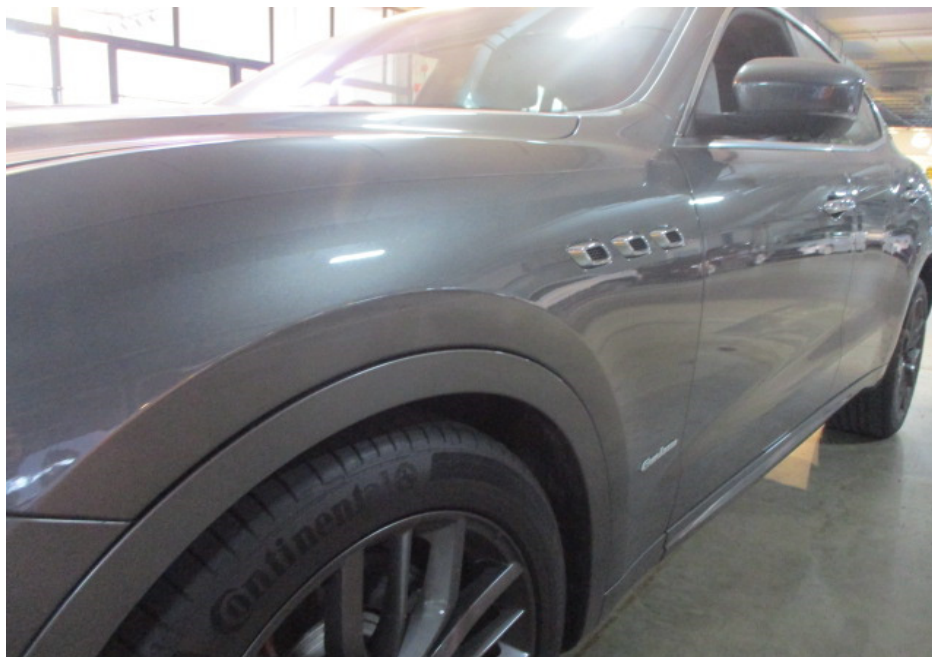
**Photo 7** shows a closer view of the Motor Car's front left fender wheel arc garnish. The body parts of the Motor Car were visually examined, and it was noted that the repair/restoration works carried out to the damaged area of the Motor Car (refer to photograph 1 - 3 above) were reasonably adequate and in order.

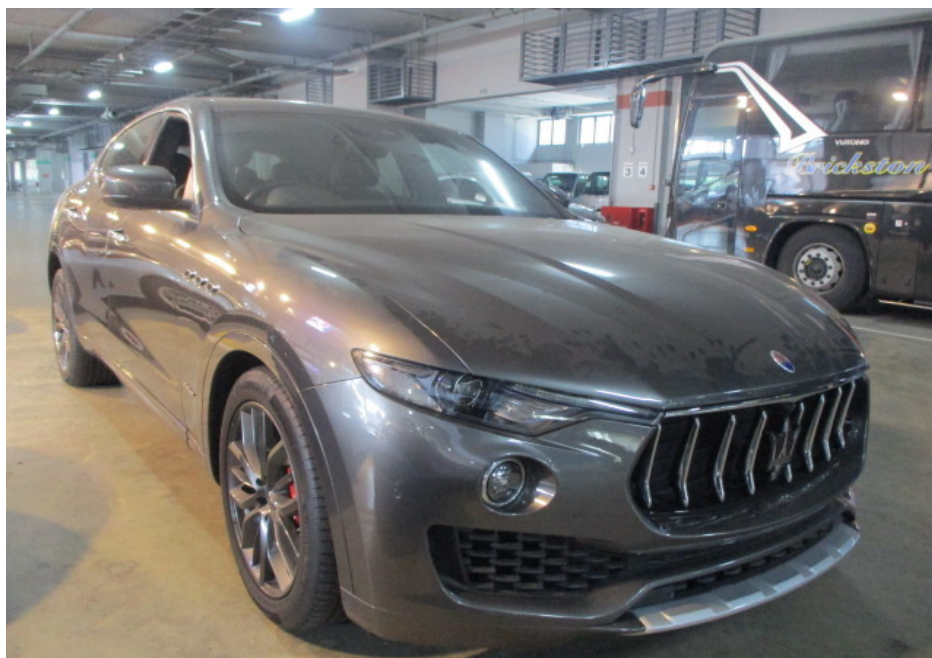
**Photo 8** shows a general view of the front right body of the Motor Car at the time of my inspection. The Motor Car was observed to be in a relatively good general condition with no loose exterior fittings observed. The body parts of the Motor Car were visually examined, and it was noted that the repair/restoration works carried out to the damaged area of the Motor Car (refer to photograph 1 - 3 above) were reasonably adequate and in order.

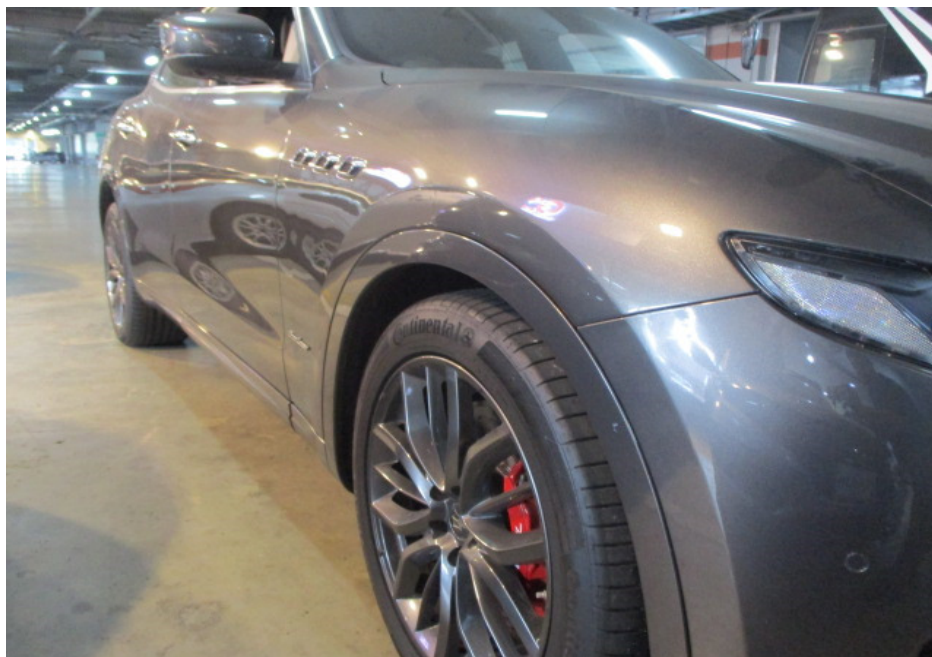
**Photo 9** shows a closer view of the Motor Car's front right fender wheel arc garnish. The body parts of the Motor Car were visually examined, and it was noted that the repair/restoration works carried out to the damaged area of the Motor Car (refer to photograph 1 - 3 above) were reasonably adequate and in order.

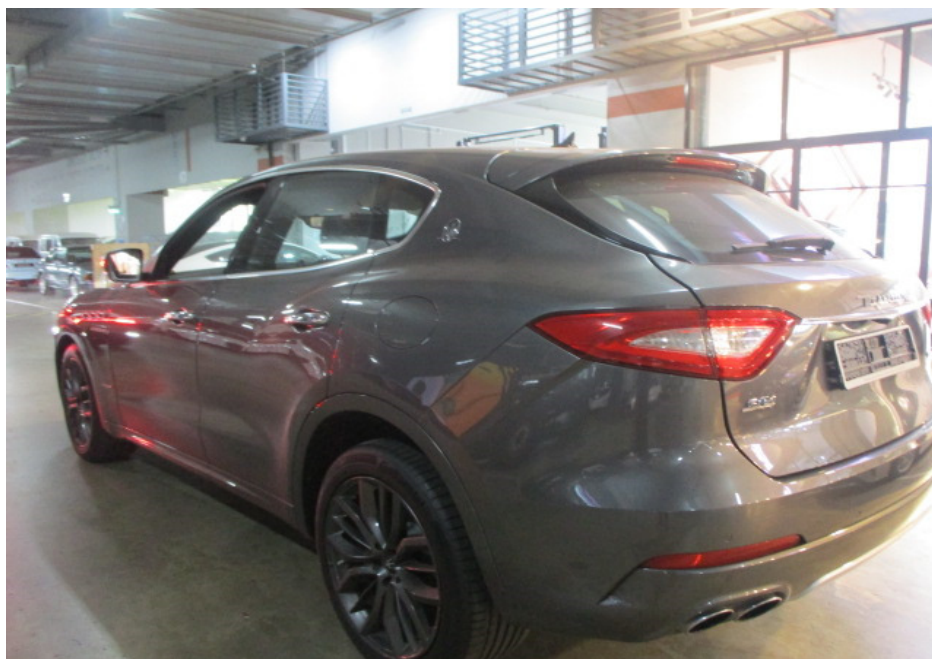
**Photo 10** shows a general view of the rear left body of the Motor Car at the time of my inspection. The Motor Car was observed to be in a relatively good general condition with no loose exterior fittings observed. The mileage of the Motor Car recorded at the time of my inspection was 5,988km.

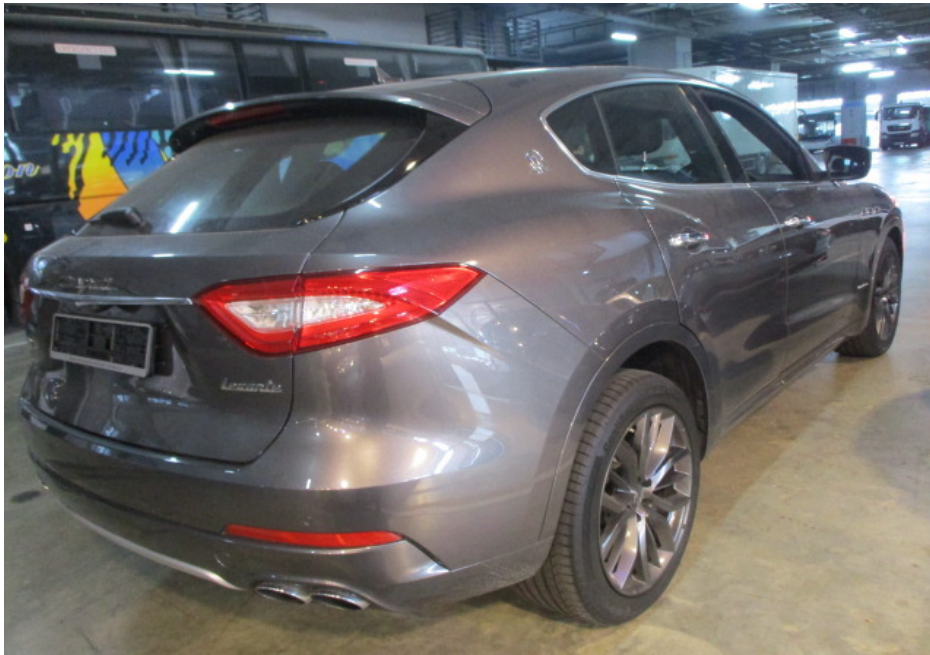
**Photo 11** shows a general view of the rear right body of the Motor Car at the time of my inspection. The Motor Car was observed to be in a relatively good general condition with no loose exterior fittings observed. The mileage of the Motor Car recorded at the time of my inspection was 5,988km.

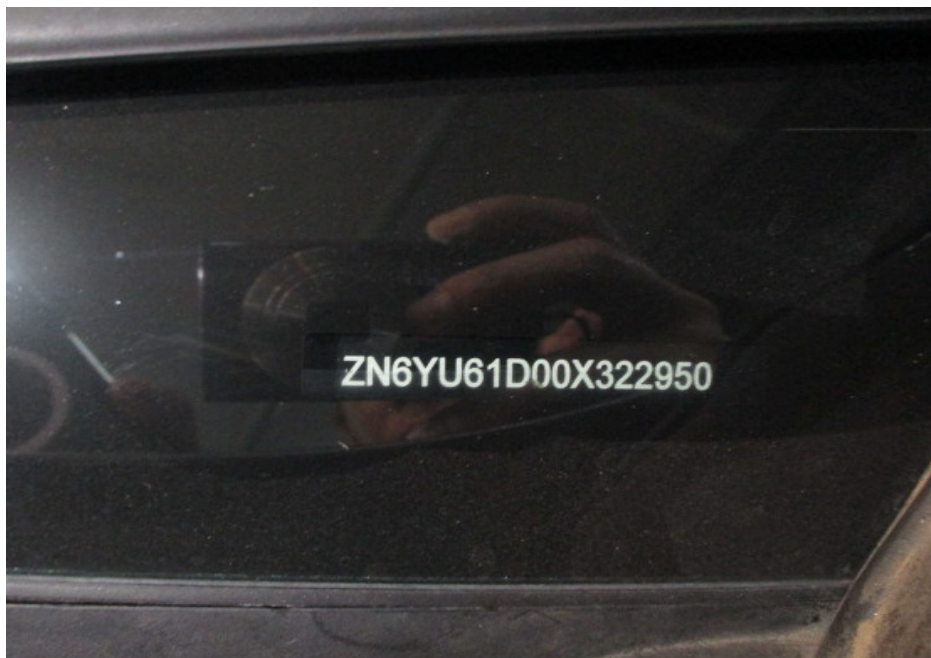
**Photo 12** shows the chassis number of the Motor Car. The chassis number recorded was ZN6YU61D00X322950.

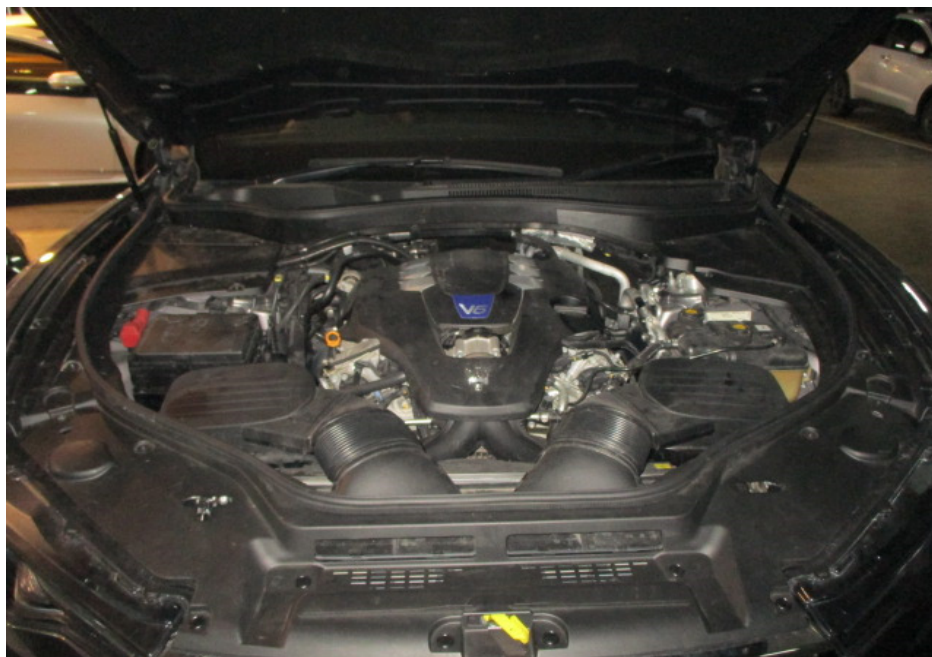
**Photo 13** shows a general view of the engine compartment of the Motor Car at the time of my inspection. The various parts and components within the engine compartment were all observed to be intact and properly fitted. There was also no sign(s) or indication(s) of fluid leak and/or fluid stain found inside the engine compartment.

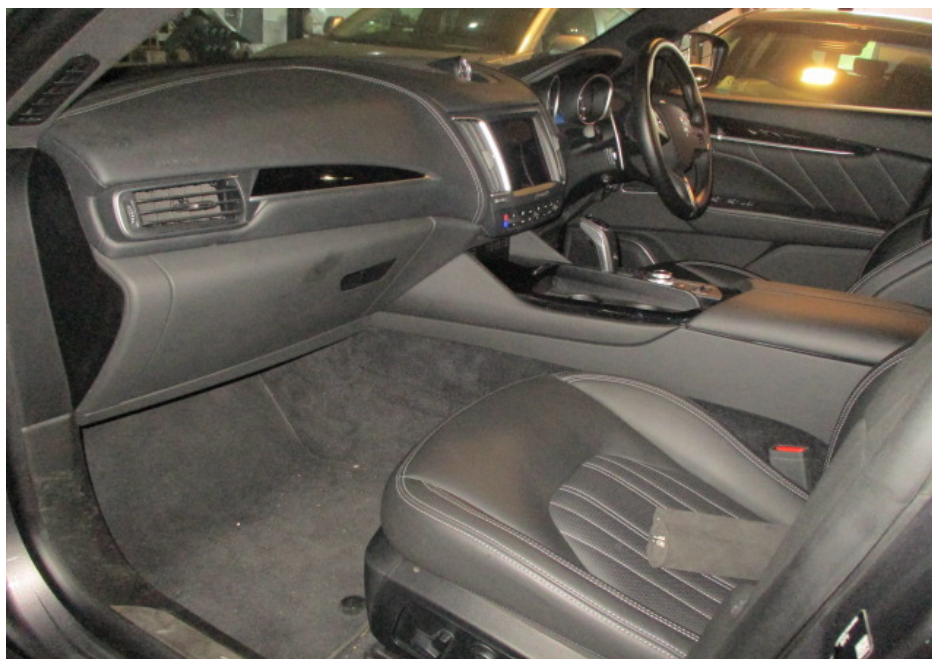
**Photo 14** shows the interior compartment of the Motor Car at the time of my inspection. The various parts and components, trims, carpet and upholstery inside the interior compartment were all observed to be intact and properly fitted.

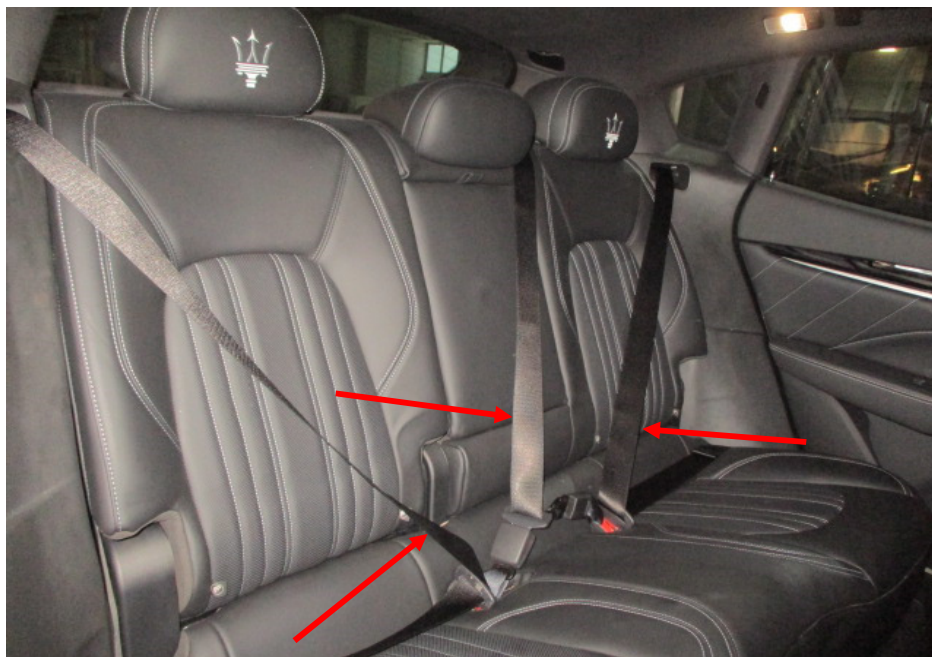
**Photo 15** shows the rear seats of the Motor Car. All the seats of the Motor Car were secured via seat rails to the floorboard. They were also fitted with a retractable seat belt reel and a pre-tensioner. The seat belts (arrowed) were tested and were able to be fastened into the respective pre-tensions that were fitted on the side of each individual seat.

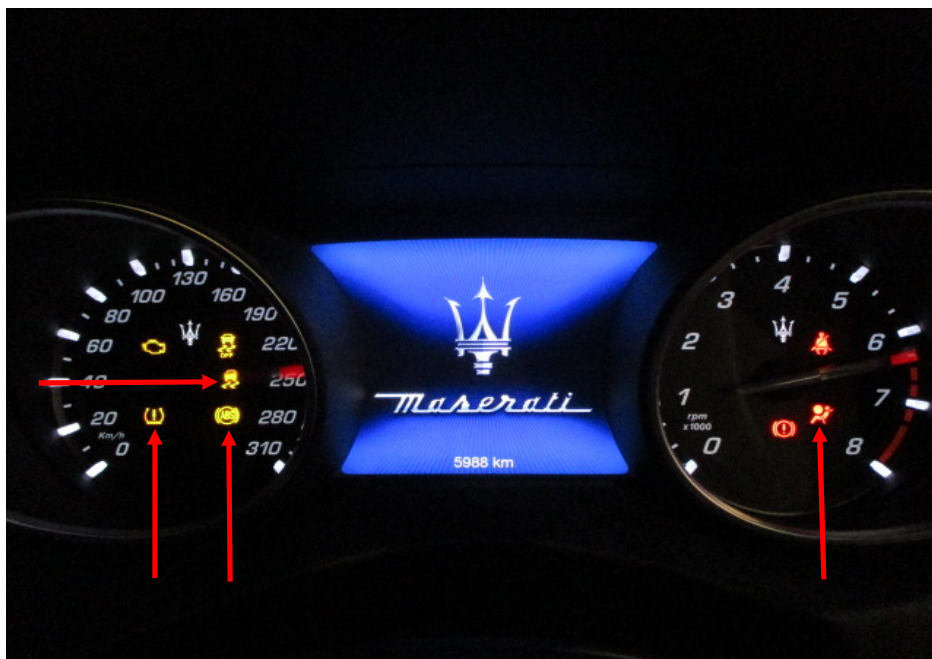
**Photo 16** shows the warning lights for the various electronic safety features appearing on the instrument panel of the Motor Car during its self-test when the engine is cranked, in particular the ABS, SRS, TPM and TCS lights (arrowed).

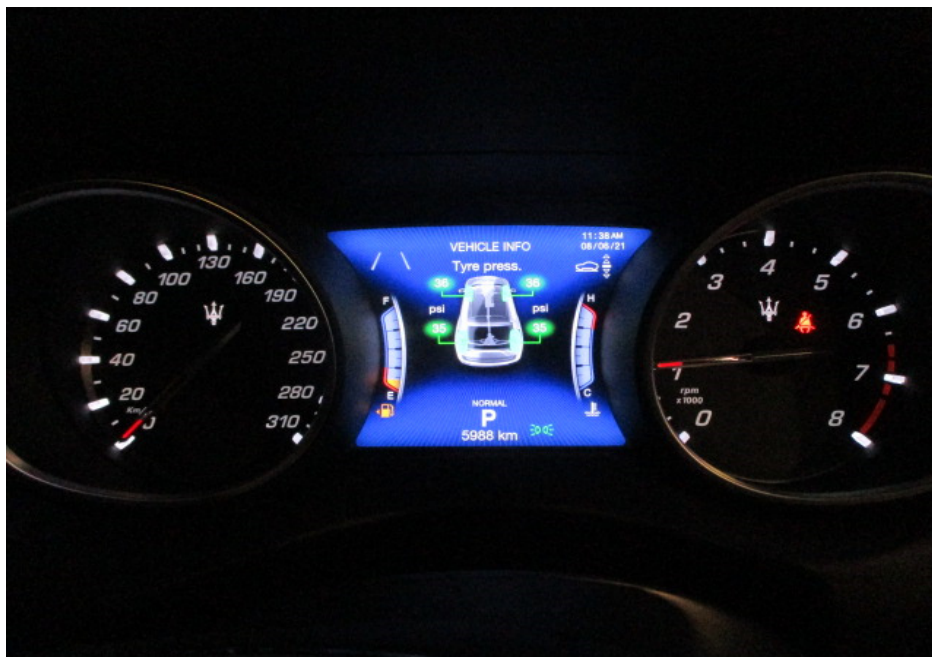
**Photo 17** shows the respective warning lights no longer illuminated, indicating that there is no fault detected to the ABS, SRS, TPM and TCS systems of the Motor Car during the self-test. These electronic systems were hence in working condition at the time of my inspection.

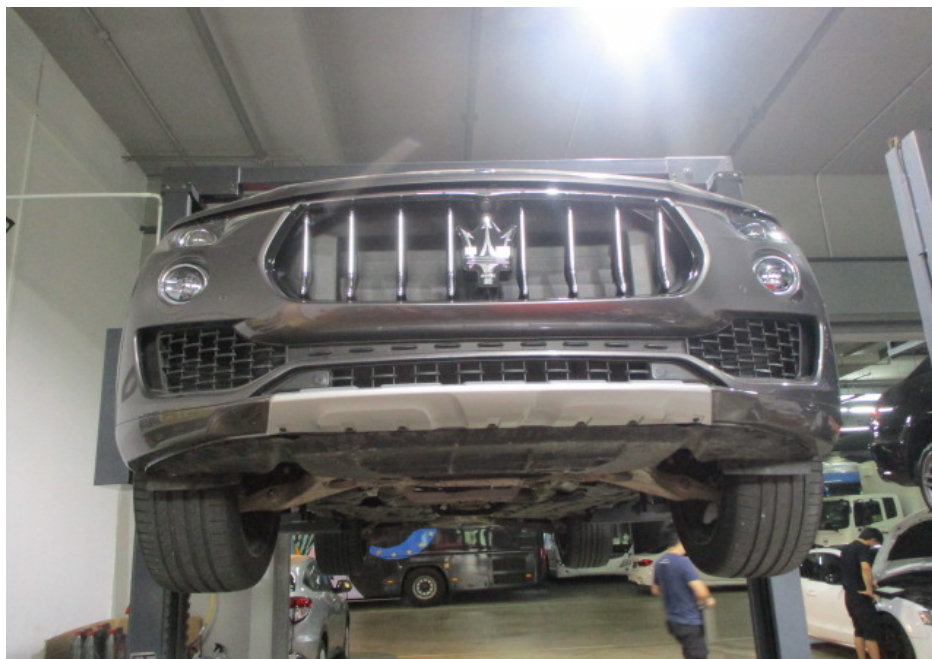
**Photo 18** shows the Motor Car hoisted up for checks on its undercarriage. There was no sign(s) or indication(s) of fluid leakage and/or fluid stain(s) on the underside of the Motor Car. The undercarriage components of the Motor Car were also all observed to be intact and secured in an appropriate manner.

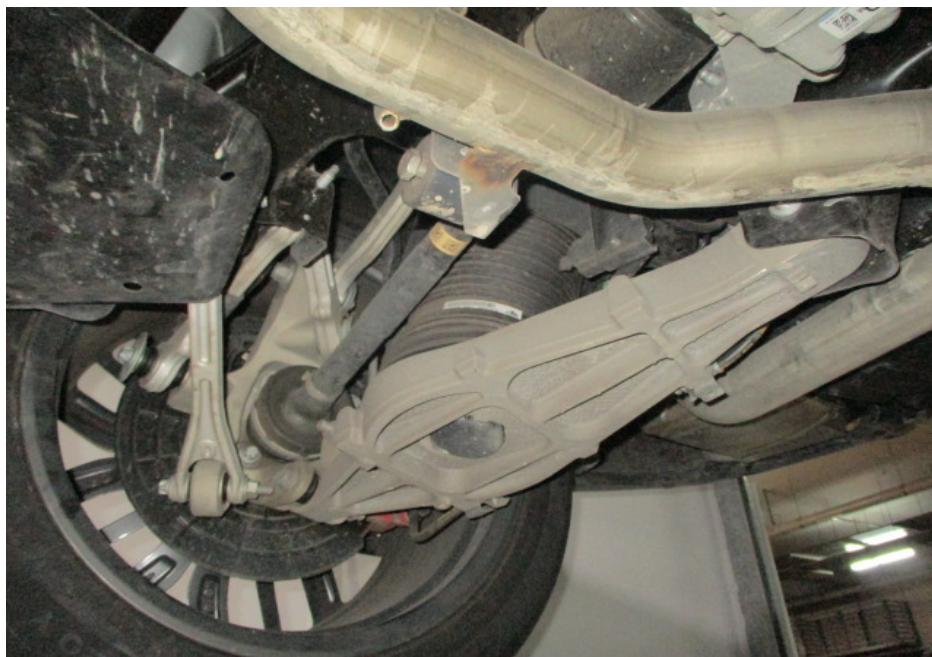
**Photo 19** shows a general view of the control arms and linkages at the rear right wheel of the Motor Car. I did not observe any fluid leak and/or fluid stain on the underside of the Motor Car. All the Motor Car's undercarriage components were observed to be intact and secured in an appropriate manner.

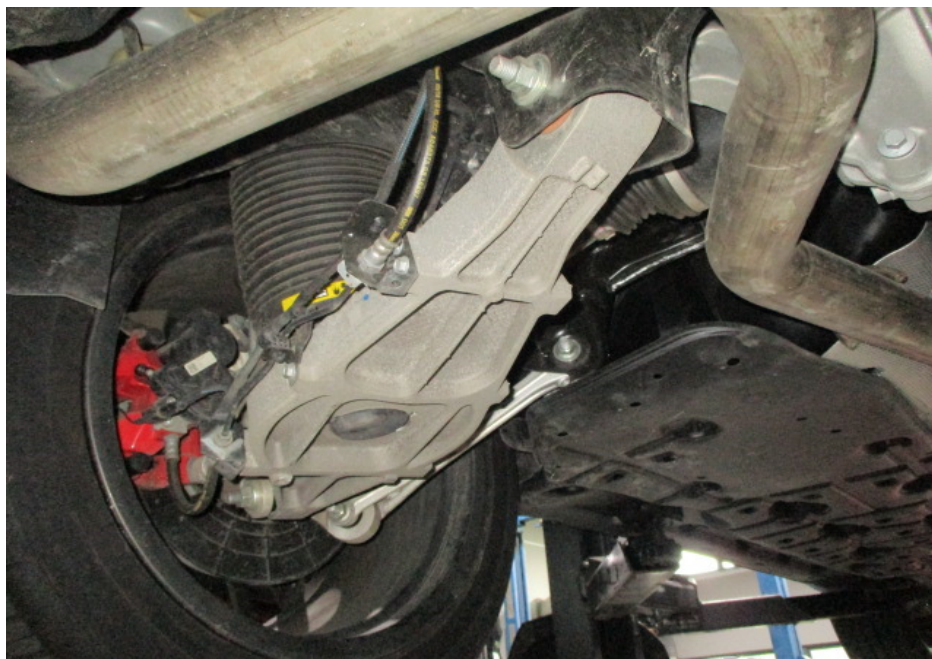
**Photo 20** shows a general view of the control arms and linkages at the rear left wheel of the Motor Car. I did not observe any fluid leak and/or fluid stain on the underside of the Motor Car. All the Motor Car's undercarriage components were observed to be intact and secured in an appropriate manner.

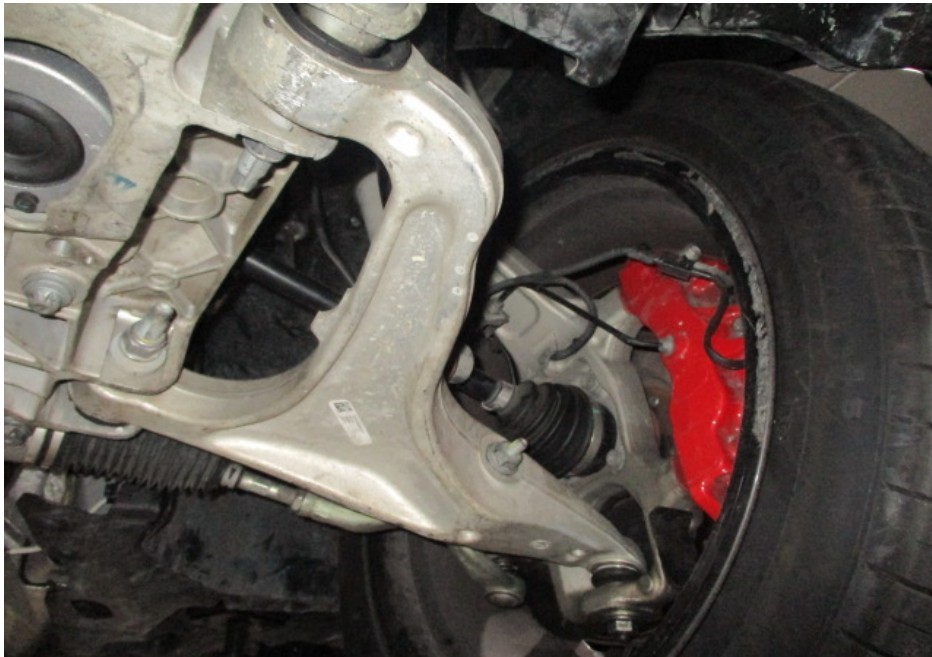
**Photo 21** shows the various undercarriage components at the front left wheel of the Motor Car. I did not observe any fluid leak and/or fluid stain on the underside of the Motor Car. All the Motor Car's undercarriage components were observed to be intact and secured in an appropriate manner.

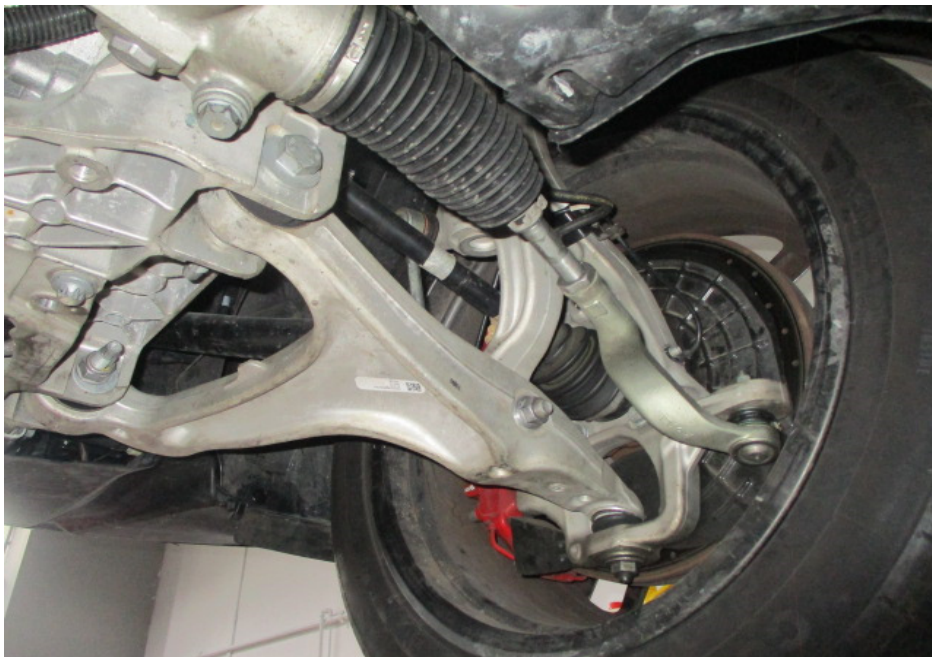
**Photo 22** shows the various undercarriage components at the front right wheel of the Motor Car. The mechanical components, control arms and linkages were all found to be intact and secured in an appropriate manner. I also did not observe any fluid leak and/or fluid stain on the underside of the Motor Car.

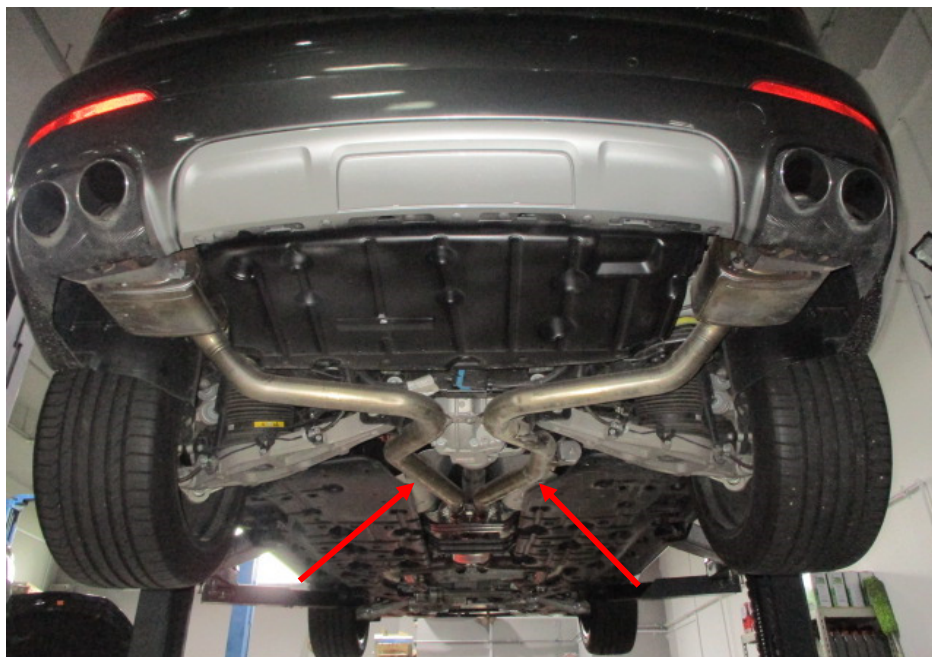
**Photo 23** shows the rear section of the Motor Car's exhaust system. My examination of the Motor Car's exhaust system revealed no sign(s) or indication(s) of any cut or weld marks along its exhaust pipes (arrowed), on its centre resonator box, on its rear mufflers and on its catalytic converters.

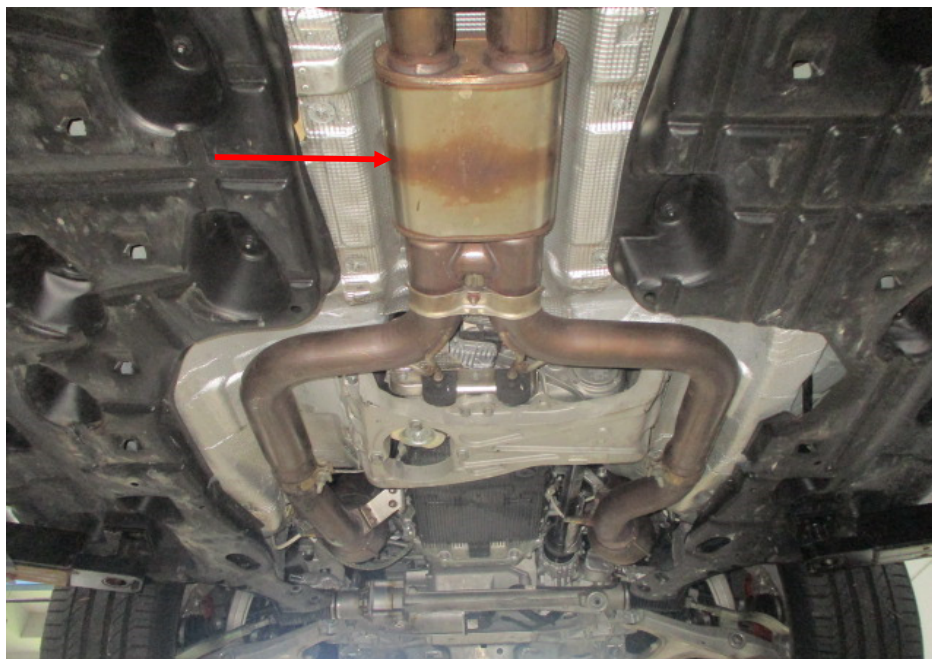
**Photo 24** shows the front section of the Motor Car's exhaust system. My examination of the Motor Car's exhaust system revealed no sign(s) or indication(s) of any cut or weld marks along its exhaust pipes, on its centre resonator box (arrowed), on its rear mufflers and on its catalytic converters.

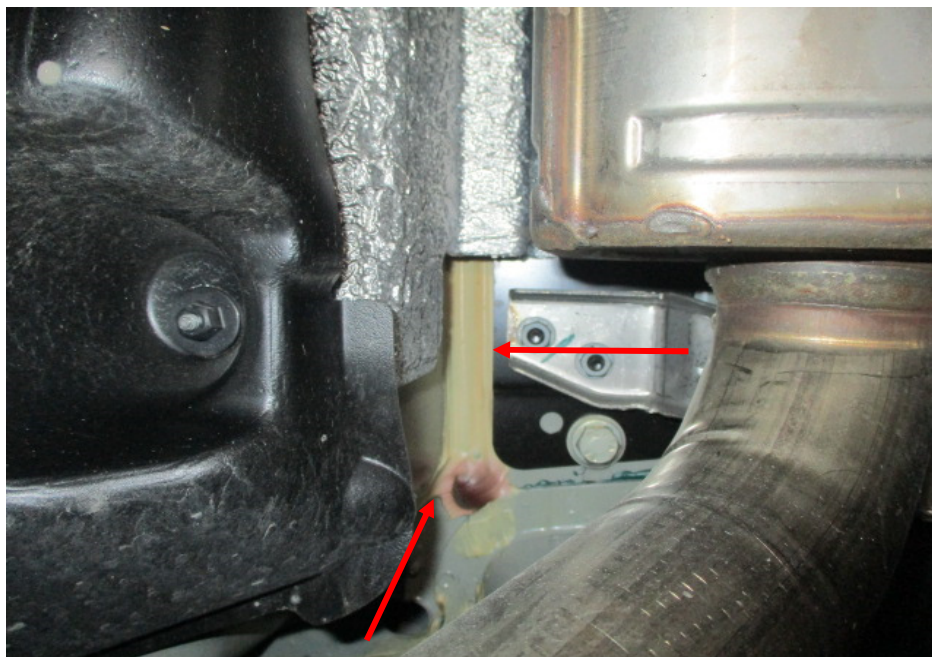
**Photo 25** shows the chassis/structural body at the underside rear right of the Motor Car. I did not find any weld marks other than original spot weld marks on the chassis/structural body of the Motor Car. The original factory sealant (arrowed) at the joints along the chassis/structural body was untouched, indicating no work was done on the chassis/structural body of the Motor Car and that the chassis/structural body was originally fitted.

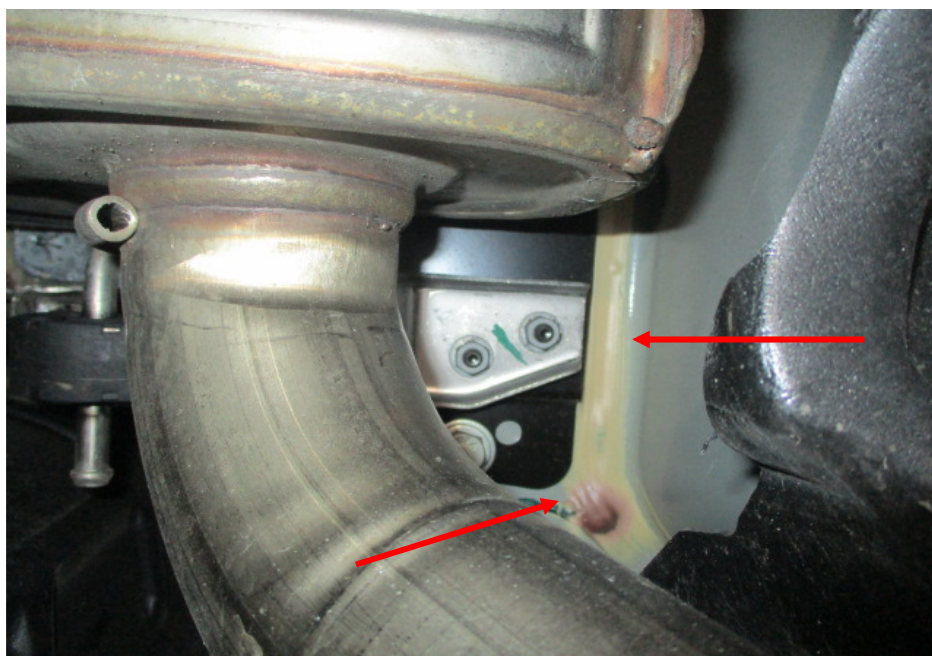
**Photo 26** shows the chassis/structural body at the underside rear left of the Motor Car. The original factory sealant (arrowed) at the joints along the chassis/structural body was observed to be untouched. In general, I had found no work was carried out on the chassis/structural body of the Motor Car. The chassis/structural body of the Motor Car was originally fitted.

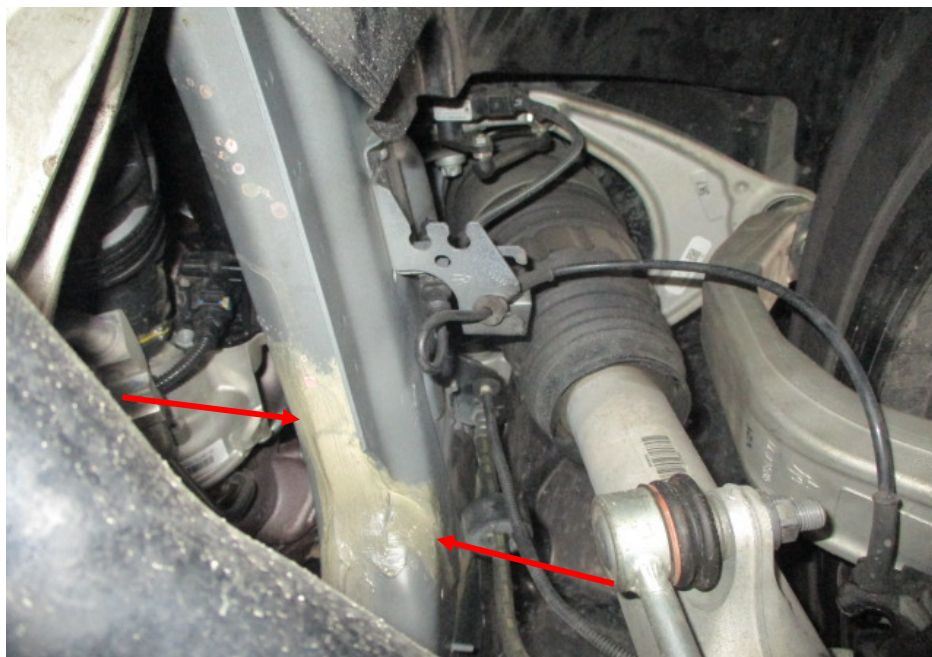
**Photo 27** shows the chassis/structural body at the underside front left of the Motor Car. I did not find any weld marks other than original spot weld marks on the chassis/structural body of the Motor Car. The original factory sealant (arrowed) at the joints along the chassis/structural body was untouched, indicating no work was done on the chassis/structural body of the Motor Car and that the chassis/structural body was originally fitted.

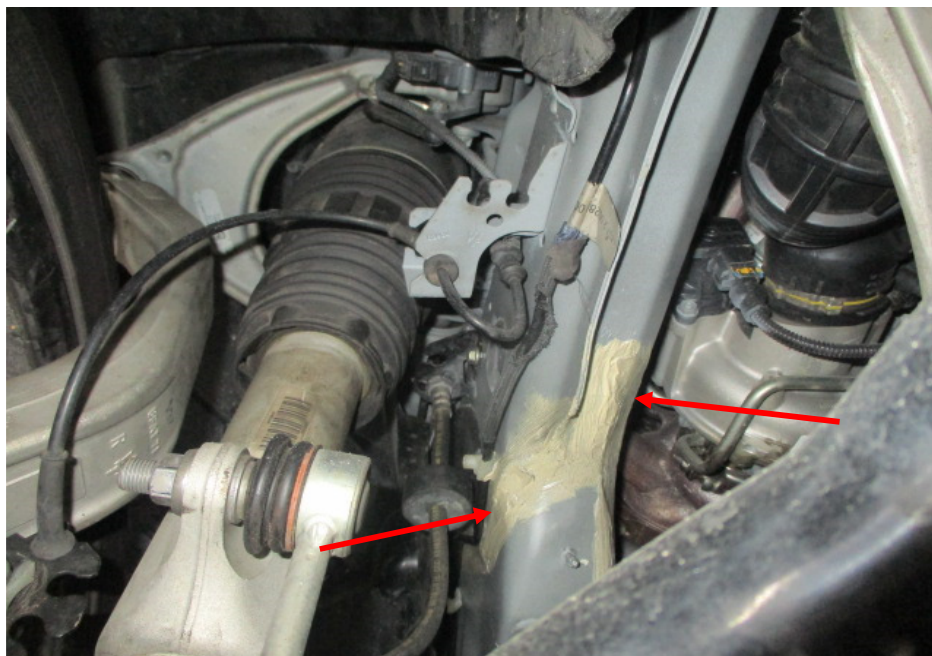
**Photo 28** shows the chassis/structural body at the underside front right of the Motor Car. The original factory sealant (arrowed) at the joints along the chassis/structural body was observed to be untouched. In general, I had found no work was carried out on the chassis/structural body of the Motor Car. The chassis/structural body of the Motor Car was originally fitted.

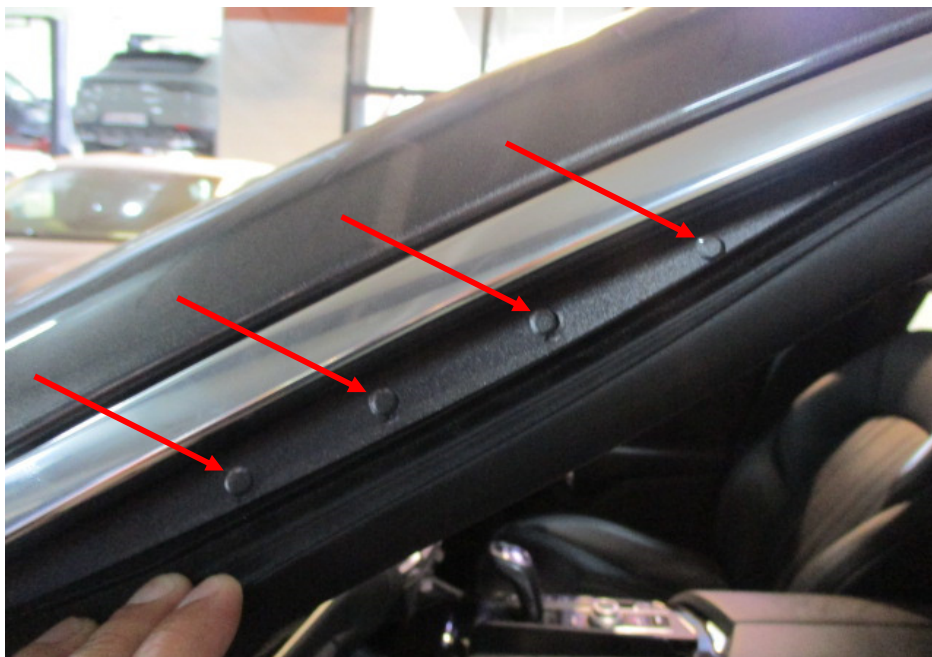
**Photo 29** shows the left side "A" pillar of the Motor Car. I did not find any weld marks other than original spot weld marks (arrowed) on the left side "A" pillar of the Motor Car which, indicates that there was no re-welding works carried out. In general, I had found all the non-detachable body panels of the Motor Car to be originally fitted at the time of my inspection.

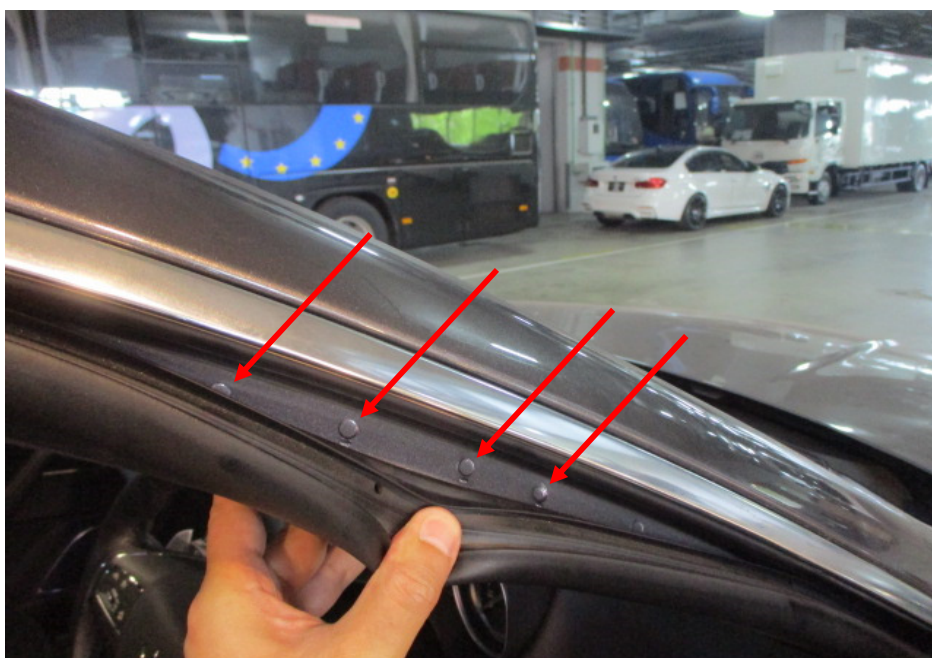
**Photo 30** shows the right side "A" pillar of the Motor Car. I did not find any weld marks other than original spot weld marks (arrowed) on the right side "A" pillar of the Motor Car which, indicates that there was no re-welding works carried out. In general, I had found all the non-detachable body panels of the Motor Car to be originally fitted at the time of my inspection.
