Your Ref: Maserati Levante  
(chassis number ZN6YU61D00X322950)  
Our Ref : CI/TP21011315/D

**INSPECTION REPORT OF AN UNREGISTERED MASERATI LEVANTE  
MOTOR CAR WITH CHASSIS NUMBER ZN6YU61D00X322950**

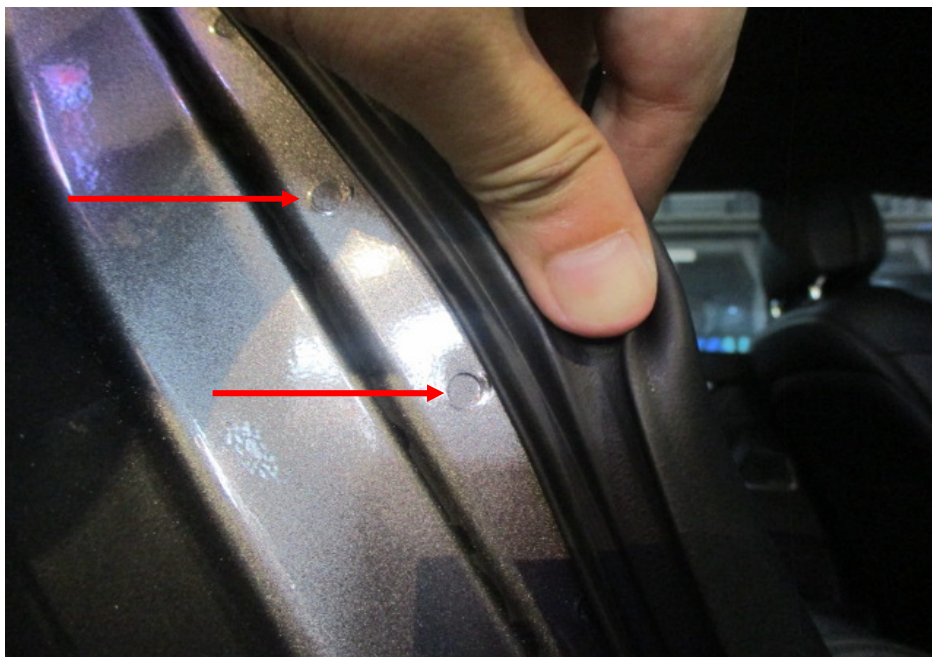
**Photo 31** shows the right side "C" pillar of the Motor Car. I did not find any weld marks other than original spot weld marks (arrowed) on the right side "C" pillar of the Motor Car which, indicates that there was no re-welding works carried out. In general, I had found all the non-detachable body panels of the Motor Car to be originally fitted at the time of my inspection.
