Your Ref: BMW 340i  
(chassis number WBA5U92040FH38098)  
Our Ref : CI/TP21011316/D

**INSPECTION REPORT OF AN UNREGISTERED BMW 340i MOTOR CAR  
WITH CHASSIS NUMBER WBA5U92040FH38098**

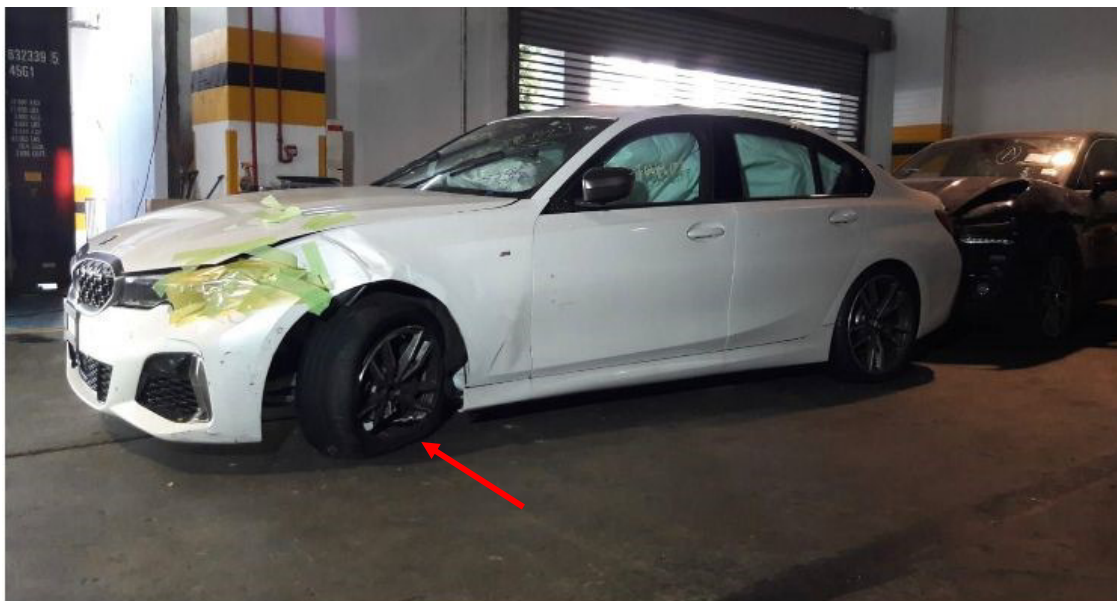
**Photo 1** shows the front left body of the Motor Car (photograph provided to me). The Motor Car was observed to have sustained damage at its front left portion. Body parts damaged include the front bumper, front bonnet, front windscreen, front left headlamp, front left fender, front left fender inner shield, front left wheel rim and front left tyre amongst others. The front left wheel (arrowed) and front right wheel (refer to photograph 4 below) were orientated in different direction, which suggests damage to the Motor Car's front left undercarriage parts. The left side curtain airbag was deployed.

23. The body parts and the undercarriage parts at the front left portion of the Motor Car were visually examined and it was noted that the repair/restoration works carried out to the damaged area of the Motor Car (refer to photograph 1, 2, 3 & 5 above) were reasonably adequate and in order.

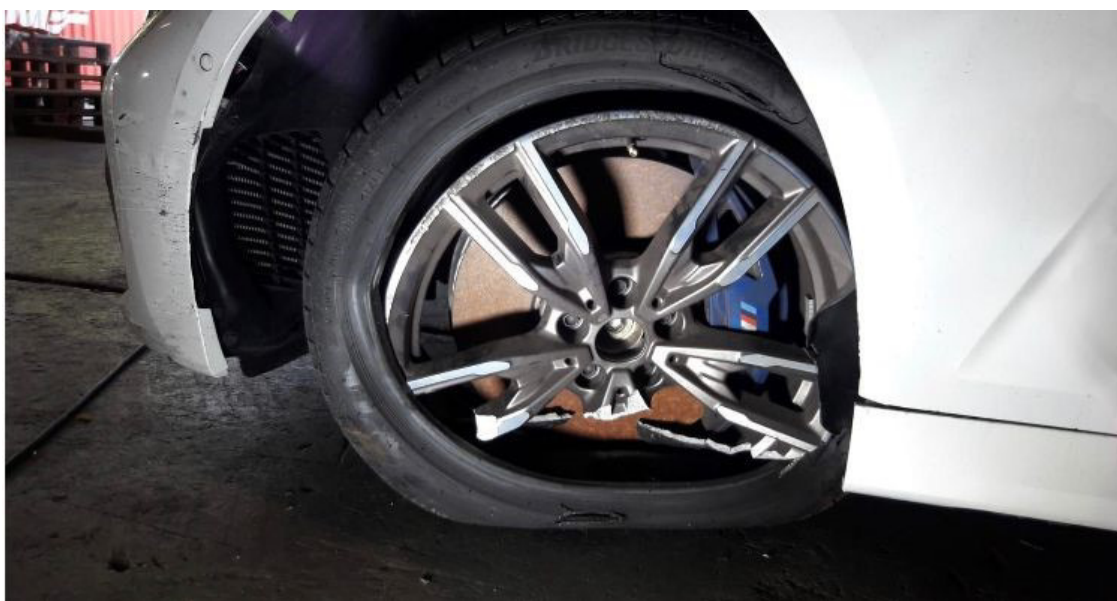
**Photo 2** shows a closer view of the damage to the front left wheel rim and front left tyre of the Motor Car prior to any repairs being carried out (photograph provided to me). The front left wheel and front right wheel (refer to photograph 4 below) were orientated in different direction, which suggests damage to the Motor Car's front left undercarriage parts.

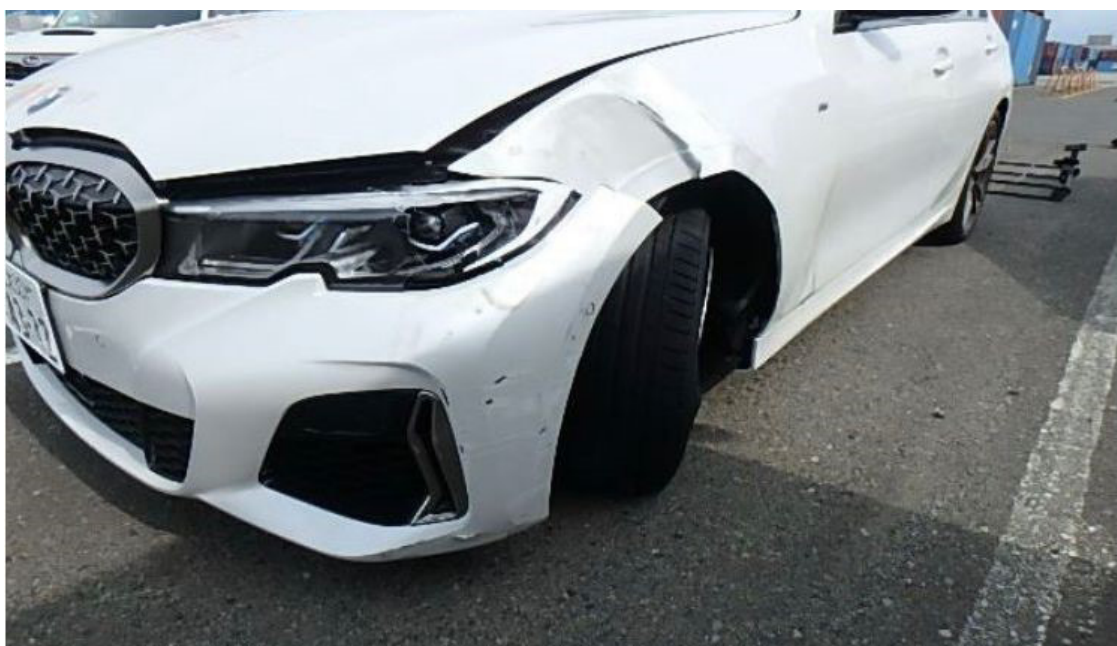
**Photo 3** shows a closer view of the front left body of the Motor Car (photograph provided to me). The Motor Car was observed to have sustained damage at its front left portion. Body parts damaged include the front bumper, front bonnet, front left headlamp and front left fender amongst others.

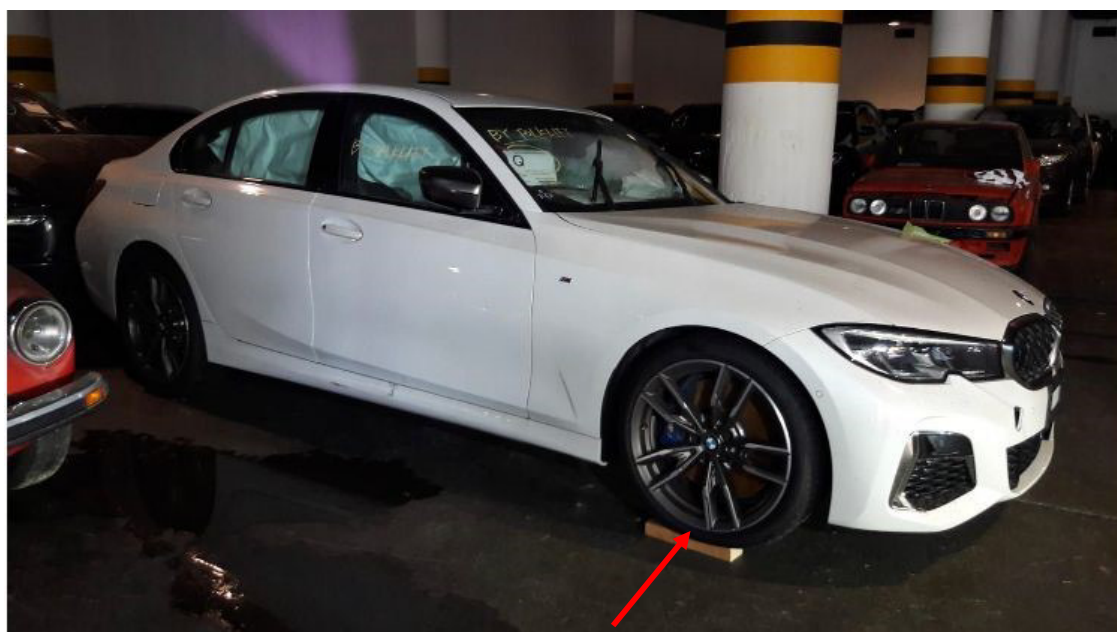
**Photo 4** shows the front right body of the Motor Car (photograph provided to me). The front right portion of the Motor Car was observed to be relatively unaffected. The front left wheel (refer to photograph 1 & 2 above) and front right wheel (arrowed) were orientated in different direction, which suggests damage to the Motor Car's front left undercarriage parts. The right side curtain airbag was deployed.

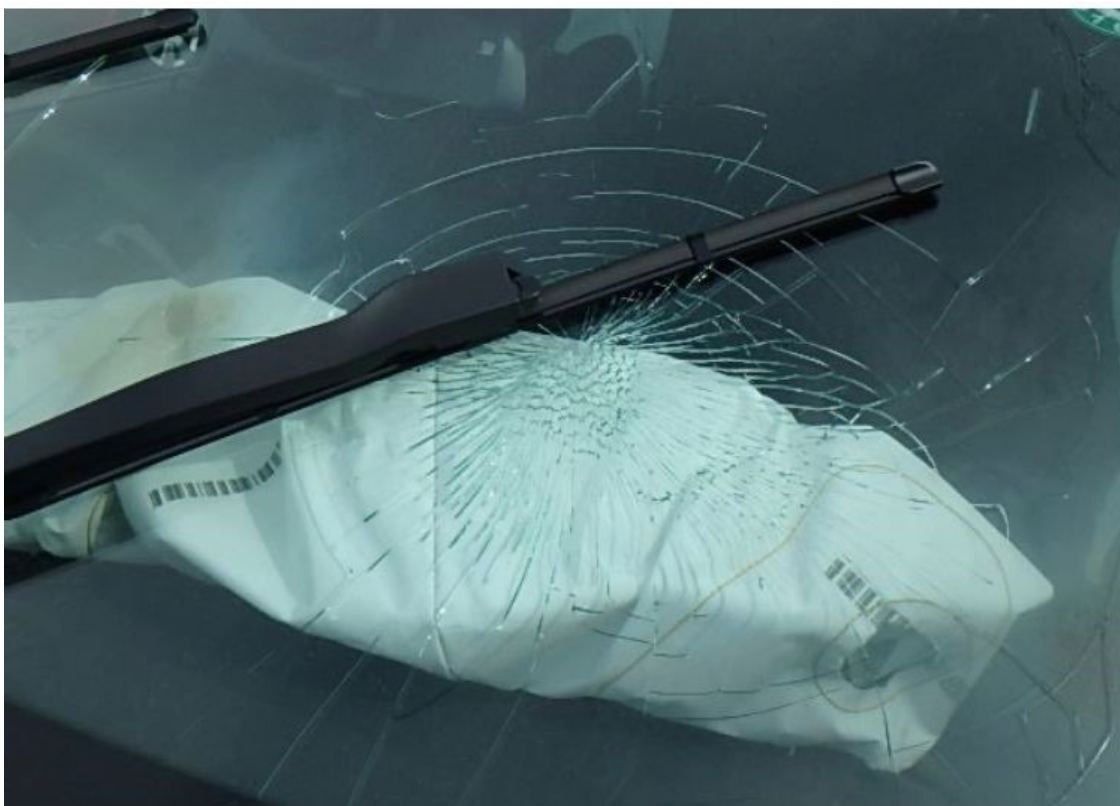
**Photo 5** shows a closer view of the cracked front windscreen of the Motor Car (photograph provided to me). The front left passenger airbag was deployed.

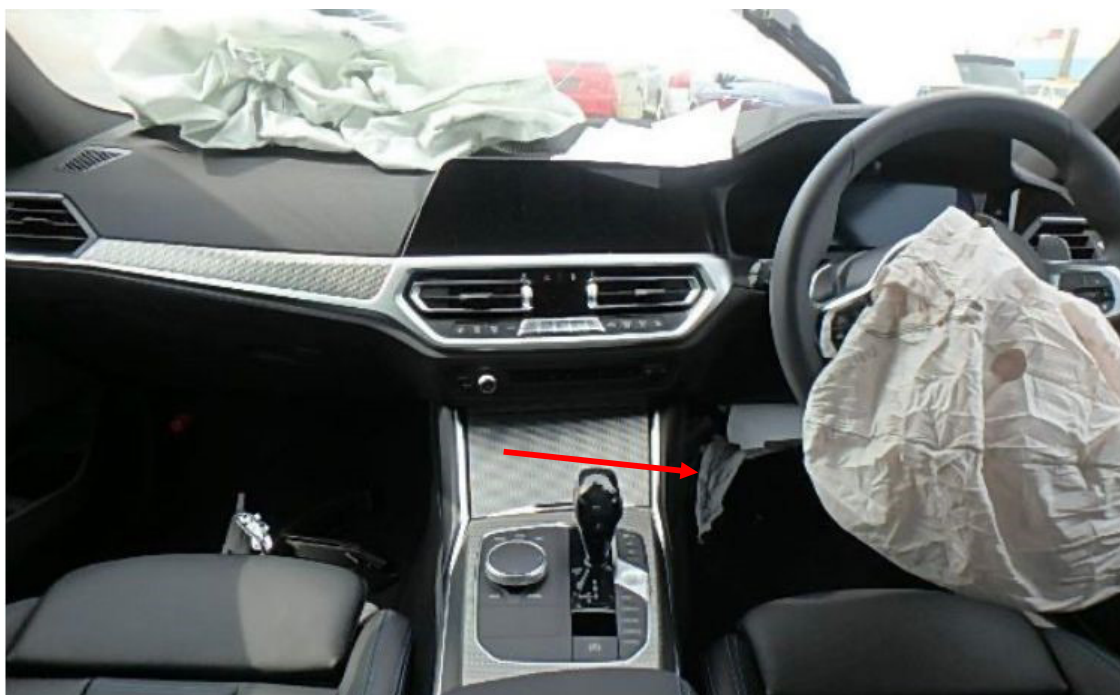
**Photo 6** shows the interior compartment of the Motor Car (photograph provided to me). The front left passenger airbag, driver airbag and driver knee airbag (arrowed) were deployed.

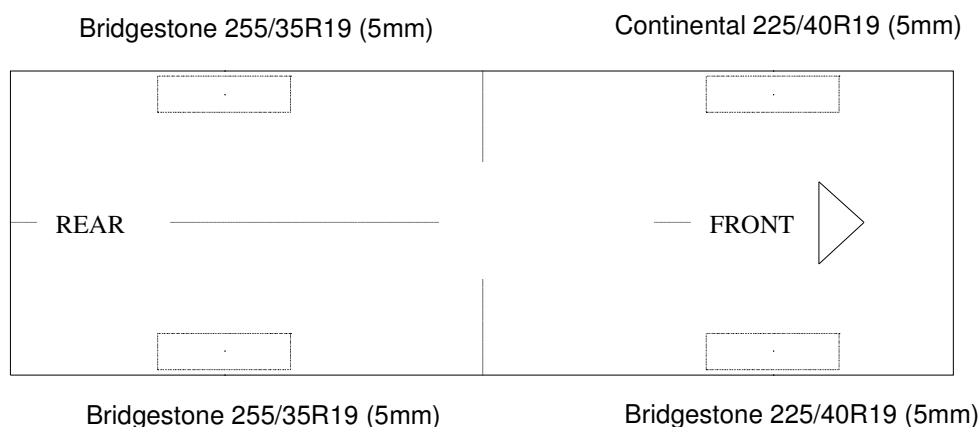
9. It was fitted with 19inch sport wheel rims that were wrapped with tyres that were observed to be of serviceable condition. The tyres were also sufficiently inflated for vehicular operation. The tyre brand, tyre size and approximate remaining tread depth of the 4 tyres of the Motor Car were recorded as follows: -

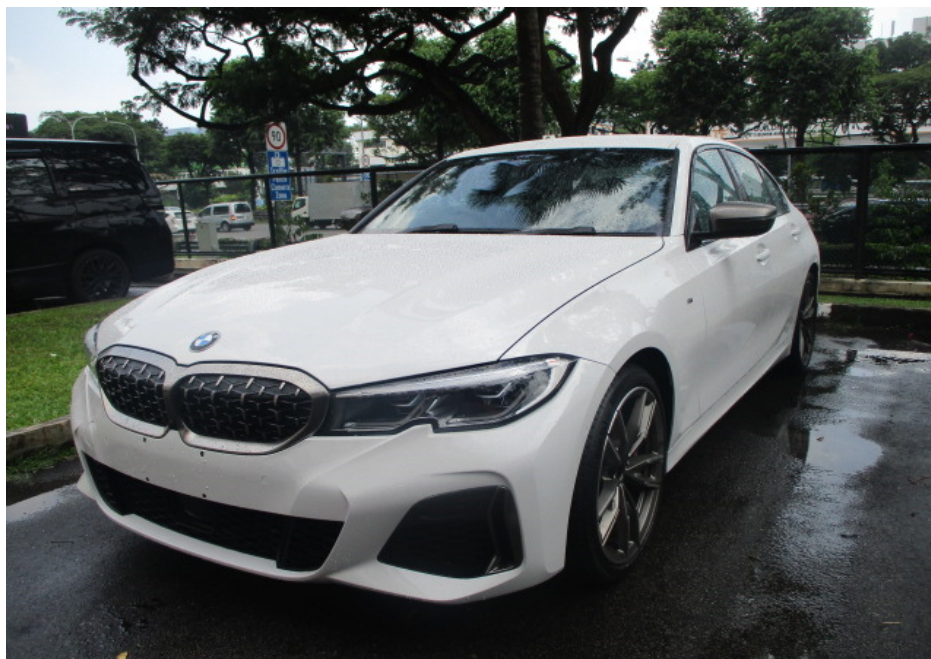
**Photo 7** shows a general view of the front left body of the Motor Car at the time of my inspection. The Motor Car was observed to be in a relatively good general condition with no loose exterior fittings observed. The body parts and undercarriage parts at the front left portion of the Motor Car were visually examined and it was observed that the repair/restoration works carried out to the damaged area of the Motor Car (refer to photograph 1, 2, 3 and 5 above) were reasonably adequate and in order.

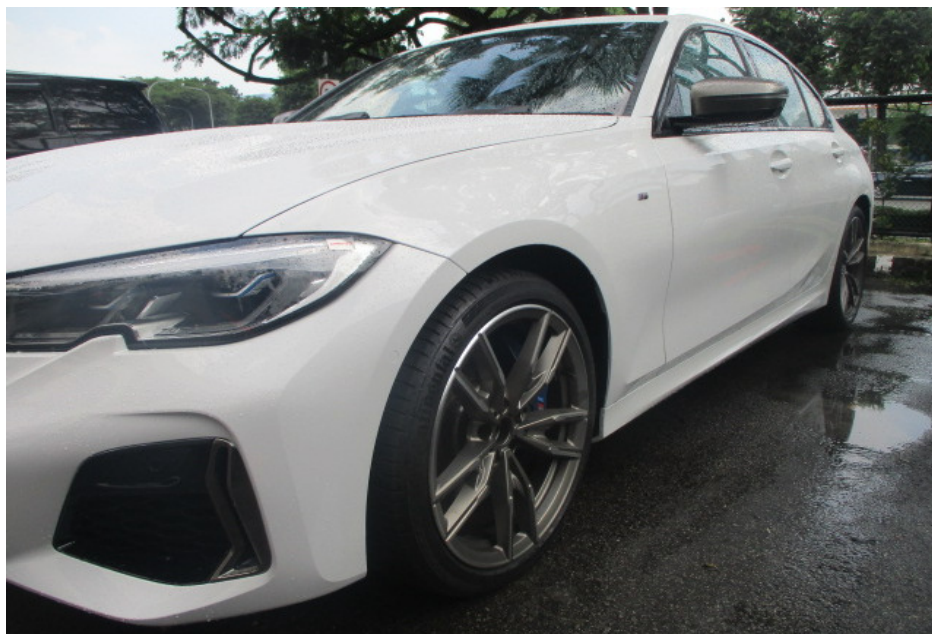
**Photo 8** shows a closer view of the Motor Car's front bumper, front bonnet, front left headlamp, front left fender and front left wheel rim. The body parts and undercarriage parts at the front left portion of the Motor Car were visually examined and it was observed that the repair/restoration works carried out to the damaged area of the Motor Car (refer to photograph 1, 2, 3 and 5 above) were reasonably adequate and in order.

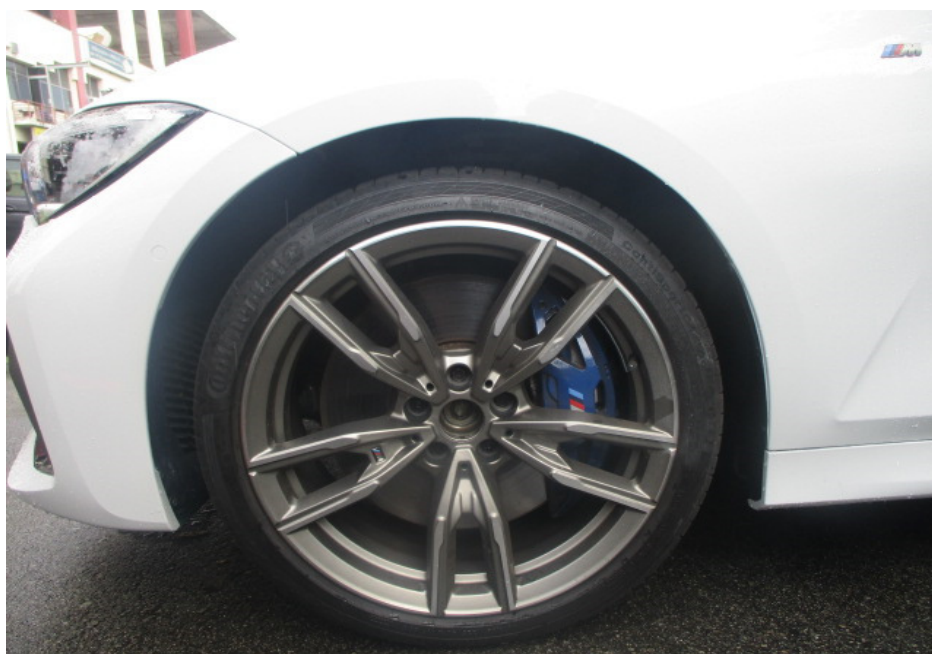
**Photo 9** shows a closer view of the Motor Car's front bumper, front left fender, front left tyre and front left wheel rim. The body parts and undercarriage parts at the front left portion of the Motor Car were visually examined and it was observed that the repair/restoration works carried out to the damaged area of the Motor Car (refer to photograph 1, 2, 3 and 5 above) were reasonably adequate and in order.

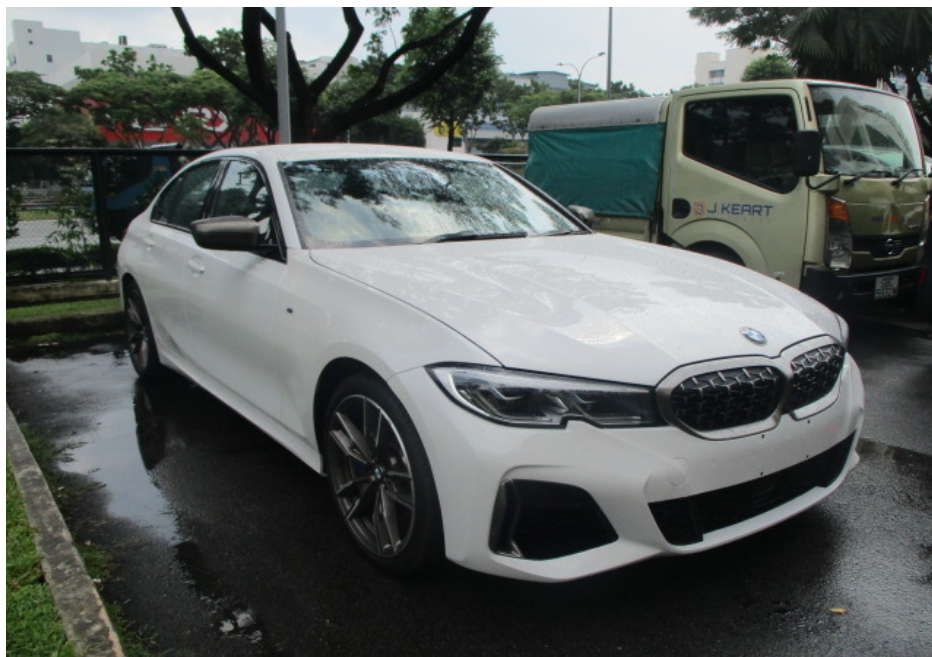
**Photo 10** shows a general view of the front right body of the Motor Car at the time of my inspection. The Motor Car was observed to be in a relatively good general condition with no loose exterior fittings observed. The mileage of the Motor Car recorded at the time of my inspection was 3,586km.

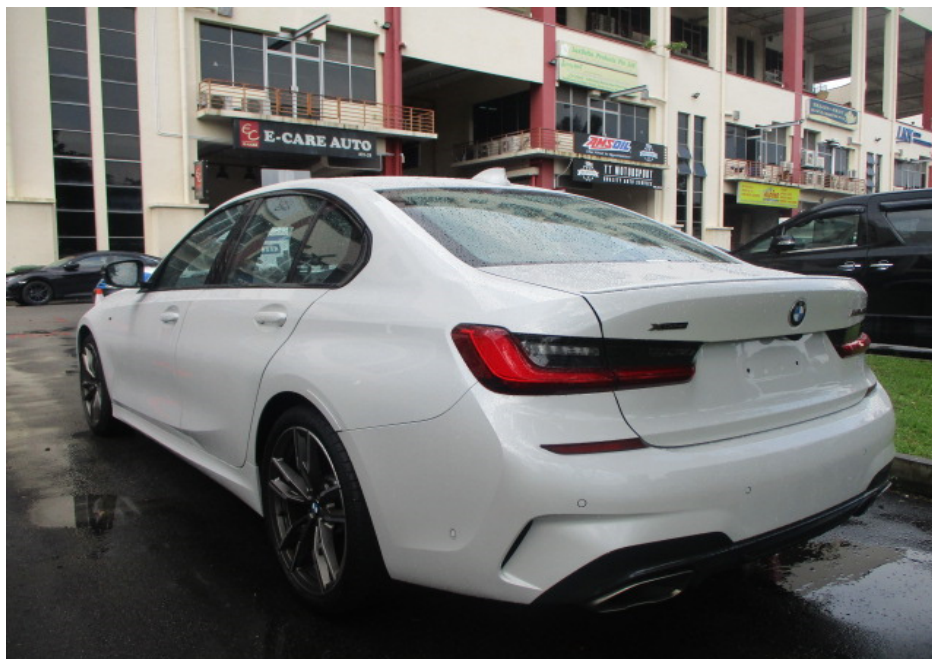
**Photo 11** shows a general view of the rear left body of the Motor Car at the time of my inspection. The Motor Car was observed to be in a relatively good general condition with no loose exterior fittings observed. The mileage of the Motor Car recorded at the time of my inspection was 3,586km.

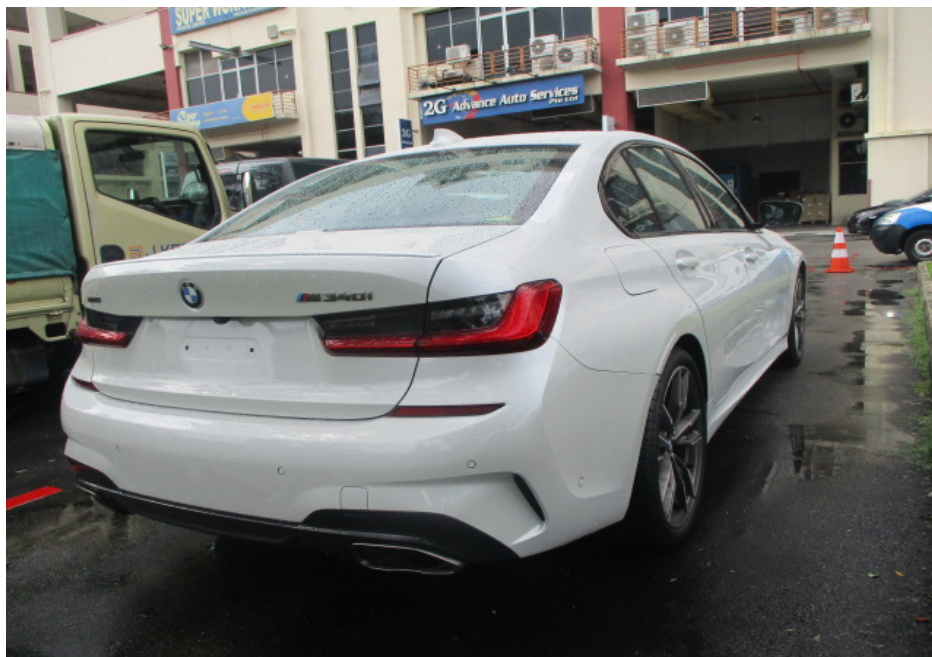
**Photo 12** shows a general view of the rear right body of the Motor Car at the time of my inspection. The Motor Car was observed to be in a relatively good general condition with no loose exterior fittings observed. The mileage of the Motor Car recorded at the time of my inspection was 3,586km.

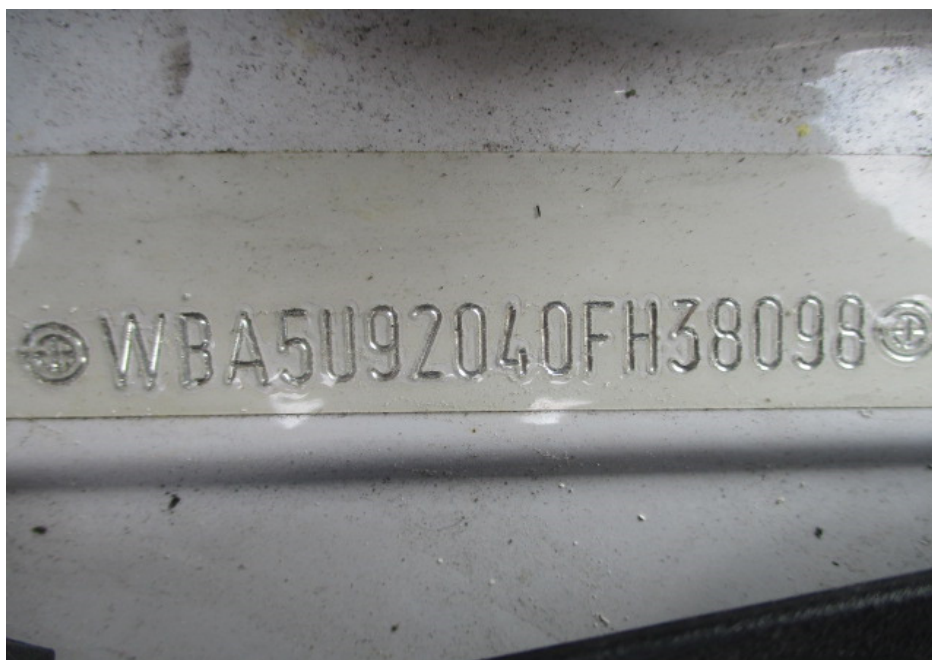
**Photo 13** shows the chassis number of the Motor Car. The chassis number recorded was WBA5U92040FH38098.

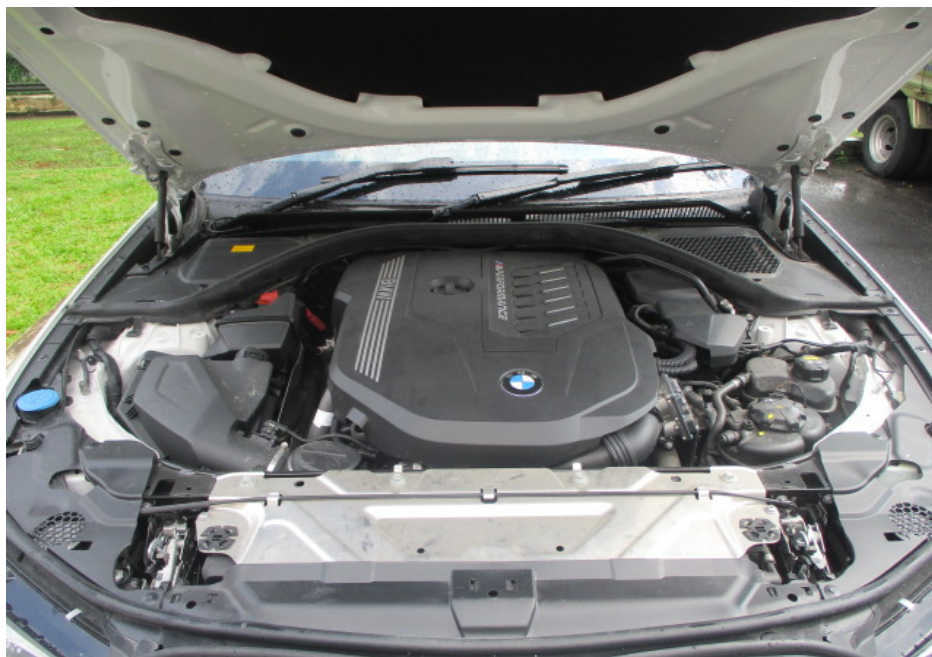
**Photo 14** shows a general view of the engine compartment of the Motor Car at the time of my inspection. The various parts and components inside the engine compartment were all observed to be intact and properly fitted. There was also no sign(s) or indication(s) of fluid leak and/or fluid stain found inside the engine compartment.

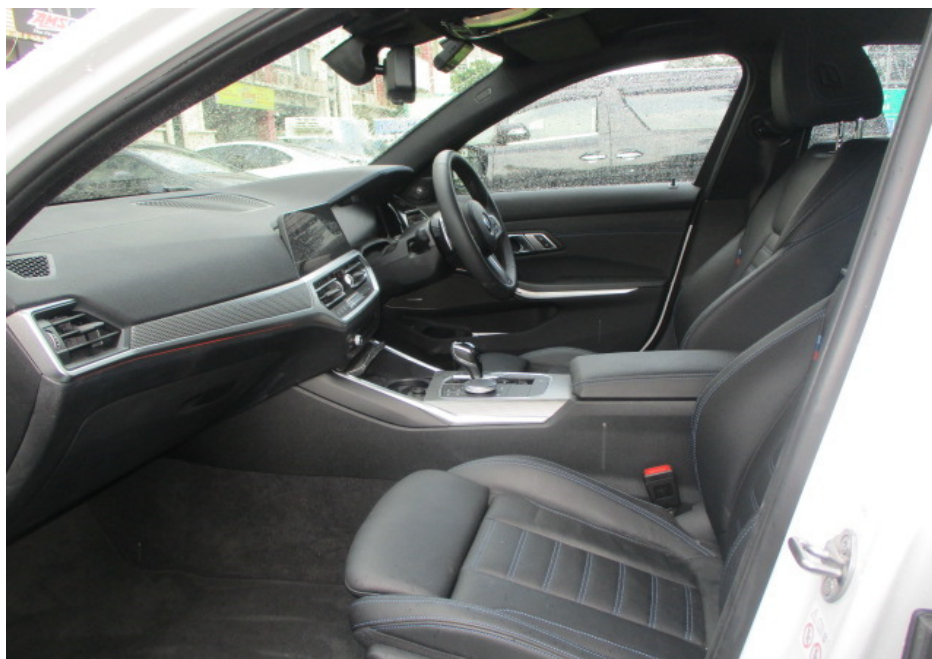
**Photo 15** shows the interior compartment of the Motor Car at the time of my inspection. The various parts and components, trims, carpet and upholstery inside the interior compartment were all observed to be intact and properly fitted.

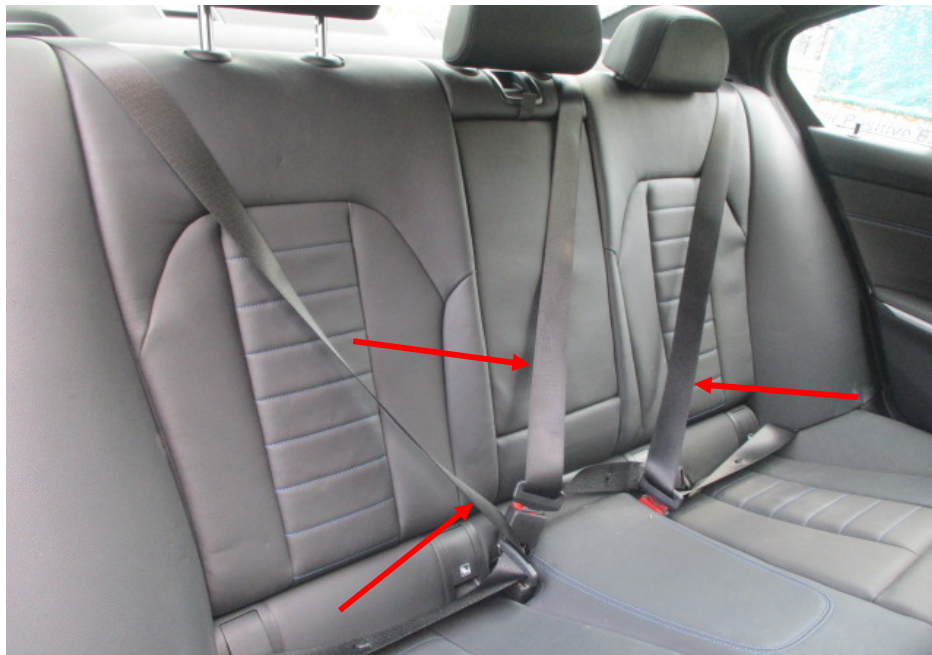
**Photo 16** shows the rear seats of the Motor Car. All the seats of the Motor Car were secured via seat rails to the floorboard. They were also fitted with a retractable seat belt reel and a pre-tensioner. The seat belts (arrowed) were tested and were able to be fastened into the respective pre-tensions that were fitted on the side of each individual seat.

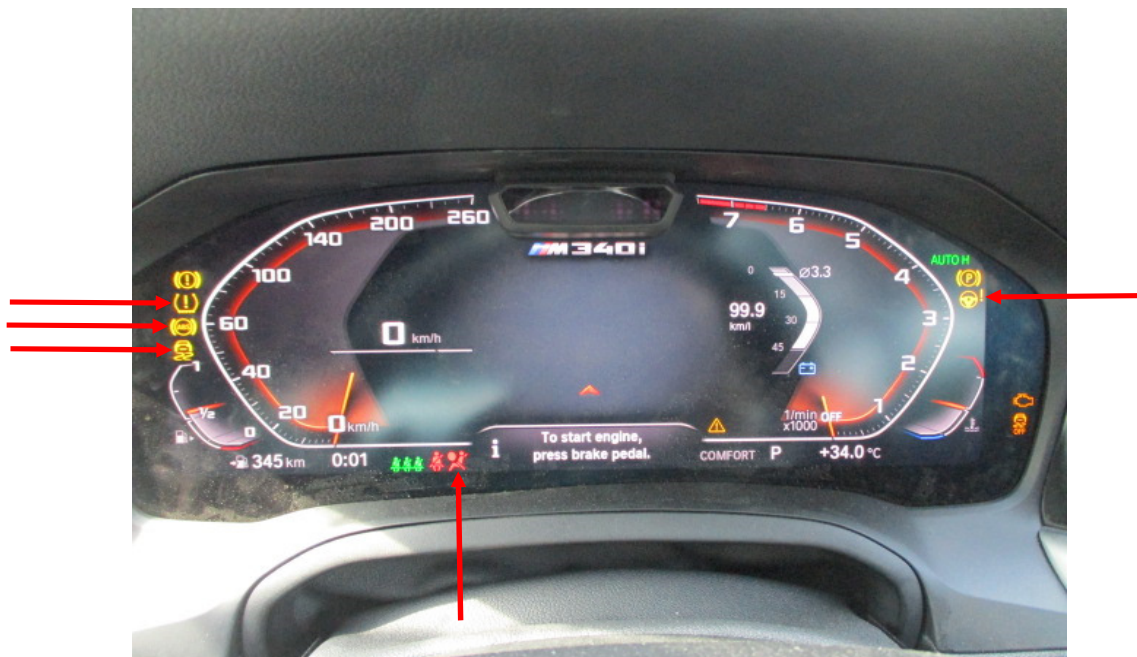
**Photo 17** shows the warning lights for the various electronic safety features appearing on the instrument panel of the Motor Car during its self-test when the engine is cranked, in particular the ABS, SRS, IAS, TPM and DSC lights (arrowed).

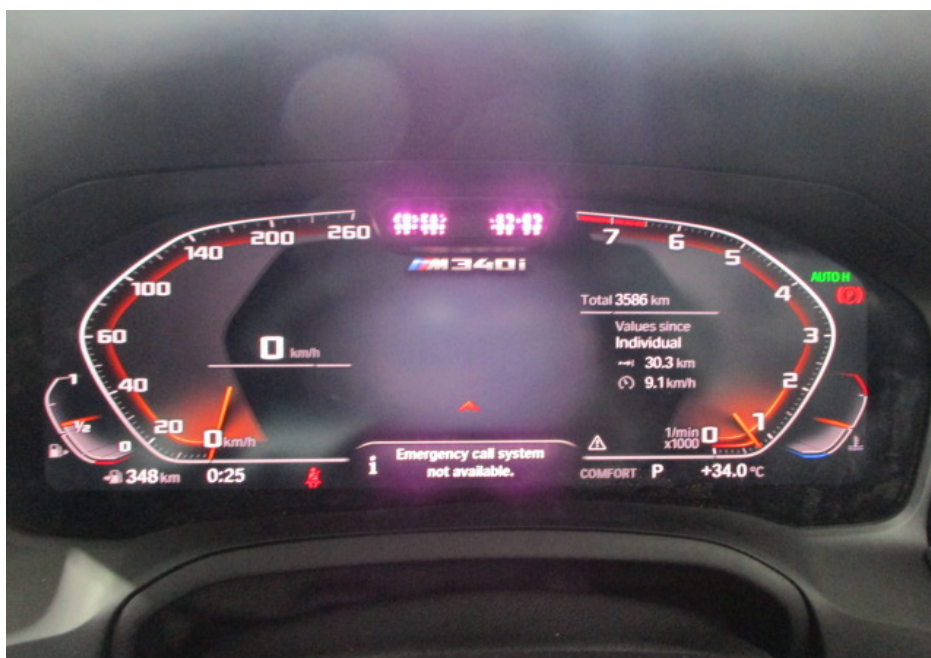
**Photo 18** shows the respective warning lights no longer illuminated, indicating that there is no fault detected to the ABS, SRS, IAS, TPM and DSC systems of the Motor Car during the self-test. These electronic systems were hence in working condition at the time of my inspection.

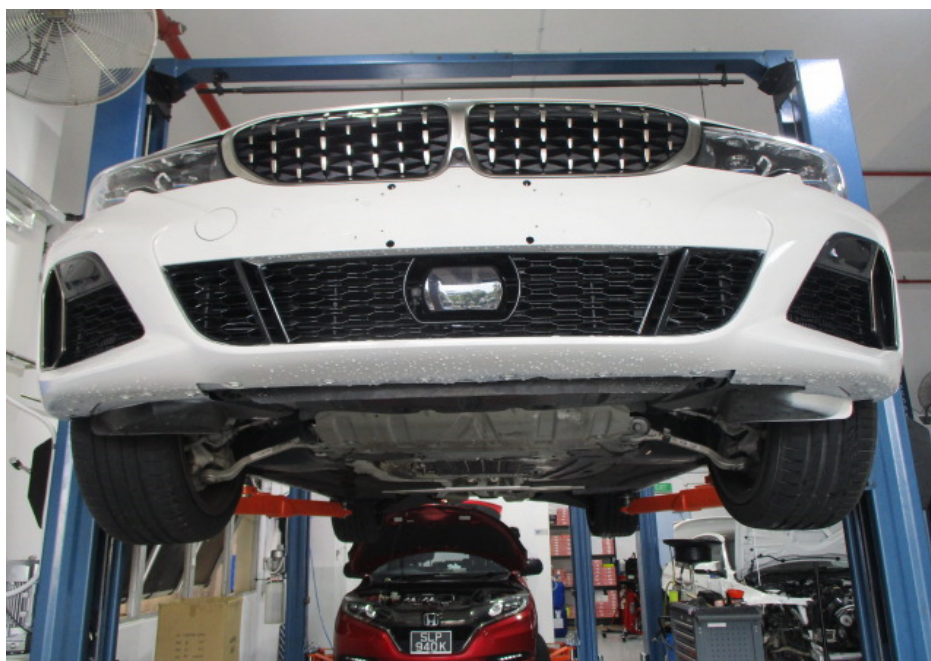
**Photo 19** shows the Motor Car hoisted up for checks on its undercarriage. There was no sign(s) or indication(s) of fluid leakage and/or fluid stain(s) on the underside of the Motor Car. The undercarriage components of the Motor Car were also all observed to be intact and secured in an appropriate manner.

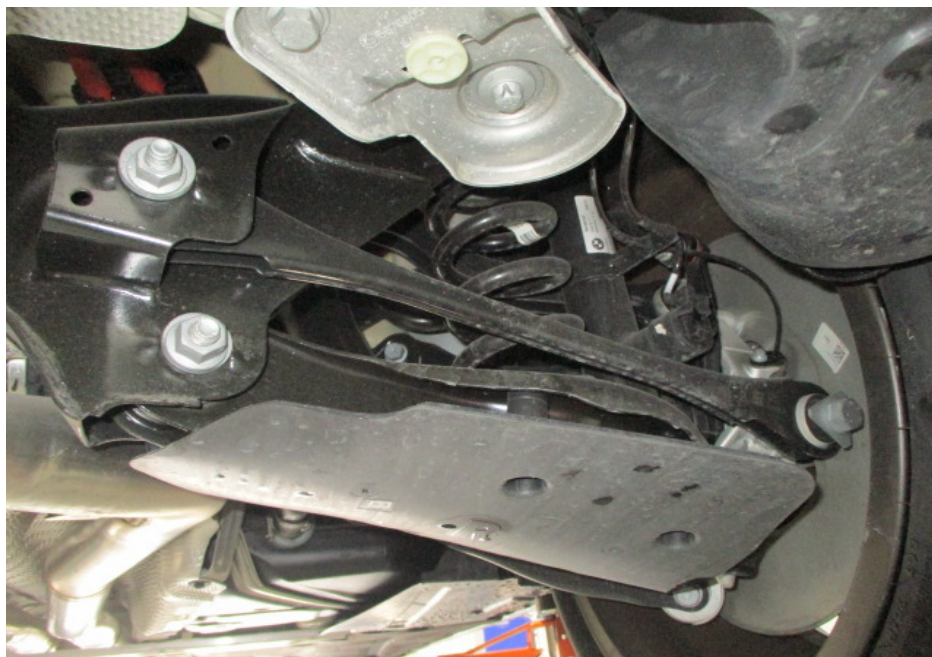
**Photo 20** shows a general view of the control arms and linkages at the rear right wheel of the Motor Car. I did not observe any fluid leak and/or fluid stain on the underside of the Motor Car. All the Motor Car's undercarriage components were observed to be intact and secured in an appropriate manner.

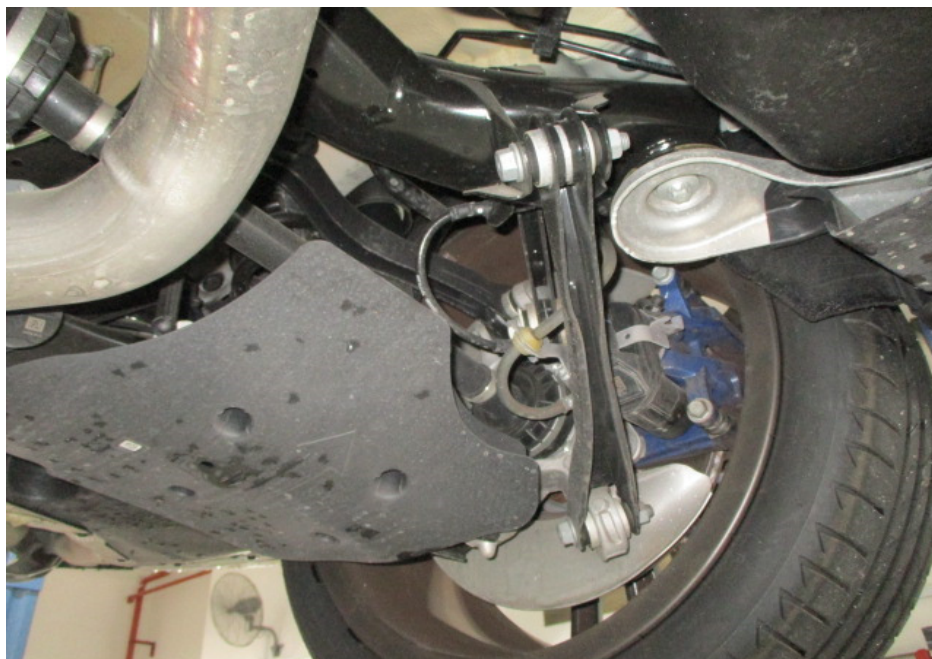
**Photo 21** shows a general view of the control arms and linkages at the rear left wheel of the Motor Car. I did not observe any fluid leak and/or fluid stain on the underside of the Motor Car. All the Motor Car's undercarriage components were observed to be intact and secured in an appropriate manner.

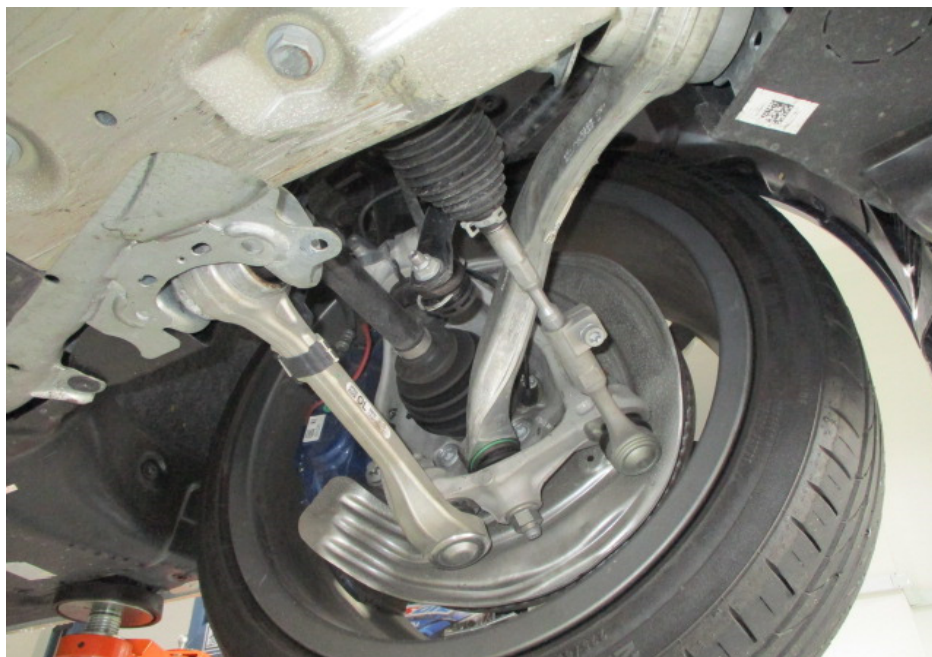
**Photo 22** shows the various undercarriage components at the front left wheel of the Motor Car. The mechanical components, control arms and linkages were all found to be intact and secured in an appropriate manner. The undercarriage parts at the front left portion of the Motor Car were visually examined and it was observed that the repair/restoration works carried out to the damaged area of the Motor Car (refer to photograph 1 - 3 above) were reasonably adequate and in order.

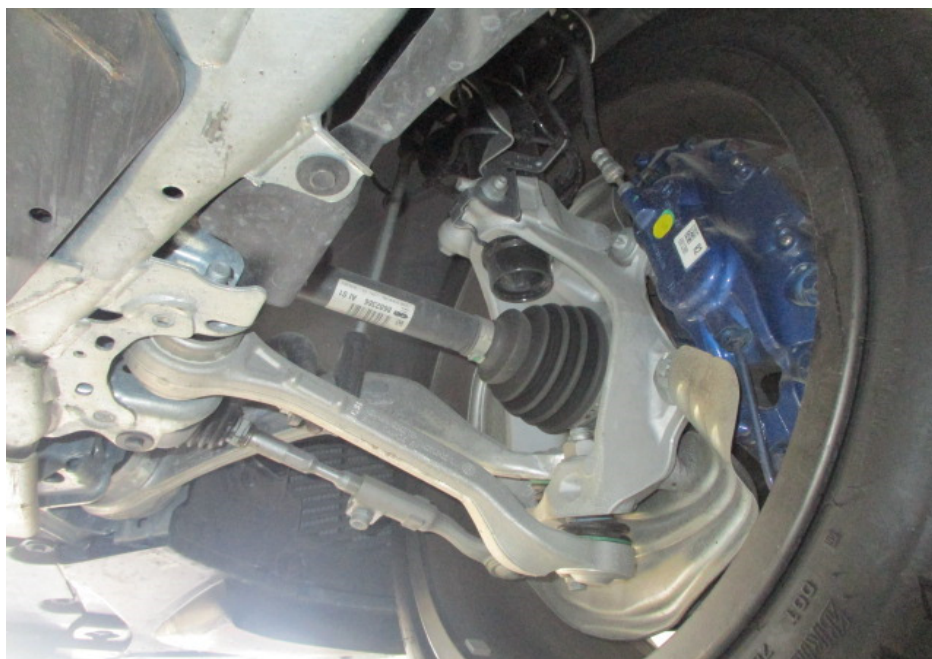
**Photo 23** shows the various undercarriage components at the front right wheel of the Motor Car. The mechanical components, control arms and linkages were all found to be intact and secured in an appropriate manner. I also did not observe any fluid leak and/or fluid stain on the underside of the Motor Car.

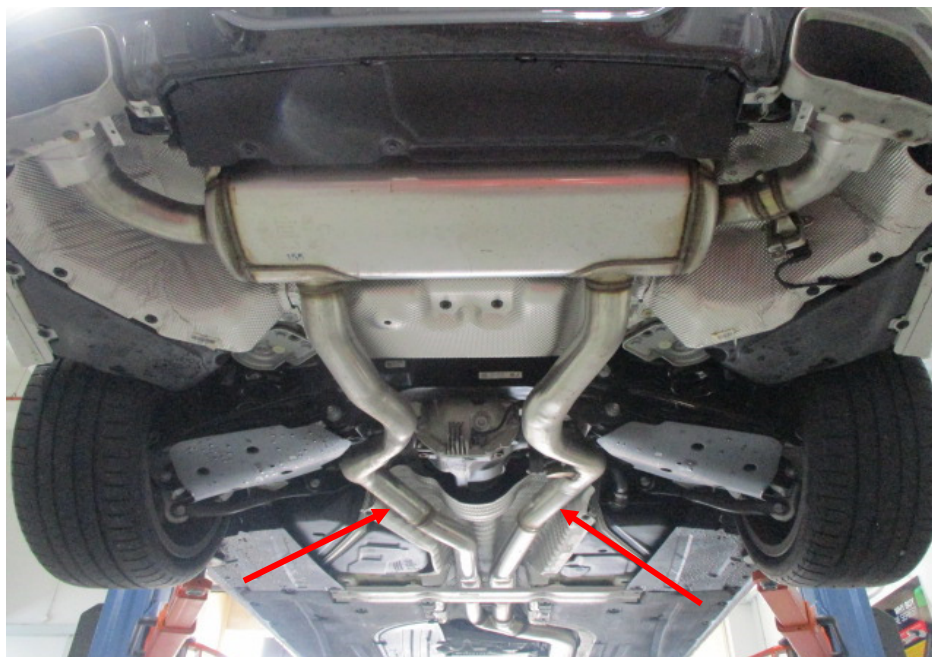
**Photo 24** shows the rear section of the Motor Car's exhaust system. My examination of the Motor Car's exhaust system revealed no sign(s) or indication(s) of any cut or weld marks along its exhaust pipes (arrowed), on its rear muffler and on its catalytic converter.

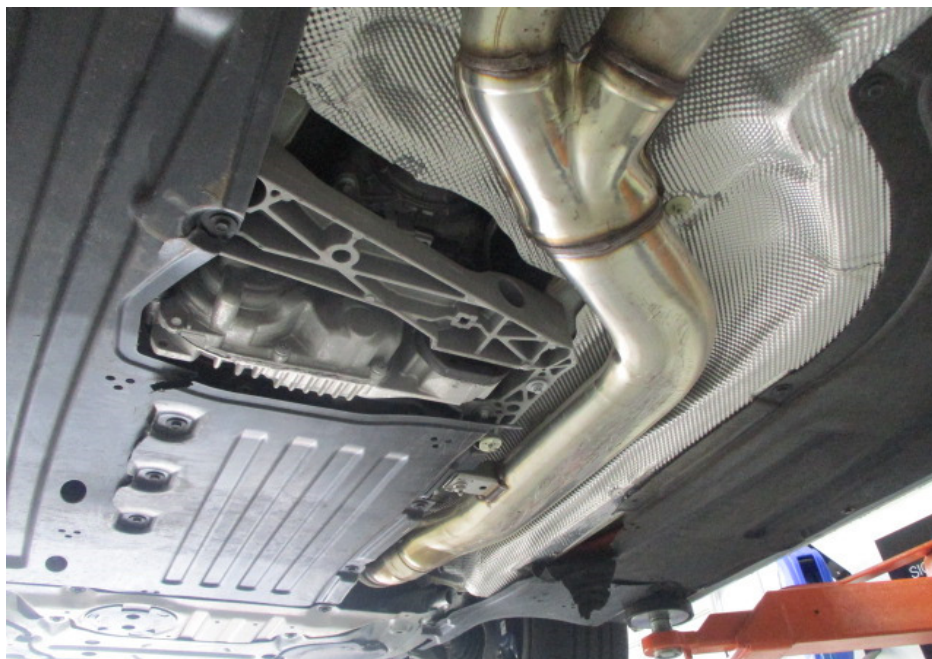
**Photo 25** shows the front section of the Motor Car's exhaust system. My examination of the Motor Car's exhaust system revealed no sign(s) or indication(s) of any cut or weld marks along its exhaust pipes, on its rear muffler and on its catalytic converter.

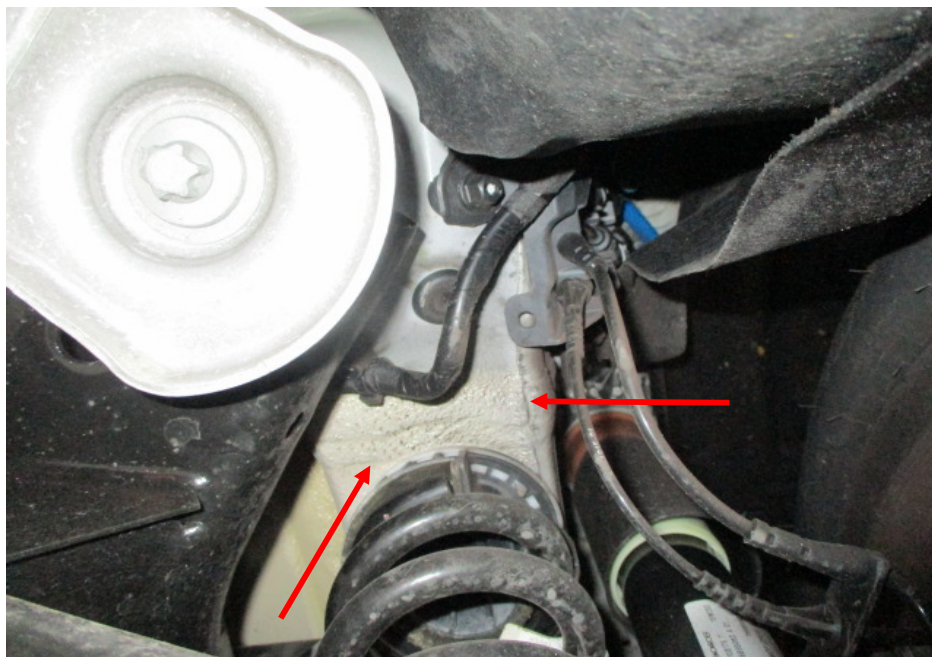
**Photo 26** shows the chassis/structural body at the underside rear right of the Motor Car. I did not find any weld marks other than original spot weld marks on the chassis/structural body of the Motor Car. The original factory sealant (arrowed) at the joints along the chassis/structural body was untouched, indicating no work was done on the chassis/structural body of the Motor Car and that the chassis/structural body was originally fitted.

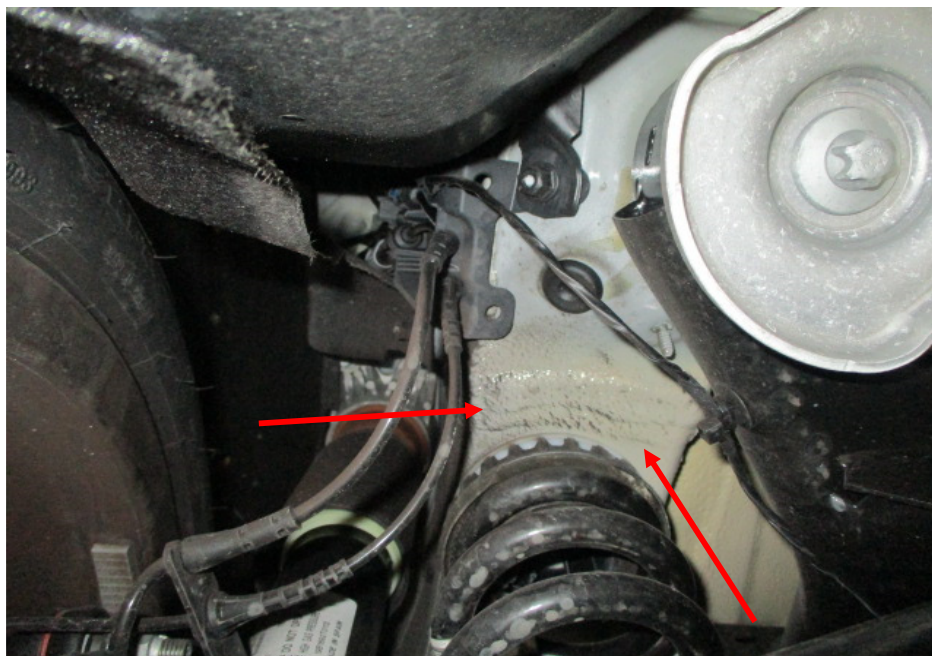
**Photo 27** shows the chassis/structural body at the underside rear left of the Motor Car. The original factory sealant (arrowed) at the joints along the chassis/structural body was observed to be untouched. In general, I had found no work was carried out on the chassis/structural body of the Motor Car. The chassis/structural body of the Motor Car was originally fitted.

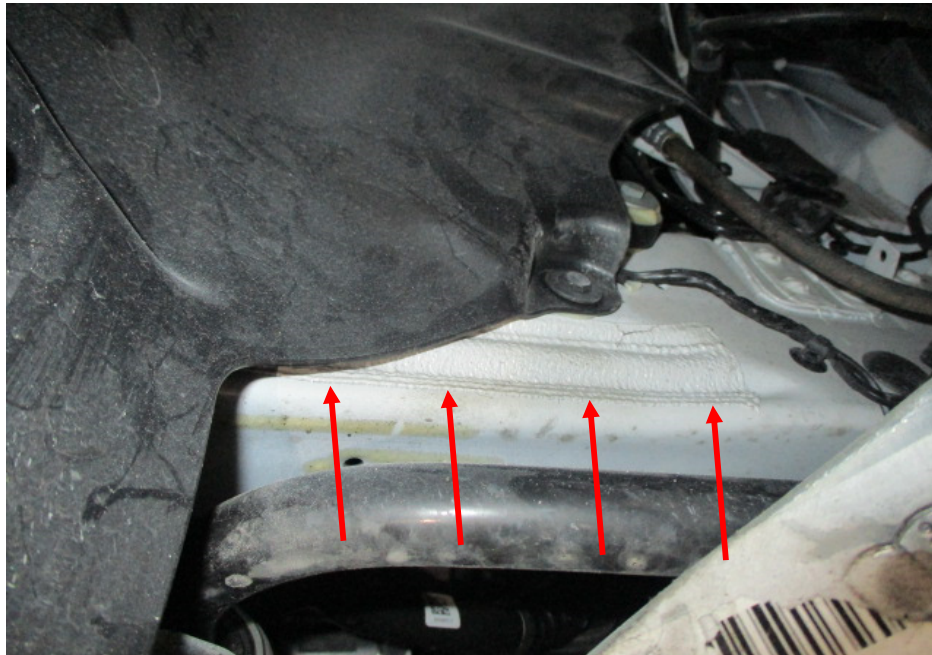
**Photo 28** shows the chassis/structural body at the underside front left of the Motor Car. I did not find any weld marks other than original spot weld marks on the chassis/structural body of the Motor Car. The original factory sealant (arrowed) at the joints along the chassis/structural body was untouched, indicating no work was done on the chassis/structural body of the Motor Car and that the chassis/structural body was originally fitted.

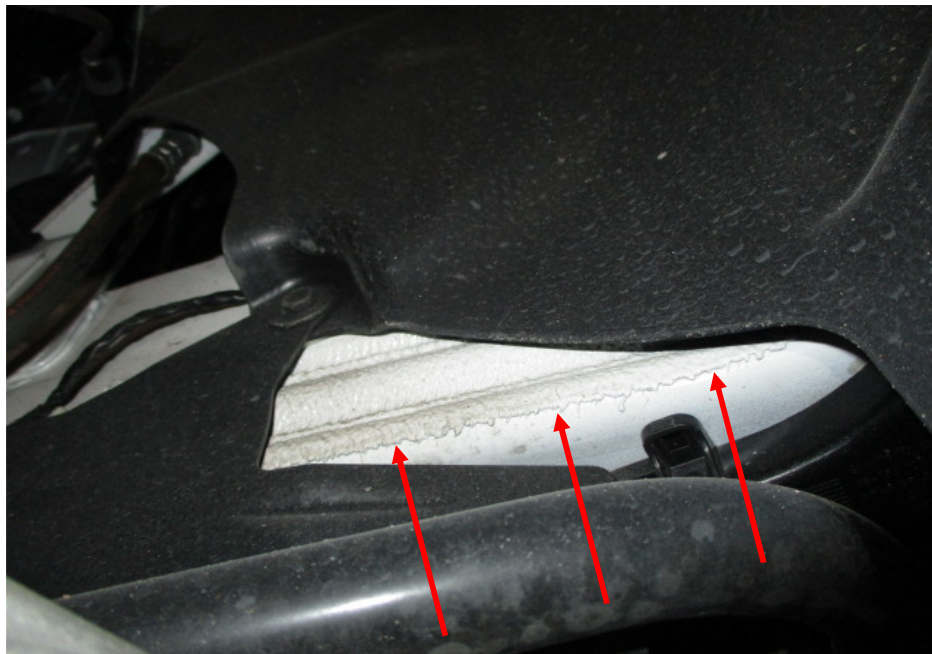
**Photo 29** shows the chassis/structural body at the underside front right of the Motor Car. The original factory sealant (arrowed) at the joints along the chassis/structural body was observed to be untouched. In general, I had found no work was carried out on the chassis/structural body of the Motor Car. The chassis/structural body of the Motor Car was originally fitted.

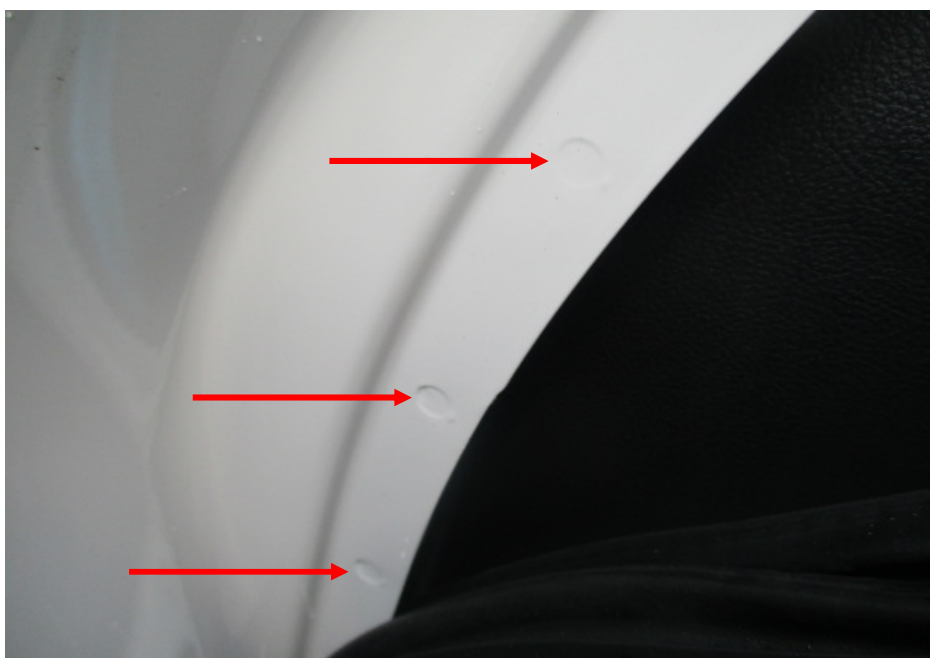
**Photo 30** shows the left side "A" pillar of the Motor Car. I did not find any weld marks other than original spot weld marks (arrowed) on the left side "A" pillar of the Motor Car which, indicates that there was no re-welding works carried out. In general, I had found all the non-detachable body panels of the Motor Car to be originally fitted at the time of my inspection.
