Your Ref: BMW 340i  
(chassis number WBA5U92040FH38098)  
Our Ref : CI/TP21011316/D

**INSPECTION REPORT OF AN UNREGISTERED BMW 340i MOTOR CAR  
WITH CHASSIS NUMBER WBA5U92040FH38098**

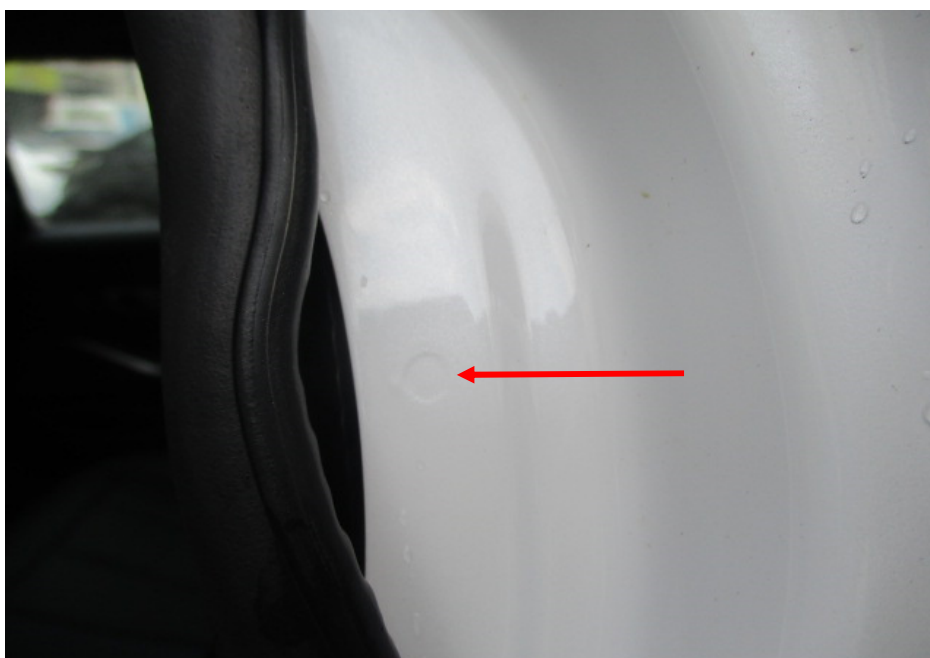
**Photo 31** shows the left side "C" pillar of the Motor Car. I did not find any weld marks other than original spot weld marks (arrowed) on the left side "C" pillar of the Motor Car which, indicates that there was no re-welding works carried out. In general, I had found all the non-detachable body panels of the Motor Car to be originally fitted at the time of my inspection.

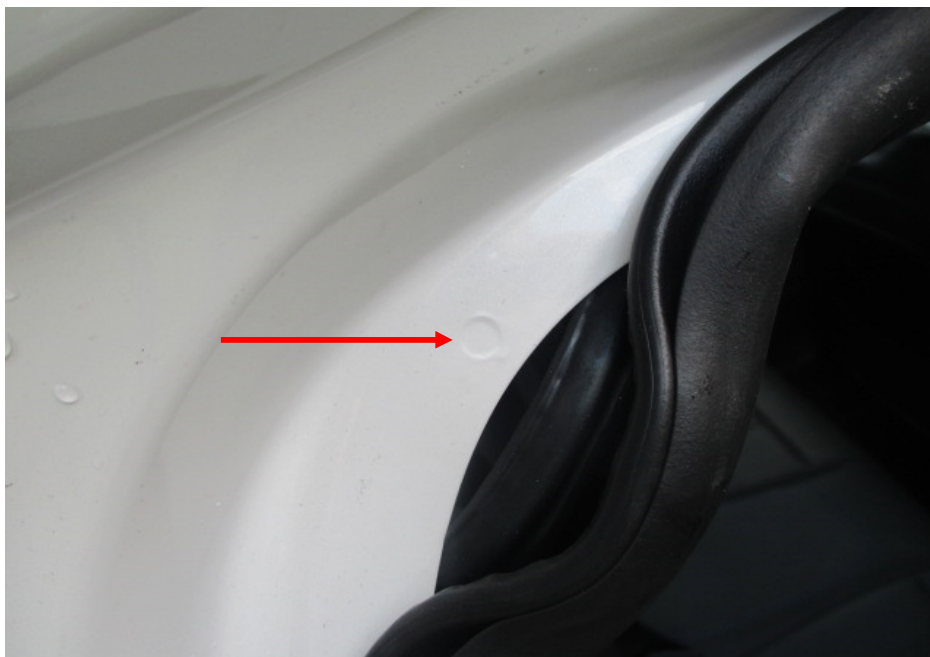
**Photo 32** shows the right side "C" pillar of the Motor Car. I did not find any weld marks other than original spot weld marks (arrowed) on the right side "C" pillar of the Motor Car which, indicates that there was no re-welding works carried out. In general, I had found all the non-detachable body panels of the Motor Car to be originally fitted at the time of my inspection.
