Your Ref: Mercedes GLA 250  
(chassis number WDC1569462J609587)  
Our Ref : CI/TP21011317/D

05 November 2021

**INSPECTION REPORT OF AN UNREGISTERED MERCEDES BENZ GLA 250  
MOTOR CAR WITH CHASSIS NUMBER WDC1569462J609587**

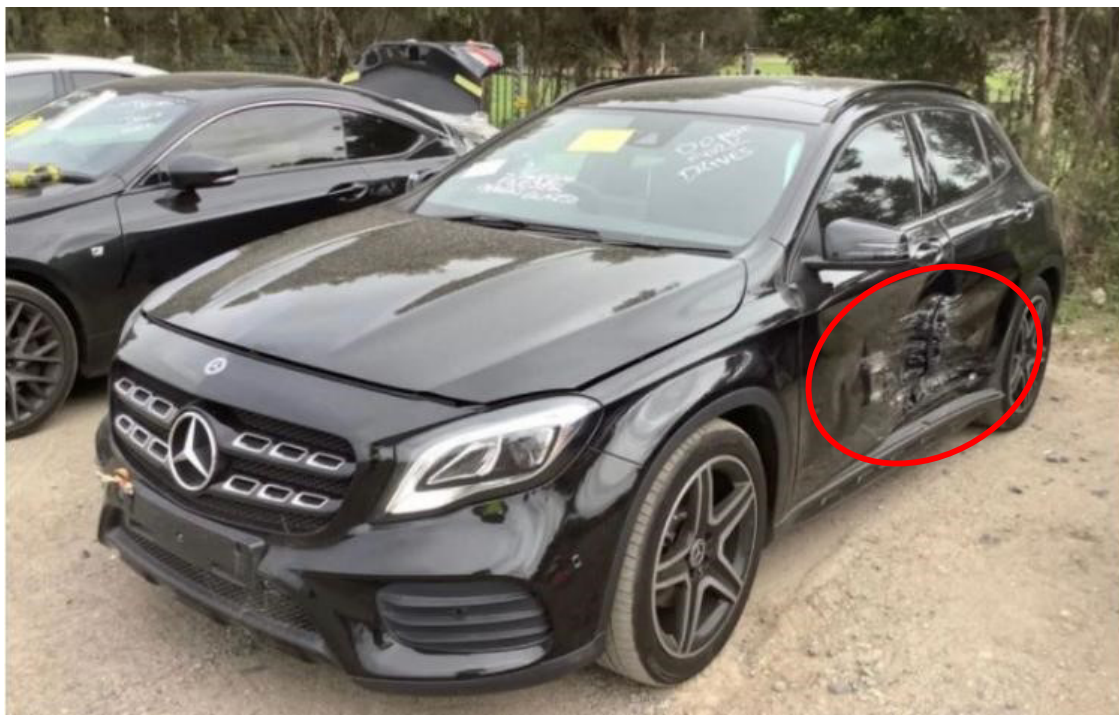
3. The photographs provided to me had showed damage to the left side centre portion of the Motor Car. The left front door, left rear door and left side rocker panel garnish amongst others were observed to have been damaged. The left side curtain airbag and rear left passenger seat airbag were deployed.
4. No physical damage was seen to other areas of the Motor Car apart for the left side centre portion. See photo 1 – 4 below.

**Photo 1** shows the front left body of the Motor Car (photograph provided to me). The Motor Car was observed to have sustained damage at its left side centre portion (circled). Body parts damaged include the left front door, left rear door and left side rocker panel garnish amongst others.

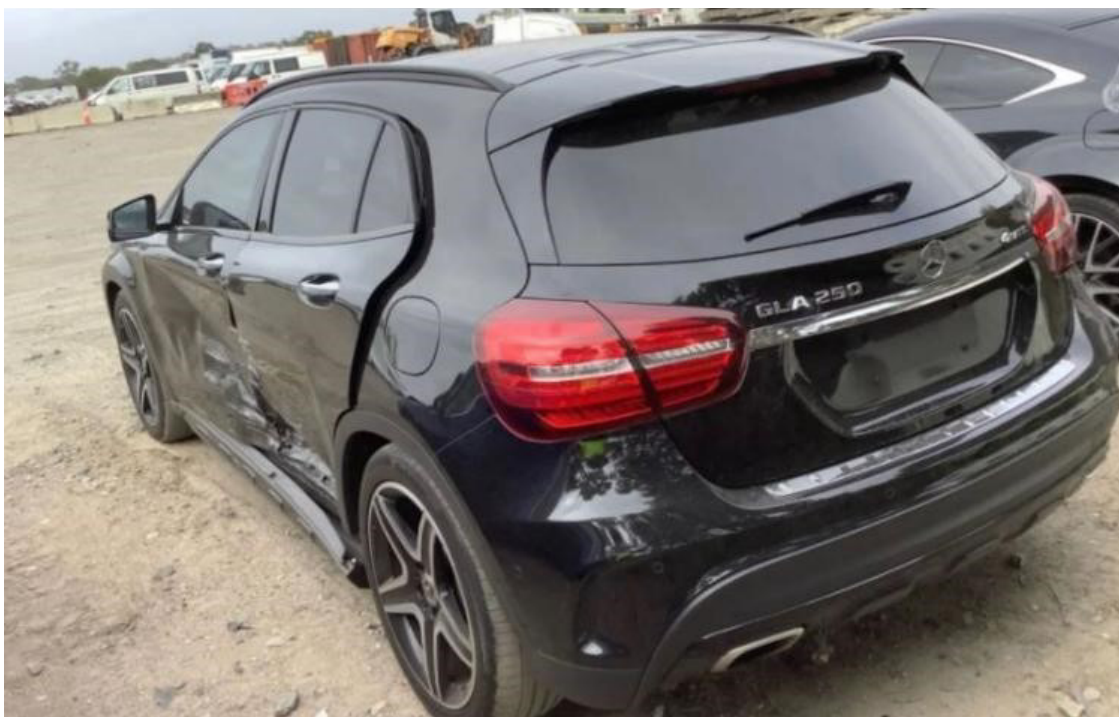
**Photo 2** shows the rear left body of the Motor Car (photograph provided to me). The Motor Car was observed to have sustained damage at its left side centre portion. Body parts damaged include the left front door, left rear door and left side rocker panel garnish amongst others.

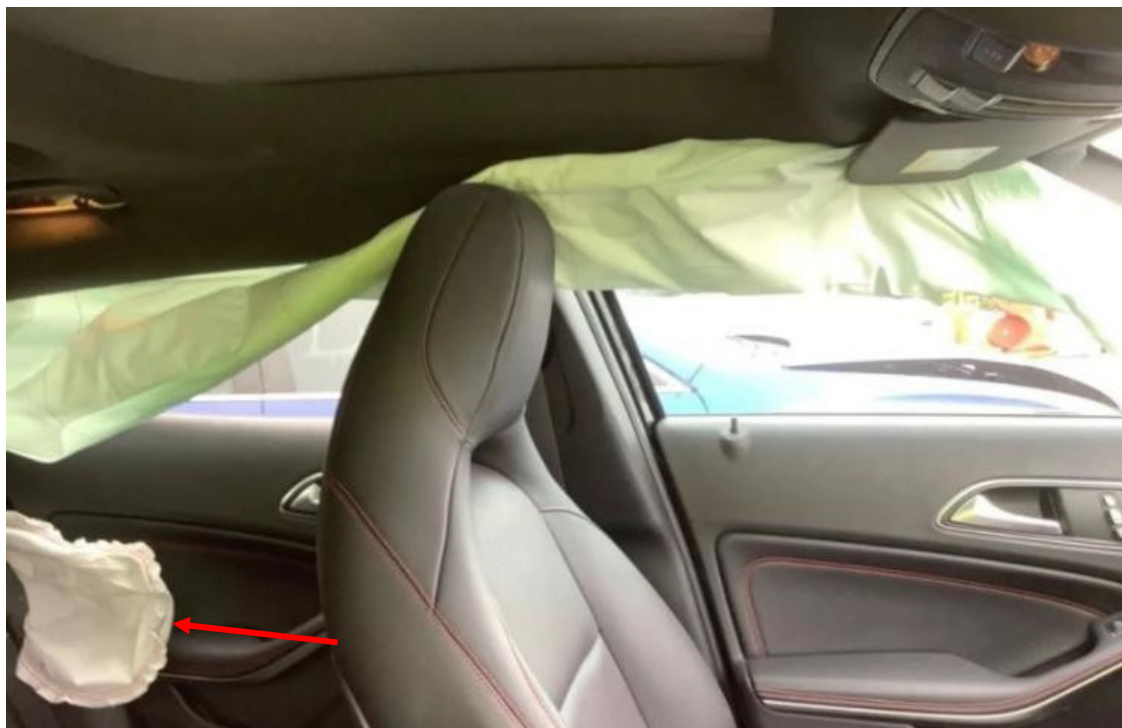
**Photo 3** shows the interior compartment of the Motor Car (photograph provided to me). The left side curtain airbag and rear left passenger seat airbag (arrowed) were deployed.

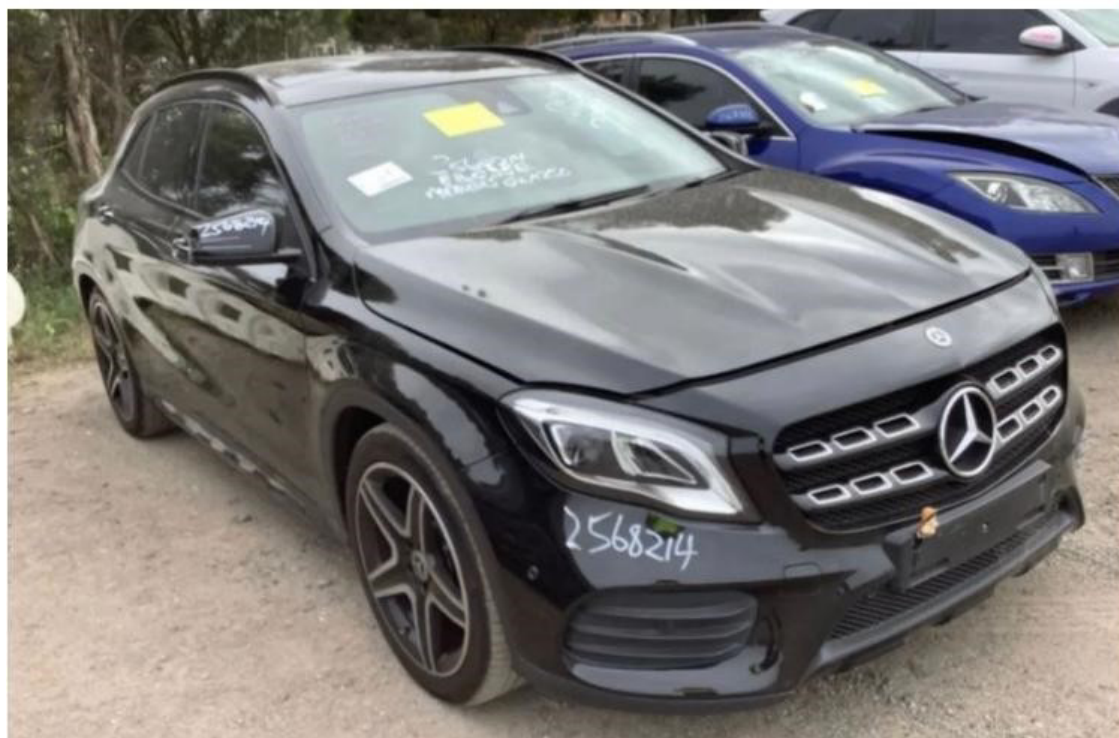
**Photo 4** shows the front right body of the Motor Car (photograph provided to me). Apart for the left side centre portion, there was no physical damage seen to other areas of the Motor Car.

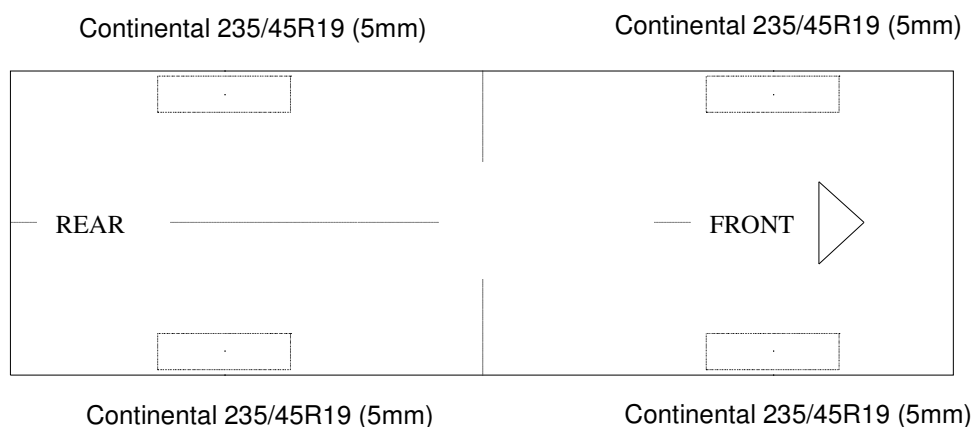
8. It was fitted with 19inch sport wheel rims that were wrapped with tyres that were observed to be of serviceable condition. The tyres were also sufficiently inflated for vehicular operation. The tyre brand, tyre size and approximate remaining tread depth of the 4 tyres of the Motor Car were recorded as follows: -

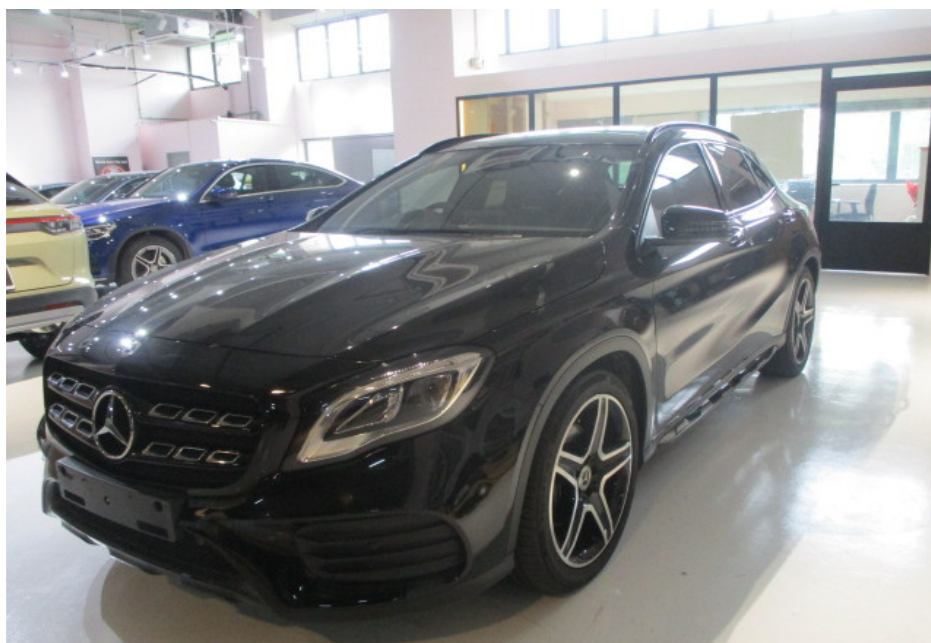
**Photo 5** shows a general view of the front left body of the Motor Car at the time of my inspection. The Motor Car was observed to be in a relatively good general condition with no loose exterior fittings observed. The body parts at the left side centre portion of the Motor Car were visually examined and it was observed that the repair/restoration works carried out to the damaged area of the Motor Car (refer to photograph 1 & 2 above) were reasonably adequate and in order.

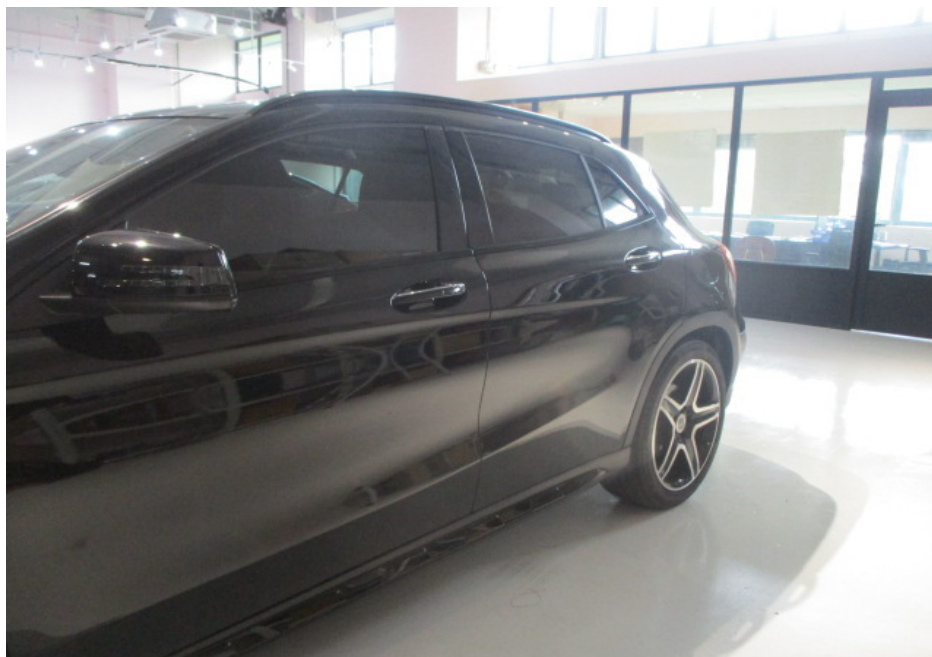
**Photo 6** shows a closer view of the Motor Car's left front door, left rear door and left side rocker panel garnish. The body parts at the left side centre portion of the Motor Car were visually examined and it was observed that the repair/restoration works carried out to the damaged area of the Motor Car (refer to photograph 1 & 2 above) were reasonably adequate and in order.

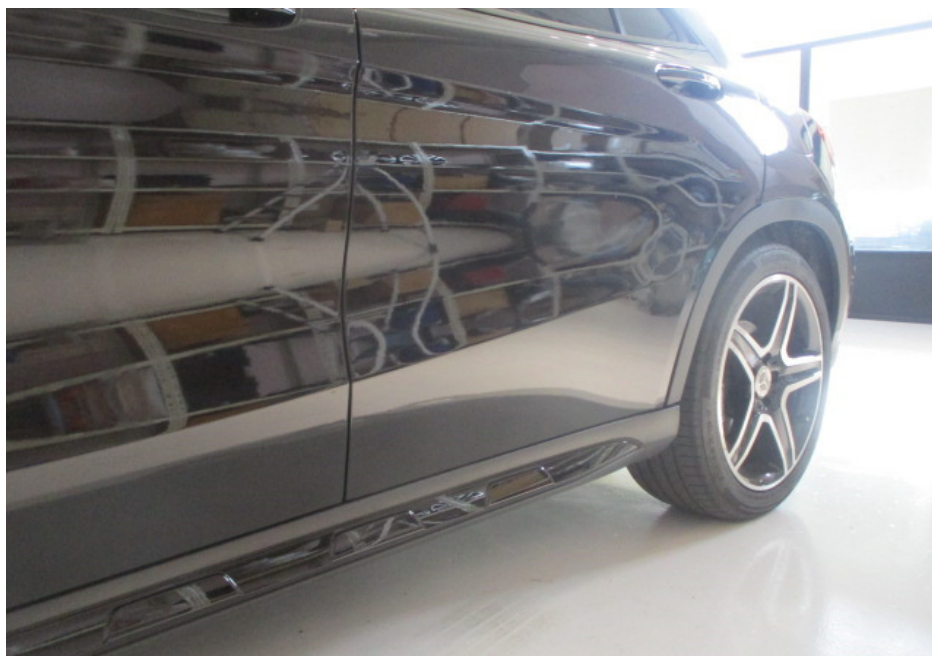
**Photo 7** shows another view of the Motor Car's left front door, left rear door and left side rocker panel garnish. The body parts at the left side centre portion of the Motor Car were visually examined and it was observed that the repair/restoration works carried out to the damaged area of the Motor Car (refer to photograph 1 & 2 above) were reasonably adequate and in order.

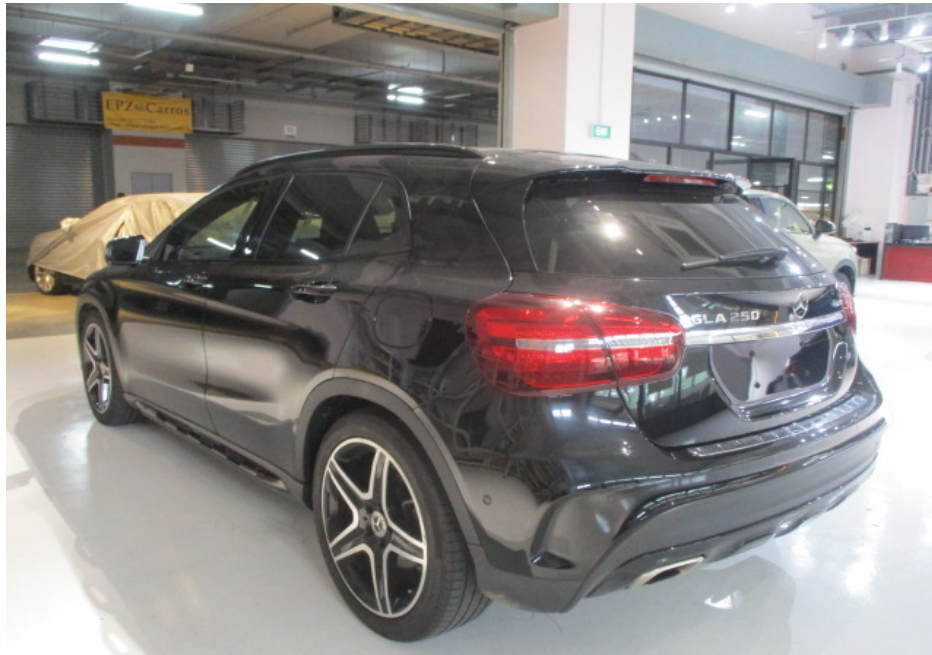
**Photo 8** shows a general view of the rear left body of the Motor Car at the time of my inspection. The Motor Car was observed to be in a relatively good general condition with no loose exterior fittings observed. The mileage of the Motor Car recorded at the time of my inspection was 33,465km.

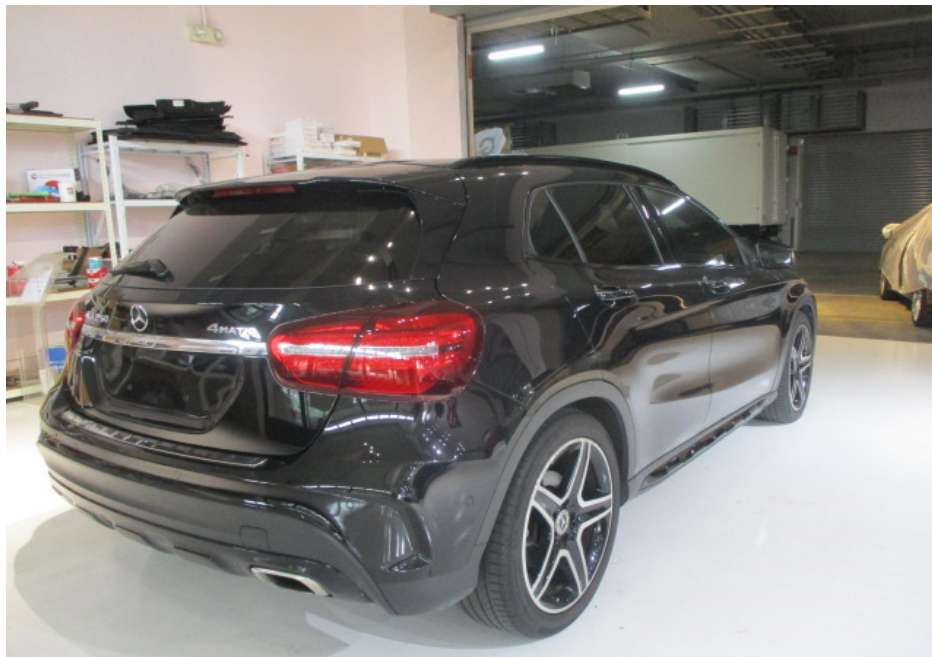
**Photo 9** shows a general view of the rear right body of the Motor Car at the time of my inspection. The Motor Car was observed to be in a relatively good general condition with no loose exterior fittings observed. The mileage of the Motor Car recorded at the time of my inspection was 33,465km.

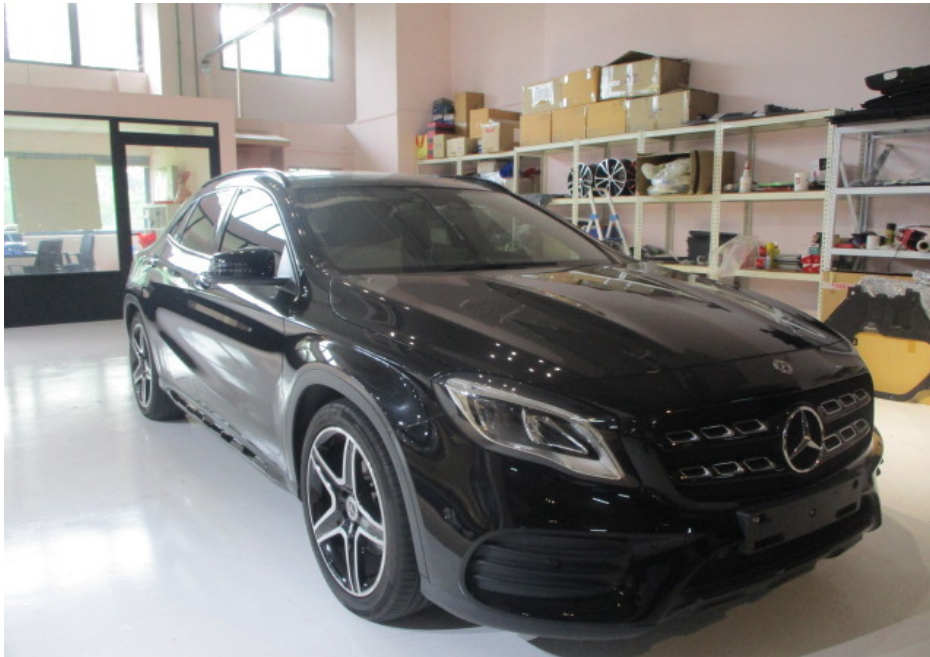
**Photo 10** shows a general view of the front right body of the Motor Car at the time of my inspection. The Motor Car was observed to be in a relatively good general condition with no loose exterior fittings observed. The mileage of the Motor Car recorded at the time of my inspection was 33,465km.

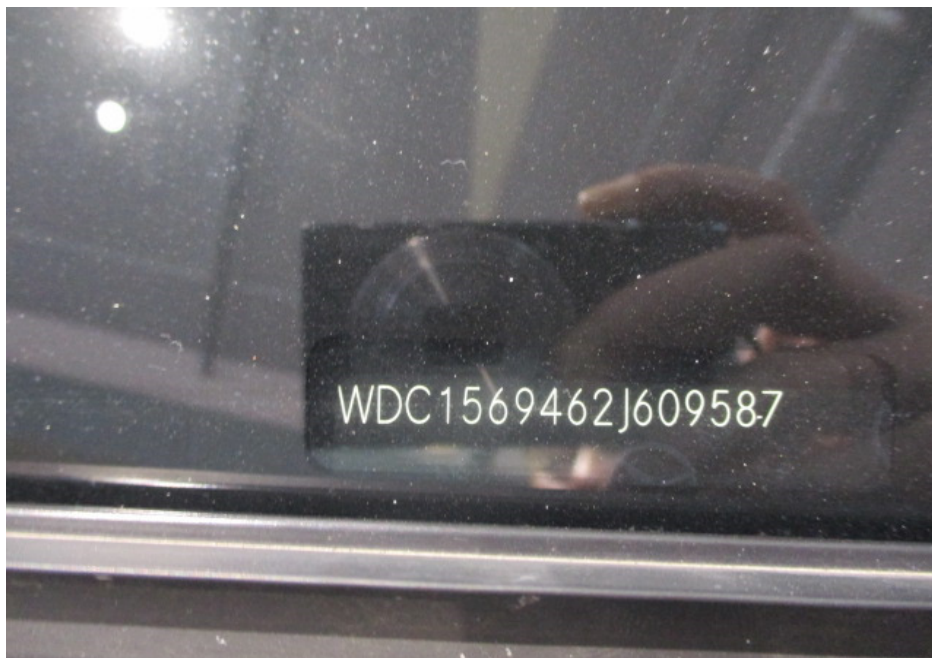
**Photo 11** shows the chassis number of the Motor Car. The chassis number recorded was WDC1569462J609587.

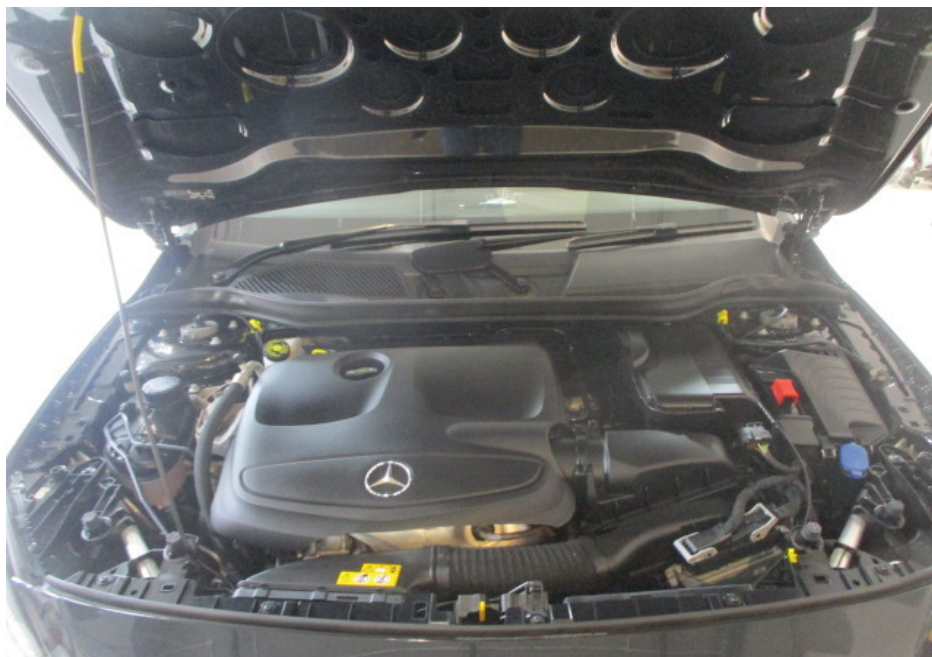
**Photo 12** shows a general view of the engine compartment of the Motor Car at the time of my inspection. The various parts and components inside the engine compartment were all observed to be intact and properly fitted. There was also no sign(s) or indication(s) of fluid leak and/or fluid stain found inside the engine compartment.

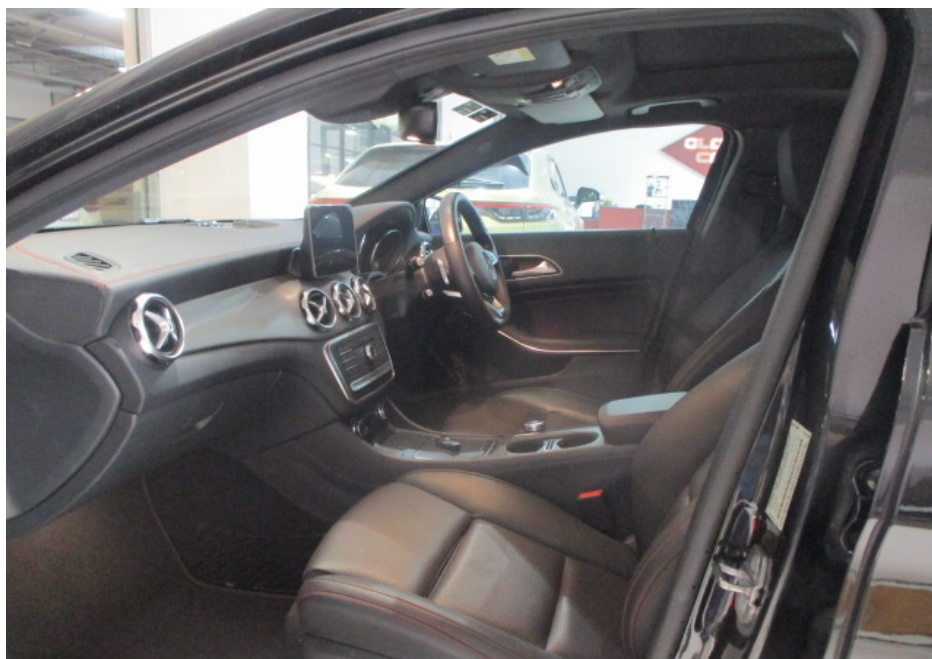
**Photo 13** shows the interior compartment of the Motor Car at the time of my inspection. The various parts and components, trims, carpet and upholstery inside the interior compartment were all observed to be intact and properly fitted.

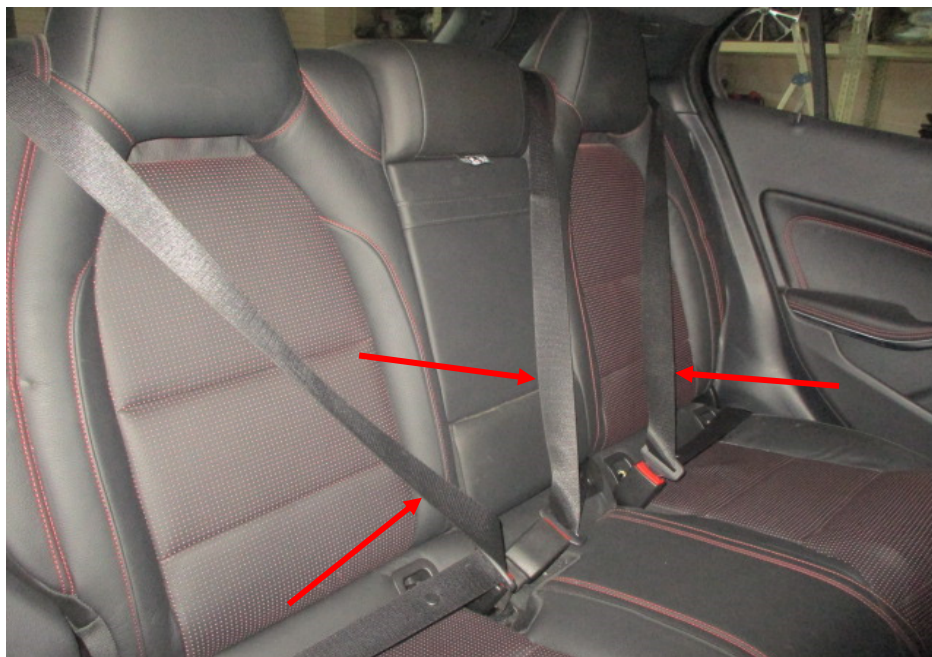
**Photo 14** shows the rear seats of the Motor Car. All the seats of the Motor Car were secured via seat rails to the floorboard. They were also fitted with a retractable seat belt reel and a pre-tensioner. The seat belts (arrowed) were tested and were able to be fastened into the respective pre-tensions that were fitted on the side of each individual seat.

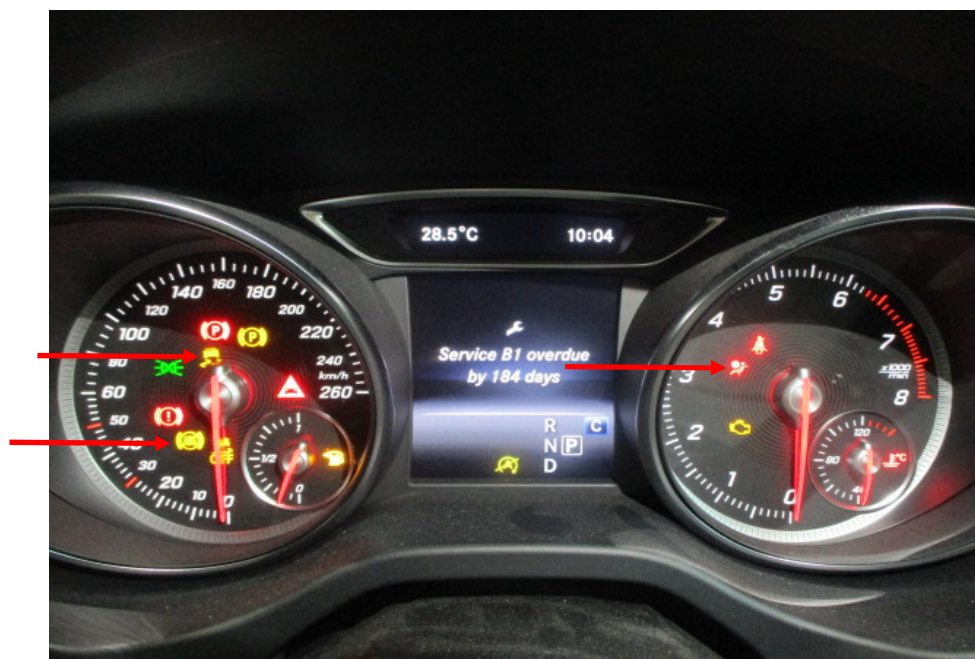
**Photo 15** shows the warning lights for the various electronic safety features appearing on the instrument panel of the Motor Car during its self-test when the engine is cranked, in particular the ABS, SRS and TCS lights (arrowed).

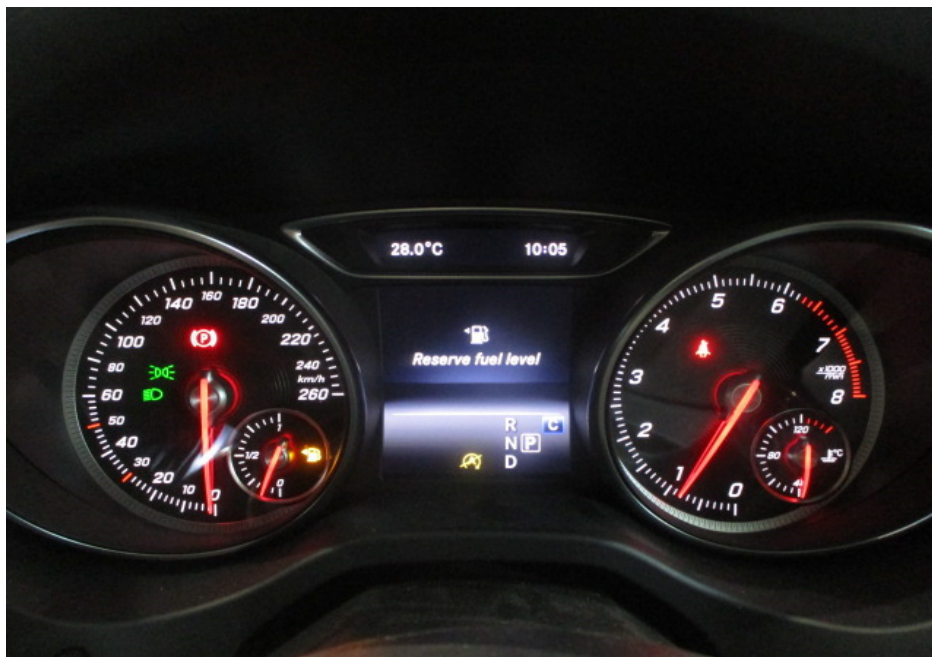
**Photo 16** shows the respective warning lights no longer illuminated, indicating that there is no fault detected to the ABS, SRS and TCS systems of the Motor Car during the self-test. These electronic systems were hence in working condition at the time of my inspection.

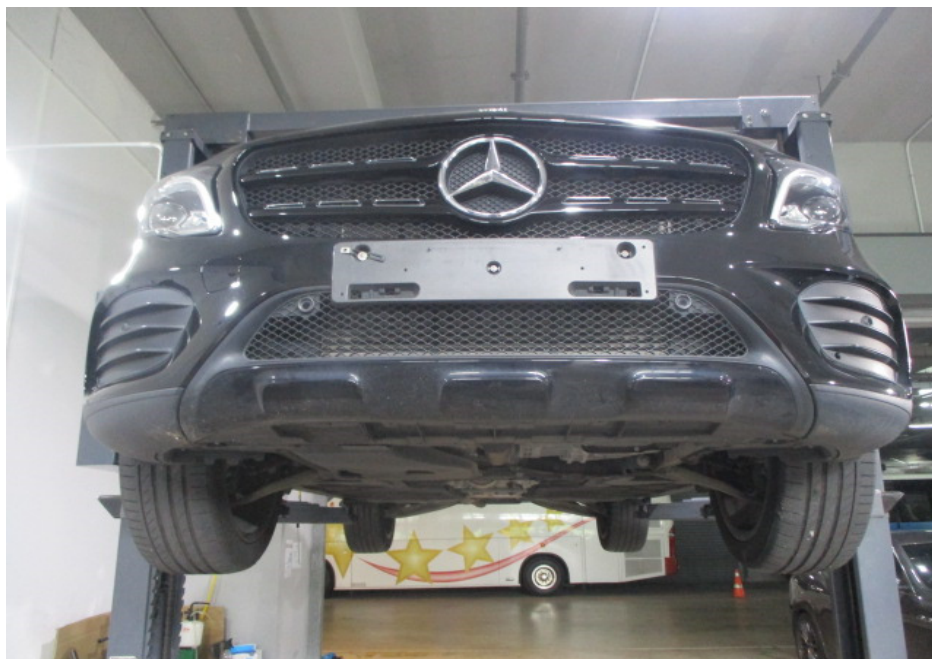
**Photo 17** shows the Motor Car hoisted up for checks on its undercarriage. There was no sign(s) or indication(s) of fluid leakage and/or fluid stain(s) on the underside of the Motor Car. The undercarriage components of the Motor Car were also all observed to be intact and secured in an appropriate manner.

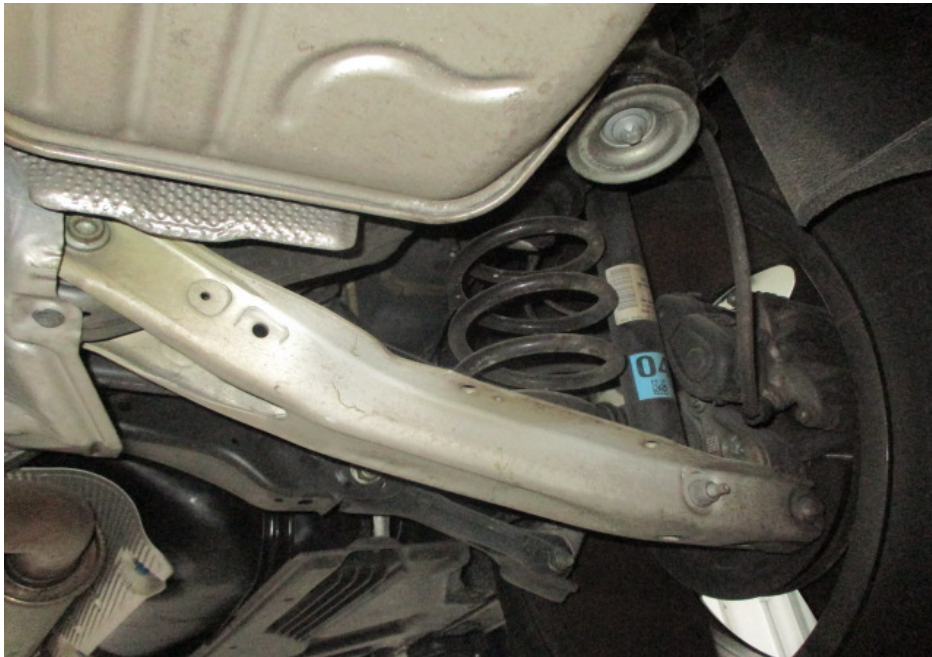
**Photo 18** shows a general view of the control arms and linkages at the rear right wheel of the Motor Car. I did not observe any fluid leak and/or fluid stain on the underside of the Motor Car. All the Motor Car's undercarriage components were observed to be intact and secured in an appropriate manner.

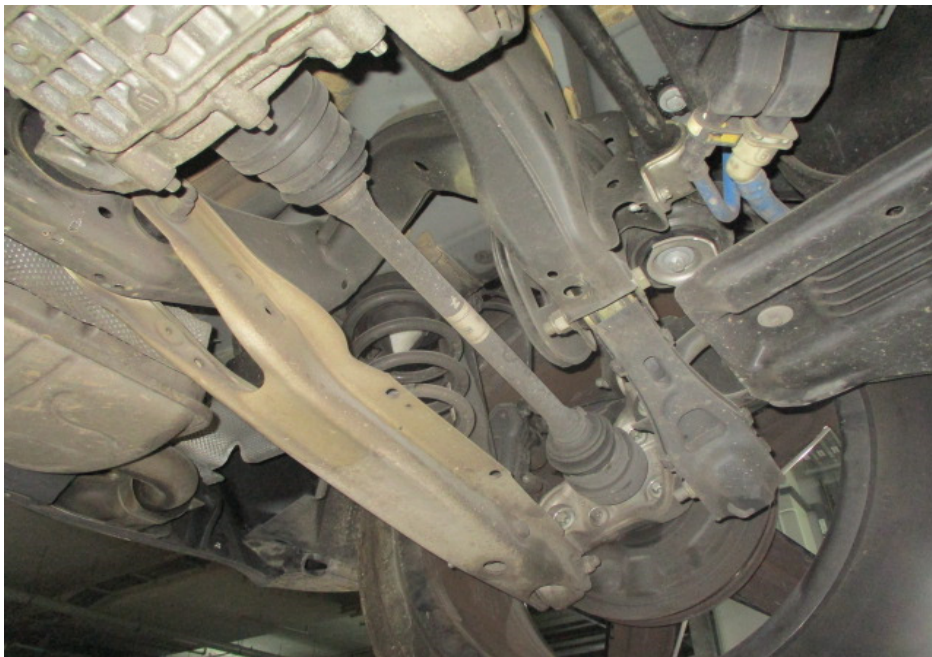
**Photo 19** shows a general view of the control arms and linkages at the rear left wheel of the Motor Car. I did not observe any fluid leak and/or fluid stain on the underside of the Motor Car. All the Motor Car's undercarriage components were observed to be intact and secured in an appropriate manner.

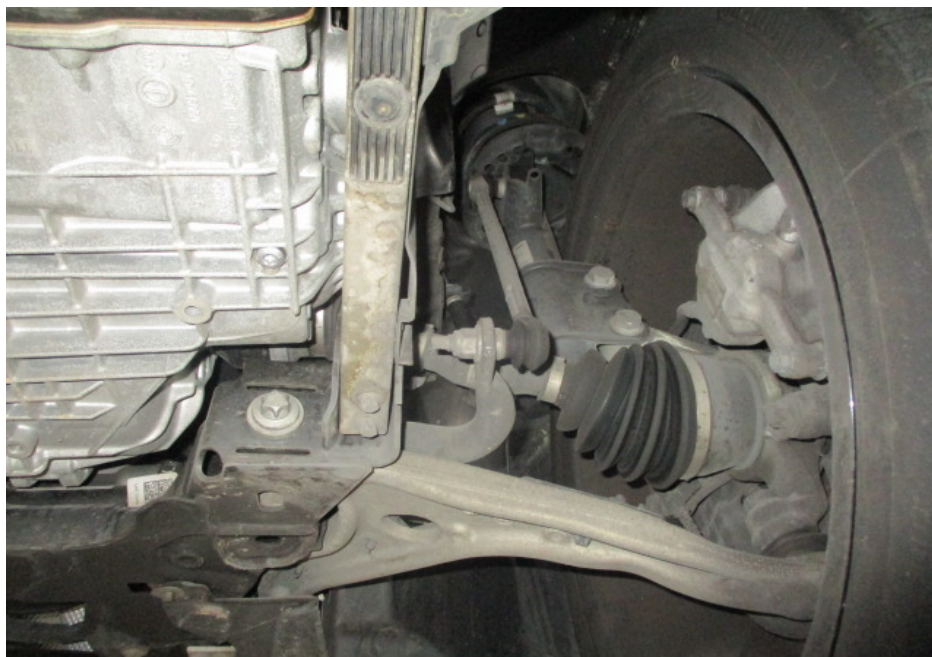
**Photo 20** shows the various undercarriage components at the front left wheel of the Motor Car. I did not observe any fluid leak and/or fluid stain on the underside of the Motor Car. All the Motor Car's undercarriage components were observed to be intact and secured in an appropriate manner.

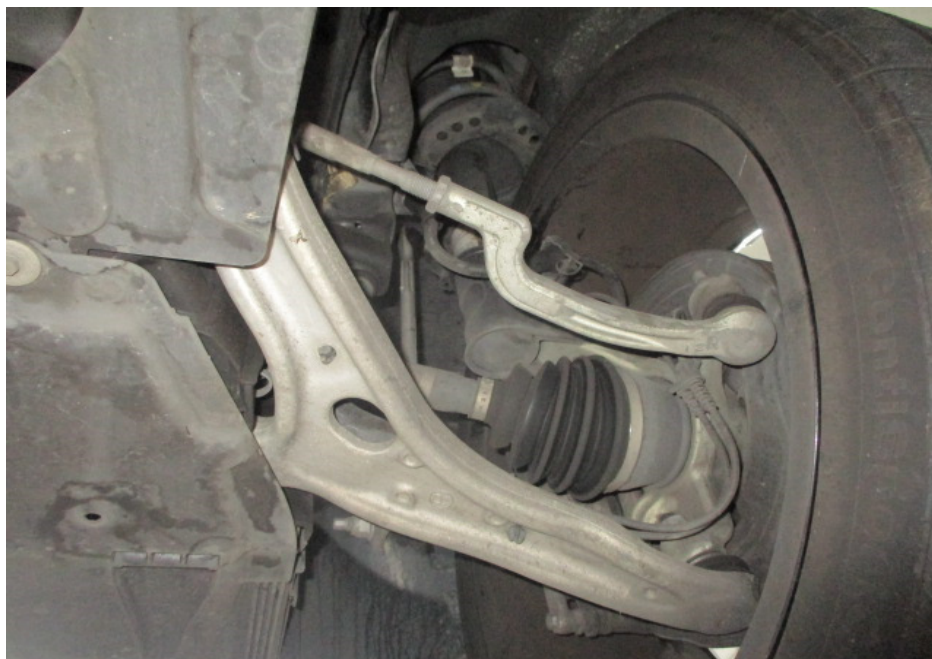
**Photo 21** shows the various undercarriage components at the front right wheel of the Motor Car. The mechanical components, control arms and linkages were all found to be intact and secured in an appropriate manner. I also did not observe any fluid leak and/or fluid stain on the underside of the Motor Car.

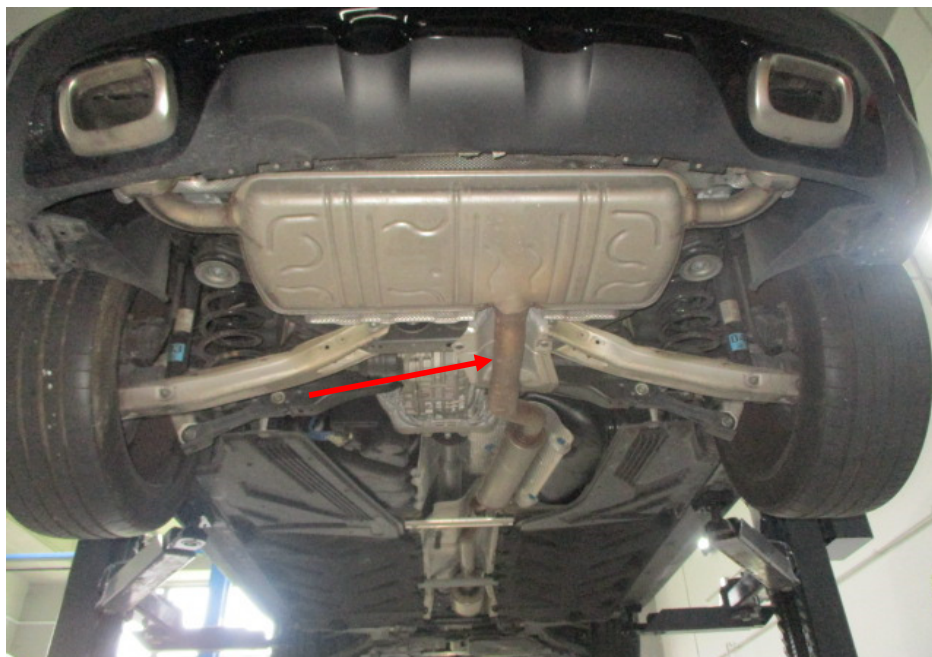
**Photo 22** shows the rear section of the Motor Car's exhaust system. My examination of the Motor Car's exhaust system revealed no sign(s) or indication(s) of any cut or weld marks along its exhaust pipes (arrowed), on its centre resonator boxes, on its rear muffler and on its catalytic converter.

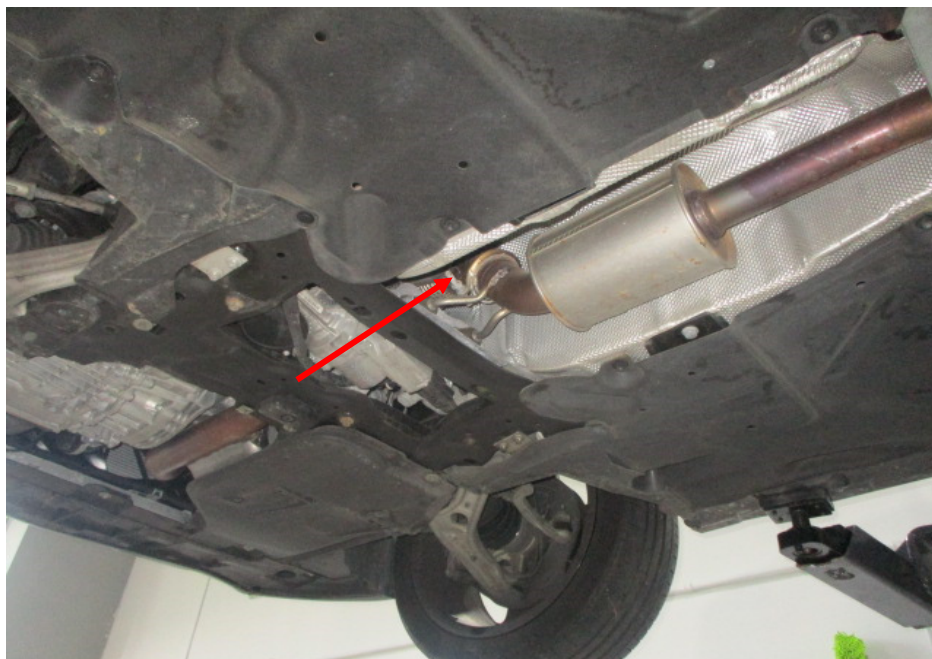
**Photo 23** shows the front section of the Motor Car's exhaust system. My examination of the Motor Car's exhaust system revealed no sign(s) or indication(s) of any cut or weld marks along its exhaust pipes, on its centre resonator boxes, on its rear muffler and on its catalytic converter (arrowed).

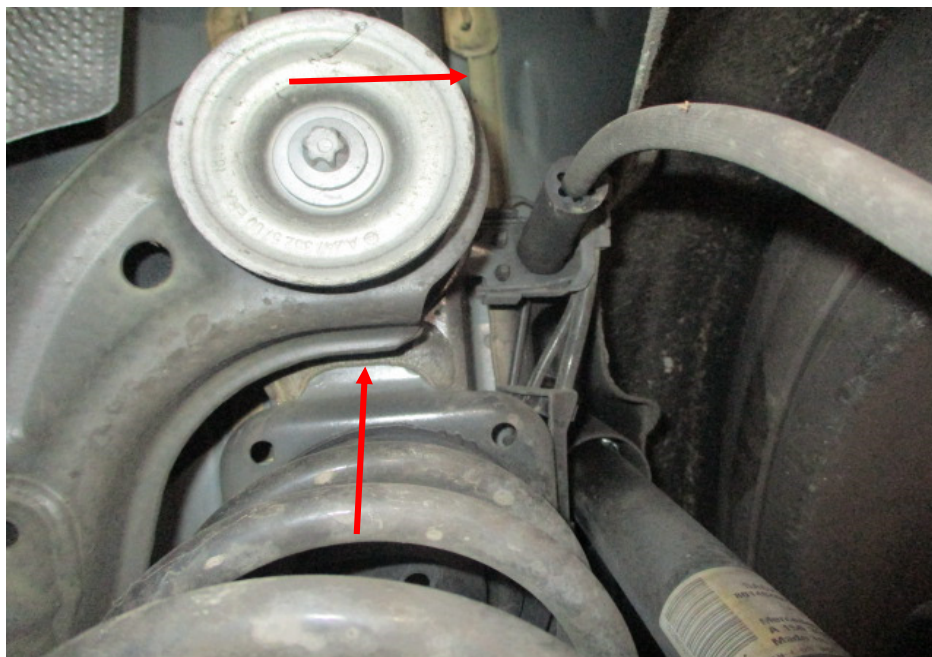
**Photo 24** shows the chassis/structural body at the underside rear right of the Motor Car. I did not find any weld marks other than original spot weld marks on the chassis/structural body of the Motor Car. The original factory sealant (arrowed) at the joints along the chassis/structural body was untouched, indicating no work was done on the chassis/structural body of the Motor Car and that the chassis/structural body was originally fitted.

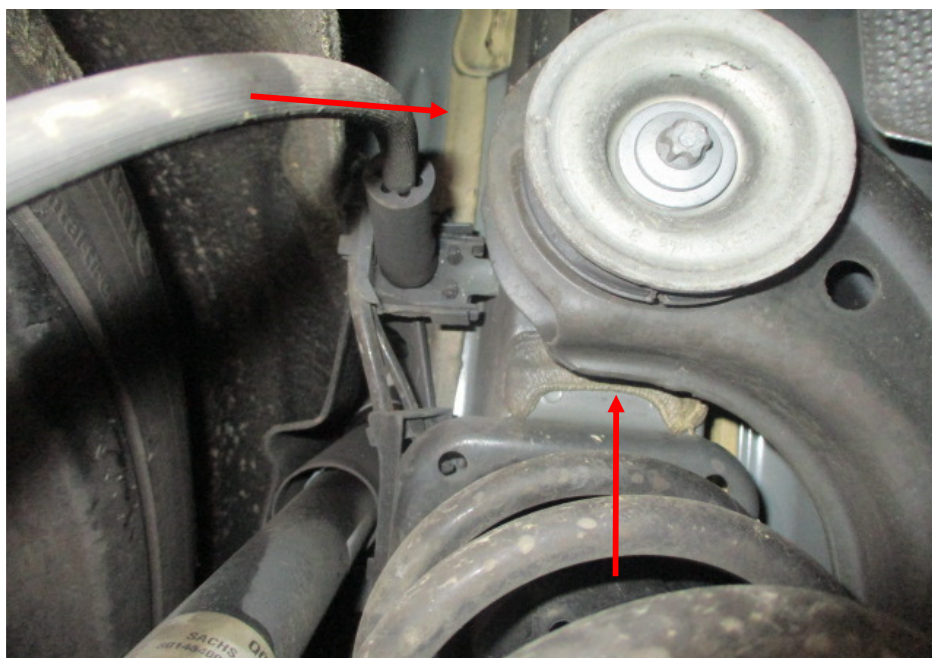
**Photo 25** shows the chassis/structural body at the underside rear left of the Motor Car. The original factory sealant (arrowed) at the joints along the chassis/structural body was observed to be untouched. In general, I had found no work was carried out on the chassis/structural body of the Motor Car. The chassis/structural body of the Motor Car was originally fitted.

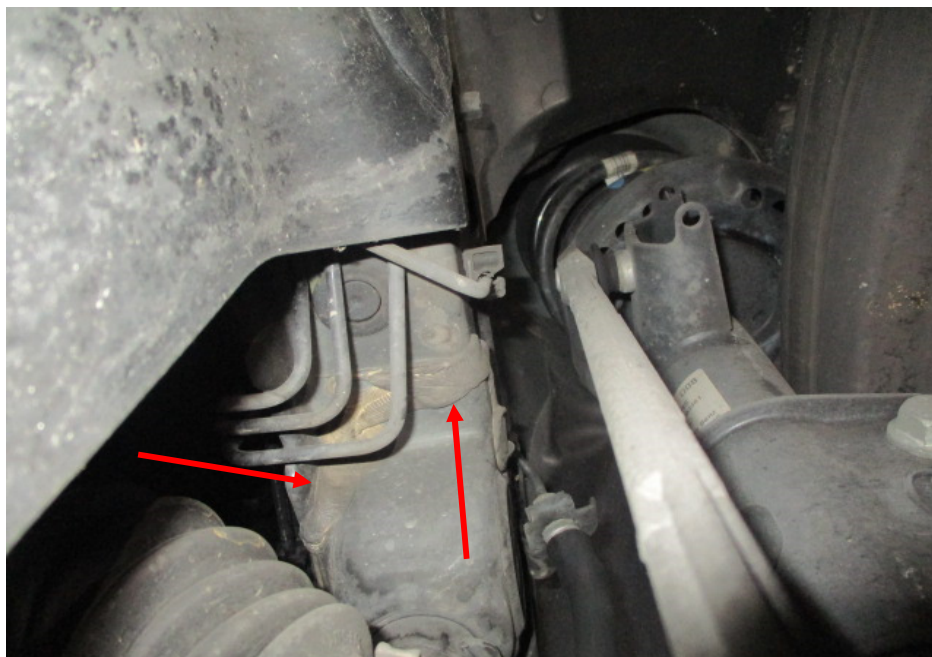
**Photo 26** shows the chassis/structural body at the underside front left of the Motor Car. I did not find any weld marks other than original spot weld marks on the chassis/structural body of the Motor Car. The original factory sealant (arrowed) at the joints along the chassis/structural body was untouched, indicating no work was done on the chassis/structural body of the Motor Car and that the chassis/structural body was originally fitted.

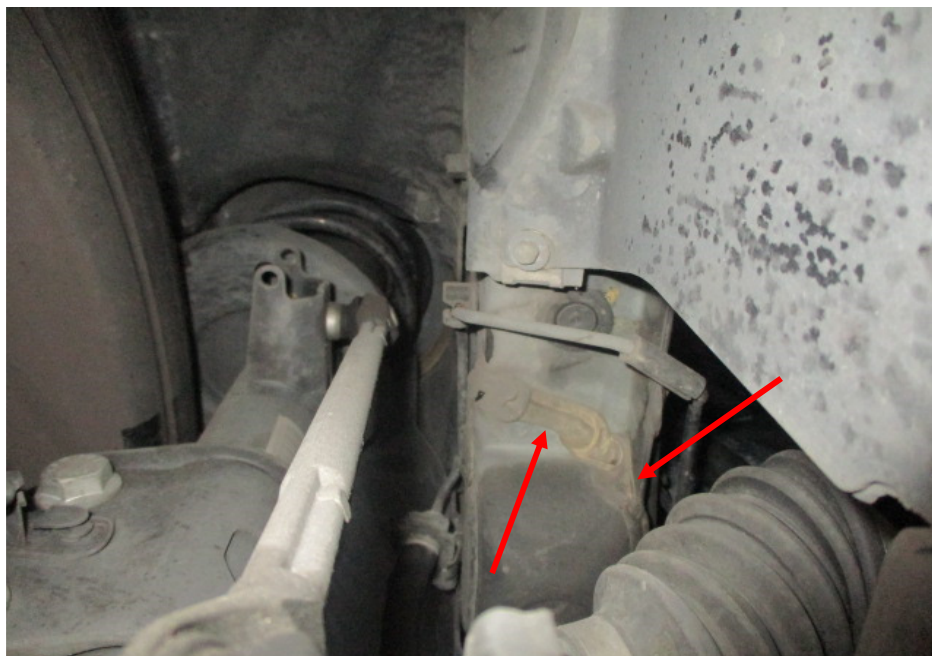
**Photo 27** shows the chassis/structural body at the underside front right of the Motor Car. The original factory sealant (arrowed) at the joints along the chassis/structural body was observed to be untouched. In general, I had found no work was carried out on the chassis/structural body of the Motor Car. The chassis/structural body of the Motor Car was originally fitted.

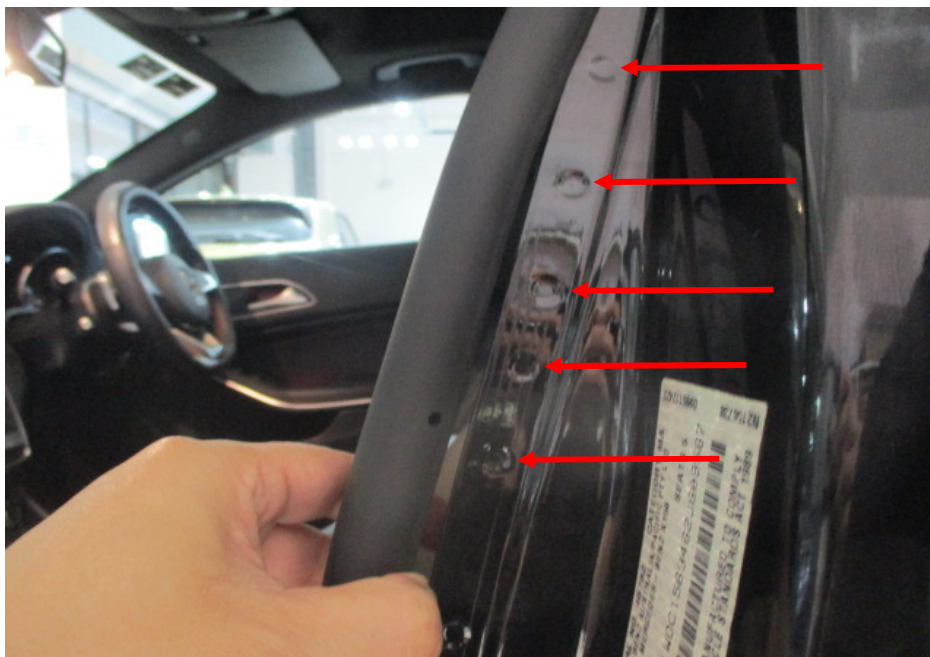
**Photo 28** shows the left side "B" pillar of the Motor Car. I did not find any weld marks other than original spot weld marks (arrowed) on the left side "B" pillar of the Motor Car which, indicates that there was no re-welding works carried out. In general, I had found all the non-detachable body panels of the Motor Car to be originally fitted at the time of my inspection.

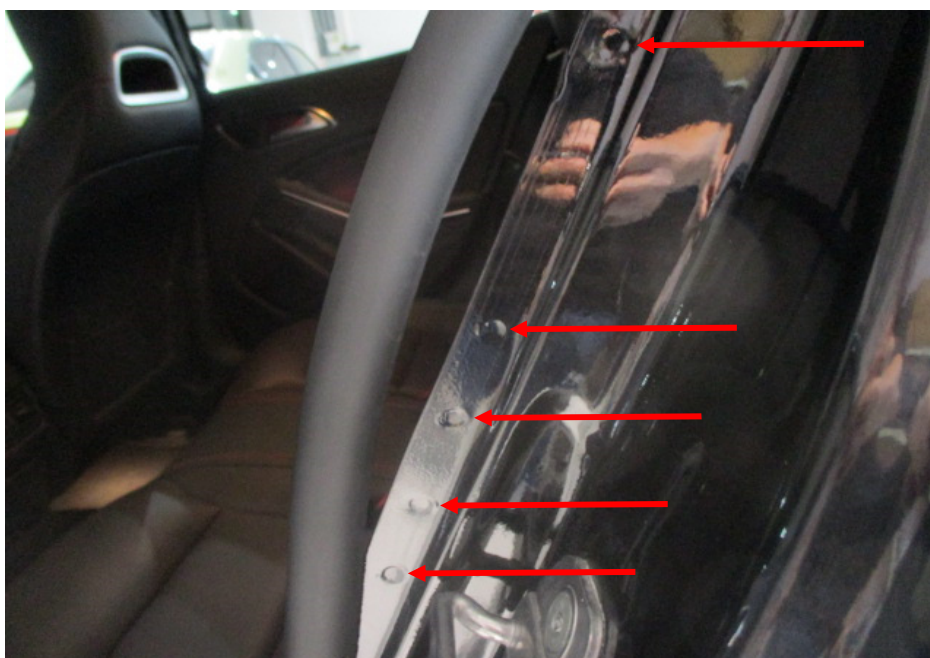
**Photo 29** shows the left side "C" pillar of the Motor Car. I did not find any weld marks other than original spot weld marks (arrowed) on the left side "C" pillar of the Motor Car which, indicates that there was no re-welding works carried out. In general, I had found all the non-detachable body panels of the Motor Car to be originally fitted at the time of my inspection.

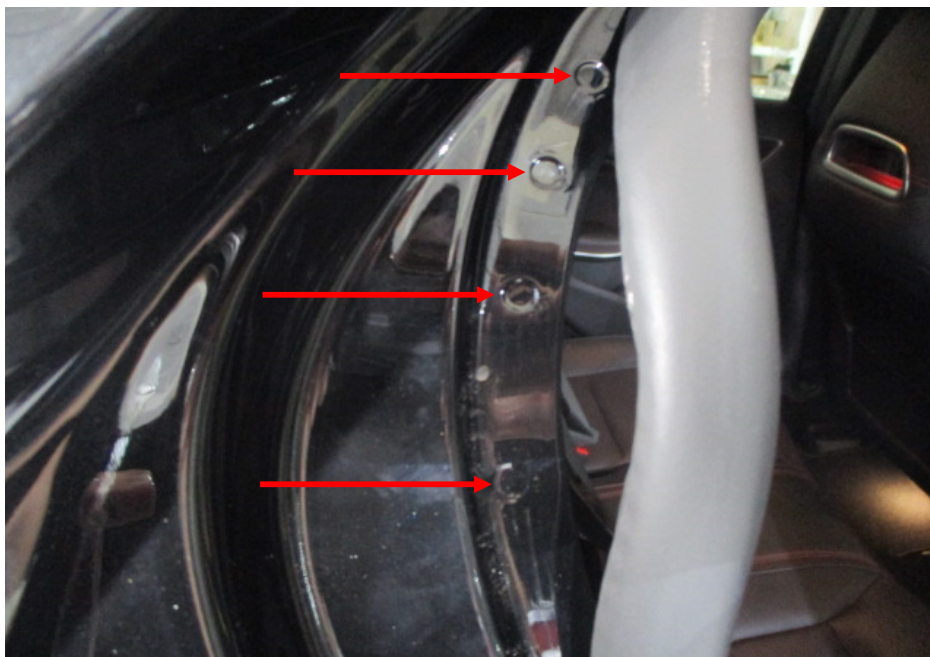
**Photo 30** shows the right side "C" pillar of the Motor Car. I did not find any weld marks other than original spot weld marks (arrowed) on the right side "C" pillar of the Motor Car which, indicates that there was no re-welding works carried out. In general, I had found all the non-detachable body panels of the Motor Car to be originally fitted at the time of my inspection.
