Your Ref: MTS2021D0004812
Our Ref : CI/III21011342/P

**TECHNICAL INVESTIGATION REPORT OF WARRANTY CLAIM INVOLVING
THE INSURED VEHICLE SKK 8524P ON 5th November 2021**

Vehicle Registration No.	: SKK 8524P
Make / Model	: MERCEDES BENZ CLA 200
Chassis No	: WDD1173432N023370
Year of Registration	: SEP 2013
Mileage	: 131,402KM

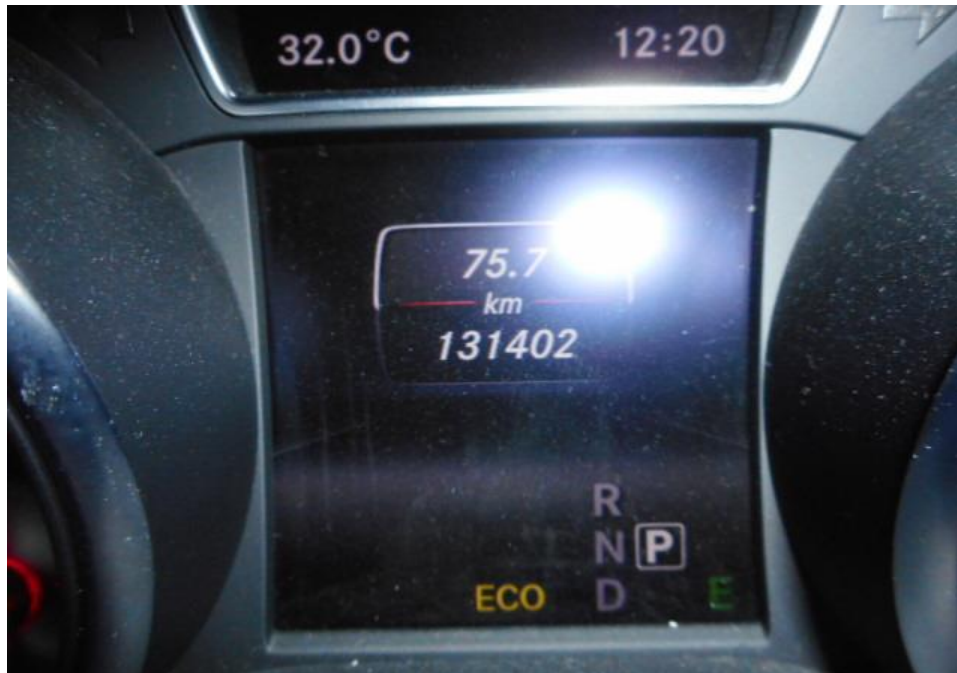
Photo 1 shows the mileage of the Insured Vehicle recorded at the time inspection at 131,402KM

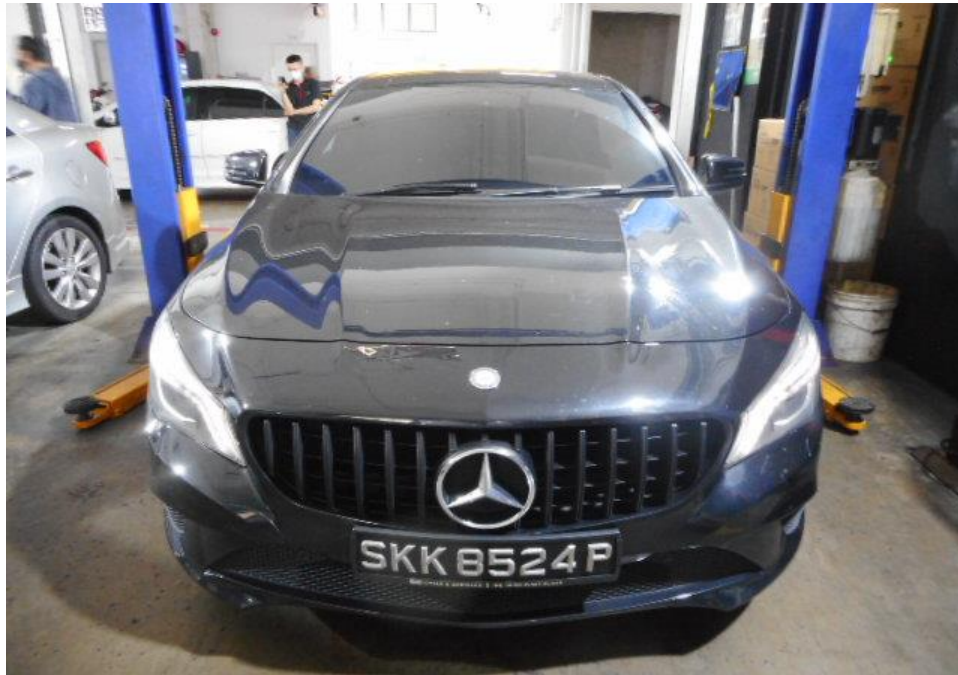
Photo 2 shows the general view of the front portion of the Insured Vehicle at the time of our inspection. The Insured Vehicle is observed to be unaffected by any signs of accident.

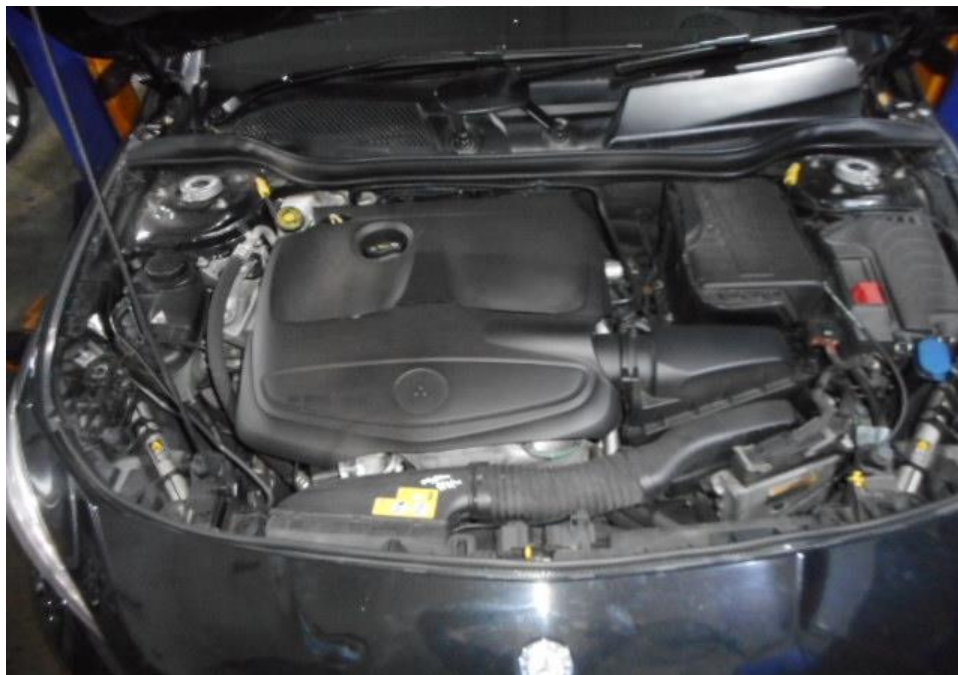
Photo 3 shows the general view of the engine portion of the Insured Vehicle at the time of our inspection. The engine compartment is observed to be unaffected by any signs of accident.

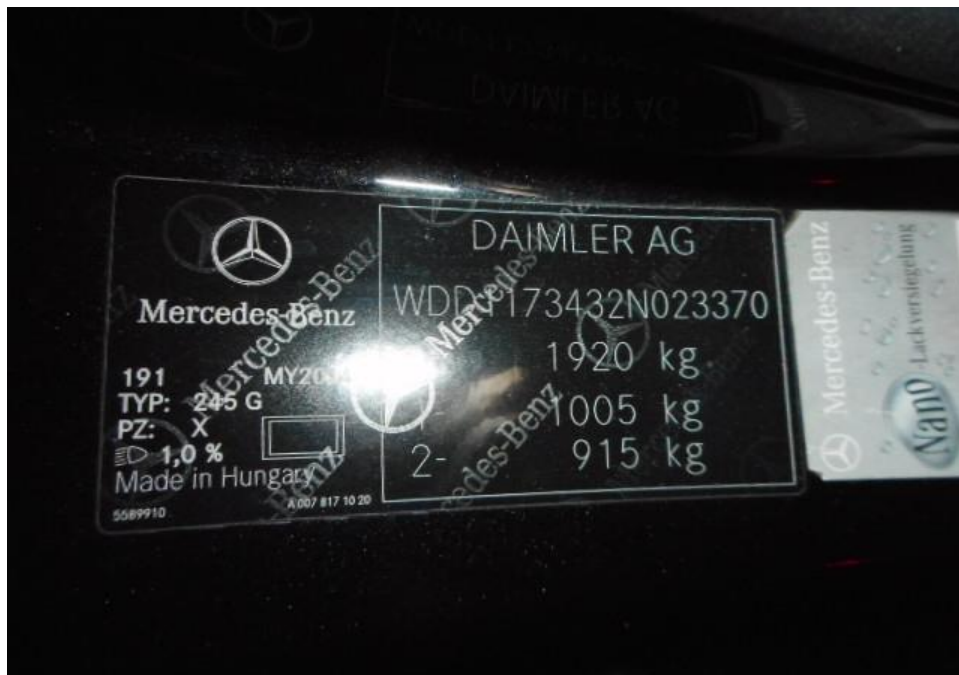
Photo 4 shows the chassis number of the Insured Vehicle at the time of our inspection.

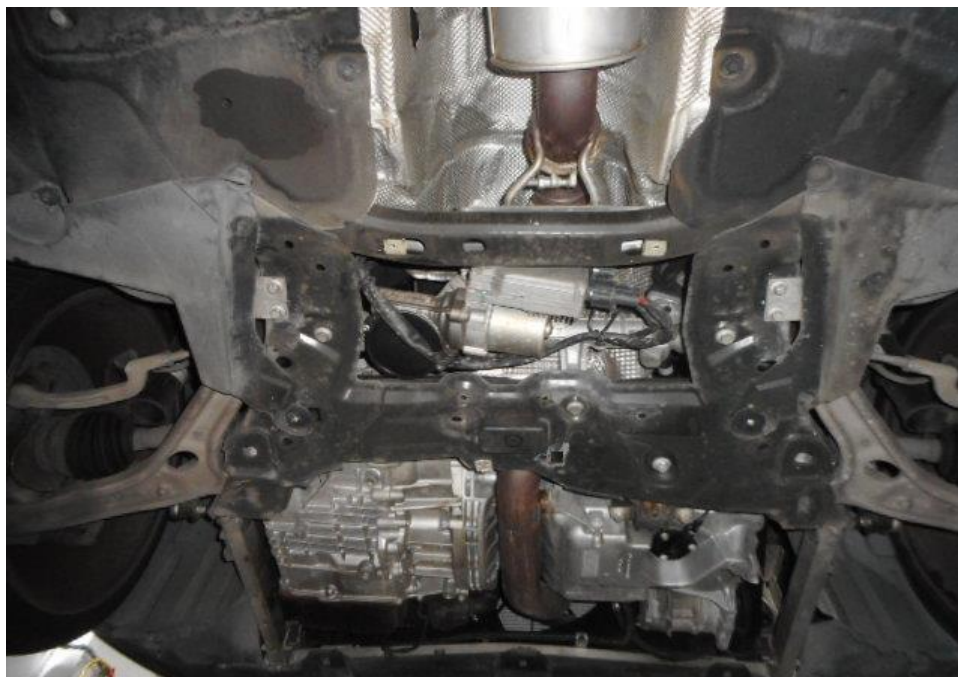
Photo 5 shows the general view of the engine underside portion of the Insured Vehicle at the time of our inspection. The engine underside compartment is observed to be unaffected and by any signs of accident.

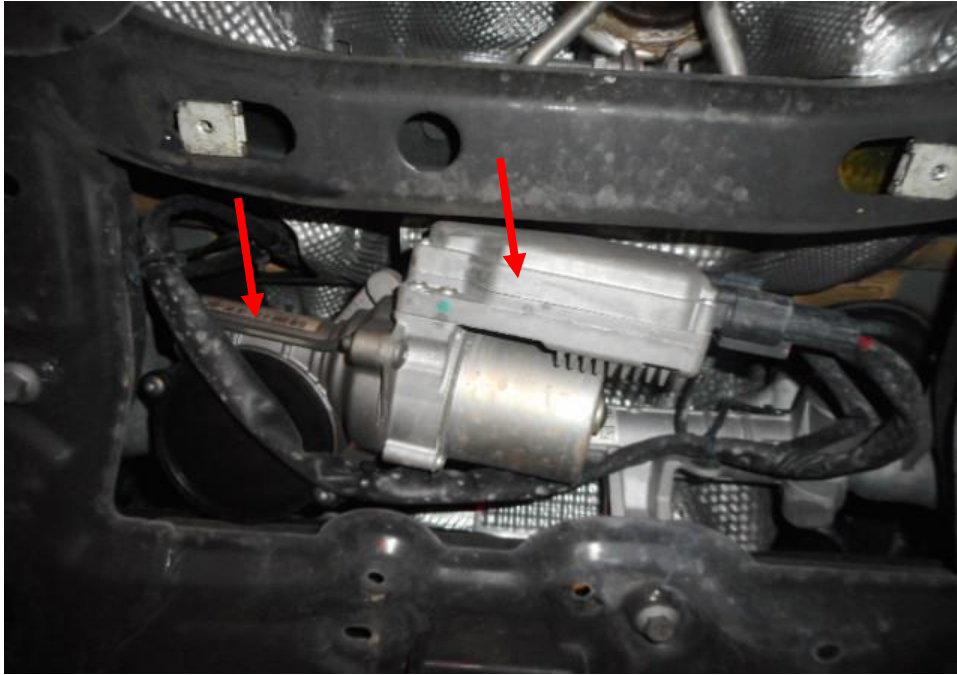
5. The complaint on the Insured Vehicle was noted be to knocking noise from steering rack and pinion when turning the steering wheel and when the vehicle is driving over bumps and uneven road surfaces. There is a recommendation by the workshop to replace the steering rack and pinion unit. The vehicle was observed to be unaffected by any signs of accident.

Photo 6 shows the close up view of the power steering portion of the Insured Vehicle at the time of our inspection. The Electronic Power Steering unit and its steering rack and pinion component is observed to be unaffected and by any signs of accident.

8. We did not find any evidence which had suggested that the cause of abnormalities to the Insured Vehicle was due to poor maintenance and/or recurring problem.
9. The recommendation to replace the Power steering rack and pinion unit at \$3,279.55 is justifiable as all the relevant checks has been conducted.

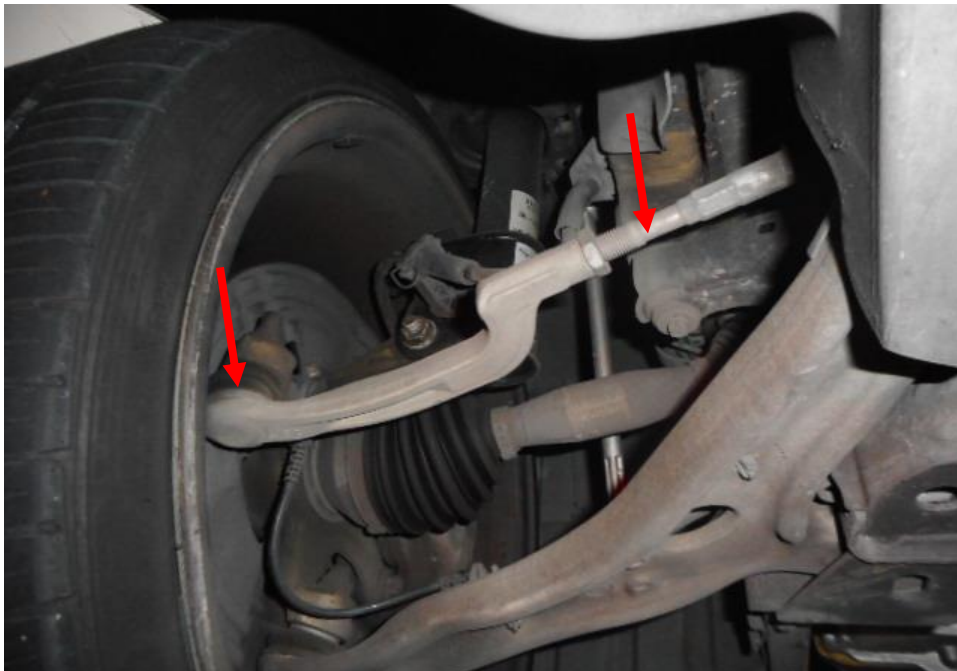
Photo 7 shows the close up view of the front left wheel of the Insured Vehicle at the time of our inspection. The steering tie rod (arrowed) is observed to be unaffected and by any signs of accident.

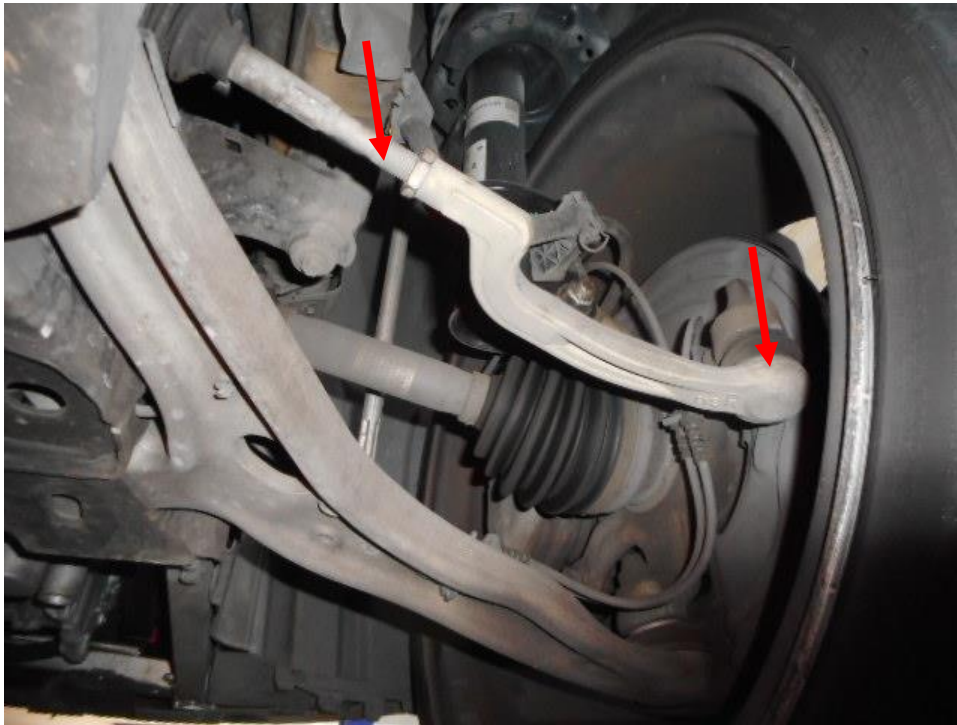
Photo 8 shows the close up view of the front right wheel of the Insured Vehicle at the time of our inspection. The steering tie rod (arrowed) is observed to be unaffected and by any signs of accident.

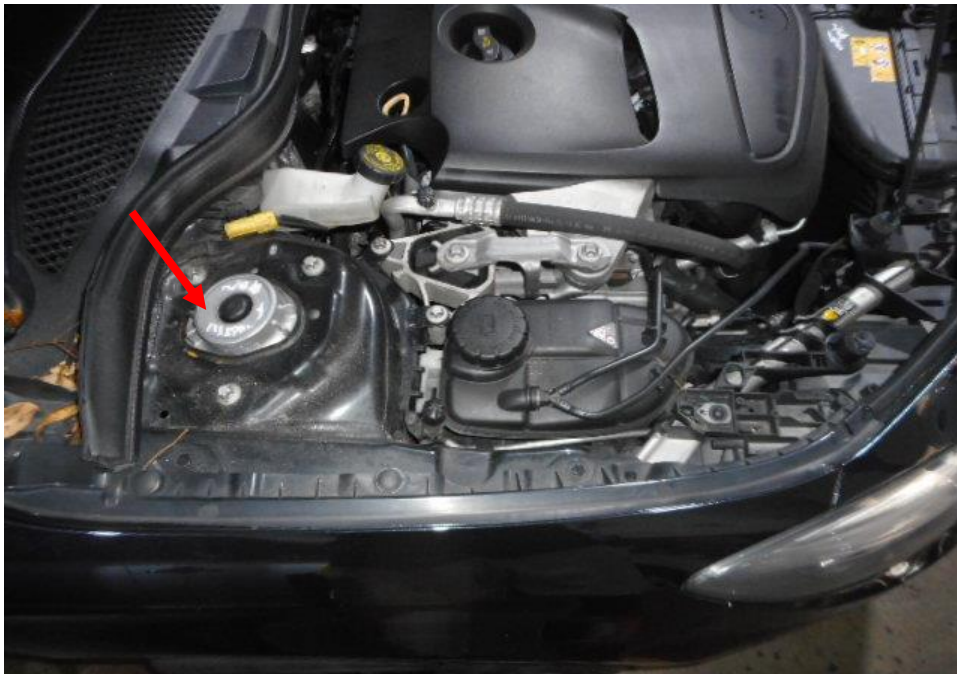
Photo 9 shows the general view of the front right wheel of the Insured Vehicle at the time of our inspection. The suspension system (arrowed) is observed to be just replaced approximately 6,000km from the material time of inspection and visually unaffected by any signs of accident.

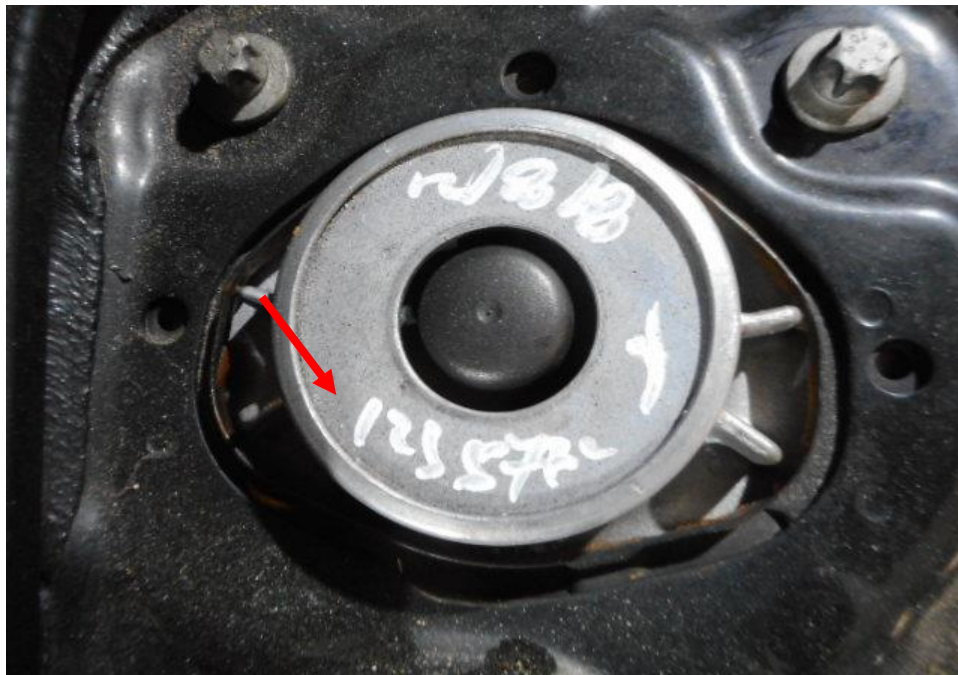
Photo 10 shows the close up view of the front right wheel of the Insured Vehicle at the time of our inspection. The suspension system (arrowed) is observed to be just replaced approximately 6,000km from the material time of inspection and visually unaffected by any signs of accident.

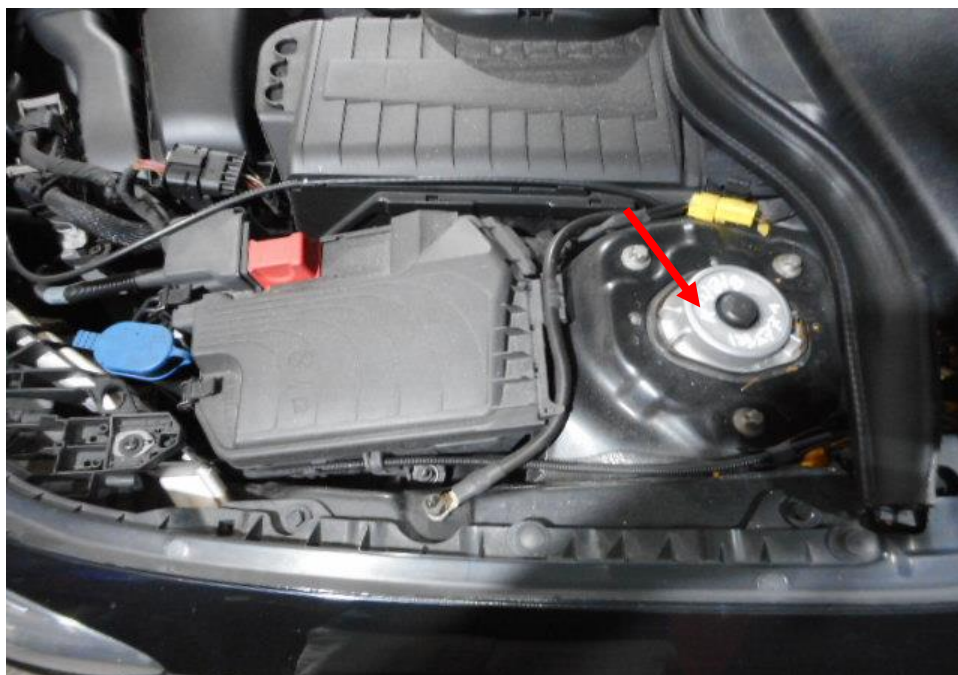
Photo 11 shows the general view of the front left wheel of the Insured Vehicle at the time of our inspection. The suspension system (arrowed) is observed to be just replaced approximately 6,000km from the material time of inspection and visually unaffected by any signs of accident.

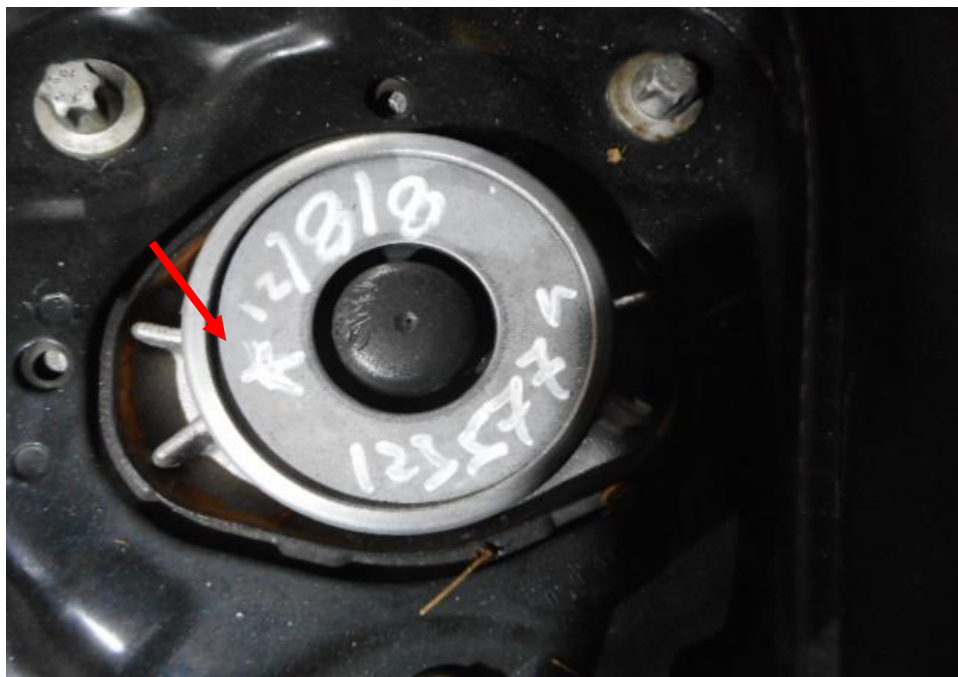
Photo 12 shows the close up view of the front left wheel of the Insured Vehicle at the time of our inspection. The suspension system (arrowed) is observed to be just replaced approximately 6,000km from the material time of inspection and visually unaffected by any signs of accident.

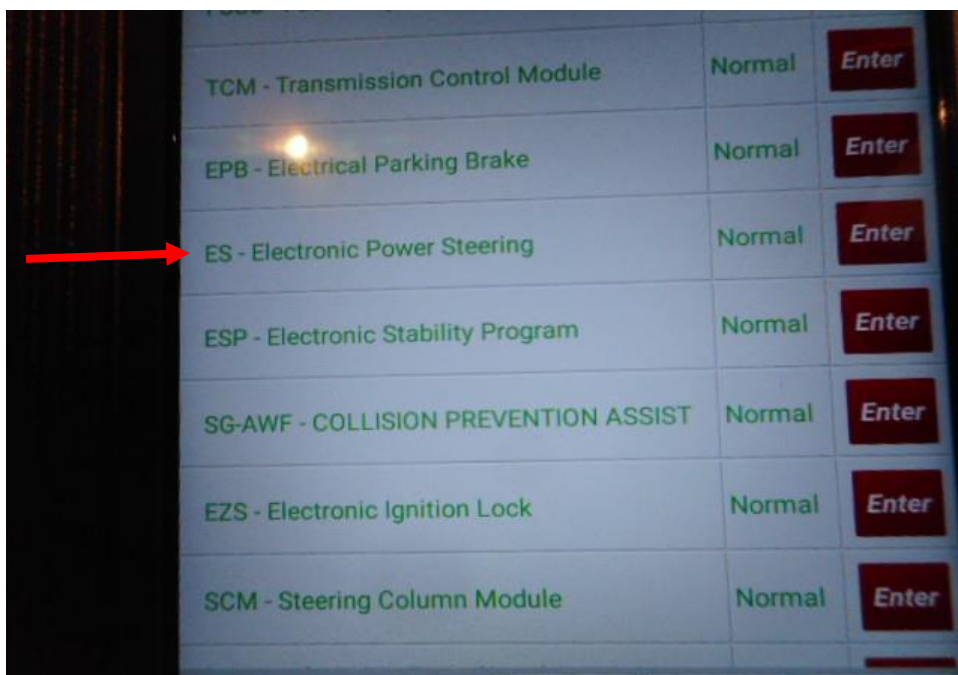
Photo 13 shows the conducted ECU diagnosis of the Insured Vehicle at the time of our inspection. There was no electronic error on the Electronic Power Steering of the Insured Vehicle (arrowed).
