## LKK Auto Consultants Pte Ltd

## INSPECTION CHECKLIST

Reference no: CS5/TP21011364/Cq

Applicant	VENTURE CARS PTE LTD
Date of Inspection	8/11/2021
Time of Inspection	10:30 HRS
Vehicle Make	HONDA
Vehicle Model	FIT 1.3 BASIC
Vehicle Model Code	6BA-GR1
Engine Number	L13B1604297
Chassis Number	GR11103237
Motor Number (if any)	-
Odometer Reading	78 KM

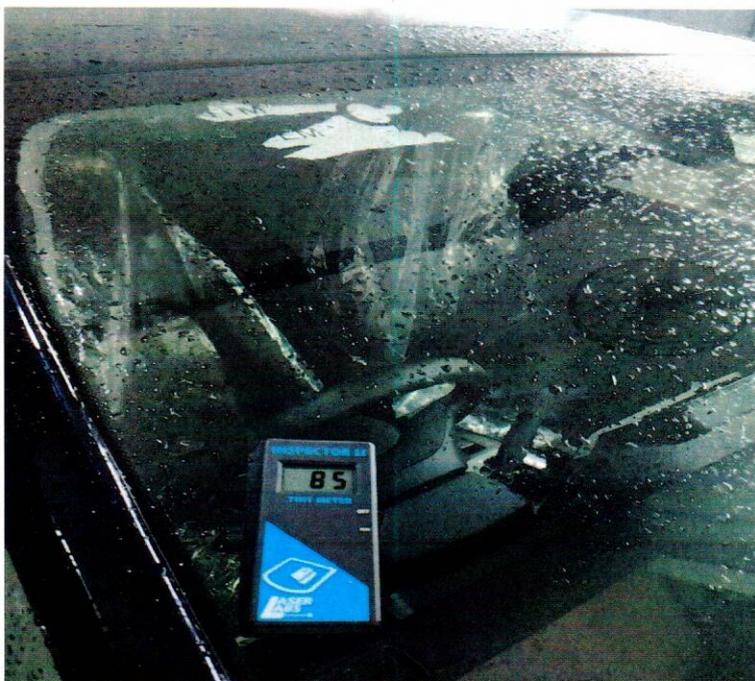
Windscreen VLT Reading: 85% (front)

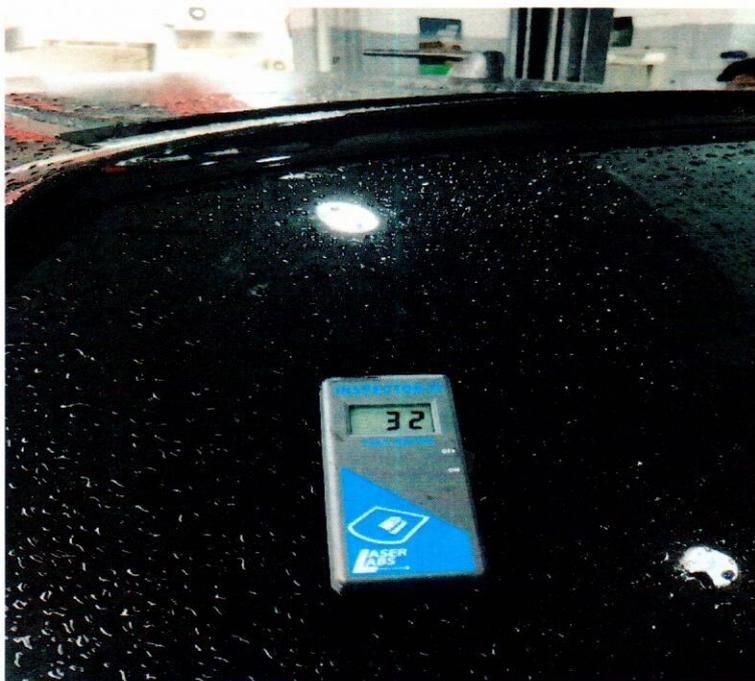
Windscreen VLT Reading: 32% (rear)

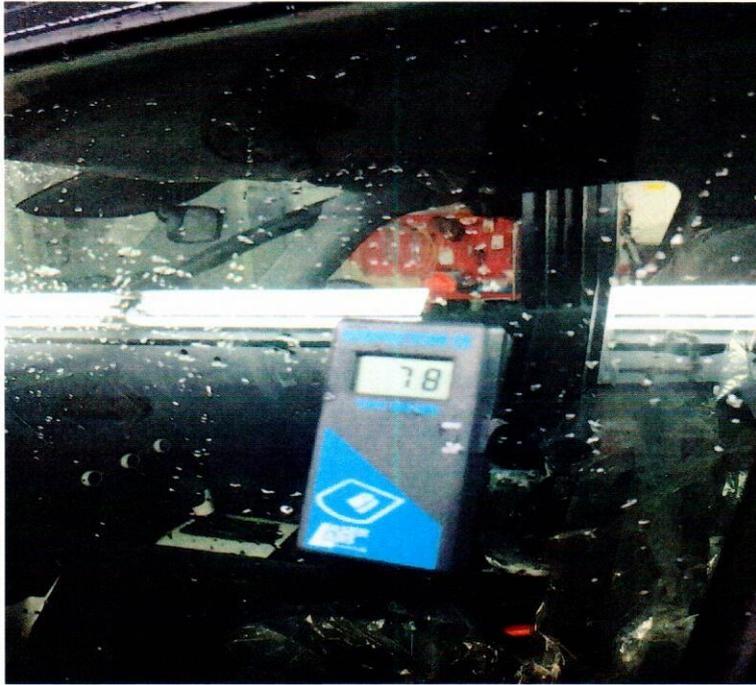
### Front Windows VLT Reading: 78% (left)

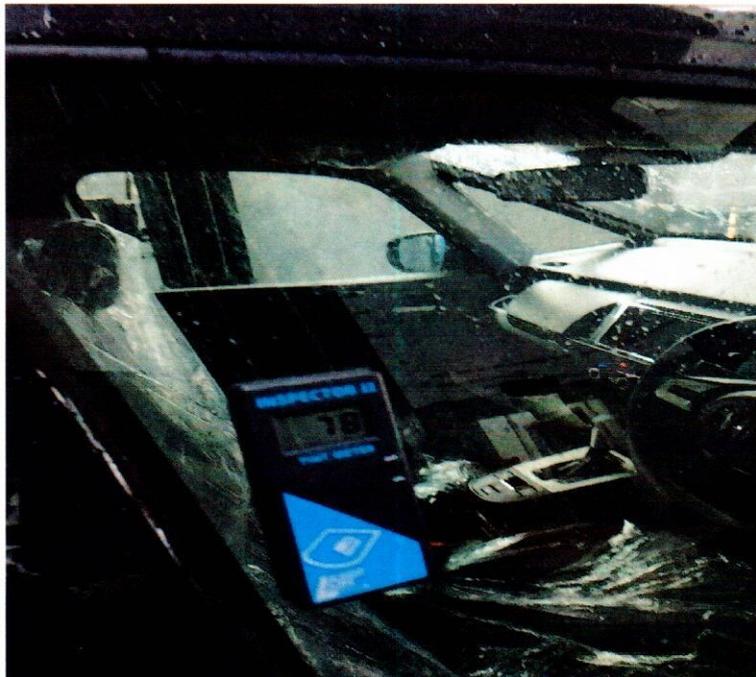
### Front Windows VLT Reading: 78% (right)

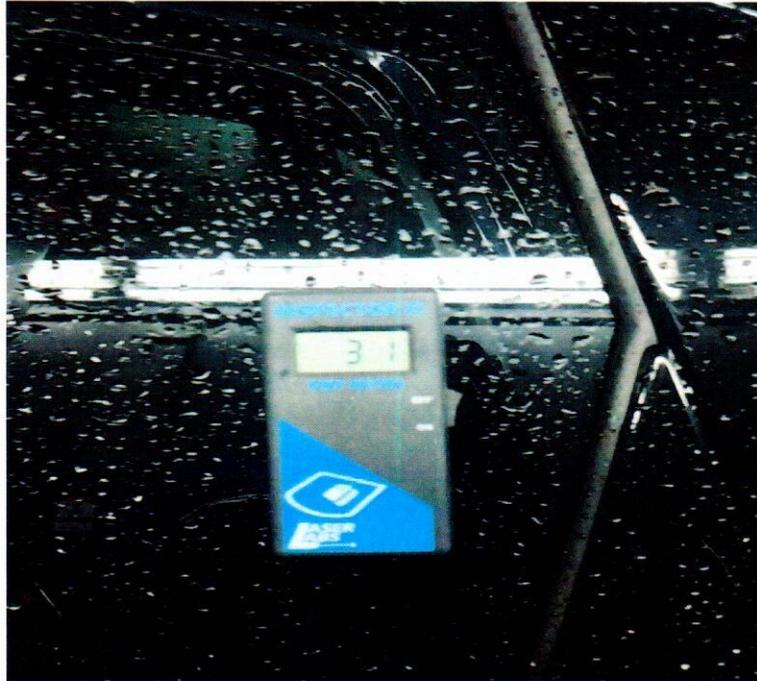
### Rear Windows VLT Reading: 31% (left)

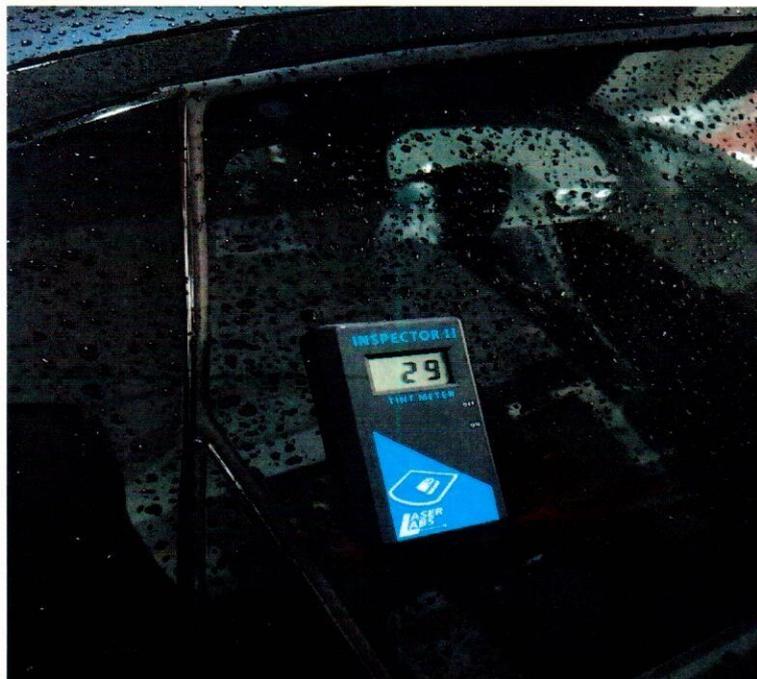
### Rear Windows VLT Reading: 29% (right)

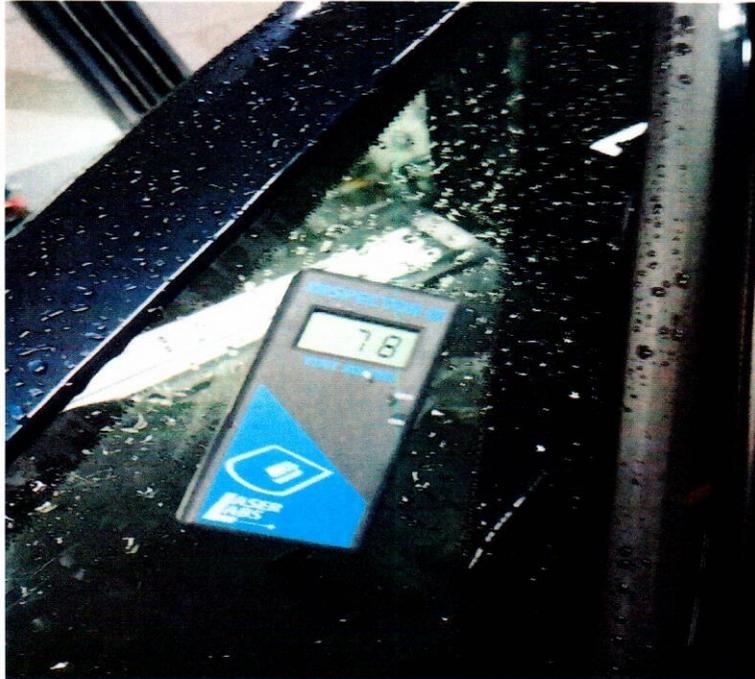
### Front Quarter Glass VLT Reading: 78 % (Left)

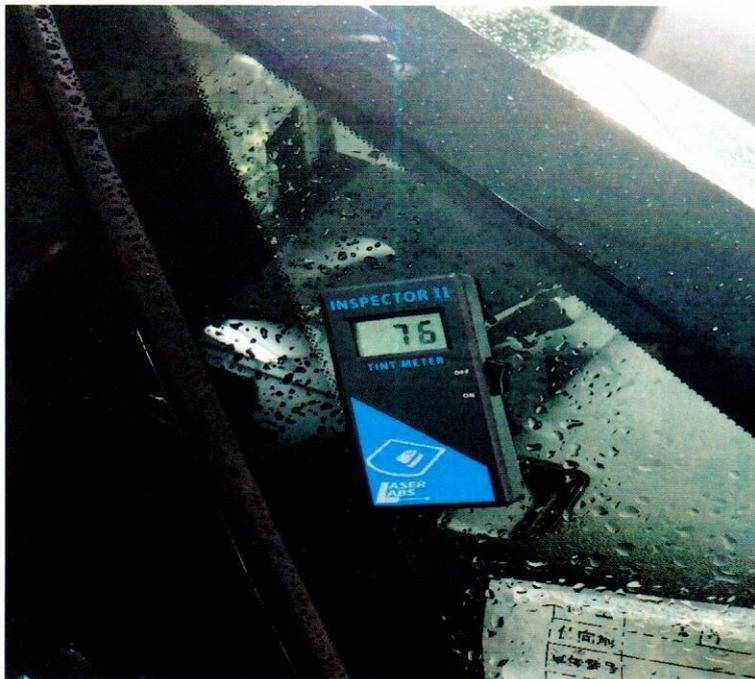
### Front Quarter Glass VLT Reading: 76% (Right)

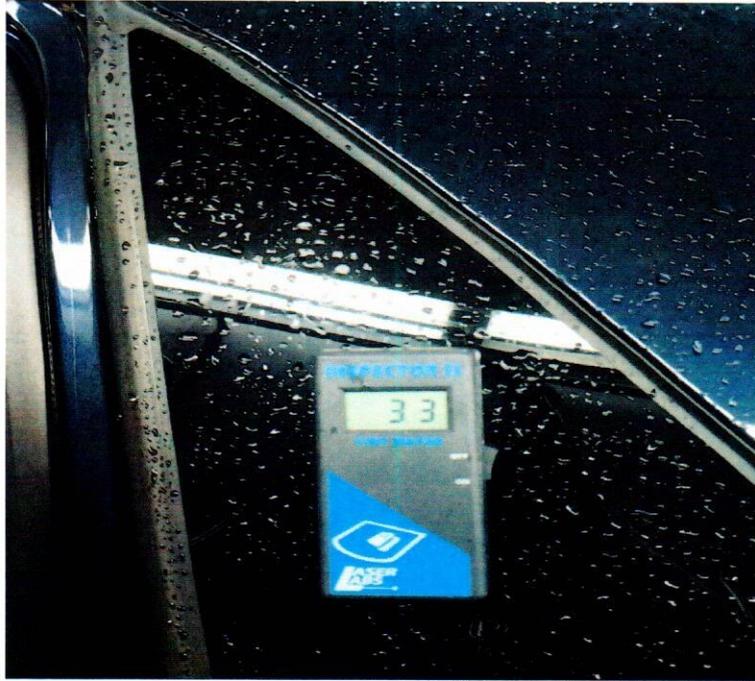
### Rear Quarter Glass VLT Reading: 33% (Left)

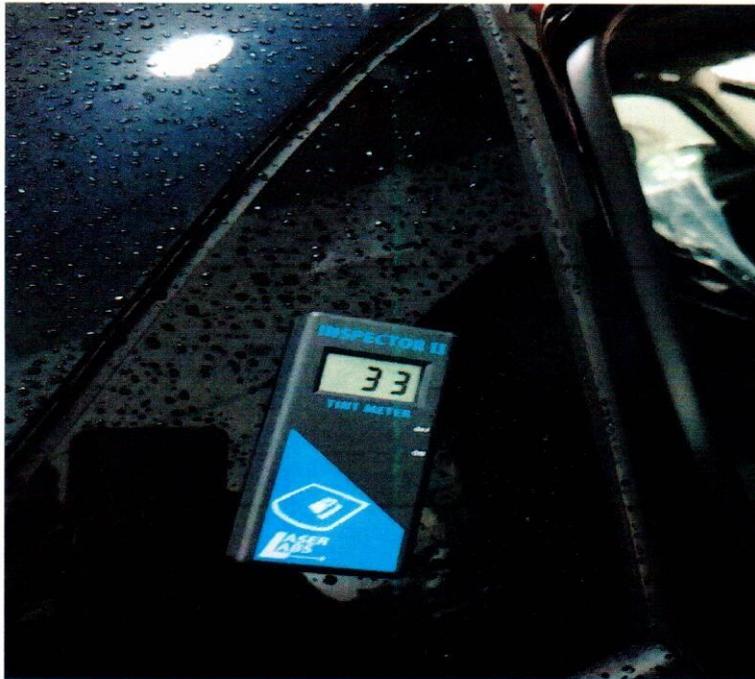
### Rear Quarter Glass VLT Reading: 33% (Right)
