## INSPECTION CHECKLIST

Reference no: CS5/TP21011366/Cq

| Vehicle Make | HONDA |
| Vehicle Model | FIT 1.3 BASIC |

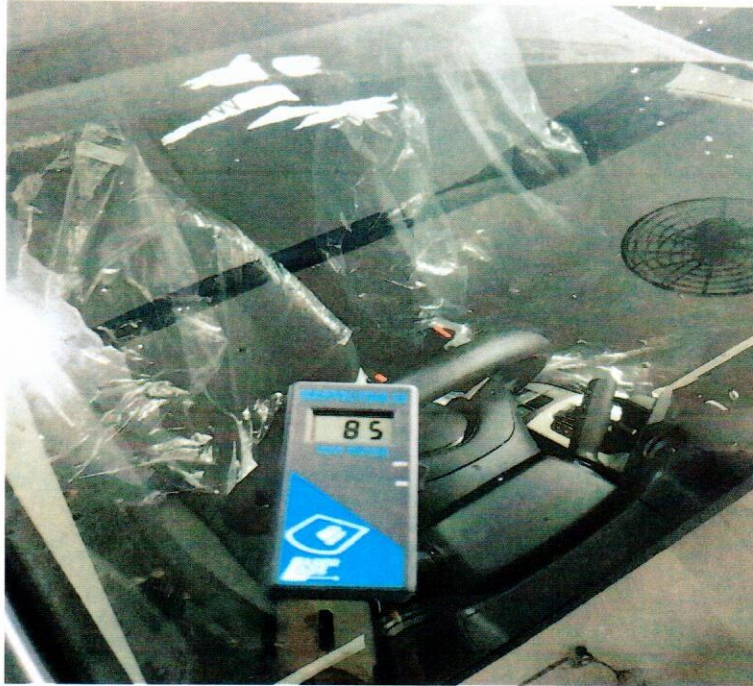
Windscreen VLT Reading: 85% (front)

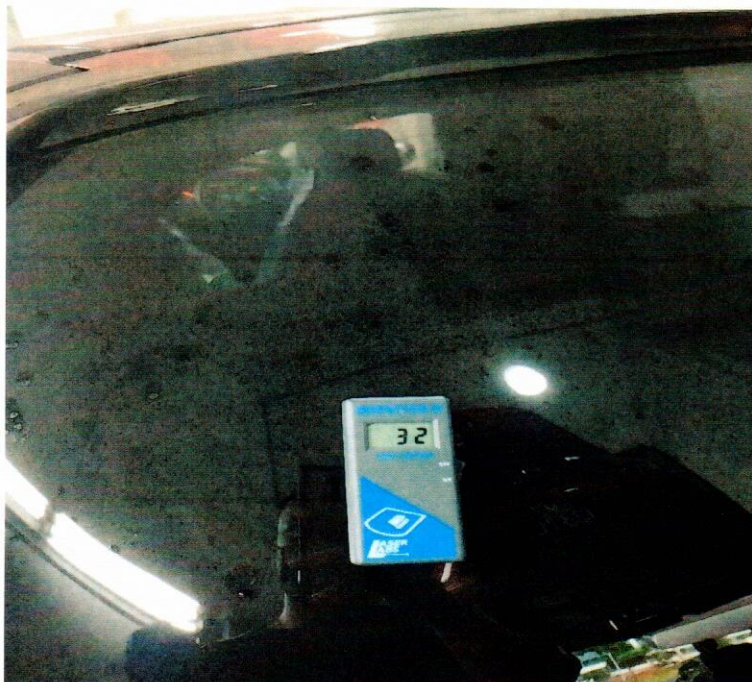
Windscreen VLT Reading: 32% (rear)

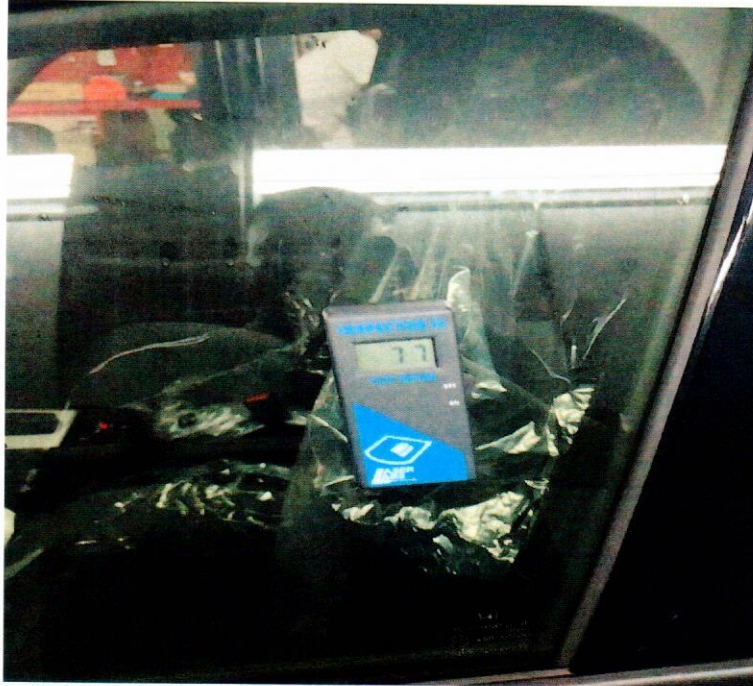
## Front Windows VLT Reading: 77% (left)

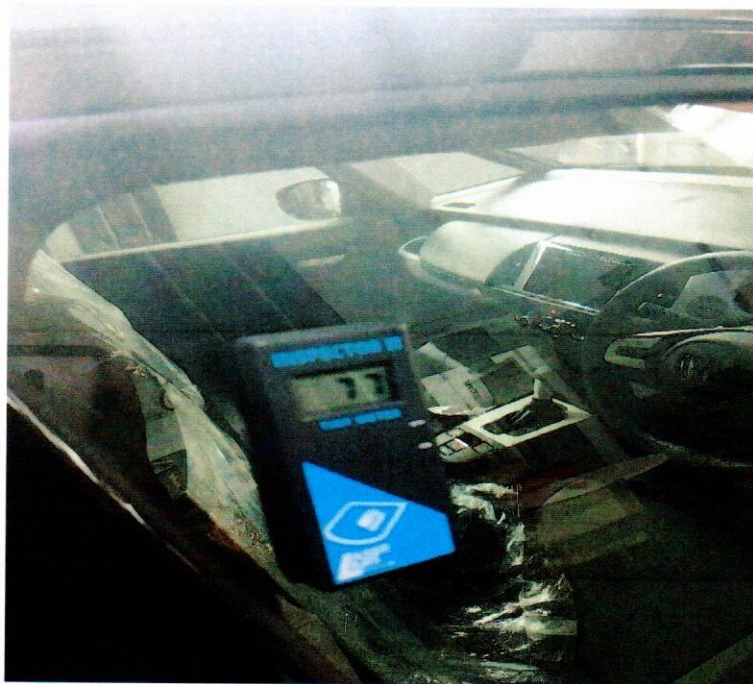
## Front Windows VLT Reading: 77% (right)

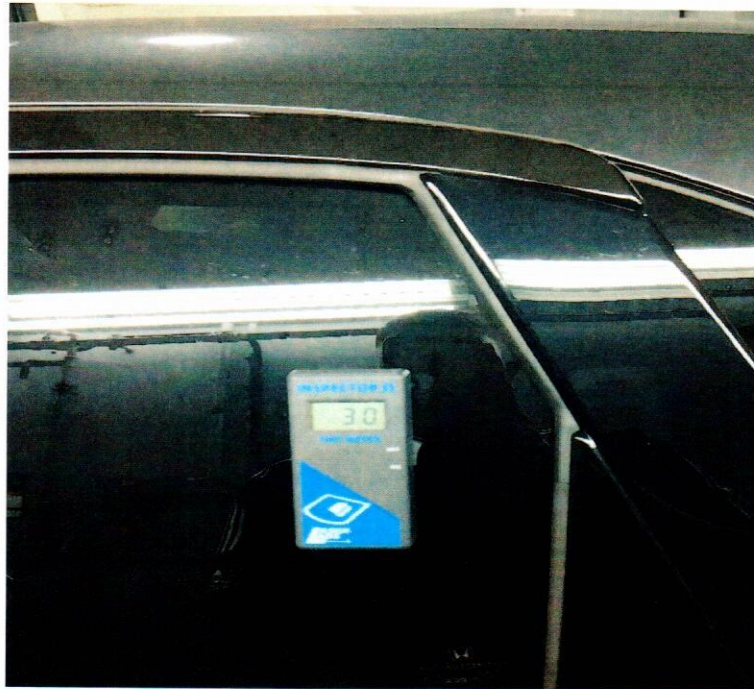
Rear Windows VLT Reading: 30% (left)

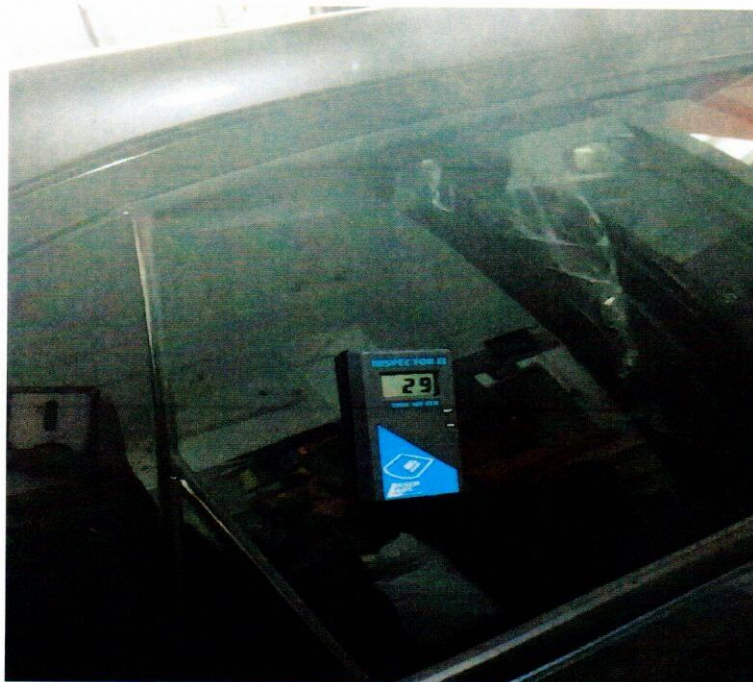
Rear Windows VLT Reading: 29% (right)

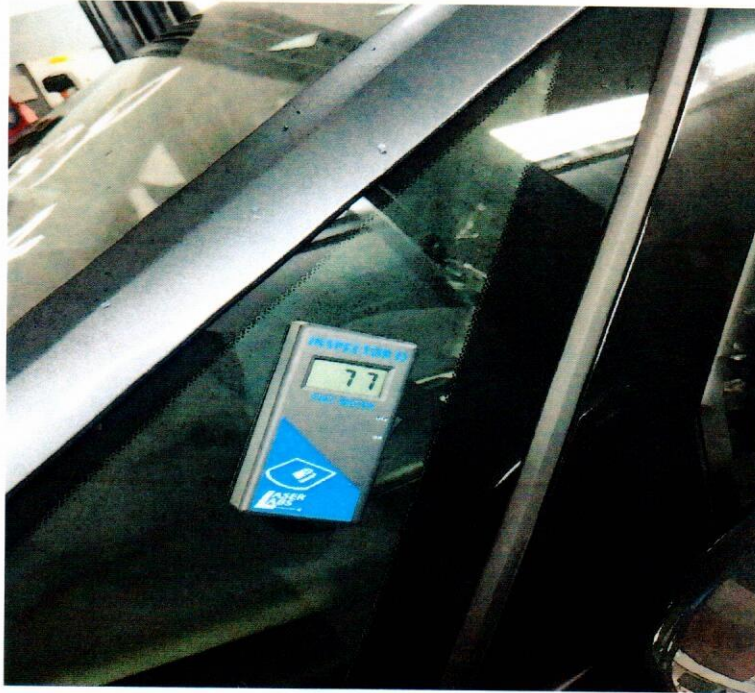
### Front Quarter Glass VLT Reading: 77 % (Left)

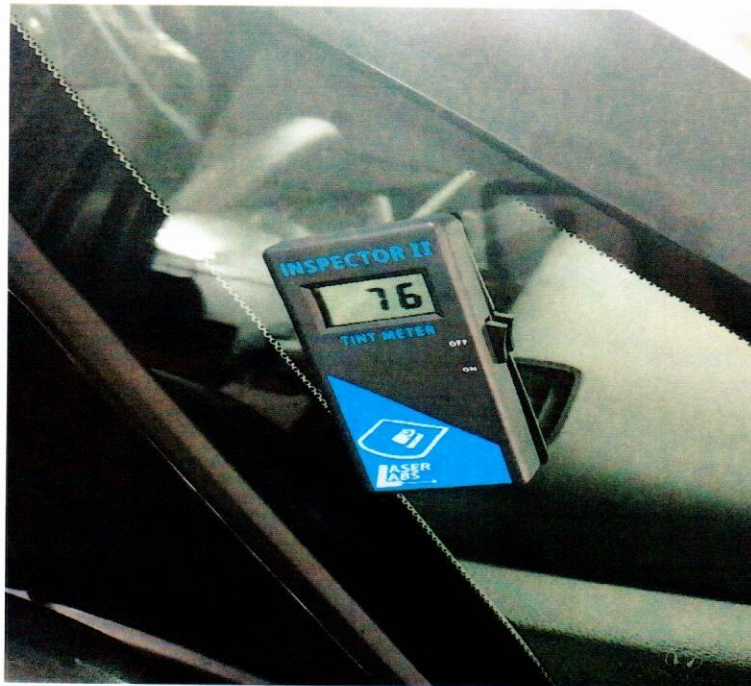
### Front Quarter Glass VLT Reading: 76% (Right)

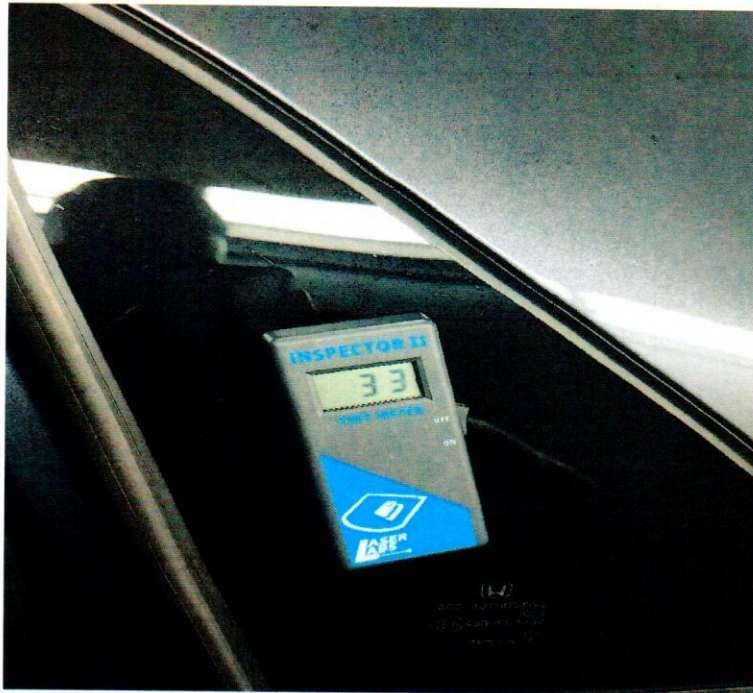
## Rear Quarter Glass VLT Reading: 33% (Left)

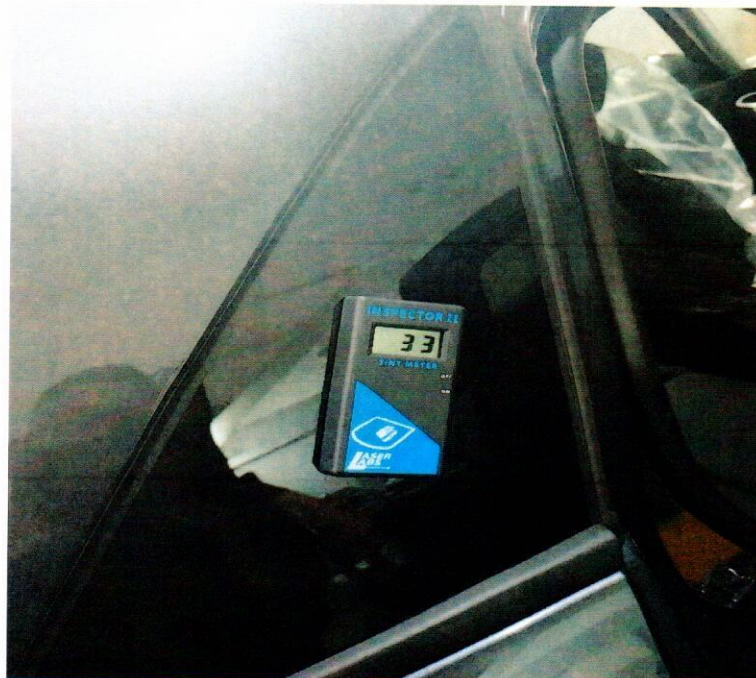
## Rear Quarter Glass VLT Reading: 33% (Right)
