## INSPECTION CHECKLIST

Reference no: CS5/TP21011368/Cq

| Vehicle Make | HONDA |
| Vehicle Model | FIT 1.3 BASIC |

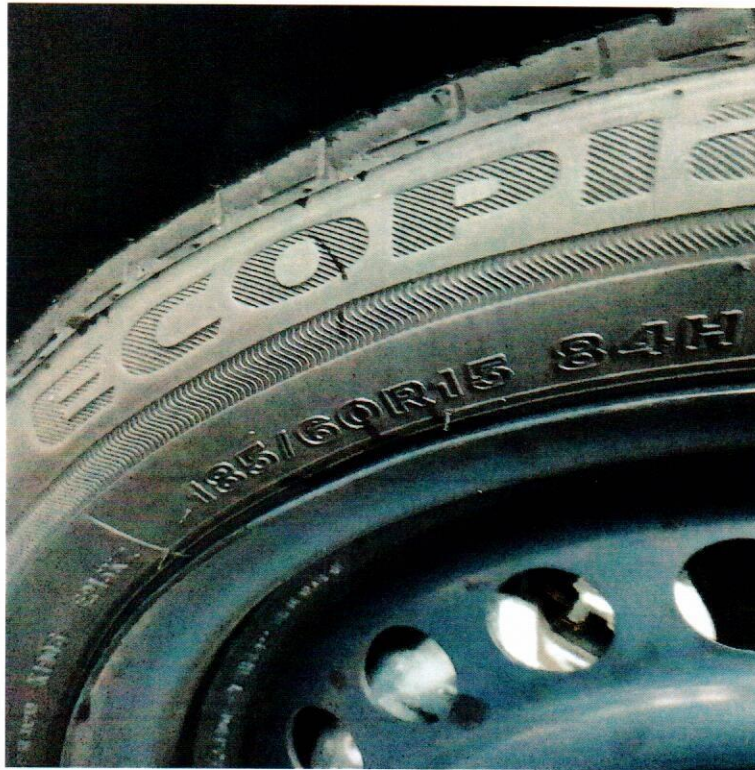
## Front Tyre Size

| Front Tyre Size | 185/60R15 |

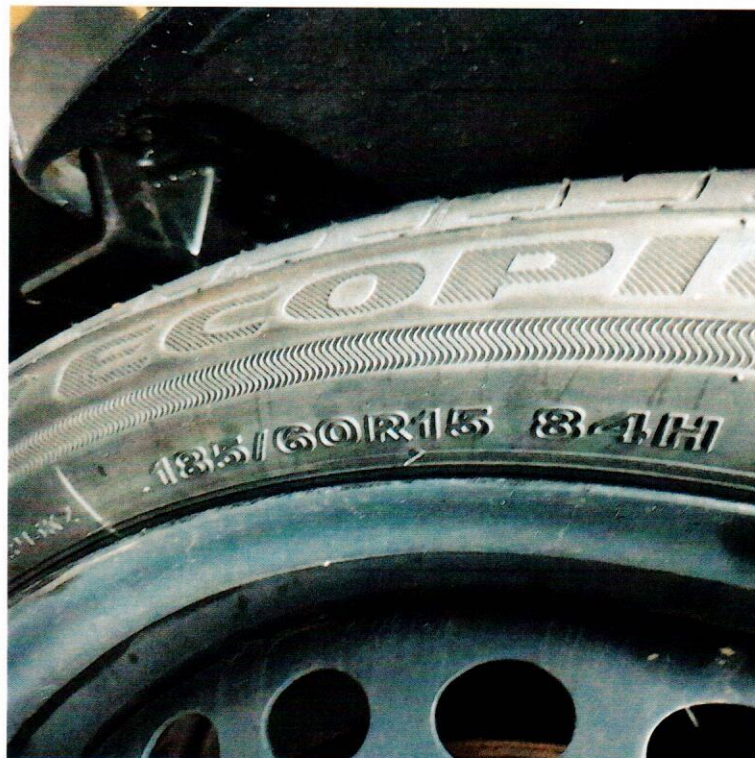
## Rear Tyre Size

| Rear Tyre Size | 185/60R15 |

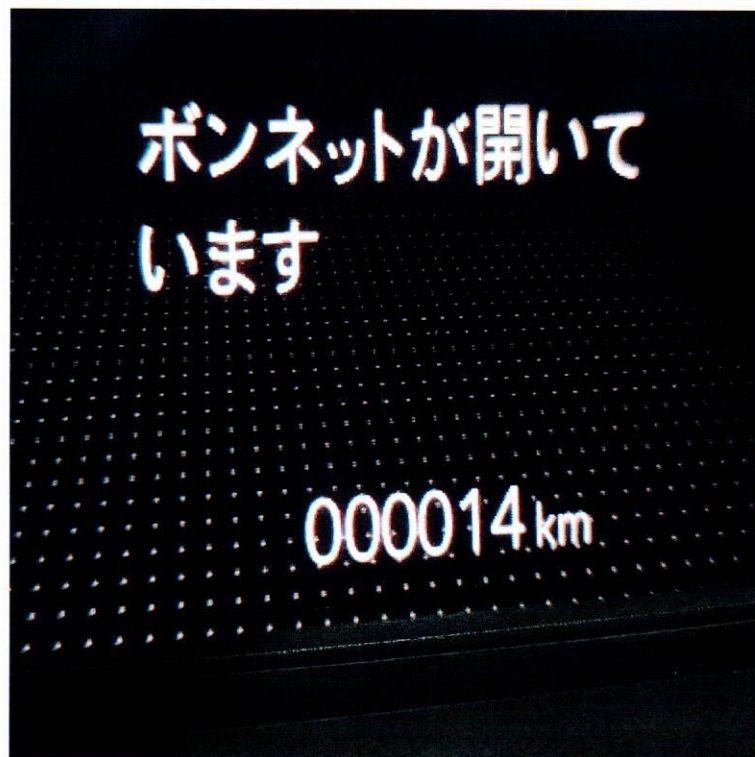
## Odometer

| Odometer Reading | 14 KM |

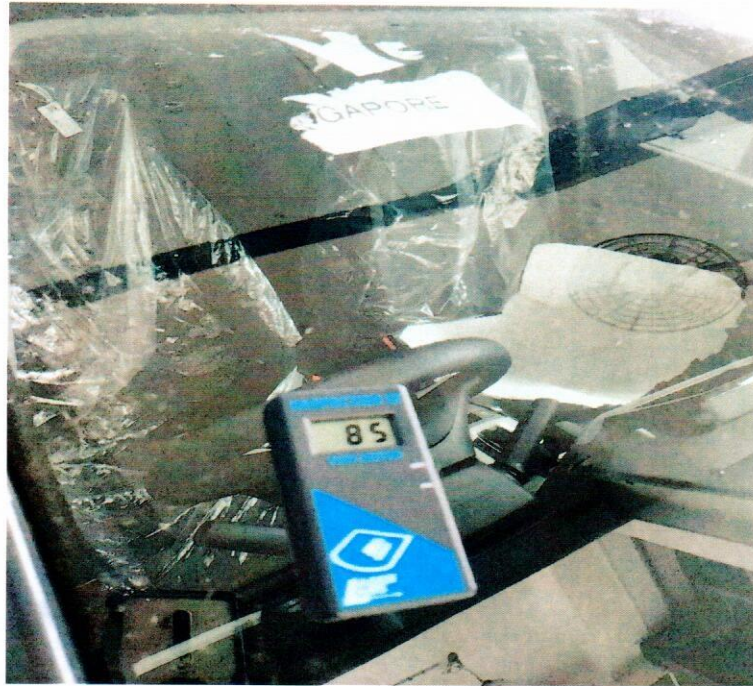
Windscreen VLT Reading: 85% (front)

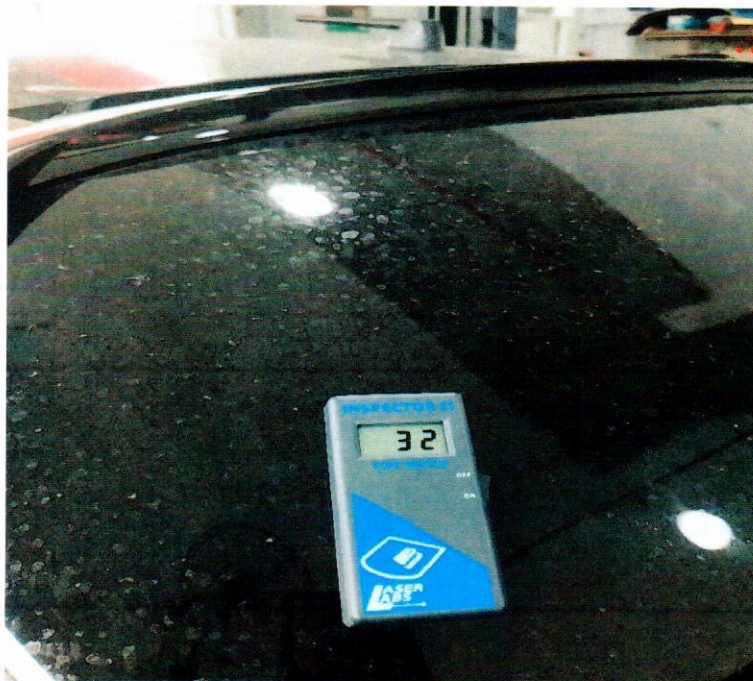
Windscreen VLT Reading: 32% (rear)

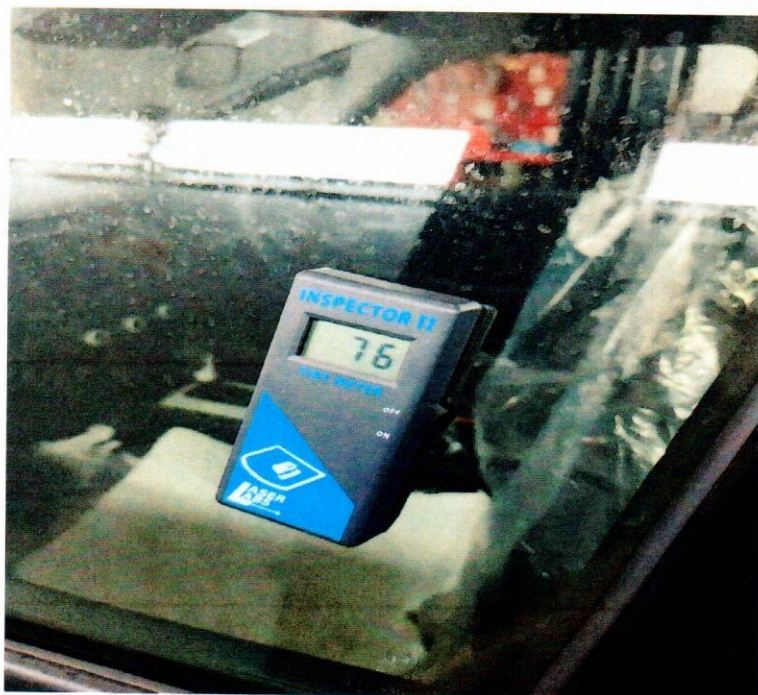
### Front Windows VLT Reading: 76% (left)

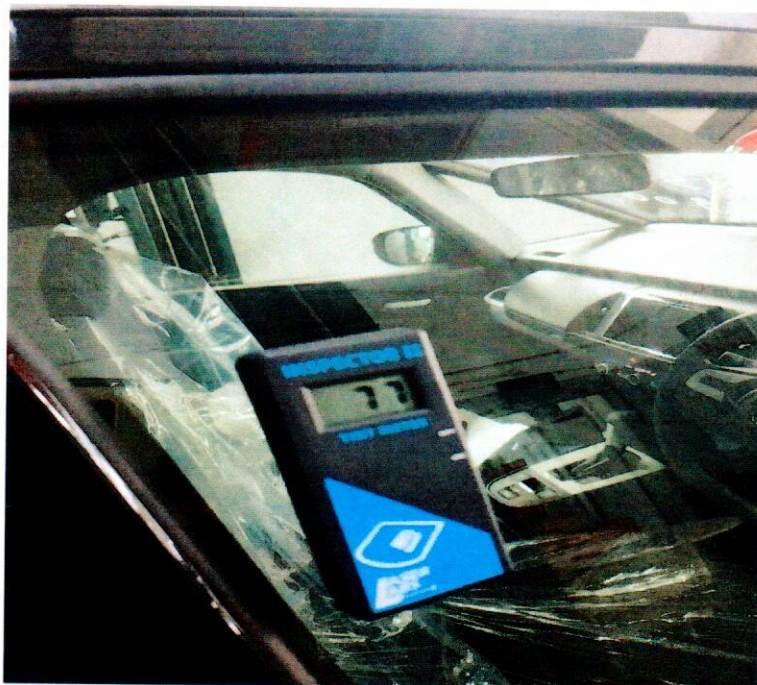
### Front Windows VLT Reading: 77% (right)

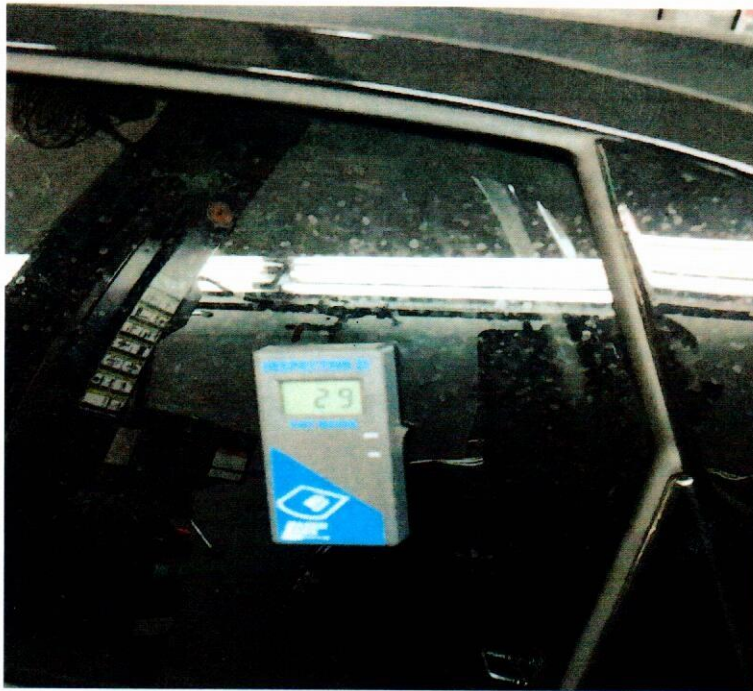
## Rear Windows VLT Reading: 29% (left)

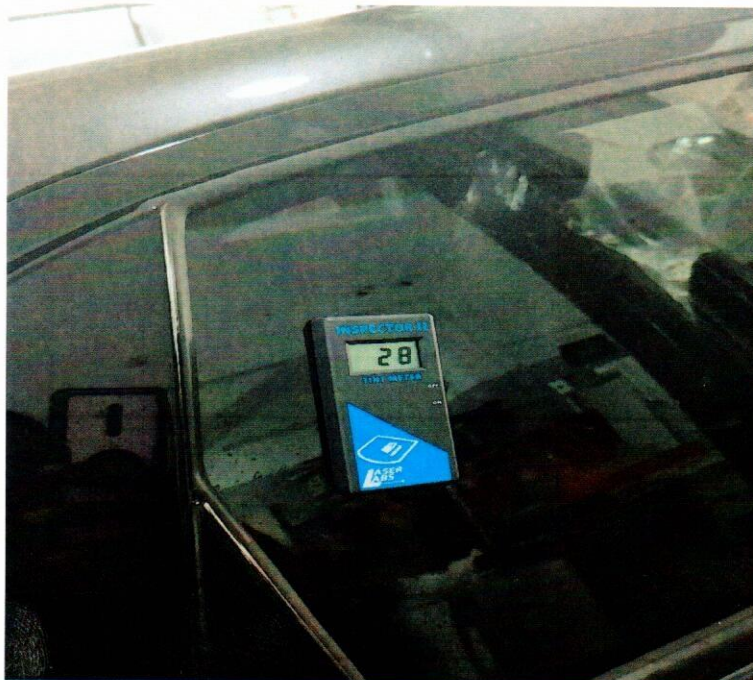
## Rear Windows VLT Reading: 28% (right)

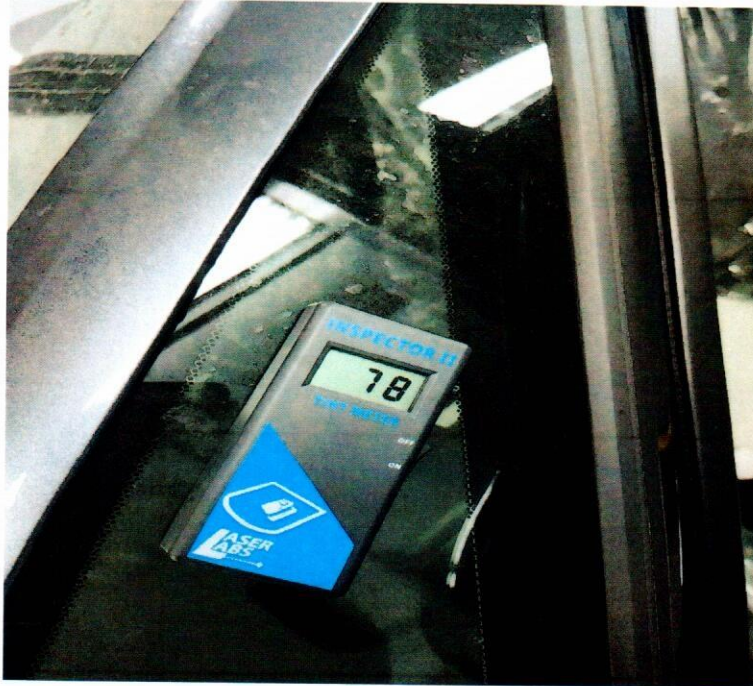
Front Quarter Glass VLT Reading: 78 % (Left)

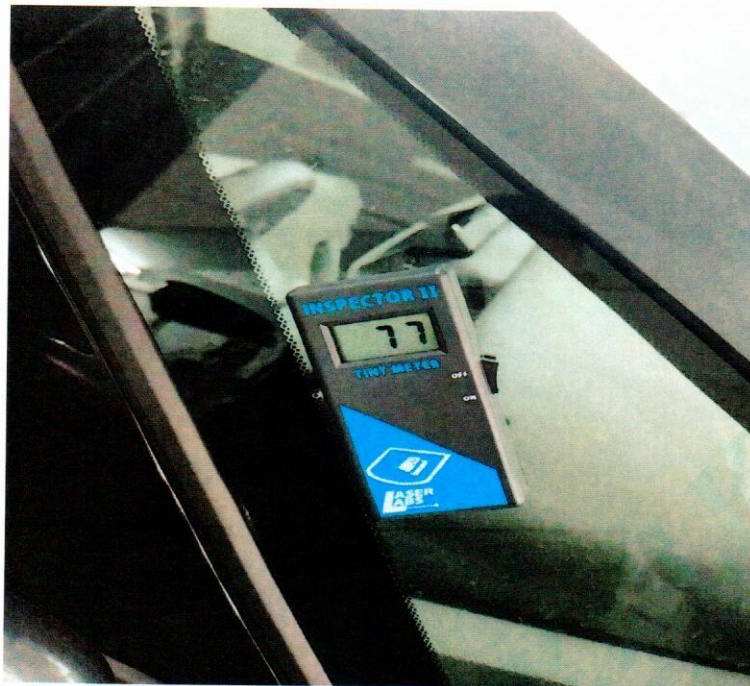
Front Quarter Glass VLT Reading: 77% (Right)

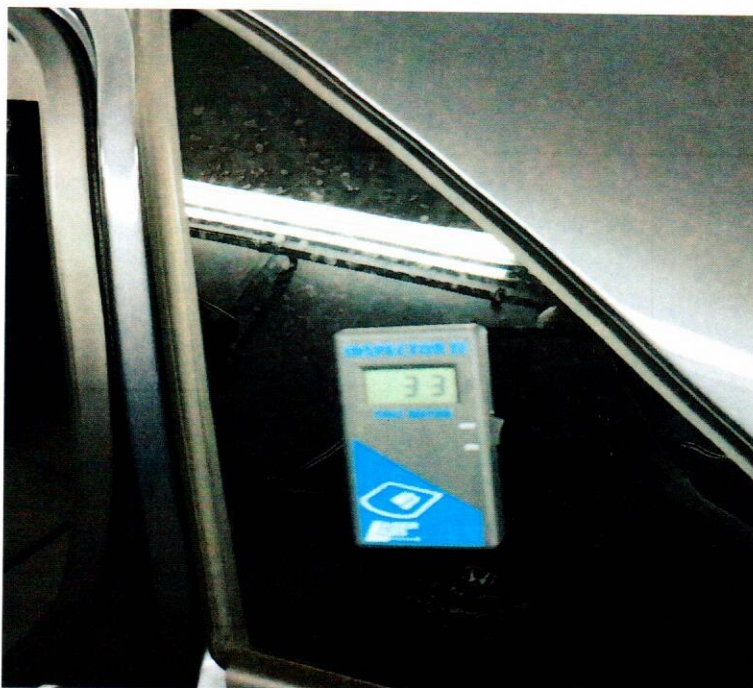
### Rear Quarter Glass VLT Reading: 33% (Left)

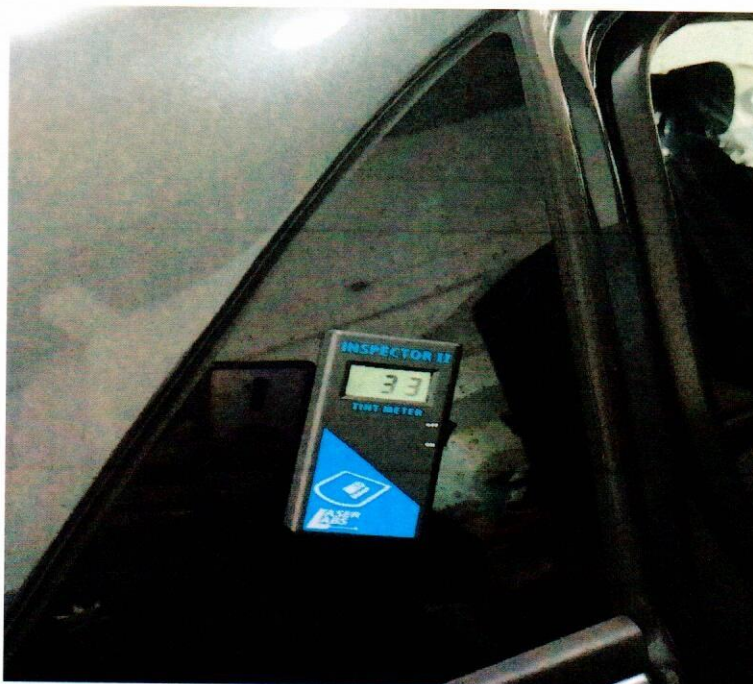
### Rear Quarter Glass VLT Reading: 33% (Right)
