## INSPECTION CHECKLIST

Reference no: CS5/TP21011370/Cq

| Vehicle Make | HONDA |
| Vehicle Model | FIT 1.3 BASIC |

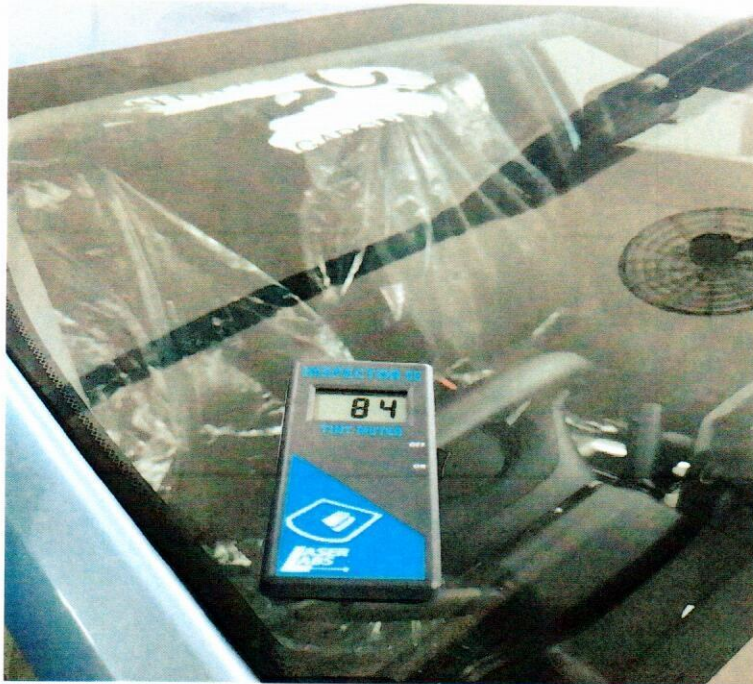
Windscreen VLT Reading: 84% (front)

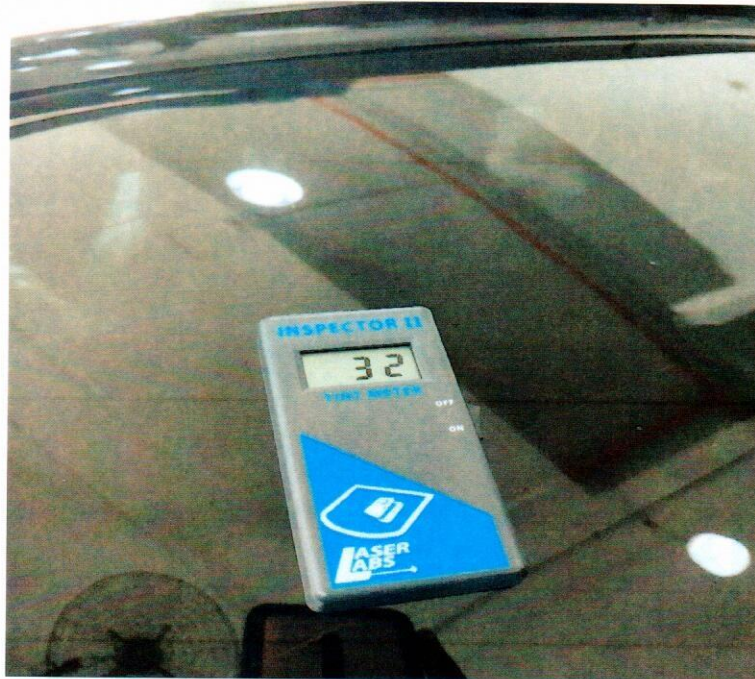
Windscreen VLT Reading: 32% (rear)

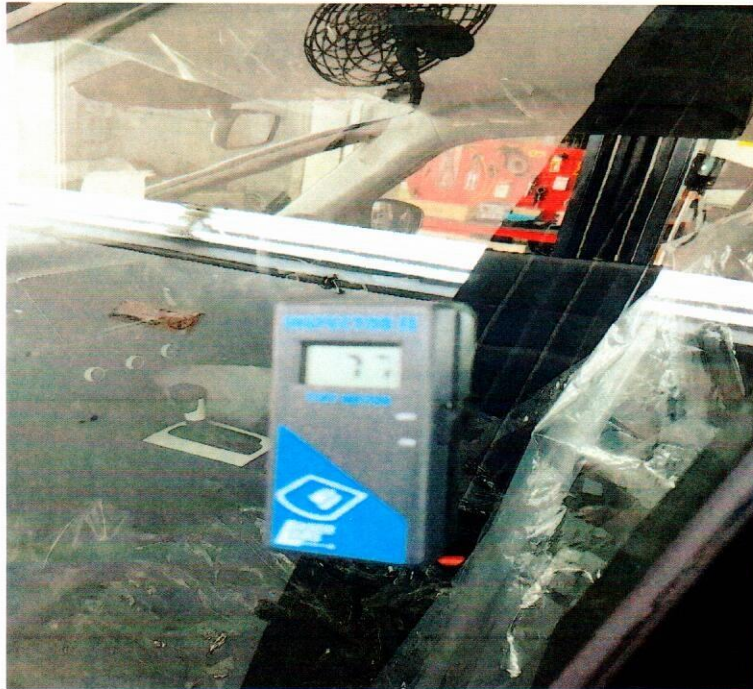
## Front Windows VLT Reading: 77% (left)

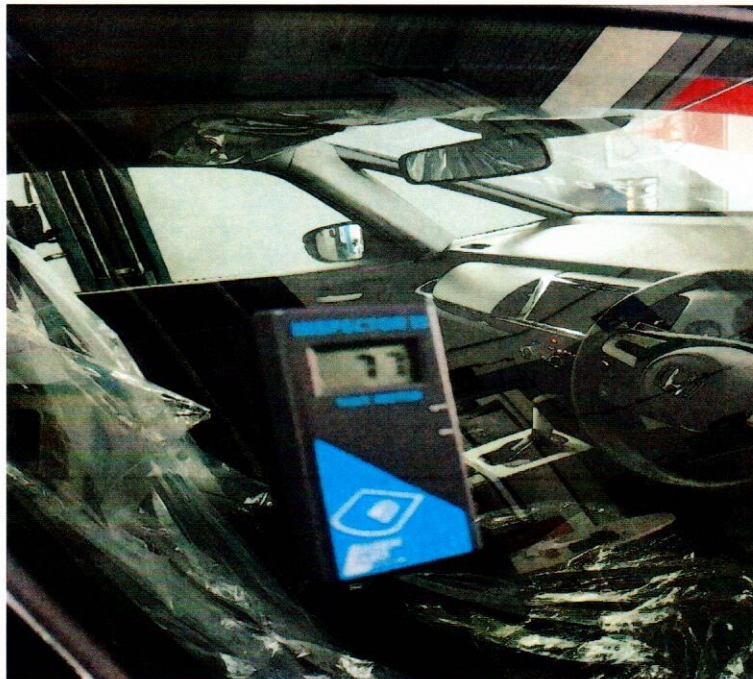
## Front Windows VLT Reading: 77% (right)

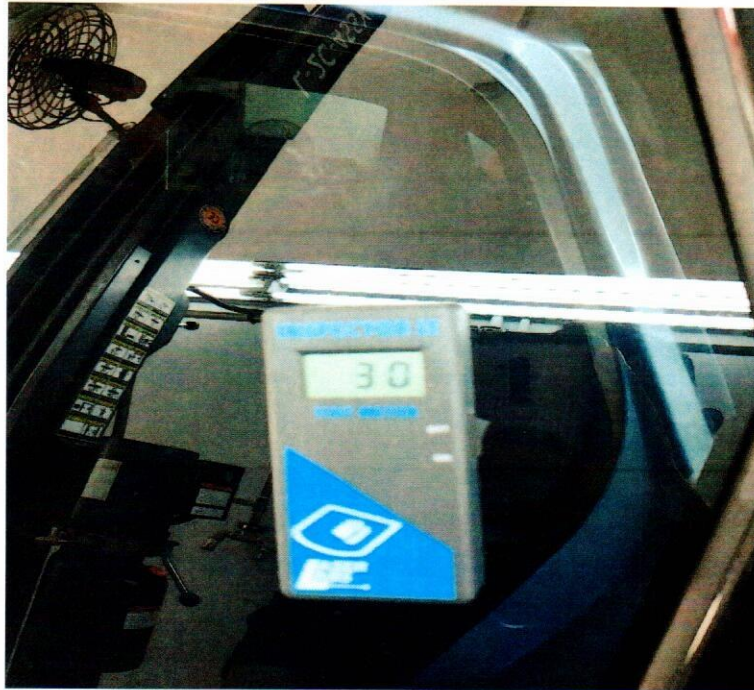
### Rear Windows VLT Reading: 30% (left)

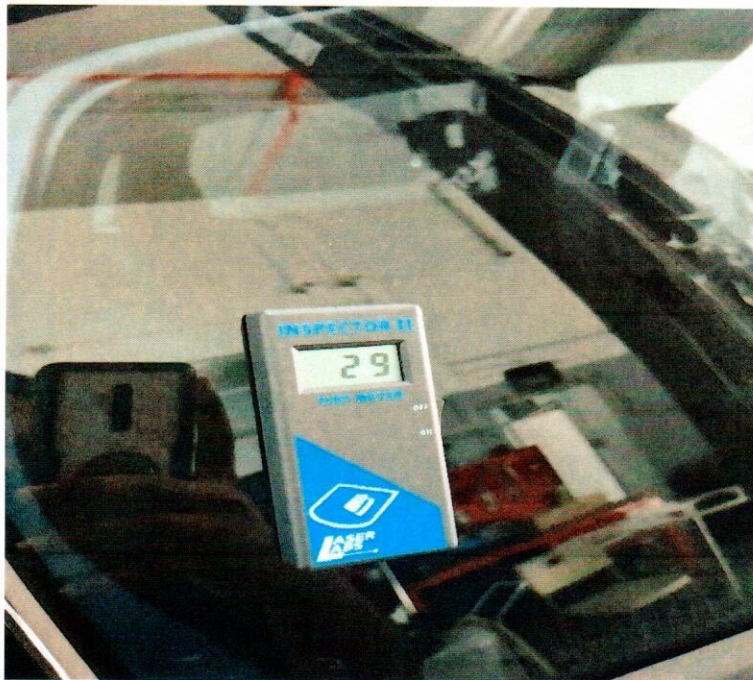
### Rear Windows VLT Reading: 29% (right)

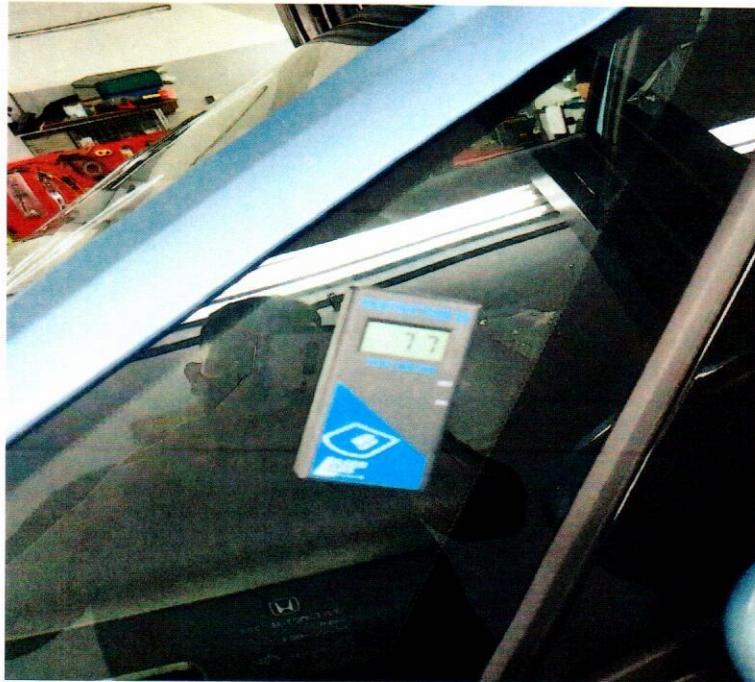
### Front Quarter Glass VLT Reading: 77 % (Left)

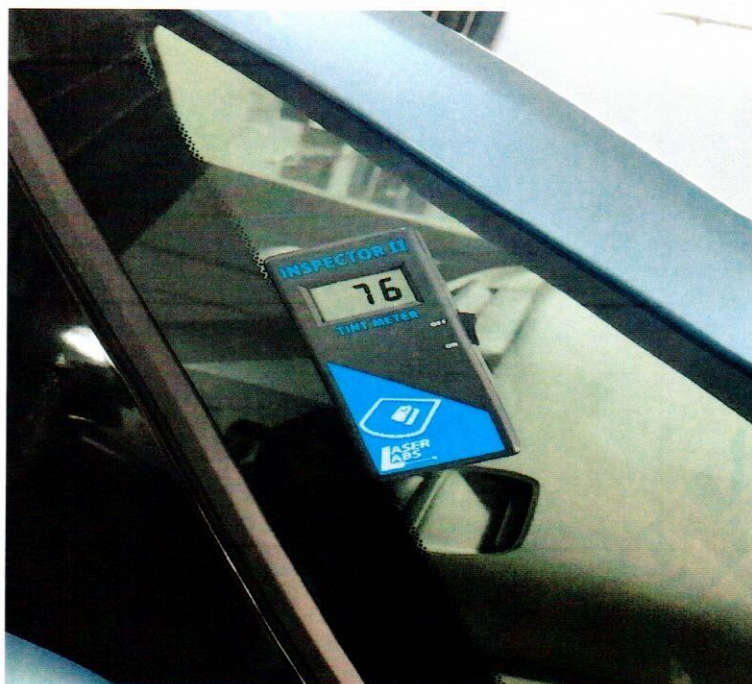
### Front Quarter Glass VLT Reading: 76% (Right)

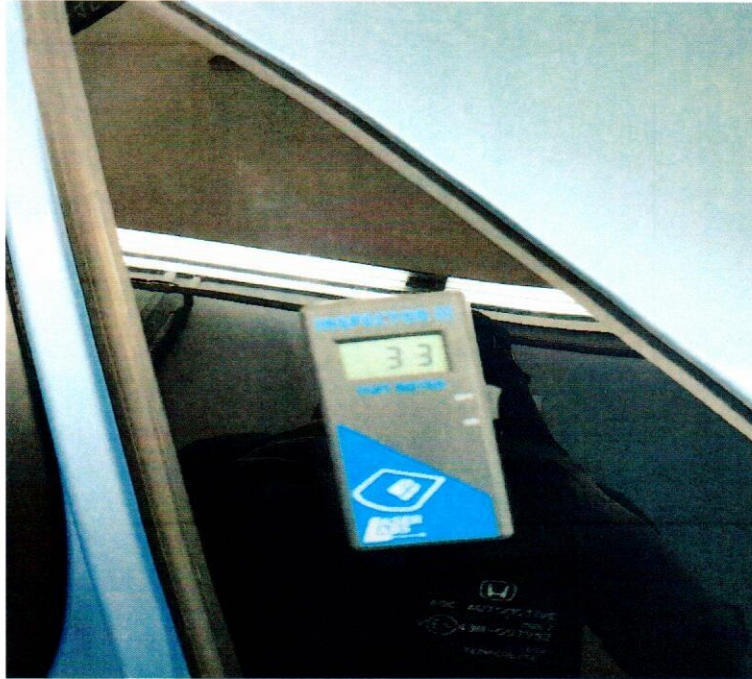
## Rear Quarter Glass VLT Reading: 33% (Left)

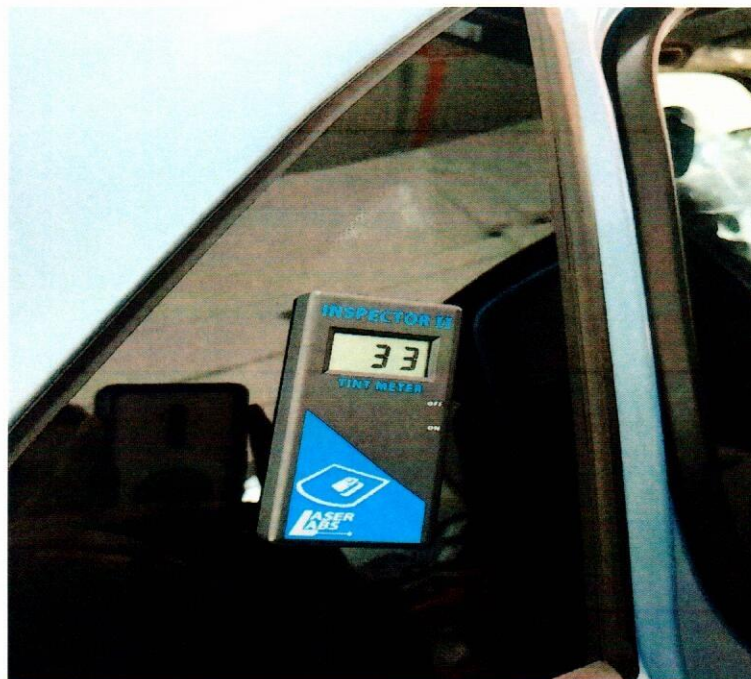
## Rear Quarter Glass VLT Reading: 33% (Right)
