INSPECTION CHECKLIST

Reference no: CS5/TP21011371/Cq

Applicant	VENTURE CARS PTE LTD
Date of Inspection	9/11/2021
Time of Inspection	12:30 HRS
Vehicle Make	HONDA
Vehicle Model	FIT 1.3 BASIC
Vehicle Model Code	6BA-GR1
Engine Number	L13B1604764
Chassis Number	GR11103650
Motor Number (if any)	-
Odometer Reading	36 KM

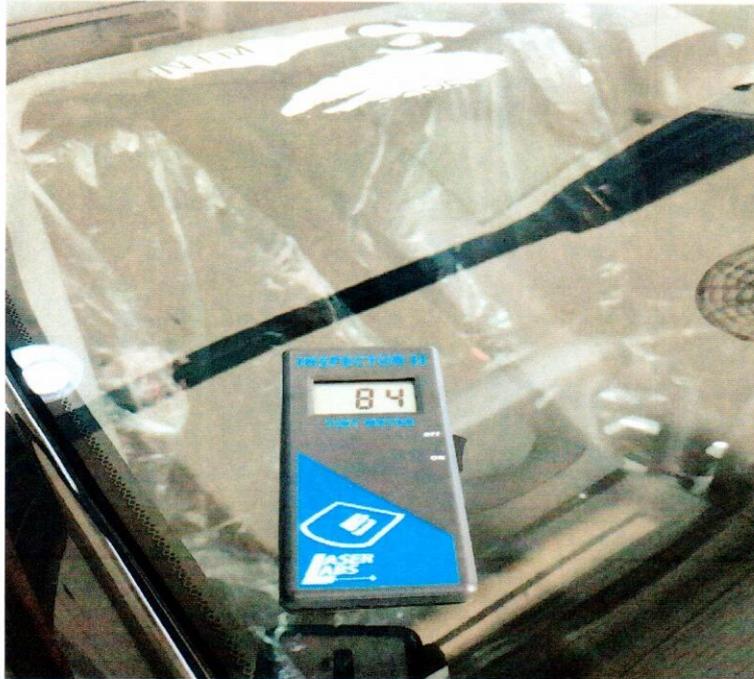
Windscreen VLT Reading: 84% (front)

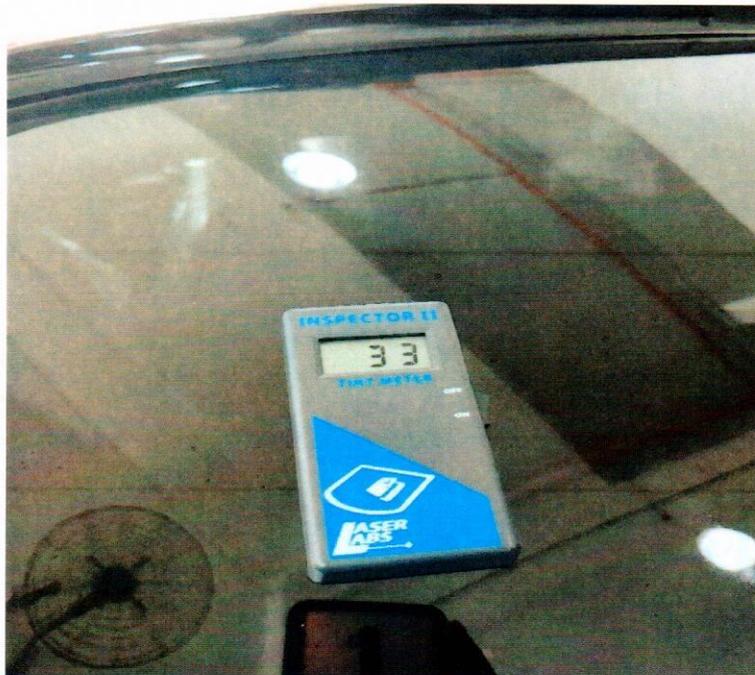
Windscreen VLT Reading: 33% (rear)

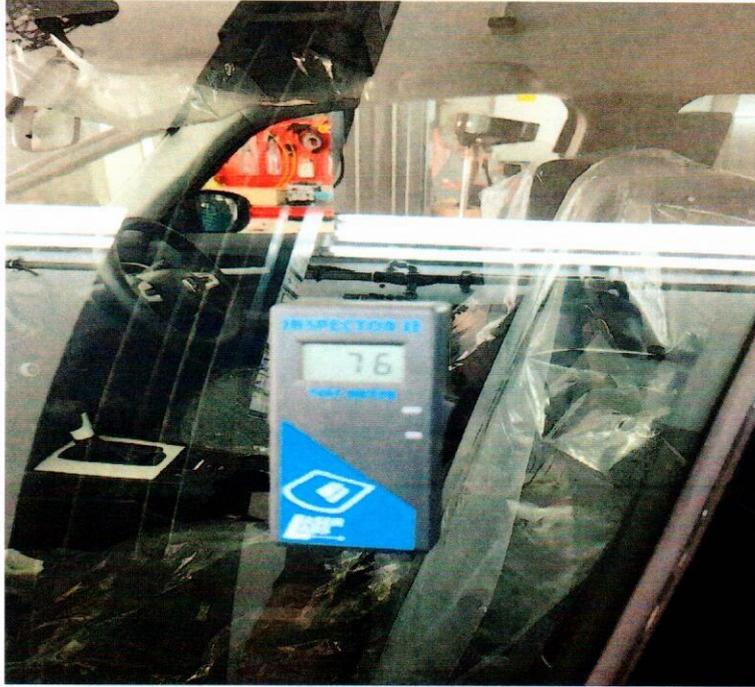
Front Windows VLT Reading: 76% (left)

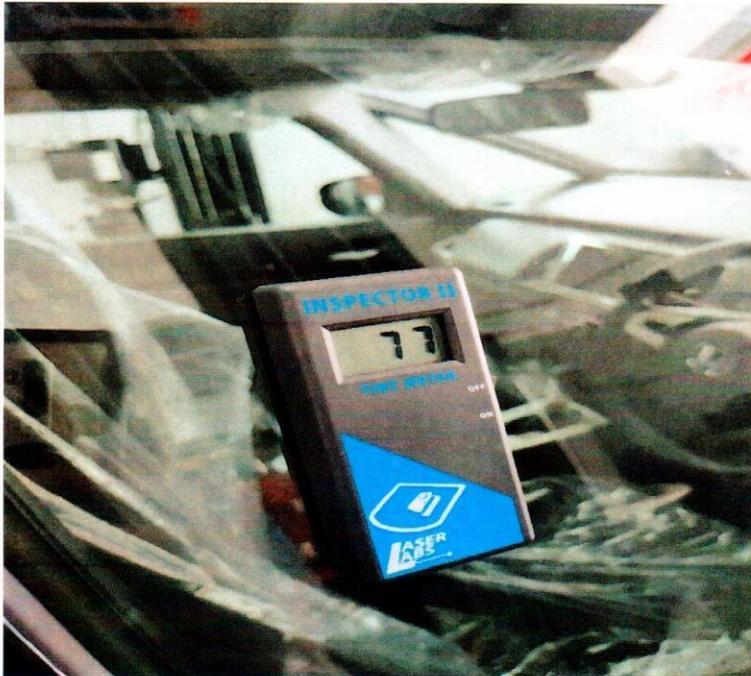
**Front Windows VLT Reading: 77% (right)**

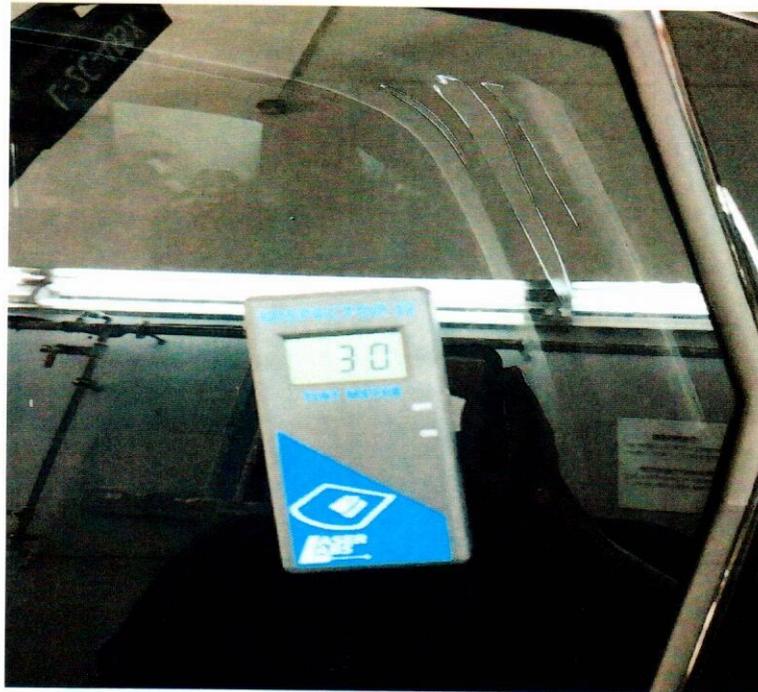
Rear Windows VLT Reading: 30% (left)

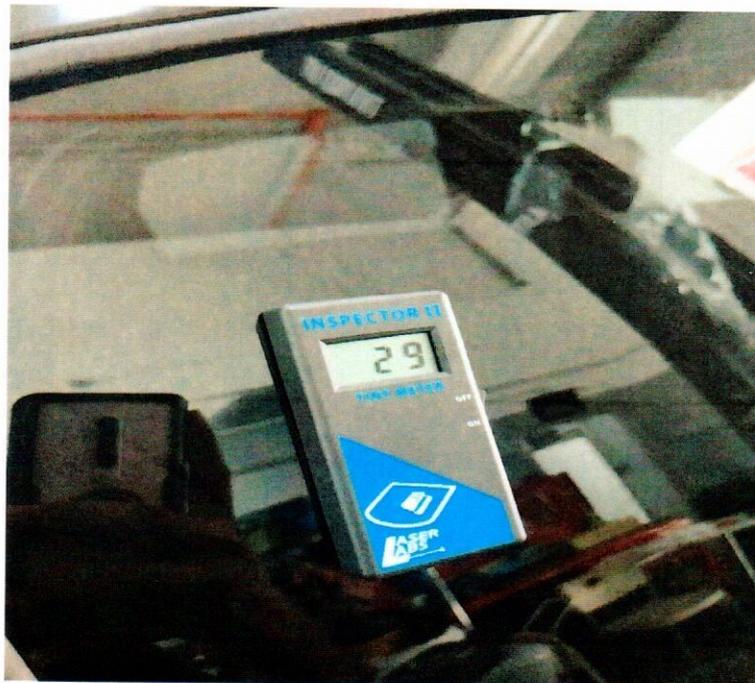
Rear Windows VLT Reading: 29% (right)

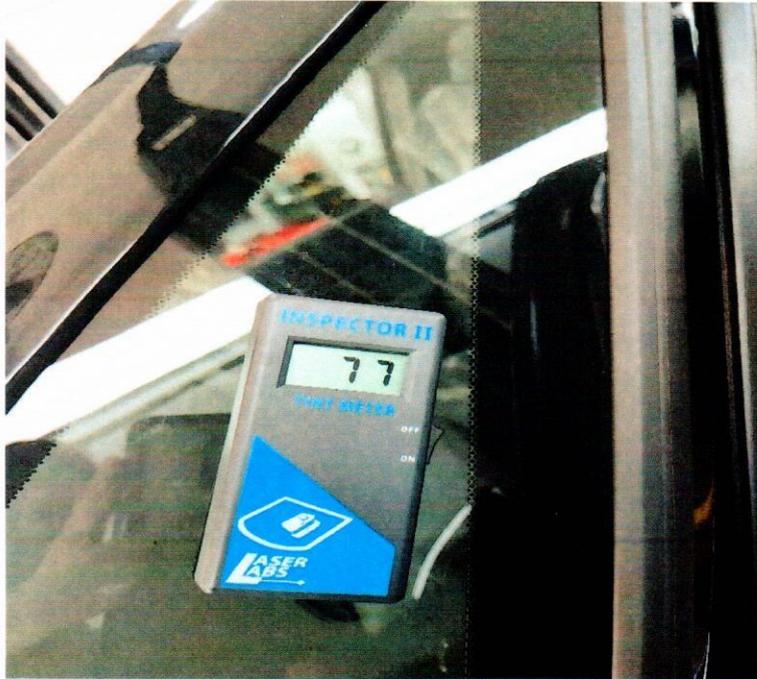
Front Quarter Glass VLT Reading: 77 % (Left)

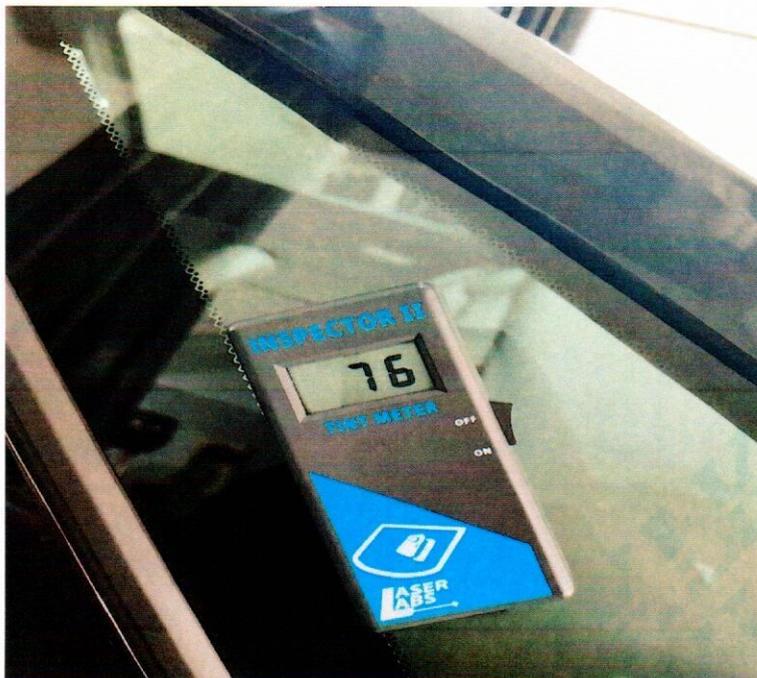
Front Quarter Glass VLT Reading: 76% (Right)

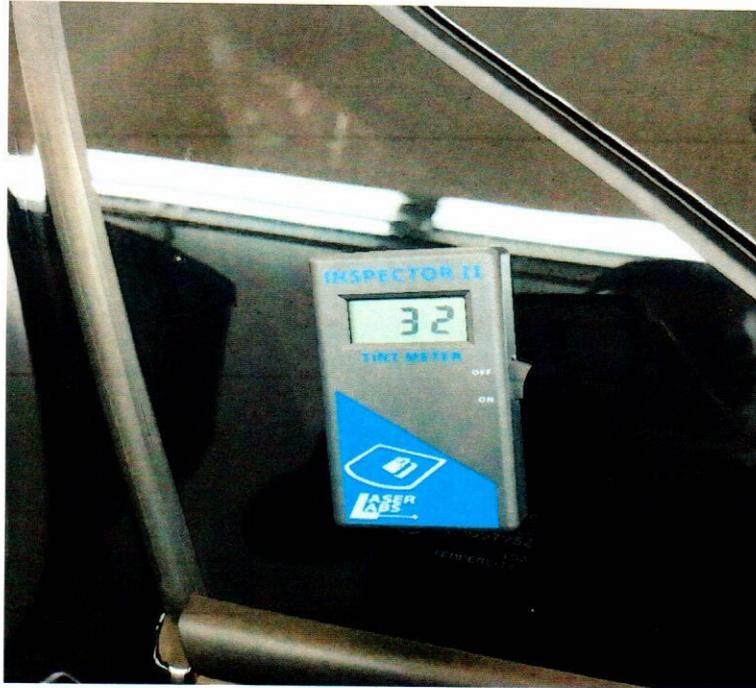
Rear Quarter Glass VLT Reading: 32% (Left)

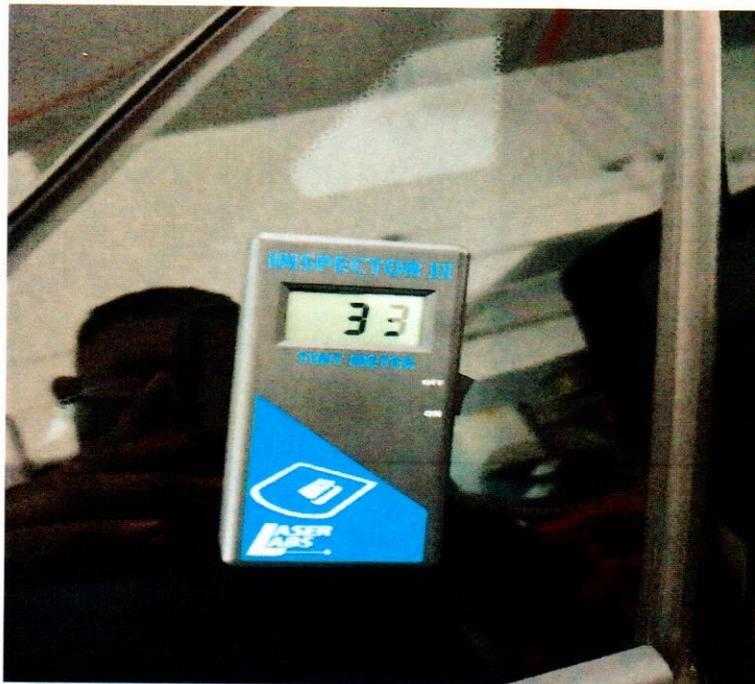
Rear Quarter Glass VLT Reading: 33% (Right)
