**LKK Auto Consultants Pte Ltd**

## INSPECTION CHECKLIST

Reference no: CS5/TP21011372/Cq

| Vehicle Make | HONDA |

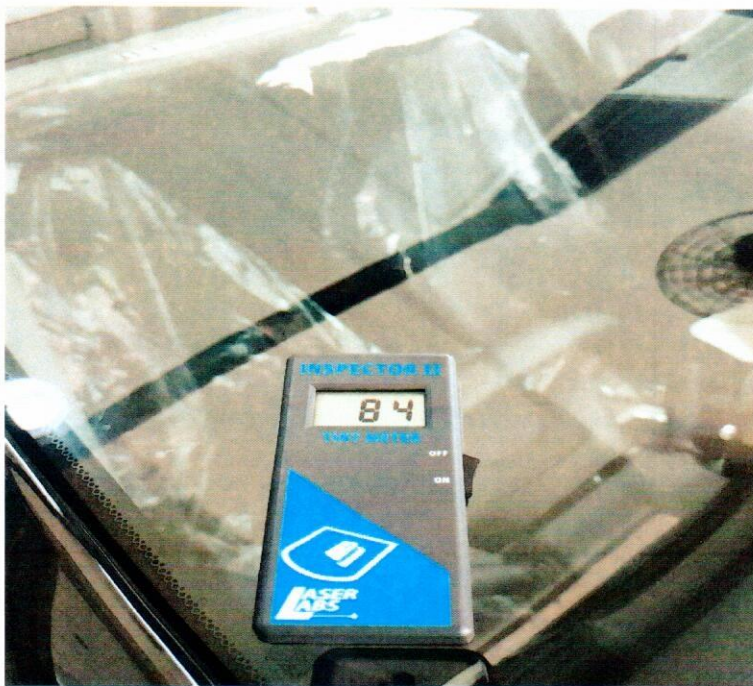
Windscreen VLT Reading: 84% (front)

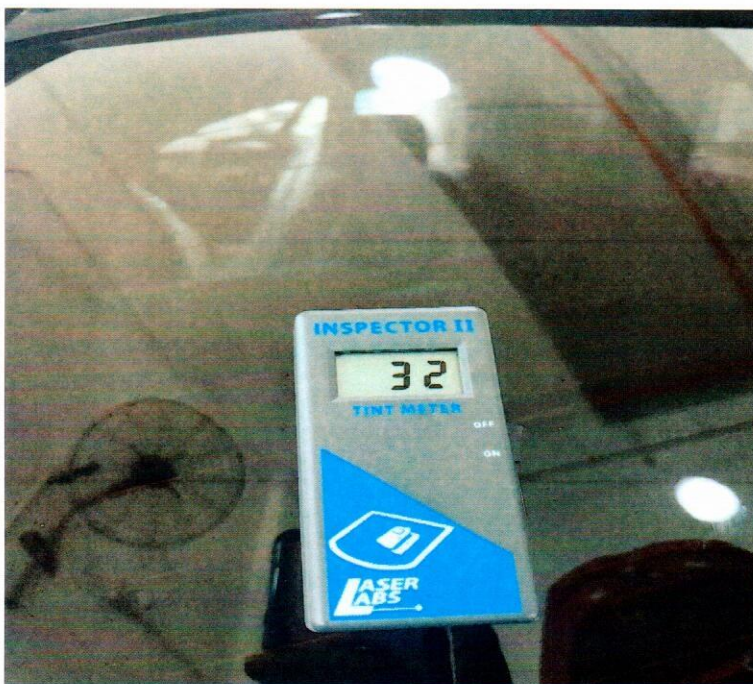
Windscreen VLT Reading: 32% (rear)

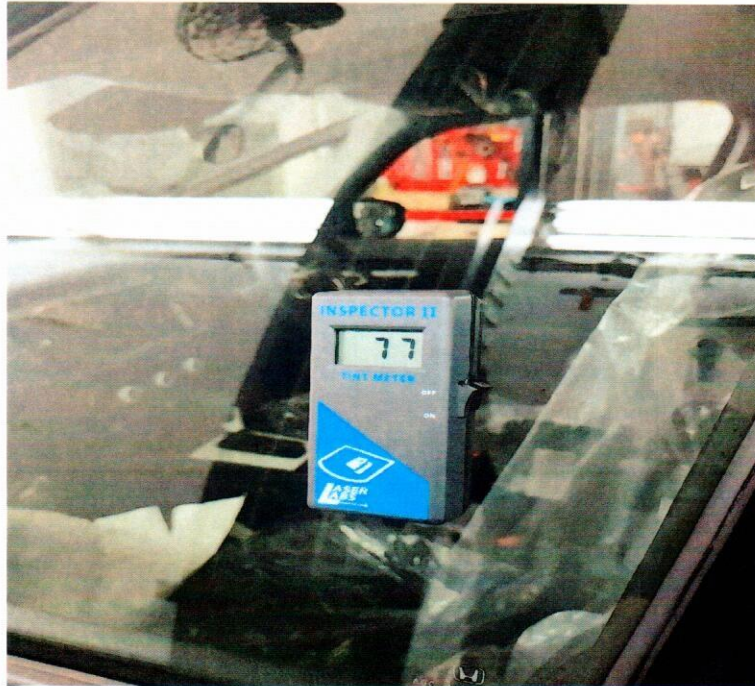
### Front Windows VLT Reading: 77% (left)

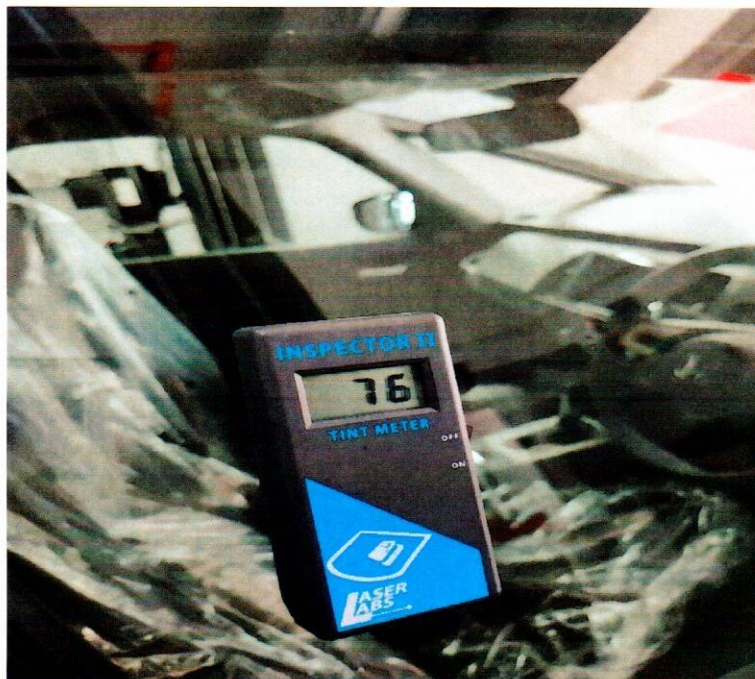
### Front Windows VLT Reading: 76% (right)

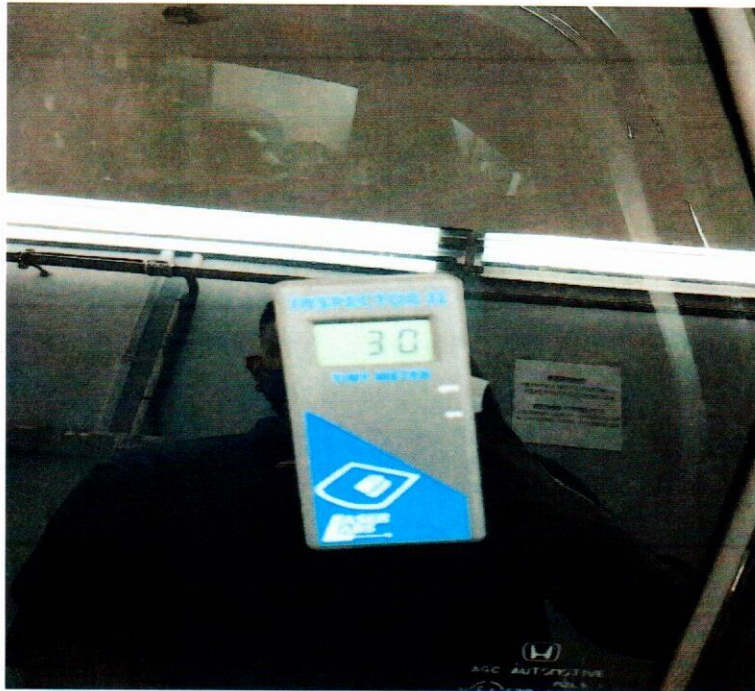
### Rear Windows VLT Reading: 30% (left)

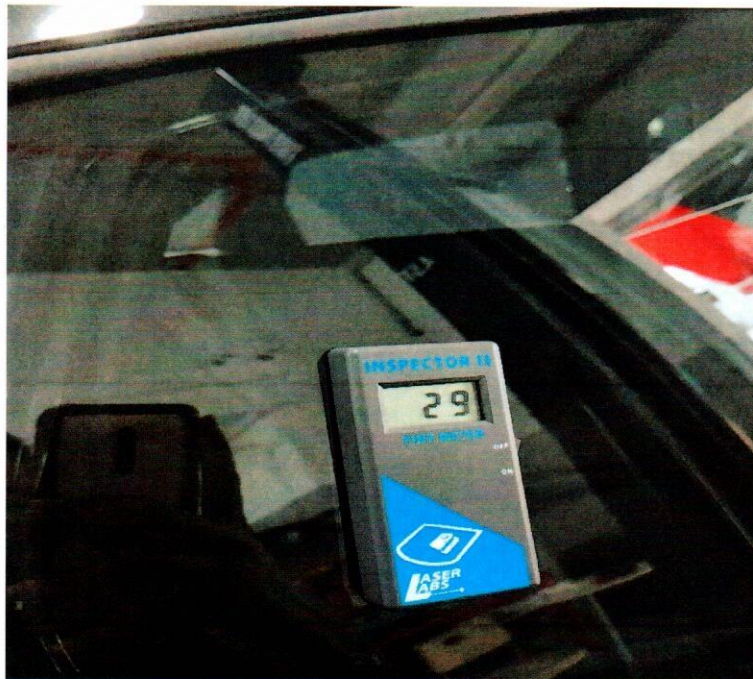
### Rear Windows VLT Reading: 29% (right)

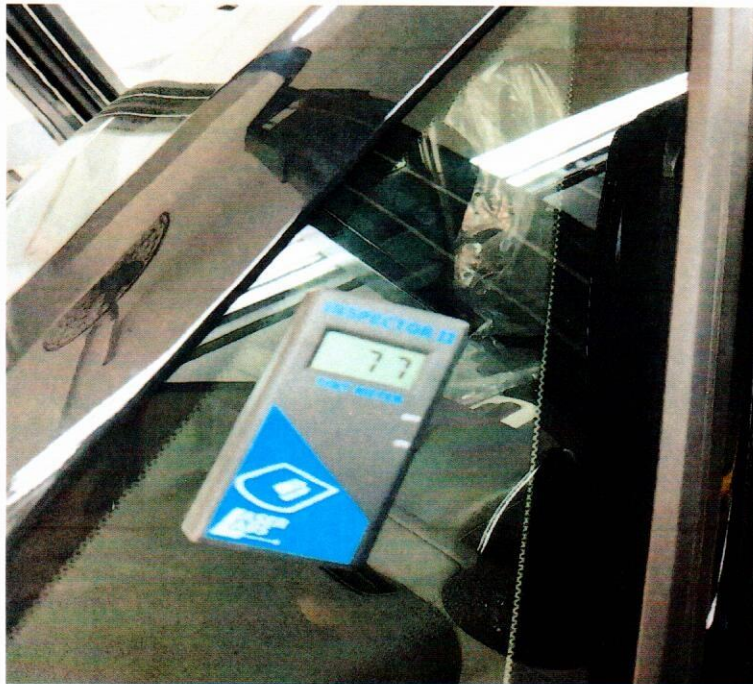
### Front Quarter Glass VLT Reading: 77 % (Left)

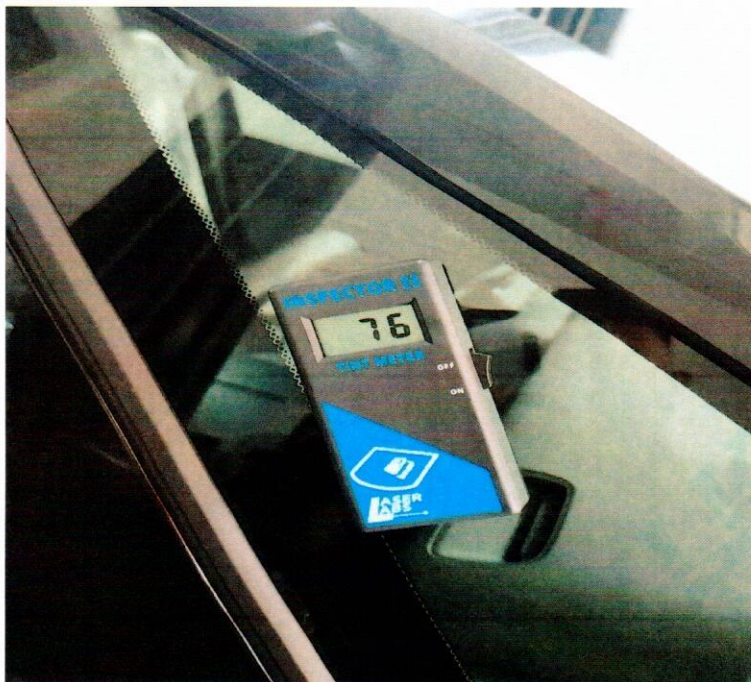
### Front Quarter Glass VLT Reading: 76% (Right)

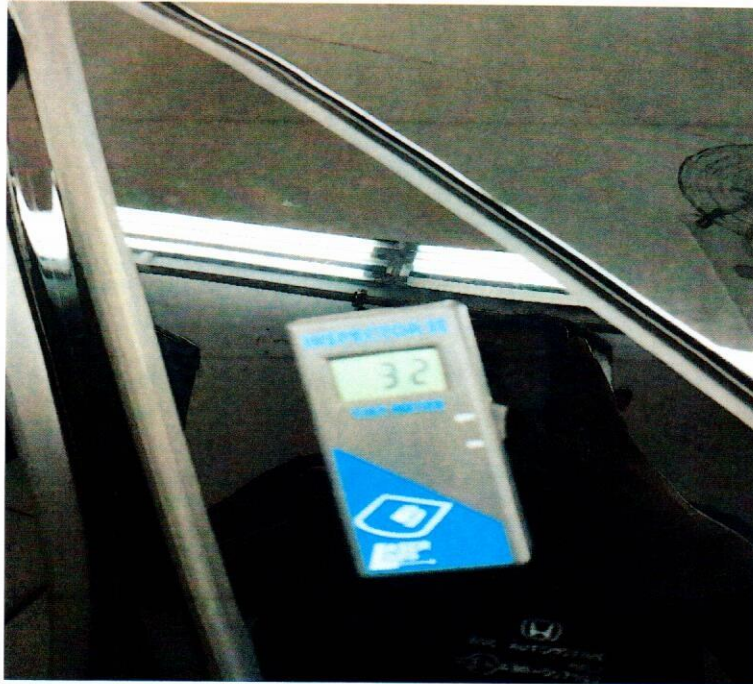
### Rear Quarter Glass VLT Reading: 32% (Left)

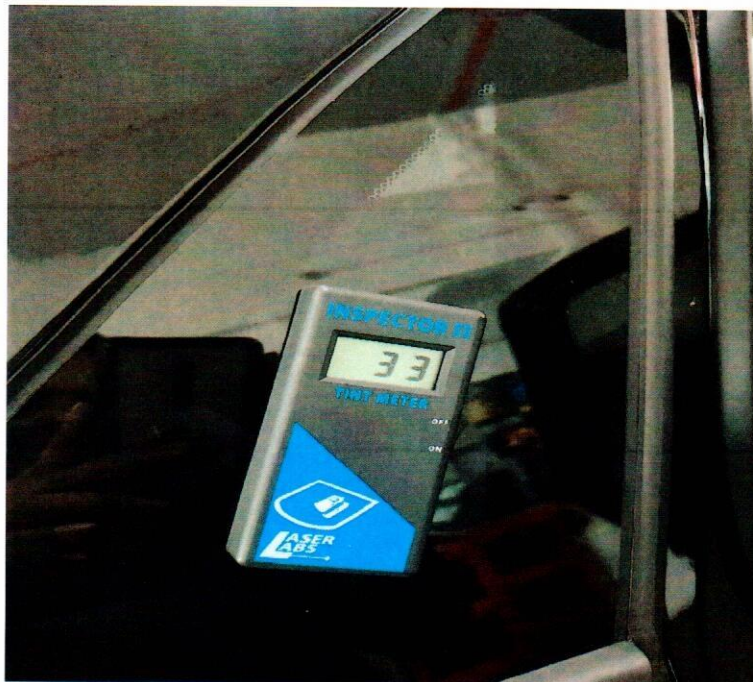
### Rear Quarter Glass VLT Reading: 33% (Right)
