LKK Auto Consultants Pte Ltd

INSPECTION CHECKLIST

Reference no: CS5/TP21011373/Cq

Applicant	VENTURE CARS PTE LTD
Date of Inspection	9/11/2021
Time of Inspection	14:30 HRS
Vehicle Make	HONDA
Vehicle Model	FIT 1.3 BASIC
Vehicle Model Code	6BA-GR1
Engine Number	L13B1604675
Chassis Number	GR11103575
Motor Number (if any)	-
Odometer Reading	10 KM

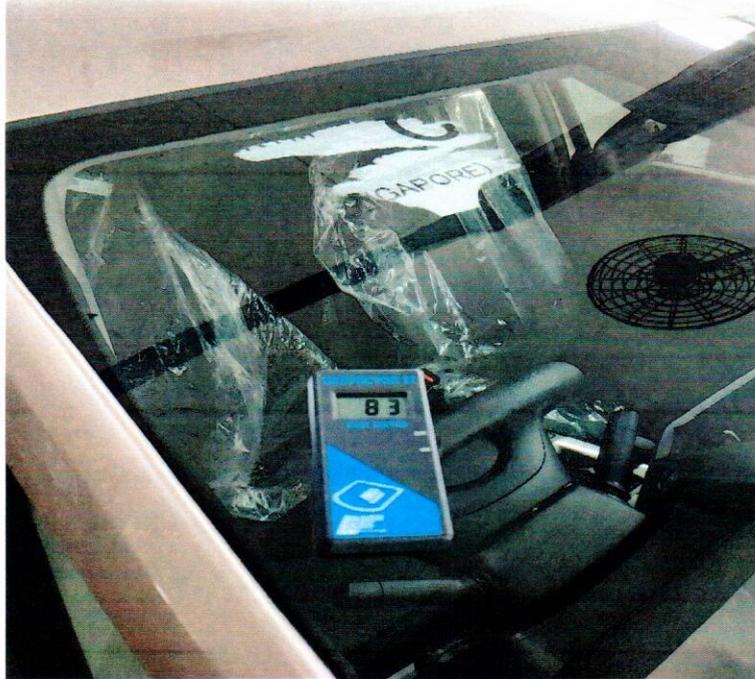
Windscreen VLT Reading: 83% (front)

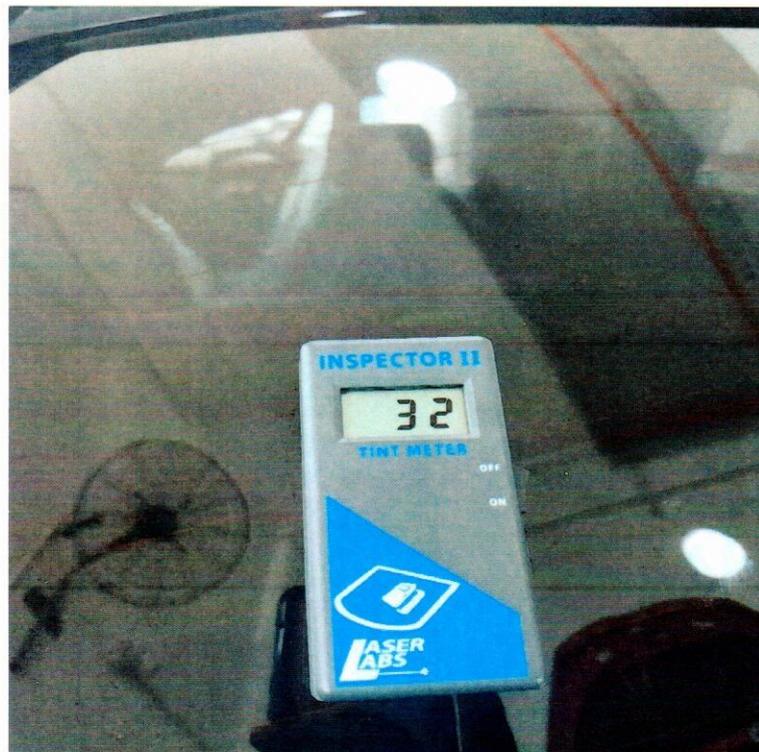
Windscreen VLT Reading: 32% (rear)

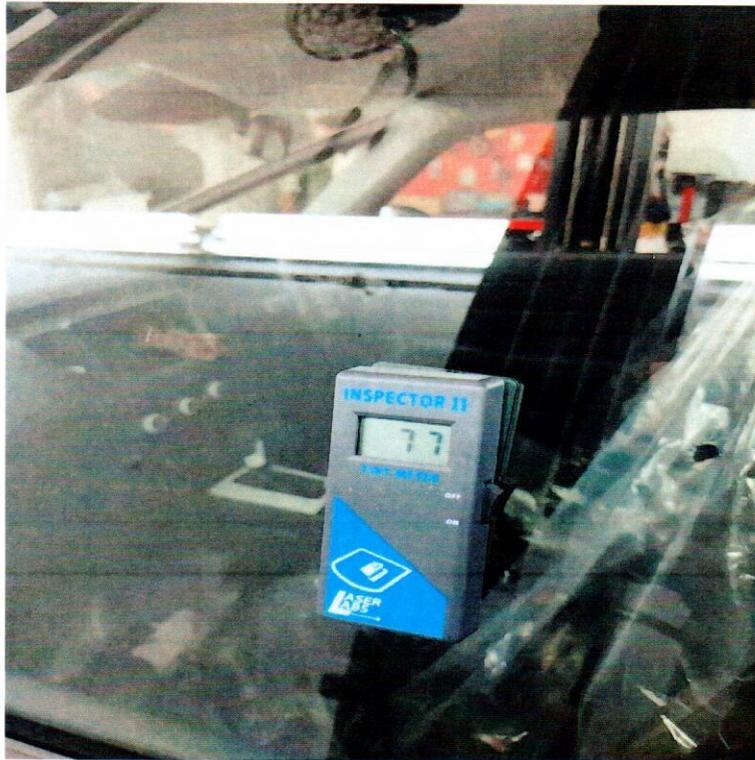
Front Windows VLT Reading: 77% (left)

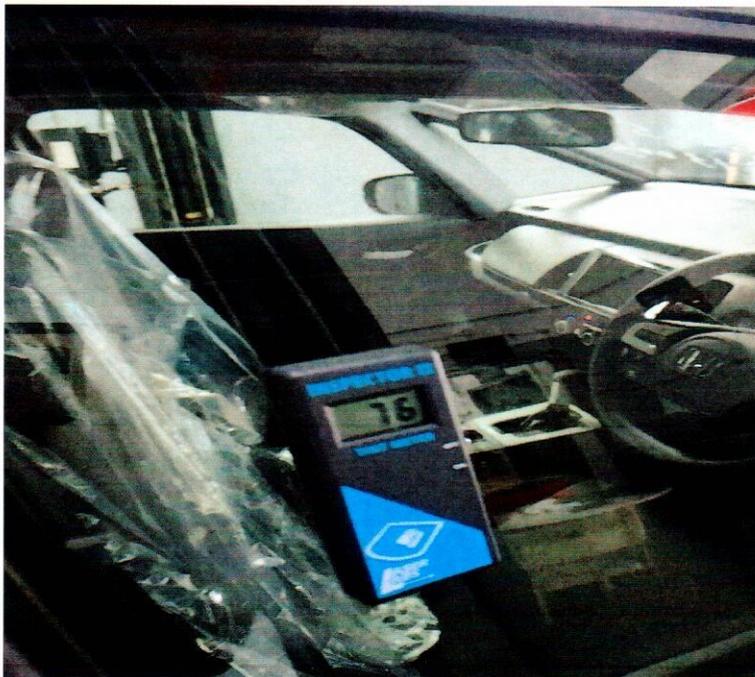
Front Windows VLT Reading: 76% (right)

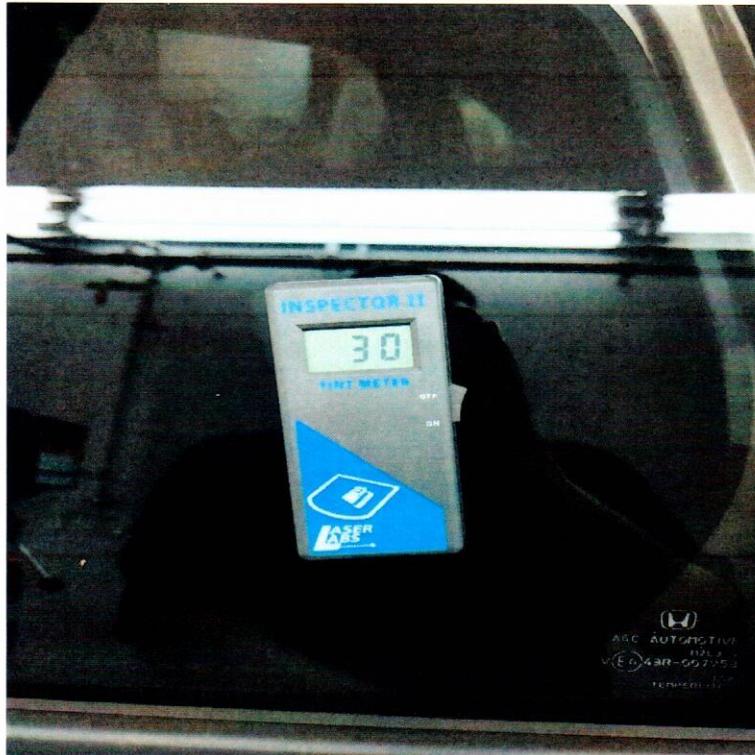
Rear Windows VLT Reading: 30% (left)

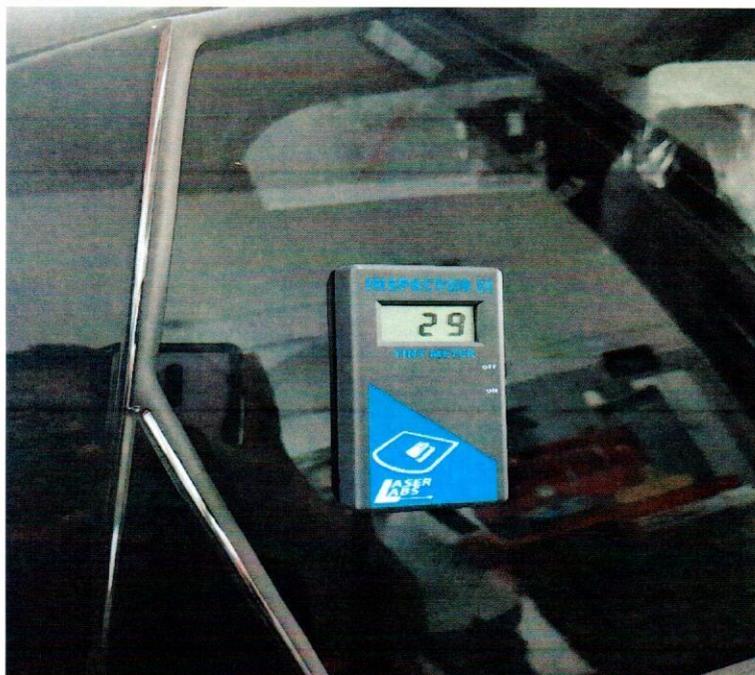
Rear Windows VLT Reading: 29% (right)

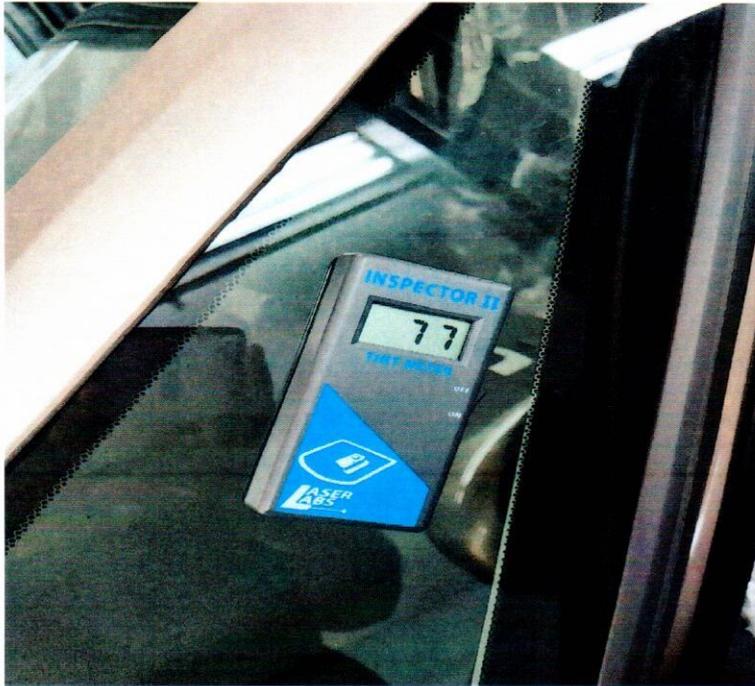
Front Quarter Glass VLT Reading: 77 % (Left)

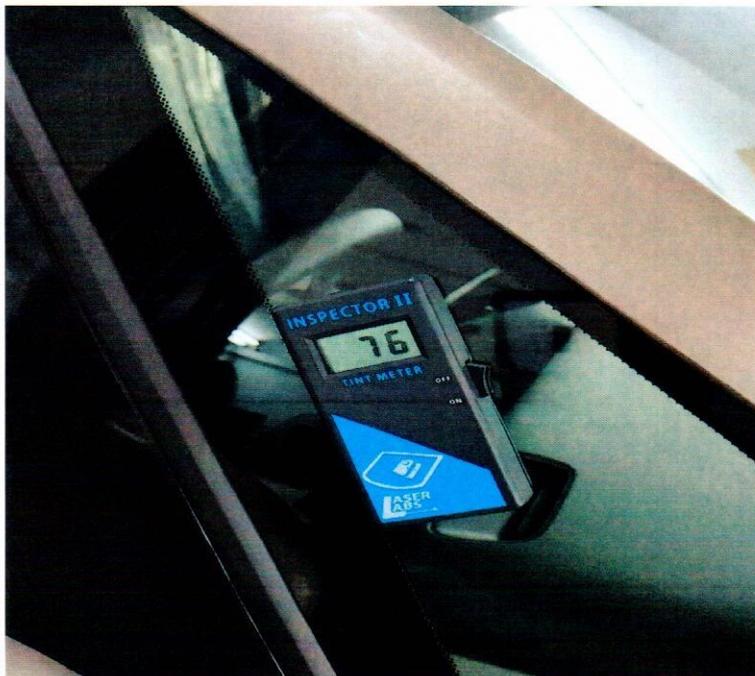
Front Quarter Glass VLT Reading: 76% (Right)

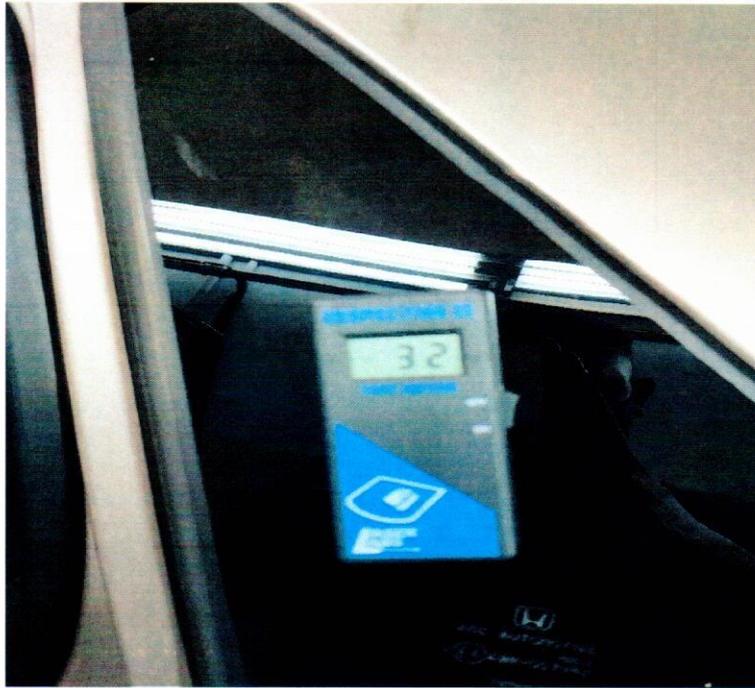
Rear Quarter Glass VLT Reading: 32% (Left)

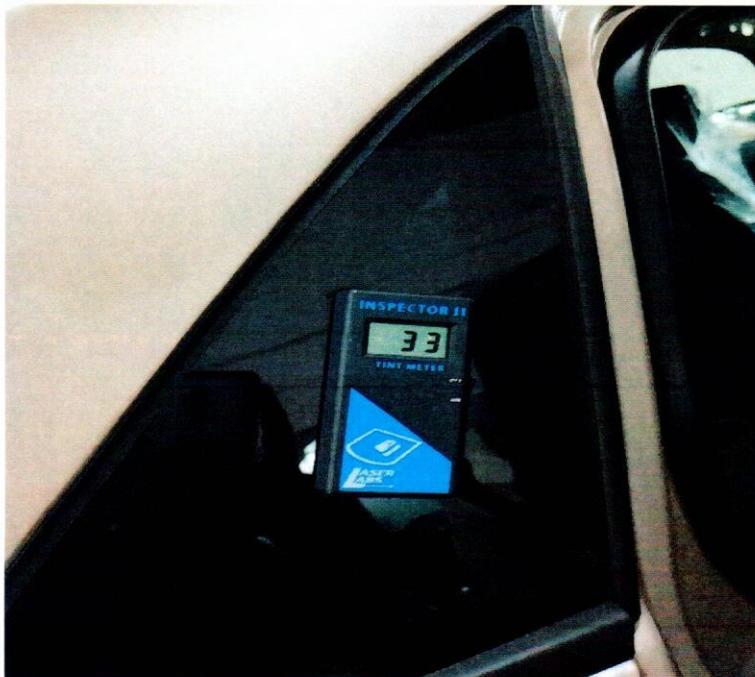
Rear Quarter Glass VLT Reading: 33% (Right)
