Your Ref: Mercedes Benz C300  
(chassis number W1K2050832R608813)  
Our Ref : CI/TP21011427/D

09 November 2021

**INSPECTION REPORT OF AN UNREGISTERED MERCEDES BENZ C300  
MOTOR CAR WITH CHASSIS NUMBER W1K2050832R608813**

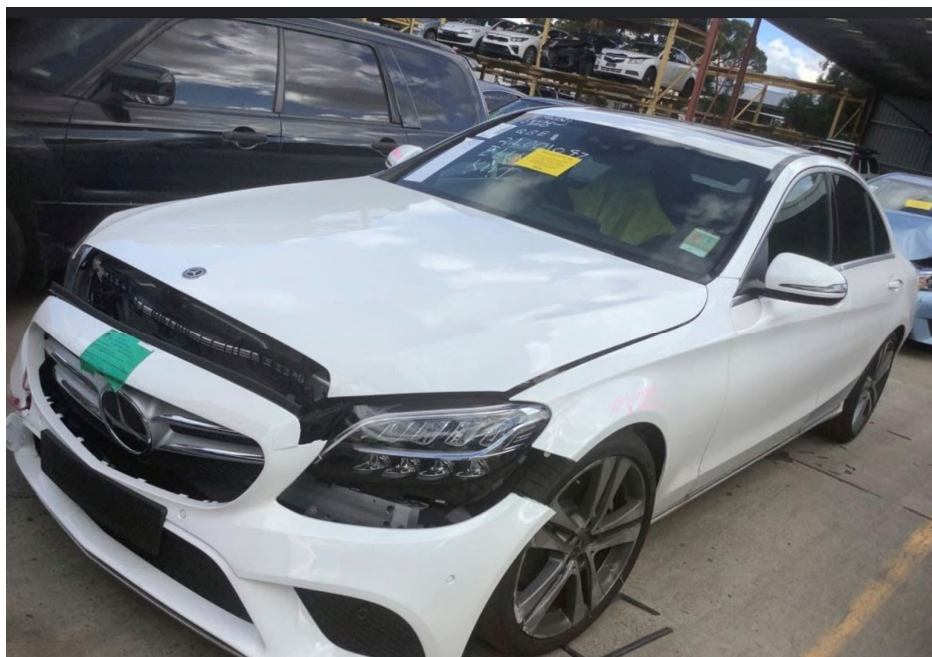
**Photo 1** shows the front left body of the Motor Car (photograph provided to me). The Motor Car was observed to have sustained damage at its frontal portion. Body parts damaged include the front bumper and radiator grille amongst others.

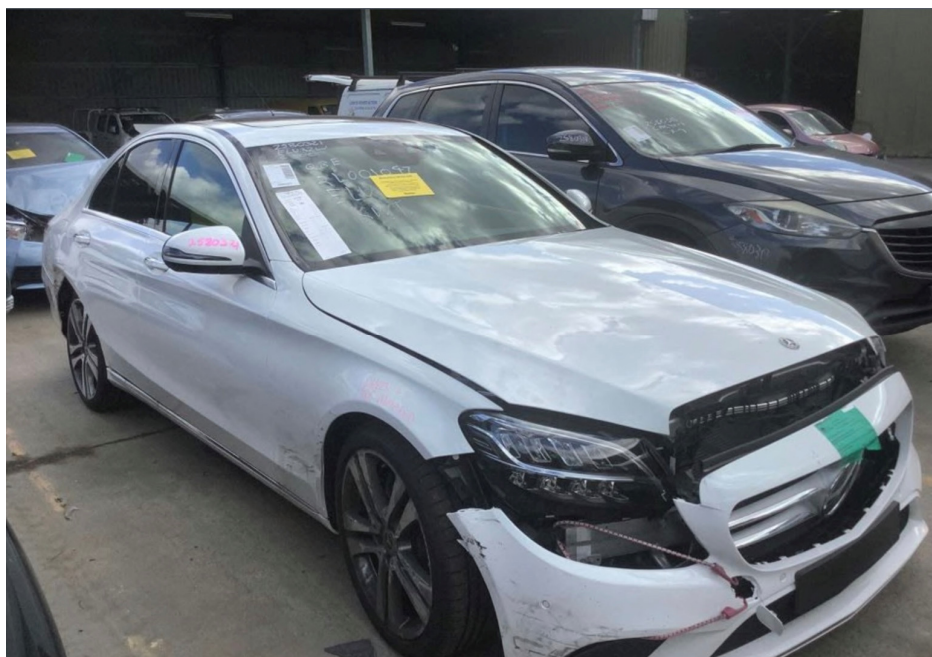
**Photo 2** shows the front right body of the Motor Car (photograph provided to me). The Motor Car was observed to have sustained damage at its frontal portion. Body parts damaged include the front bumper and radiator grille amongst others.

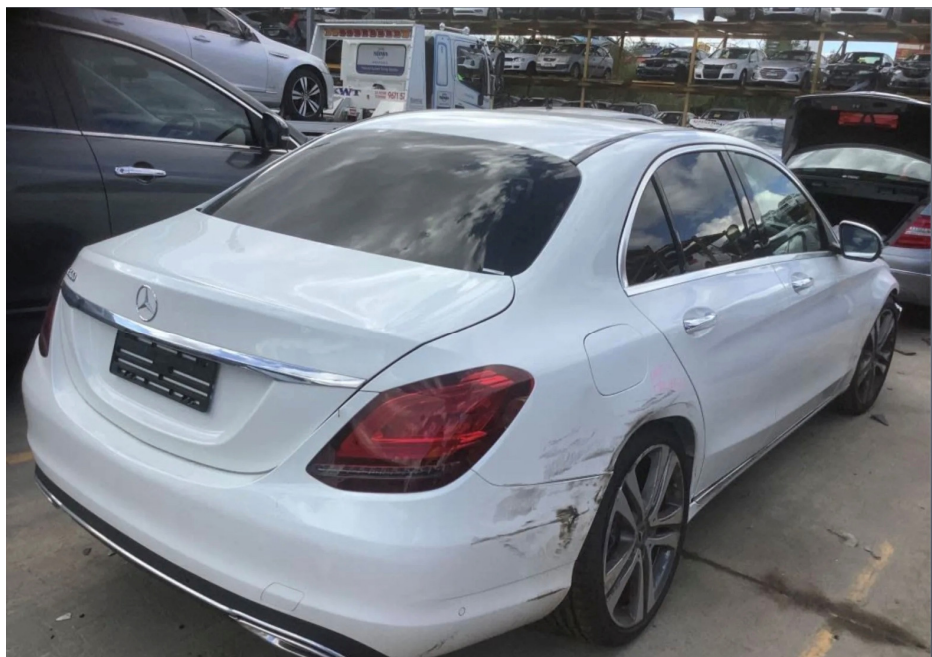
**Photo 3** shows the rear right body the Motor Car (photograph provided to me). Apart for the frontal portion, I had also observed damage to the rear right portion of the Motor Car. Body parts damaged include the rear bumper and rear right fender amongst others.

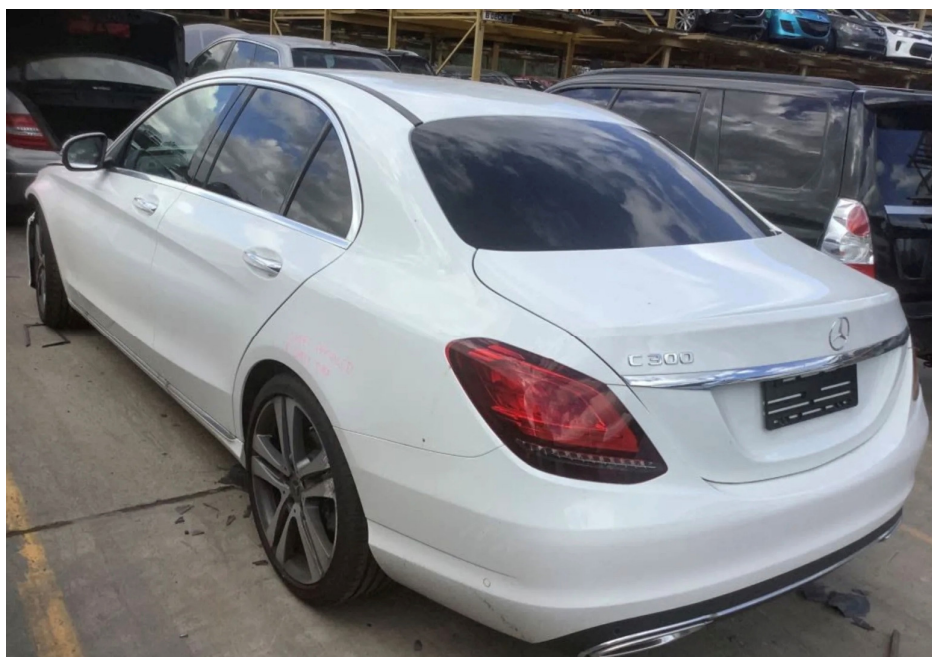
**Photo 4** shows the rear left body the Motor Car (photograph provided to me). No physical damage was observed to the left side of the Motor Car.

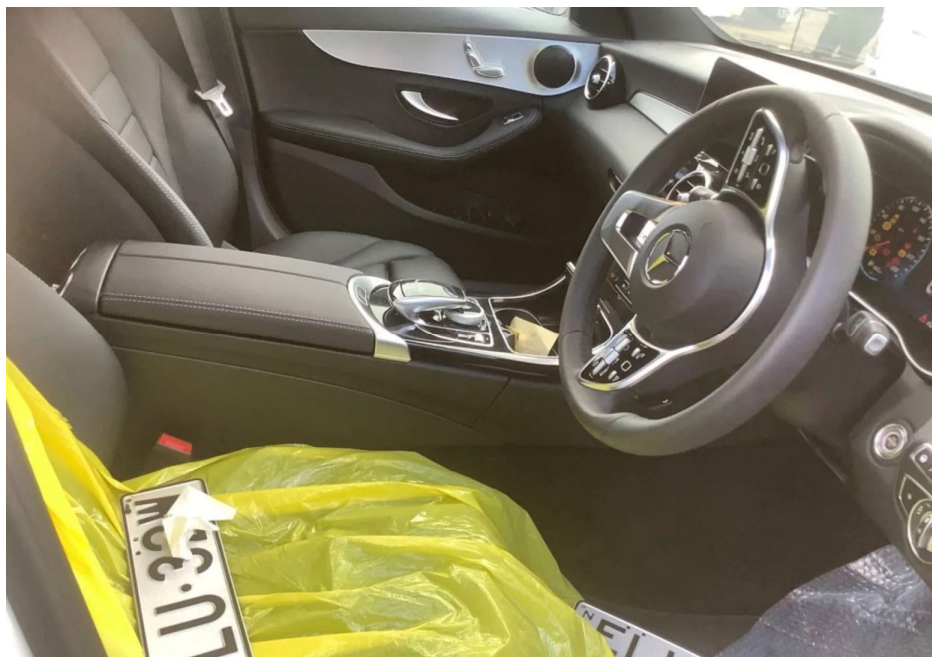
**Photo 5** shows the interior compartment of the Motor Car (photograph provided to me). The various parts and components, upholstery, carpet and inner trims were all intact and undamaged. The airbag(s) of the Motor Car was not deployed as seen from the photographs that were provided to me.

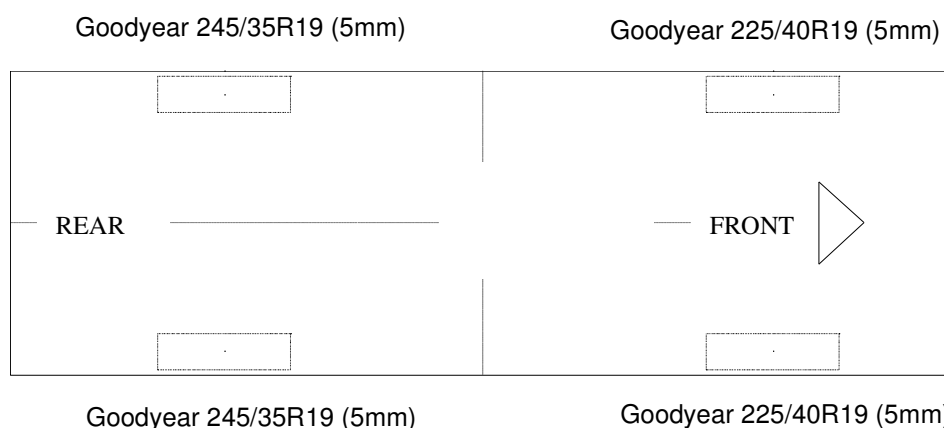
8. The Motor Car was fitted with 19inch sport wheel rims that were wrapped with tyres that were observed to be of serviceable condition. The tyres were also sufficiently inflated for vehicular operation. The tyre brand, tyre size and approximate remaining tread depth of the 4 tyres of the Motor Car were recorded as follows: -

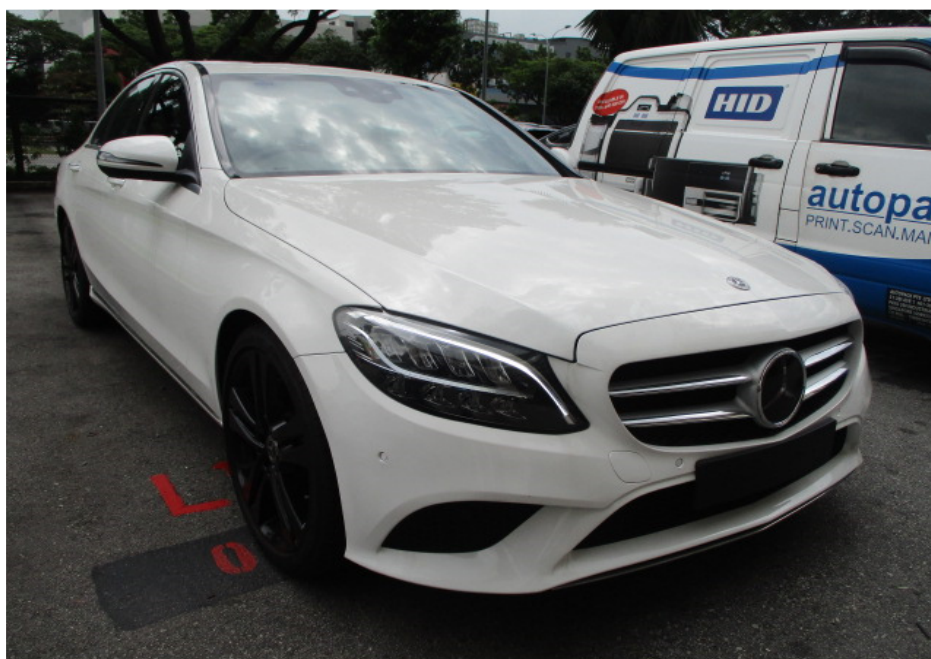
**Photo 6** shows a general view of the front right body of the Motor Car at the time of my inspection. The Motor Car was observed to be in a relatively good general condition with no loose exterior fittings observed. The body parts at the frontal portion of the Motor Car were visually examined and it was observed that the repair/restoration works carried out to the damaged area of the Motor Car (refer to photograph 1 & 2 above) were reasonably adequate and in order.

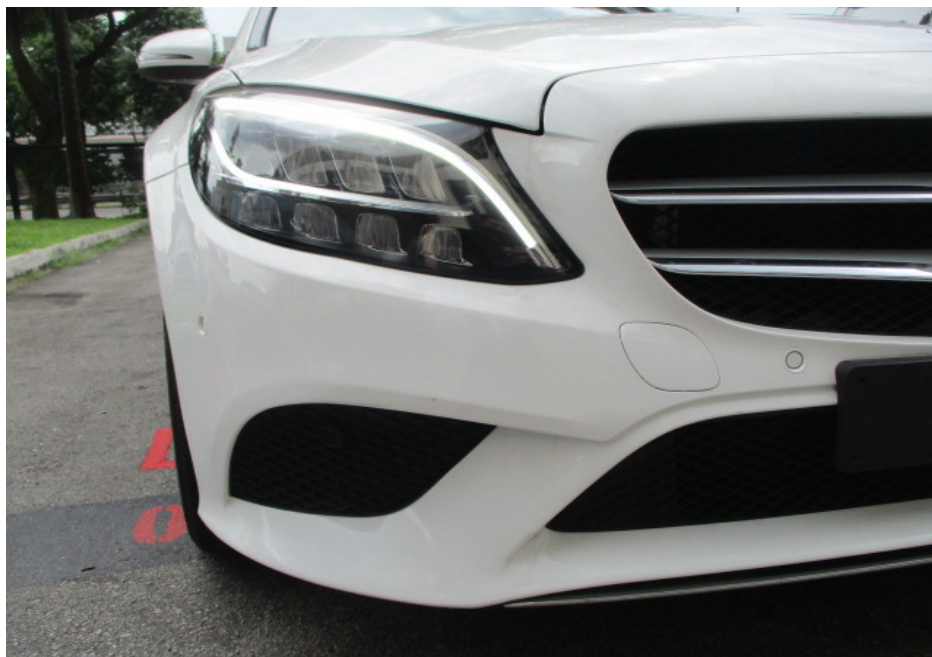
**Photo 7** shows a closer view of the Motor Car's front bumper, front bumper right lower grille and front right headlamp. The body parts at the frontal portion of the Motor Car were visually examined and it was observed that the repair/restoration works carried out to the damaged area of the Motor Car (refer to photograph 1 & 2 above) were reasonably adequate and in order.

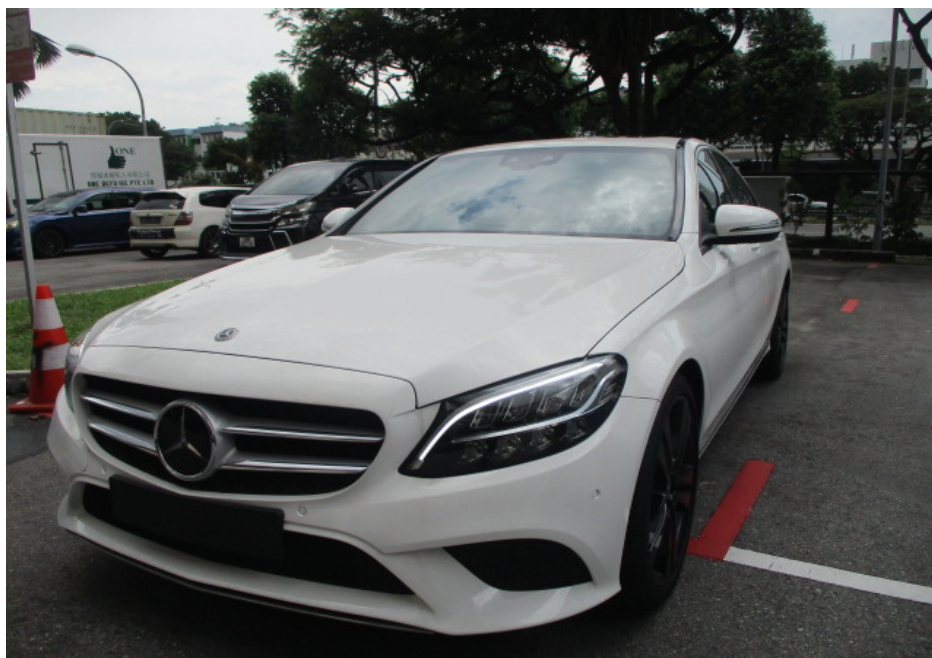
**Photo 8** shows a general view of the front left body of the Motor Car at the time of my inspection. The Motor Car was observed to be in a relatively good general condition with no loose exterior fittings observed. The body parts at the frontal portion of the Motor Car were visually examined and it was observed that the repair/restoration works carried out to the damaged area of the Motor Car (refer to photograph 1 & 2 above) were reasonably adequate and in order.

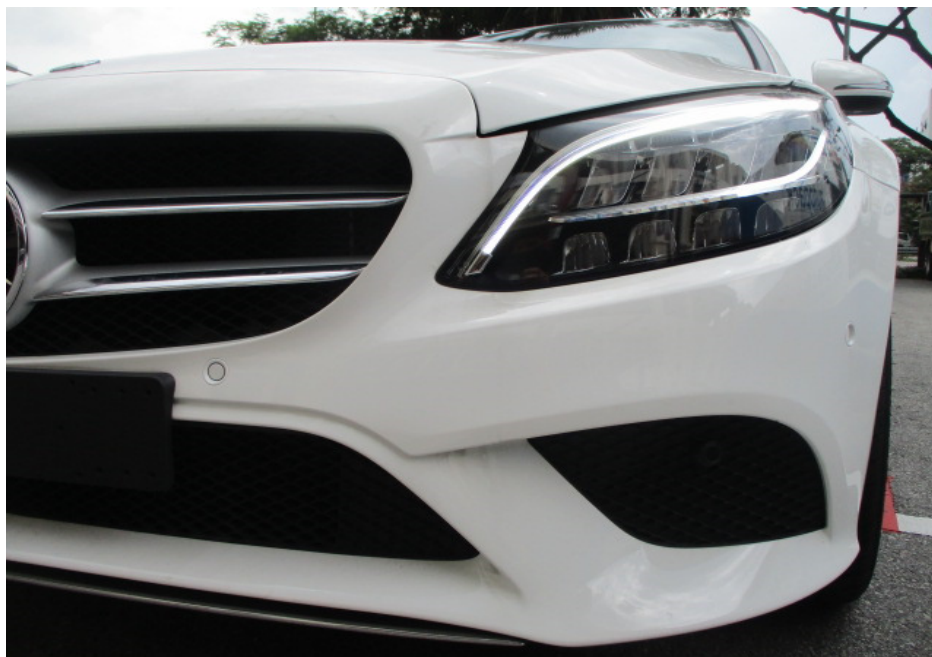
**Photo 9** shows a closer view of the Motor Car's front bumper, front bumper left lower grille and front left headlamp. The body parts at the frontal portion of the Motor Car were visually examined and it was observed that the repair/restoration works carried out to the damaged area of the Motor Car (refer to photograph 1 & 2 above) were reasonably adequate and in order.

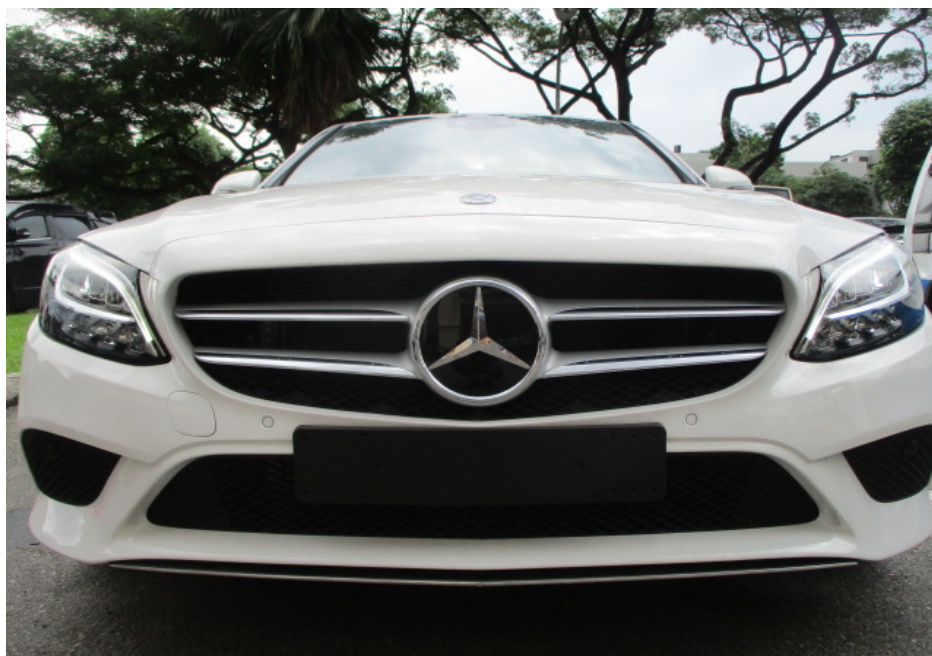
**Photo 10** shows a closer view of the Motor Car's front bumper, radiator grille and radiator grille emblem. The body parts at the frontal portion of the Motor Car were visually examined and it was observed that the repair/restoration works carried out to the damaged area of the Motor Car (refer to photograph 1 & 2 above) were reasonably adequate and in order.

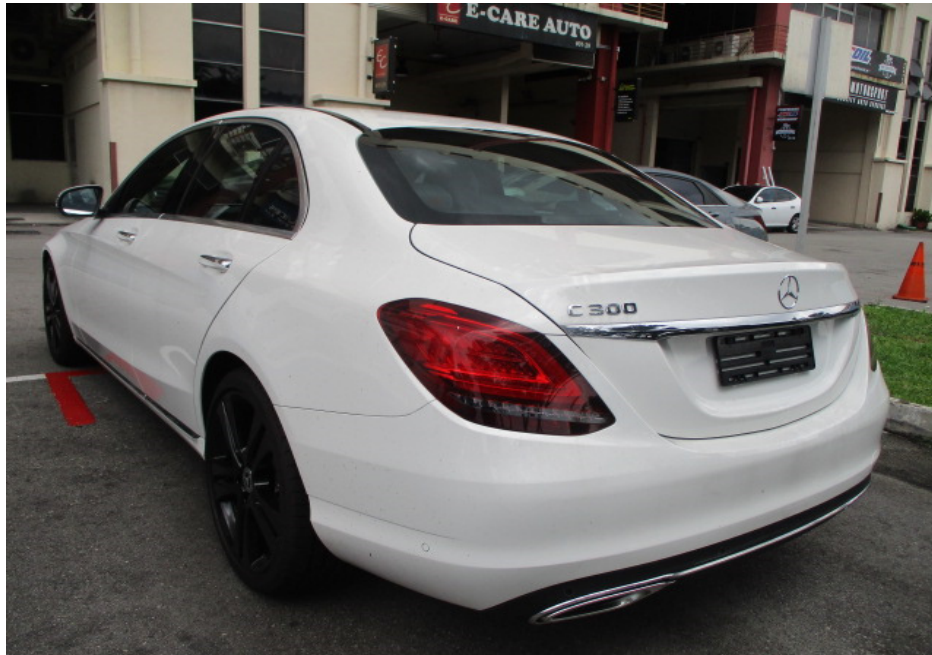
**Photo 11** shows a general view of the rear left body of the Motor Car at the time of my inspection. The Motor Car was observed to be in a relatively good general condition with no loose exterior fittings observed. The mileage of the Motor Car recorded at the time of my inspection was 987km.

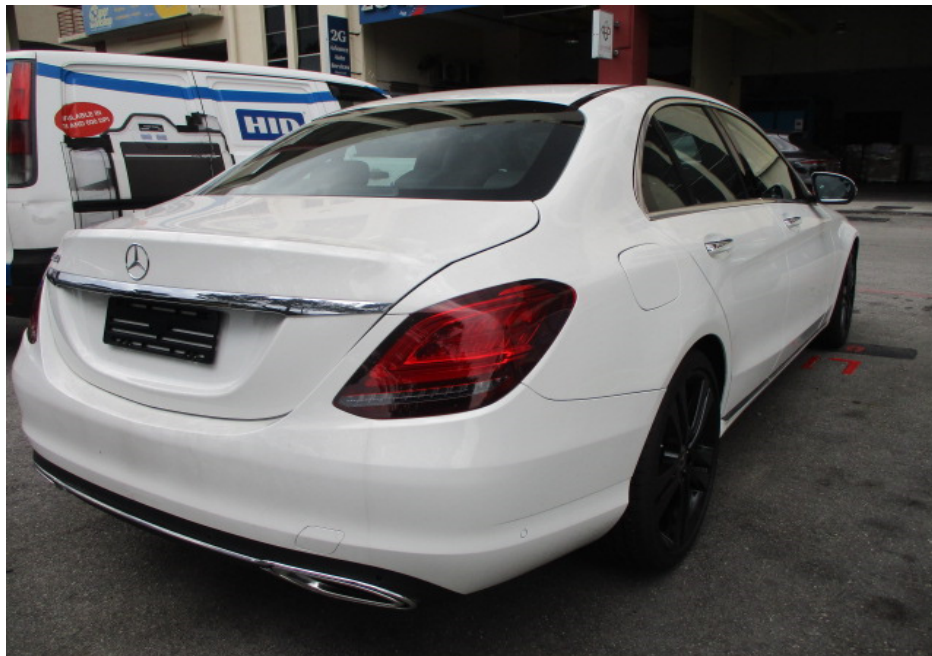
**Photo 12** shows a general view of the rear right body of the Motor Car at the time of my inspection. The Motor Car was observed to be in a relatively good general condition with no loose exterior fittings observed. The body parts at the rear right portion of the Motor Car were visually examined and it was observed that the repair/restoration works carried out to the damaged area of the Motor Car (refer to photograph 3 above) were reasonably adequate and in order.

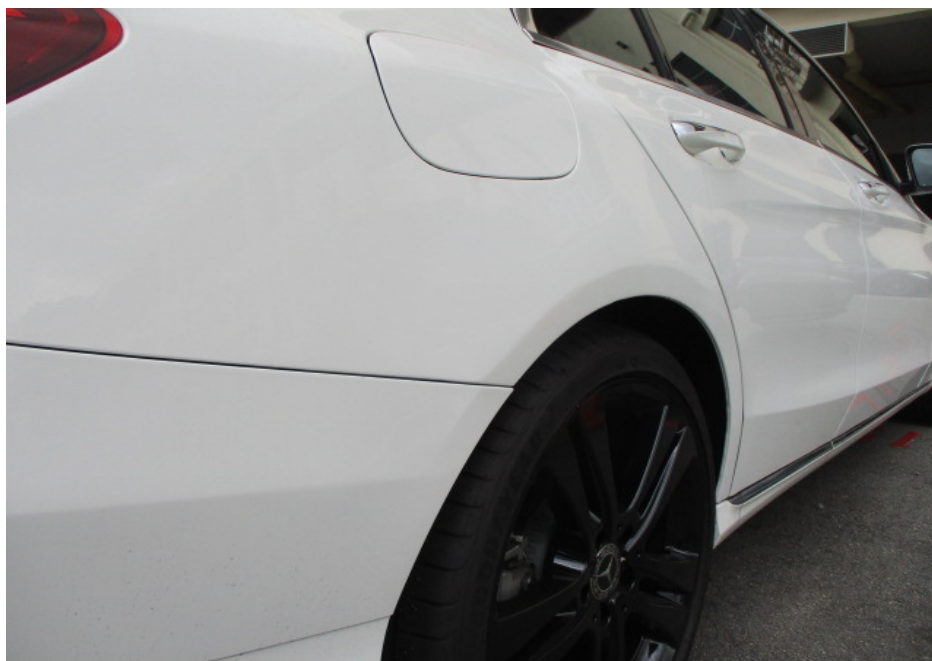
**Photo 13** shows a closer view of the Motor Car's rear bumper and rear right fender. The body parts at the rear right portion of the Motor Car were visually examined and it was observed that the repair/restoration works carried out to the damaged area of the Motor Car (refer to photograph 3 above) were reasonably adequate and in order.

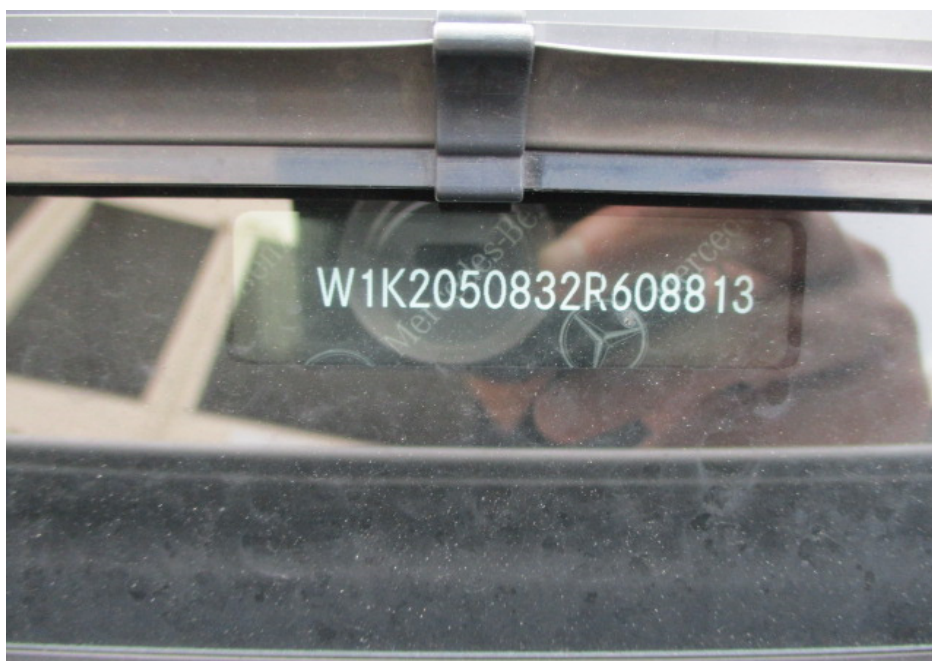
**Photo 14** shows the chassis number of the Motor Car. The chassis number recorded was W1K2050832R608813.

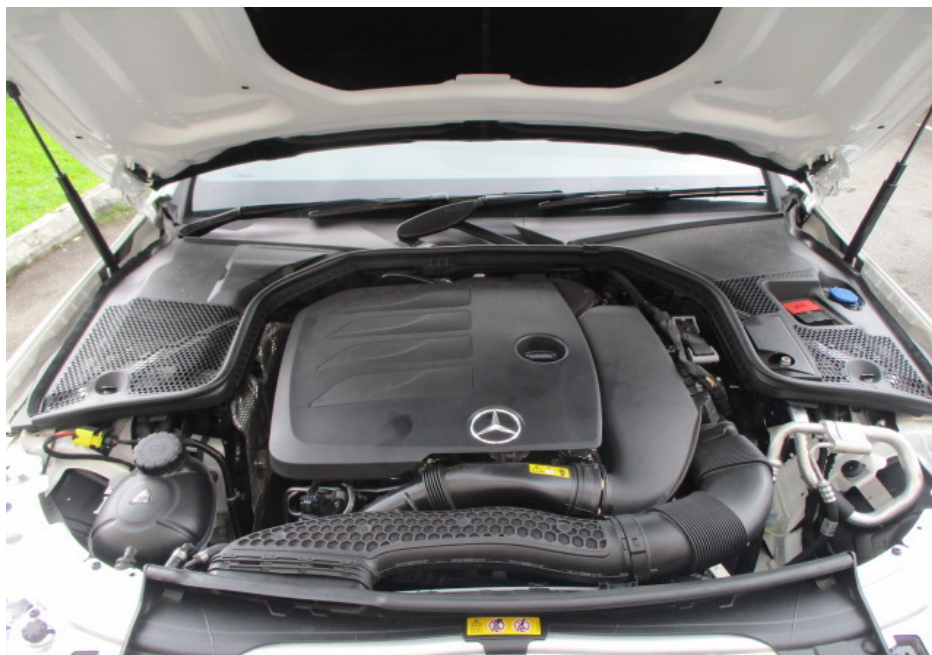
**Photo 15** shows a general view of the engine compartment of the Motor Car at the time of my inspection. The various parts and components inside the engine compartment were all observed to be intact and properly fitted. There was also no sign(s) or indication(s) of fluid leak and/or fluid stain found inside the engine compartment.

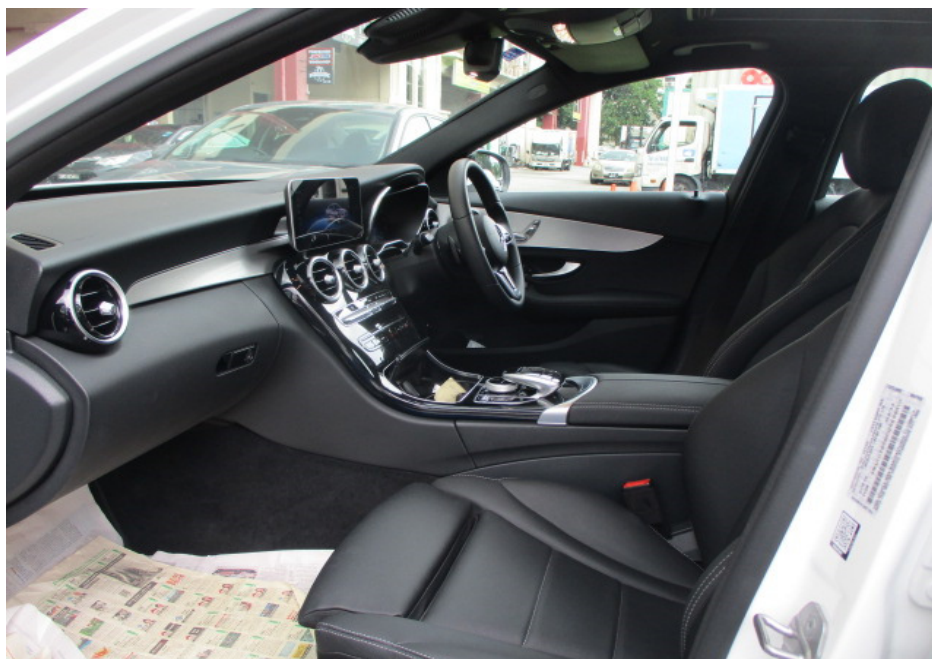
**Photo 16** shows the interior compartment of the Motor Car at the time of my inspection. The various parts and components, trims, carpet and upholstery inside the interior compartment were all observed to be intact and properly fitted.

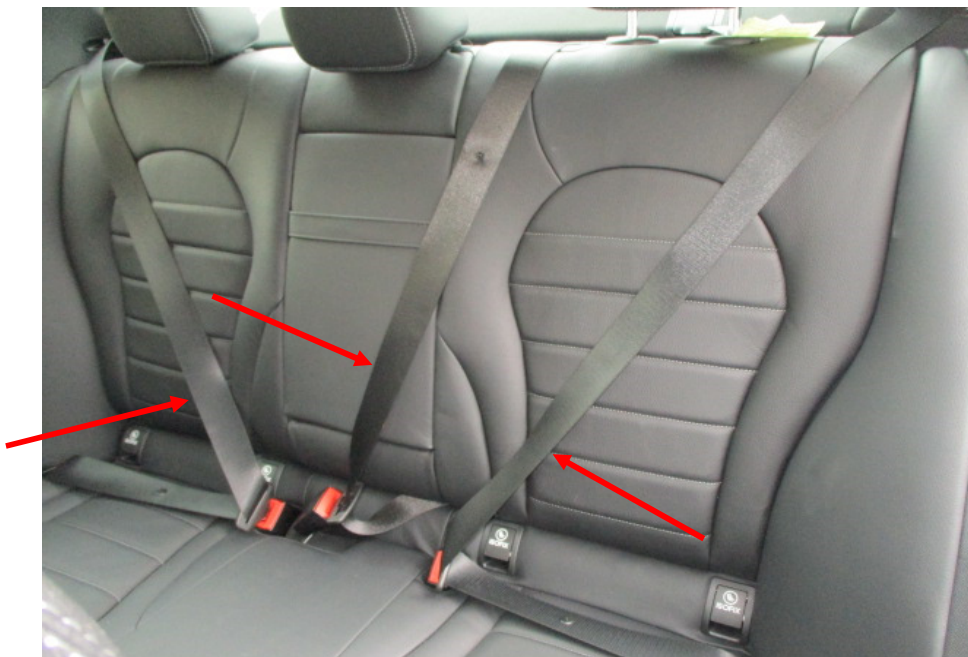
**Photo 17** shows the rear seats of the Motor Car. All the seats of the Motor Car were secured via seat rails to the floorboard. They were also fitted with a retractable seat belt reel and a pre-tensioner. The seat belts (arrowed) were tested and were able to be fastened into the respective pre-tensions that were fitted on the side of each individual seat.

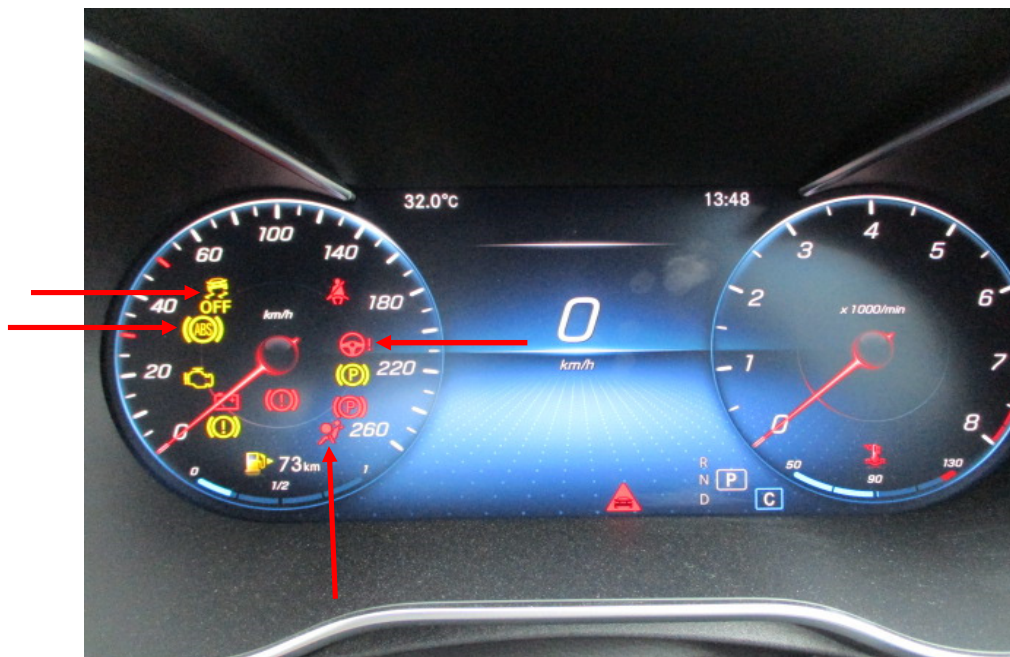
**Photo 18** shows the warning lights for the various electronic safety features appearing on the instrument panel of the Motor Car during its self-test when the engine is cranked, in particular the ABS, SRS, EPS and TCS lights (arrowed).

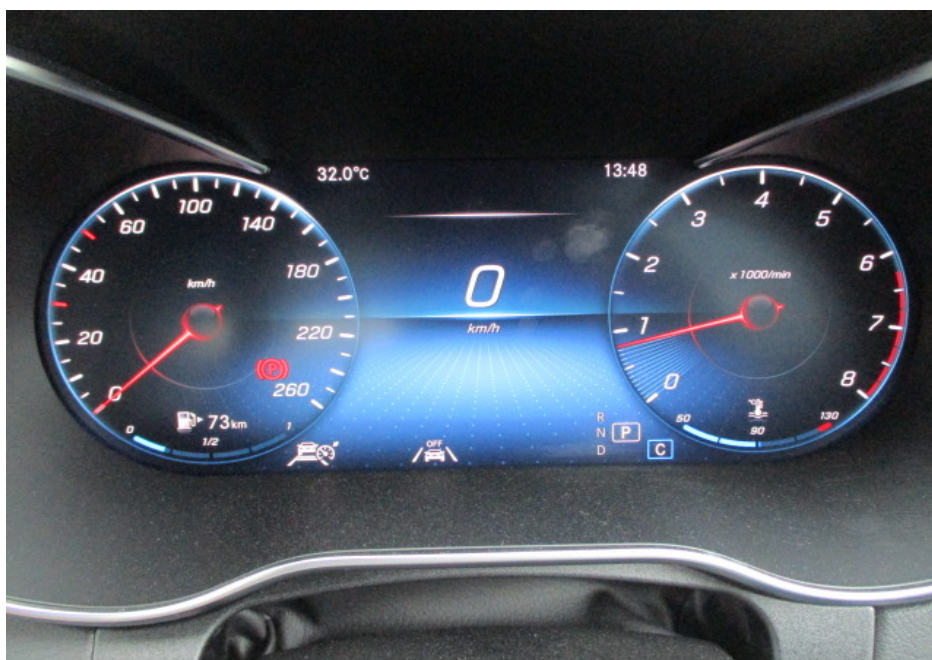
**Photo 19** shows the respective warning lights no longer illuminated, indicating that there is no fault detected to the ABS, SRS, EPS and TCS systems of the Motor Car during the self-test. These electronic systems were hence in working condition at the time of my inspection.

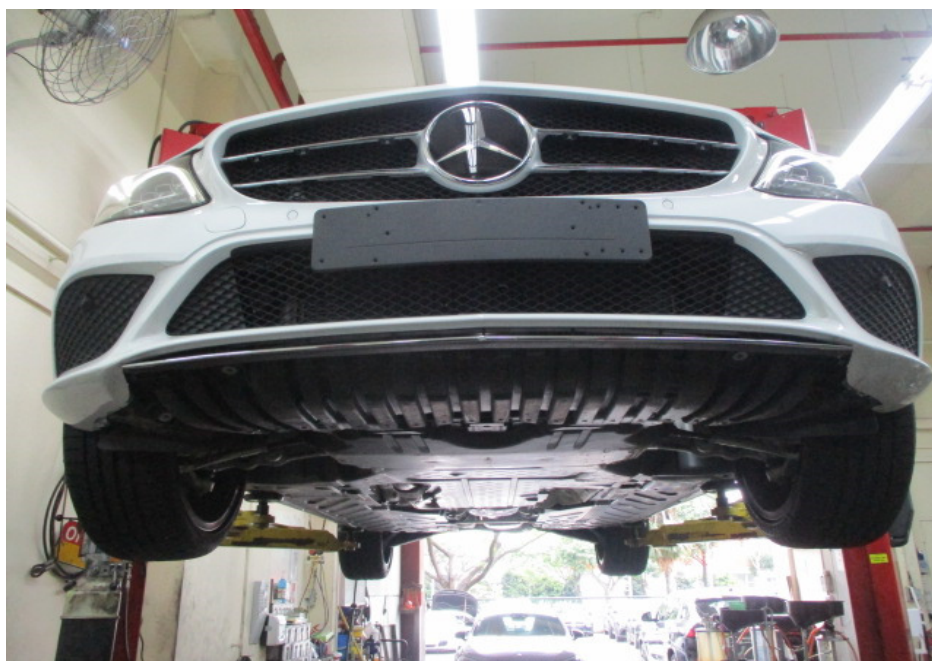
**Photo 20** shows the Motor Car hoisted up for checks on its undercarriage. There was no sign(s) or indication(s) of fluid leakage and/or fluid stain(s) on the underside of the Motor Car. The undercarriage components of the Motor Car were also all observed to be intact and secured in an appropriate manner.

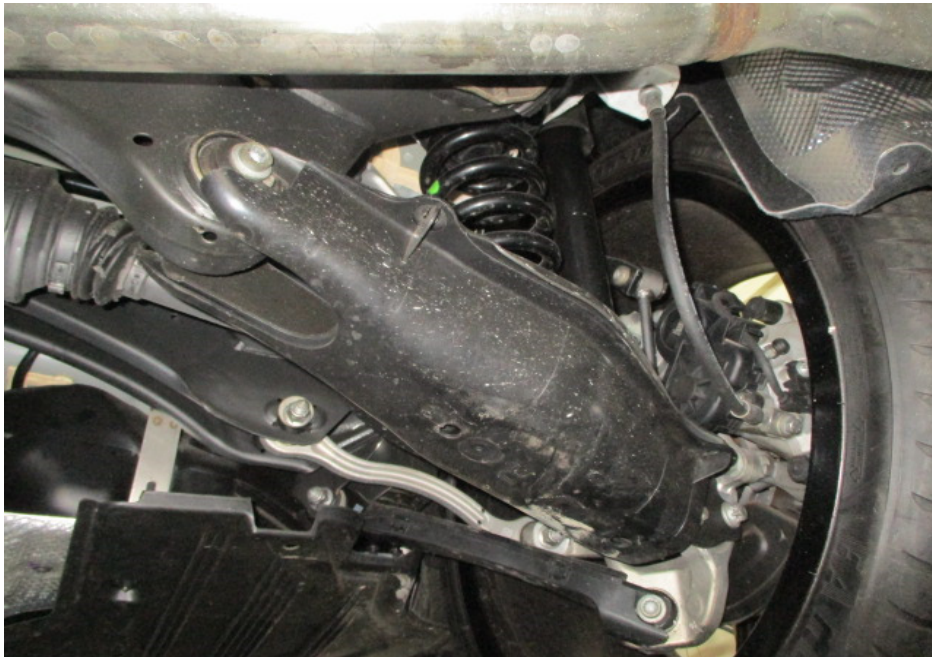
**Photo 21** shows a general view of the control arms and linkages at the rear right wheel of the Motor Car. I did not observe any fluid leak and/or fluid stain on the underside of the Motor Car. All of the Motor Car's undercarriage components were observed to be intact and secured in an appropriate manner.

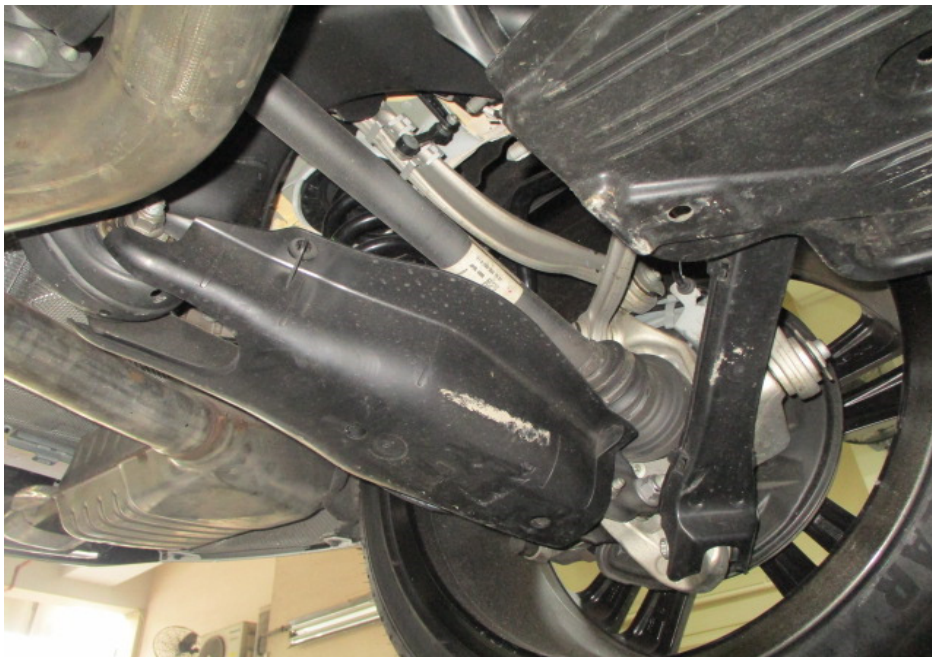
**Photo 22** shows a general view of the control arms and linkages at the rear left wheel of the Motor Car. I did not observe any fluid leak and/or fluid stain on the underside of the Motor Car. All of the Motor Car's undercarriage components were observed to be intact and secured in an appropriate manner.

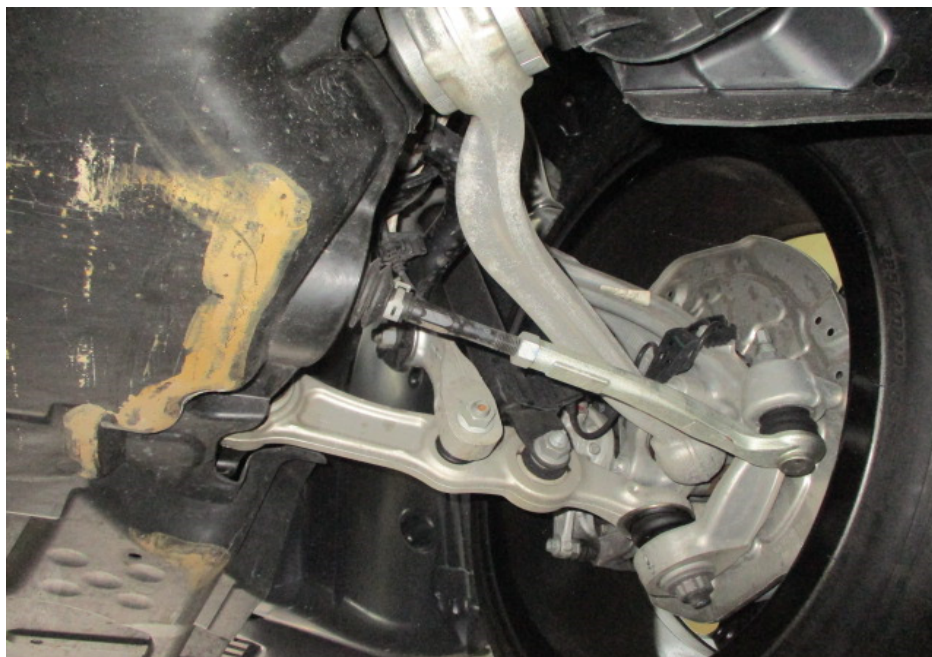
**Photo 23** shows the various undercarriage components at the front left wheel of the Motor Car. The mechanical components, control arms and linkages were all found to be intact and secured in an appropriate manner.

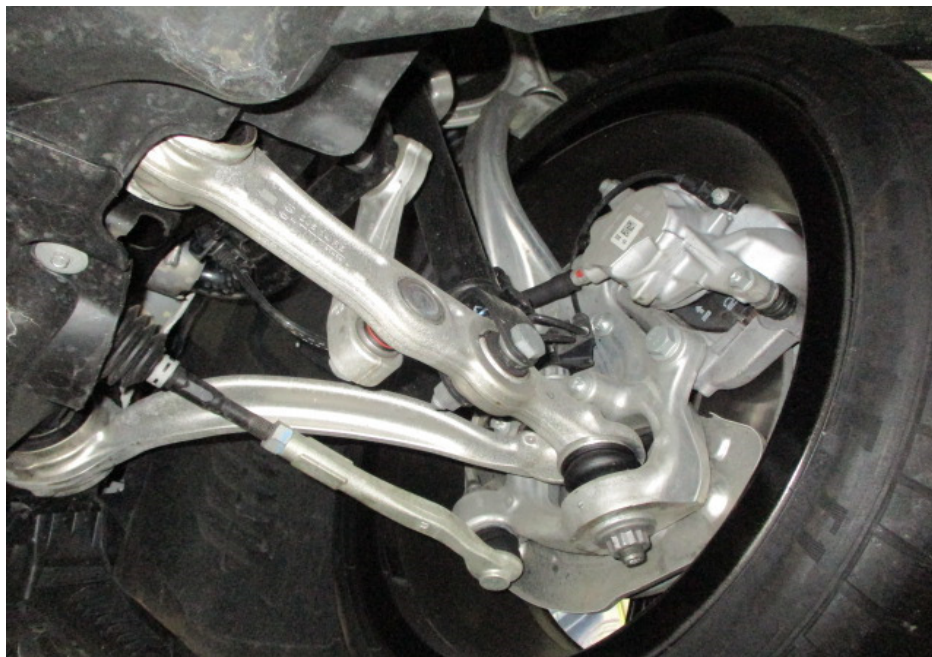
**Photo 24** shows the various undercarriage components at the front right wheel of the Motor Car. The mechanical components, control arms and linkages were all found to be intact and secured in an appropriate manner. I also did not observe any fluid leak and/or fluid stain on the underside of the Motor Car.

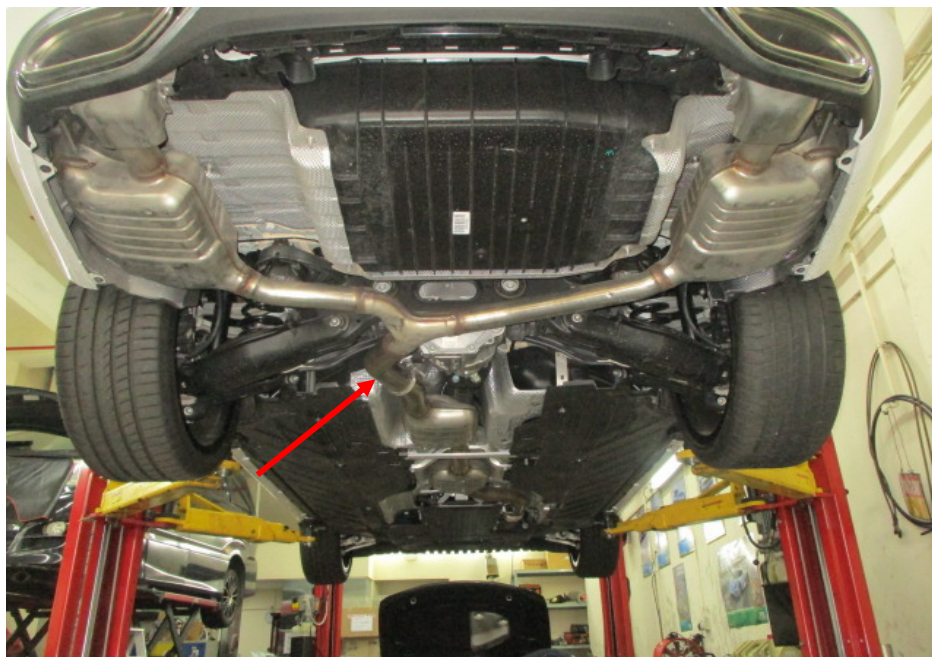
**Photo 25** shows the rear section of the Motor Car's exhaust system. My examination of the Motor Car's exhaust system revealed no sign(s) or indication(s) of any cut or weld marks along its exhaust pipes (arrowed), on its centre resonator boxes, on its rear mufflers and on its catalytic converter.

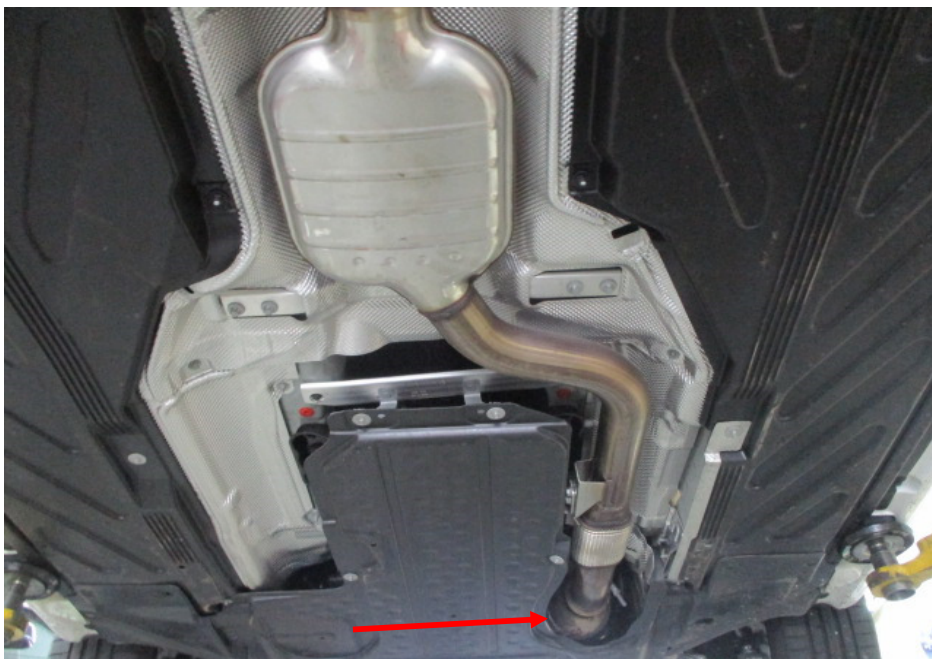
**Photo 26** shows the front section of the Motor Car's exhaust system. My examination of the Motor Car's exhaust system revealed no sign(s) or indication(s) of any cut or weld marks along its exhaust pipes, on its centre resonator boxes, on its rear mufflers and on its catalytic converter (arrowed).

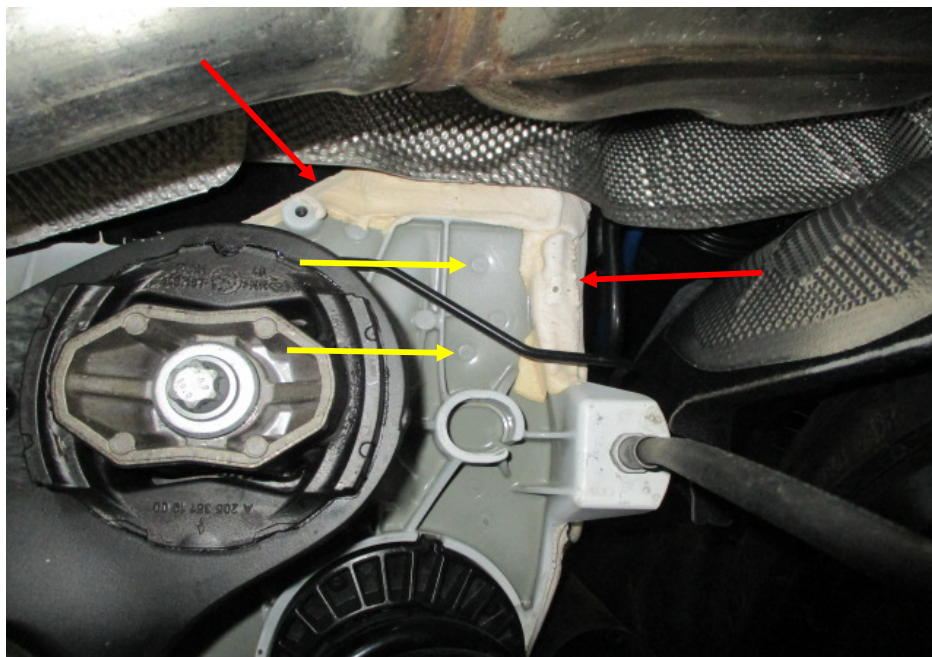
**Photo 27** shows the chassis/structural body at the underside rear right of the Motor Car. I did not find any weld marks other than original spot weld marks (yellow arrow) on the chassis/structural body of the Motor Car. The original factory sealant (red arrow) at the joints along the chassis/structural body was also untouched, indicating no work was done on the chassis/structural body of the Motor Car and that the chassis/structural body was originally fitted.

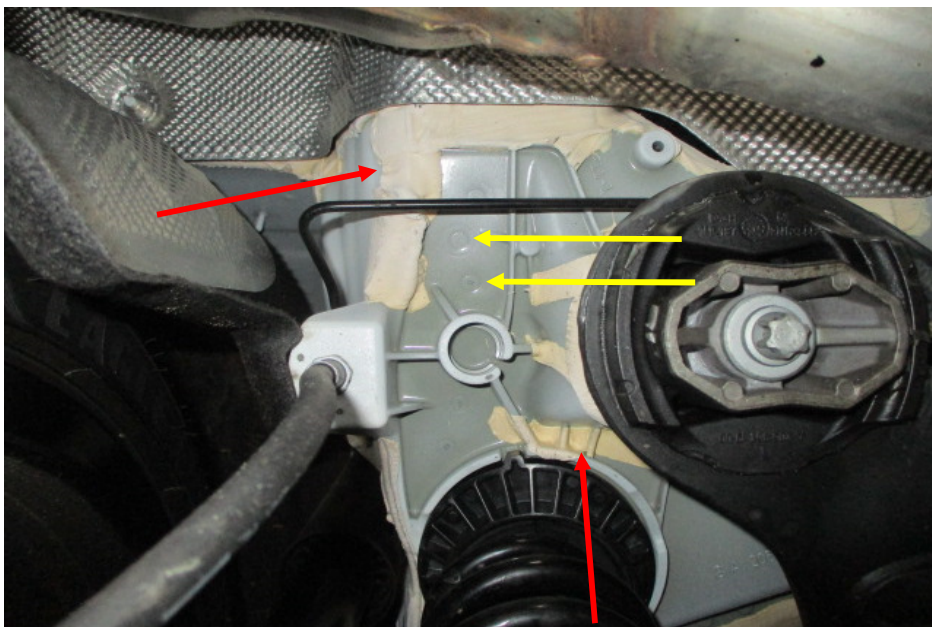
**Photo 28** shows the chassis/structural body at the underside rear left of the Motor Car. I did not find any weld marks other than original spot weld marks (yellow arrow) on the chassis/structural body of the Motor Car. The original factory sealant (red arrow) at the joints along the chassis/structural body was also untouched, indicating no work was done on the chassis/structural body of the Motor Car and that the chassis/structural body was originally fitted.

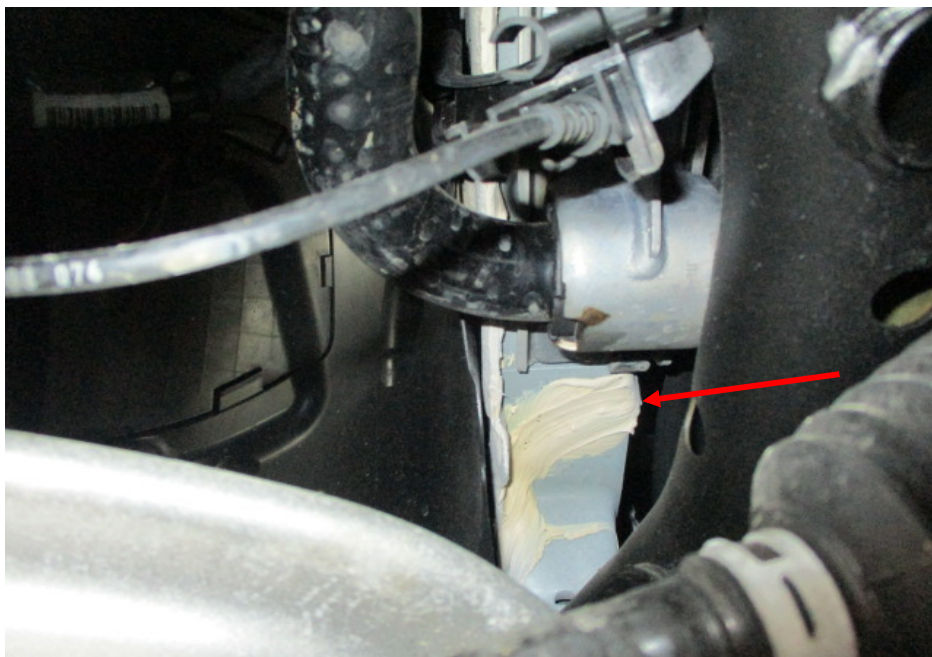
**Photo 29** shows the chassis/structural body at the underside front left of the Motor Car. The original factory sealant (arrowed) at the joints along the chassis/structural body was observed to be untouched. In general, I had found no work was carried out on the chassis/structural body of the Motor Car. The chassis/structural body of the Motor Car was originally fitted.

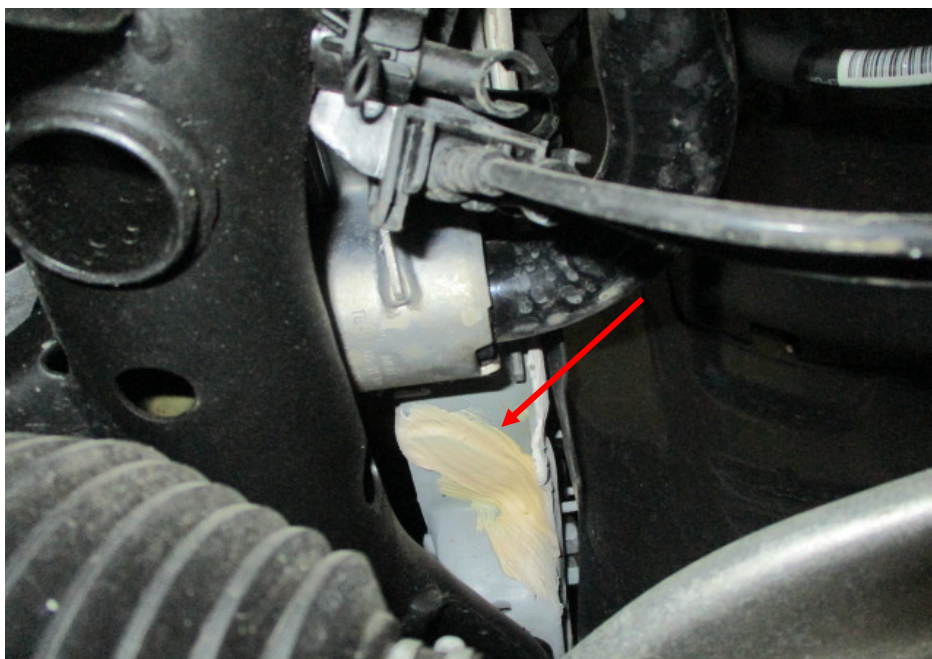
**Photo 30** shows the chassis/structural body at the underside front right of the Motor Car. The original factory sealant (arrowed) at the joints along the chassis/structural body was observed to be untouched. In general, I had found no work was carried out on the chassis/structural body of the Motor Car. The chassis/structural body of the Motor Car was originally fitted.

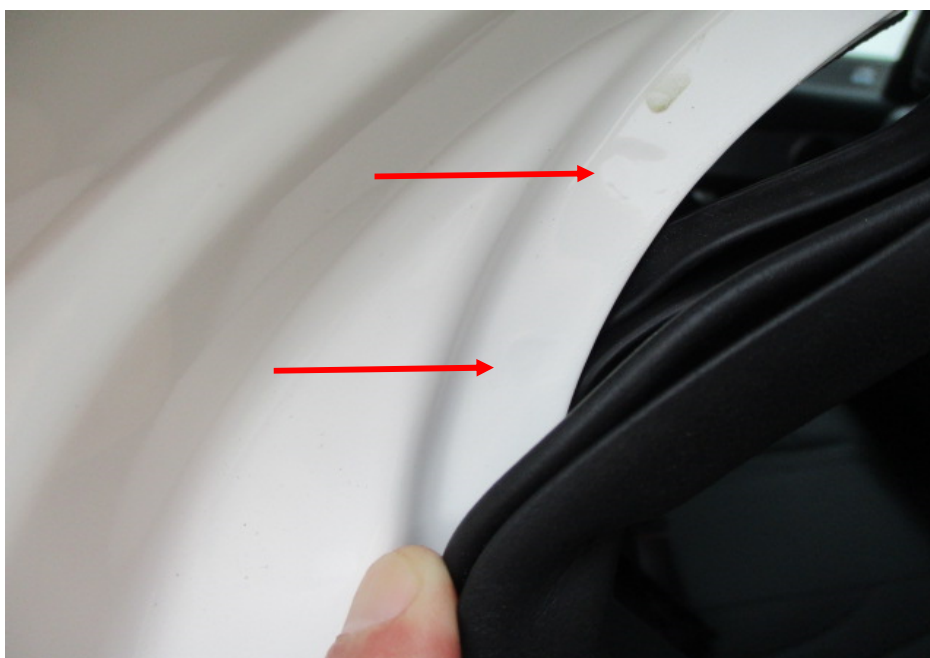
**Photo 31** shows the right side "C" pillar of the Motor Car. I did not find any weld marks other than original spot weld marks (arrowed) on the right side "C" pillar of the Motor Car which, indicates that there was no re-welding works carried out. In general, I had found all the non-detachable body panels of the Motor Car to be originally fitted at the time of my inspection.

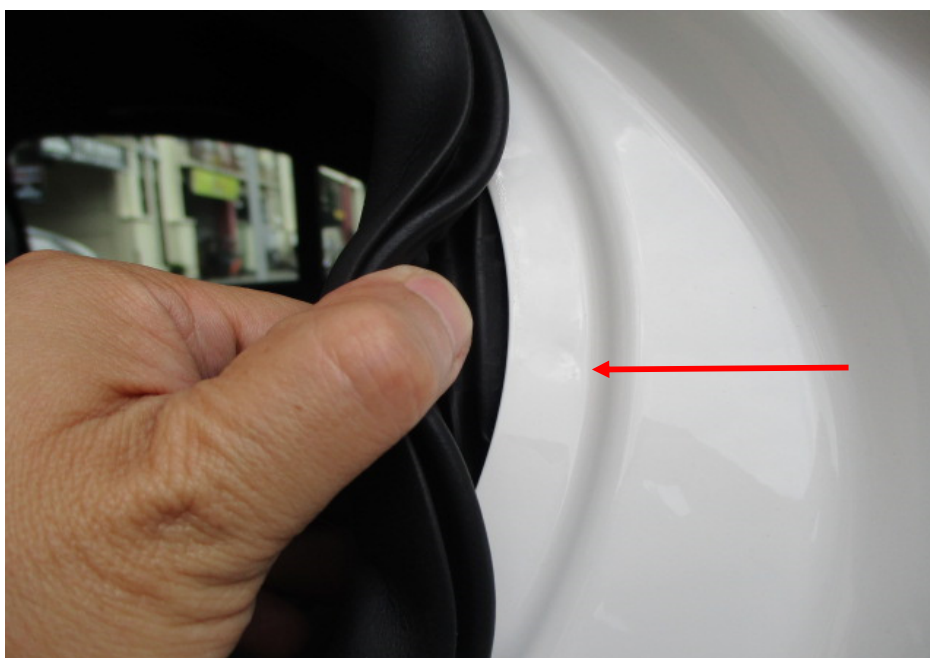
**Photo 32** shows the left side "C" pillar of the Motor Car. I did not find any weld marks other than original spot weld marks (arrowed) on the left side "C" pillar of the Motor Car which, indicates that there was no re-welding works carried out. In general, I had found all the non-detachable body panels of the Motor Car to be originally fitted at the time of my inspection.
