Your Ref: Mercedes Benz C300  
(chassis number W1K2050832R608813)  
Our Ref : CI/TP21011427/D

09 November 2021

**INSPECTION REPORT OF AN UNREGISTERED MERCEDES BENZ C300  
MOTOR CAR WITH CHASSIS NUMBER W1K2050832R608813**

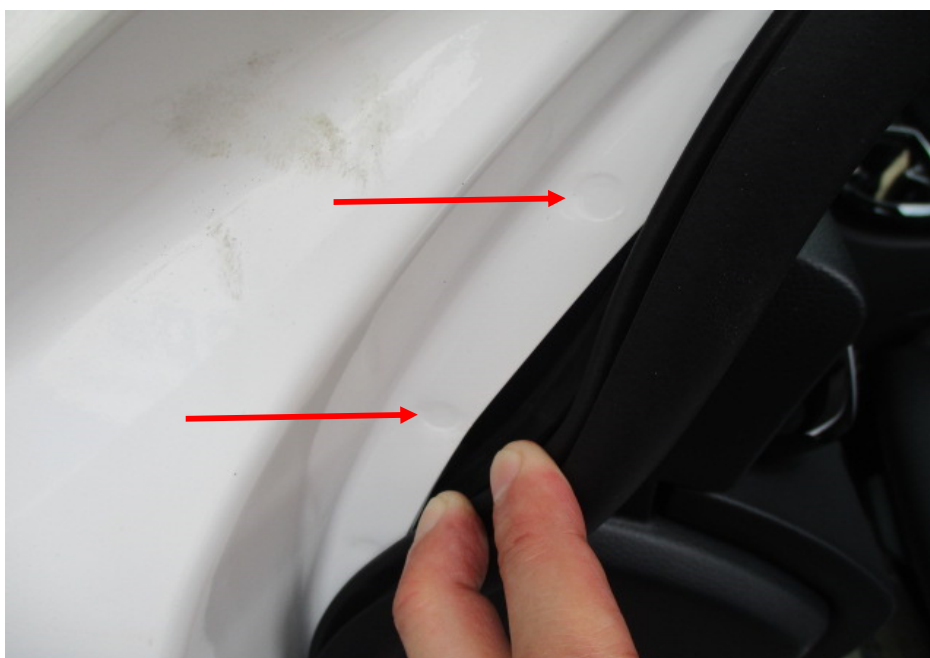
**Photo 33** shows the left side "A" pillar of the Motor Car. I did not find any weld marks other than original spot weld marks (arrowed) on the left side "A" pillar of the Motor Car which, indicates that there was no re-welding works carried out. In general, I had found all the non-detachable body panels of the Motor Car to be originally fitted at the time of my inspection.
