Your Ref: Mercedes Benz A45s  
(chassis number WDD1770542N138985)  
Our Ref : CI/TP21011428/D

08 November 2021

**INSPECTION REPORT OF AN UNREGISTERED MERCEDES BENZ A45s  
MOTOR CAR WITH CHASSIS NUMBER WDD1770542N138985**

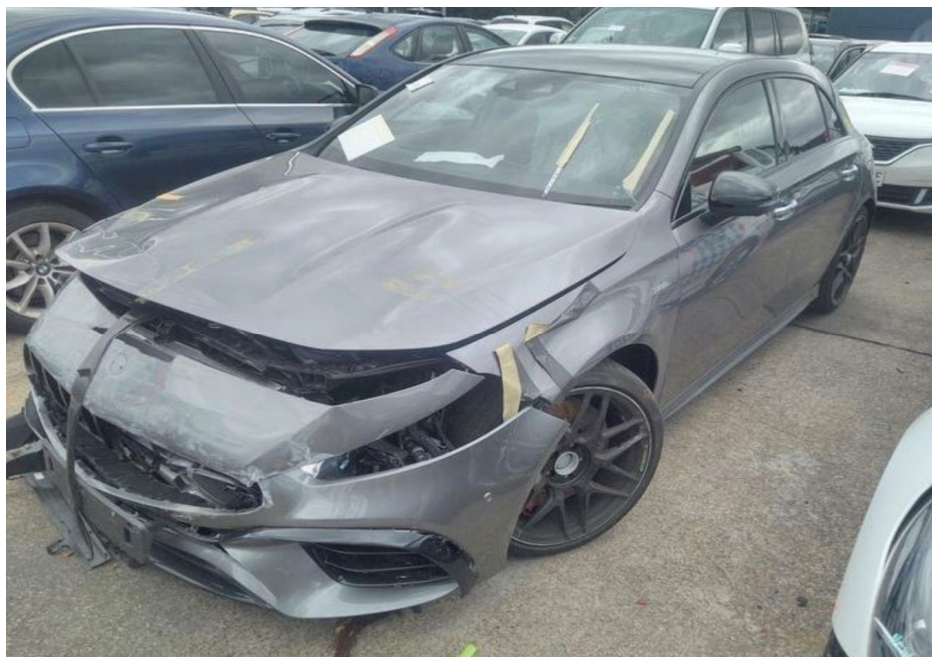
**Photo 1** shows the front left body of the Motor Car (photograph provided to me). The Motor Car was observed to have sustained damage at its frontal portion. Body parts damaged include the front bumper, front bumper sponge, front bumper centre garnish, front support panel and radiator grille amongst others. The front left headlamp was also observed to be missing/dislodged/damaged.

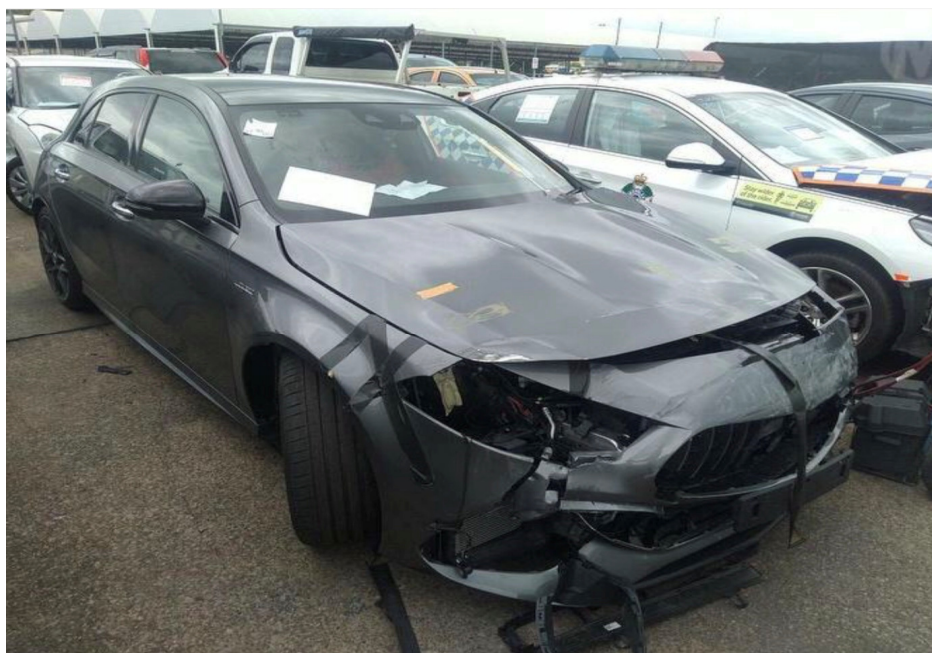
**Photo 2** shows the front right body of the Motor Car (photograph provided to me). The Motor Car was observed to have sustained damage at its frontal portion. Body parts damaged include the front bumper, front bumper sponge, front bumper reinforcement, front bumper centre lower grille, front bumper right lower grille, front bonnet and radiator grille amongst others. The front right headlamp was also observed to be missing/dislodged/damaged.

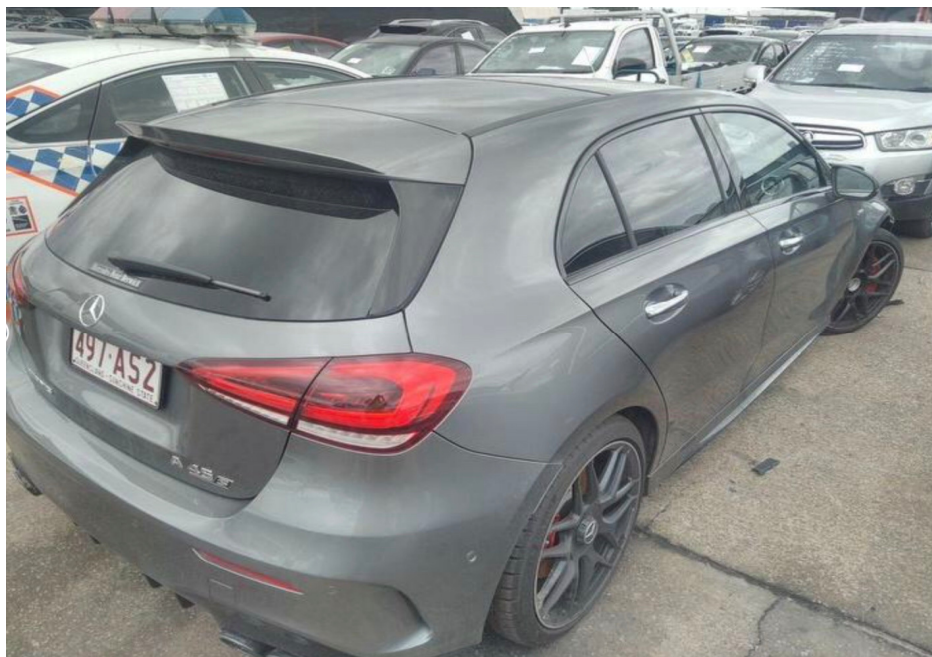
**Photo 3** shows the rear right body the Motor Car (photograph provided to me). Apart for the frontal portion, there was no physical damage observed to other areas of the Motor Car.

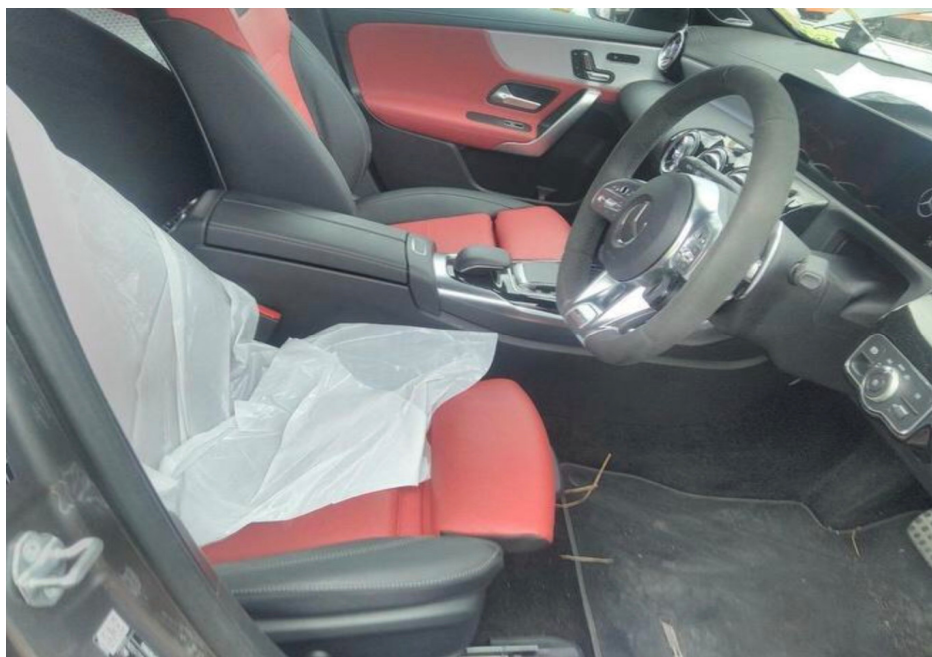
**Photo 4** shows the interior compartment of the Motor Car (photograph provided to me). The various parts and components, upholstery, carpet and inner trims were all intact and undamaged. The airbag(s) of the Motor Car was not deployed as seen from the photographs that were provided to me.

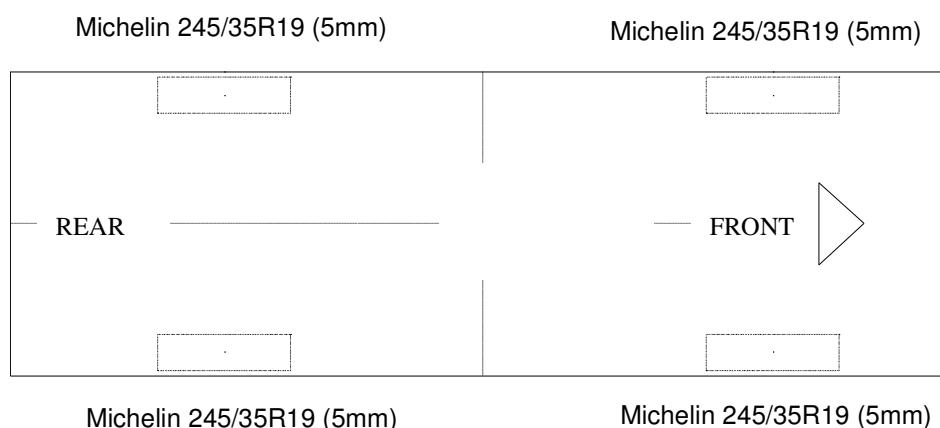
8. The Motor Car was fitted with 19inch sport wheel rims that were wrapped with tyres that were observed to be of serviceable condition. The tyres were also sufficiently inflated for vehicular operation. The tyre brand, tyre size and approximate remaining tread depth of the 4 tyres of the Motor Car were recorded as follows: -

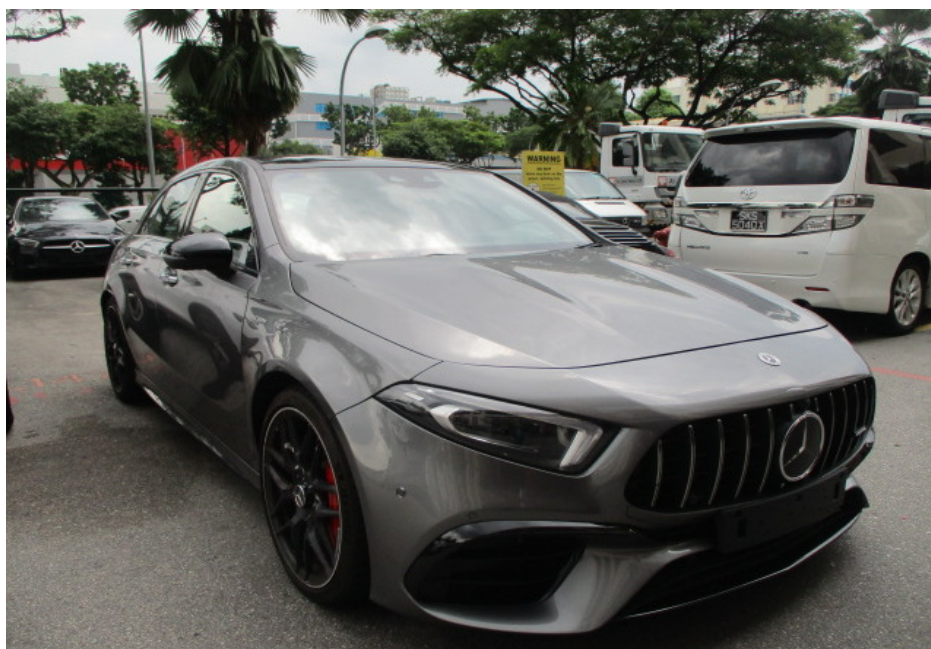
**Photo 5** shows a general view of the front right body of the Motor Car at the time of my inspection. The Motor Car was observed to be in a relatively good general condition with no loose exterior fittings observed. The body parts at the frontal portion of the Motor Car were visually examined and it was observed that the repair/restoration works carried out to the damaged area of the Motor Car (refer to photograph 1 & 2 above) were reasonably adequate and in order.

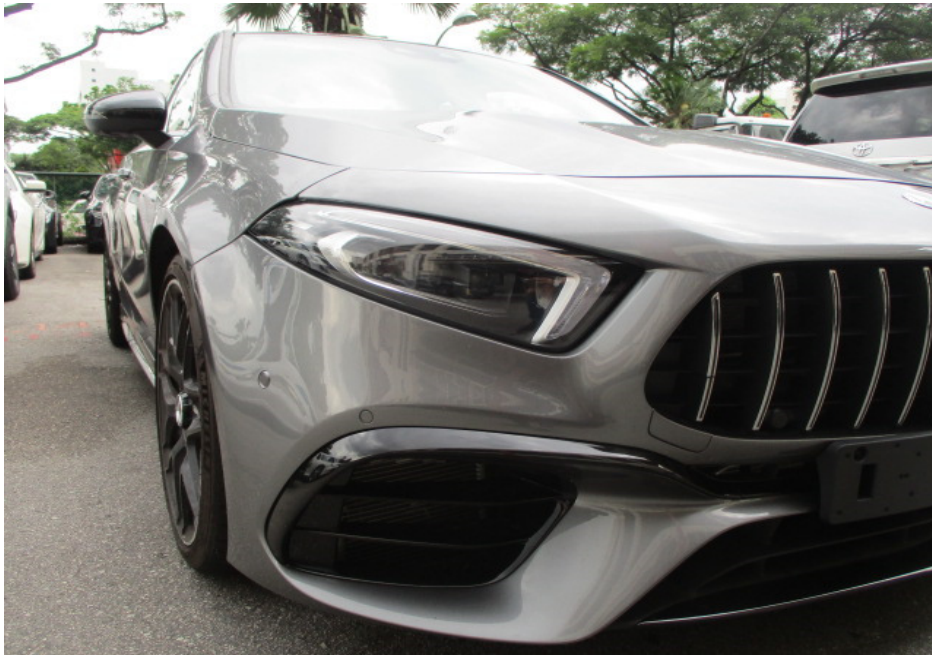
**Photo 6** shows a closer view of the Motor Car's front bumper, front bumper centre garnish, front bumper right lower grille and front right headlamp. The body parts at the frontal portion of the Motor Car were visually examined and it was observed that the repair/restoration works carried out to the damaged area of the Motor Car (refer to photograph 1 & 2 above) were reasonably adequate and in order.

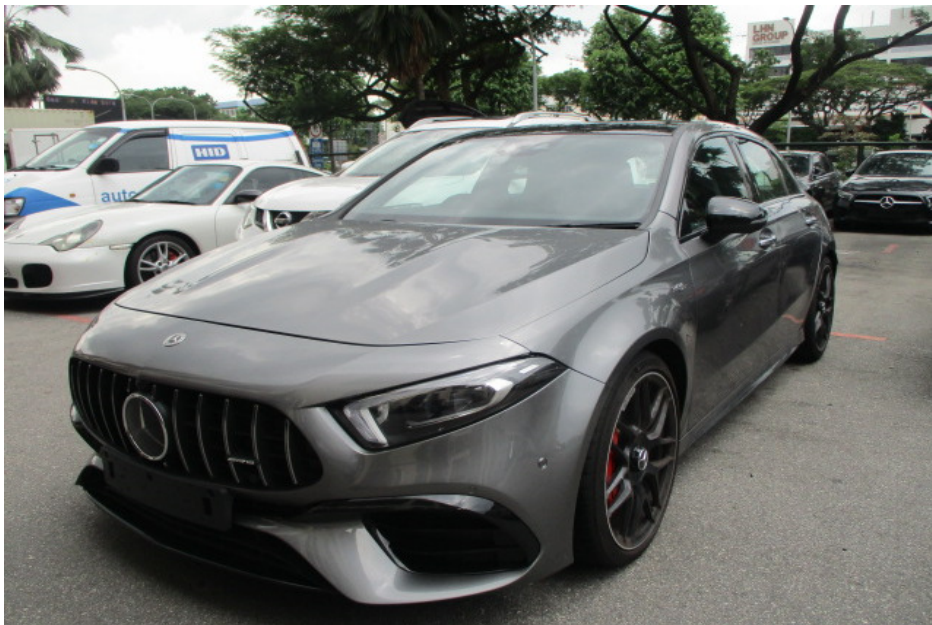
**Photo 7** shows a general view of the front left body of the Motor Car at the time of my inspection. The Motor Car was observed to be in a relatively good general condition with no loose exterior fittings observed. The body parts at the frontal portion of the Motor Car were visually examined and it was observed that the repair/restoration works carried out to the damaged area of the Motor Car (refer to photograph 1 & 2 above) were reasonably adequate and in order.

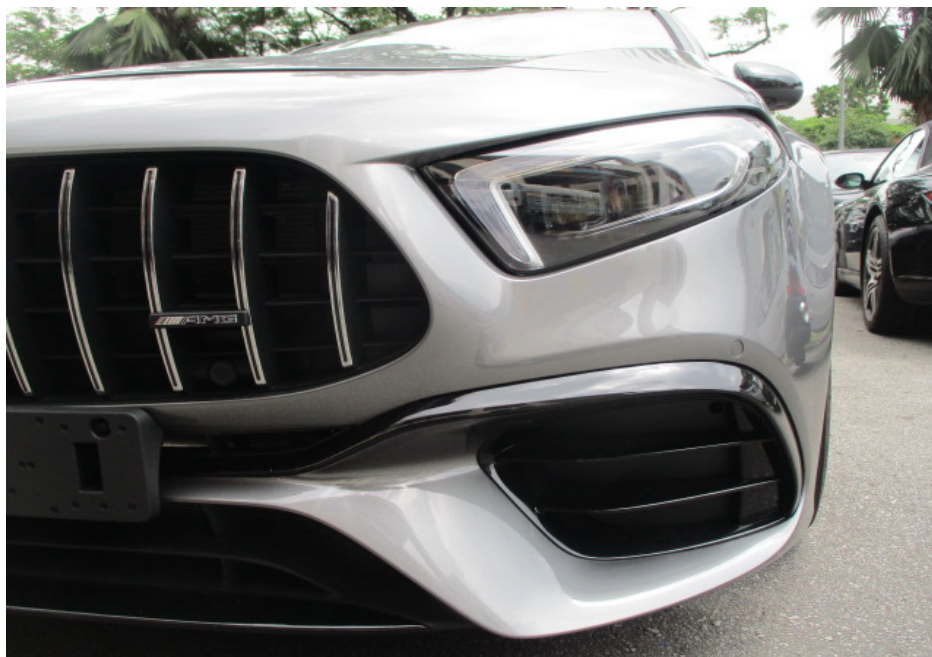
**Photo 8** shows a closer view of the Motor Car's front bumper, front bumper centre garnish, front bumper left lower grille and front left headlamp. The body parts at the frontal portion of the Motor Car were visually examined and it was observed that the repair/restoration works carried out to the damaged area of the Motor Car (refer to photograph 1 & 2 above) were reasonably adequate and in order.

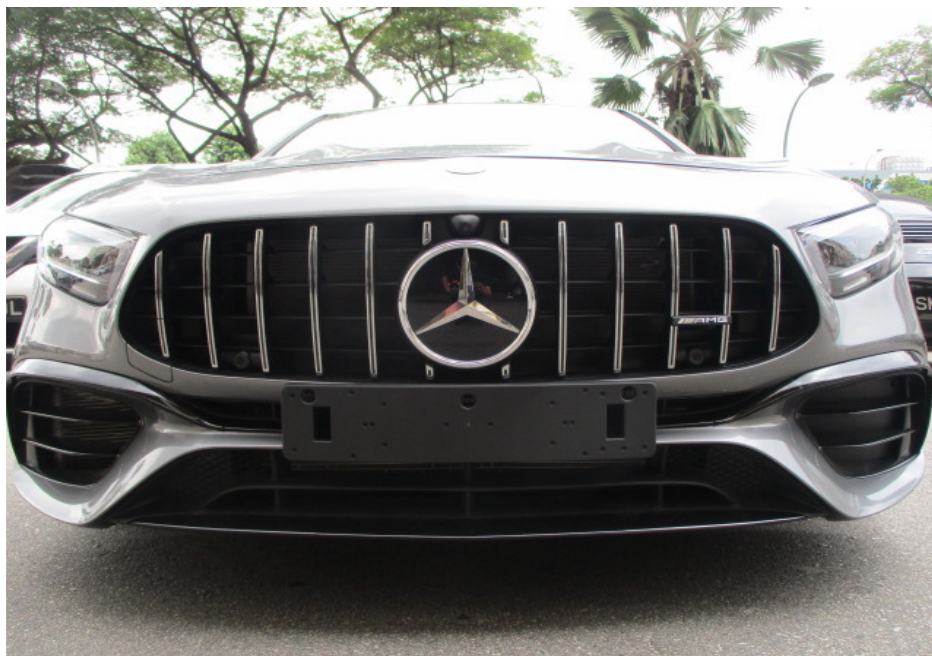
**Photo 9** shows a closer view of the Motor Car's front bumper, front bumper centre lower grille, radiator grille and radiator grille emblem. The body parts at the frontal portion of the Motor Car were visually examined and it was observed that the repair/restoration works carried out to the damaged area of the Motor Car (refer to photograph 1 & 2 above) were reasonably adequate and in order.

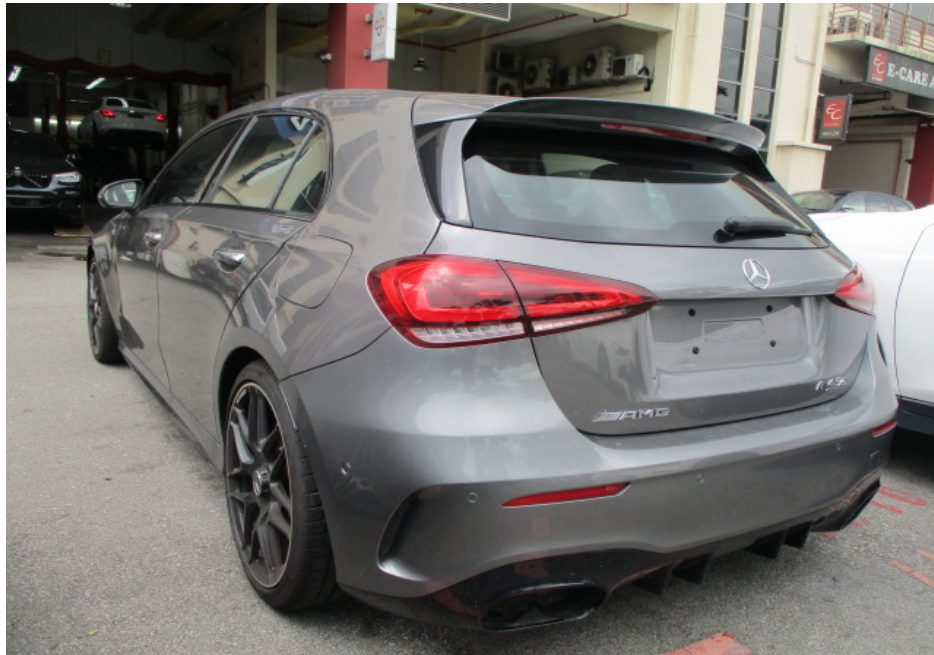
**Photo 10** shows a general view of the rear left body of the Motor Car at the time of my inspection. The Motor Car was observed to be in a relatively good general condition with no loose exterior fittings observed. The mileage of the Motor Car recorded at the time of my inspection was 7,220km.

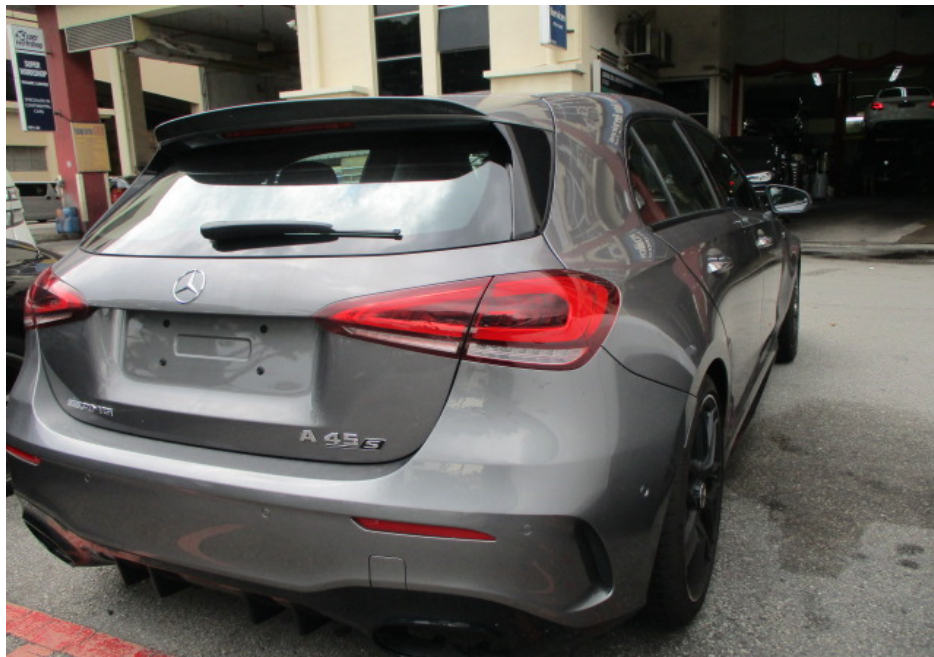
**Photo 11** shows a general view of the rear right body of the Motor Car at the time of my inspection. The Motor Car was observed to be in a relatively good general condition with no loose exterior fittings observed. The mileage of the Motor Car recorded at the time of my inspection was 7,220km.

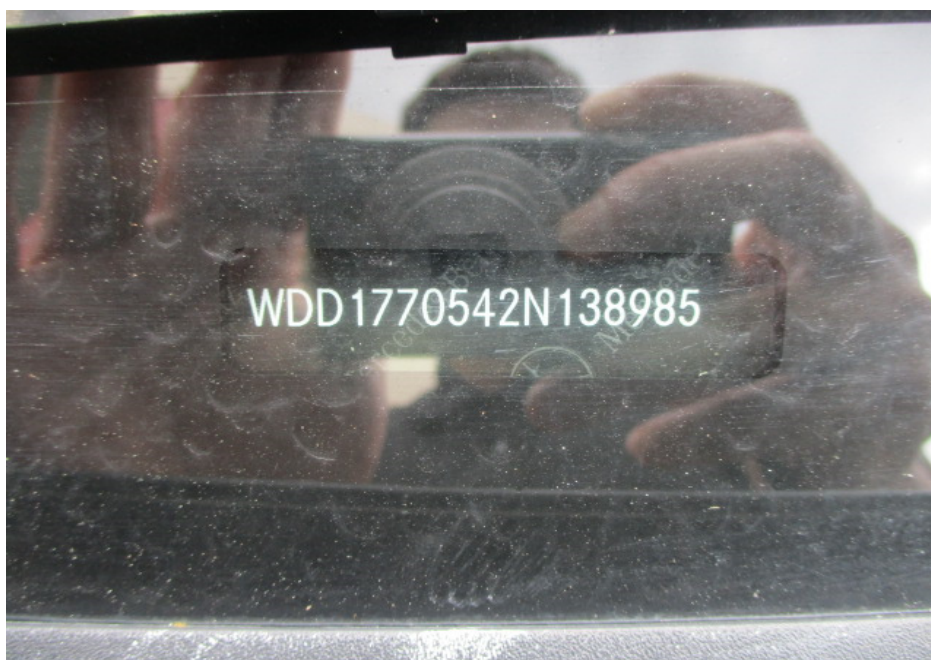
**Photo 12** shows the chassis number of the Motor Car. The chassis number recorded was WDD1770542N138985.

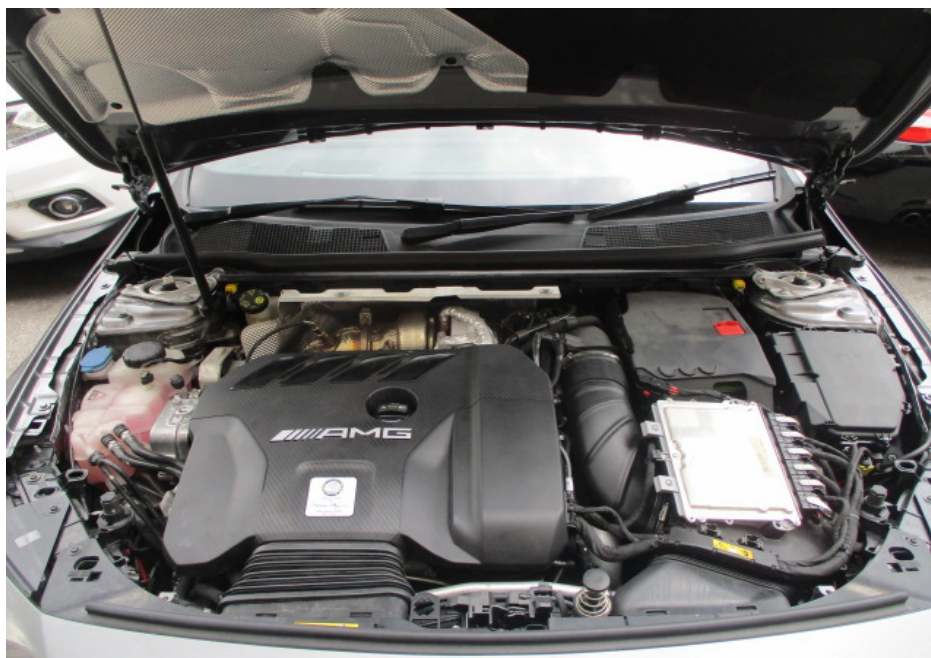
**Photo 13** shows a general view of the engine compartment of the Motor Car at the time of my inspection. The various parts and components inside the engine compartment were all observed to be intact and properly fitted. There was also no sign(s) or indication(s) of fluid leak and/or fluid stain found inside the engine compartment.

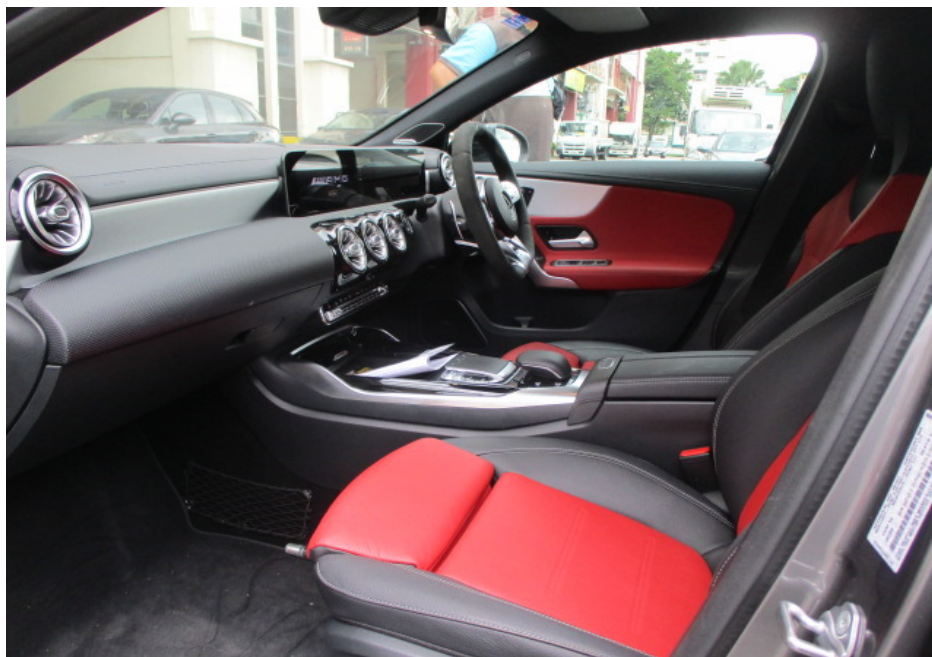
**Photo 14** shows the interior compartment of the Motor Car at the time of my inspection. The various parts and components, trims, carpet and upholstery inside the interior compartment were all observed to be intact and properly fitted.

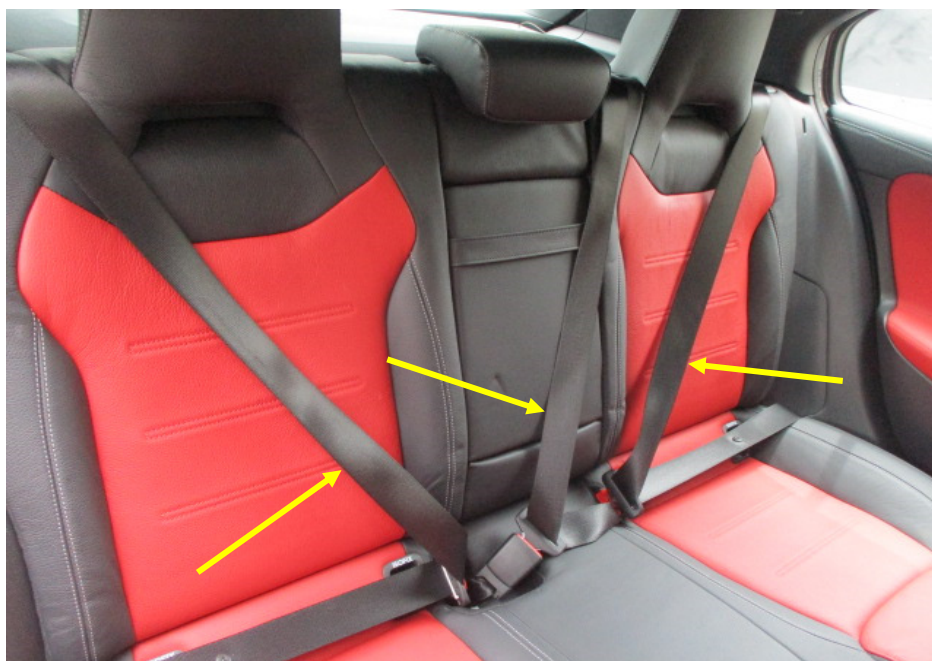
**Photo 15** shows the rear seats of the Motor Car. All the seats of the Motor Car were secured via seat rails to the floorboard. They were also fitted with a retractable seat belt reel and a pre-tensioner. The seat belts (arrowed) were tested and were able to be fastened into the respective pre-tensions that were fitted on the side of each individual seat.

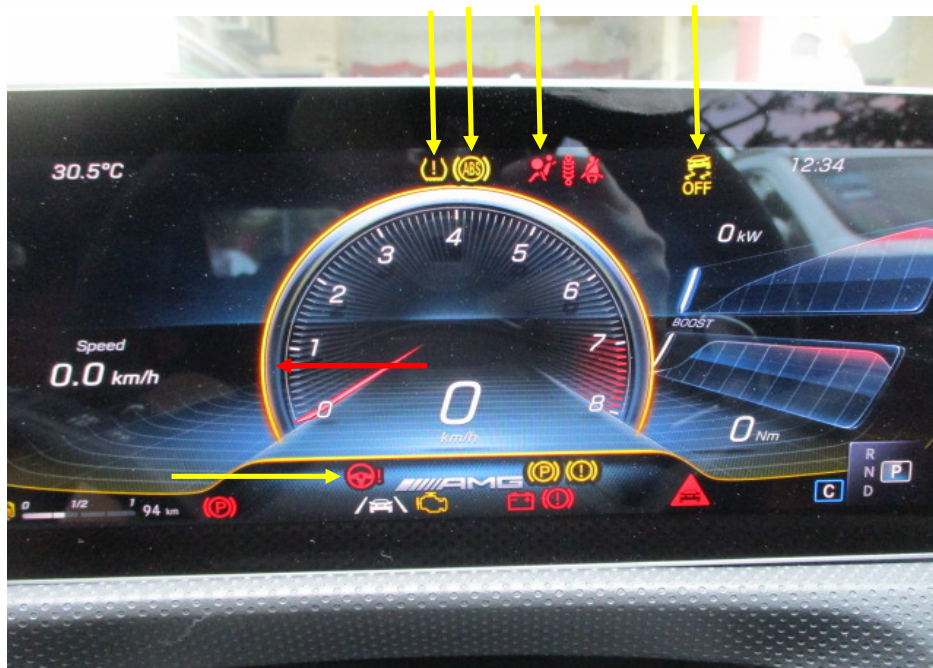
**Photo 16** shows the warning lights for the various electronic safety features appearing on the instrument panel of the Motor Car during its self-test when the engine is cranked, in particular the ABS, SRS, EPS, TPM and TCS lights (arrowed).

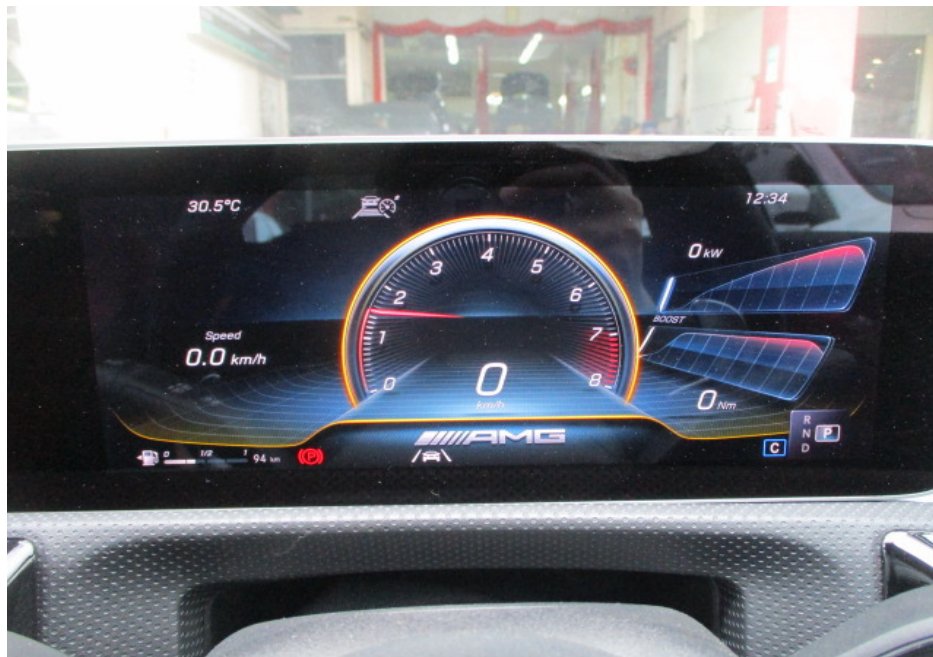
**Photo 17** shows the respective warning lights no longer illuminated, indicating that there is no fault detected to the ABS, SRS, EPS, TPM and TCS systems of the Motor Car during the self-test. These electronic systems were hence in working condition at the time of my inspection.

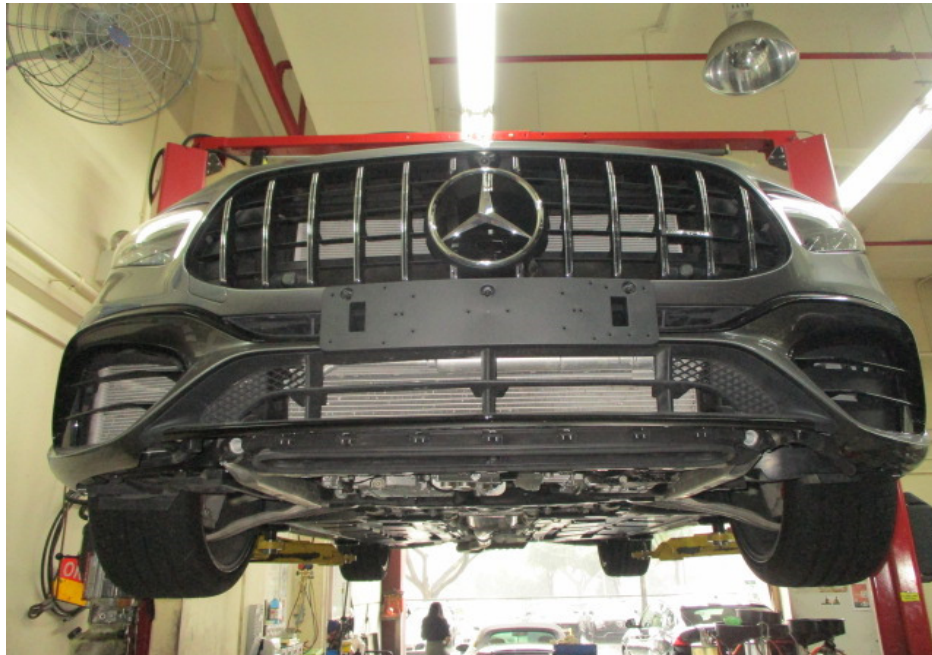
**Photo 18** shows the Motor Car hoisted up for checks on its undercarriage. There was no sign(s) or indication(s) of fluid leakage and/or fluid stain(s) on the underside of the Motor Car. The undercarriage components of the Motor Car were also all observed to be intact and secured in an appropriate manner.

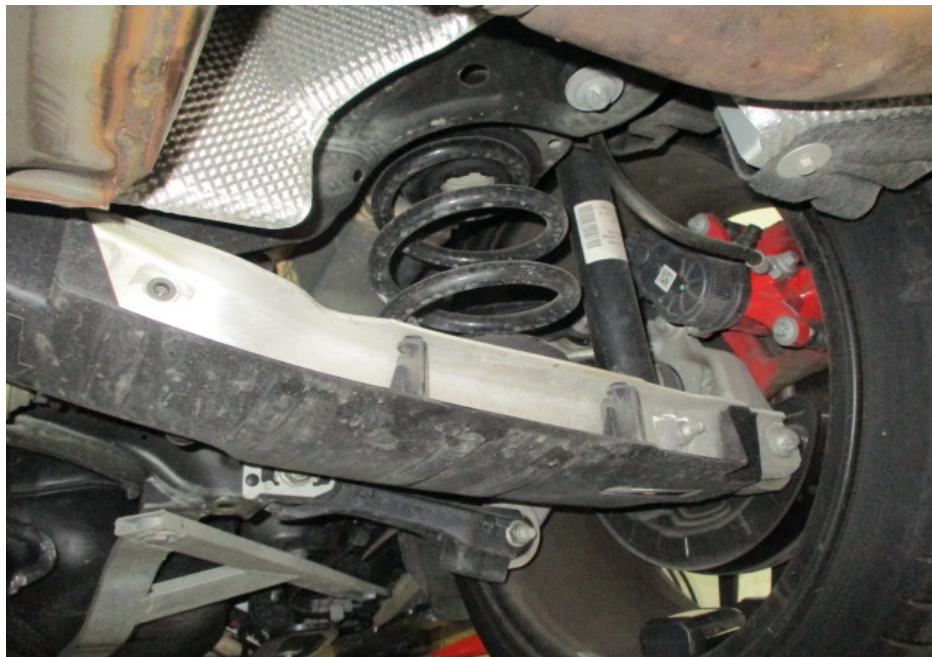
**Photo 19** shows a general view of the control arms and linkages at the rear right wheel of the Motor Car. I did not observe any fluid leak and/or fluid stain on the underside of the Motor Car. All of the Motor Car's undercarriage components were observed to be intact and secured in an appropriate manner.

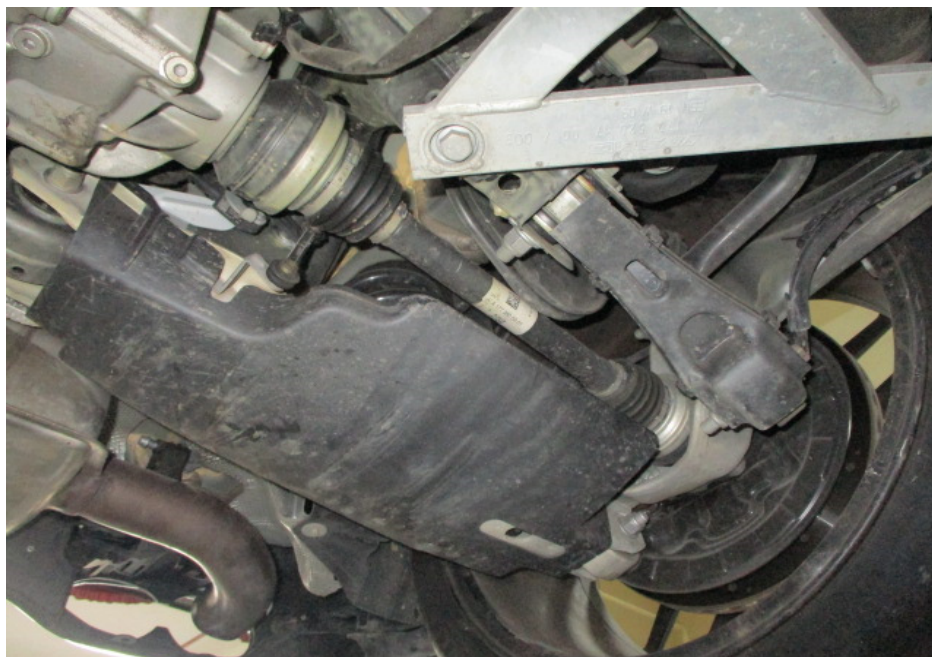
**Photo 20** shows a general view of the control arms and linkages at the rear left wheel of the Motor Car. I did not observe any fluid leak and/or fluid stain on the underside of the Motor Car. All of the Motor Car's undercarriage components were observed to be intact and secured in an appropriate manner.

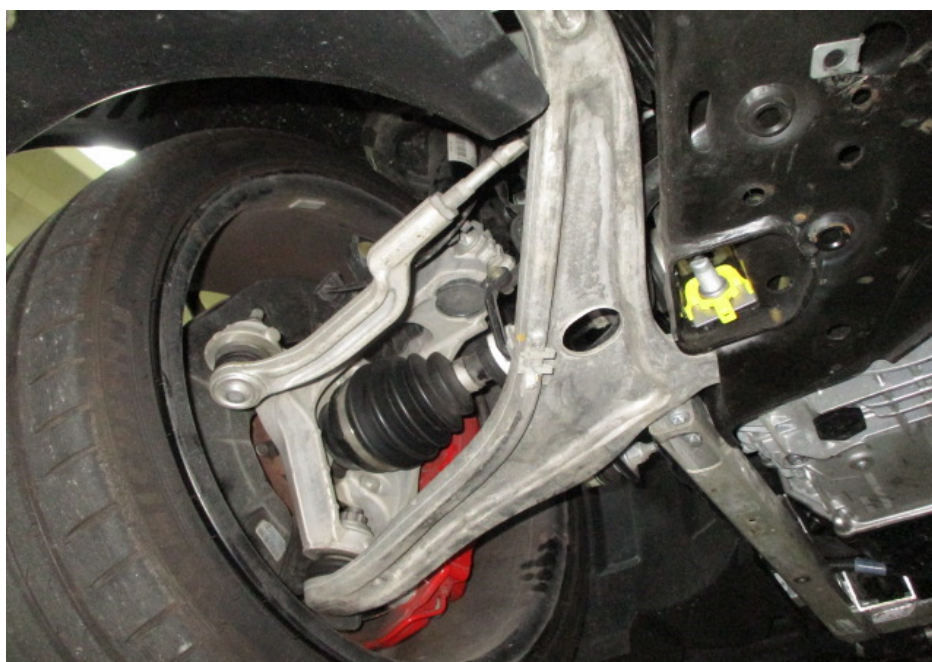
**Photo 21** shows the various undercarriage components at the front left wheel of the Motor Car. The mechanical components, control arms and linkages were all found to be intact and secured in an appropriate manner.

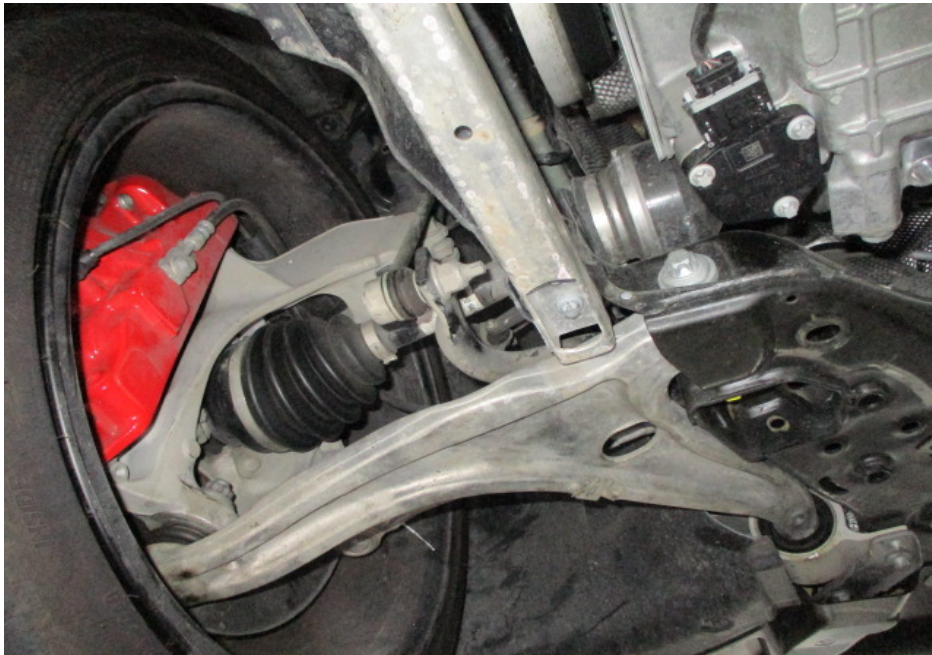
**Photo 22** shows the various undercarriage components at the front right wheel of the Motor Car. The mechanical components, control arms and linkages were all found to be intact and secured in an appropriate manner. I also did not observe any fluid leak and/or fluid stain on the underside of the Motor Car.

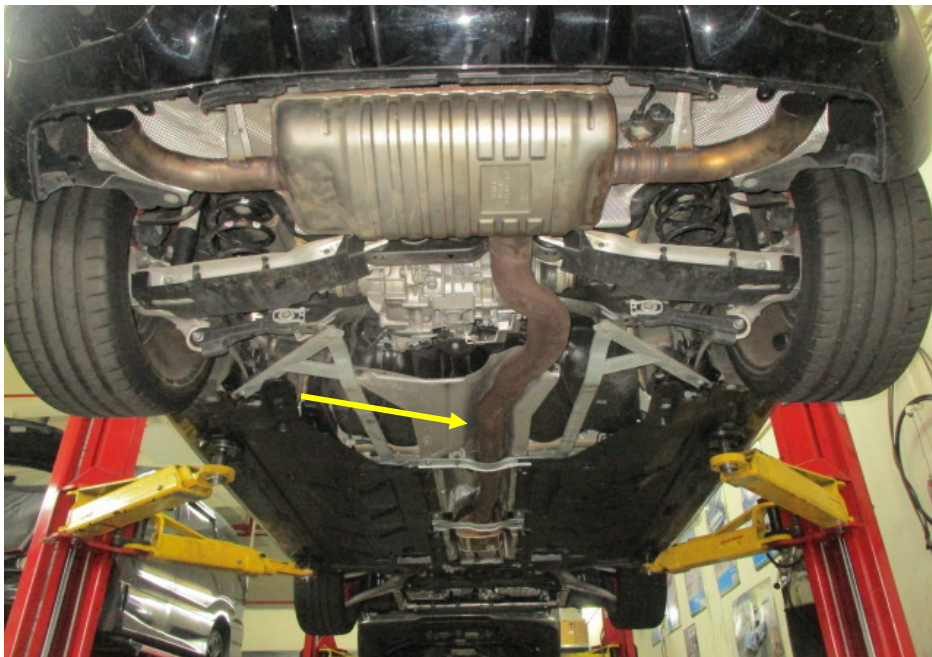
**Photo 23** shows the rear section of the Motor Car's exhaust system. My examination of the Motor Car's exhaust system revealed no sign(s) or indication(s) of any cut or weld marks along its exhaust pipes (arrowed), on its centre resonator box, on its rear muffler and on its catalytic converter.

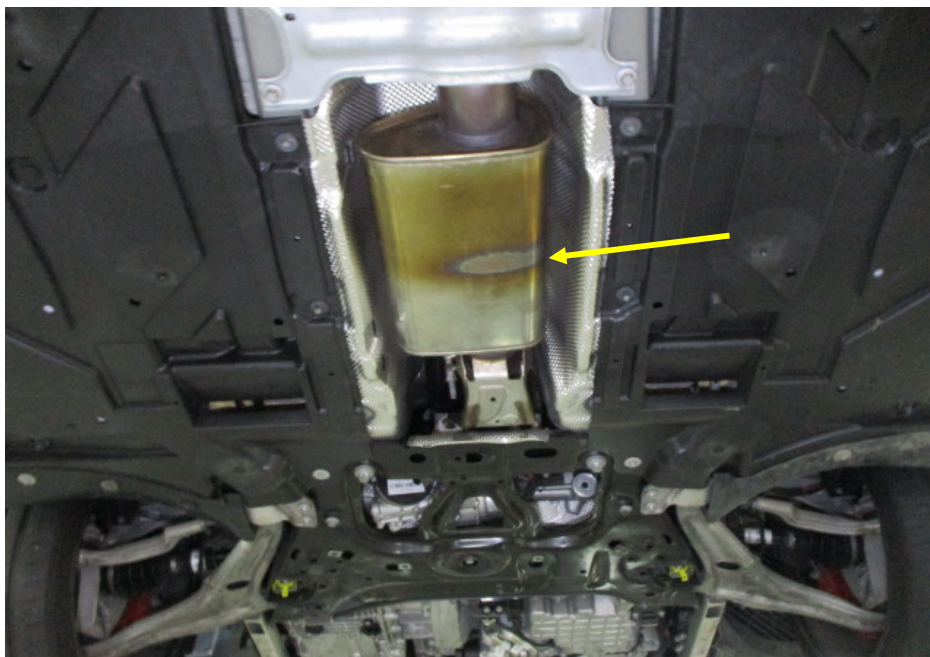
**Photo 24** shows the front section of the Motor Car's exhaust system. My examination of the Motor Car's exhaust system revealed no sign(s) or indication(s) of any cut or weld marks along its exhaust pipes, on its centre resonator box (arrowed), on its rear muffler and on its catalytic converter.

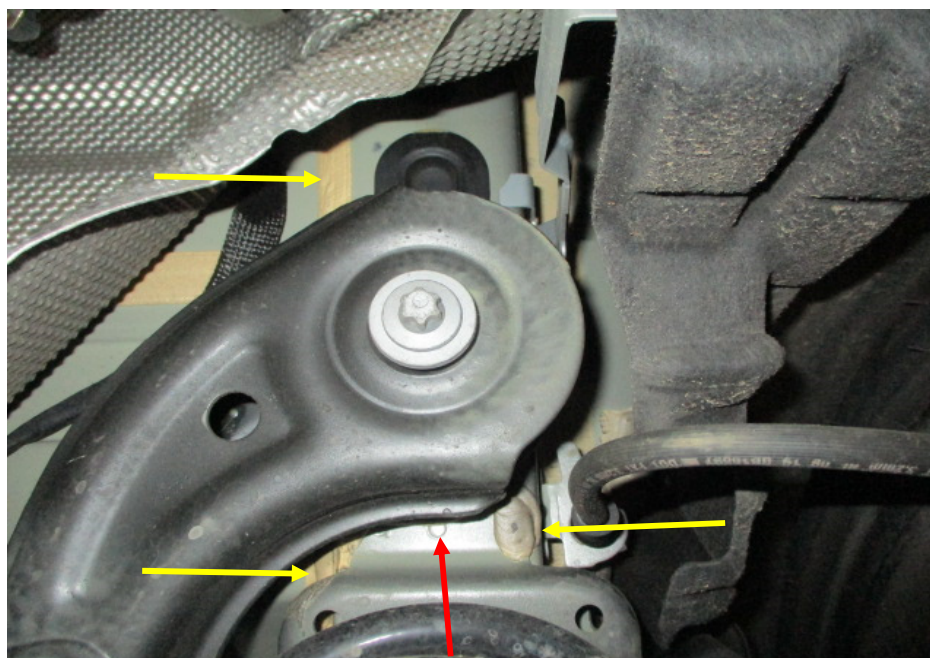
**Photo 25** shows the chassis/structural body at the underside rear right of the Motor Car. I did not find any weld marks other than original spot weld marks (red arrow) on the chassis/structural body of the Motor Car. The original factory sealant (yellow arrow) at the joints along the chassis/structural body was also untouched, indicating no work was done on the chassis/structural body of the Motor Car and that the chassis/structural body was originally fitted.

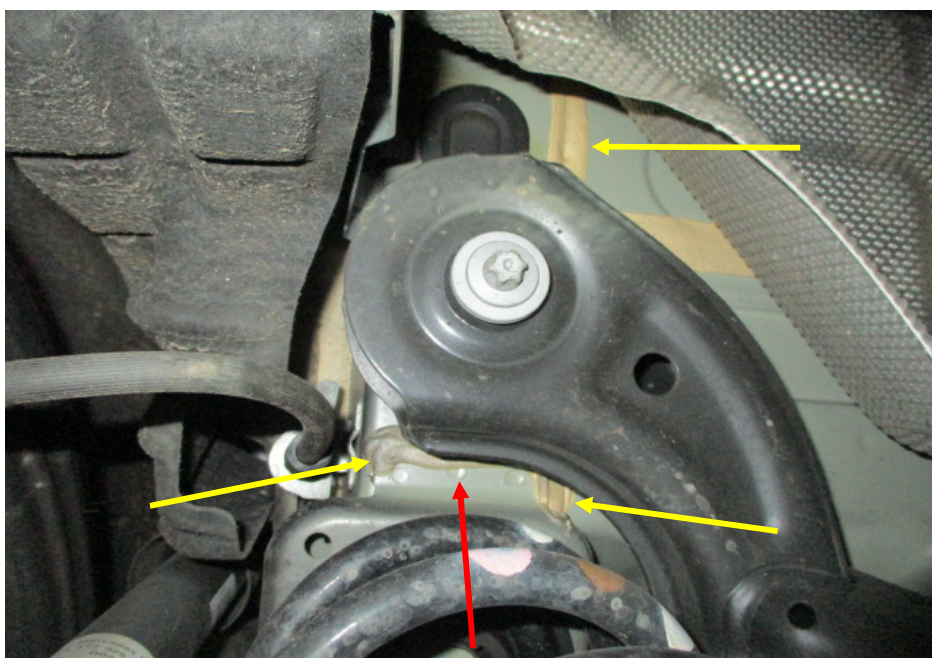
**Photo 26** shows the chassis/structural body at the underside rear left of the Motor Car. I did not find any weld marks other than original spot weld marks (red arrow) on the chassis/structural body of the Motor Car. The original factory sealant (yellow arrow) at the joints along the chassis/structural body was also untouched, indicating no work was done on the chassis/structural body of the Motor Car and that the chassis/structural body was originally fitted.

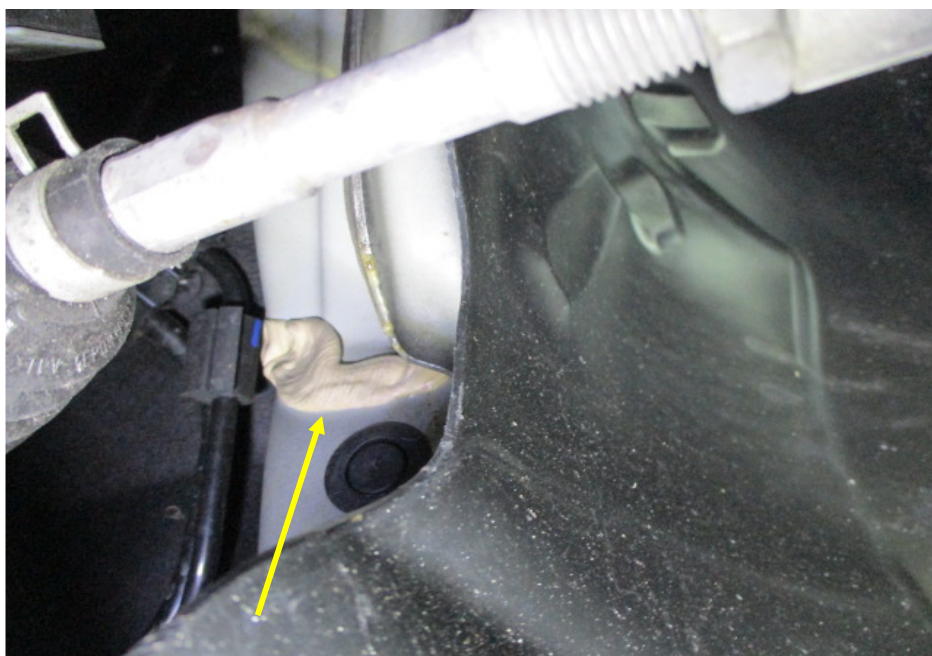
**Photo 27** shows the chassis/structural body at the underside front left of the Motor Car. The original factory sealant (arrowed) at the joints along the chassis/structural body was observed to be untouched. In general, I had found no work was carried out on the chassis/structural body of the Motor Car. The chassis/structural body of the Motor Car was originally fitted.

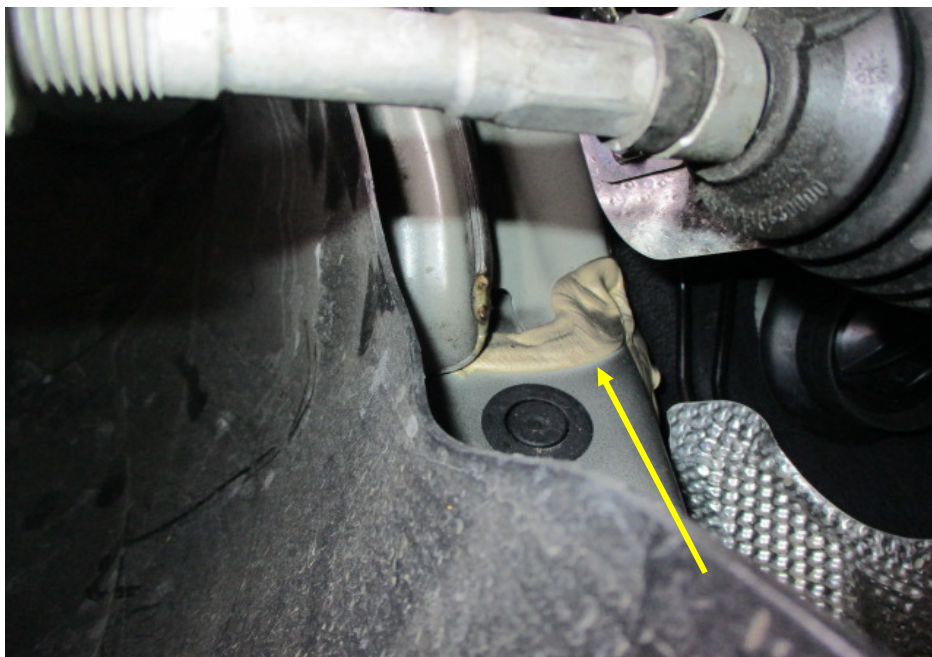
**Photo 28** shows the chassis/structural body at the underside front right of the Motor Car. The original factory sealant (arrowed) at the joints along the chassis/structural body was observed to be untouched. In general, I had found no work was carried out on the chassis/structural body of the Motor Car. The chassis/structural body of the Motor Car was originally fitted.

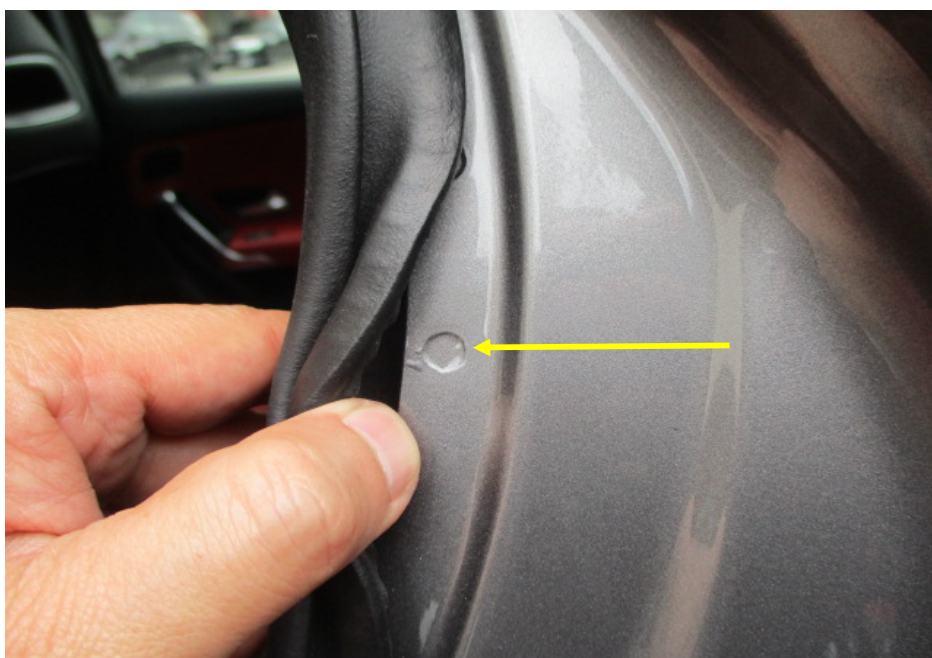
**Photo 29** shows the left side "C" pillar of the Motor Car. I did not find any weld marks other than original spot weld marks (arrowed) on the left side "C" pillar of the Motor Car which, indicates that there was no re-welding works carried out. In general, I had found all the non-detachable body panels of the Motor Car to be originally fitted at the time of my inspection.

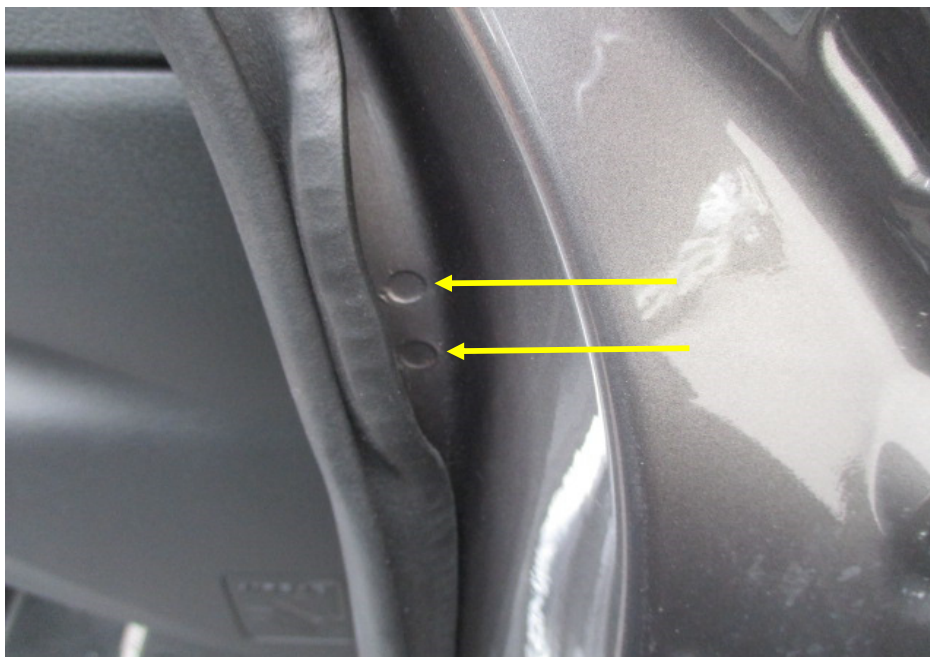
**Photo 30** shows the right side "A" pillar of the Motor Car. I did not find any weld marks other than original spot weld marks (arrowed) on the right side "A" pillar of the Motor Car which, indicates that there was no re-welding works carried out. In general, I had found all the non-detachable body panels of the Motor Car to be originally fitted at the time of my inspection.
