THIRD PARTY SURVEY **ACCIDENT HAPPENED ON**

18 Sep 2021

Registration No : GBD 4061 C

: Nissan Cabstar

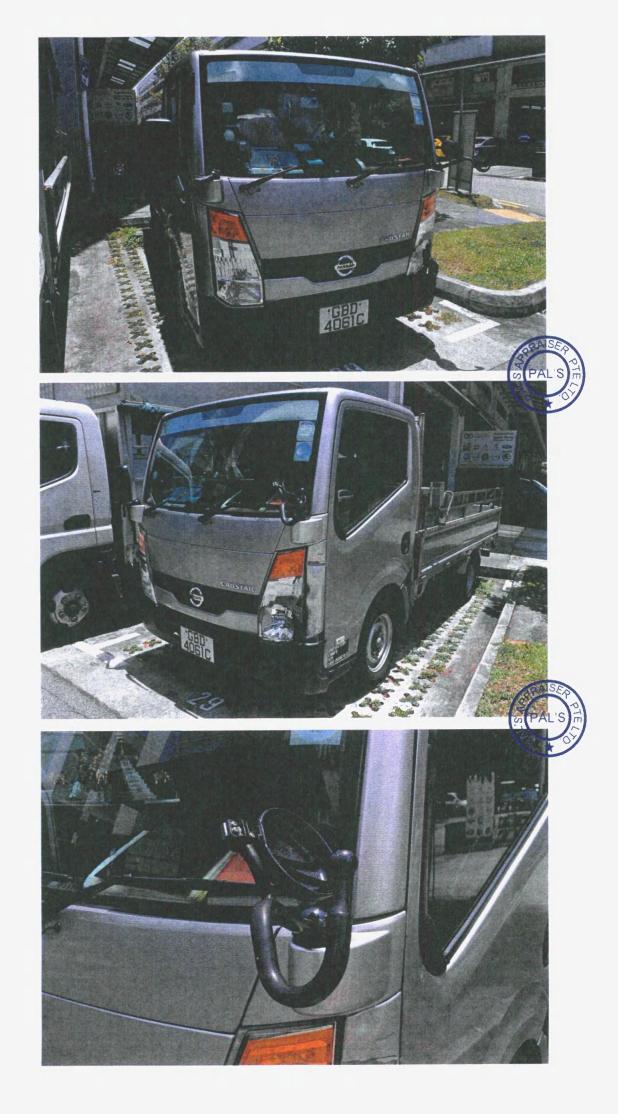
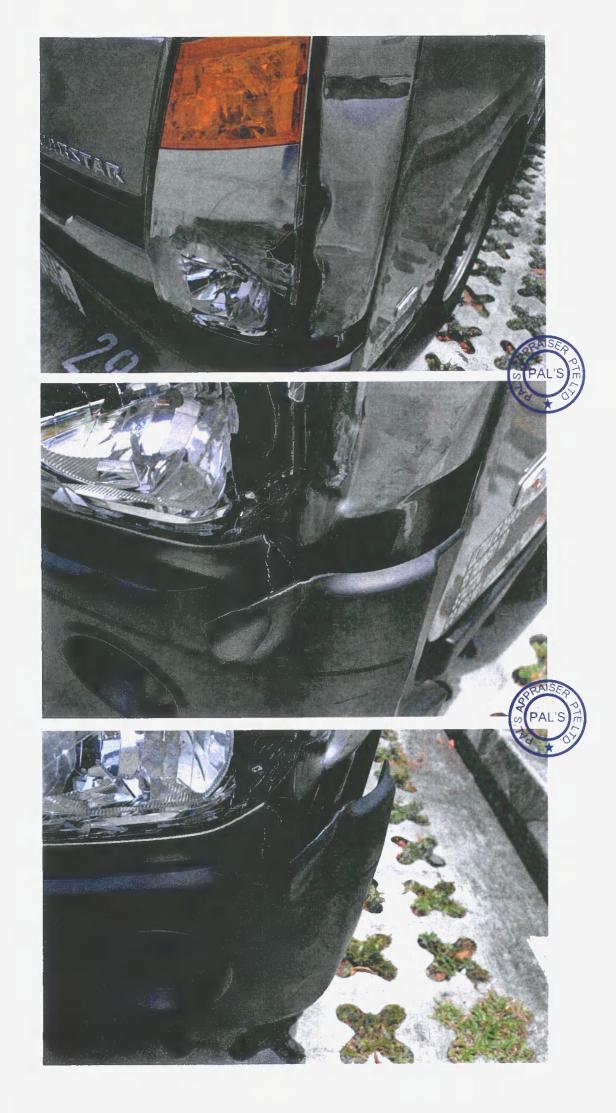
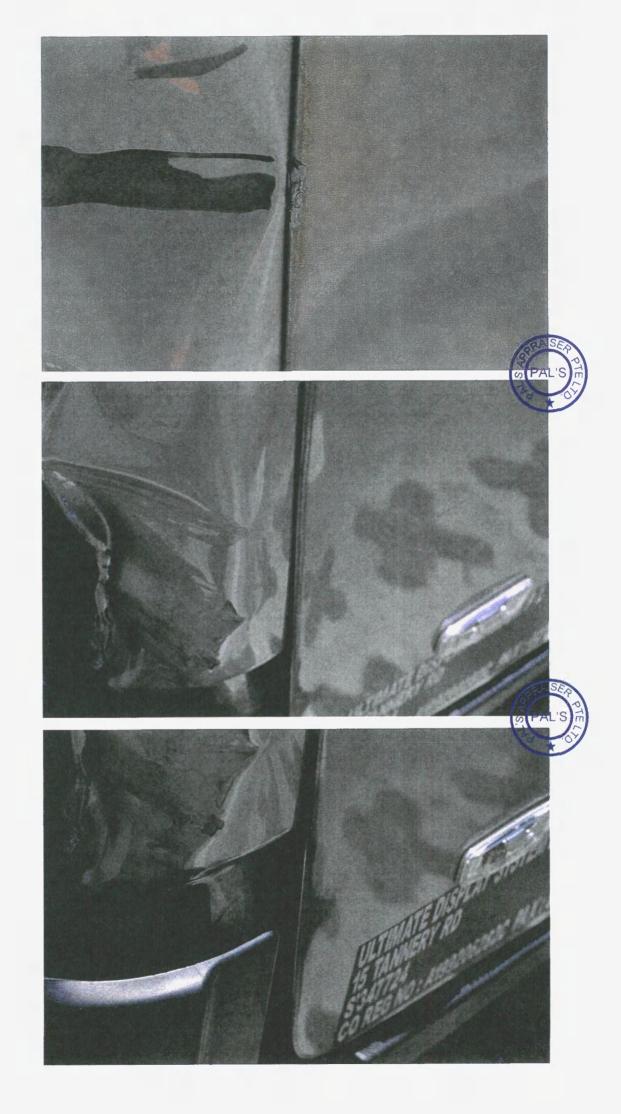
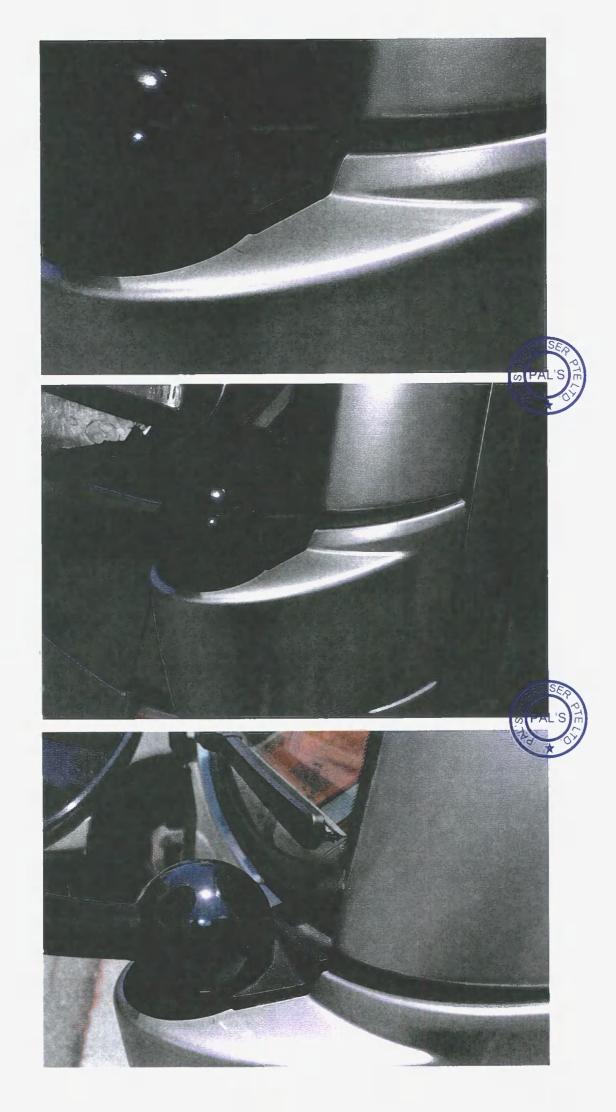
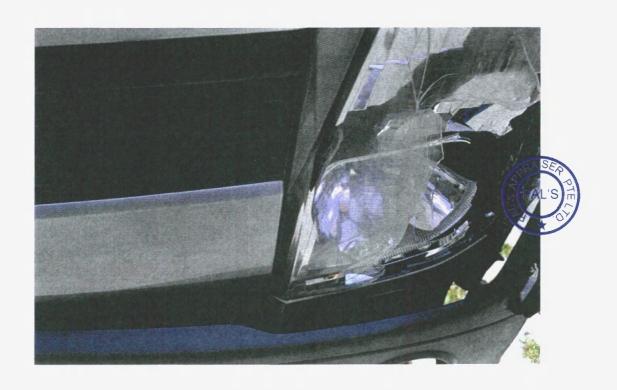
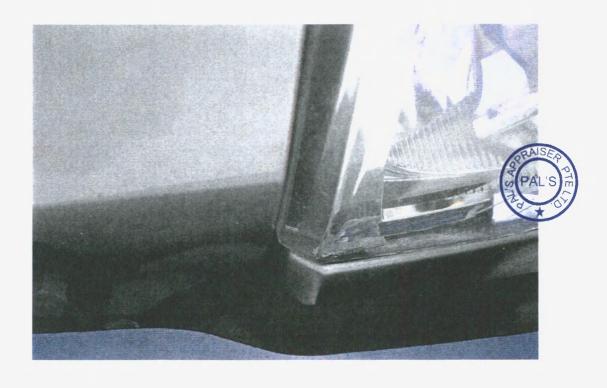
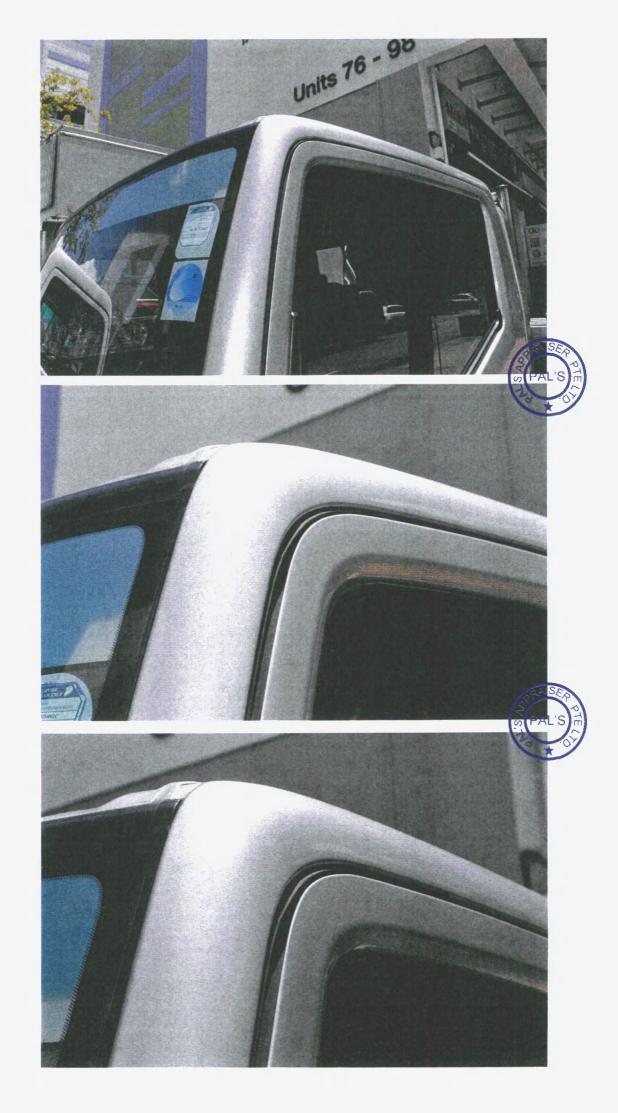
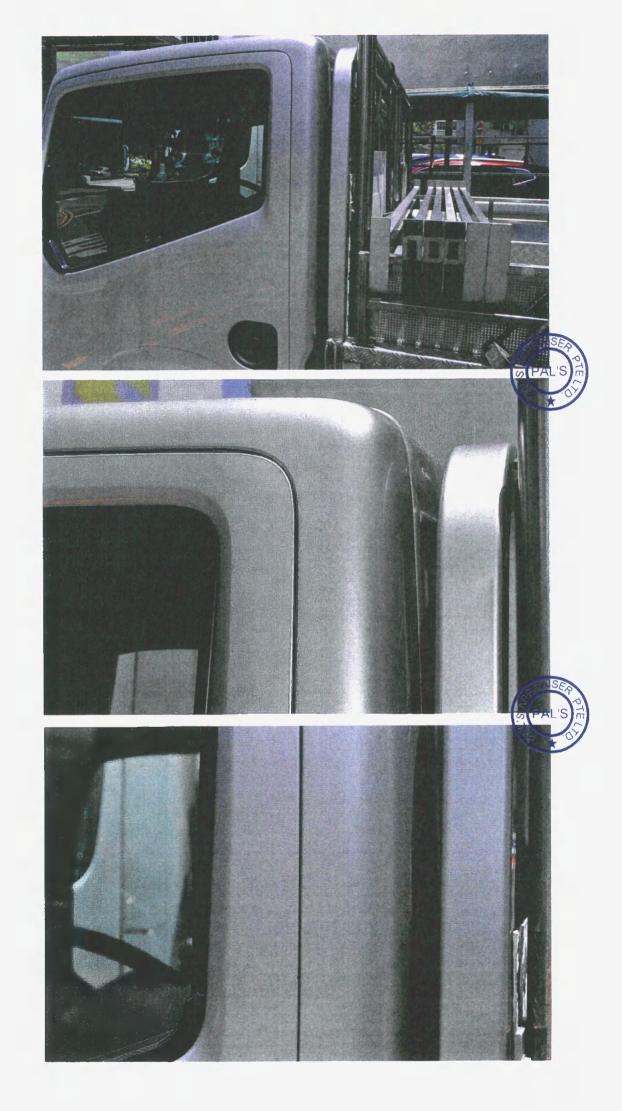
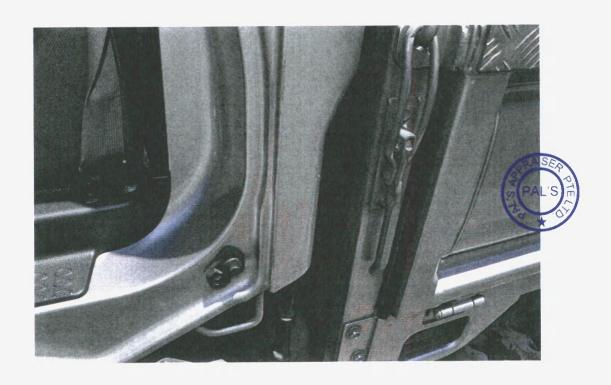
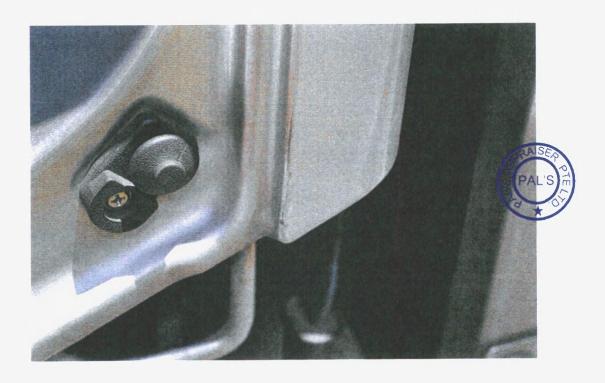
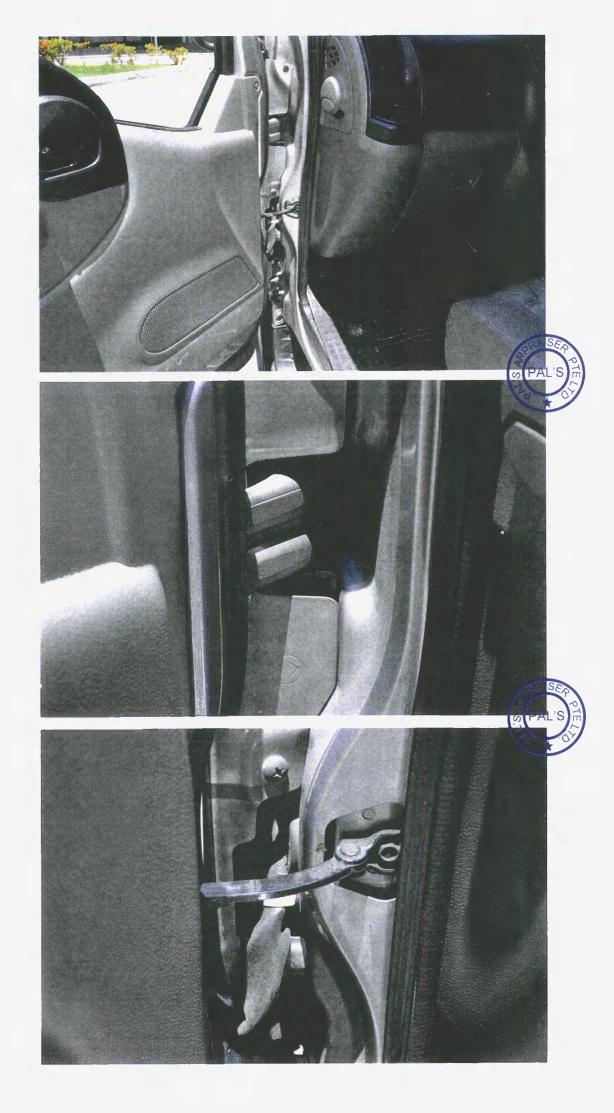
At the time of inspection, we noted that the vehicle has sustained an impact damages on the front n/s portion(s). For more detail of the damages, please see photograph attached.
