Our Ref: CI/III21011507/P

TECHNICAL INVESTIGATION REPORT OF WARRARTY CLAIM INVOLVING THE INSURED VEHICLE SGV 8188R ON 8th November 2021

Vehicle Registration No. : SGV 8188R

Make / Model : TOYOTA APLHARD 7-SEATER 2.5 SC CVT

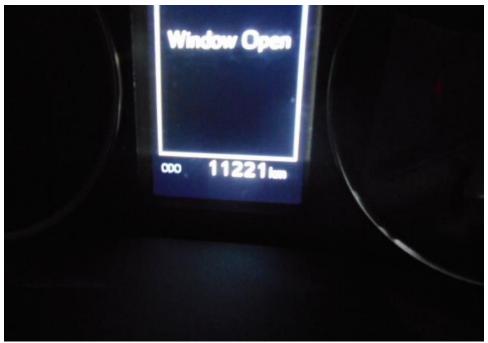
Photo 1 shows the mileage of the Insured Vehicle recorded at the time inspection at 11,221KM

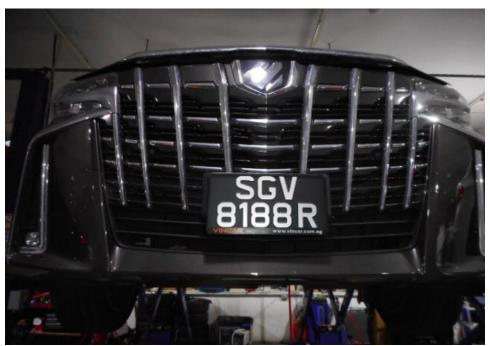
Photo 2 shows the general view of the front portion of the Insured Vehicle at the time of our inspection. The Insured Vehicle is observed to be unaffected by any signs of accident.

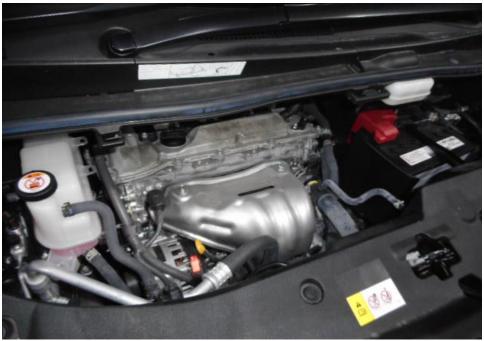
Photo 3 shows the general view of the engine portion of the Insured Vehicle at the time of our inspection. The engine compartment is observed to be unaffected by any signs of accident.

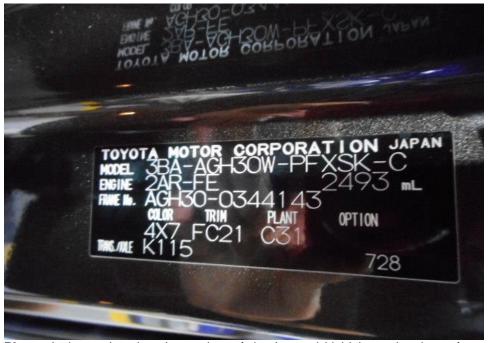
Photo 4 shows the chassis number of the Insured Vehicle at the time of our inspection.

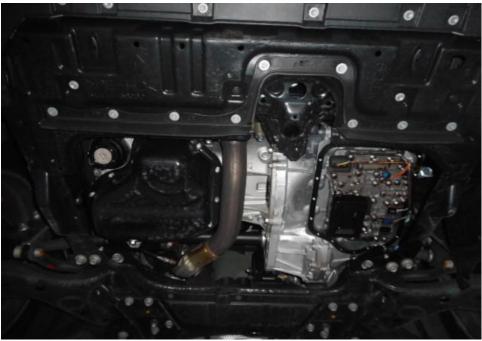
Photo 5 shows the general view of the engine and transmission underside portion of the Insured Vehicle at the time of our inspection. The engine and transmission underside compartment is observed to be unaffected and by any signs of accident.

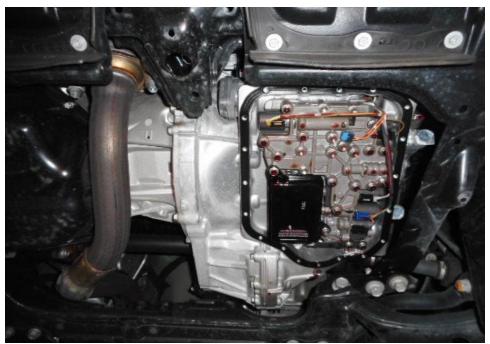
Photo 6 shows the general view of the CVT transmission unit underside portion of the Insured Vehicle at the time of our inspection. The CVT transmission unit oil sump was dismantle for inspection.

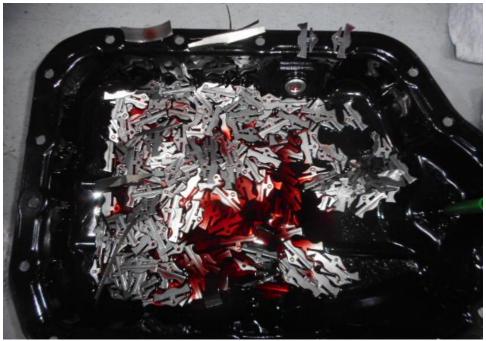
5. The complaint on the Insured Vehicle was noted be to a faulty gearbox as the CVT automatic transmission belt broke while driving and the vehicle had lost its driving ability at the material time. The recommendation by the workshop to was to replace the gears, shafts, clutches and CVT chain in the CVT automatic transmission unit. The vehicle was observed to be unaffected by any signs of accident. See photos 1 – 12 below.

Photo 7 shows the close up view of the CVT transmission unit underside portion of the Insured Vehicle at the time of our inspection. We observed broken CVT transmission drive belt and transmission components that had fallen down to the oil sump.

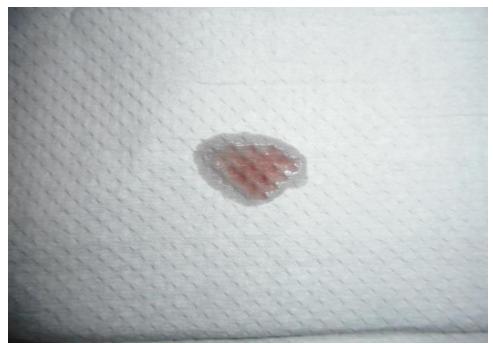
Photo 8 shows the close up view of the CVT transmission fluid of the Insured Vehicle at the time of our inspection. We observed that CVT transmission fluid was observed to be without any visible contamination.

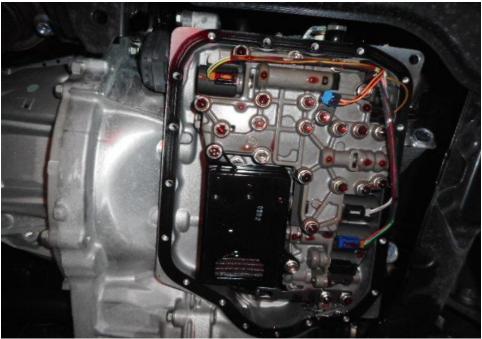
Photo 9 shows the general view of the CVT transmission unit underside portion of the Insured Vehicle at the time of our inspection. We observed that there was still CVT transmission drive belt and components still stuck inside the CVT transmission unit.

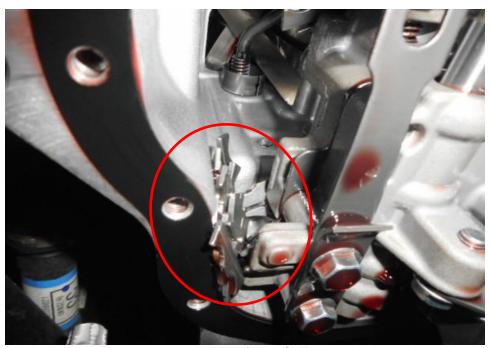
Photo 10 shows the close up view of the CVT transmission unit underside portion of the Insured Vehicle at the time of our inspection. We observed that there was still CVT transmission drive belt and components (circled) still stuck inside the CVT transmission unit.

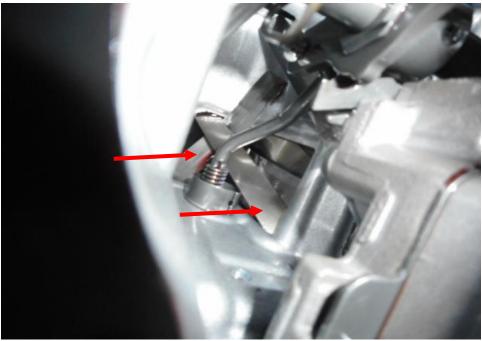
Photo 11 shows the close up view of the CVT transmission unit underside portion of the Insured Vehicle at the time of our inspection. We observed that there was still CVT transmission drive belt and components (arrowed) still stuck inside the CVT transmission unit.

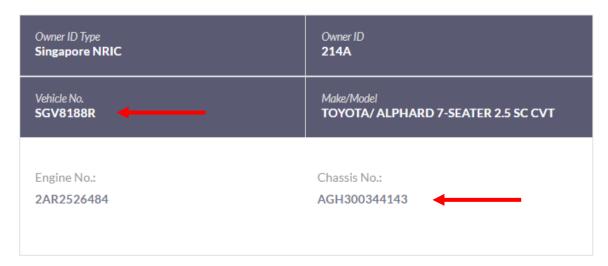
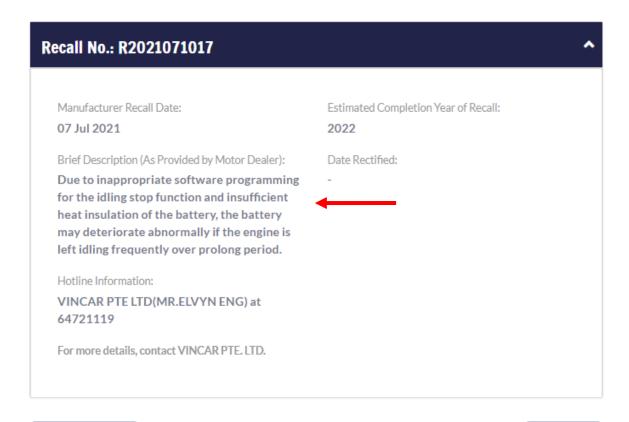
6. Our checks with both local and international bodies and associations had also revealed that at the time of writing this report, there is no manufacturer recall of similar make and model vehicle as the Insured Vehicle that may possibly be related to abnormalities being originated from the CVT transmission of the Insured Vehicle. See search result from LTA below.

Recall details. Shows the vehicle recall results retrieved from LTA's website. There was no recall regarding the CVT transmission system on the Insured Vehicle at the time of incident.

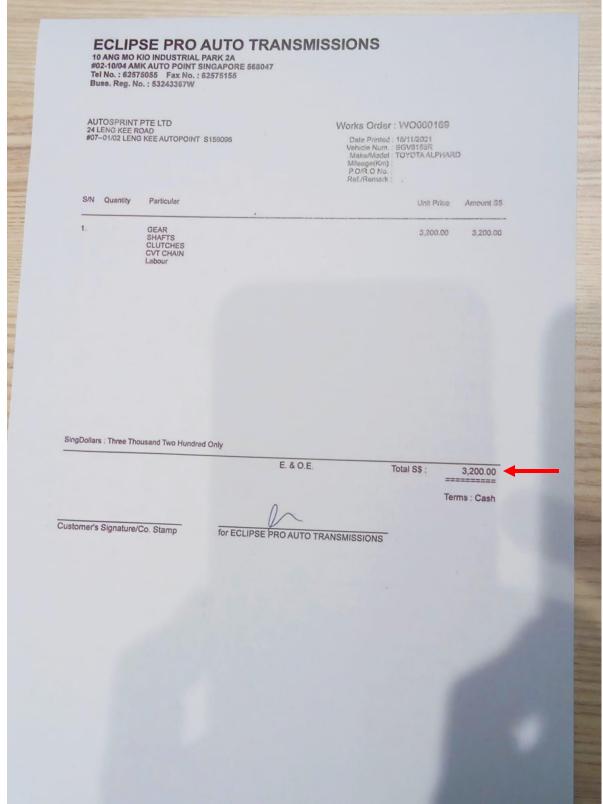
Repair details. Shows the list of components to repair retrieved from the repair shop. The recommendation to replace the gears, shafts, clutches and CVT chain in the CVT transmission system on the Insured Vehicle at \$3,200 is justifiable as all the relevant checks has been conducted.

- 7. We did not find any evidence which had suggested that the cause of abnormalities to the Insured Vehicle was due to poor maintenance and/or recurring problem.
- 8. Our investigations had also revealed that at the time of writing this report, there is no manufacturer recall to similar make and model vehicle as the Insured Vehicle that may possibly be related to this incident.
- 9. The recommendation to replace the gears, shafts, clutches and CVT chain in the CVT automatic transmission at \$3,200 is justifiable as all the relevant checks has been conducted.
