AUTOMOBILE ASSESSMENT REPORT

ASSESSMENT OF VEHICLE NO. SLG 7108 Z

DATE OF LOSS: 13-Feb-2021

Registration No.: SLG 7108 Z
Make & Model: HONDA VEZEL 1.5X A
Year of Registration: 2016
Engine Capacity: 1496
Chassis No.: RU11203681
Engine No.: L15B4403681
Colour: WHITE

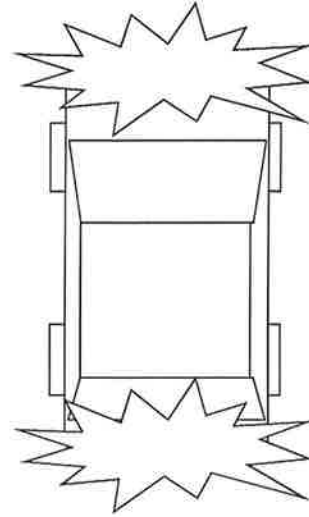
At the time of the inspection, the vehicle sustained damages to the FRONT and REAR portion.
