Your Ref: TP/IP/41879/2021
Our Ref : CI/TPD21011597/N

18 October 2021

MECHANICAL INSPECTION REPORT OF MOTORCYCLE FBD 6577T

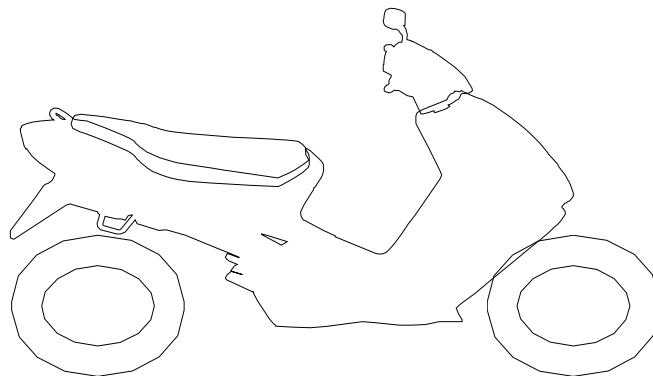
6. The condition of the 2 tyres of the Motorcycle was observed to be in serviceable condition. We did not observe any tear, burst mark(s) and/or punctured hole(s) on the sidewalls as well as across the tread of the 2 tyres. Both the tyres were observed to be sufficiently inflated for vehicular operation.
7. The tyre brand, tyre size and remaining tread depth of the 2 tyres were recorded as follows:-

Dunlop 80/90 - 17 (2mm)

Dunlop 80/80 - 17 (4mm)

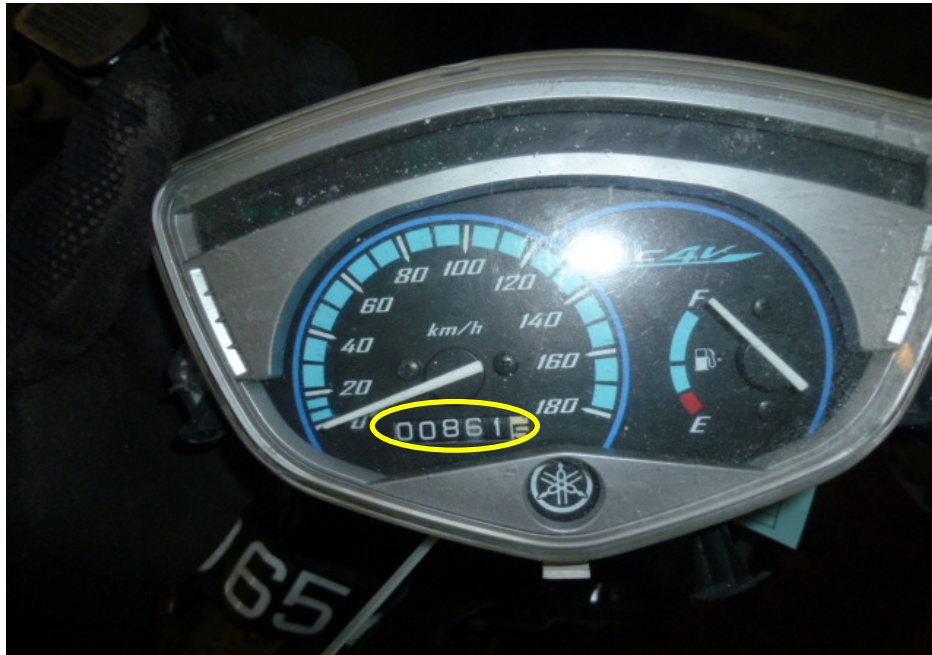
Photo 1 shows the speedometer gauge of the Motorcycle where the mileage recorded at the time of our inspection was 861km (circled).

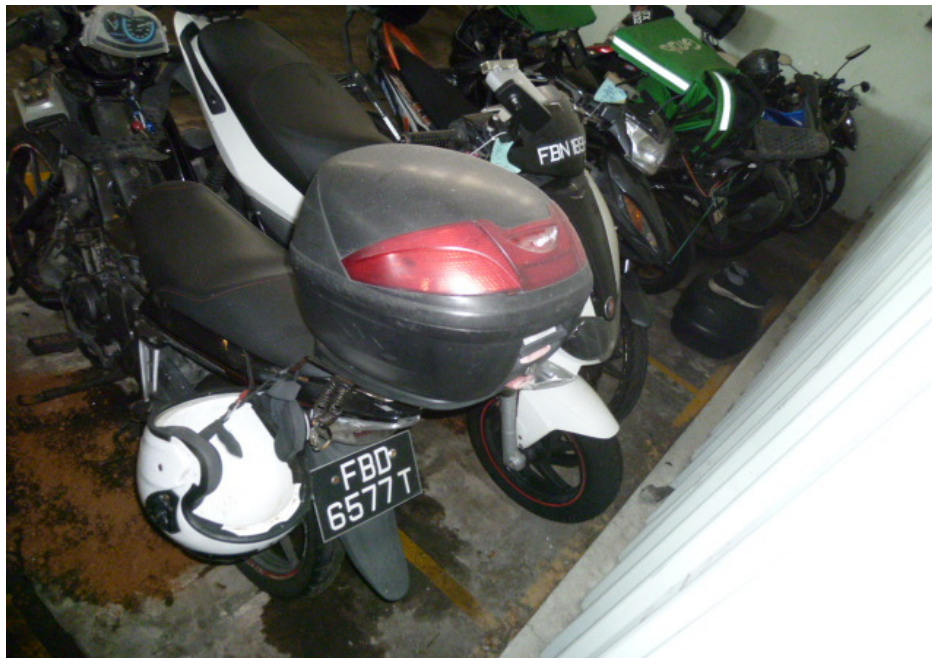
Photo 2 shows a general view of the rear portion of the Motorcycle at the time of our inspection. The Motorcycle had sustained damages all around.

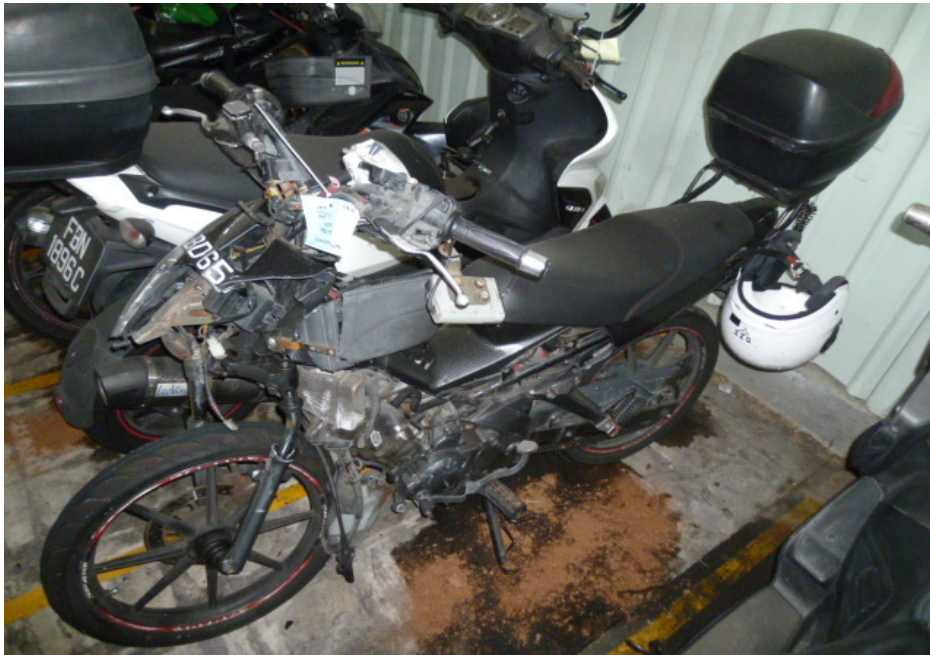
Photo 3 shows a general view of the left body of the Motorcycle at the time of our inspection. The Motorcycle had sustained damages all around. Body parts that were found to have been damaged include its headlight assembly, front cowling, front fork assembly, front mudguard, side cowlings, right side mirror, front brake lever, right handlebar end, radiator, left rear side cover and top box, amongst others.

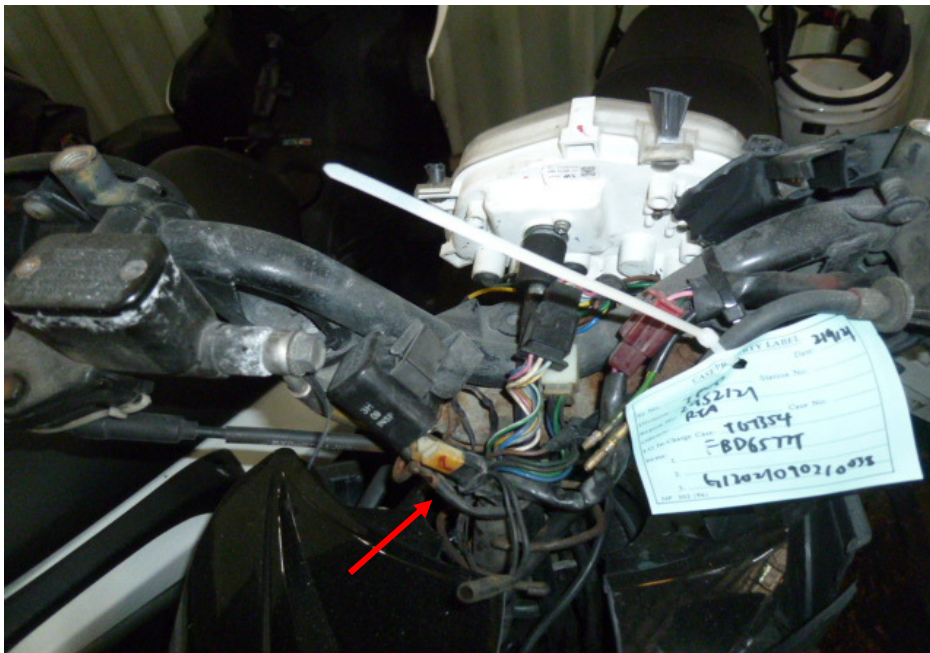
Photo 4 shows a closer view of the missing headlight assembly which was amongst the body parts at the front body of the Motorcycle that had sustained damages as a result of the accident (arrowed).

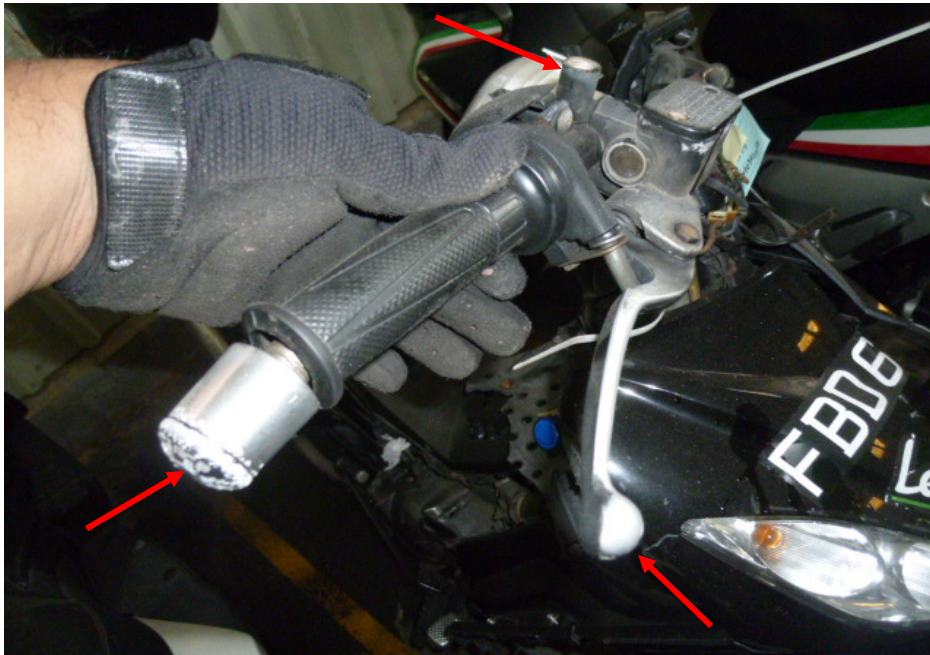
Photo 5 shows a closer view of the front brake lever, right side mirror and right handlebar end (arrowed) of the Motorcycle. These parts were amongst the body parts of the Motorcycle which were damaged as a result of the accident.

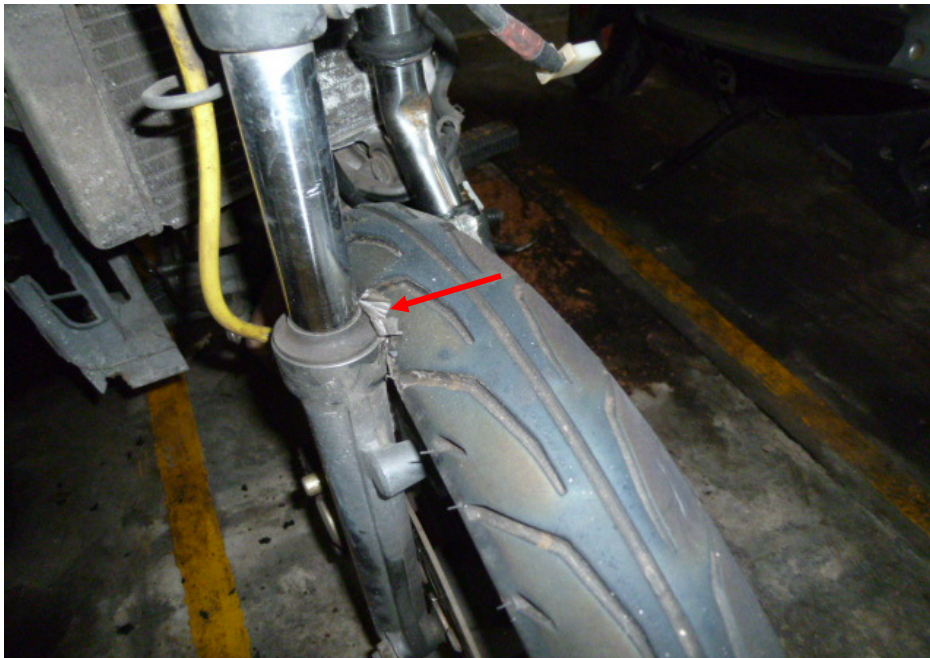
Photo 6 shows a closer view of the cracked front mudguard of the Motorcycle as a result of the accident (arrowed).

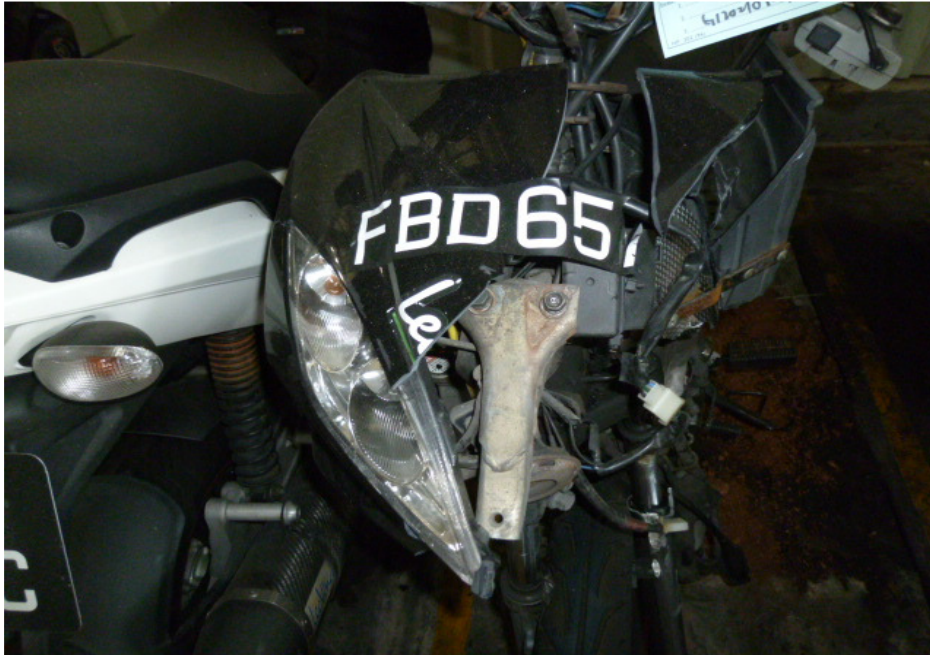
Photo 7 shows a closer view of the front cowling which was amongst the body parts at the front body of the Motorcycle that had sustained damages as a result of the accident.

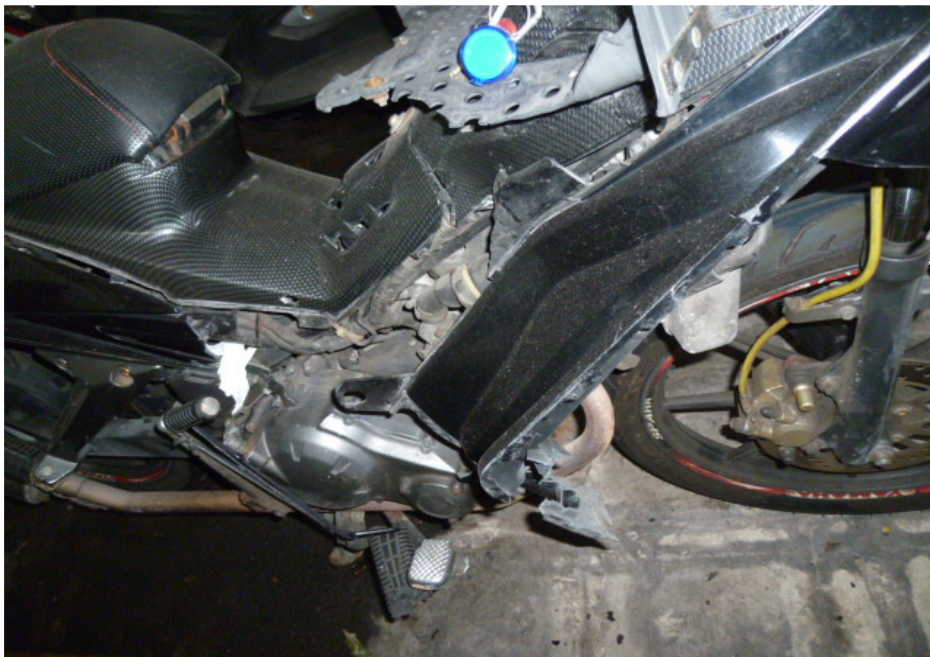
Photo 8 shows a closer view of the right cowling which was amongst the body parts at the front body of the Motorcycle that had sustained damages as a result of the accident.

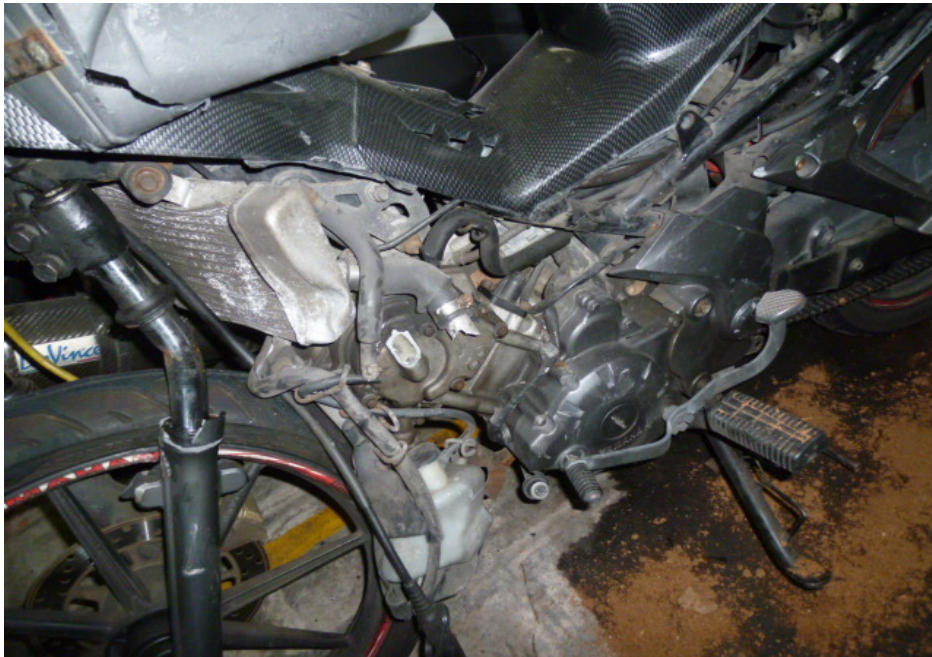
Photo 9 shows a closer view of the missing left cowling which was amongst the body parts at the front of the Motorcycle that had sustained damages as a result of the accident.

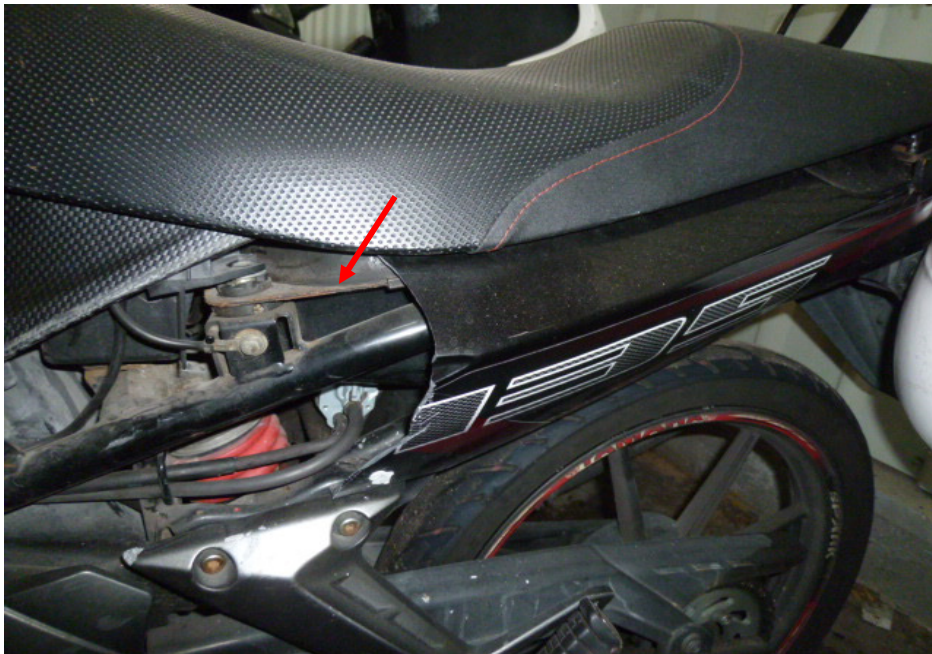
Photo 10 shows a closer view of the cracked left rear side cover (arrowed), which were amongst the body parts of the Motorcycle that had sustained damage as a result of the accident.

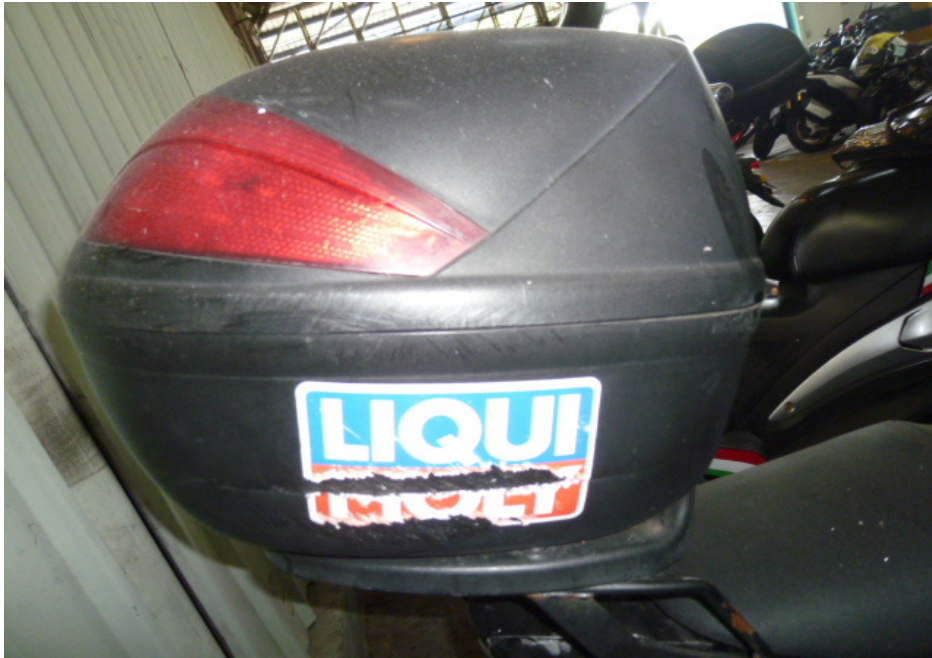
Photo 11 shows the top box which was amongst the body parts at the rear body of the Motorcycle that had sustained damages as a result of the accident.

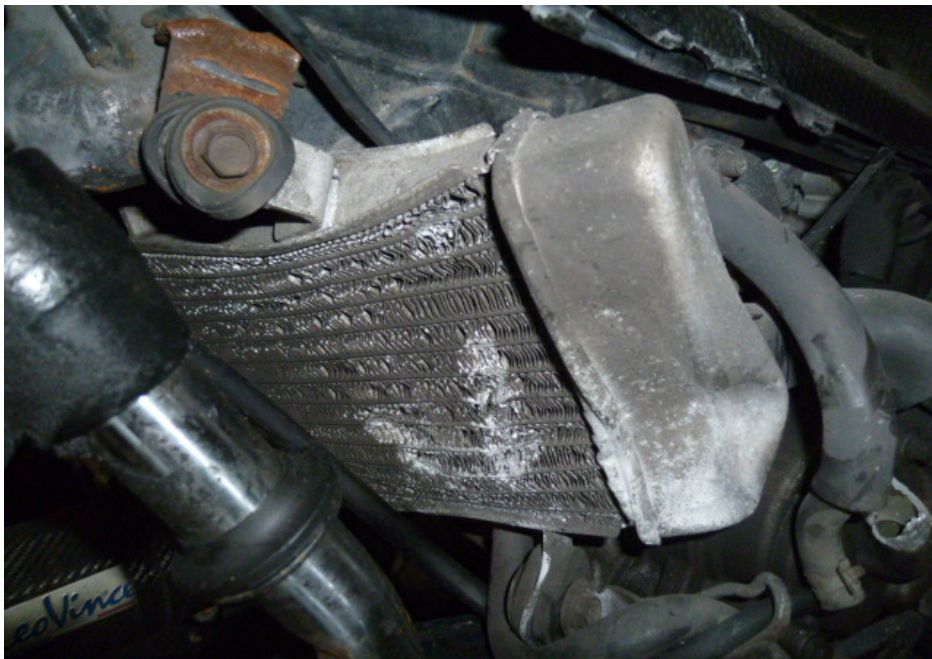
Photo 12 shows the deformed radiator of the Motorcycle as a result of the accident at the time of our inspection.

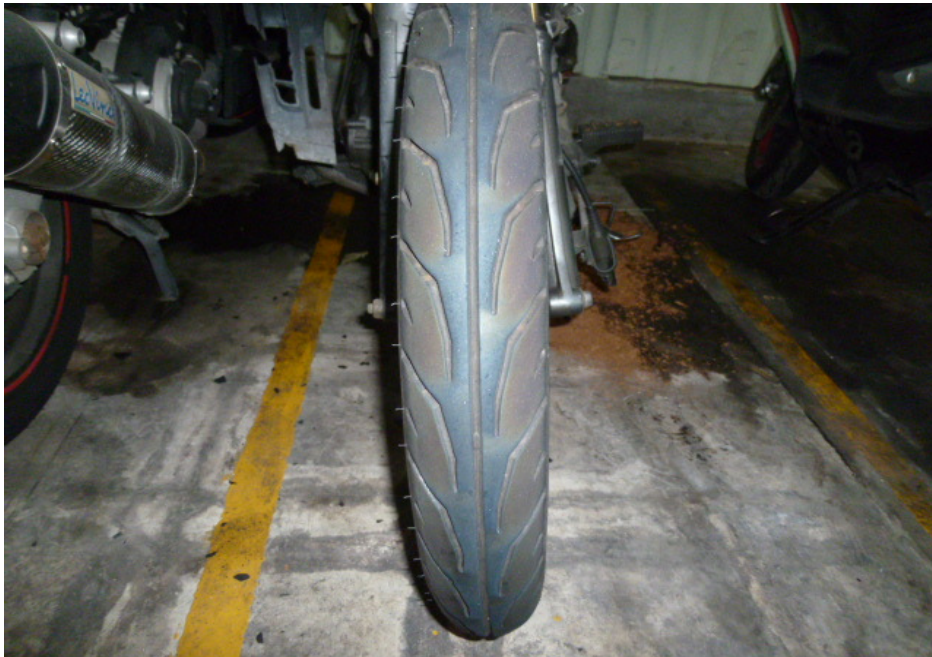
Photo 13 shows the condition of the Motorcycle's front tyre. The front tyre was observed to be in serviceable condition with remaining tread depth of approximately 4mm. The tyre was also observed to be sufficiently inflated for vehicular operation. We did not observe any tear, burst mark(s) and/or punctured hole(s) on the sidewalls as well as across the tread of the front tyre.

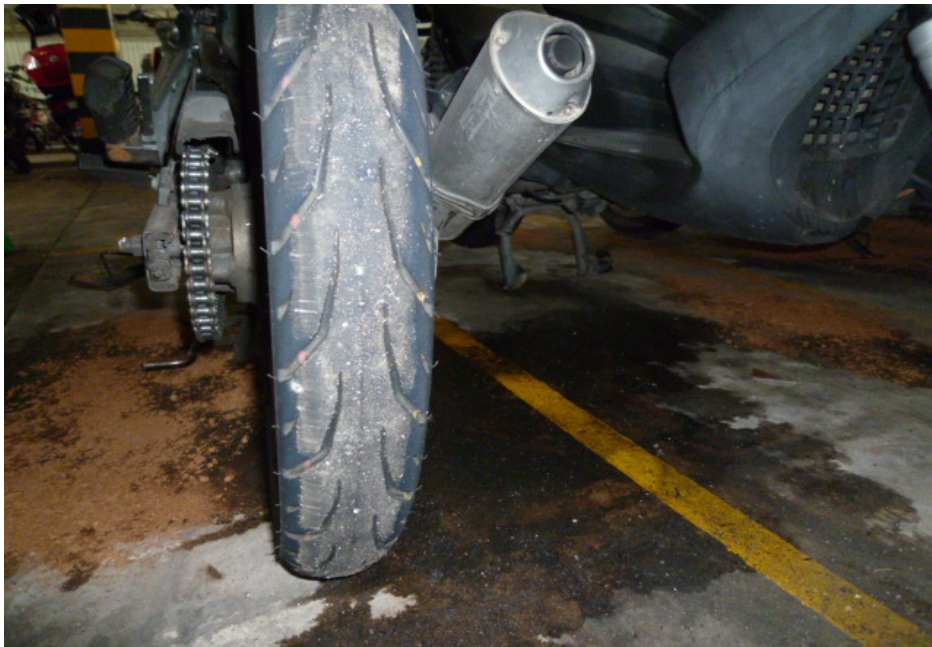
Photo 14 shows the condition of the Motorcycle's rear tyre. The rear tyre was observed to be in serviceable condition with remaining tread depth of approximately 2mm. The tyre was also observed to be sufficiently inflated for vehicular operation. We did not observe any tear, burst mark(s) and/or punctured hole(s) on the sidewalls as well as across the tread of the rear tyre.

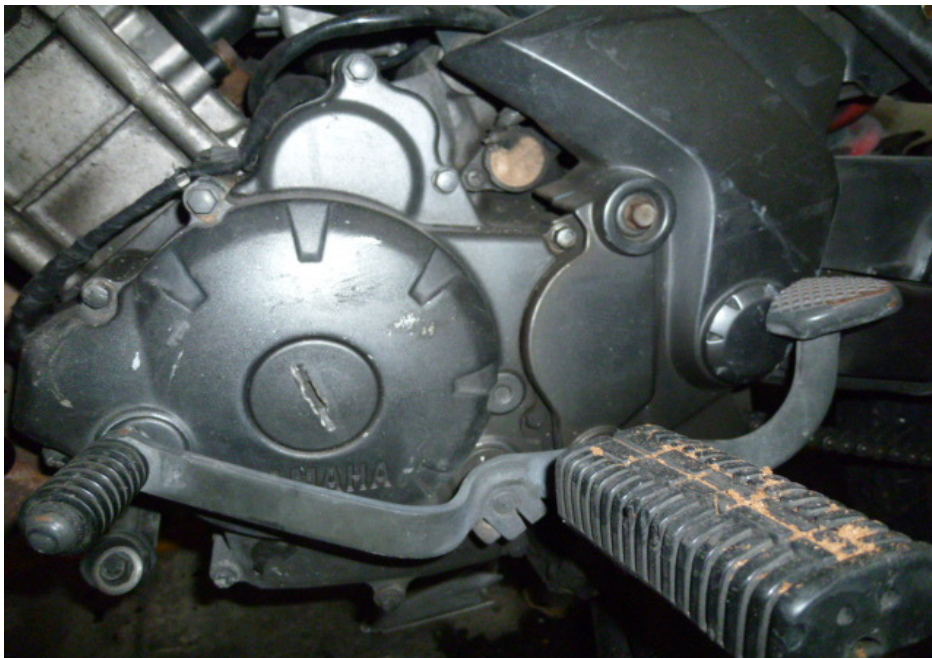
Photo 15 shows the left side of the engine of the Motorcycle at the time of our inspection. The various engine related parts and components were found to be intact with no visible damage. There was also no sign(s) or indication(s) of fluid leak observed around the left engine area of the Motorcycle.

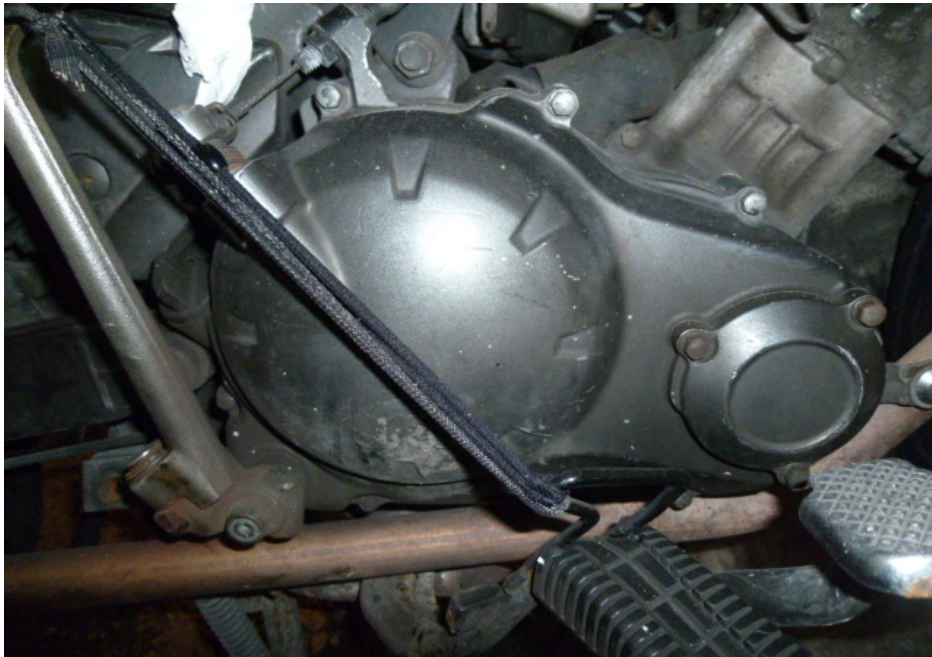
Photo 16 shows the right side of the engine of the Motorcycle at the time of our inspection. The various engine related parts and components were found to be intact with no visible damage. There was also no sign(s) or indication(s) of fluid leak observed around the right engine area of the Motorcycle.

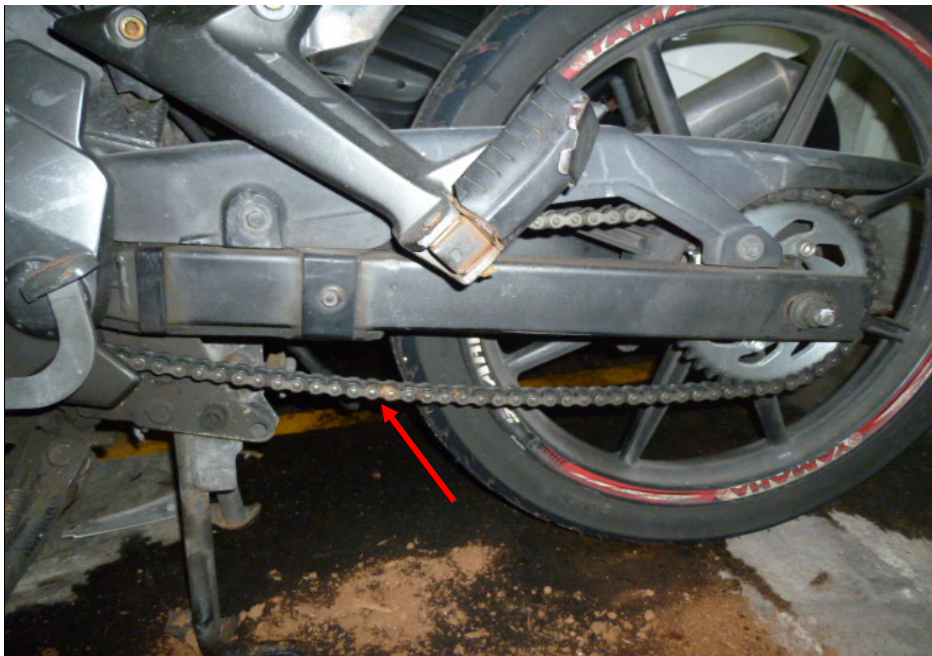
Photo 17 shows the gear train (arrowed) of the Motorcycle, which was observed to be intact with no misalignment. It was also adequately lubricated for operating purposes. The gear train rotates the rear wheel of the Motorcycle.

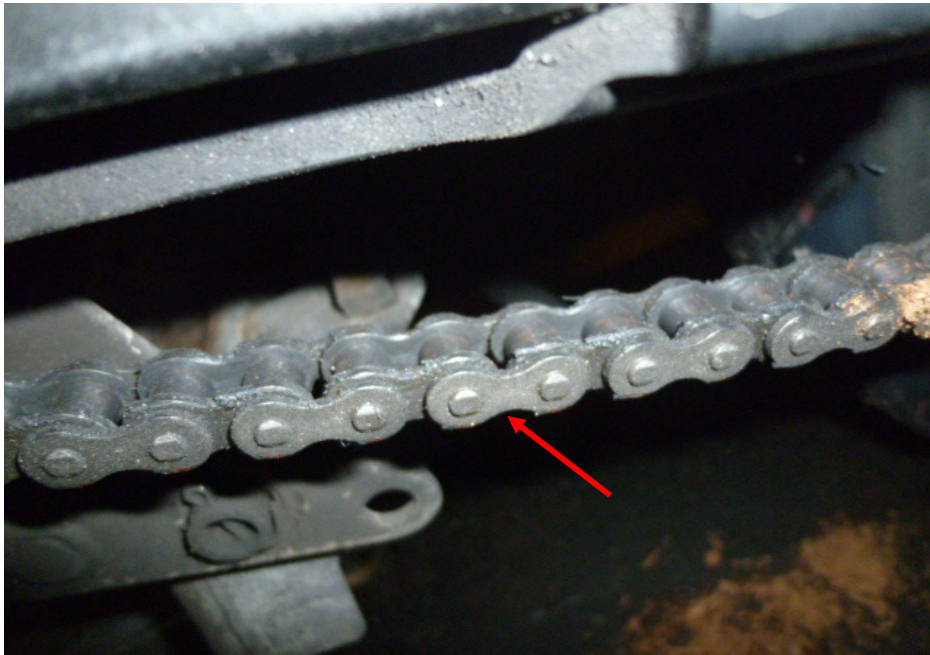
Photo 18 shows the closer view of the gear train (arrowed) of the Motorcycle, which was observed to be intact with no misalignment. It was also adequately lubricated for operating purposes.

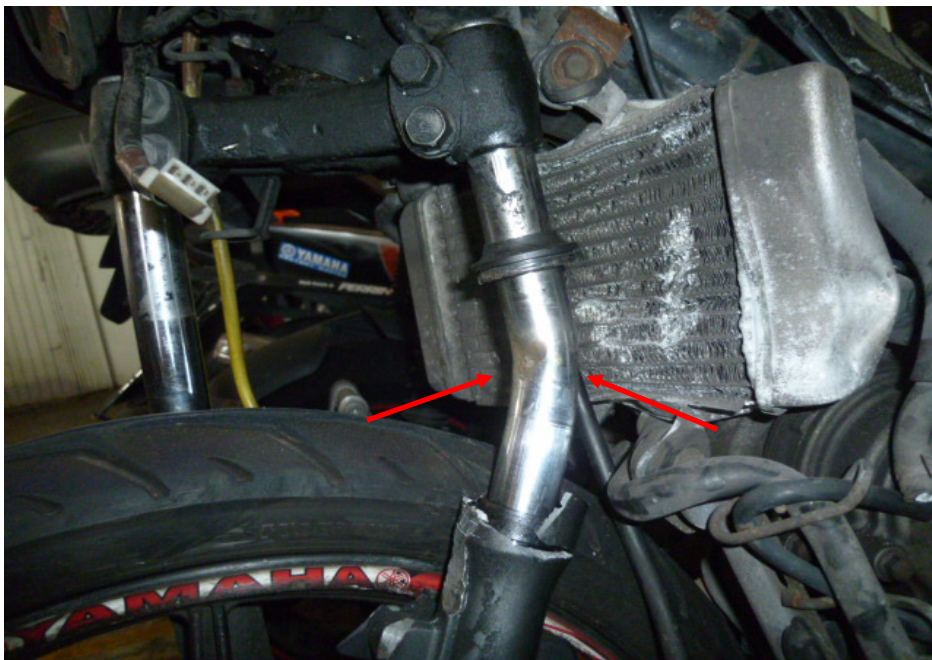
11. For this case, we were not able to conduct any test(s) on the steering system of the Motorcycle due to the damage of its front fork assembly. The left front fork was found to be bent as a result of the accident.

Photo 19 shows the front fork assembly of the Motorcycle. The front left fork (arrowed) was observed to be bent as a result of the accident. We were hence not able to conduct any tests on the steering system of the Motorcycle.

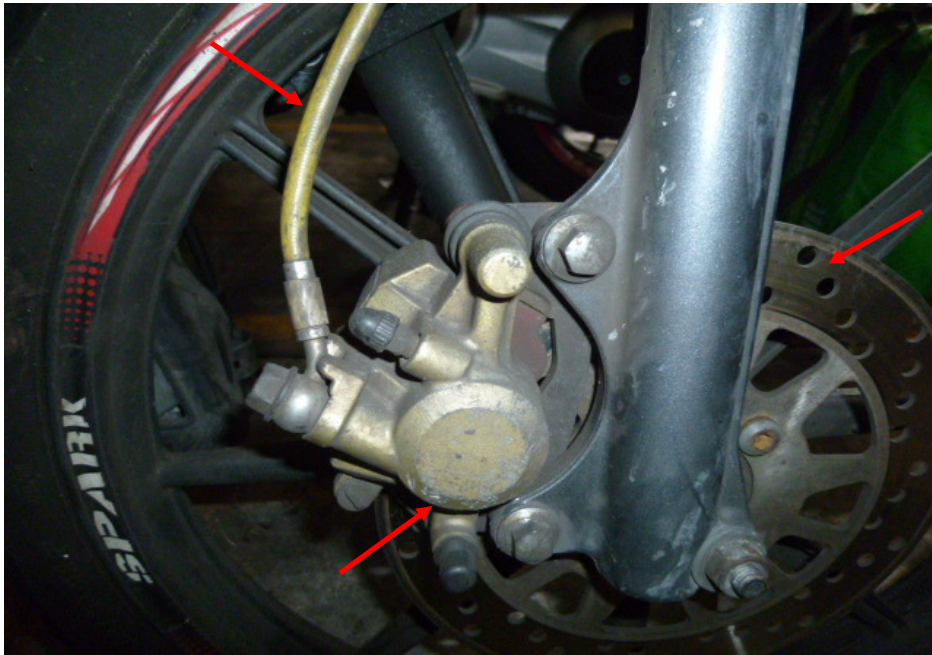
Photo 20 shows a close up view of the front brake caliper, front brake disc and front brake hose (arrowed) of the Motorcycle, which are all part of the components in the hydraulic front brake system of the Motorcycle. Our visual checks of these various components had revealed all to be intact with no visible damage. No leakage of brake fluid was also observed.

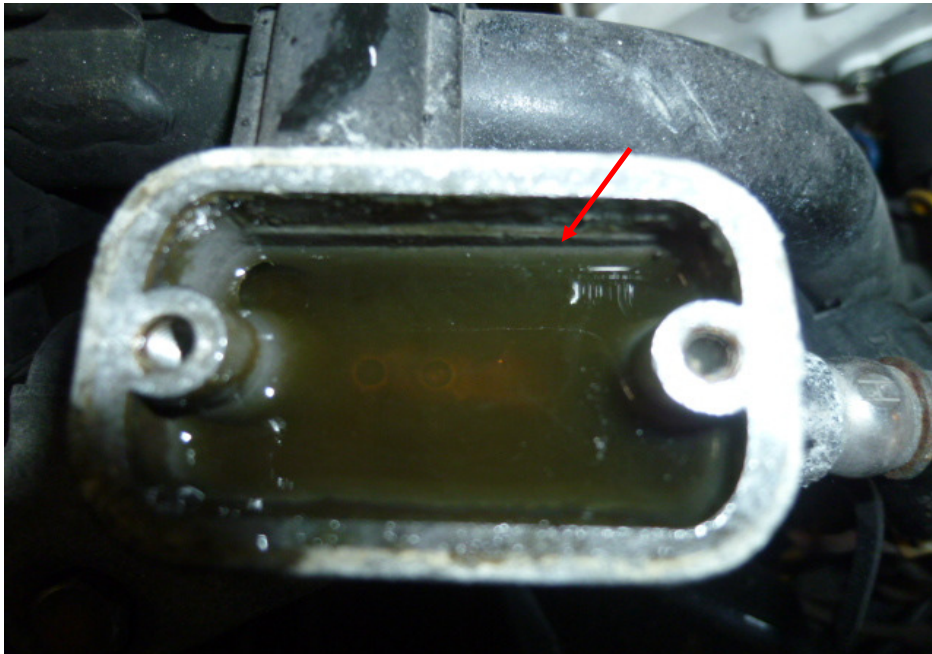
Photo 21 shows the brake fluid reservoir for the front brake of the Motorcycle. The brake fluid was found to be of sufficient level for operating purposes. However the brake fluid was found to be slightly contaminated (arrowed).

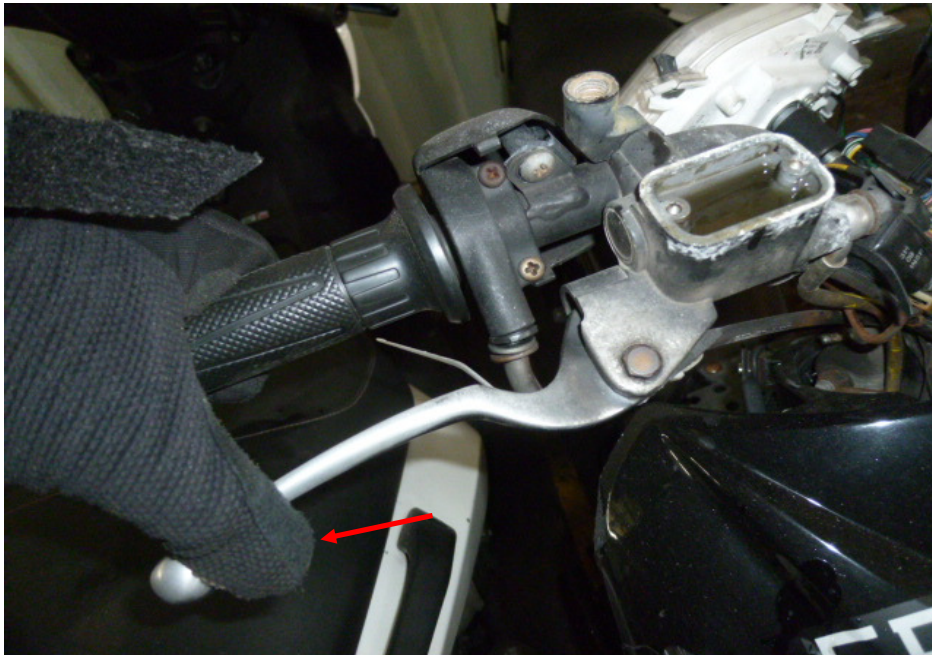
13. Static brake tests conducted on the Motorcycle had appeared to indicate that the brake system of the Motorcycle was in serviceable condition. There was some resistance felt (spongy like feel) upon pressing the front brake lever. This would indicate that there's no leakage of pressure/vacuum in the front brake system.
14. For this case, we were not able to carry out any operational tests to the steering system and braking system of the Motorcycle due to the damage of its front fork assembly, which had rendered the Motorcycle immobile. We were not able to push the Motorcycle manually forward and backward, simulating movement of the Motorcycle, for the operational tests. See photos 19 – 23 below.

Photo 22 shows the front brake lever being depressed. There was some resistance felt (spongy like feel) upon pressing the front brake lever (arrowed). This would indicate that there is no leakage of pressure/vacuum in the brake system.

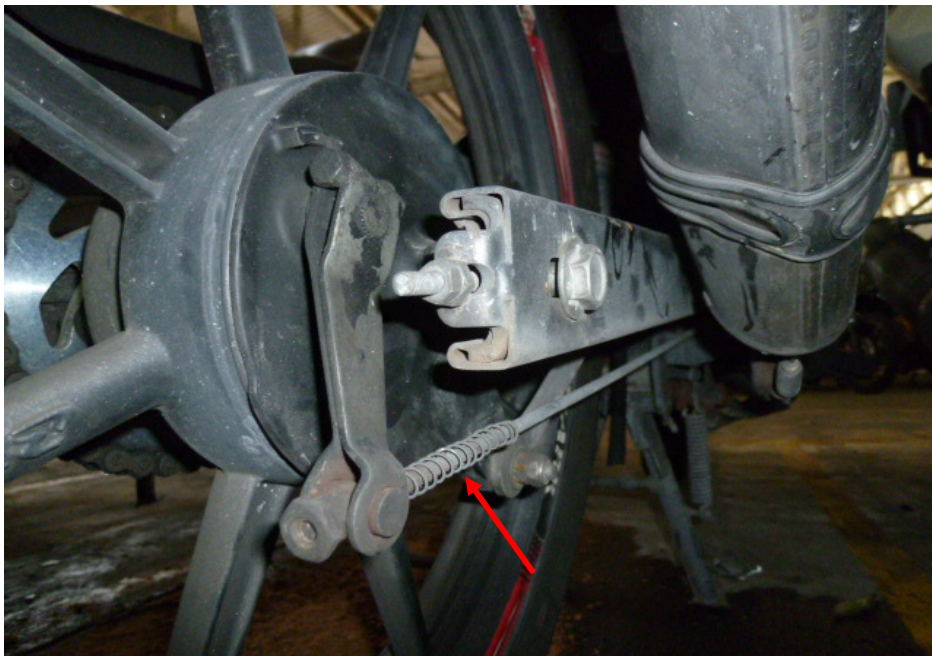
Photo 23 shows the rear wheel of the Motorcycle. The type of brake system for the rear wheel was of a mechanical type, controlled by the brake foot pedal of the Motorcycle. Our checks of the cable (arrowed), spring and drum which are all part of the components in the rear brake system of the Motorcycle reveal all to be intact and without damage.
