Your Ref: TP/IP/50125/2021
Our Ref : CI/TPD21011601/N

Fatal Accident Investigation Team

INSPECTION REPORT OF MOTORCYCLE FBN 5426A

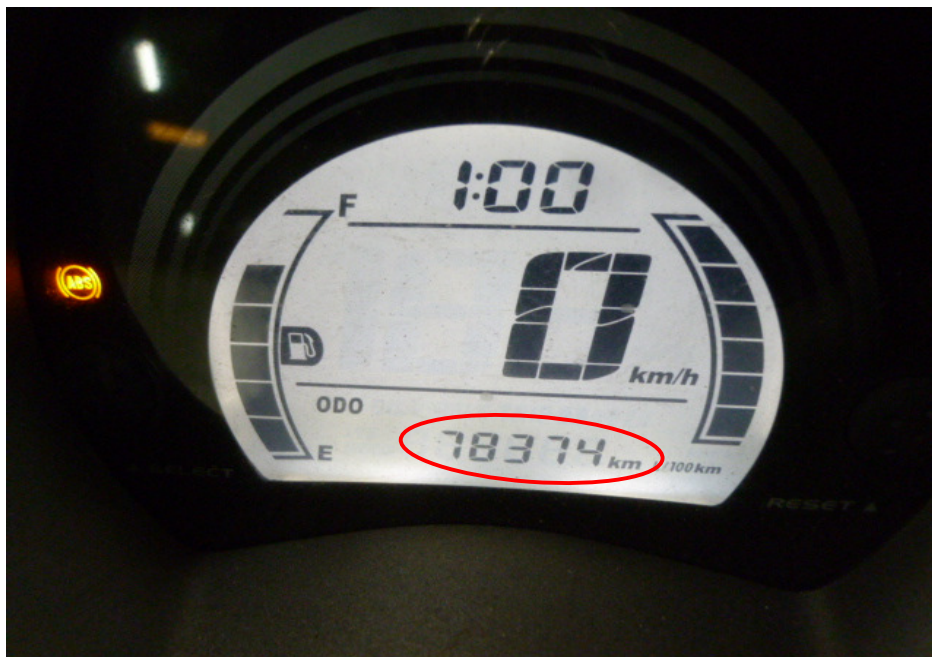
Photo 1 shows the speedometer gauge of the Motorcycle where the mileage recorded at time of our inspection was 78,374km (circled).

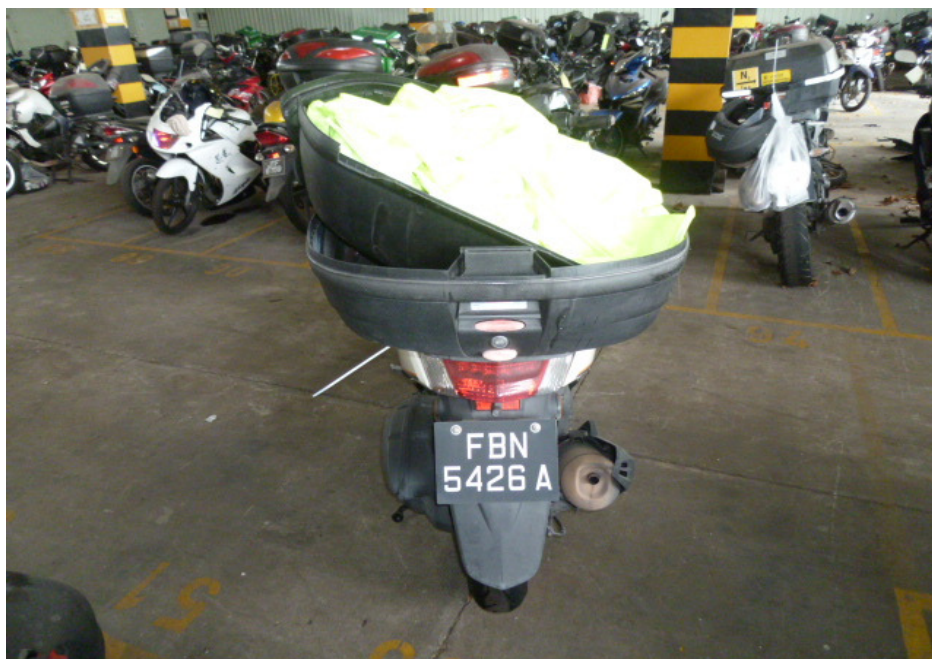
Photo 2 shows a general view of the rear portion of the Motorcycle at the time of our inspection. The Motorcycle was observed to have sustained damages at its frontal portion and right body.

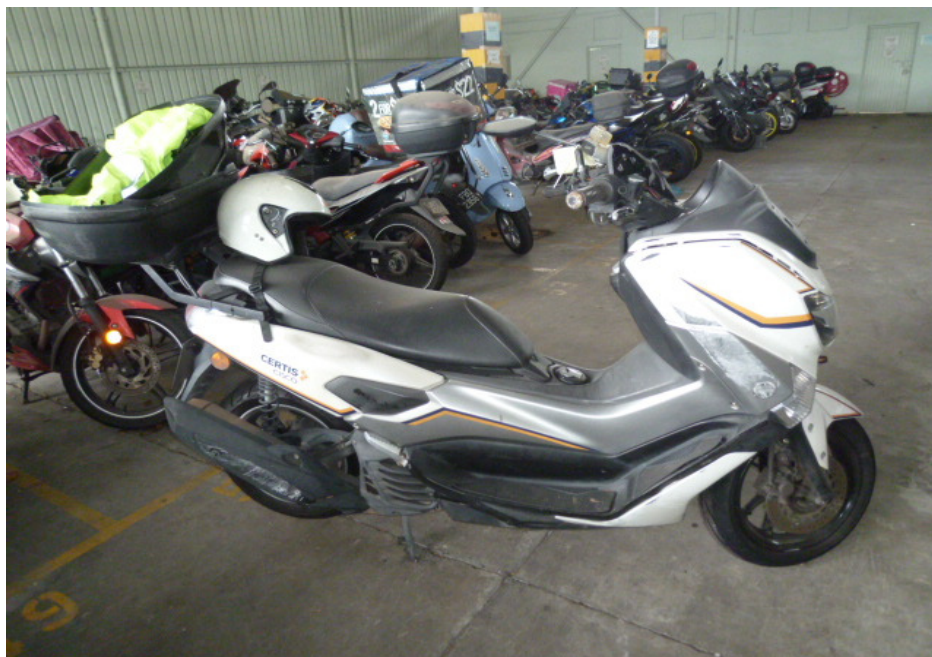
Photo 3 shows a general view of the right body of the Motorcycle at the time of our inspection. The Motorcycle was observed to have sustained damages at its frontal portion and right body.

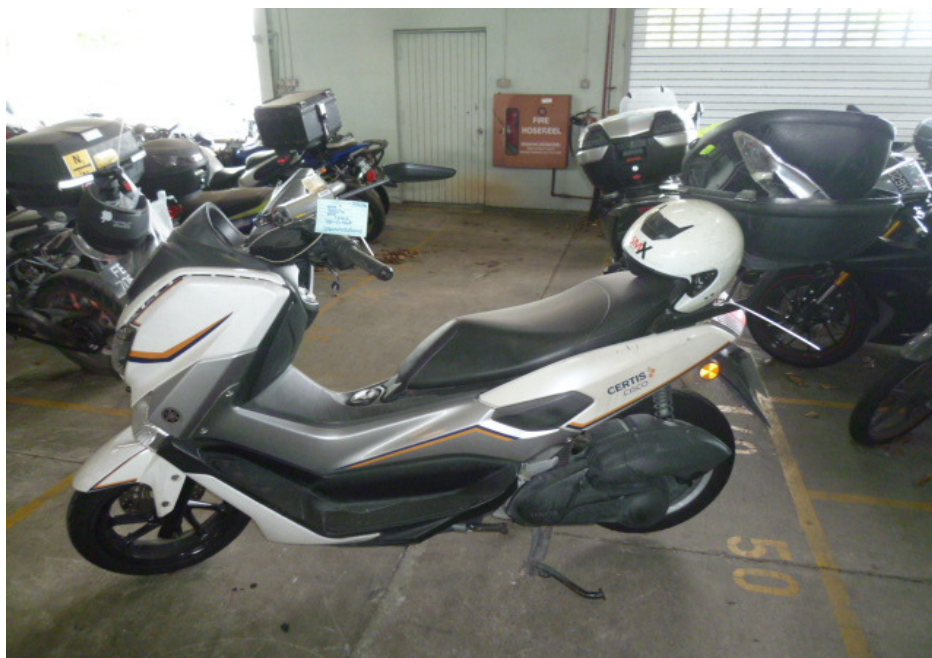
Photo 4 shows a general view of the left body of the Motorcycle at the time of our inspection. The Motorcycle was observed to have sustained damages at its frontal portion and right body. The body parts that were found to have been damaged include its windshield, front mudguard, front brake lever, front cowling, right side mirror, right handlebar end, right side cowling, right pillion foot peg, top box and exhaust muffler heat shield, amongst others as a result of the accident.

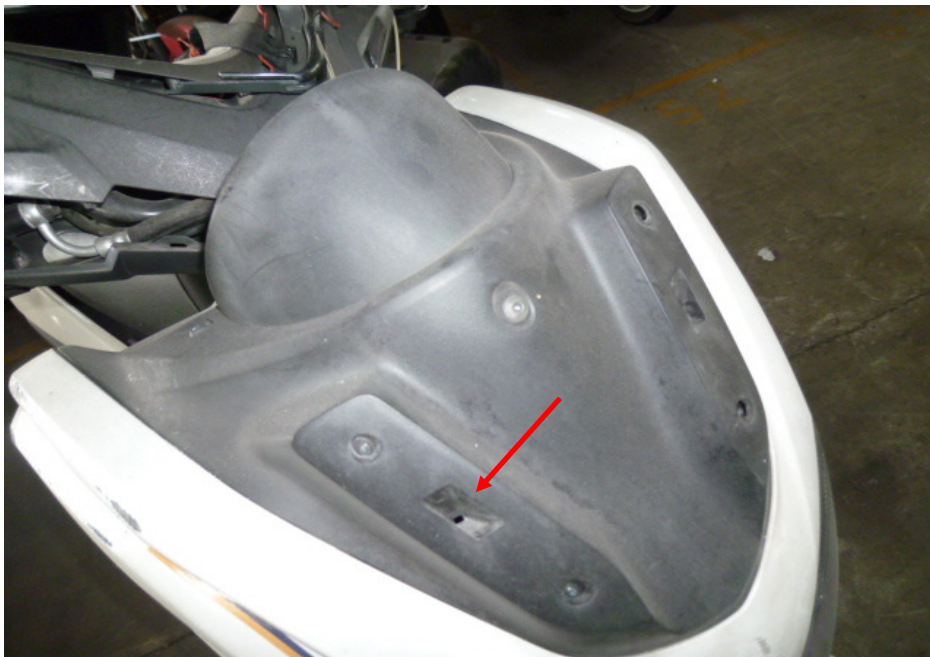
Photo 5 shows a closer view of the missing windshield of the Motorcycle at the time of our inspection (arrowed).

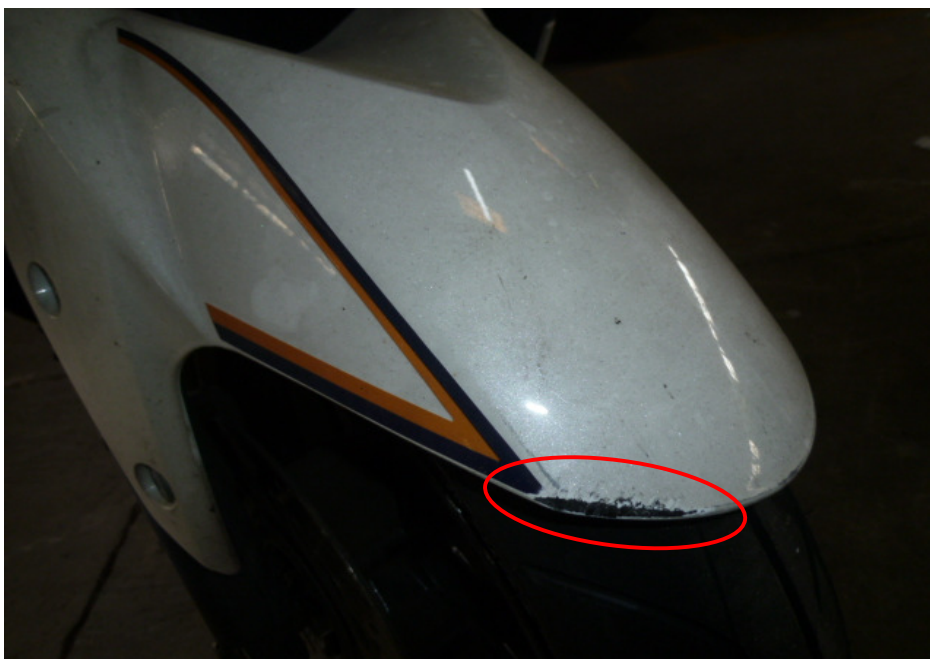
Photo 6 shows a closer view of the front mudguard which was amongst the body parts at the front body of the Motorcycle that had sustained damage as a result of the accident (circled).

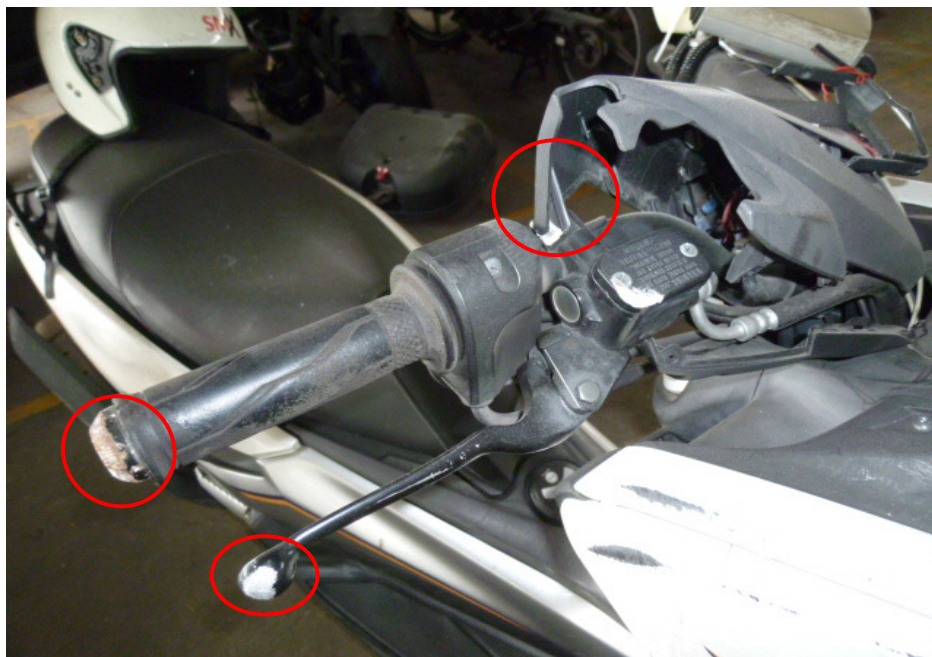
Photo 7 shows a closer view of the right side mirror, right handlebar end and front brake lever of the Motorcycle which were observed to be damaged due to the accident (circled).

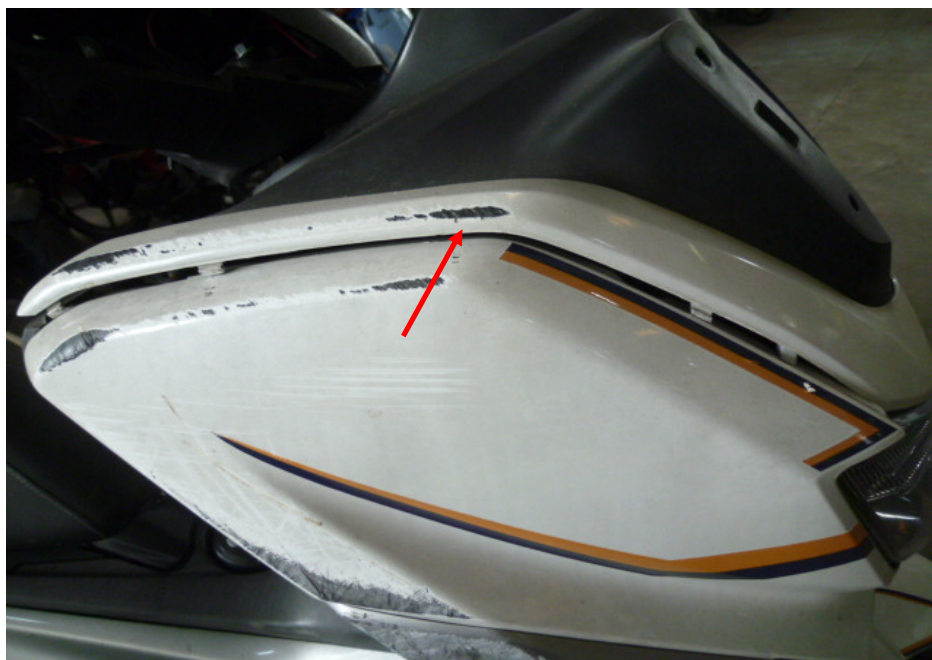
Photo 8 shows a close-up view of the grazed front cowling of the Motorcycle at the time of our inspection (arrowed).

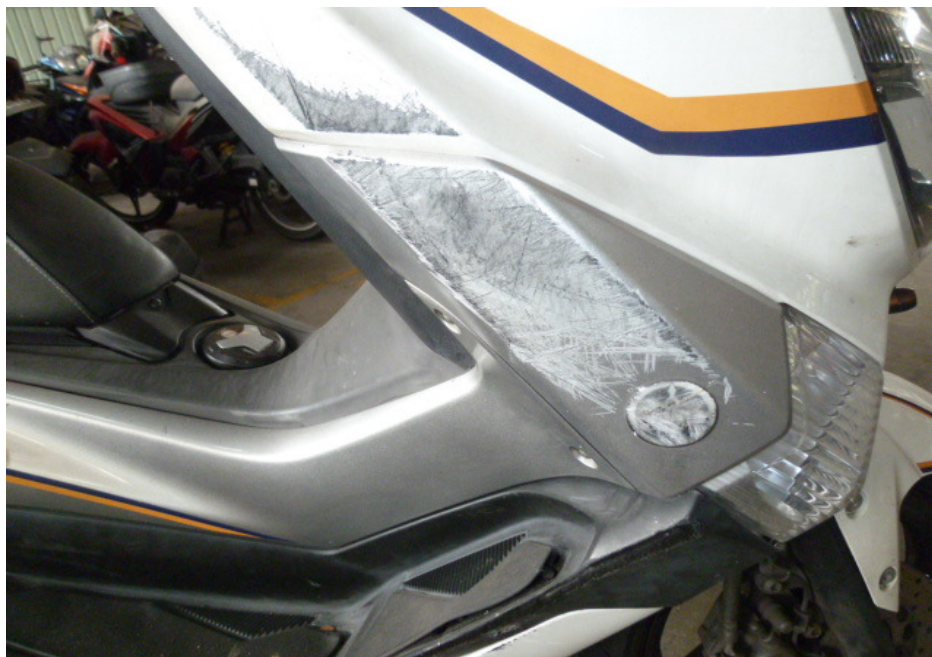
Photo 9 shows the damaged right side cowling of the Motorcycle as a result of the accident.

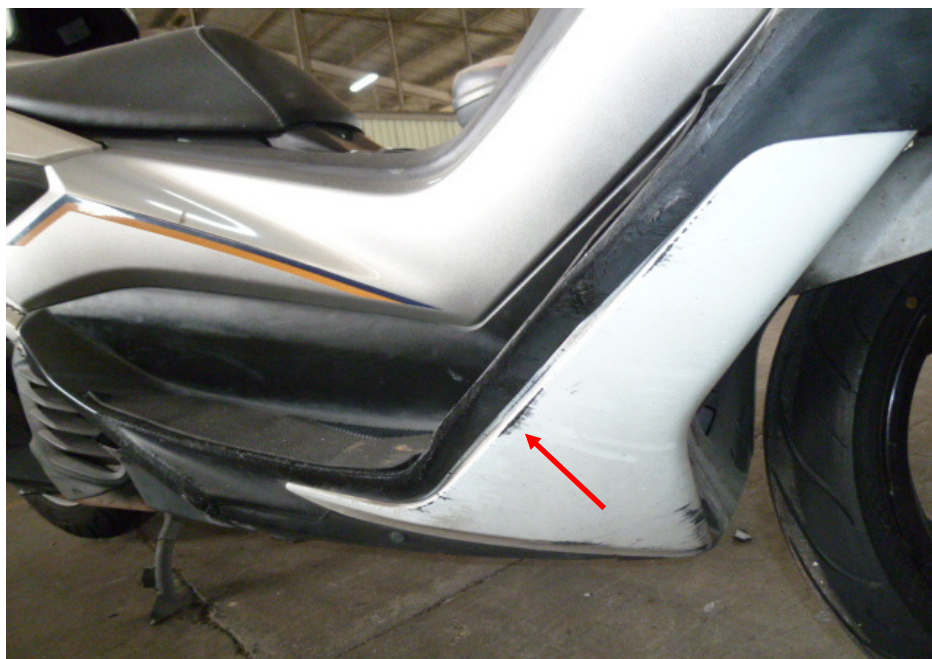
Photo 10 shows a closer view of the grazed right lower side cowling of the Motorcycle as a result of the accident (arrowed).

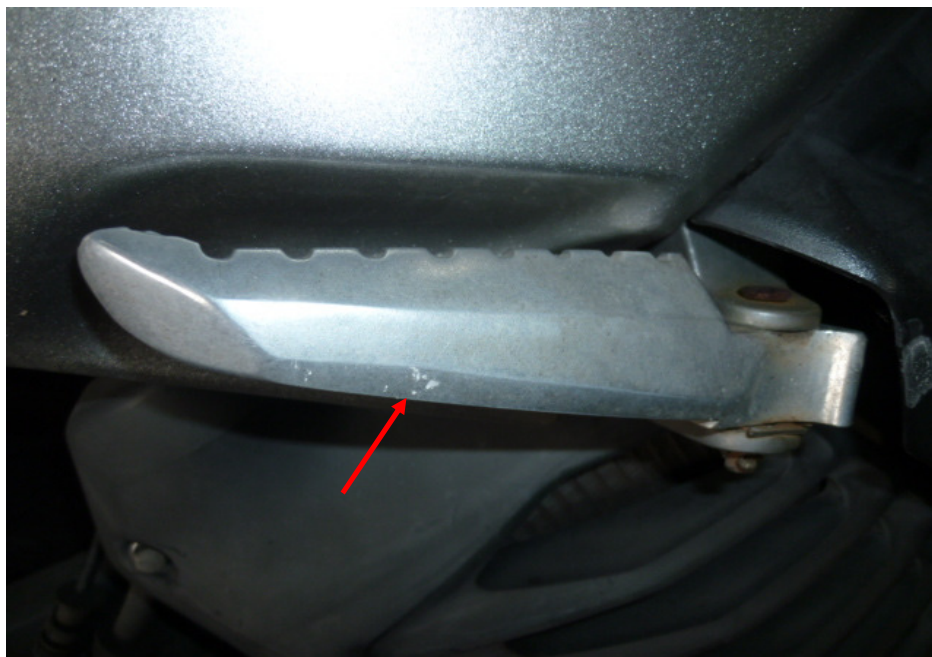
Photo 11 shows a closer view of the grazed right pillion foot peg (arrowed) of the Motorcycle as a result of the accident.

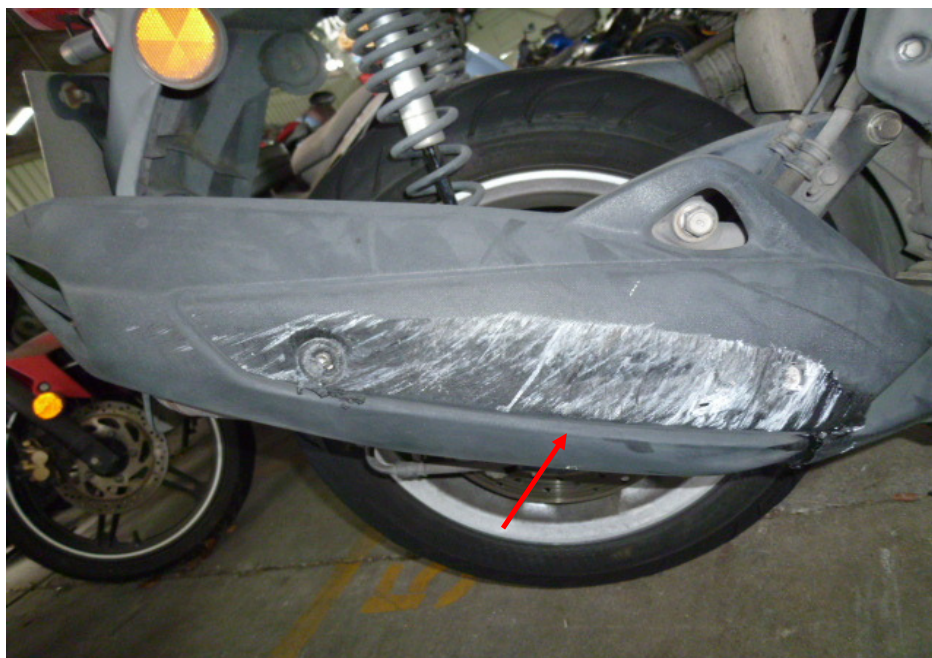
Photo 12 shows a closer view of the grazed exhaust muffler heat shield of the Motorcycle at the time of our inspection (arrowed).

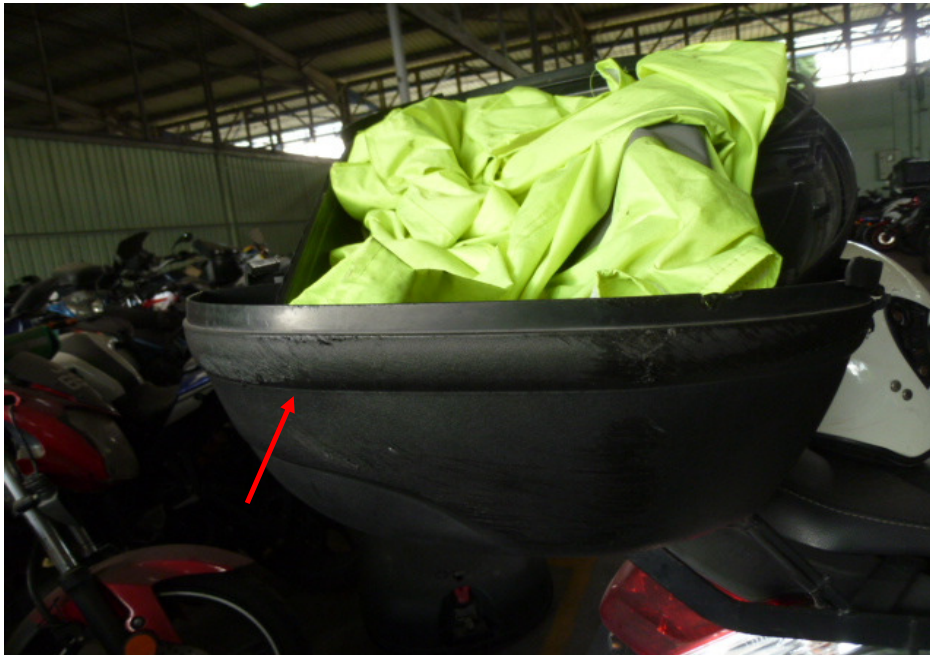
Photo 13 shows a closer view of the grazed top box of the Motorcycle as a result of the accident (arrowed).

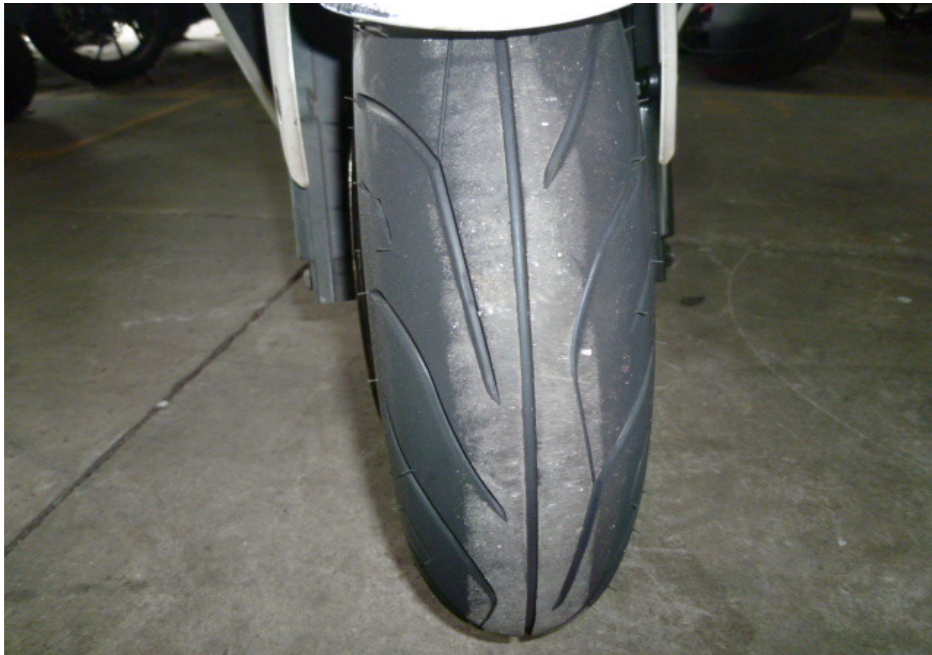
Photo 14 shows the condition of the Motorcycle's front tyre. The front tyre was observed to be in serviceable condition with remaining tread depth of approximately 6mm. There was no tear, burst mark(s) and/or punctured hole(s) on the sidewalls as well as across the tread of the front tyre.

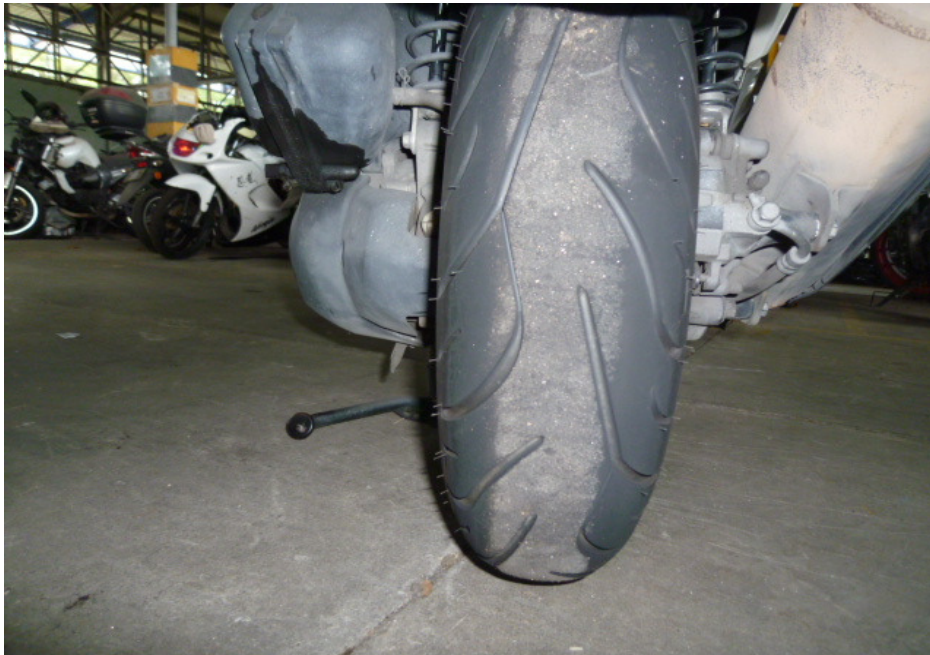
Photo 15 shows the condition of the Motorcycle's rear tyre. The rear tyre was observed to be in serviceable condition with remaining tread depth of approximately 6mm. The tyre was also observed to be sufficiently inflated for vehicular operation. We did not observe any tear, burst mark(s) and/or punctured hole(s) on the sidewalls as well as across the tread of the rear tyre.

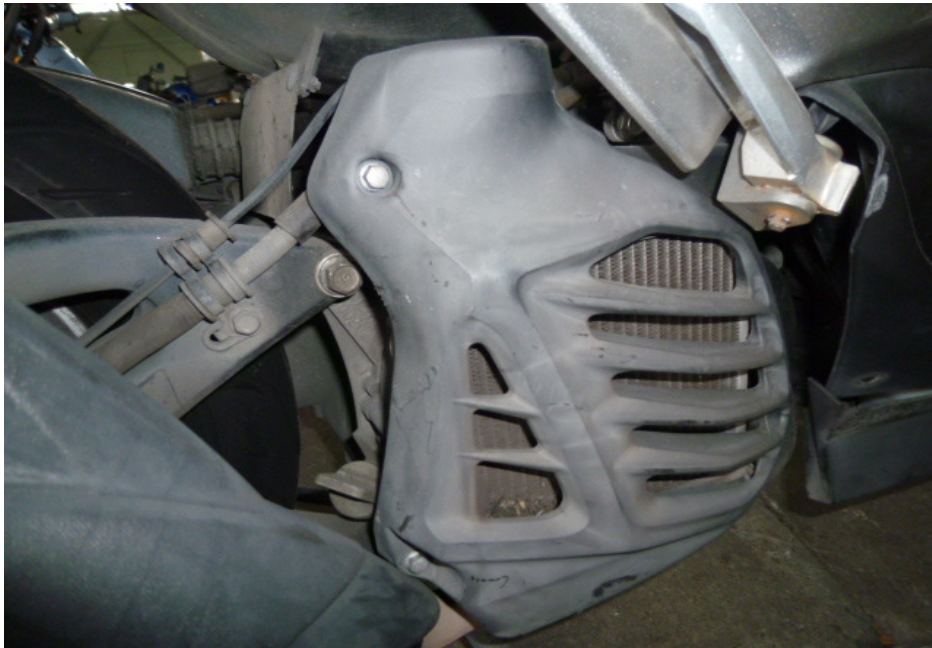
Photo 16 shows the right side of the engine of the Motorcycle at the time of our inspection. The various engine related parts and components were found to be intact with no visible damage. There was also no sign(s) or indication(s) of fluid leak observed around the right engine area of the Motorcycle.

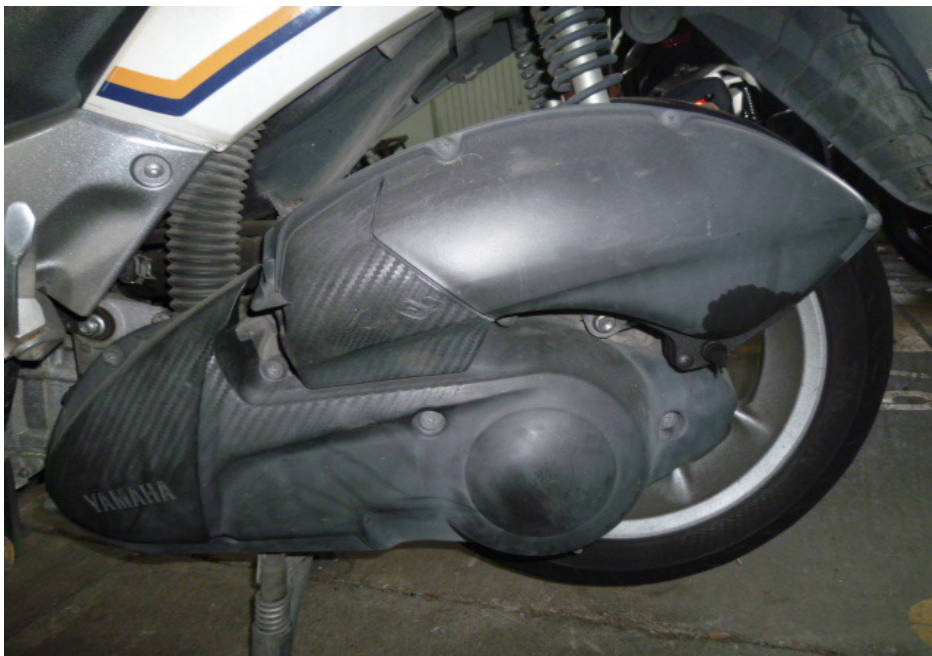
Photo 17 shows the drive train cover of the Motorcycle which was found to be intact without any misalignment. Upon examination of the Motorcycle's engine area, we had observed that the various engine related parts and components were intact with no visible damage. There was also no sign(s) or indication(s) of fluid leak observed around the engine area of the Motorcycle.

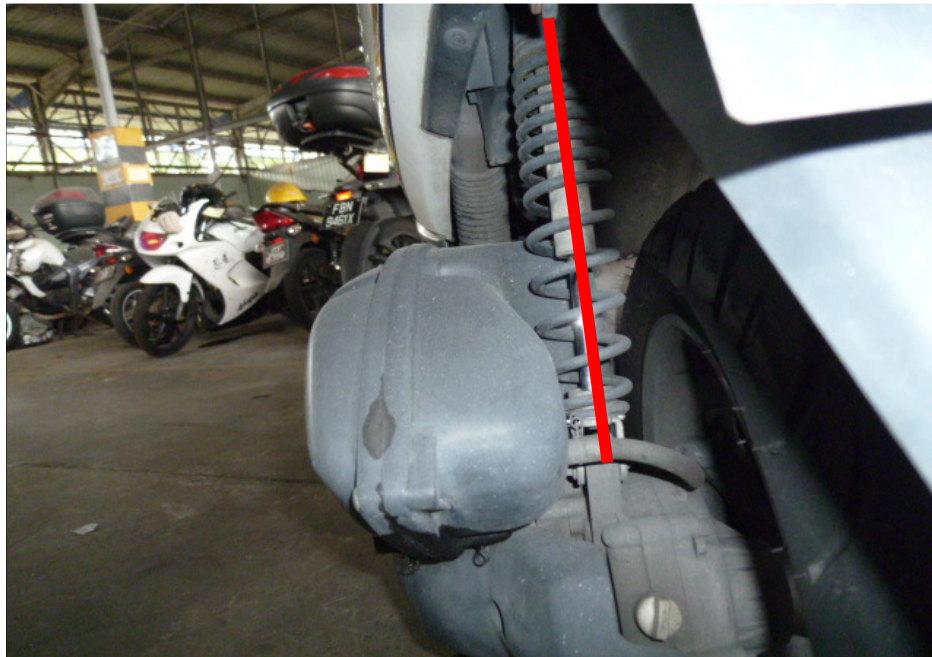
Photo 18 shows the left shock absorber of the Motorcycle which was found to be intact without any misalignment.

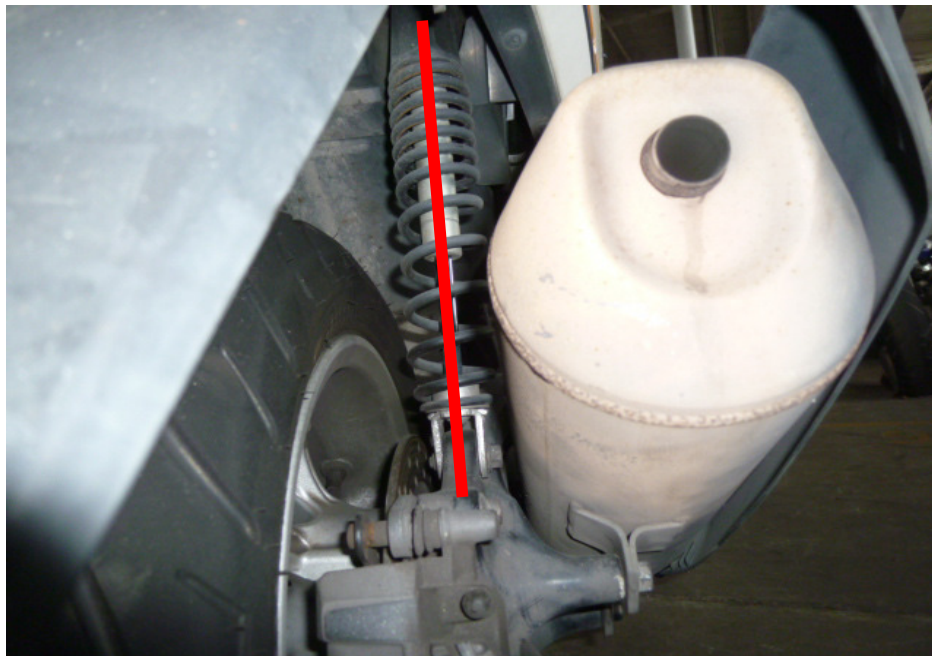
Photo 19 shows the right shock absorber of the Motorcycle which was found to be intact without any misalignment.

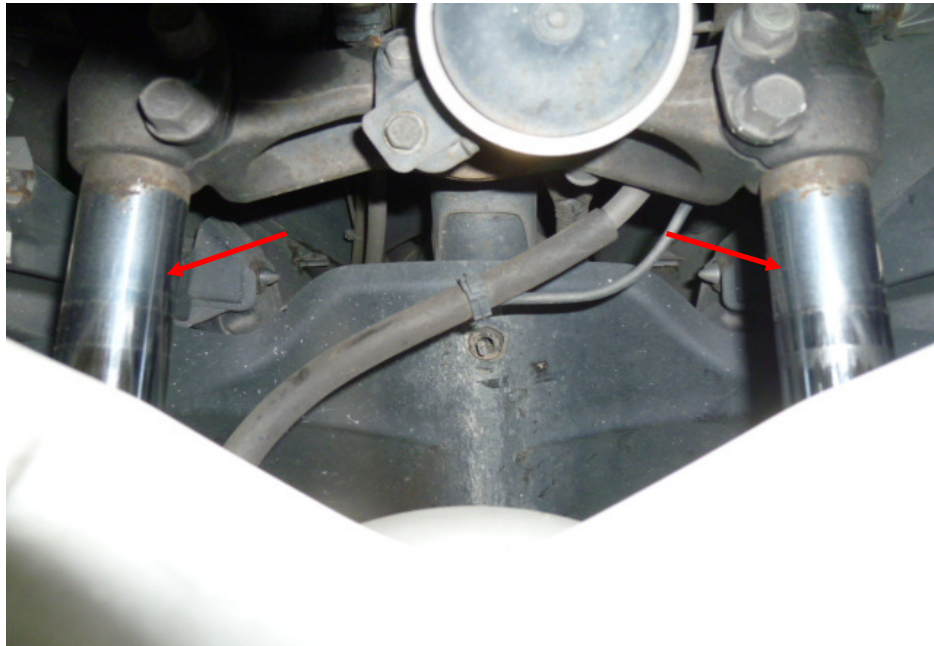
Photo 20 shows the front forks (arrowed) of the Motorcycle. The front forks and fork brackets of the Motorcycle were both found to be intact and undamaged. Turning the Motorcycle's handle bar towards the left and right did not produce any abnormal free play and/or resistance. The steering system of the Motorcycle was in serviceable condition at the time of our inspection.

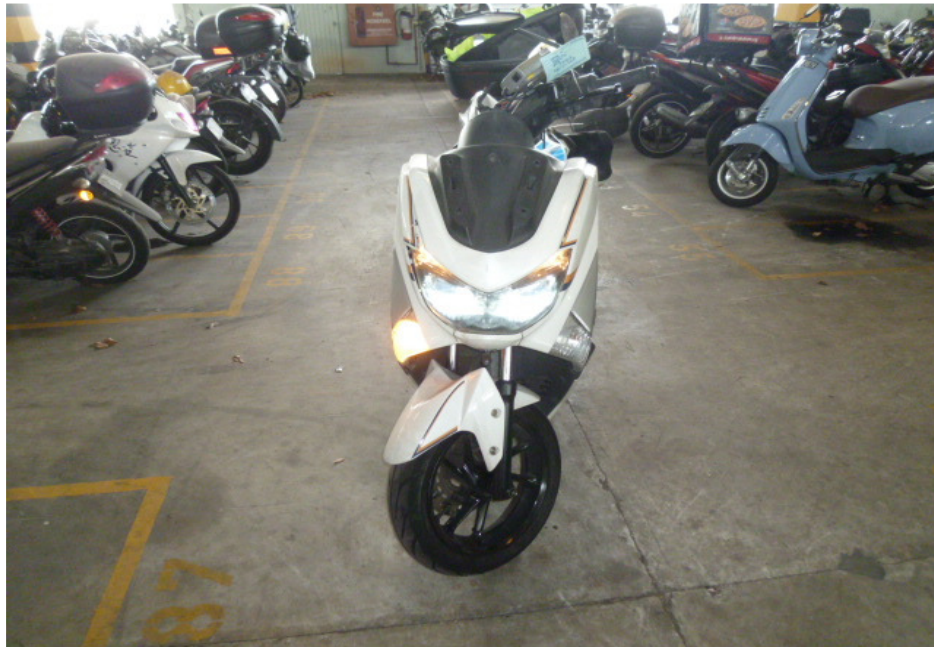
Photo 21 shows the front wheel of the Motorcycle turned towards its full right. Turning the Motorcycle's handle bar towards the left and right did not produce any abnormal free play and/or resistance. This would indicate that the steering system of the Motorcycle was in serviceable condition at the time of our inspection.

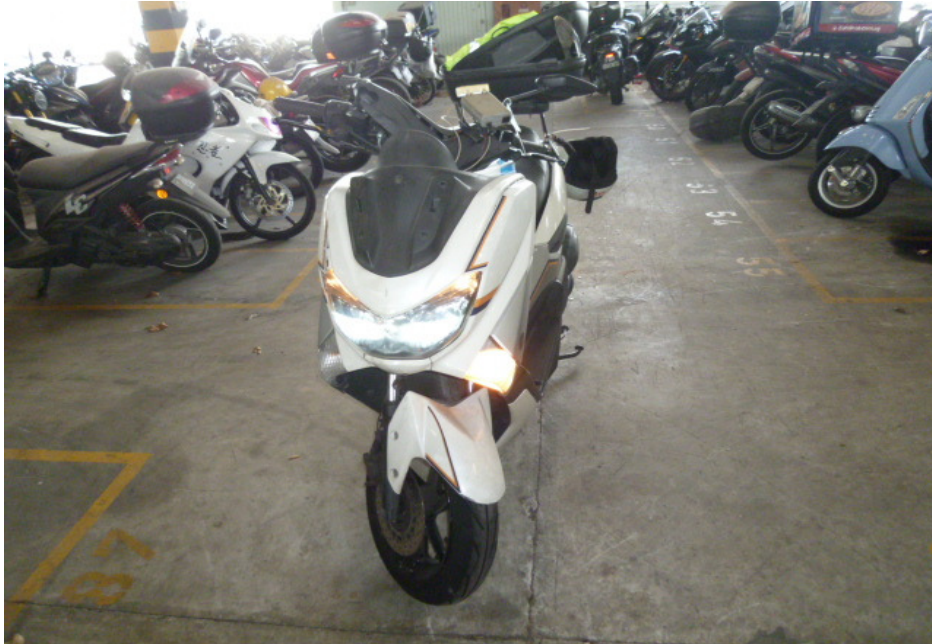
Photo 22 shows the front wheel of the Motorcycle turned towards its full left. Turning the Motorcycle's handle bar towards the left and right did not produce any abnormal free play and/or resistance. This would indicate that the steering system of the Motorcycle was in serviceable condition at the time of our inspection.

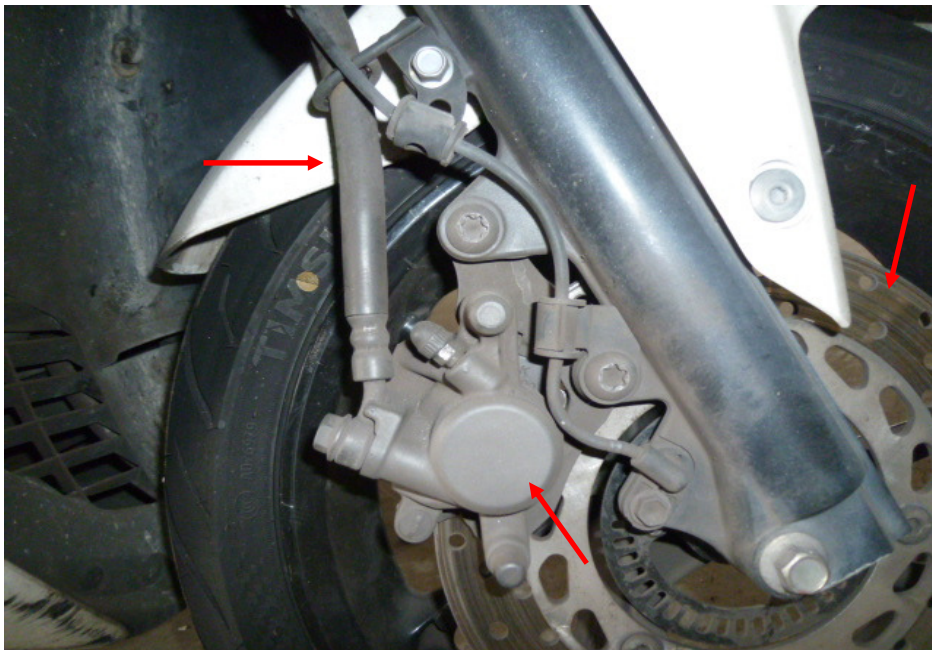
Photo 23 shows a close up view of the front brake caliper, front brake disc and front brake hose (arrowed) of the Motorcycle, which are all part of the components in the hydraulic front brake system of the Motorcycle. Our visual checks of these various components had revealed all to be intact with no visible damage. No leakage of brake fluid was also observed.

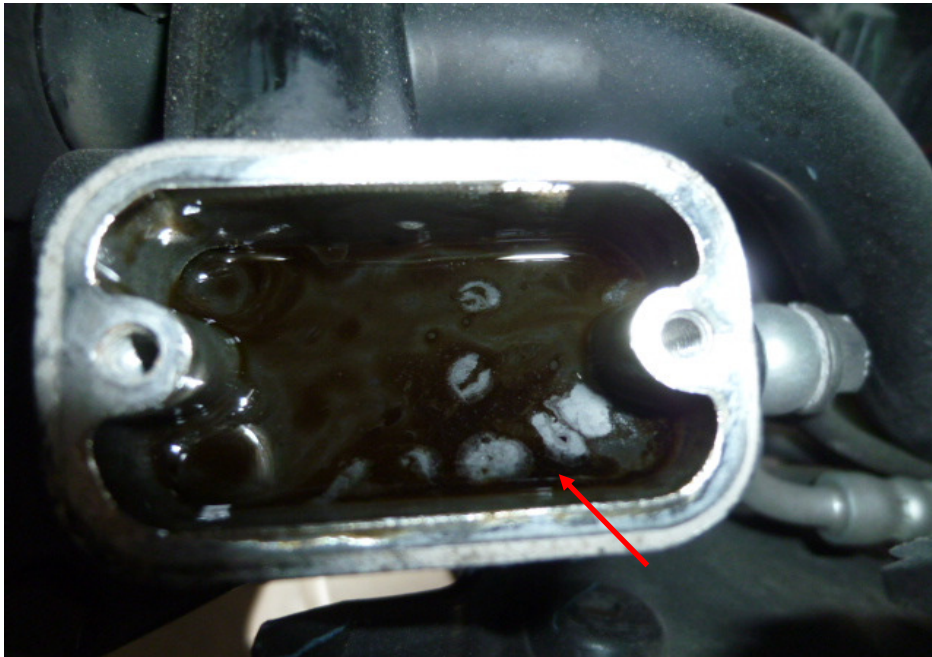
12. Static brake tests conducted on the Motorcycle had appeared to indicate that the brake system of the Motorcycle was in serviceable condition. There was some resistance felt (spongy like feel) upon pressing both brake levers. This would indicate that there's no leakage of pressure/vacuum in the braking system. Our checks on the brake fluid had also indicated that the brake fluid was of sufficient level for operational purposes. However the brake fluid for both the front brake and rear brake were found to be contaminated.

Photo 24 shows the brake fluid reservoir for the front brake of the Motorcycle. The brake fluid was observed to be of sufficient level for operational purposes. However it was found to be contaminated (arrowed).

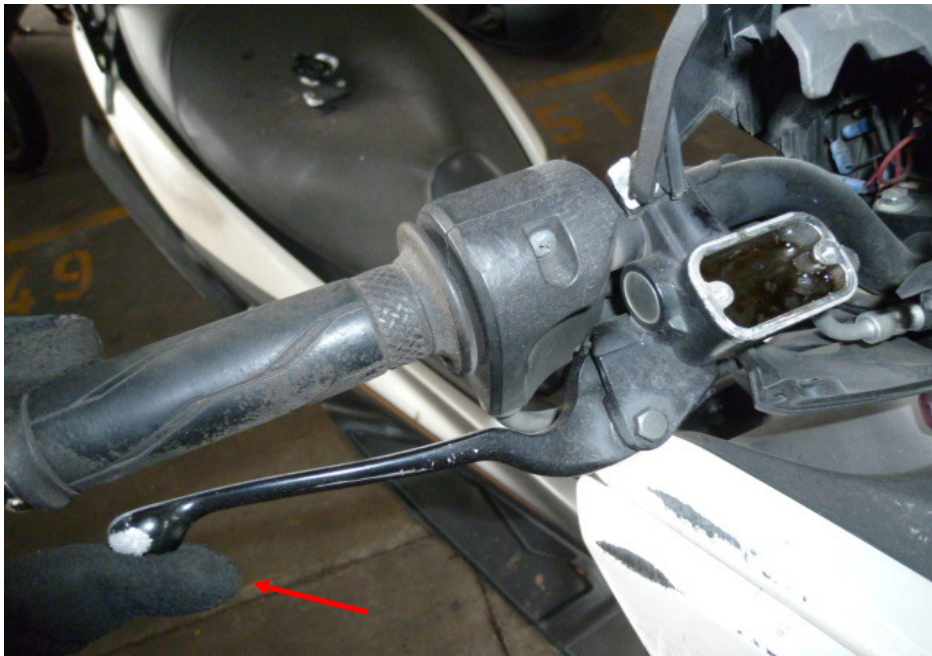
Photo 25 shows the front brake lever being depressed. There was some resistance felt (spongy like feel) upon pressing the front brake lever (arrowed). This would indicate that there is no leakage of pressure/vacuum in the front brake system.

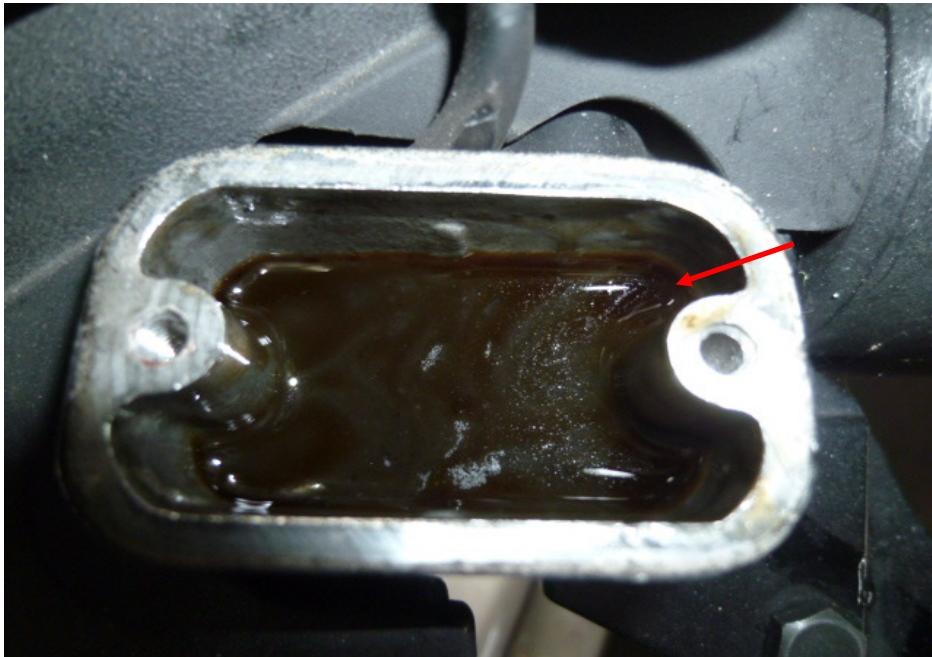
Photo 26 shows the brake fluid reservoir for the rear brake of the Motorcycle. The brake fluid was observed to be of sufficient level for operational purposes. However it was found to be contaminated (arrowed).

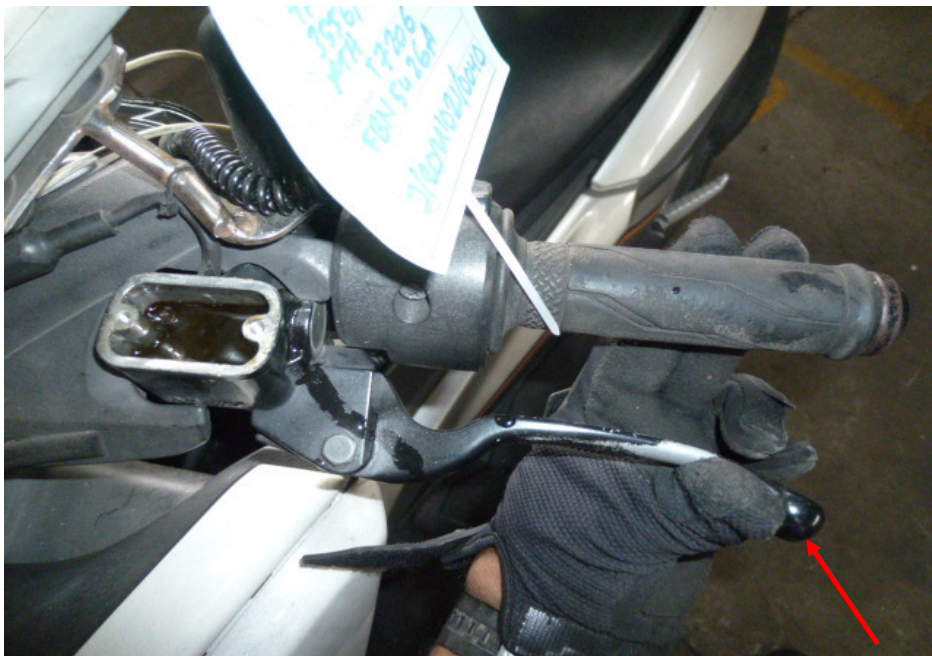
Photo 27 shows the rear brake lever being depressed. There was some resistance felt (spongy like feel) upon pressing the rear brake lever (arrowed). This would indicate that there is no leakage of pressure/vacuum in the rear brake system.

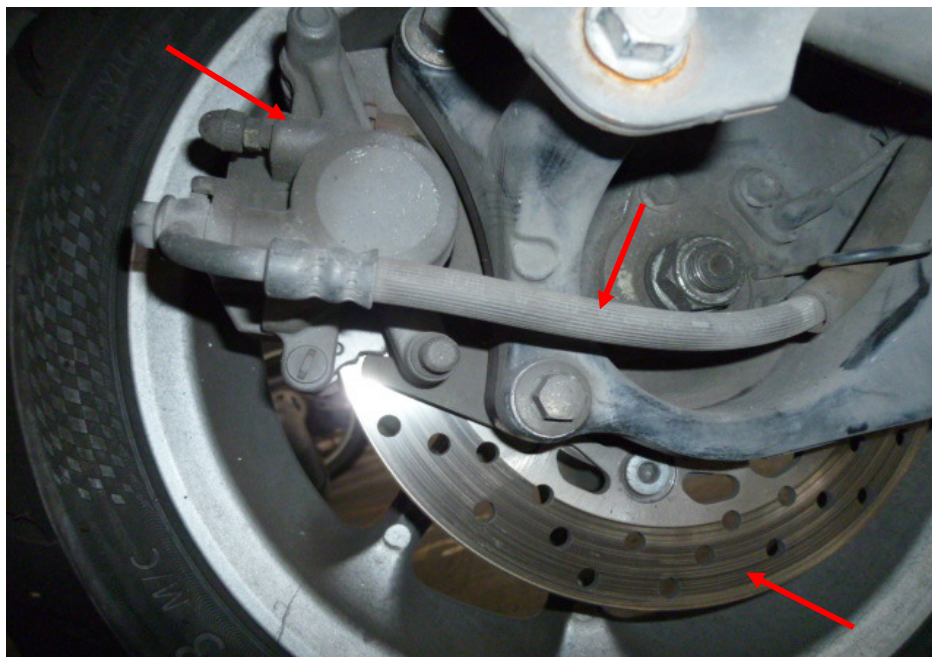
Photo 28 shows a close up view of the rear brake caliper, rear brake disc and rear brake hose (arrowed) of the Motorcycle, which are all part of the components in the hydraulic rear brake system of the Motorcycle. Our visual checks of these various components revealed all to be intact with no visible damage. No leakage of brake fluid was also observed.
