Your Ref: TP/IP/51485/2021
Our Ref : CI/TPD21011602/N

Fatal Accident Investigation Team

INSPECTION REPORT OF MOTORCYCLE FY 3218S

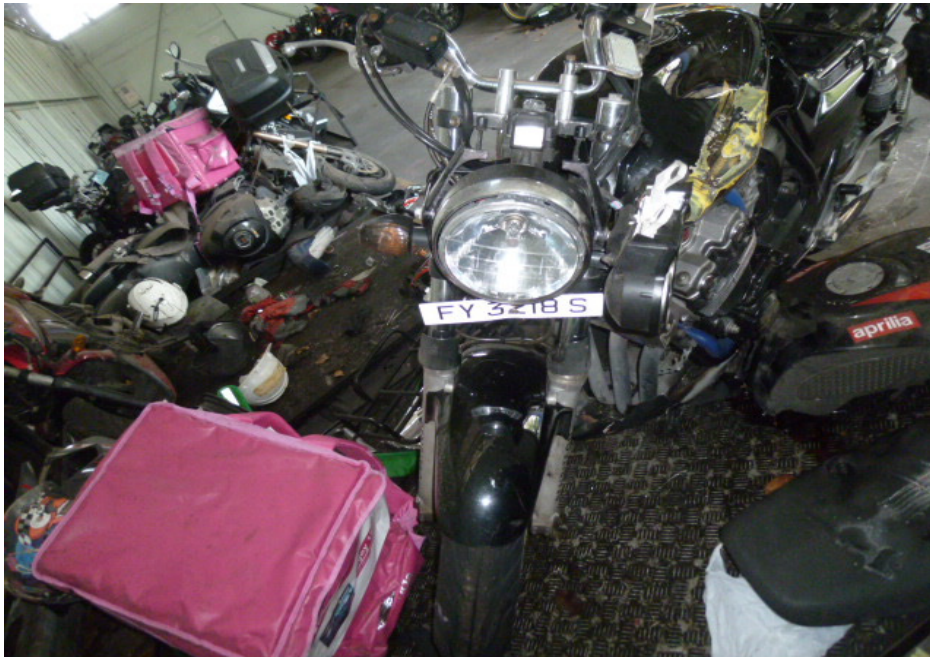
Photo 1 shows a general view of the frontal portion of the Motorcycle at the time of our inspection. The Motorcycle was observed to have sustained damages all around.

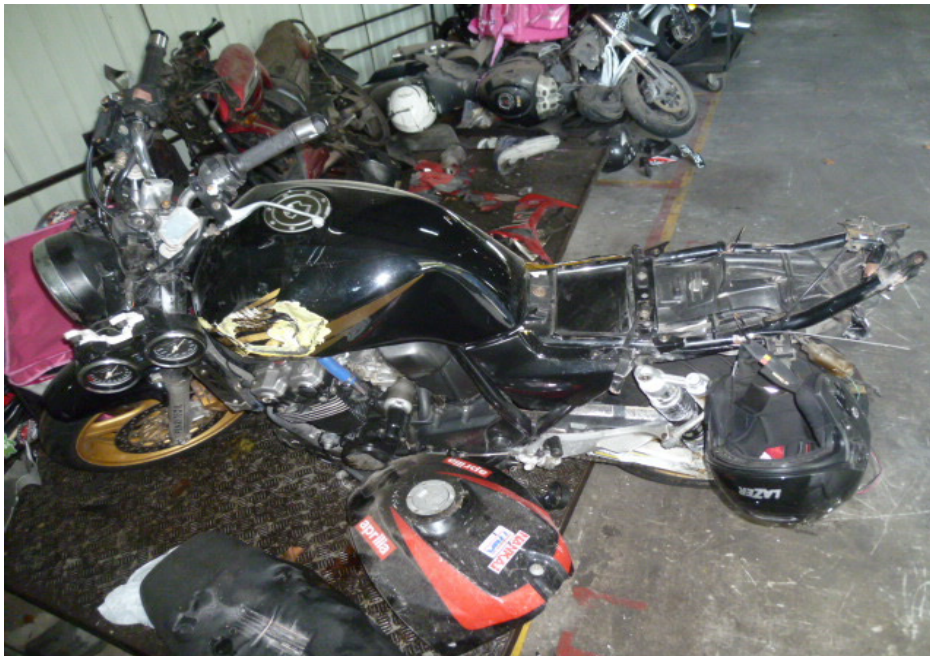
Photo 2 shows a general view of the left body of the Motorcycle at the time of our inspection. The Motorcycle was observed to have sustained damages all around.

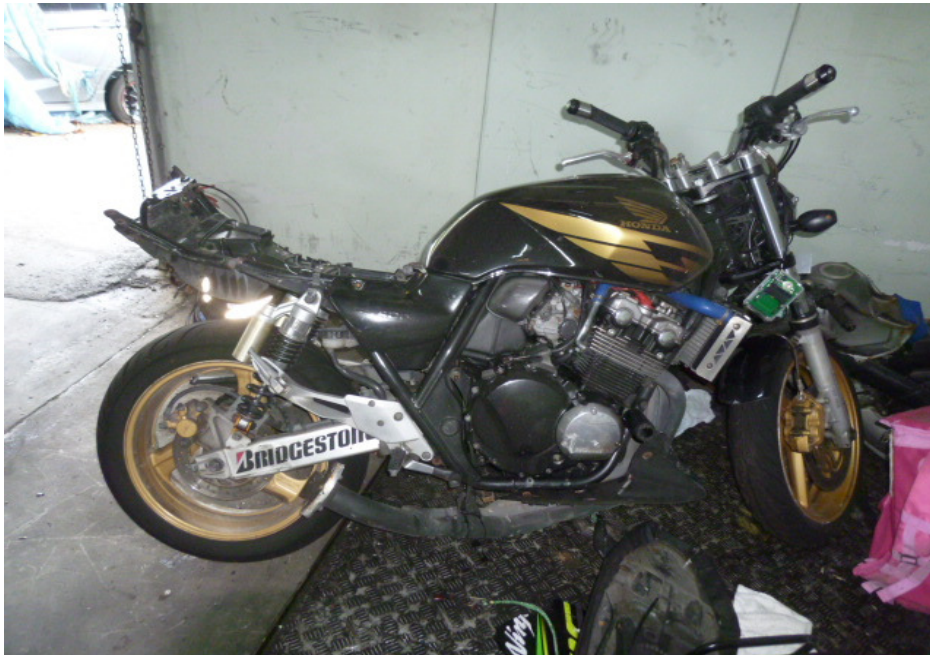
Photo 3 shows a general view of the right body of the Motorcycle at the time of our inspection. The Motorcycle was observed to have sustained damages all around. The body parts that were found to have been damaged include its speedometer gauge, headlight cover, headlight, front forks, front mudguard, left handlebar end, left side mirror, clutch lever, petrol tank, right rear side cover, left front footrest, rear swingarm, tail light assembly and exhaust muffler, amongst others.

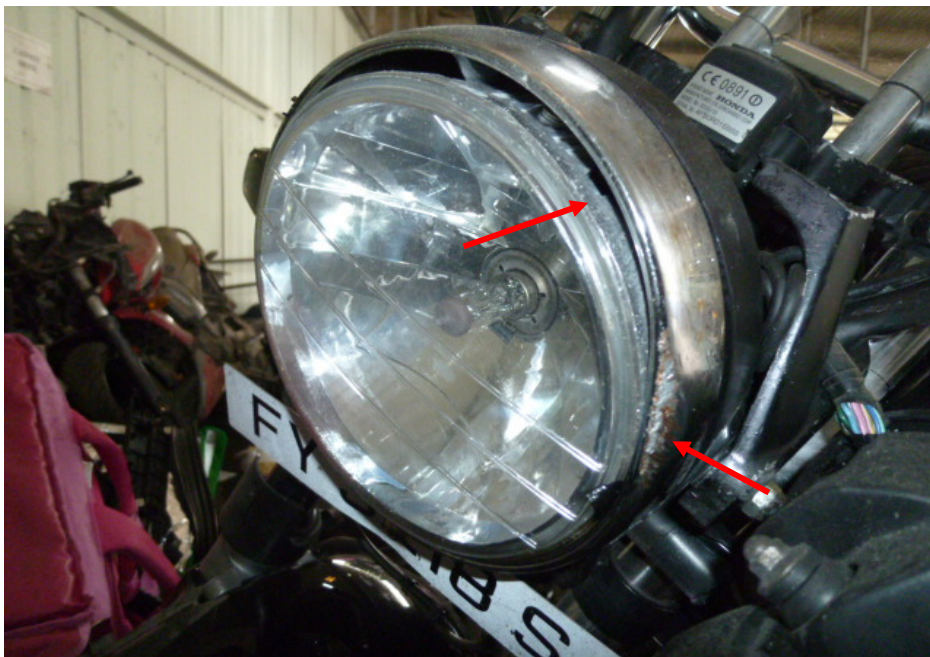
Photo 4 shows a closer view of the scratched headlight cover and cracked headlight (arrowed) of the Motorcycle as a result of the accident.

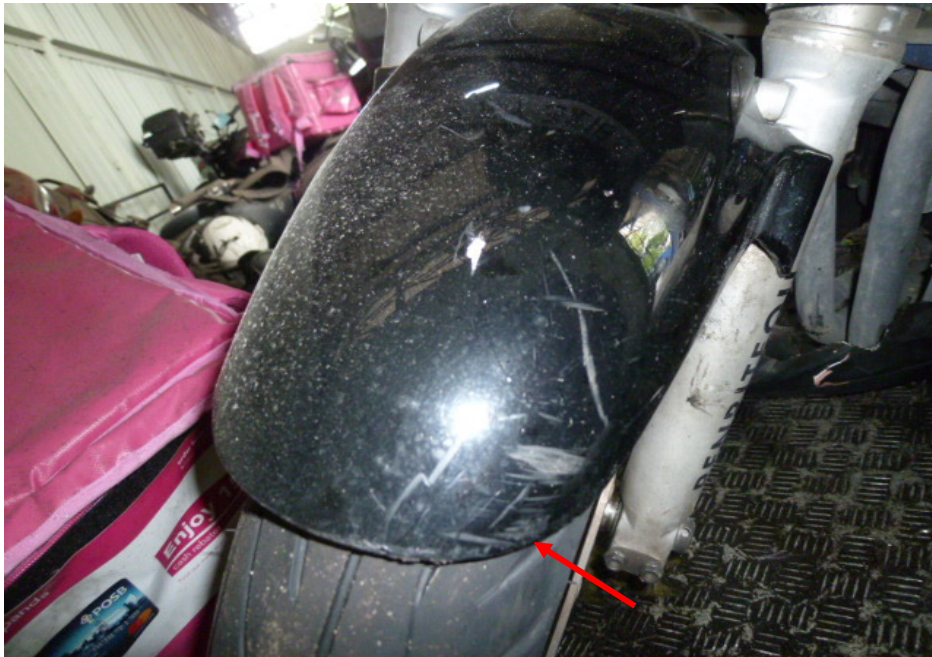
Photo 5 shows a closer view of the front mudguard which was amongst the body parts at the front body of the Motorcycle that had sustained damage as a result of the accident (arrowed).

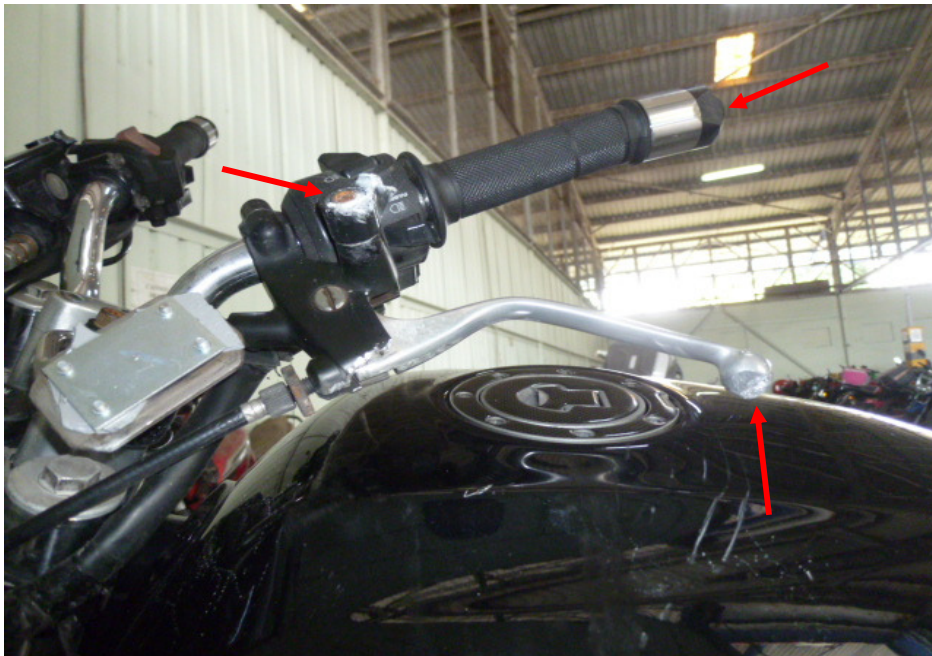
Photo 6 shows a closer view of the clutch lever, left side mirror and left handlebar end (arrowed) which were amongst the body parts at the front body of the Motorcycle that had sustained damage as a result of the accident.

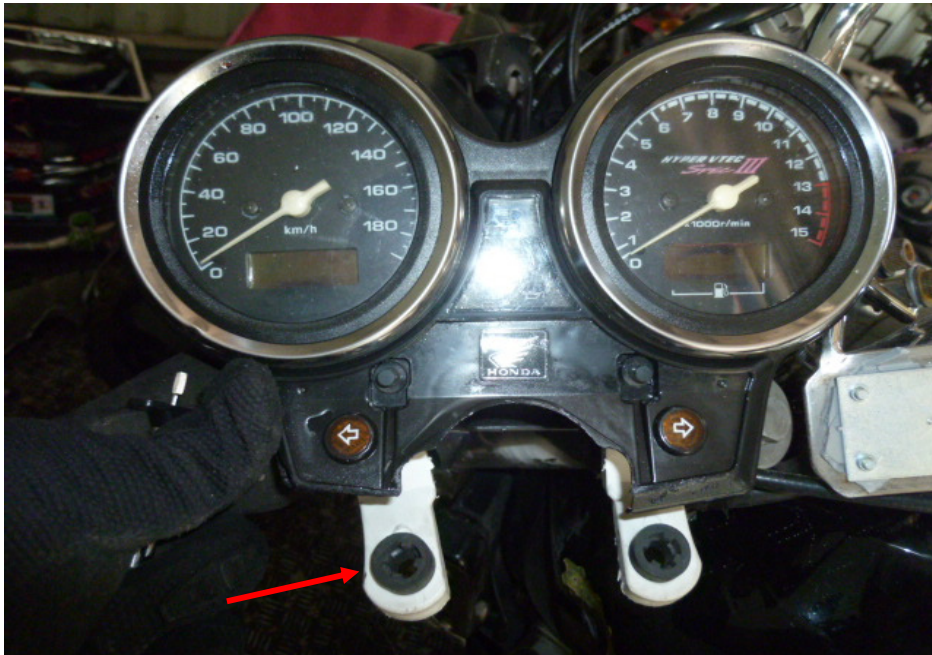
Photo 7 shows the broken speedometer of the Motorcycle as a result of the accident (arrowed).

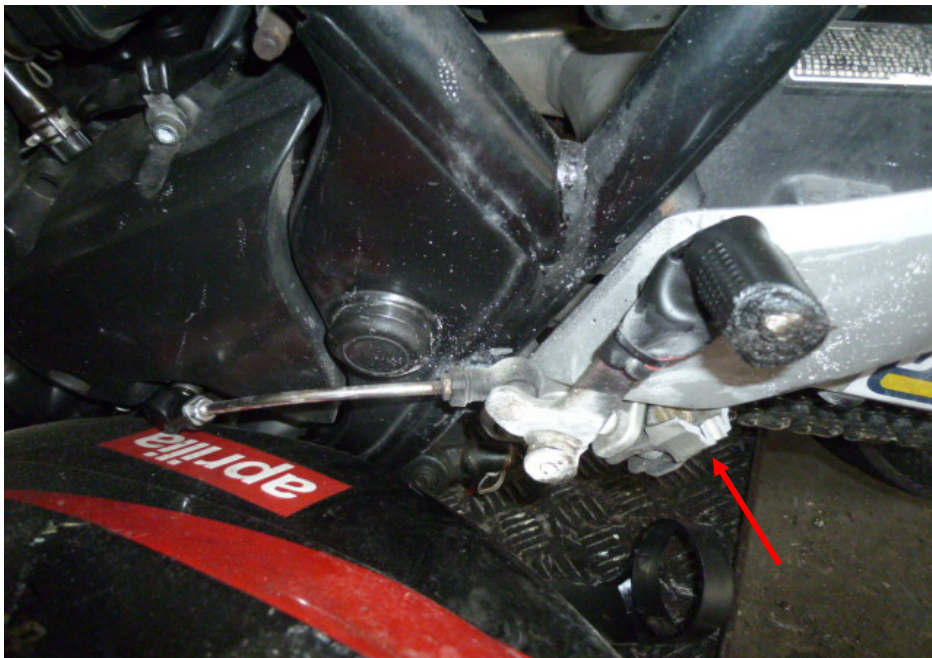
Photo 8 shows the broken left front footrest of the Motorcycle as a result of the accident (arrowed).

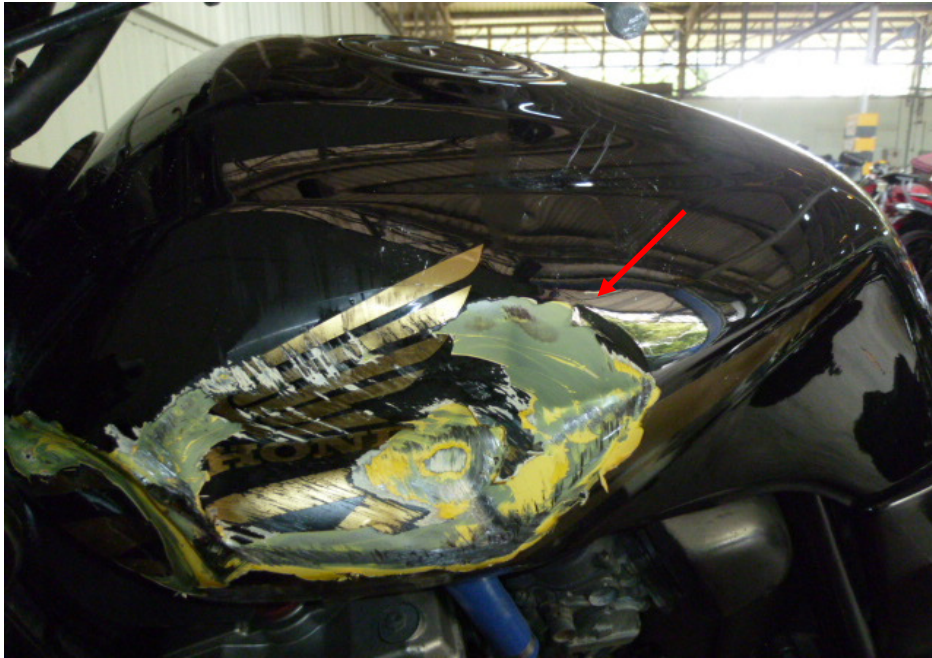
Photo 9 shows a closer view of the dented petrol tank of the Motorcycle as a result of the accident (circled).

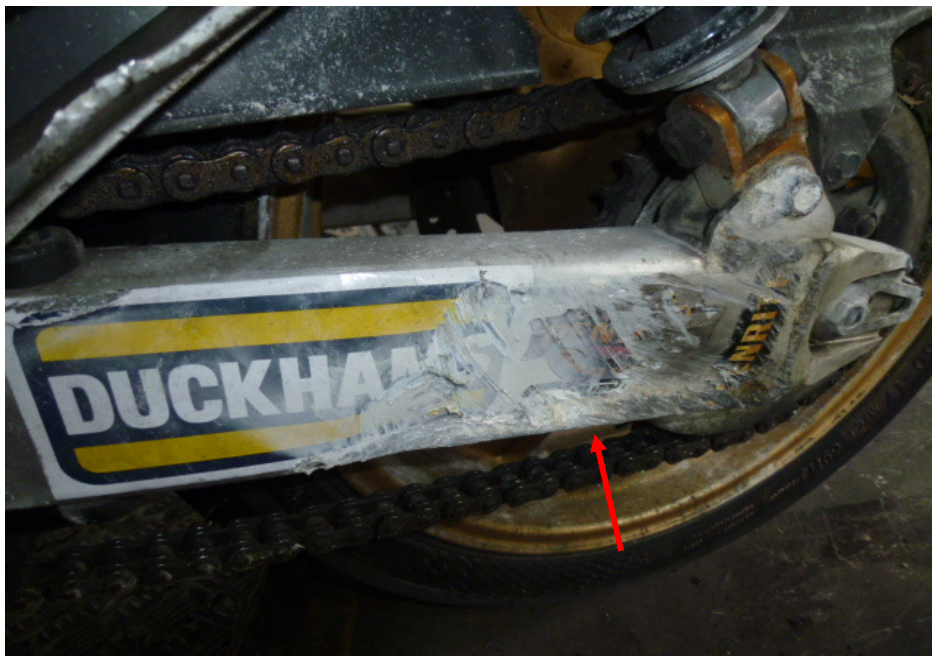
Photo 10 shows a closer view of the deformed rear swingarm (arrowed) of the Motorcycle as a result of the accident.

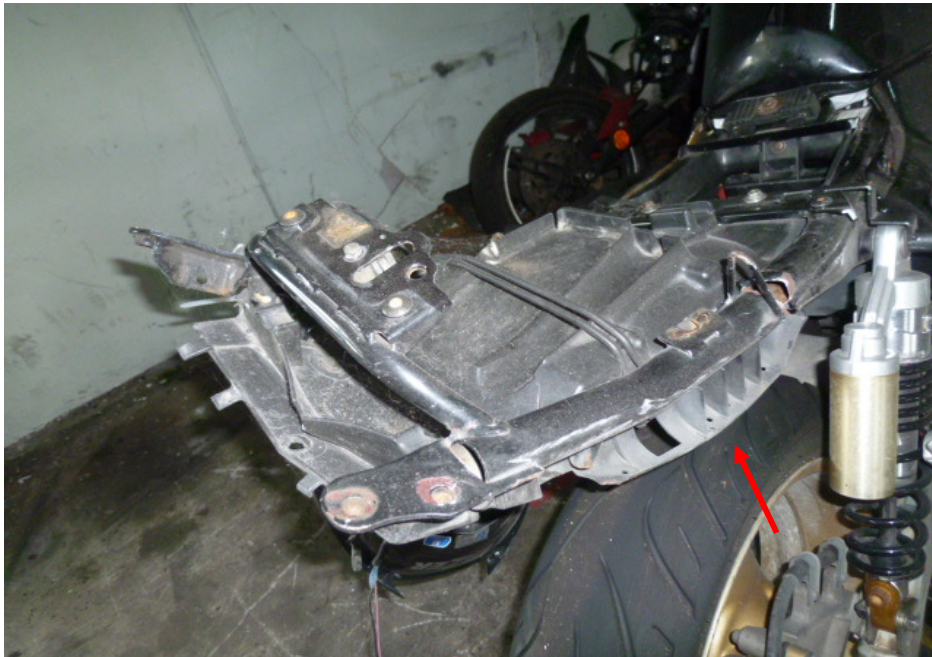
Photo 11 shows a closer view of the missing right rear side cover (arrowed) which were amongst the body parts at the rear body of the Motorcycle that had sustained damage as a result of the accident.

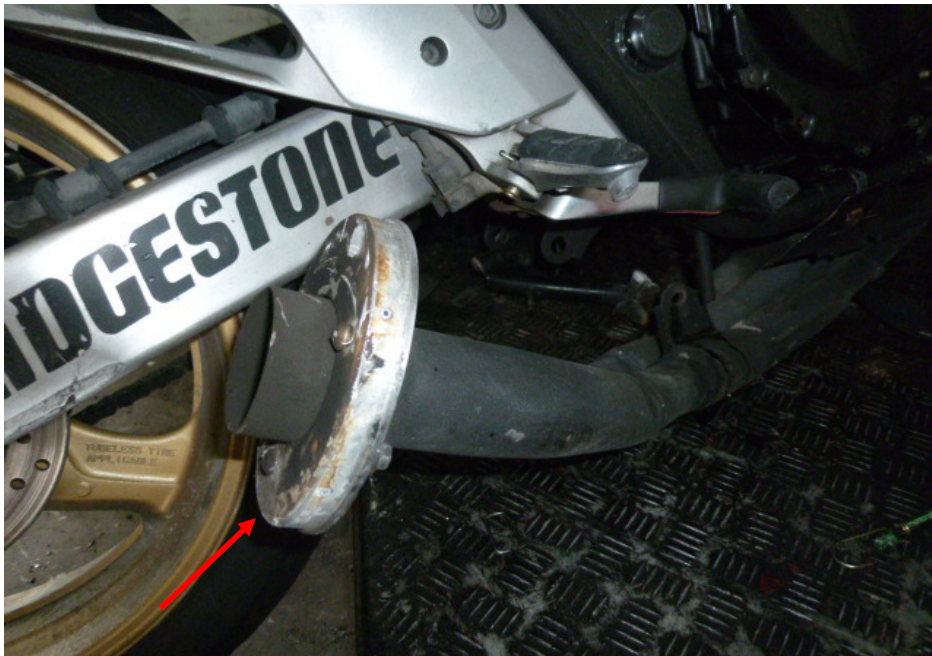
Photo 12 shows a closer view of the broken exhaust muffler (arrowed) of the Motorcycle as a result of the accident.

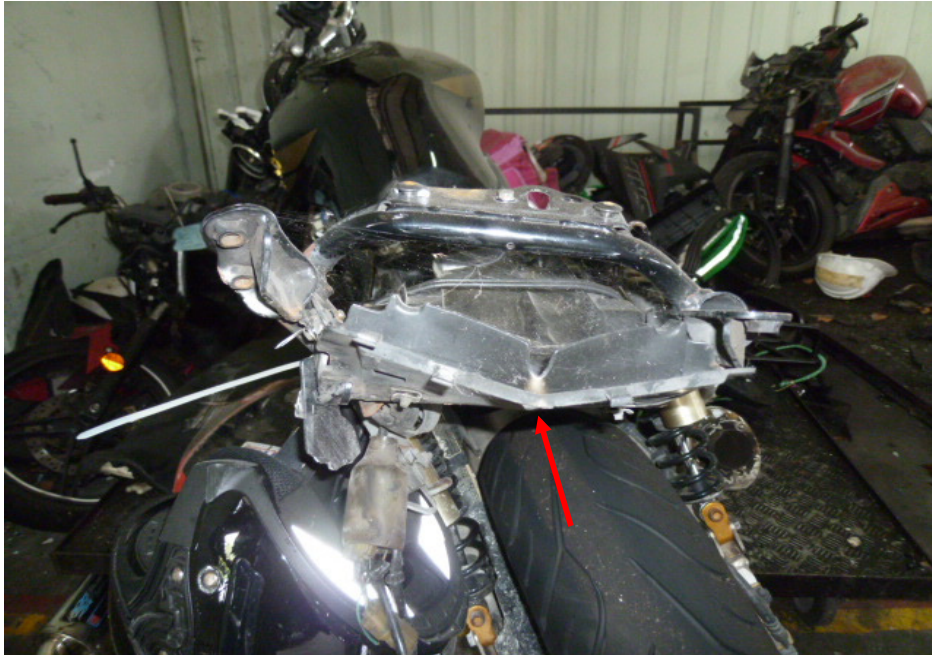
Photo 13 shows the missing tail light assembly (arrowed) of the Motorcycle as a result of the accident.

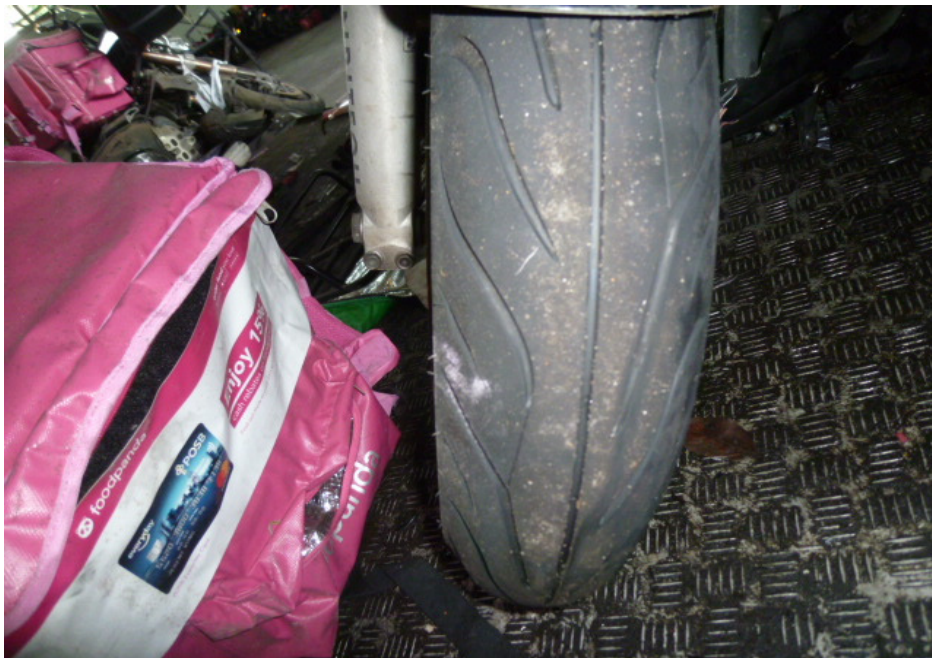
Photo 14 shows the front tyre of the Motorcycle at the time of our inspection. The front tyre was observed to be in serviceable condition with remaining tread depth of approximately 5mm. The pattern of the tread was also clearly visible. There was no tear, burst mark(s) and/or punctured hole(s) on the sidewalls as well as across the tread of the front tyre.

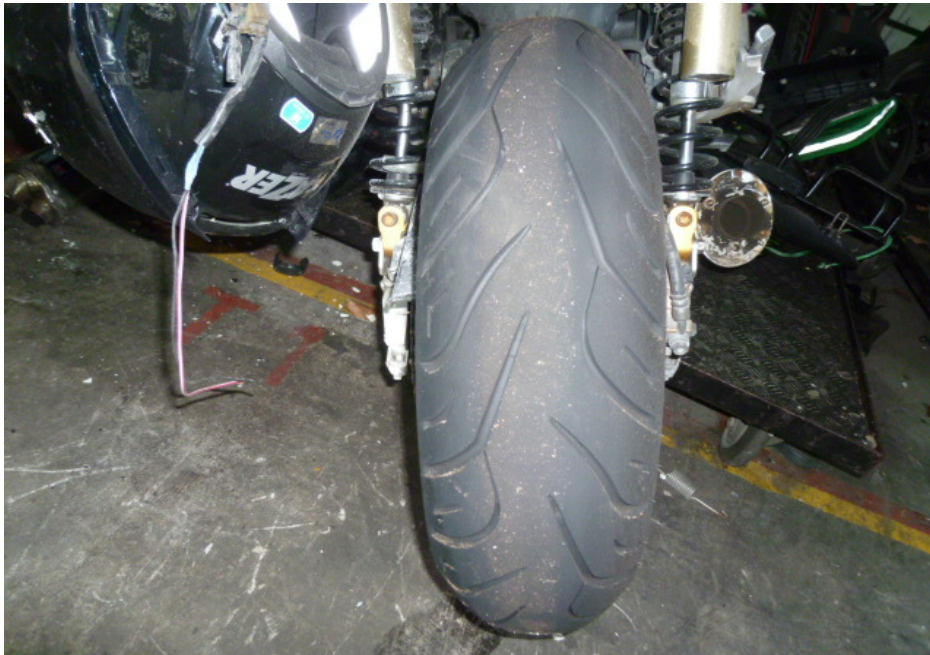
Photo 15 shows the condition of the Motorcycle's rear tyre. The rear tyre was observed to be in serviceable condition with remaining tread depth of approximately 7mm. The tyre was also observed to be sufficiently inflated for vehicular operation. We did not observe any tear, burst mark(s) and/or punctured hole(s) on the sidewalls as well as across the tread of the rear tyre.

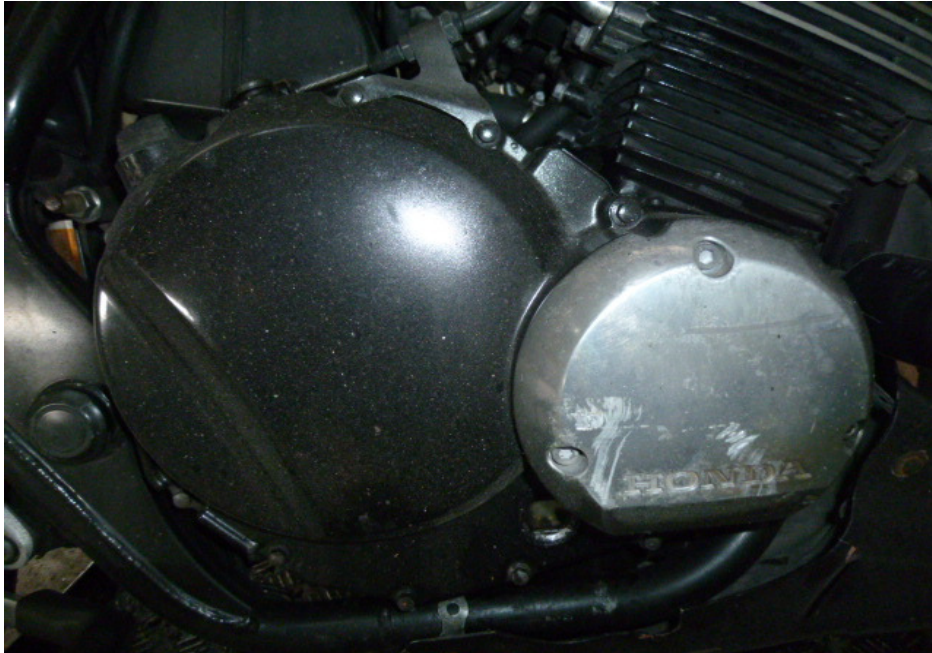
Photo 16 shows the right side of the engine of the Motorcycle at the time of our inspection. The various engine related parts and components were found to be intact with no visible damage. There was also no sign(s) or indication(s) of fluid leak observed around the right engine area of the Motorcycle.

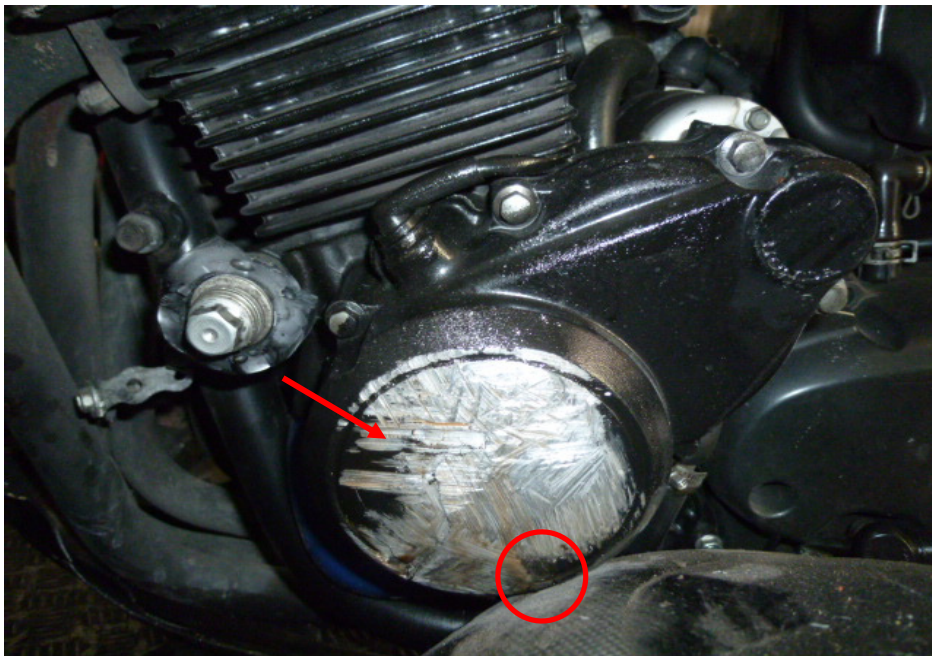
Photo 17 shows the left side of the engine of the Motorcycle at the time of our inspection. The various left engine components had sustained damage of grazing nature as a result of the accident (arrowed). Wet fluid stains were observed on the underside of the damaged left engine cover of the Motorcycle (circled).

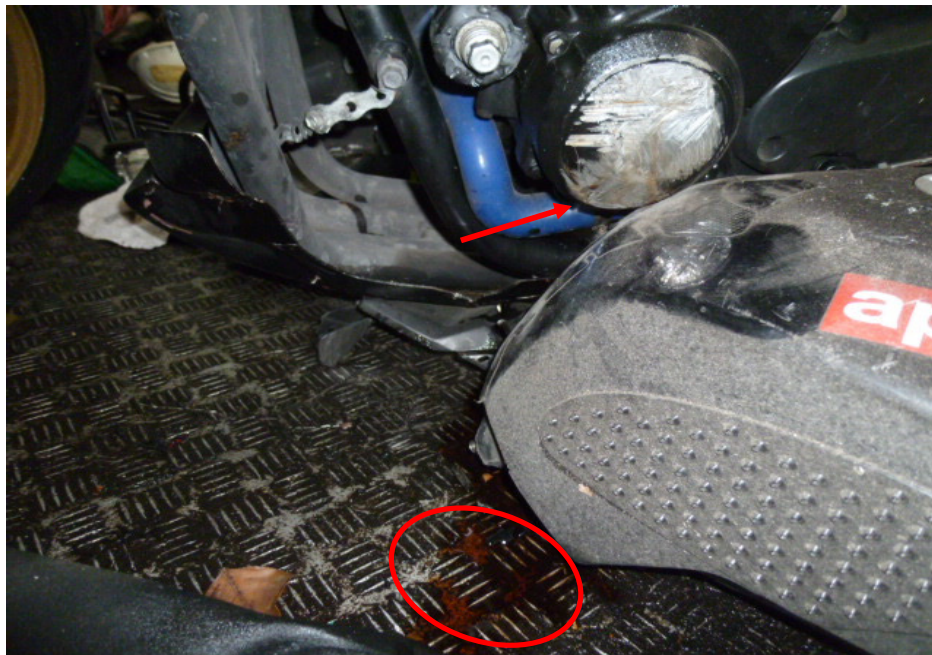
Photo 18 shows wet fluid stains observed on the ground (circled) directly below the damaged left engine cover of the Motorcycle (arrowed), indicating that a fluid leak had occurred as a result of the accident.

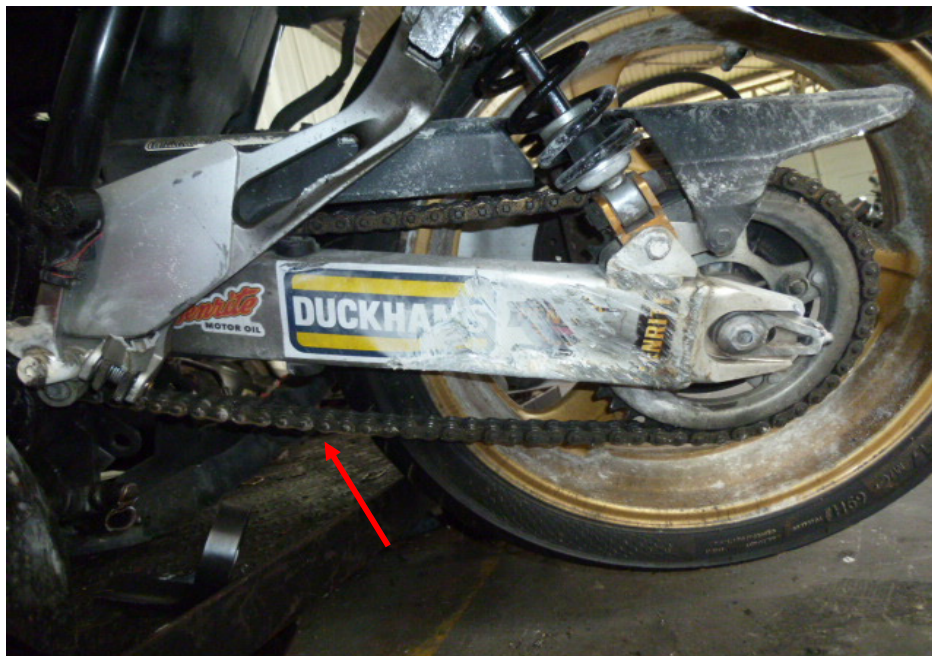
Photo 19 shows the general view of the gear train (arrowed) of the Motorcycle, which was observed to be intact with no misalignment. It was also adequately lubricated for operating purposes.

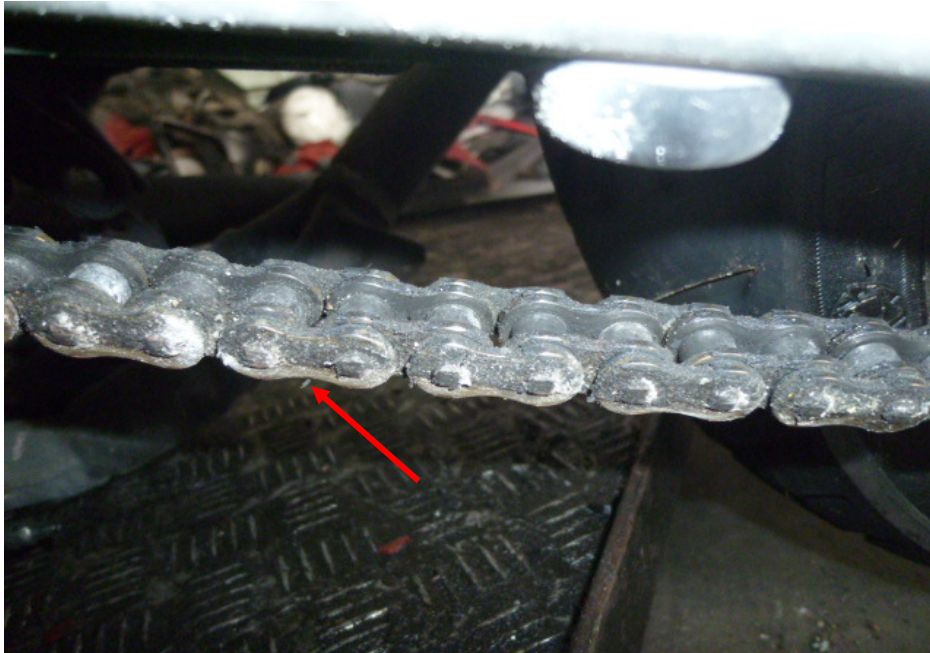
Photo 20 shows a closer view of the gear train (arrowed) of the Motorcycle, which was observed to be intact with no misalignment. It was also adequately lubricated for operating purposes.

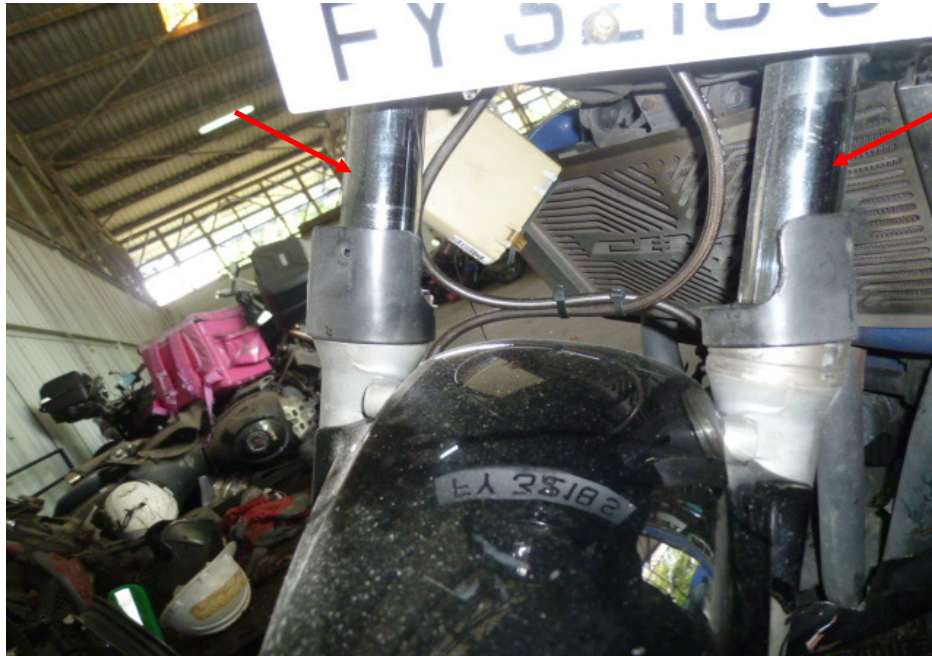
11. For this case, we were not able to conduct any test(s) on the steering system of the Motorcycle due to the damage of its front forks. The front forks were found to be bent inwards as a result of the accident which had rendered the Motorcycle immobile.

Photo 21 shows the right front fork of the Motorcycle. The right front fork (arrowed) was observed to be bent inwards as a result of the accident. We were hence not able to conduct any tests on the steering system of the Motorcycle.

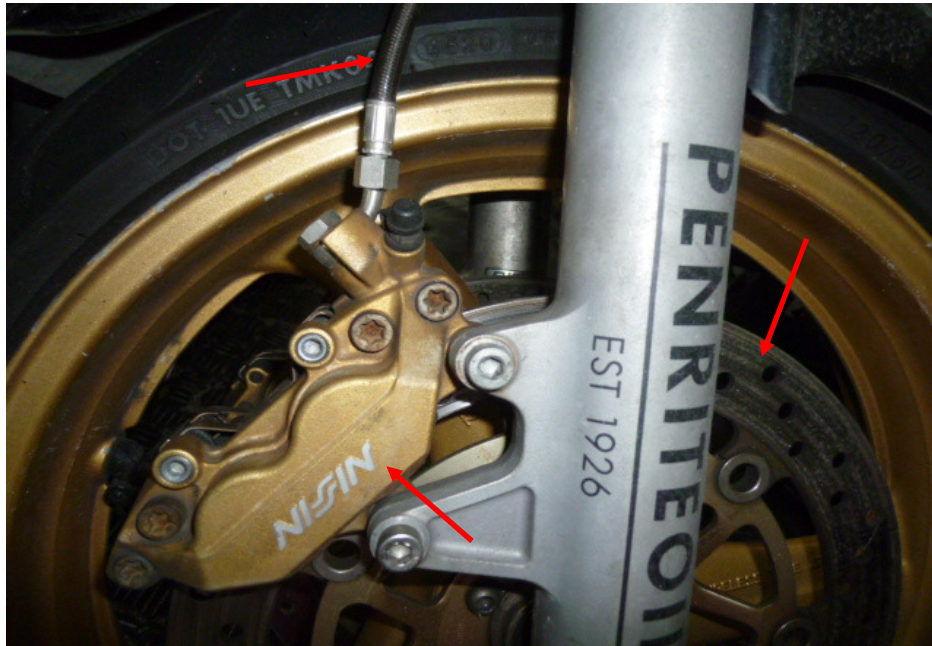
Photo 22 shows a close up view of the front brake caliper, front brake disc and front brake hose (arrowed) at the right side of the Motorcycle's front wheel, which are all part of the components in the hydraulic front brake system of the Motorcycle. Our visual checks of these various components had revealed all to be intact with no visible damage. No leakage of brake fluid was also observed.

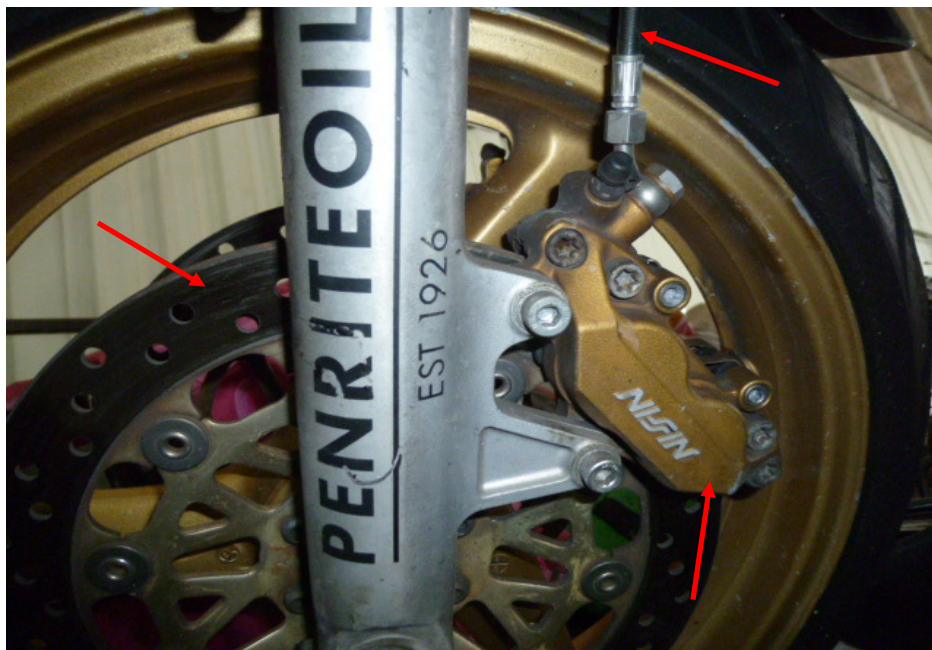
Photo 23 shows a close up view of the front brake caliper, front brake disc and front brake hose (arrowed) at the left side of the Motorcycle's front wheel, which are all part of the components in the hydraulic front brake system of the Motorcycle. Our visual checks of these various components had revealed all to be intact with no visible damage. No leakage of brake fluid was also observed.

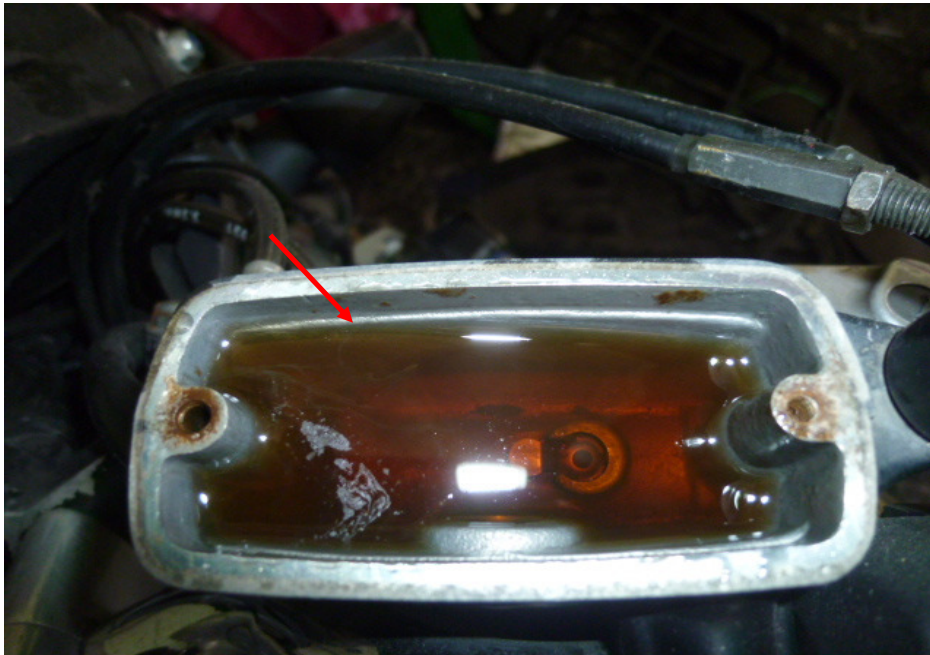
14. The brake fluid for the rear brake was found to be of sufficient level for operational purposes and without any contamination. The brake fluid for the front brake was found to be of sufficient level for operational purposes. However it was observed to be slightly contaminated.

Photo 24 shows the brake fluid reservoir for the front brake of the Motorcycle. The brake fluid was observed to be of sufficient level for operational purposes. However it was found to be slightly contaminated (arrowed).

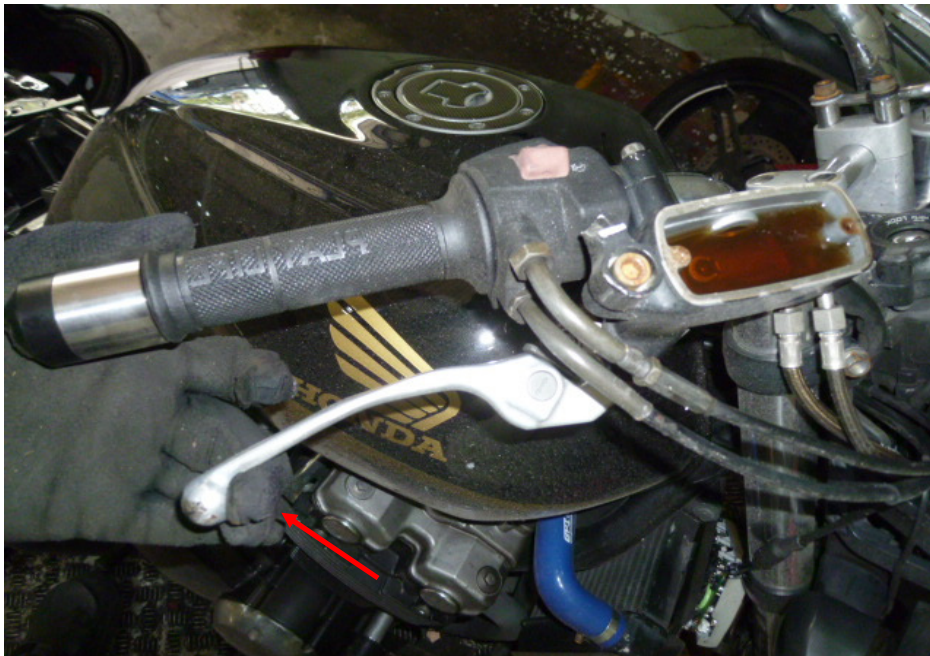
15. Static brake tests conducted on the Motorcycle had appear to indicate that the braking system of the Motorcycle was in serviceable condition. There was some resistance felt (spongy like feel) upon pressing the brake lever and upon stepping on the brake pedal. This would indicate that there was no leakage of pressure/vacuum in the brake system.

Photo 25 shows the front brake lever being depressed. There was some resistance felt (spongy like feel) upon pressing the front brake lever (arrowed). This would indicate that there is no leakage of pressure/vacuum in the brake system.

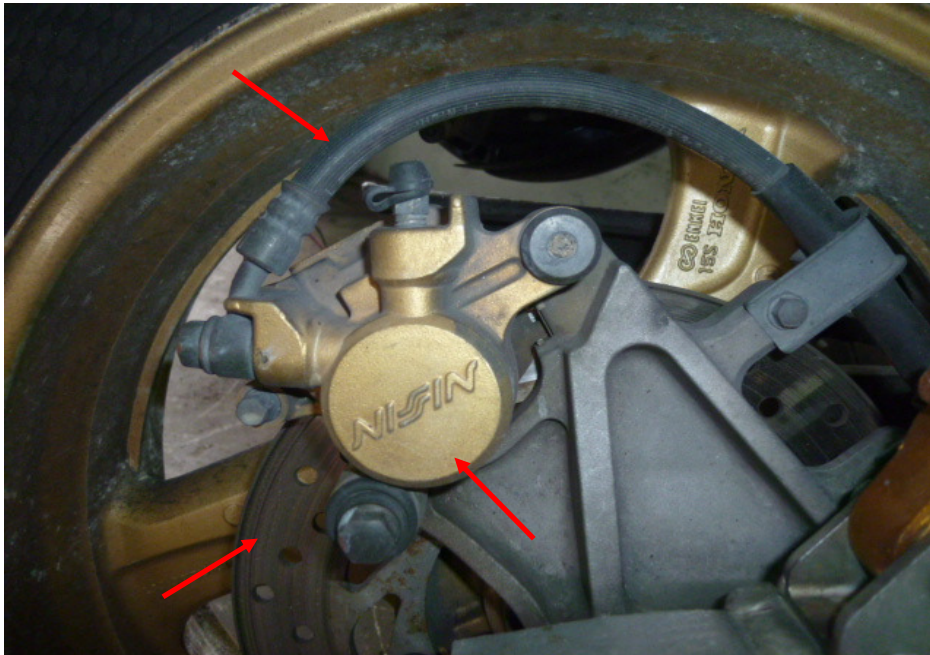
Photo 26 shows a close up view of the rear brake caliper, rear brake disc and rear brake hose (arrowed) of the Motorcycle, which are all part of the components in the hydraulic rear brake system of the Motorcycle. Our visual checks of these various components had revealed all to be intact with no visible damage. No leakage of brake fluid was also observed.

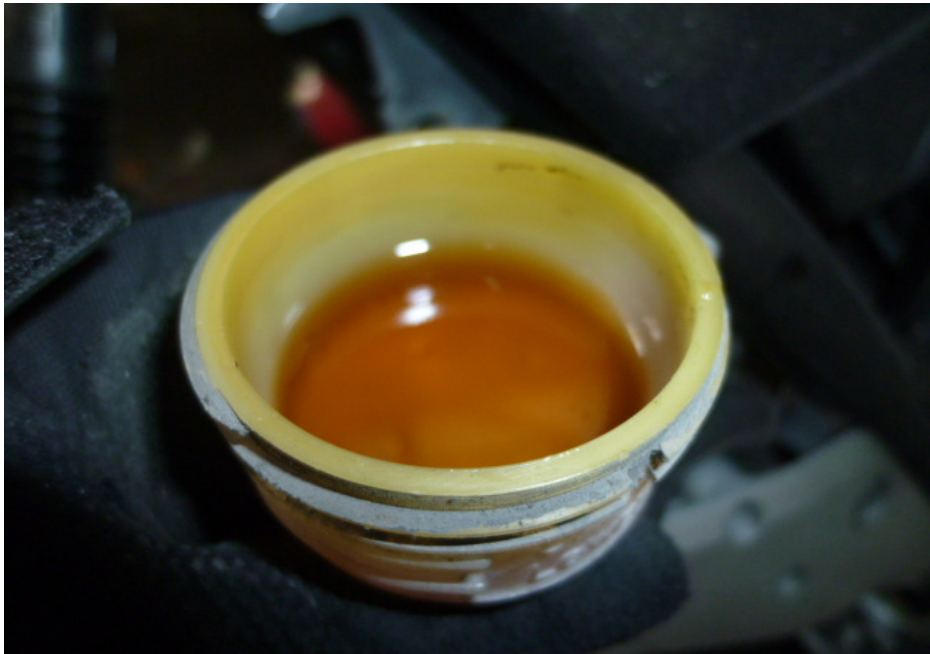
Photo 27 shows the brake fluid reservoir for the rear brake of the Motorcycle. The brake fluid was observed to be of sufficient level for operational purposes and without contamination.
