**PRO
PLUS
AUTOMOBILE
ENGINEERS**

**Re: Third Party Claim
Vehicle Registration No. GBH7054H**

VEHICLE INSPECTION REPORT

Registration Number	: GBH7054H	Odometer Reading	: - Km
Make/Model	: Citroen Berlingo 1.6	Radio/Cassette/CD	: Fitted
Year of Manuf/Reg	: 2018	Air Conditioner	: Fitted
Engine Number	: 10JBHW3019328	View Mirrors	: Fitted-o/s & n/s
Chassis Frame Number	: VF77FBHYMHJ766221	Seat Belts	: Fitted-front only
Class/Type	: Panel Van [goods]	Other Accessories	
Colour	: Metallic Silver	(Specify)	: Fitted

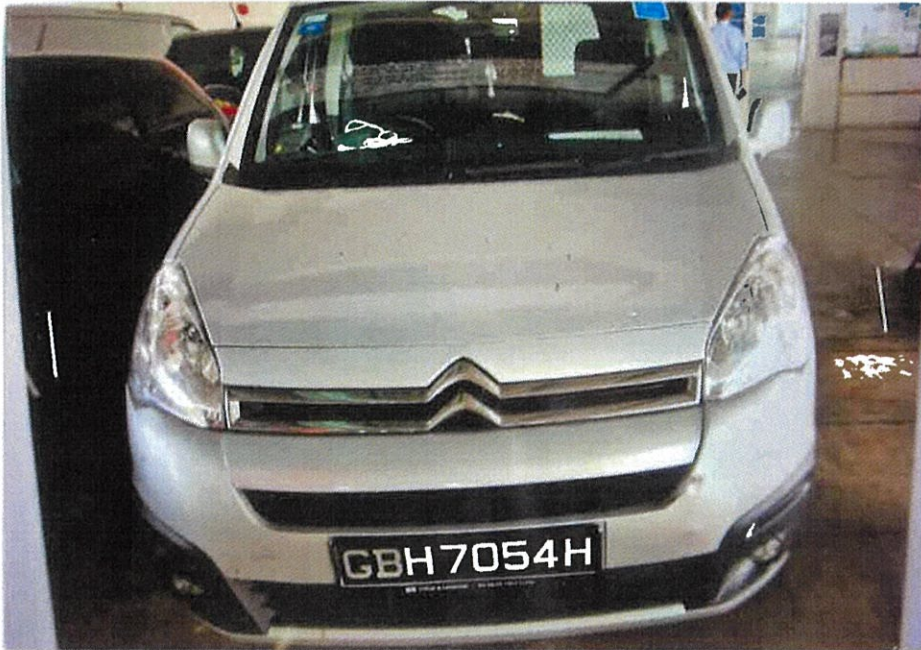
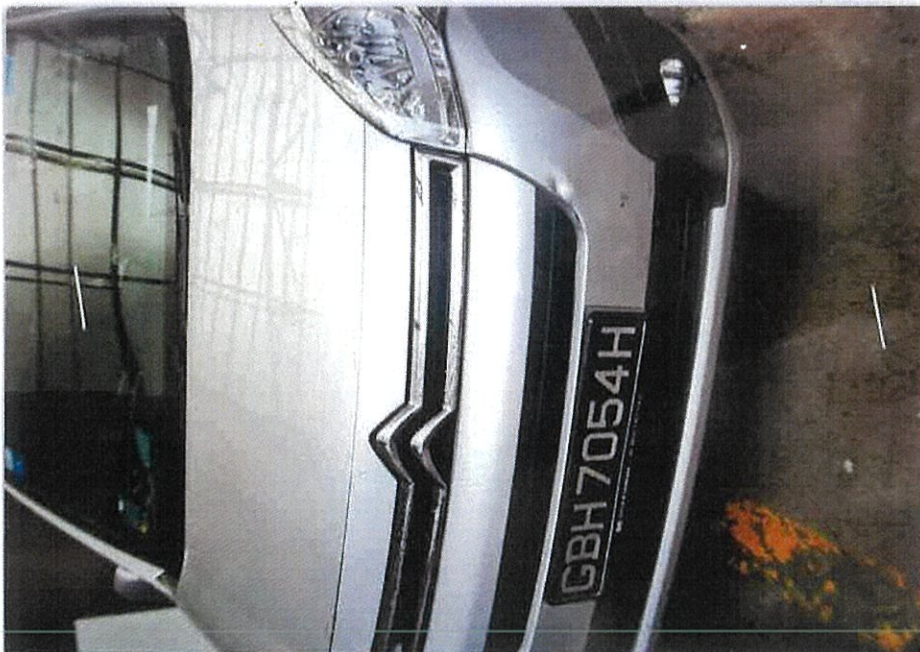
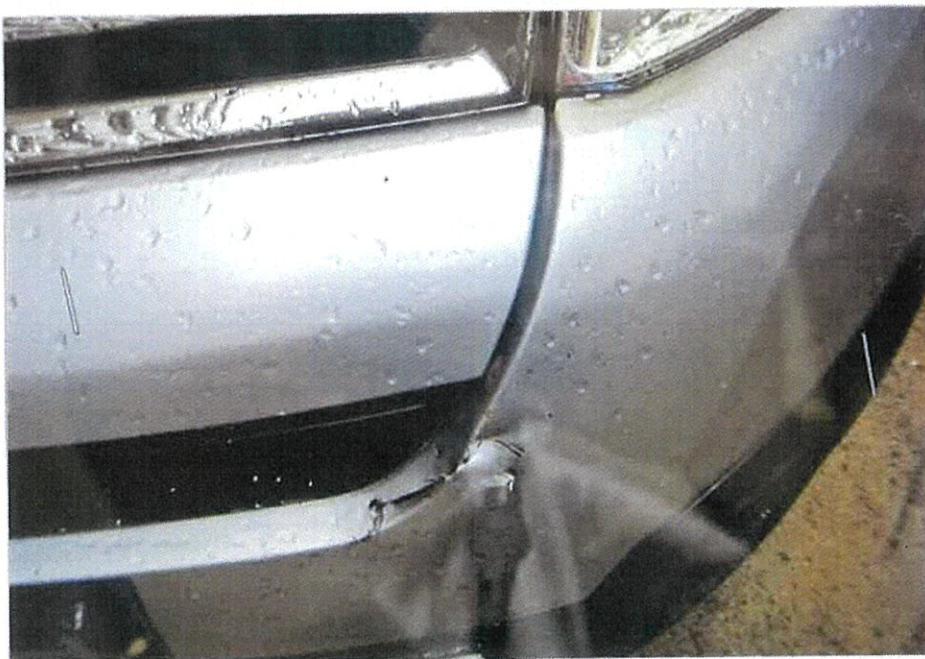
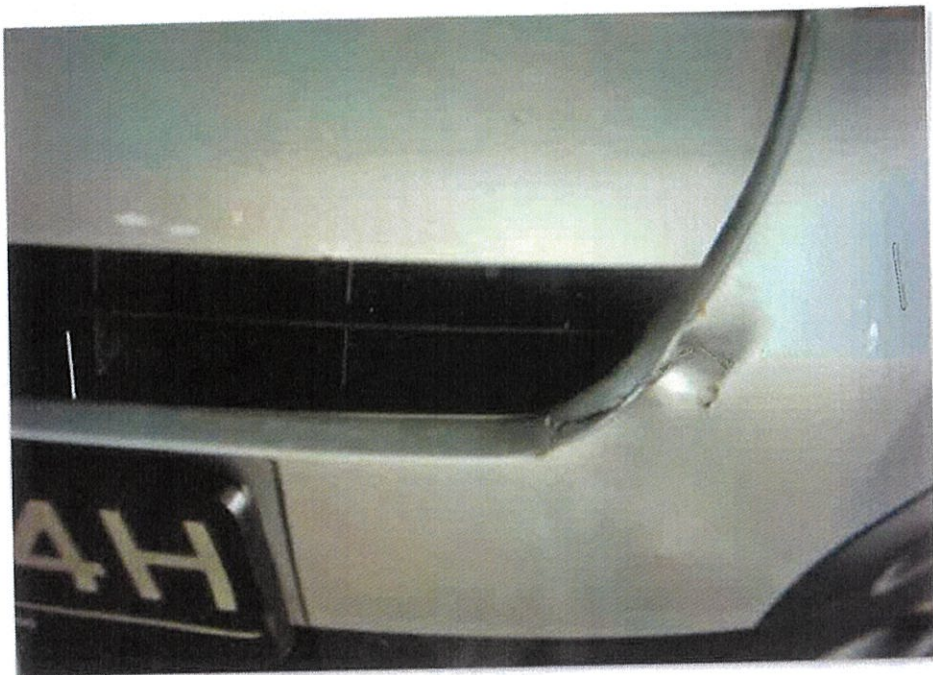
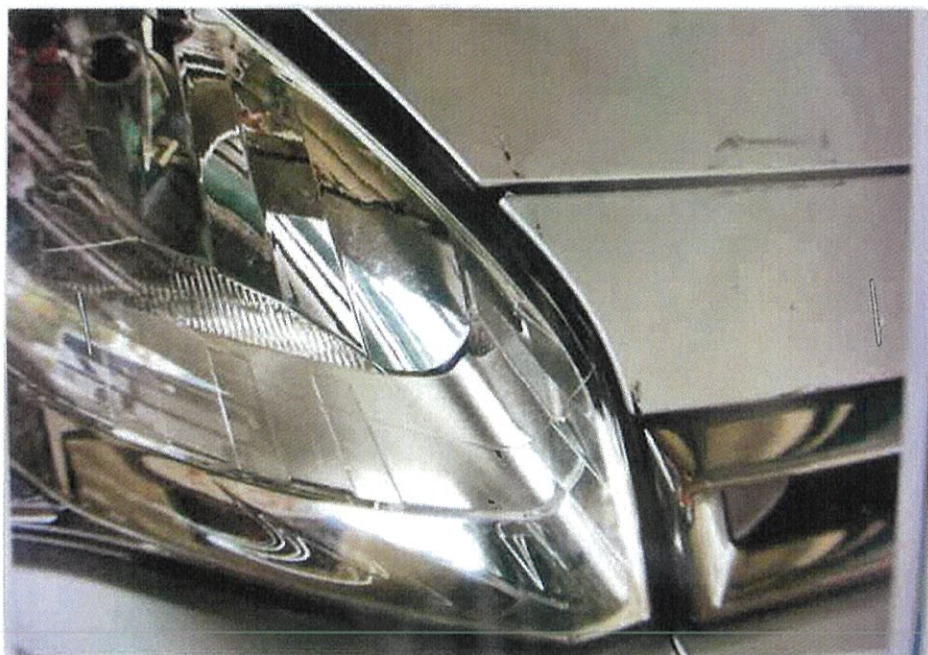
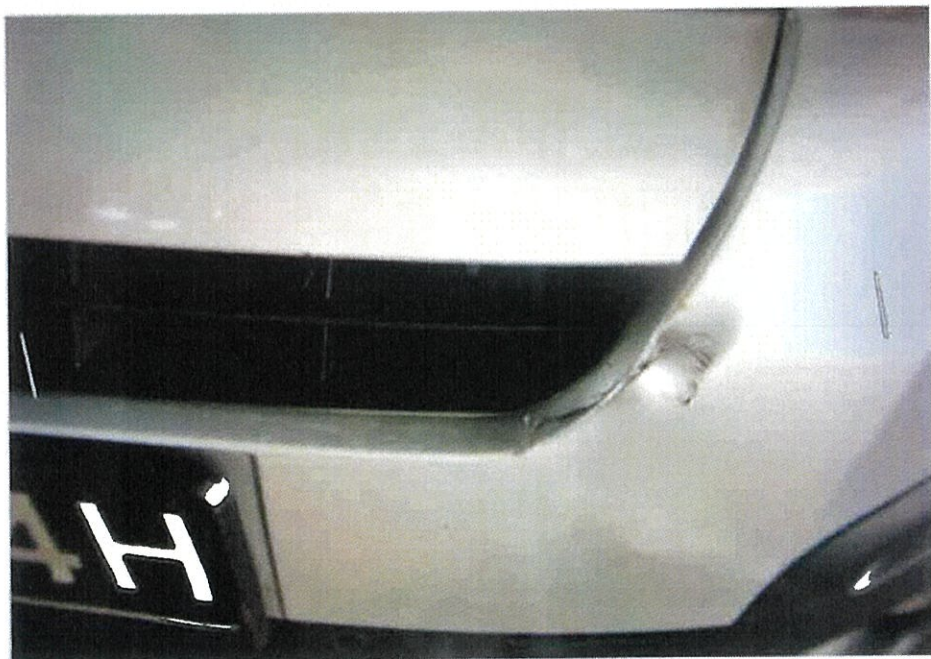
PRO PLUS AUTOMOBILE ENGINEERS (Inspection photographs)

Damages sustained were consistent with the subject vehicle being involved in a collision with another vehicle, sustaining damages to the o/s front of the vehicle.

Damaged sustained were the bonnet & its inner reinforcement - bent, bonnet inner lock/catch - bent/shifted, front bumper assembly, front fender n/s - buckled, front support panel - thrusts inwards/buckled etc.
