**PRO
PLUS
AUTOMOBILE
ENGINEERS**

**Re: Third Party Claim
Vehicle Registration No. GBH7054H**

VEHICLE INSPECTION REPORT

Registration No: GBH7054H

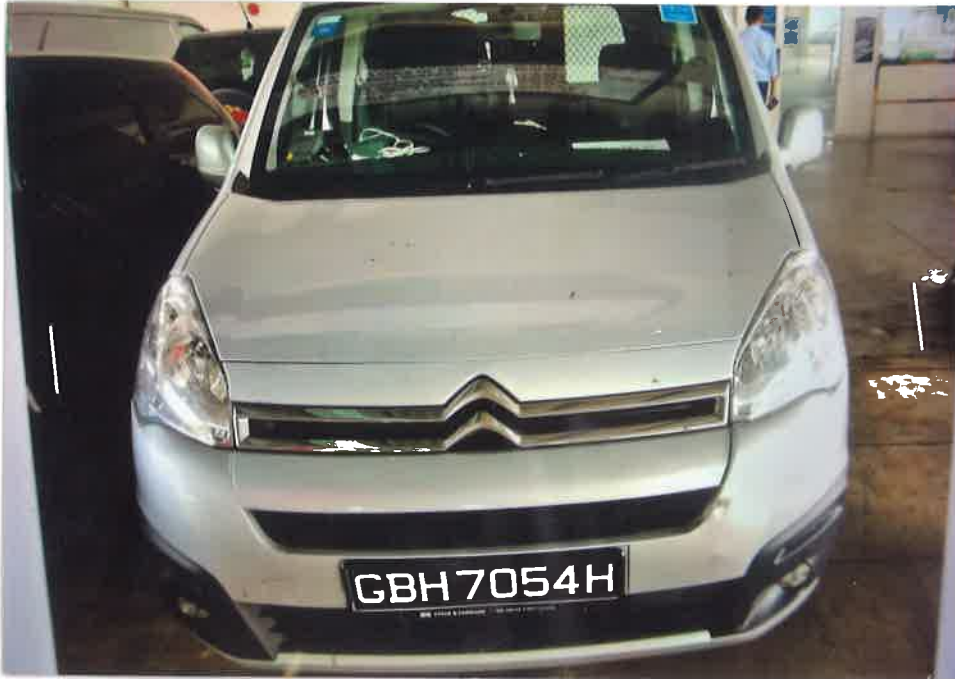
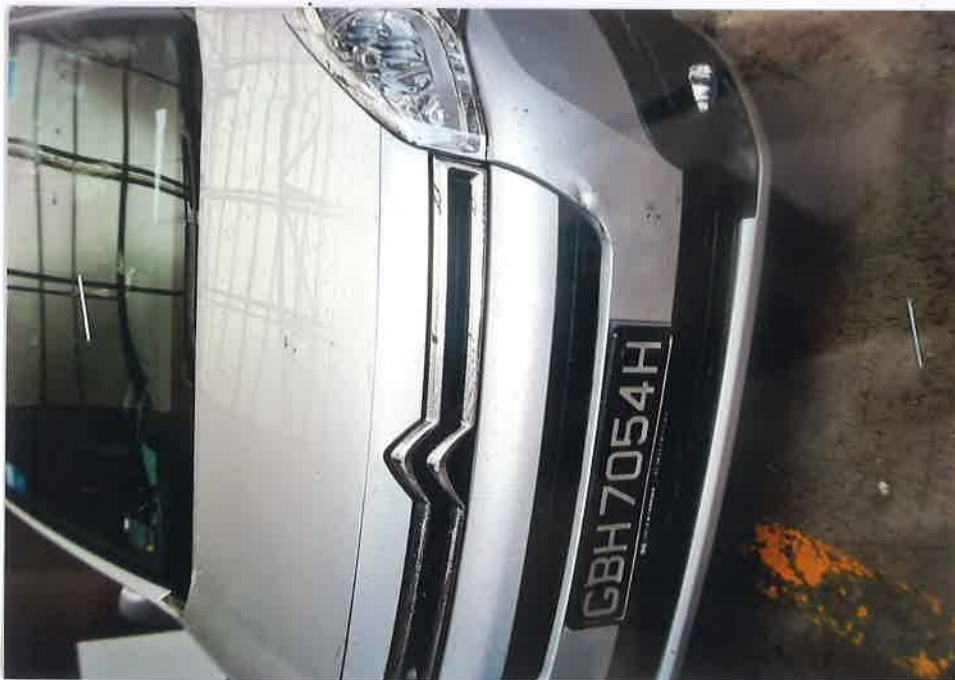
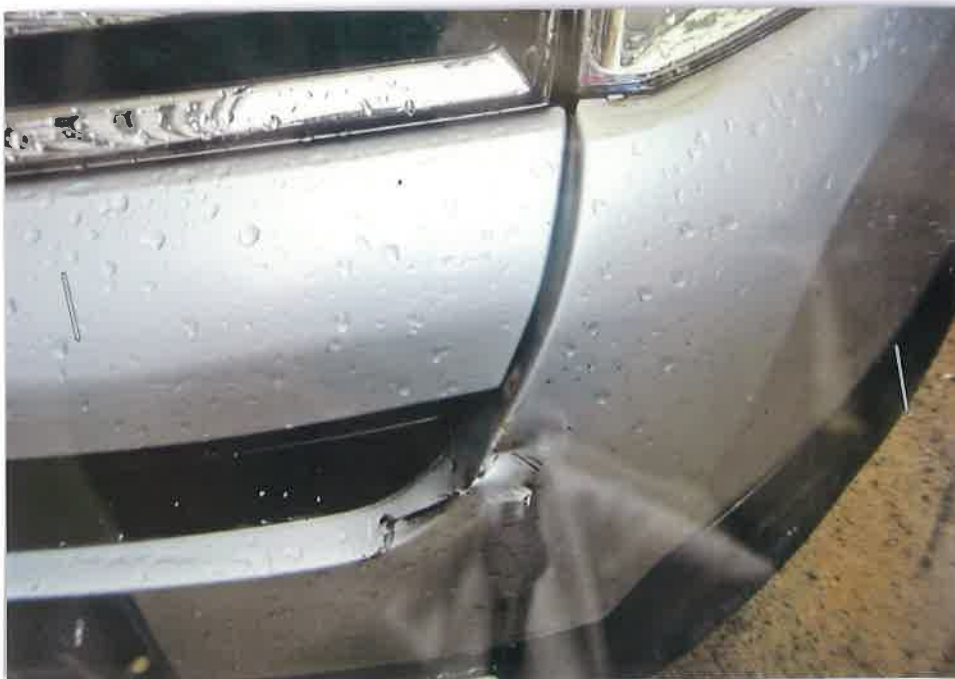
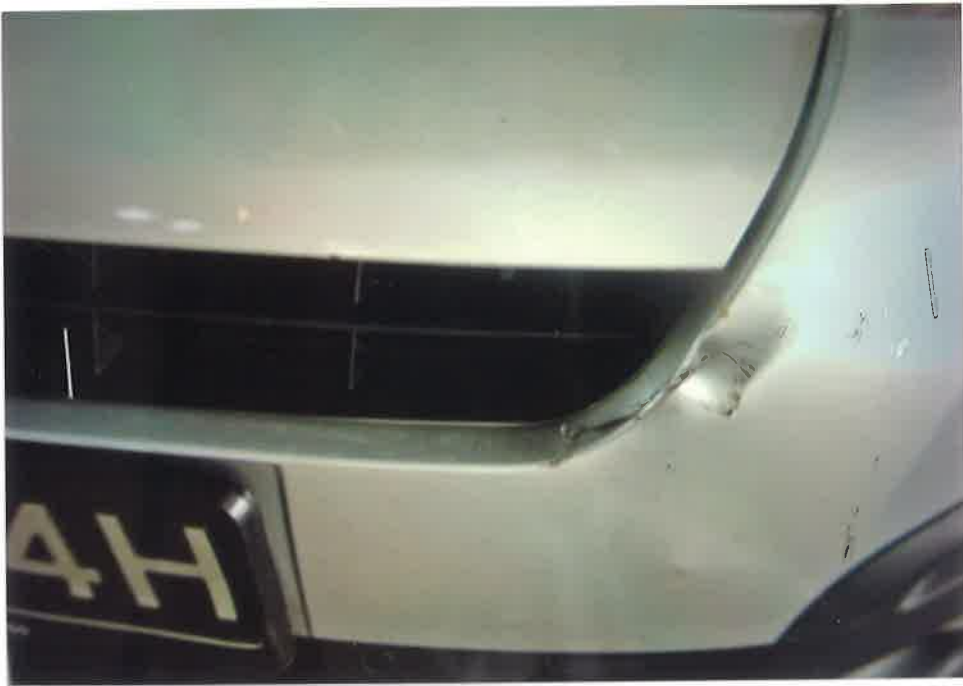
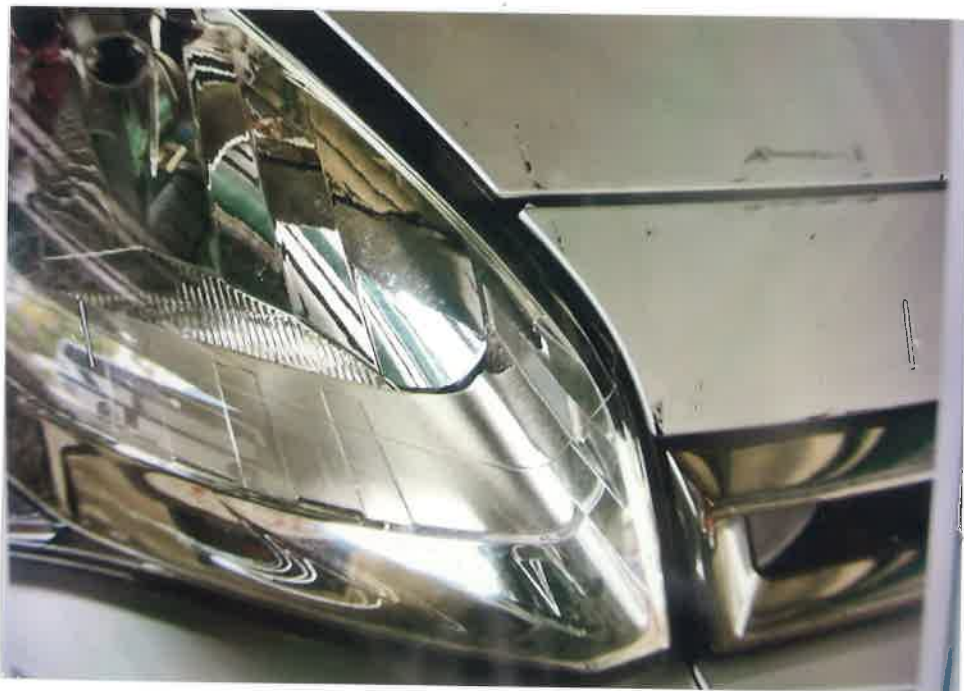
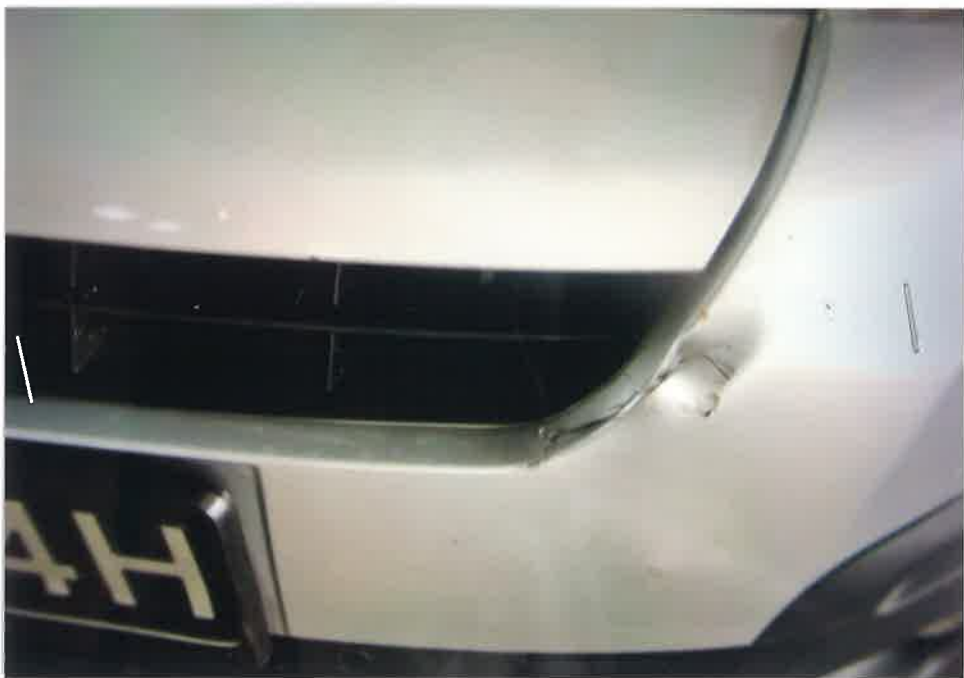
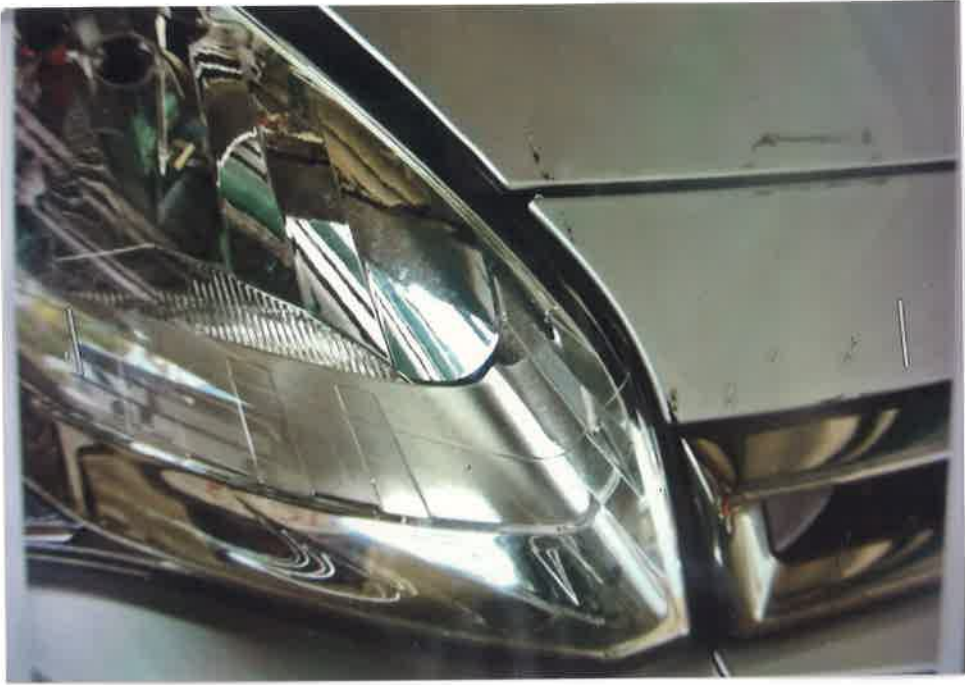
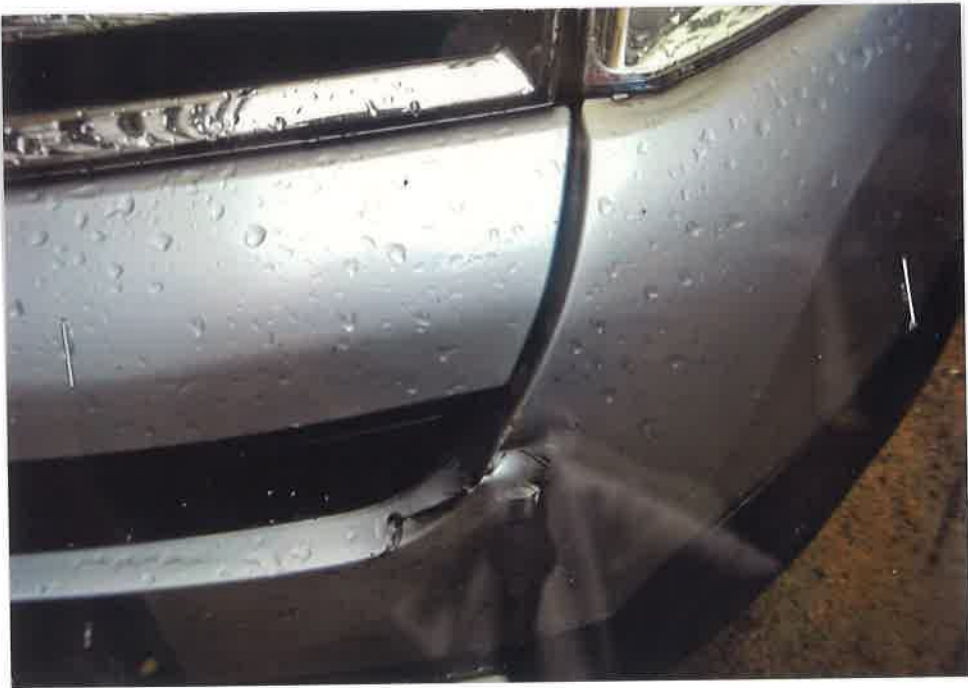
PRO PLUS AUTOMOBILE ENGINEERS (Inspection photographs)

Damages sustained were consistent with the subject vehicle being involved in a collision with another vehicle, sustaining damages to the o/s front of the vehicle.

Damaged sustained were the bonnet & its inner reinforcement - bent, bonnet inner lock/catch - bent/shifted, front bumper assembly, front fender n/s - buckled, front support panel - thrusts inwards/buckled etc.
