# LKK Auto Consultants Pte Ltd

## ADJUSTMENT ON REPAIR COST FOR VEHICLE NO. SLR 8795A

PHOTOGRAPHS FOR VEHICLE NO. SLR 8795A

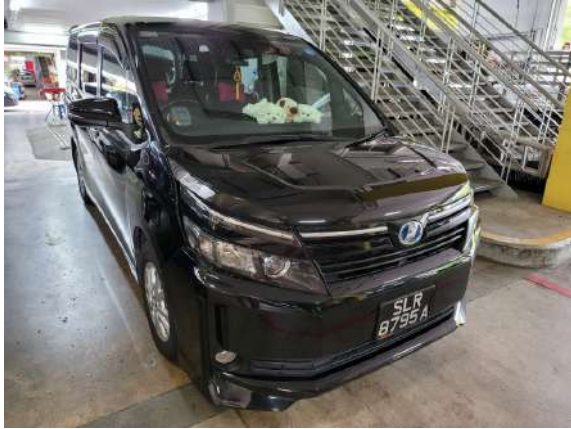
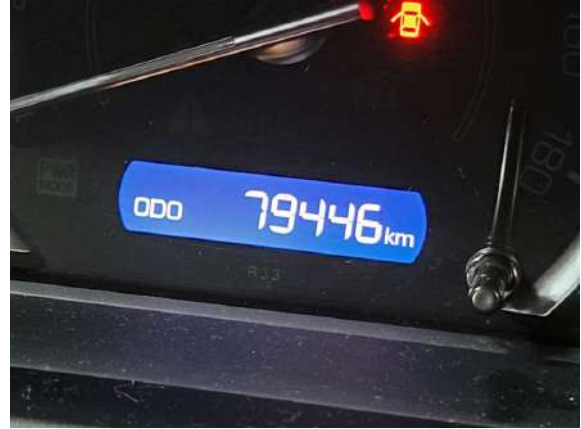
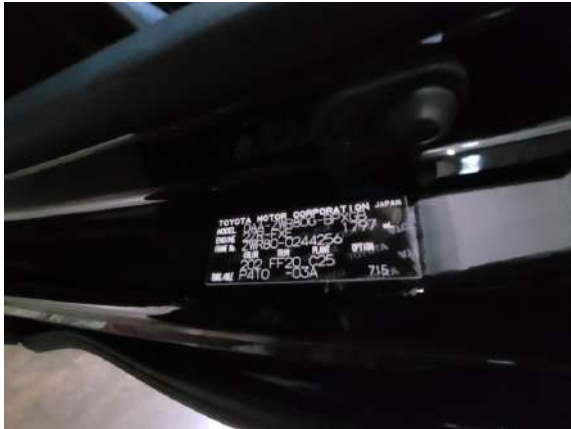
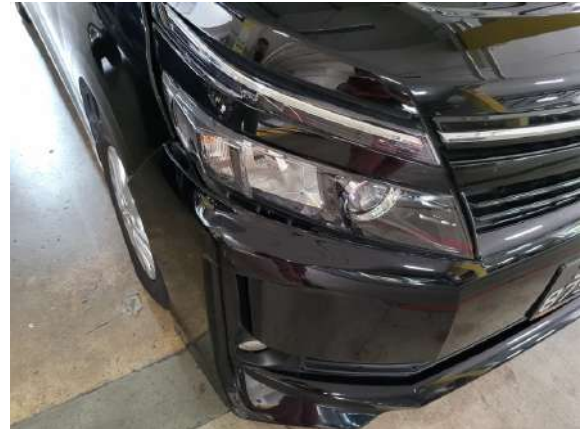
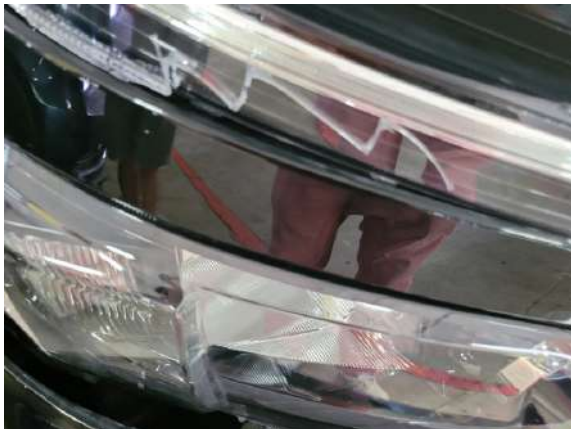
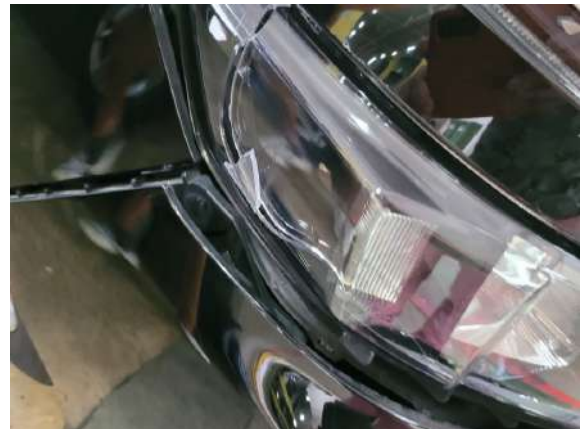
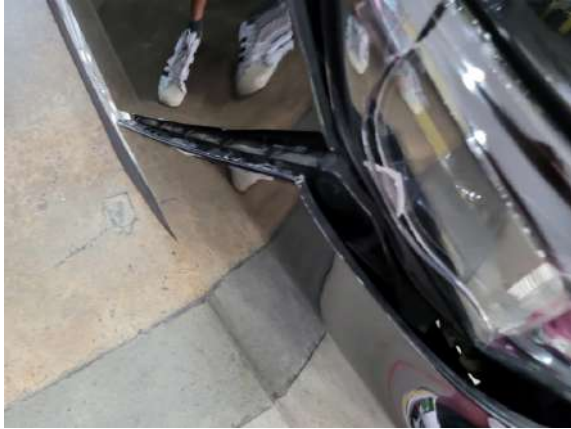
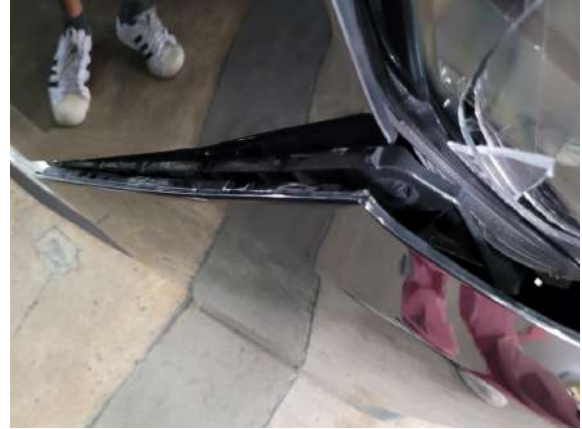
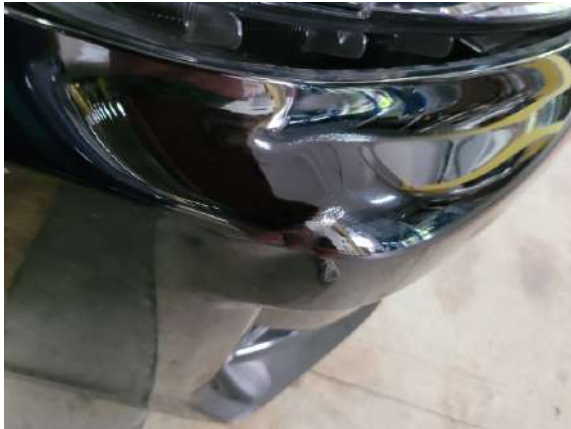
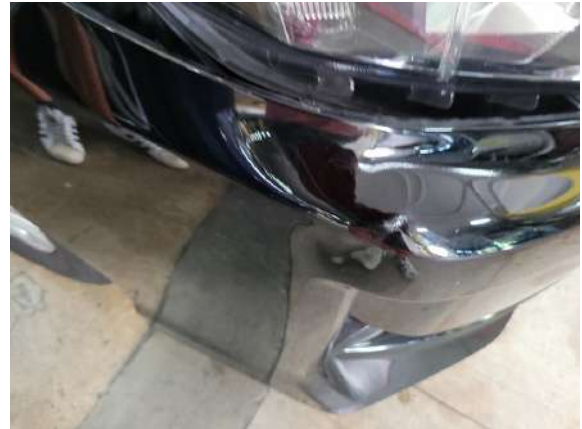
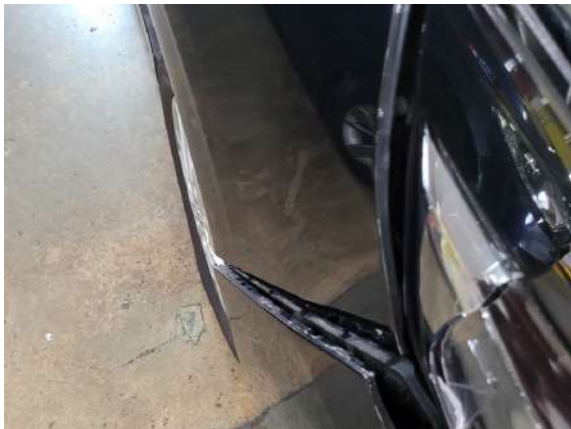
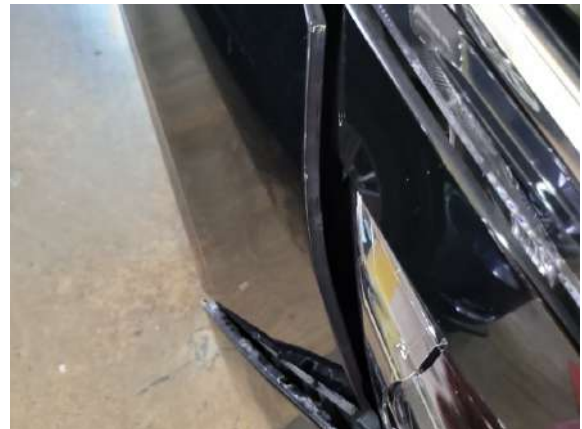
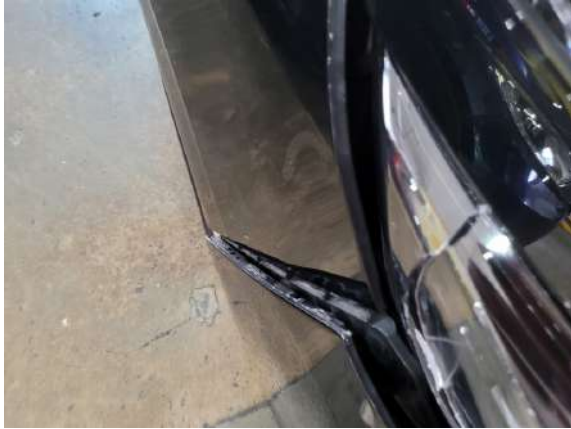
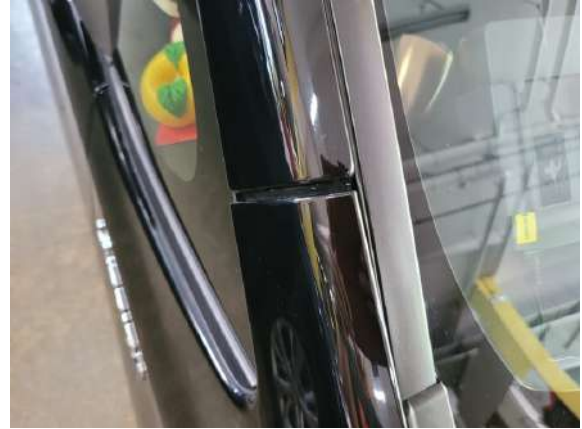
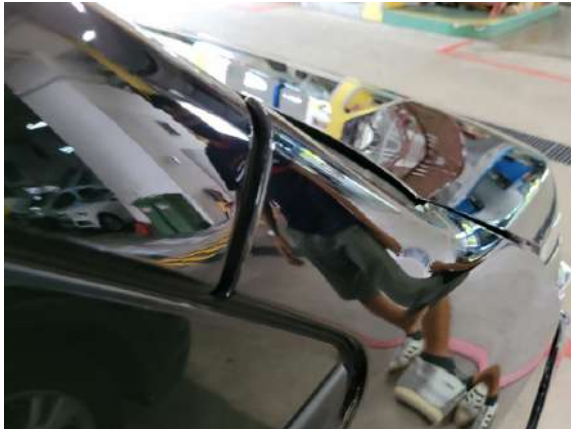
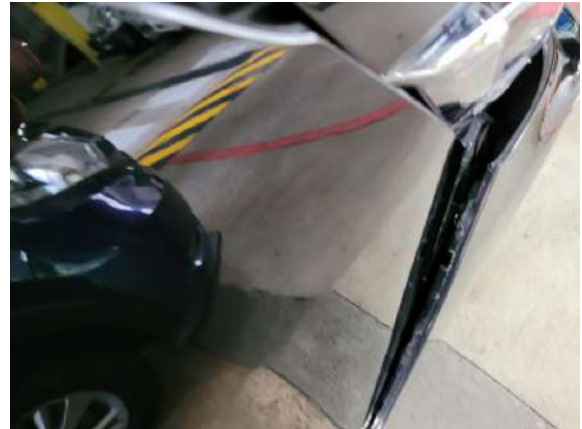
INSPECTION

| Affiliated to Federation Internationale Des Experts En Automobile | | | | |
|---|---|---|---|--|
| THE VEHICLE SUSTAINED DAMAGES AT THE FRONT O/S PORTION.<br><br>DAMAGES SEE DETAILS. | | | | |
