## LKK Auto Consultants Pte Ltd

Vehicle No. SMD 837C  
Insured Veh. GBK 5912D  
Claim No. SNM21D206507/C02  
Policy No. DMCVSNW00104192101  
Accident Date 11/11/2021  
Inspection Date 12/11/2021

### ADJUSTMENT ON REPAIR COST FOR VEHICLE NO. SMD 837C

### PHOTOGRAPHS FOR VEHICLE NO. SMD 837C

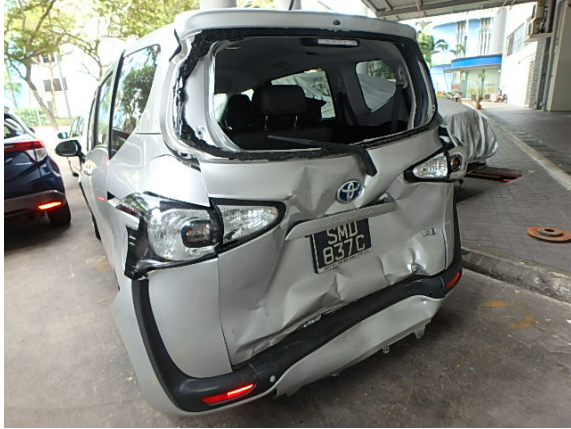
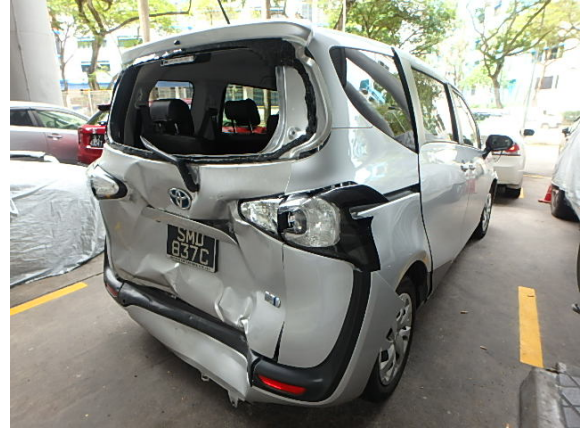
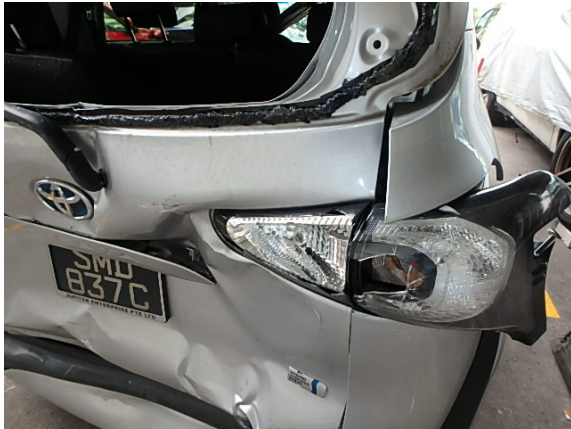
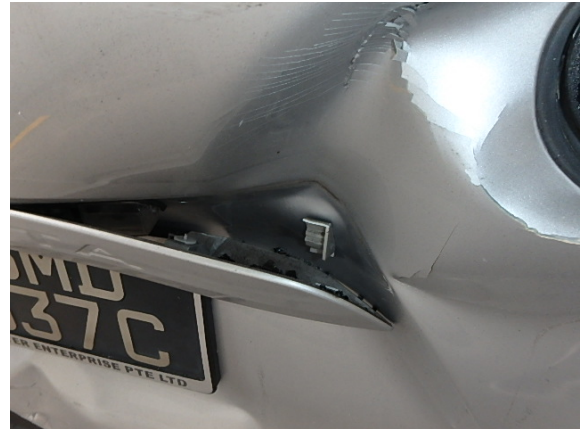
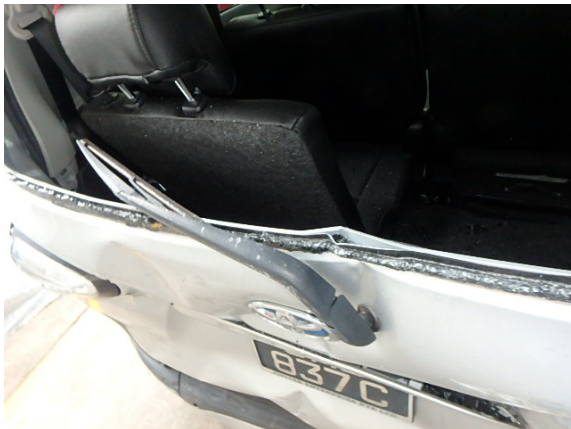
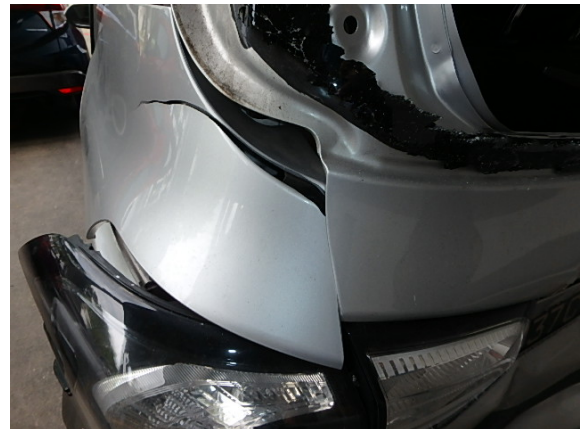
| Affiliated to Federation Internationale Des Experts En Automobile | | | | |
|---|---|---|---|---|
| | THE VEHICLE SUSTAINED DAMAGES AT THE REAR & FRONT PORTION.<br>DAMAGES SEE DETAILS. | | | |
