Our Ref : TP / ACS GBG5331B/ 09.25/21

DAMAGED VEHICLE (GBG 5331 B) INSPECTION REPORT (WITHOUT PREJUDICE)

Registration No	: GBG 5331 B ✓	Mileage	: 168457 Km
Make & Model	: NISSAN NV200 1.5MT	Engine No	: K9KC400D057261
Date of Registration	: 29 th Aug 2017	Chassis No.	: VSKYBAM20Z0145916
Colour	: Silver	Engine Capacity	: 1,461 cc

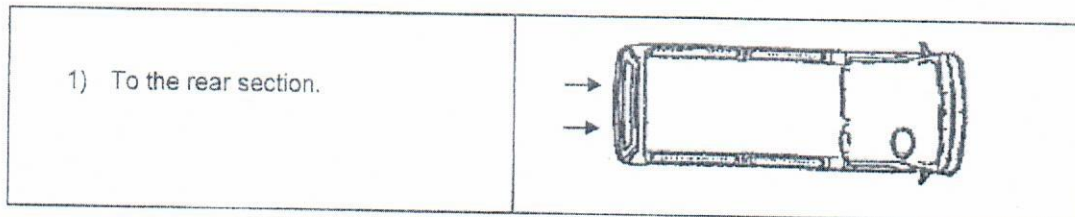
(E) Point of Impact

The impact of the collision has damaged/affected the rear door, rear bumper, rear end panel, tail lamp, parking aid sensor and etc.
