Your Ref: TP/IP/36045/2021  
Our Ref : CI/TPD21011762/N

**Fatal Accident Investigation Team**

**INSPECTION REPORT OF MOTORCYCLE JTF 9708**

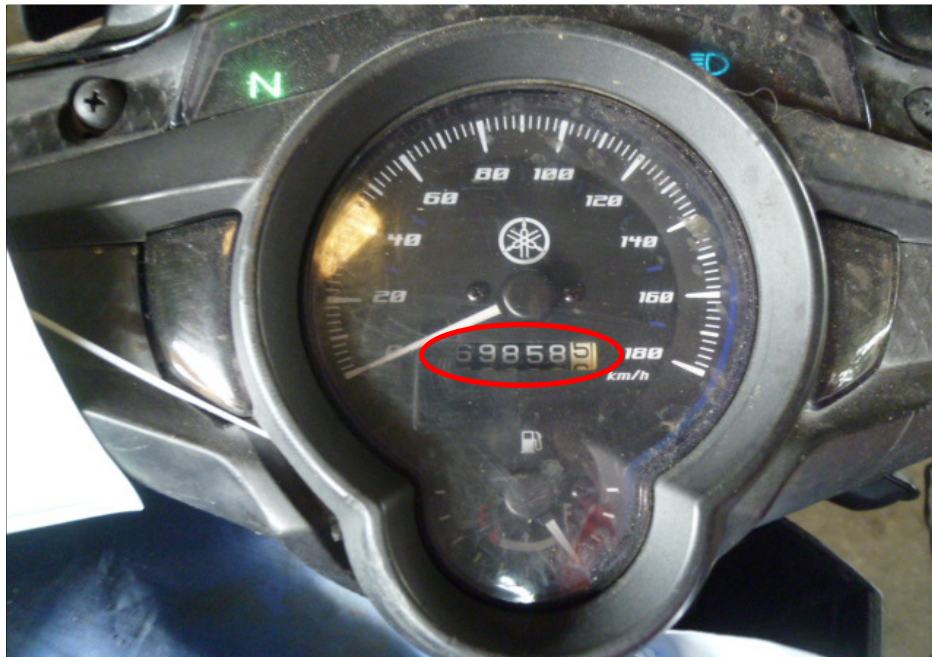
**Photo 1** shows the speedometer gauge of the Motorcycle. The mileage of the Motorcycle at the time of our inspection was 69, 858km (circled).

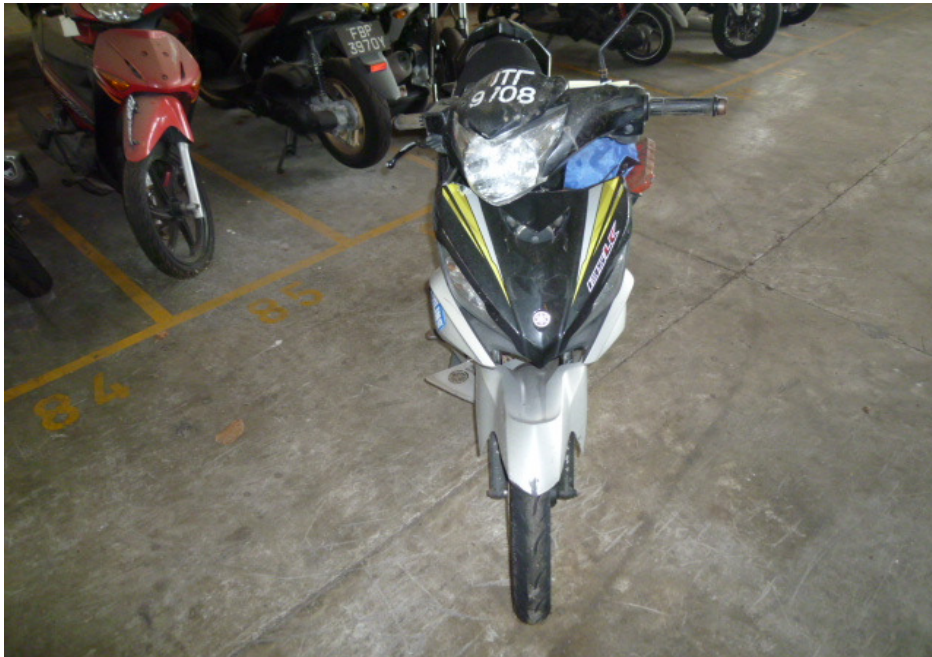
4. The mileage of the Motorcycle at the time of our inspection was 69, 858km.
5. The Motorcycle was observed to have sustained damages at its frontal portion and right body. The body parts that were found to have been damaged include its head cowl, headlight, right cowl, right side mirror, right handlebar end, front brake lever, rear brake pedal, right front footrest, right rear side cover and exhaust muffler heat shield, amongst others.

**Photo 2** shows a general view of the frontal portion of the Motorcycle at the time of our inspection. The Motorcycle was observed to have sustained damages at its frontal portion and right body.

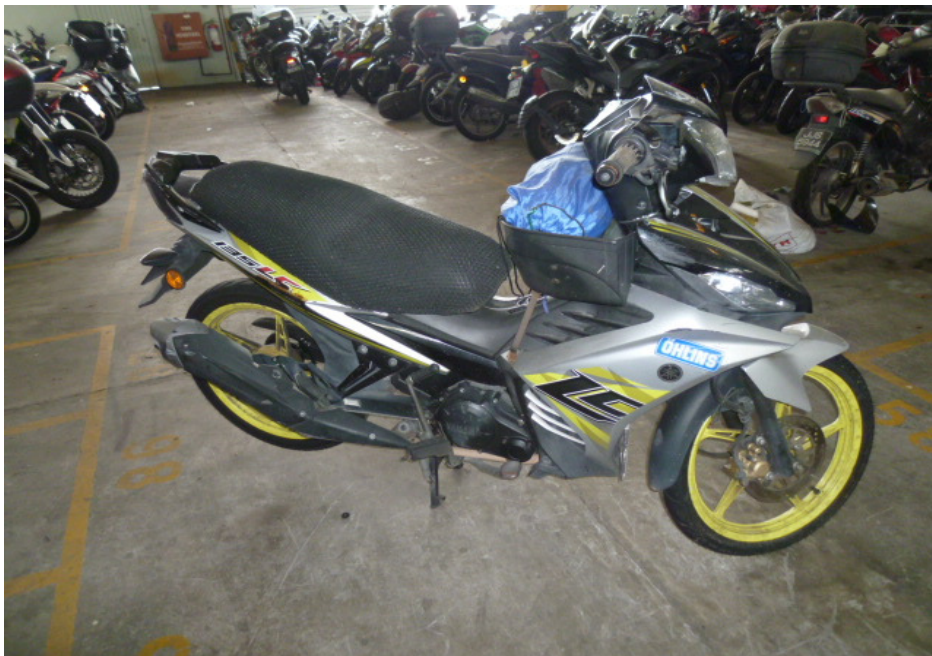
**Photo 3** shows a general view of the right body of the Motorcycle at the time of our inspection. The Motorcycle was observed to have sustained damages at its frontal portion and right body.

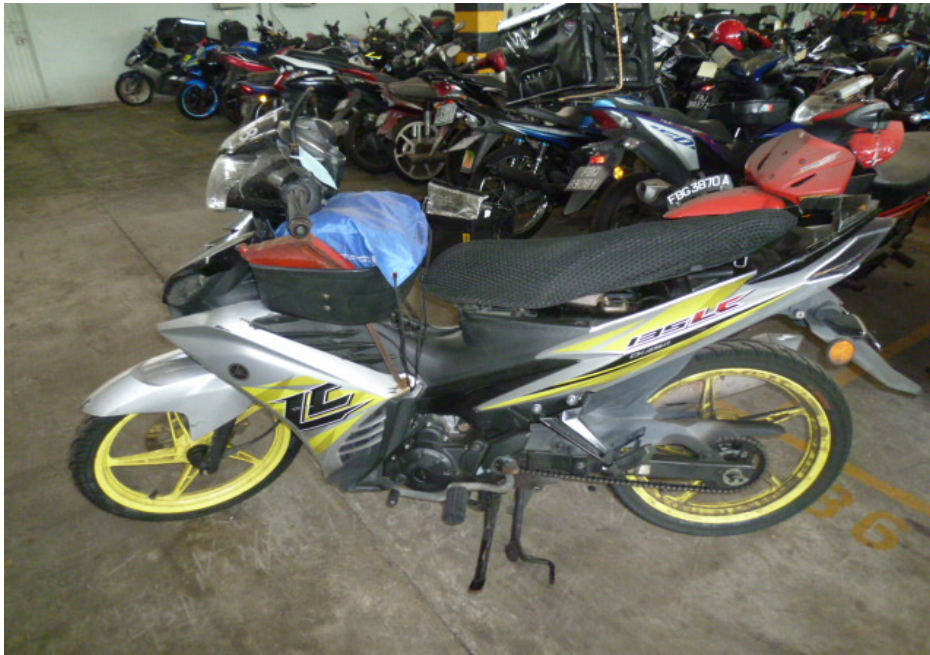
**Photo 4** shows a general view of the left body of the Motorcycle at the time of our inspection. The Motorcycle was observed to have sustained damages at its frontal portion and right body. The body parts that were found to have been damaged include its head cowl, headlight, right cowl, right side mirror, right handlebar end, front brake lever, rear brake pedal, right front footrest, right rear side cover and exhaust muffler heat shield, amongst others.

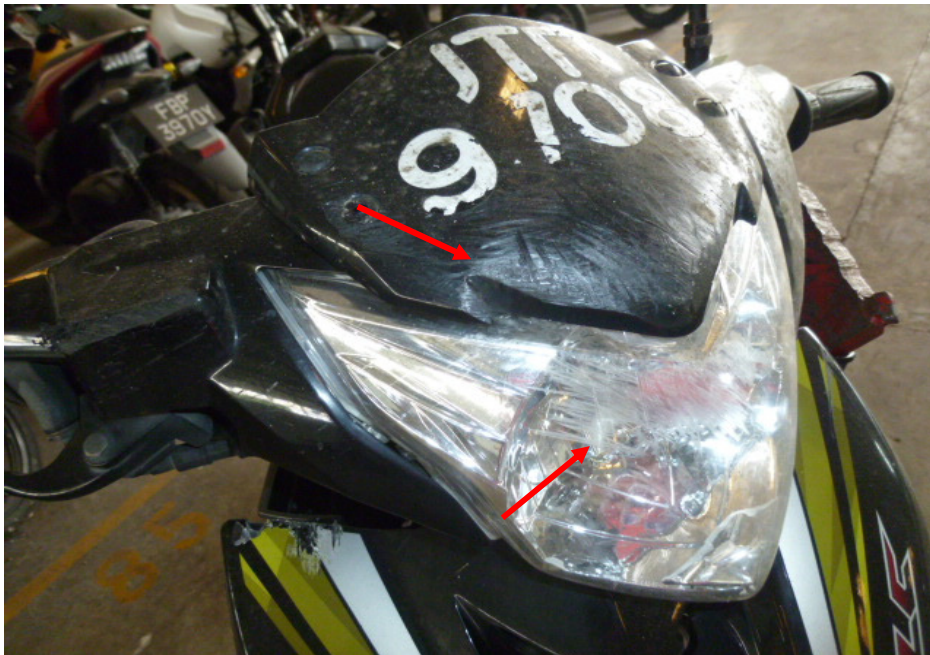
**Photo 5** shows a close up view of the grazed head cowl and headlight of the Motorcycle as a result of the accident (arrowed).

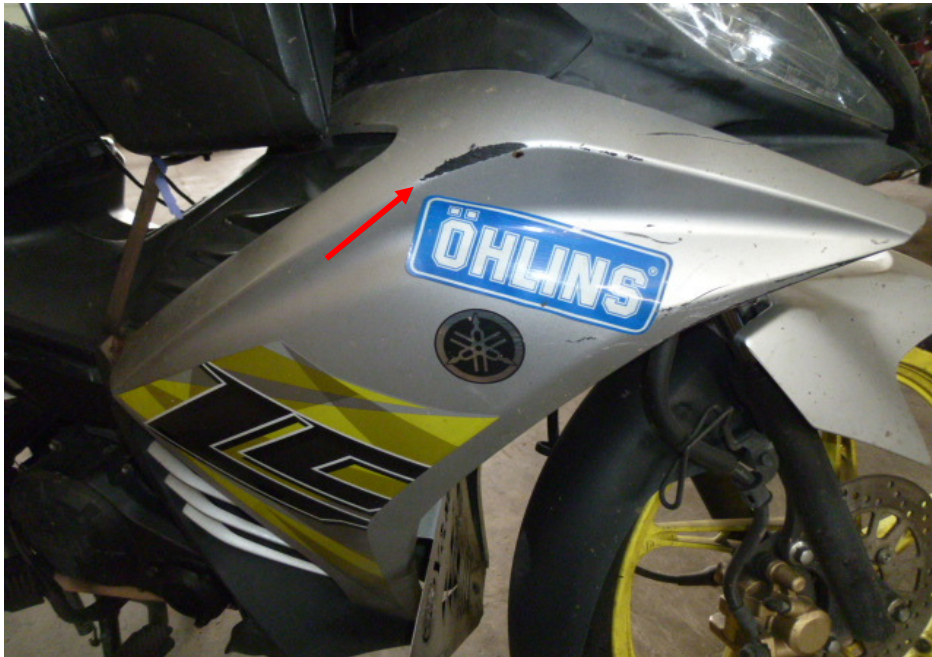
**Photo 6** shows a closer view of the grazed right cowling which was amongst the body parts of the Motorcycle that had sustained damage as a result of the accident (arrowed).

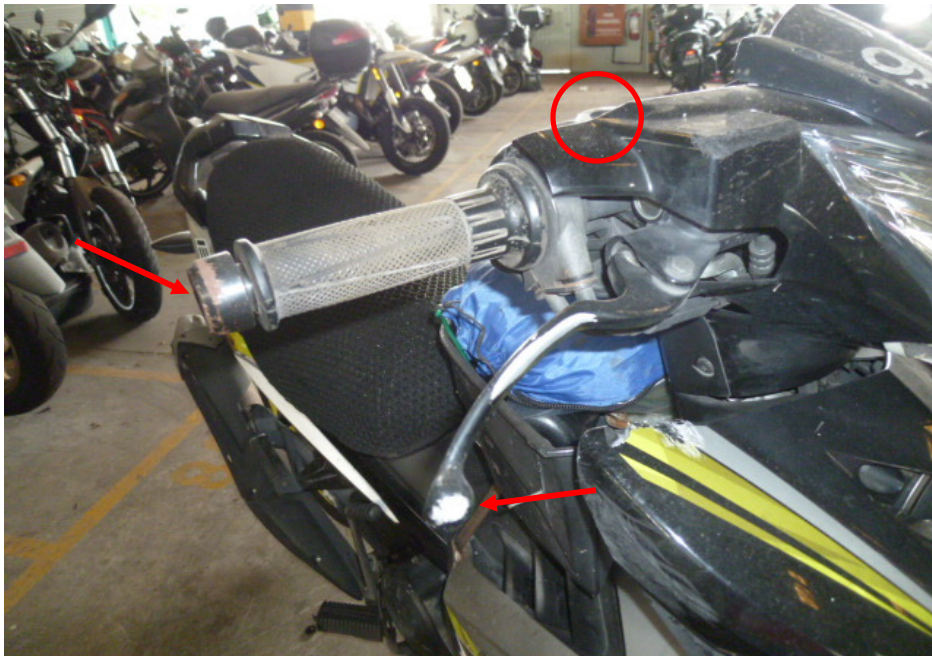
**Photo 7** shows the right handlebar end and front brake lever (arrowed) as well as the missing right side mirror (circled), which were amongst the body parts of the Motorcycle that had sustained damage as a result of the accident.

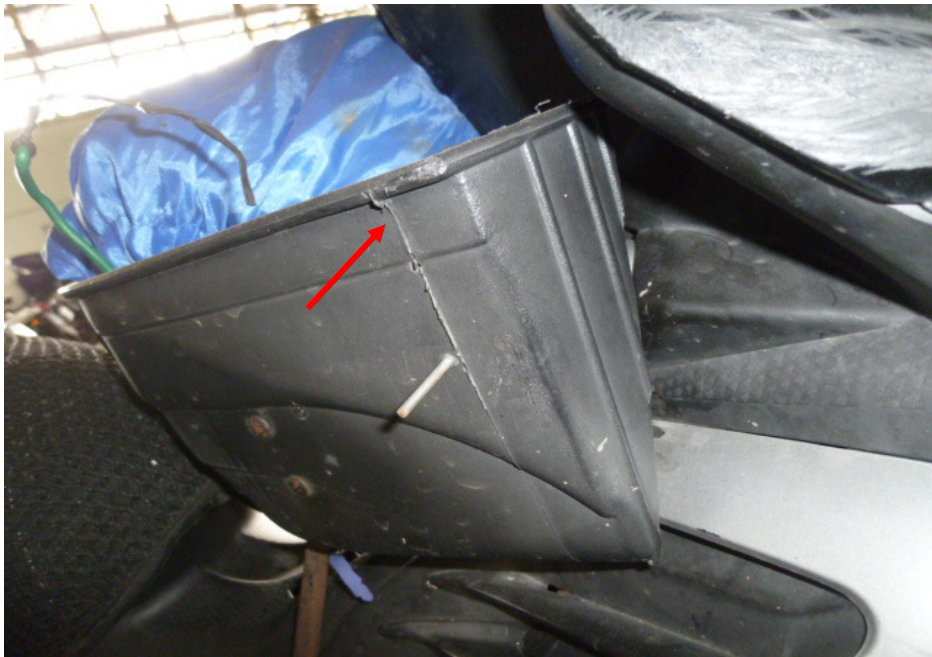
**Photo 8** shows a closer view of the grazed front basket of the Motorcycle as a result of the accident (arrowed).

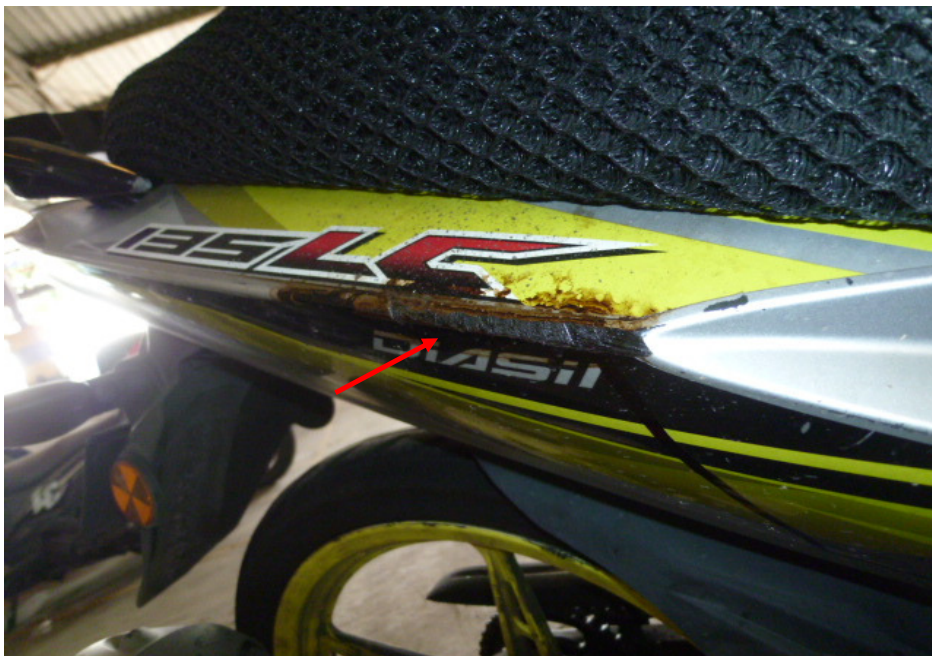
**Photo 9** shows a closer view of the grazed right rear side cover of the Motorcycle as a result of the accident (arrowed).

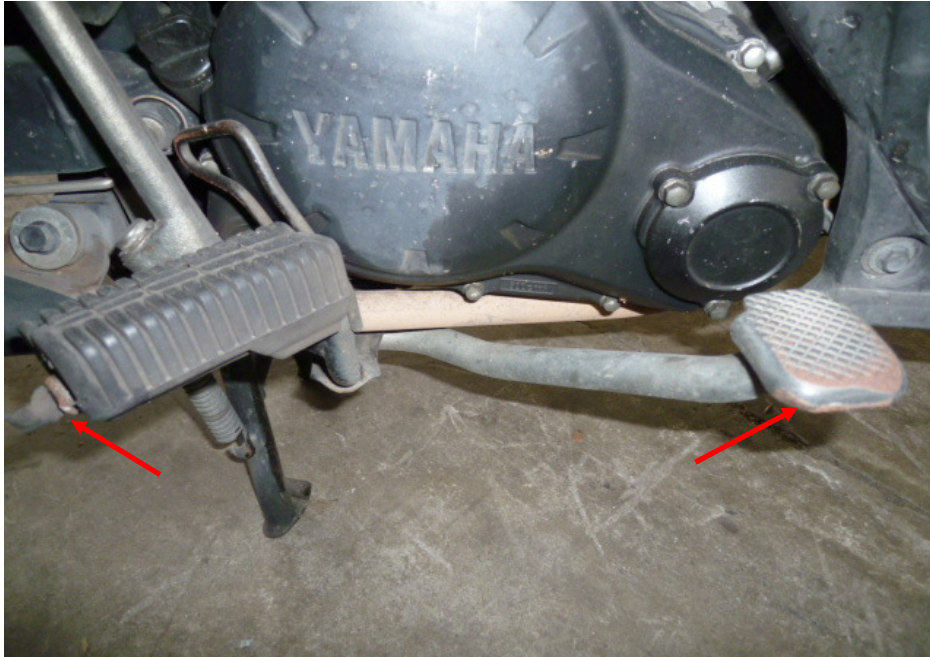
**Photo 10** shows a closer view of the right front footrest and rear brake pedal which were amongst the body parts of the Motorcycle that had sustained damages as a result of the accident (arrowed).

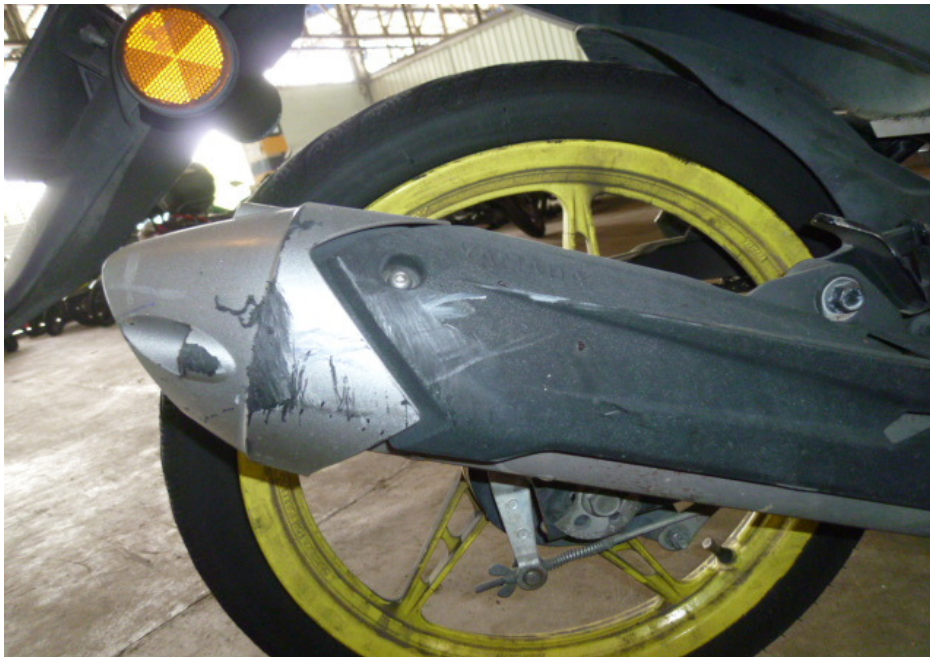
**Photo 11** shows the exhaust muffler heat shield of the Motorcycle that had sustained damages of grazing nature as a result of the accident.

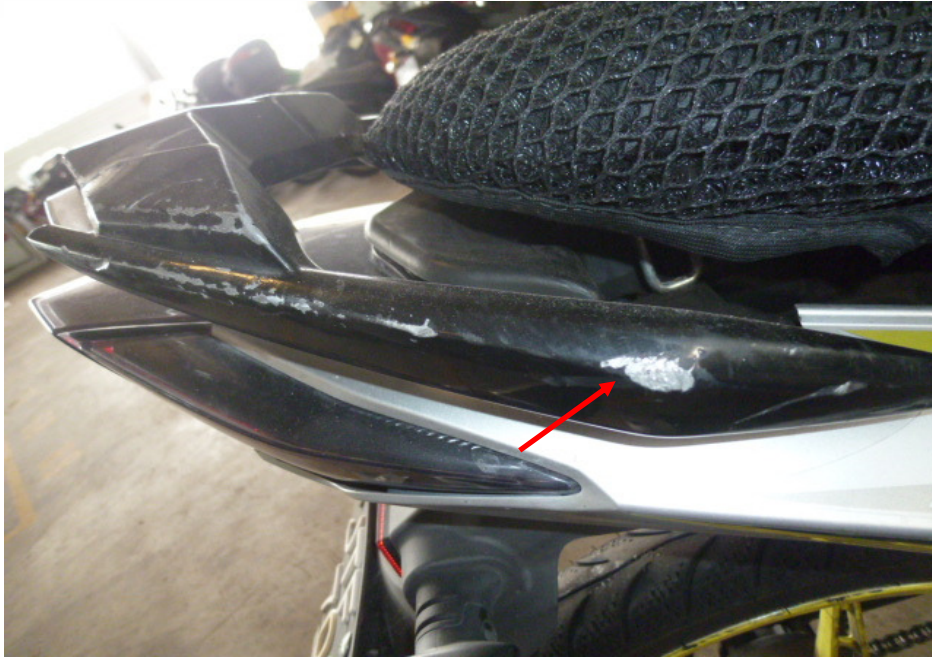
**Photo 12** shows the right pillion grab rail of the Motorcycle that had sustained damages of grazing nature as a result of the accident (arrowed).

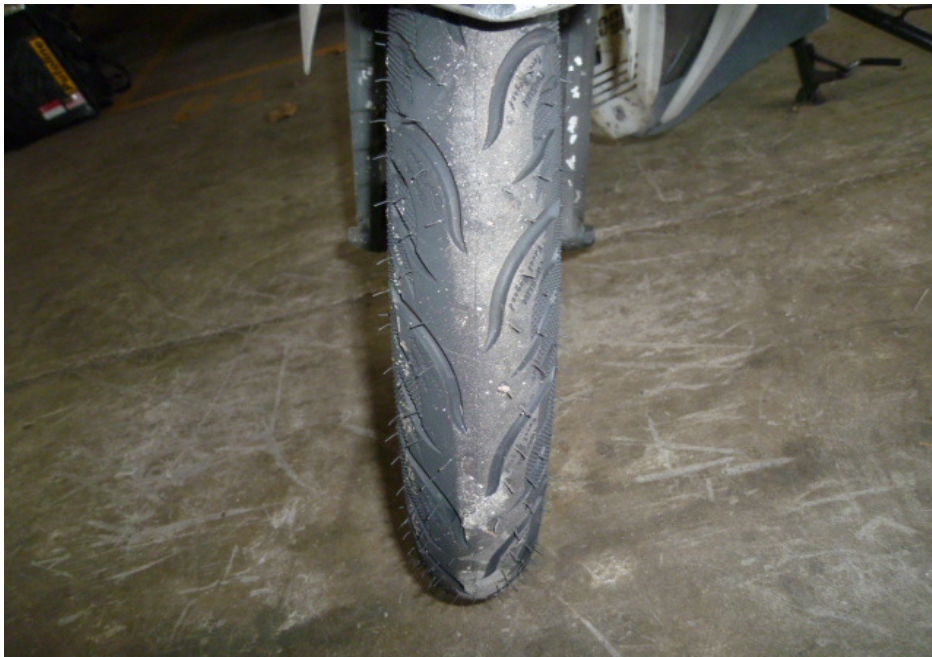
**Photo 13** shows the front tyre of the Motorcycle at the time of our inspection. The front tyre was observed to be in serviceable condition with remaining tread depth of approximately 5mm. The pattern of the tread was also clearly visible. There was no tear, burst mark(s) and/or punctured hole(s) on the sidewalls as well as across the tread of the front tyre.

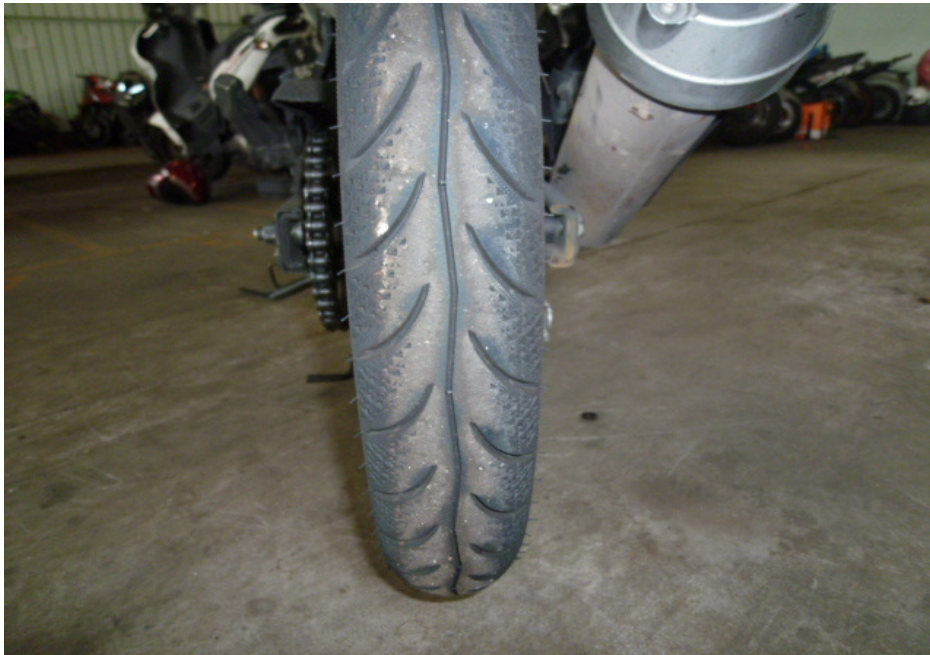
**Photo 14** shows the condition of the Motorcycle's rear tyre. The rear tyre was observed to be in serviceable condition with remaining tread depth of approximately 6mm. The tyre was also observed to be sufficiently inflated for vehicular operation. We did not observe any tear, burst mark(s) and/or punctured hole(s) on the sidewalls as well as across the tread of the rear tyre.

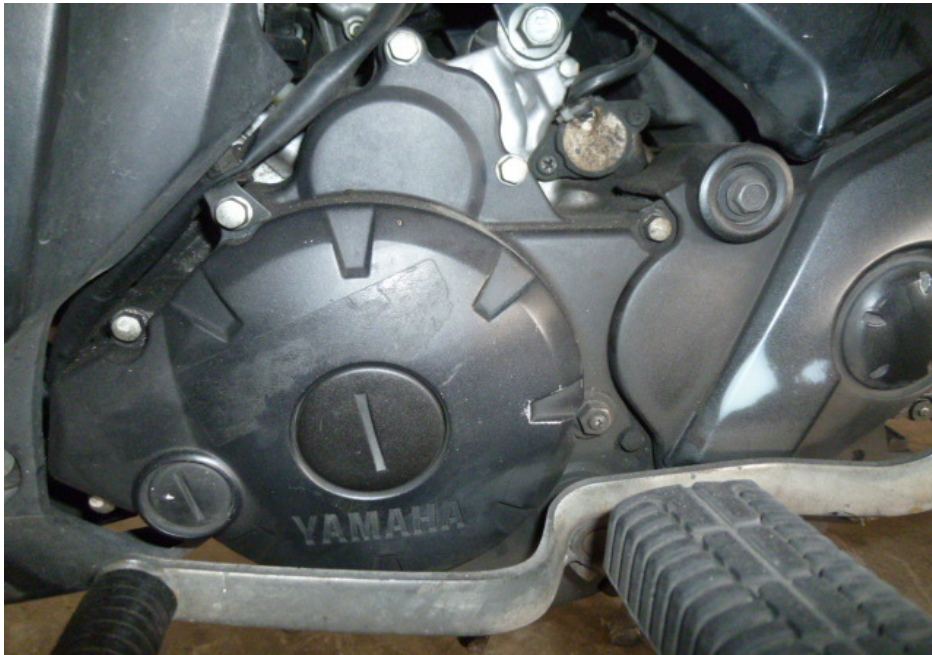
**Photo 15** shows the left side of the engine of the Motorcycle at the time of our inspection. The various engine related parts and components were found to be intact with no visible damage. There was also no sign(s) or indication(s) of fluid leak observed around the left engine area of the Motorcycle.

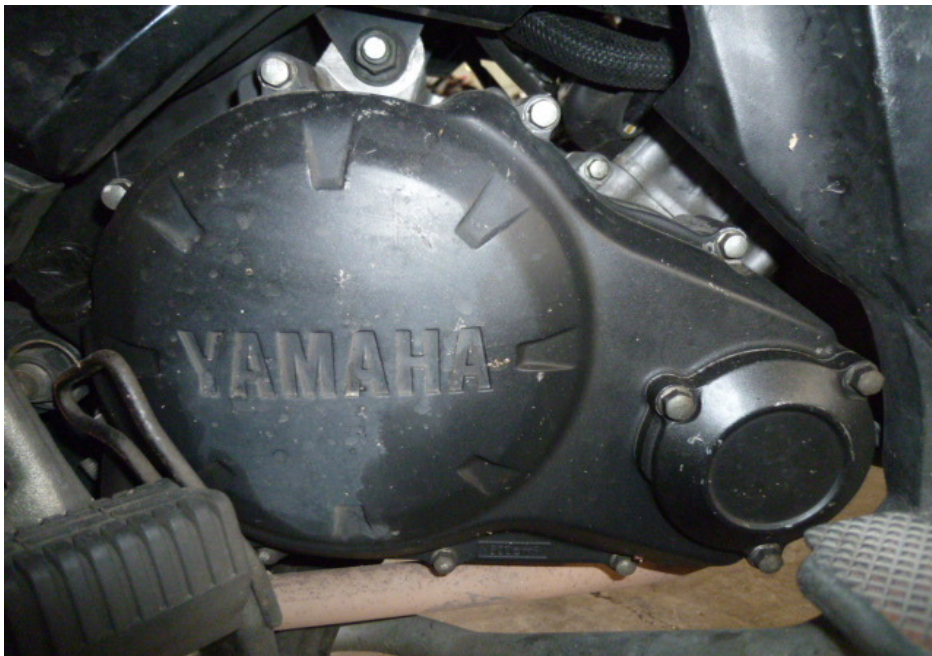
**Photo 16** shows the right side of the engine of the Motorcycle at the time of our inspection. The various engine related parts and components were found to be intact with no visible damage. There was also no sign(s) or indication(s) of fluid leak observed around the right engine area of the Motorcycle.

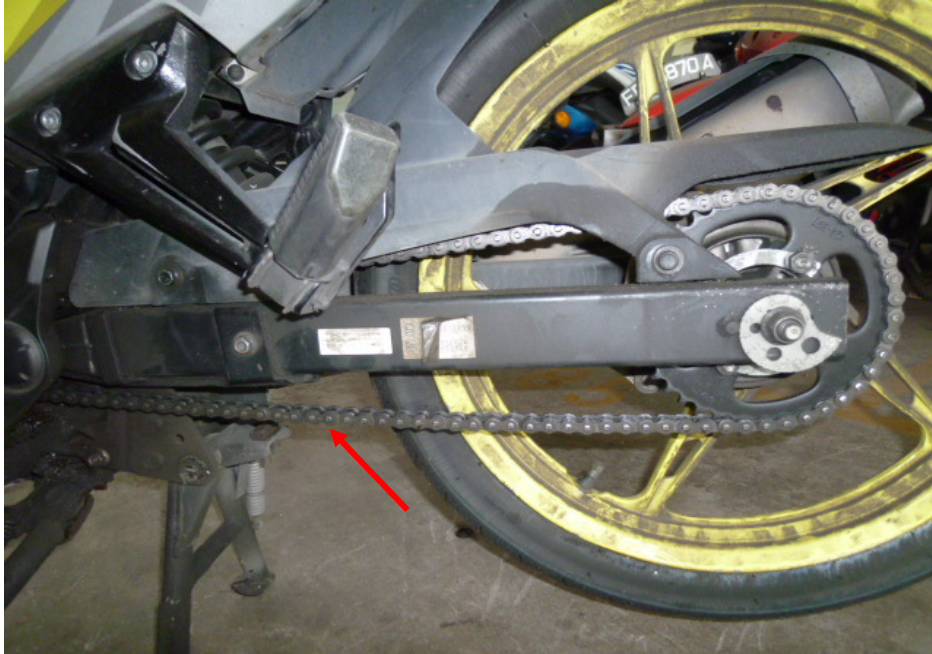
**Photo 17** shows the general view of the gear train (arrowed) of the Motorcycle, which was observed to be intact with no misalignment. It was also adequately lubricated for operating purposes.

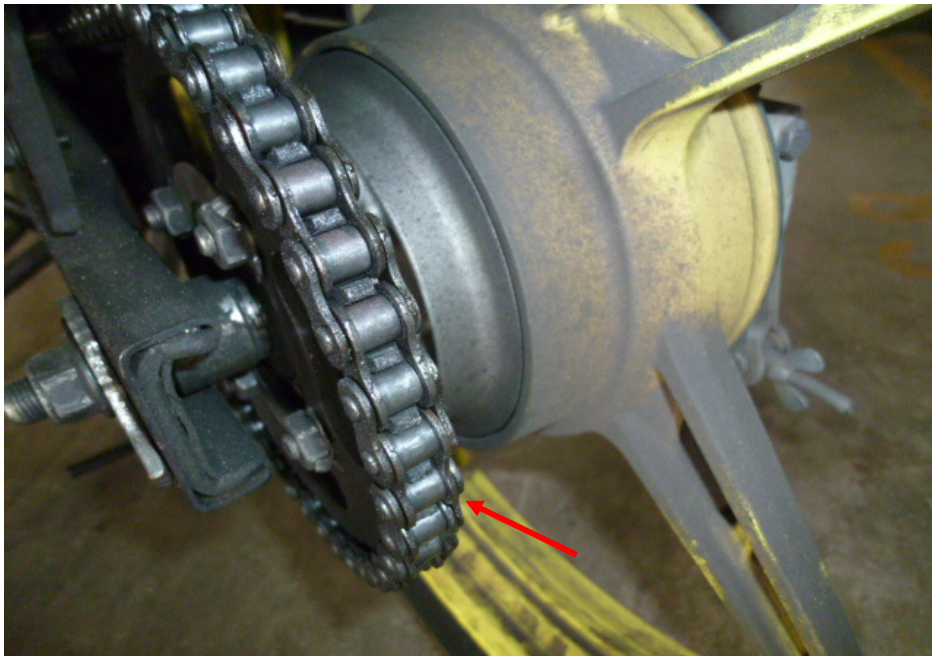
**Photo 18** shows a closer view of the gear train (arrowed) of the Motorcycle, which was observed to be intact with no misalignment. It was also adequately lubricated for operating purposes.

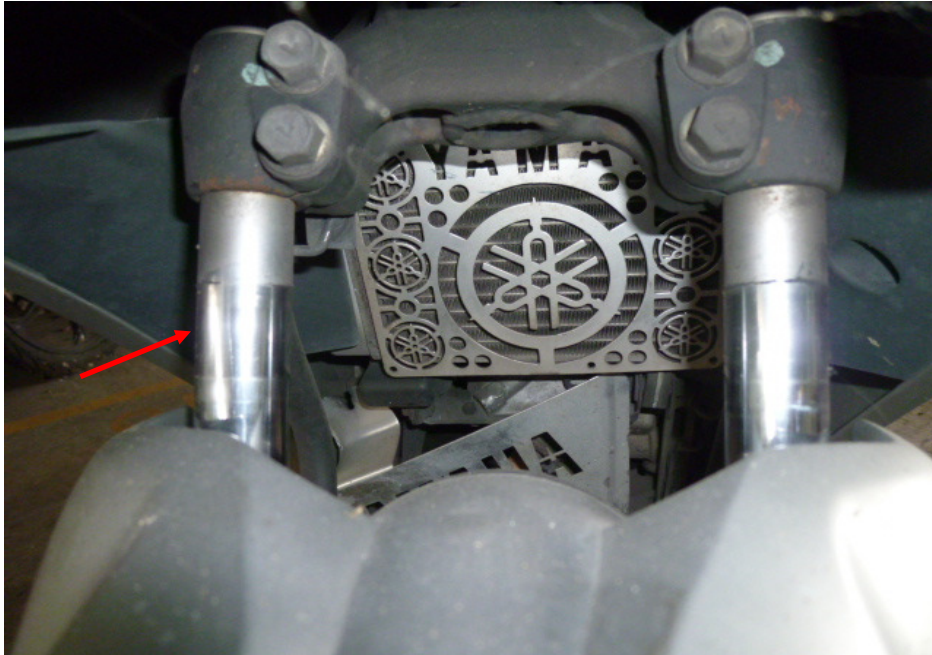
11. For this case, we were not able to conduct any test(s) on the steering system of the Motorcycle due to the damage of its front fork assembly. The front right fork was found to be slightly bent as a result of the accident.

**Photo 19** shows the front fork assembly of the Motorcycle. The front right fork was observed to be slightly bent (arrowed) as a result of the accident. We were hence not able to conduct any tests on the steering system of the Motorcycle.

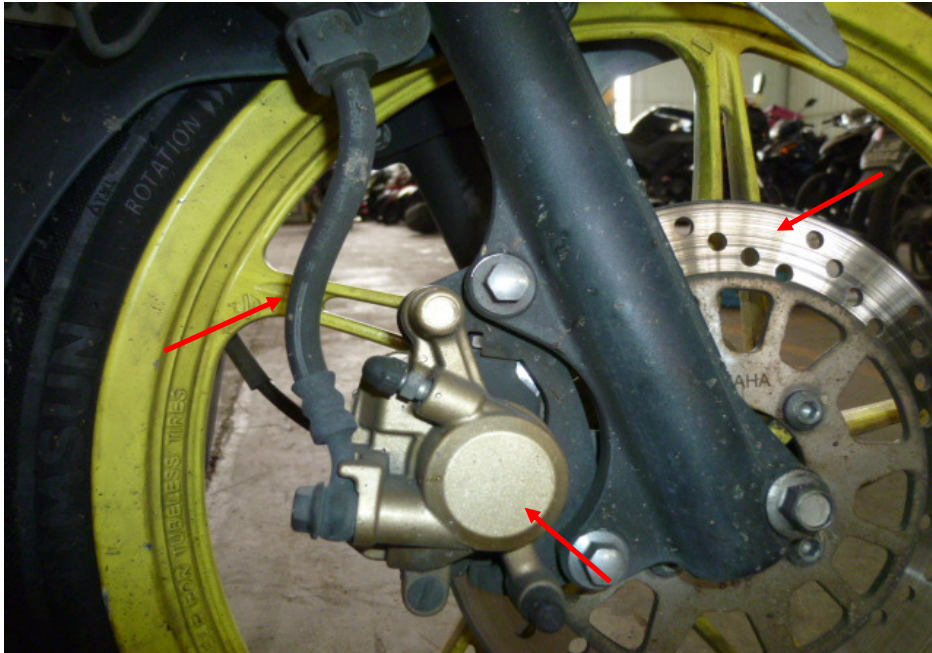
**Photo 20** shows a close up view of the front brake caliper, front brake disc and front brake hose (arrowed) of the Motorcycle, which are all part of the components in the hydraulic front brake system of the Motorcycle. Our visual checks of these various components had revealed all to be intact with no visible damage. No leakage of brake fluid was also observed.

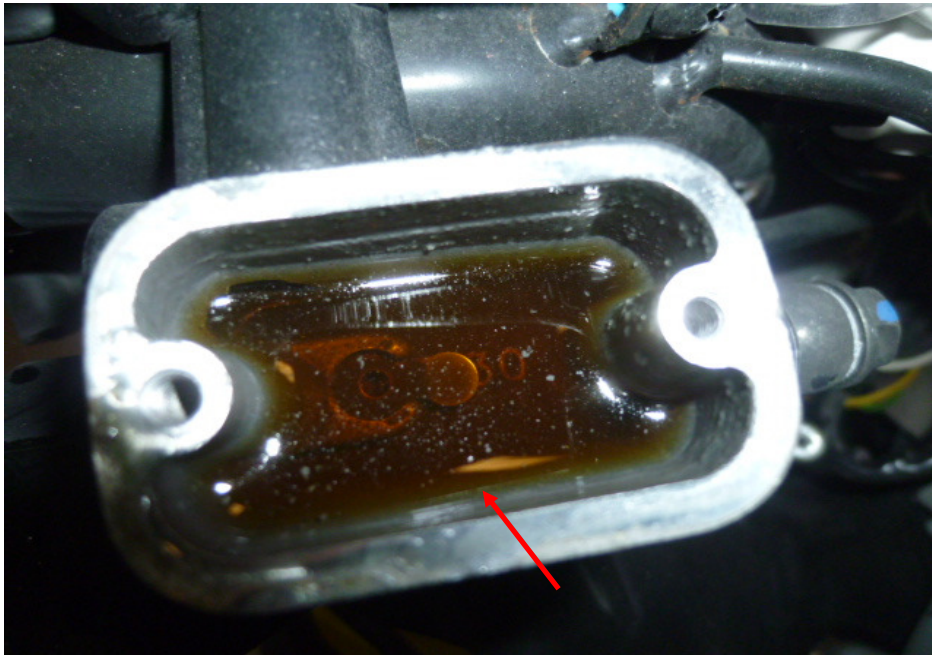
**Photo 21** shows the brake fluid reservoir for the front brake of the Motorcycle. The brake fluid was found to be of sufficient level for operating purposes. However the brake fluid was found to be slightly contaminated (arrowed).

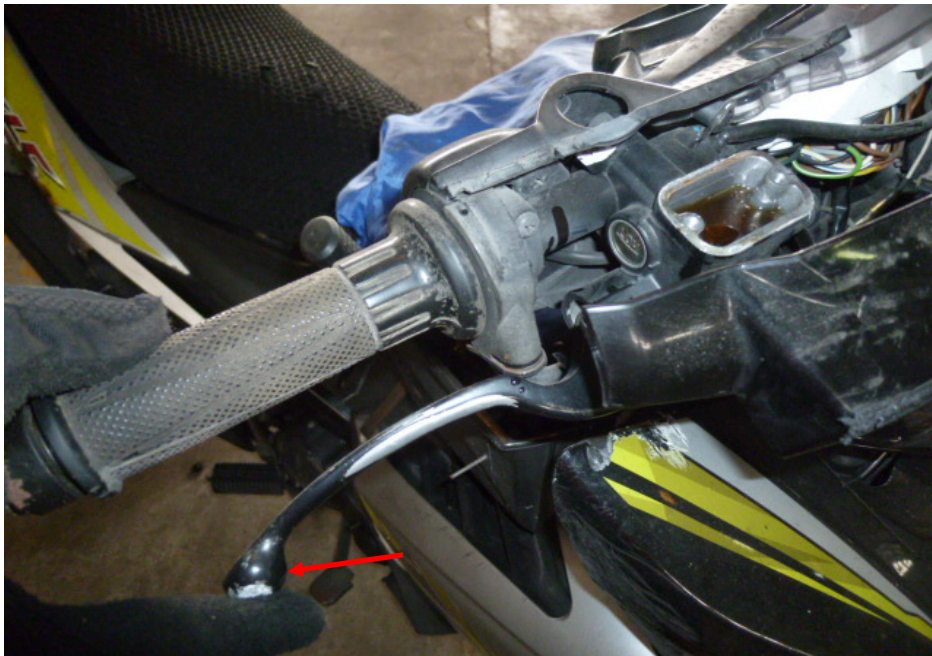
13. Static brake tests conducted on the Motorcycle had appeared to indicate that the front brake system of the Motorcycle was in serviceable condition. There was some resistance felt (spongy like feel) upon pressing the front brake lever. This would indicate that there's no leakage of pressure/vacuum in the front brake system.

**Photo 22** shows the front brake lever being depressed. There was some resistance felt (spongy like feel) upon pressing the front brake lever (arrowed). This would indicate that there is no leakage of pressure/vacuum in the brake system.

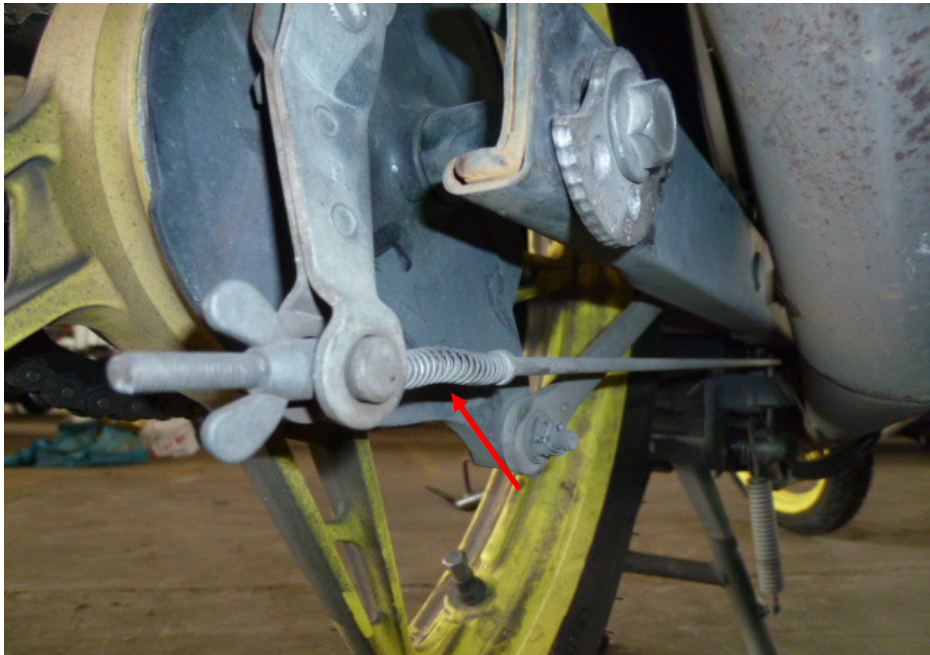
**Photo 23** shows the rear wheel of the Motorcycle. The type of brake system for the rear wheel was of a mechanical type, controlled by the brake foot pedal of the Motorcycle. Our checks of the cable (arrowed), spring and drum which are all part of the components in the rear brake system of the Motorcycle reveal all to be intact and without damage.
