Your Ref: TP/IP/36157/2021
Our Ref : CI/TPD21011763/N

Fatal Accident Investigation Team

Traffic Police Department
Singapore Police Force
10 Ubi Avenue 3
Singapore 408865

INSPECTION REPORT OF MOTORCYCLE FBJ 3675G

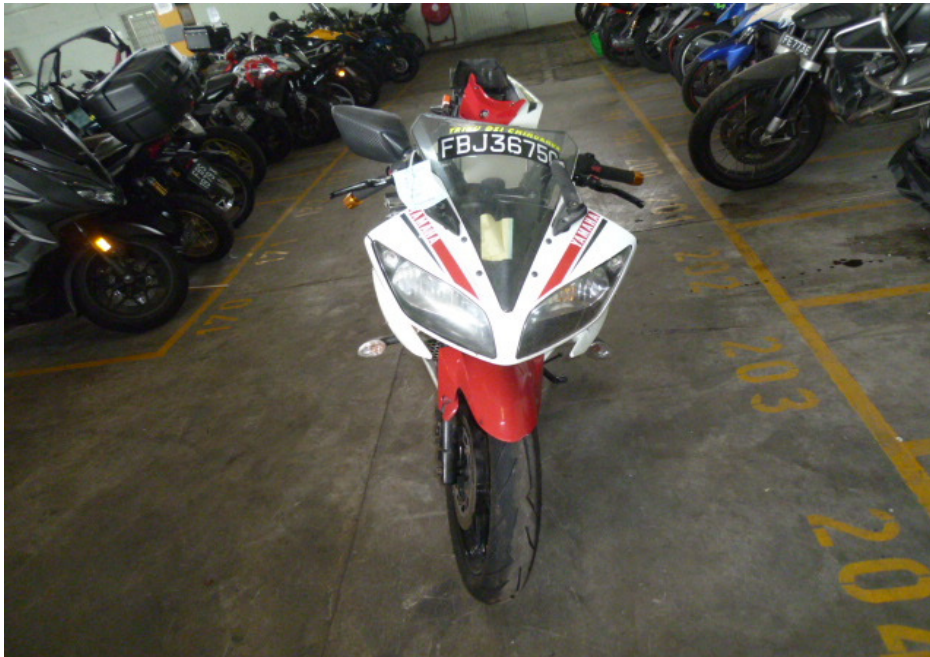
Photo 1 shows a general view of the frontal portion of the Motorcycle at the time of our inspection. The Motorcycle was observed to have sustained damages all around. The mileage of the Motorcycle could not be recorded at the time of our inspection due to the ignition key not being made available to us.

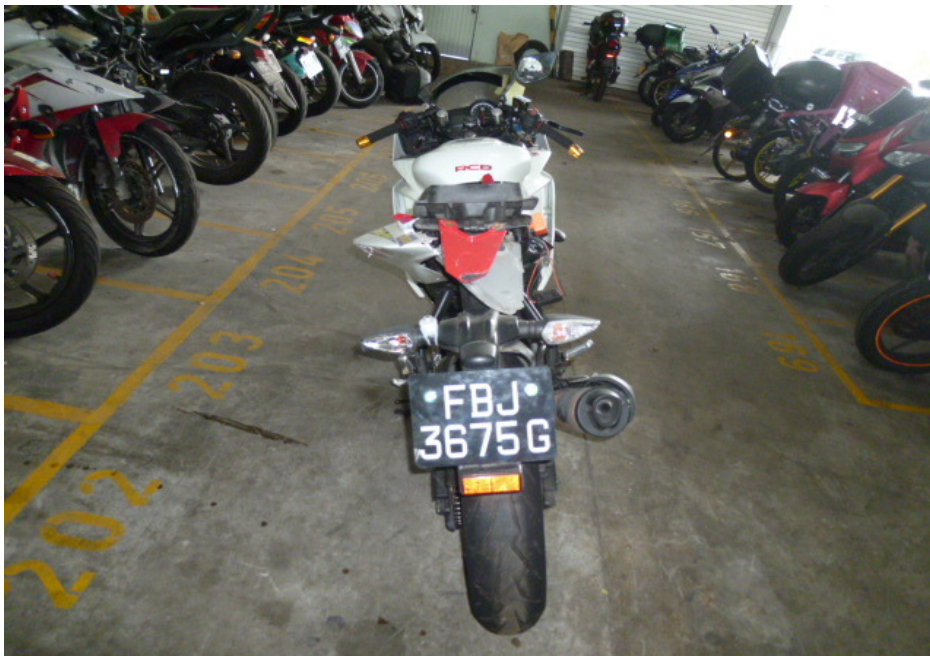
Photo 2 shows a general view of the rear portion of the Motorcycle at the time of our inspection. The Motorcycle was observed to have sustained damages all around.

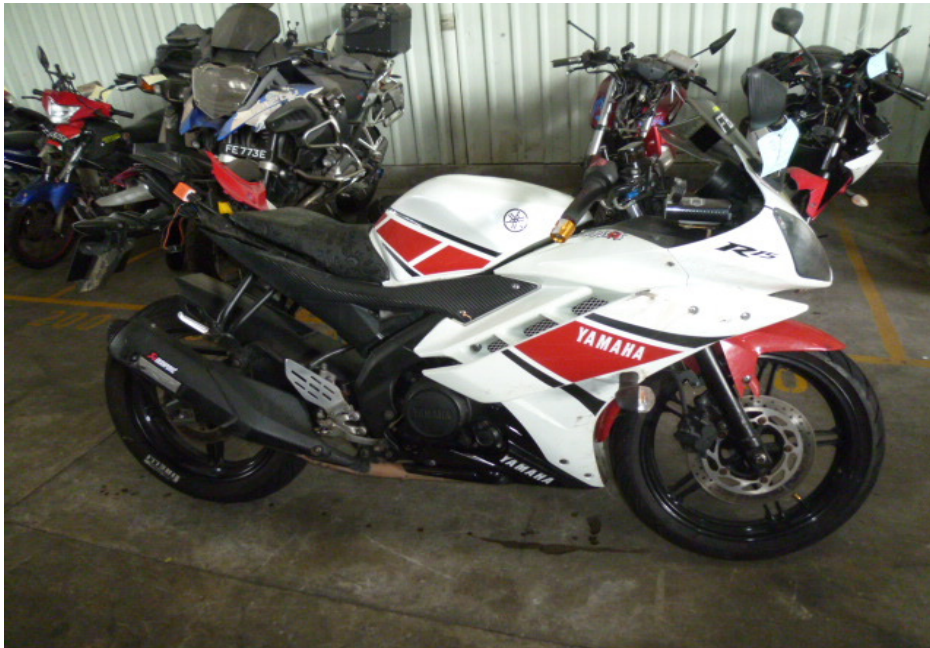
Photo 3 shows a general view of the right body of the Motorcycle at the time of our inspection. The Motorcycle was observed to have sustained damages all around.

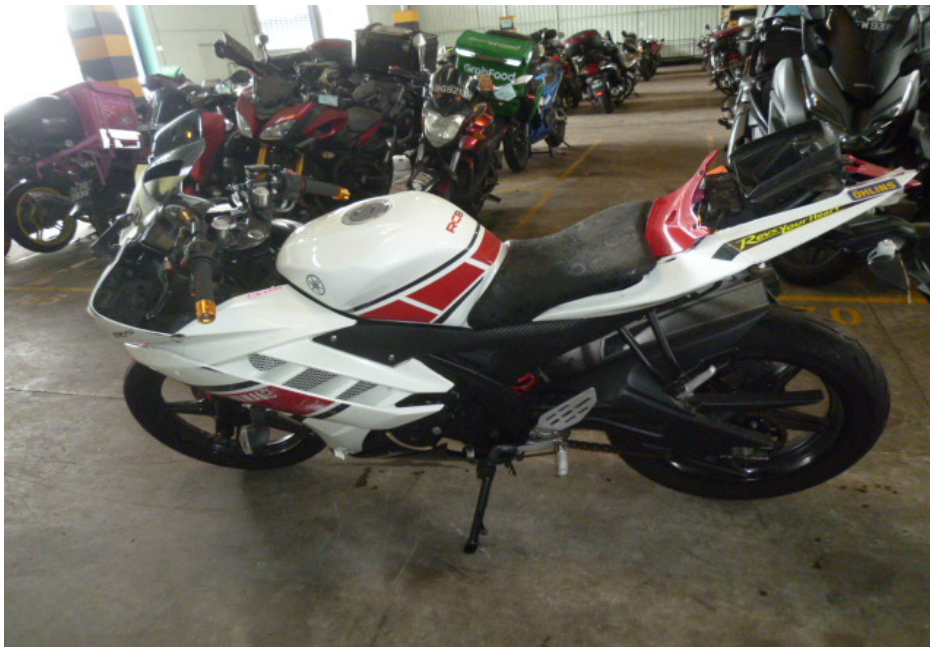
Photo 4 shows a general view of the left body of the Motorcycle at the time of our inspection. The Motorcycle was observed to have sustained damages all around. Amongst the body parts that were found to have been damaged include its head cowlings, front mudguard, side cowlings, right handlebar end, front brake lever, rear brake pedal, right front footrest, rear side covers, tail light assembly, left front footrest, gear shift pedal and exhaust muffler heat shield, amongst others.

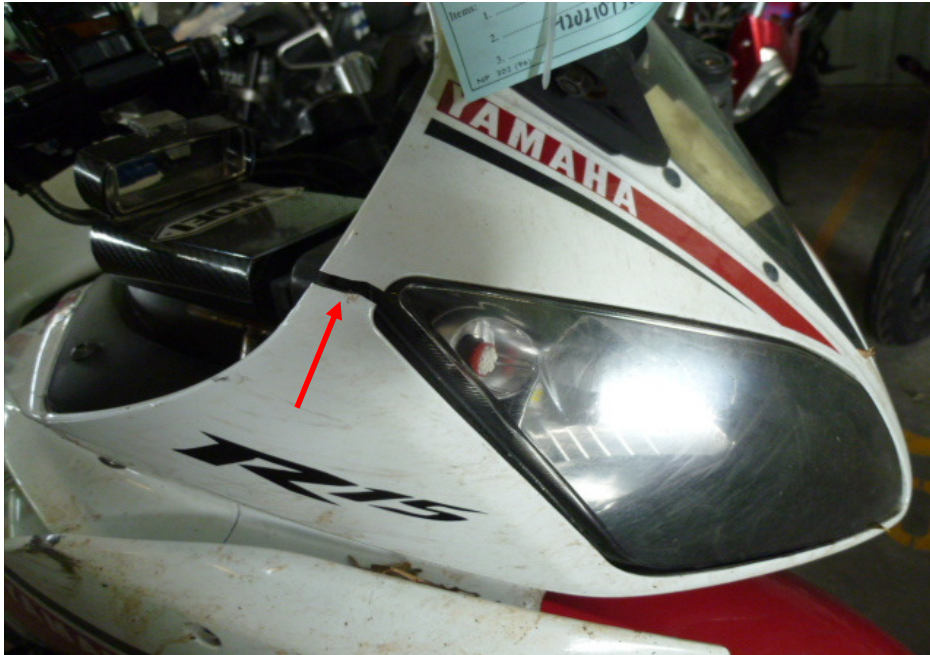
Photo 5 shows a closer view of the cracked head cowl which was amongst the body parts at the front body of the Motorcycle that had sustained damage as a result of the accident (arrowed).

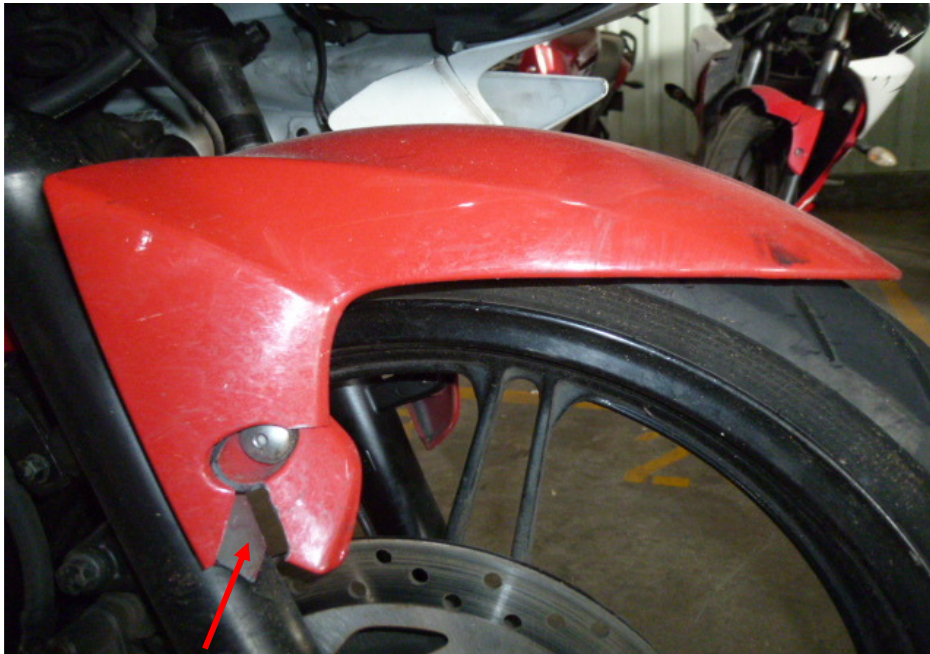
Photo 6 shows a close up view of the front mudguard which was amongst the body parts of the Motorcycle that had sustained damage as a result of the accident (arrowed).

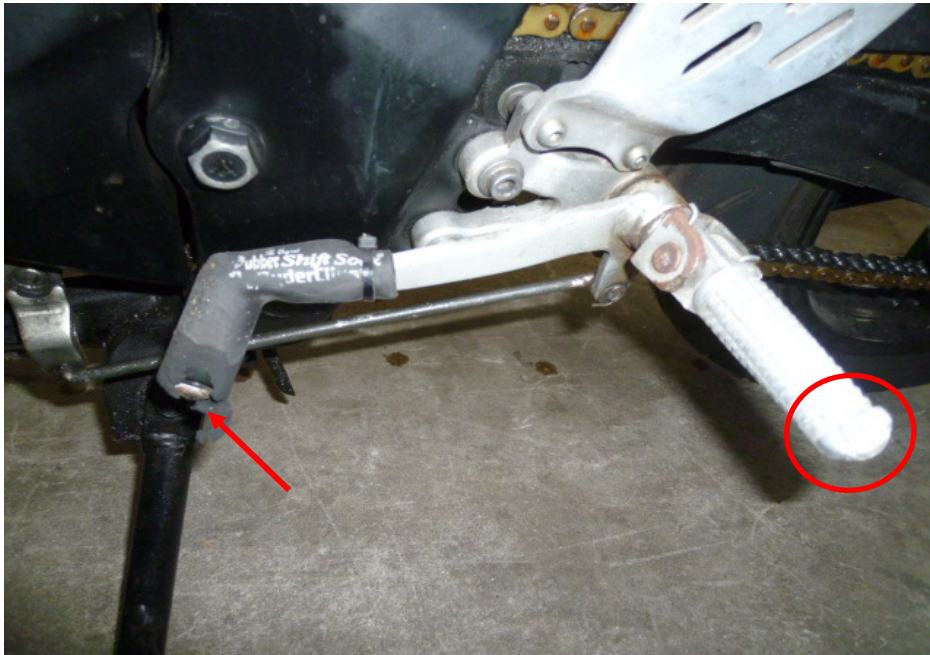
Photo 7 shows a closer view of the bent gear shift pedal (arrowed) and grazed left front footrest (circled) which were amongst the body parts of the Motorcycle that had sustained damage as a result of the accident.

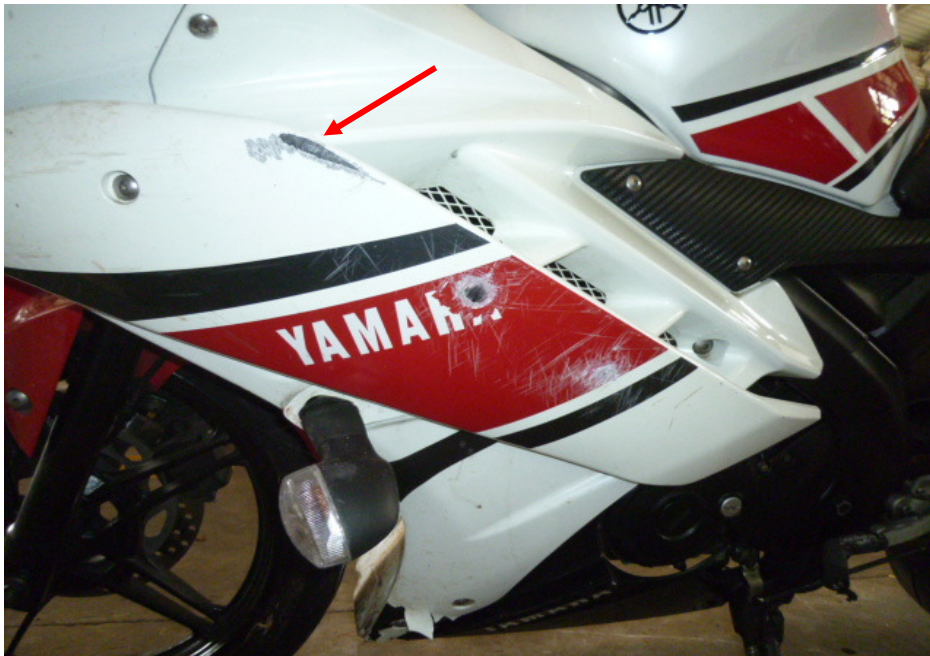
Photo 8 shows a closer view of the grazed left cowling of the Motorcycle as a result of the accident (arrowed).

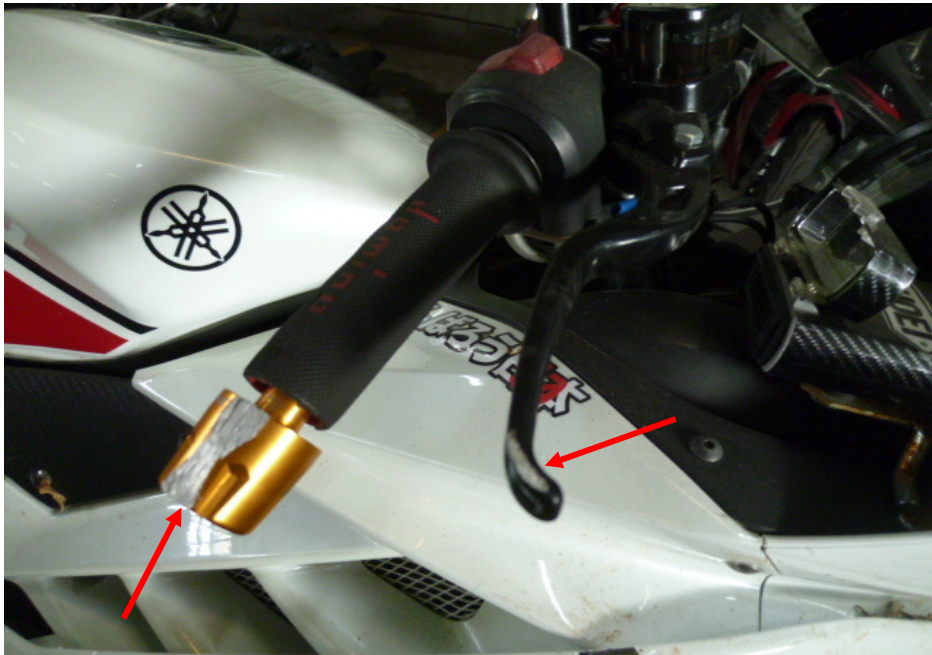
Photo 9 shows a closer view of the right handlebar end (arrowed) which were amongst the body parts of the Motorcycle that had sustained damage as a result of the accident.

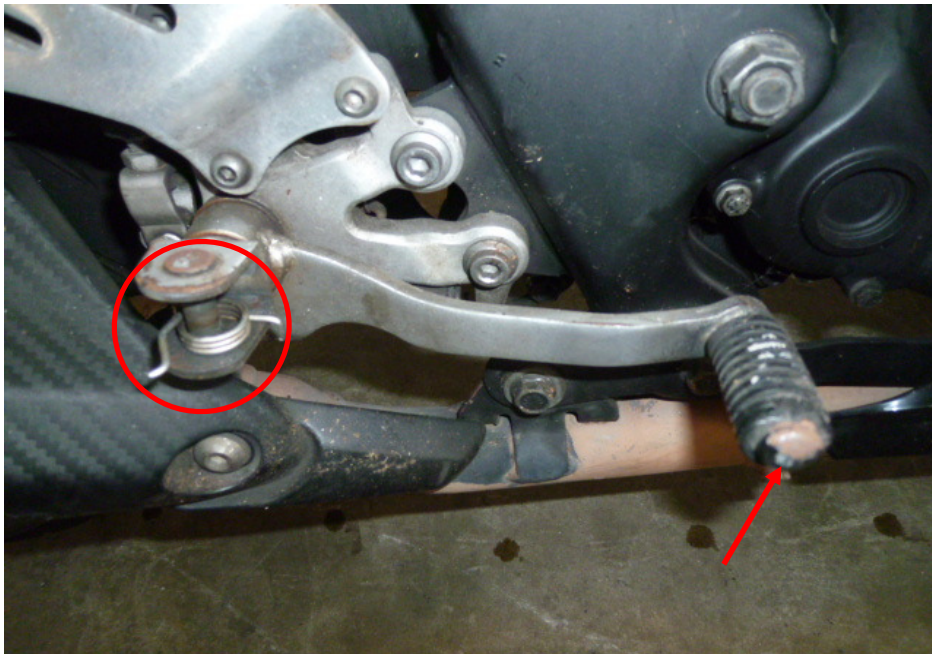
Photo 10 shows a closer view of the grazed rear brake pedal (arrowed) and missing right front footrest (circled) which were amongst the body parts of the Motorcycle that had sustained damage as a result of the accident.

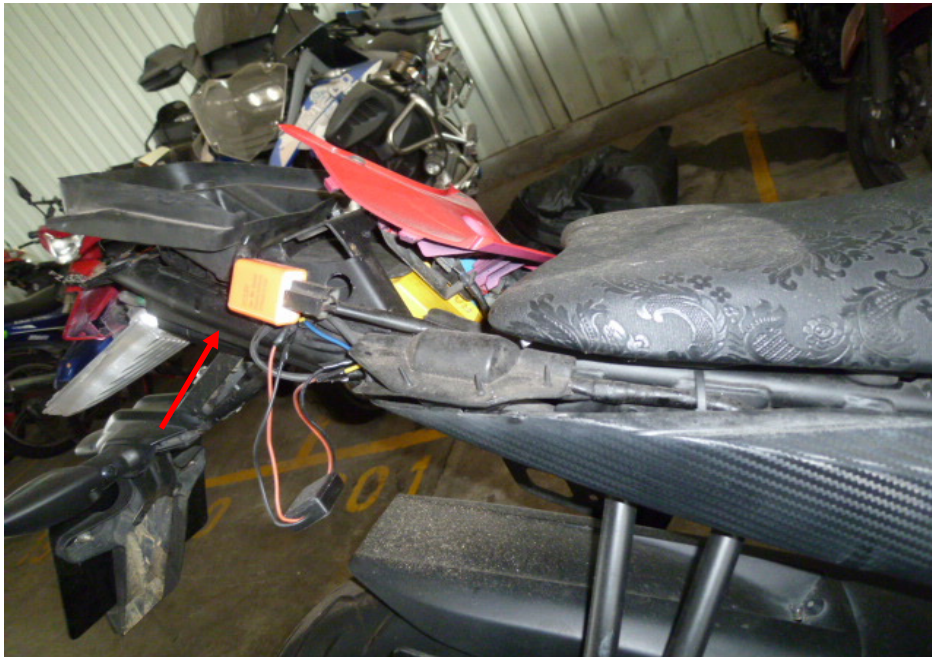
Photo 11 shows the missing right rear side cover of the Motorcycle which was amongst the body parts of the Motorcycle as a result of the accident (arrowed).

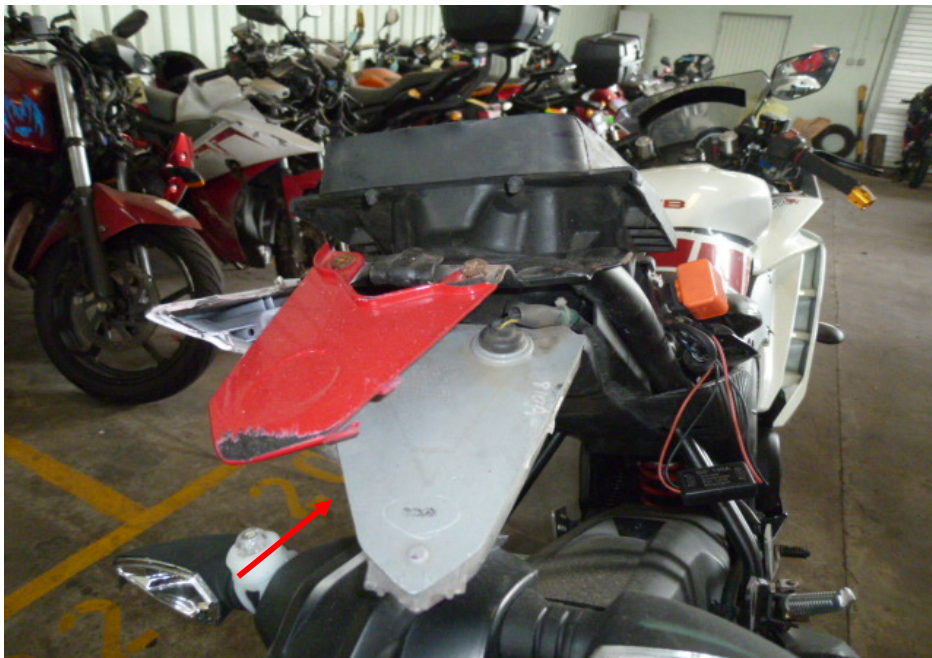
Photo 12 shows a closer view of the broken tail light assembly which was amongst the body parts of the Motorcycle that had sustained damage as a result of the accident (arrowed).

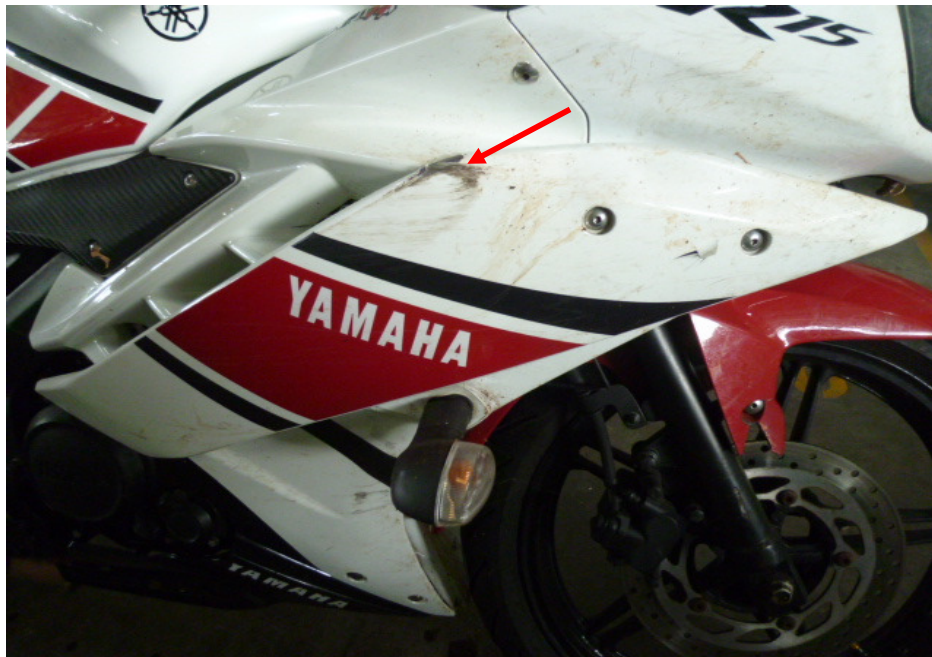
Photo 13 shows a closer view of the grazed right cowling of the Motorcycle as a result of the accident (arrowed).

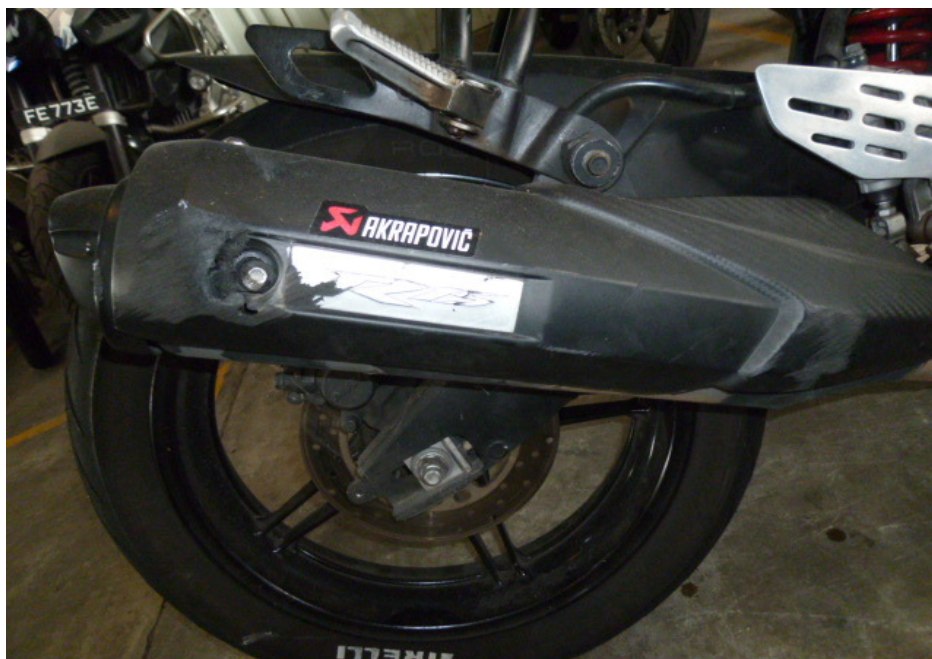
Photo 14 shows a closer view of the exhaust muffler heat shield of the Motorcycle that had sustained damages of grazing nature as a result of the accident.

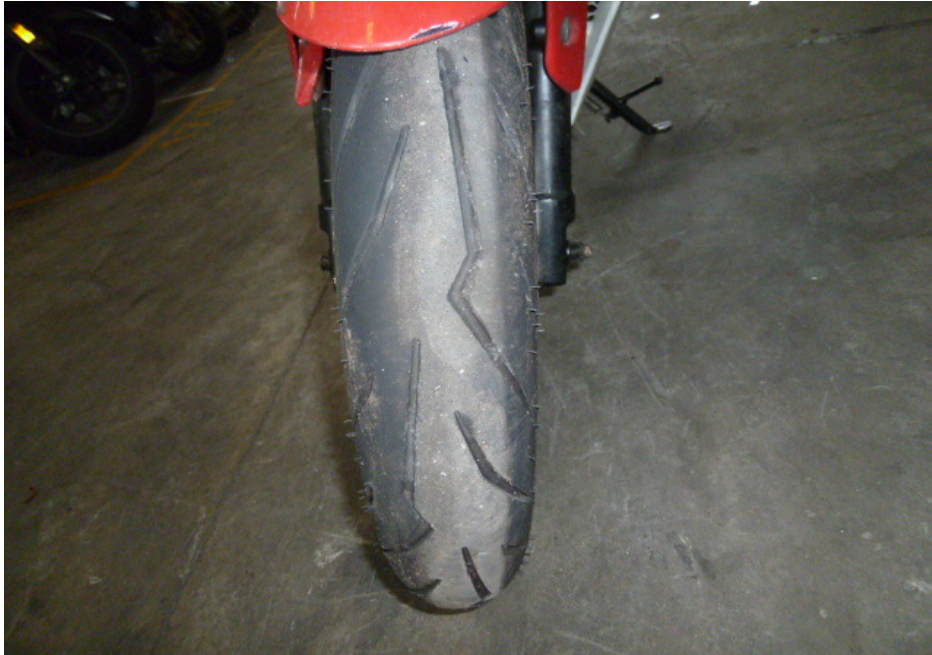
Photo 15 shows the condition of the Motorcycle's front tyre. The front tyre was observed to be in serviceable condition with remaining tread depth of approximately 5mm. There was no tear, burst mark(s) and/or punctured hole(s) on the sidewalls as well as across the tread of the front tyre.

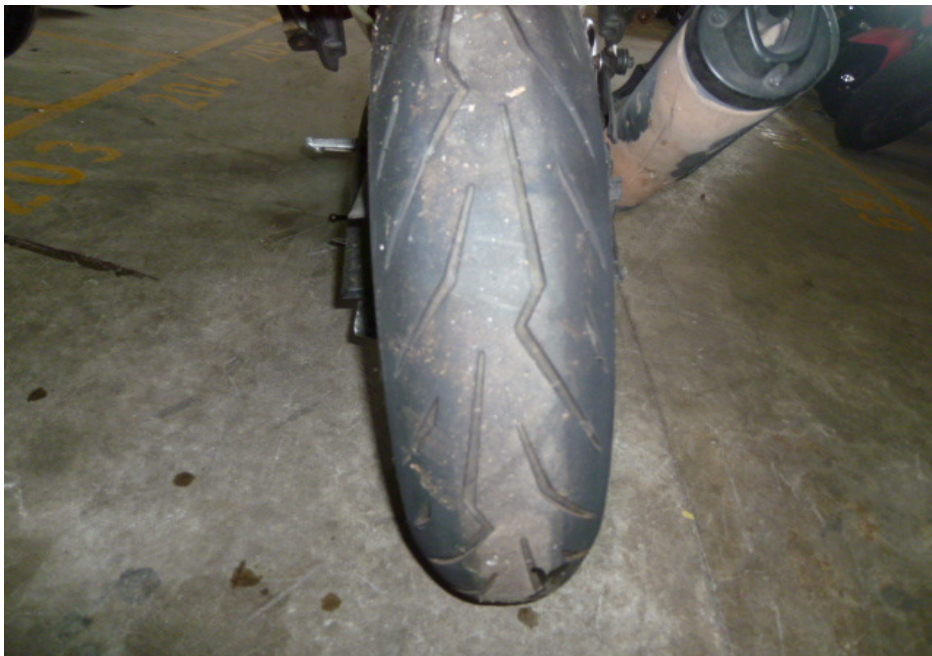
Photo 16 shows the condition of the Motorcycle's rear tyre. The rear tyre was observed to be in serviceable condition with remaining tread depth of approximately 4mm. The tyre was also observed to be sufficiently inflated for vehicular operation. We did not observe any tear, burst mark(s) and/or punctured hole(s) on the sidewalls as well as across the tread of the rear tyre.

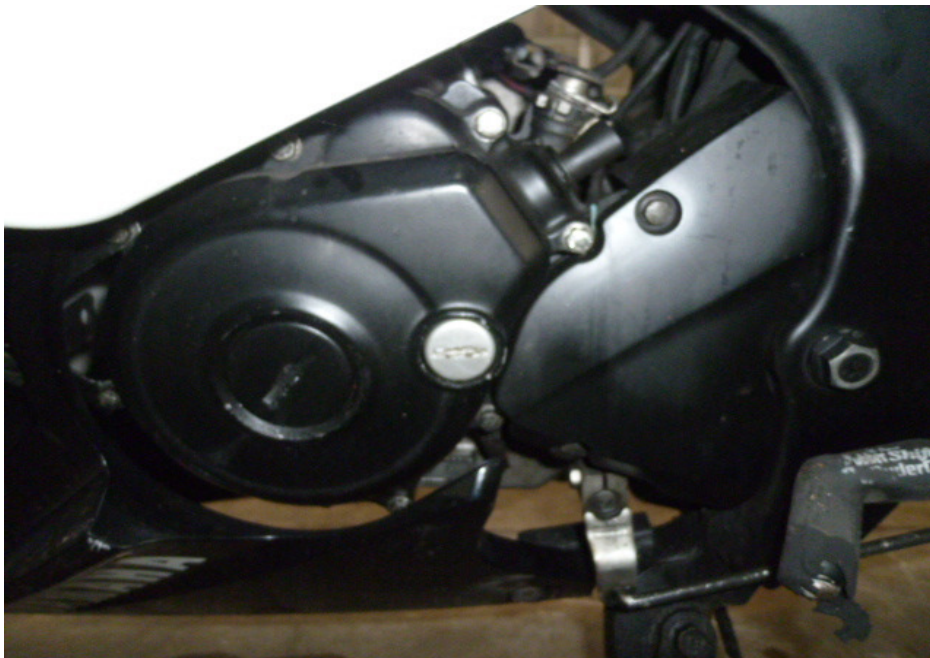
Photo 17 shows the left side of the engine of the Motorcycle at the time of our inspection. The various engine related parts and components were found to be intact with no visible damage. There was also no sign(s) or indication(s) of fluid leak observed around the left engine area of the Motorcycle.

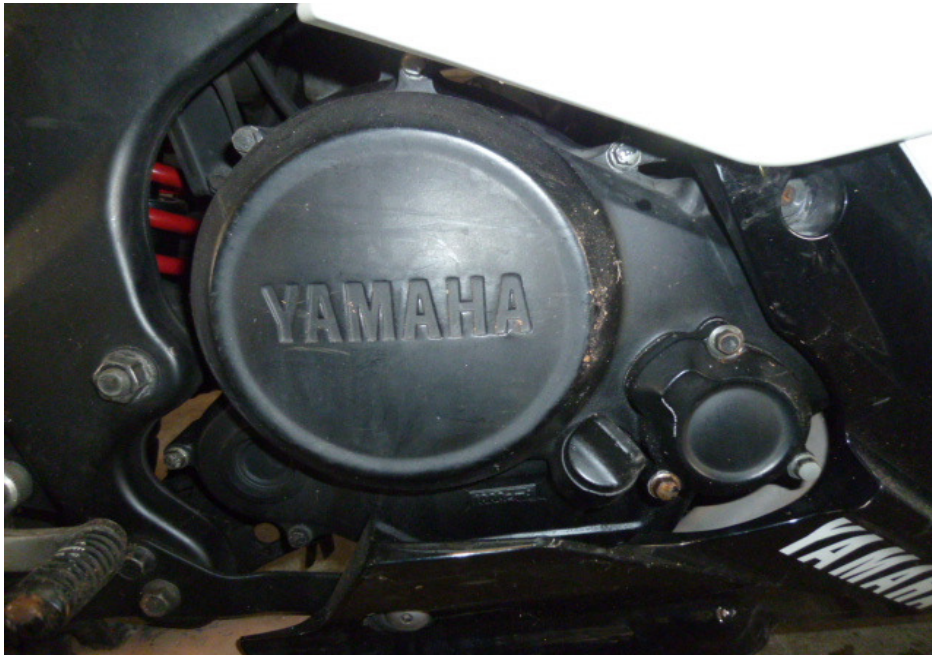
Photo 18 shows the right side of the engine of the Motorcycle at the time of our inspection. The various engine related parts and components were found to be intact with no visible damage. There was also no sign(s) or indication(s) of fluid leak observed around the right engine area of the Motorcycle.

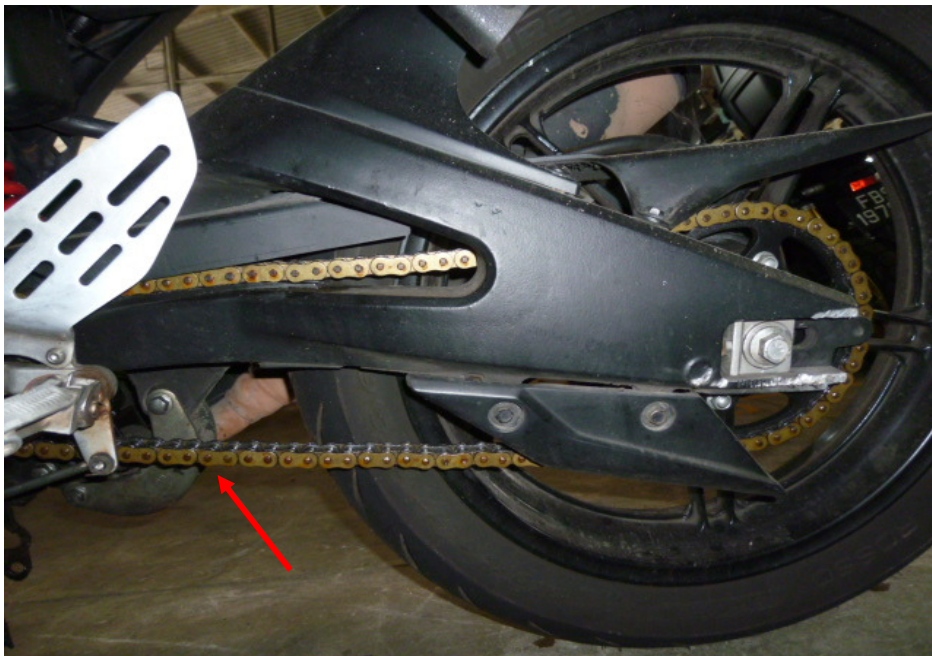
Photo 19 shows the general view of the gear train (arrowed) of the Motorcycle, which was observed to be intact with no misalignment. It was also adequately lubricated for operating purposes.

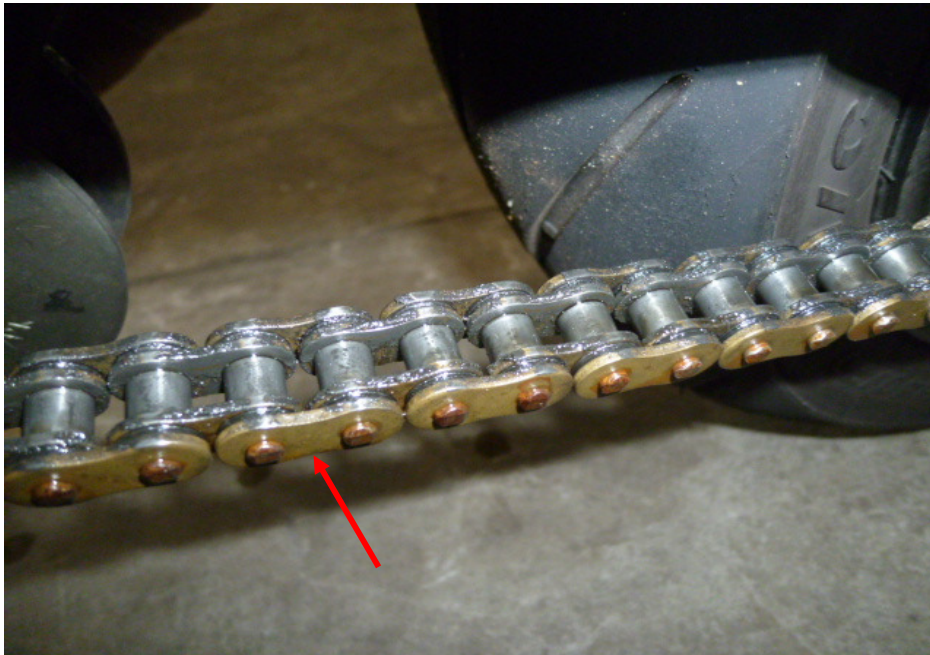
Photo 20 shows a closer view of the gear train (arrowed) of the Motorcycle, which was observed to be intact with no misalignment. It was also adequately lubricated for operating purposes.

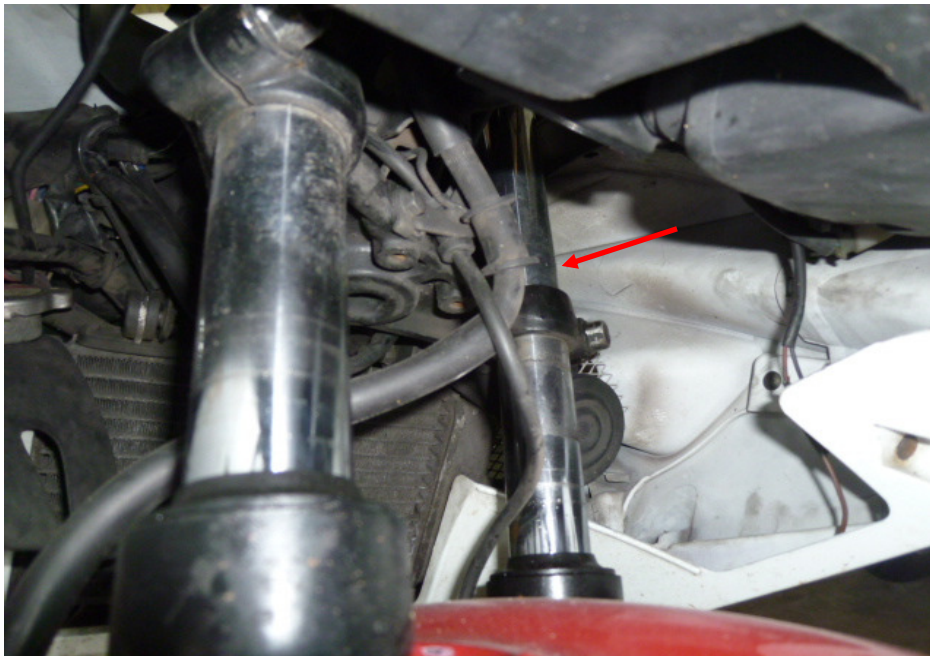
11. For this case, we were not able to conduct any test(s) on the steering system of the Motorcycle due to the damage of its front fork assembly. The front right fork was found to be slightly bent as a result of the accident.

Photo 21 shows the front fork assembly of the Motorcycle. The front left fork was observed to be slightly bent (arrowed) as a result of the accident. We were hence not able to conduct any tests on the steering system of the Motorcycle.

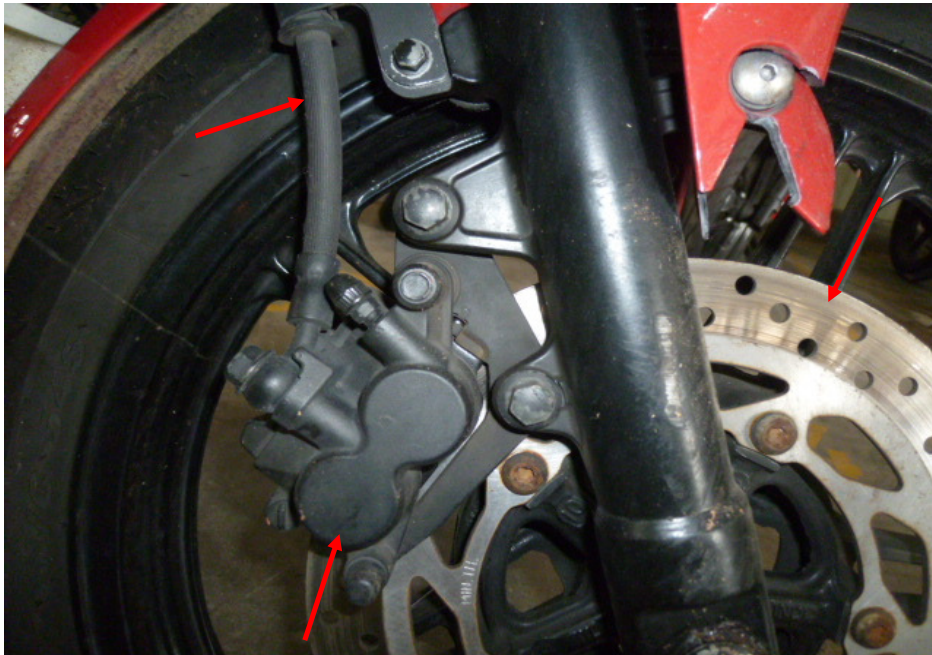
Photo 22 shows a close up view of the front brake caliper, front brake disc and front brake hose (arrowed) of the Motorcycle, which are all part of the components in the hydraulic front brake system of the Motorcycle. Our visual checks of these various components had revealed all to be intact with no visible damage. No leakage of brake fluid was also observed.

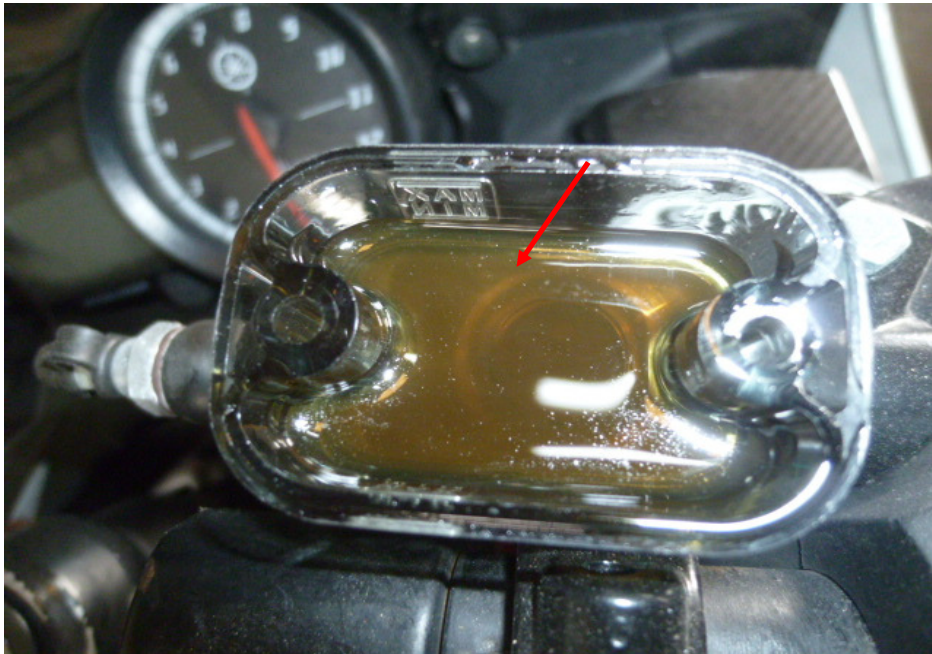
14. The brake fluid for the front brake was also found to be of sufficient level for operational purposes. However the brake fluid was found to be slightly contaminated.

Photo 23 shows the brake fluid reservoir for the front brake of the Motorcycle. The brake fluid was observed to be of sufficient level for operational purposes and without contamination. However the brake fluid was found to be slightly contaminated (arrowed).

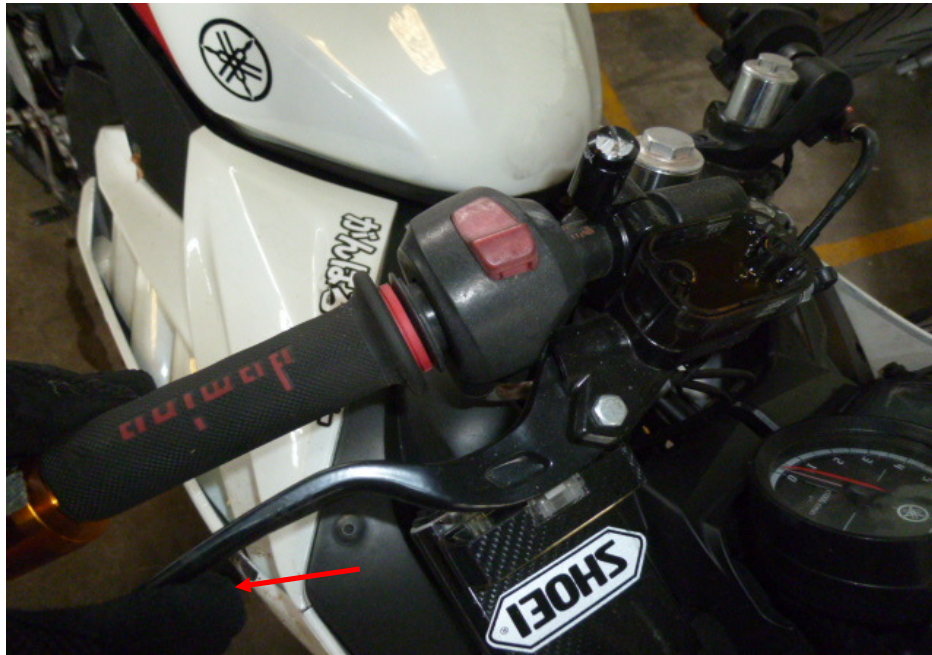
15. Static brake tests conducted on the Motorcycle had appear to indicate that the braking system of the Motorcycle was in serviceable condition. There was some resistance felt (spongy like feel) upon pressing the brake lever and upon stepping on the brake pedal. This would indicate that there was no leakage of pressure/vacuum in the brake system.

Photo 24 shows the front brake lever being depressed. There was some resistance felt (spongy like feel) upon pressing the front brake lever (arrowed). This would indicate that there is no leakage of pressure/vacuum in the brake system.

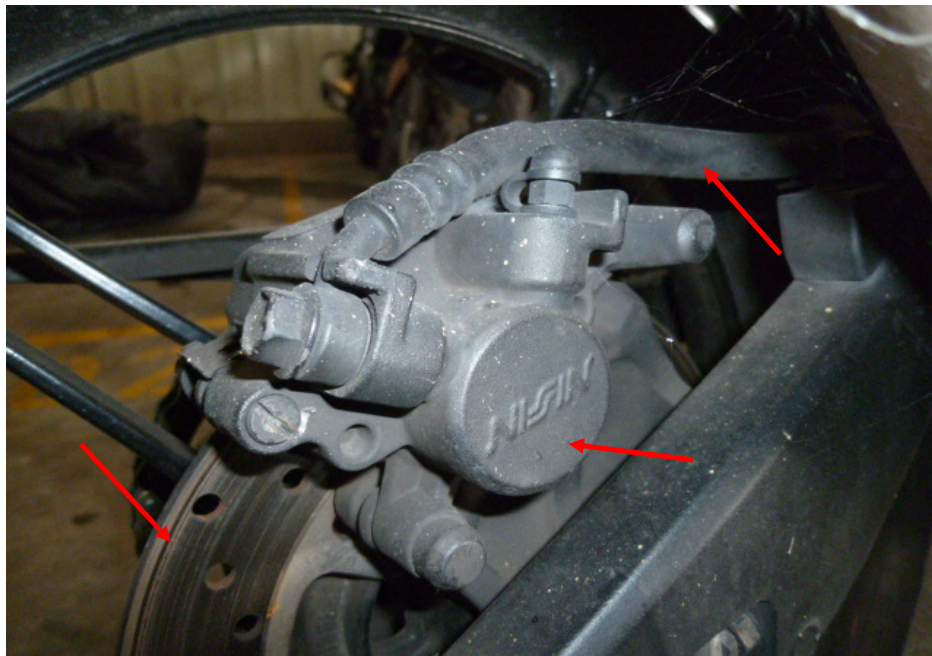
Photo 25 shows a close up view of the rear brake caliper, rear brake disc and rear brake hose (arrowed) of the Motorcycle, which are all part of the components in the hydraulic rear brake system of the Motorcycle. Our visual checks of these various components had revealed all to be intact with no visible damage. No leakage of brake fluid was also observed.
