Your Ref: G0075148  
Our Ref : CI/AVI21011784/N

11 November 2021

**TECHNICAL INVESTIGATION REPORT OF FIRE INCIDENT INVOLVING THE INSURED VEHICLE SMK 310T ON 6 NOVEMBER 2021**

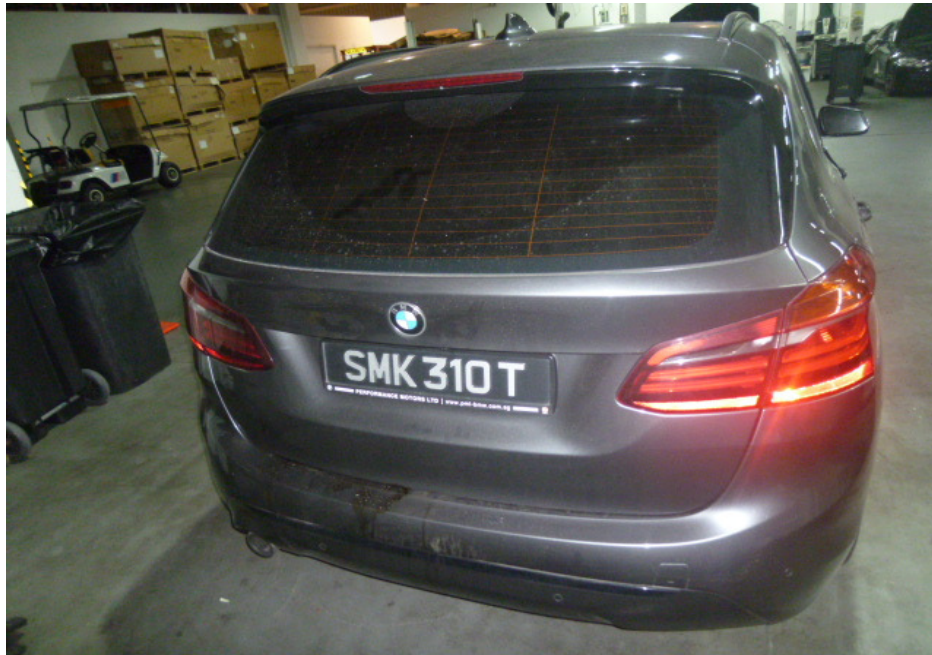
**Photo 1** shows the general view of the rear portion of the Insured Vehicle at the time of our inspection. The rear portion of the Insured Vehicle was relatively unaffected by the fire.

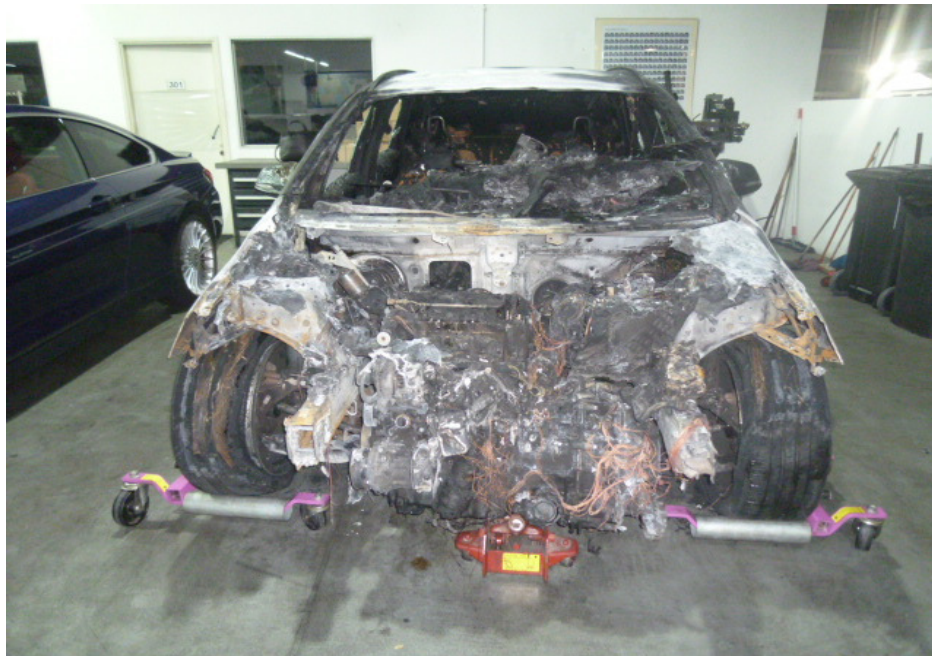
**Photo 2** shows the general view of the frontal portion of the Insured Vehicle at the time of our inspection. The fire damage to the Insured Vehicle was confined to its frontal portion. The entire engine compartment of the Insured Vehicle was observed to be severely burnt while the interior compartment was observed to be severely affected by the fire.

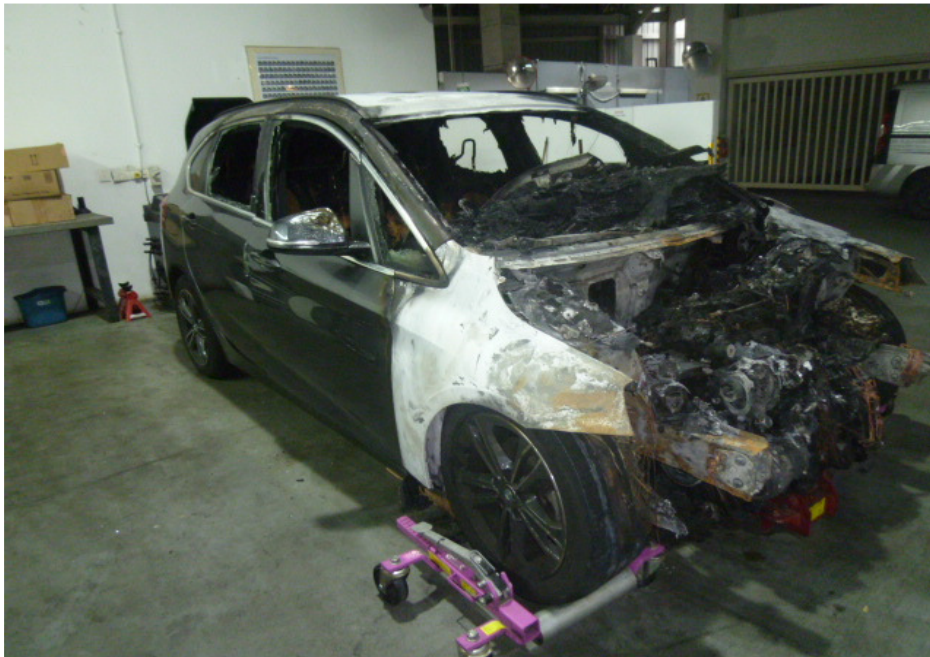
**Photo 3** shows the closer view of the right front body of the Insured Vehicle at the time of our inspection. The fire damage to the Insured Vehicle was confined to its frontal portion. Its front bumper, front bonnet, front support panel, front grille, front headlamps, front windscreen, front wheel rims, front fenders and front tyres, amongst others were amongst the body parts that were found to have been affected by the fire.

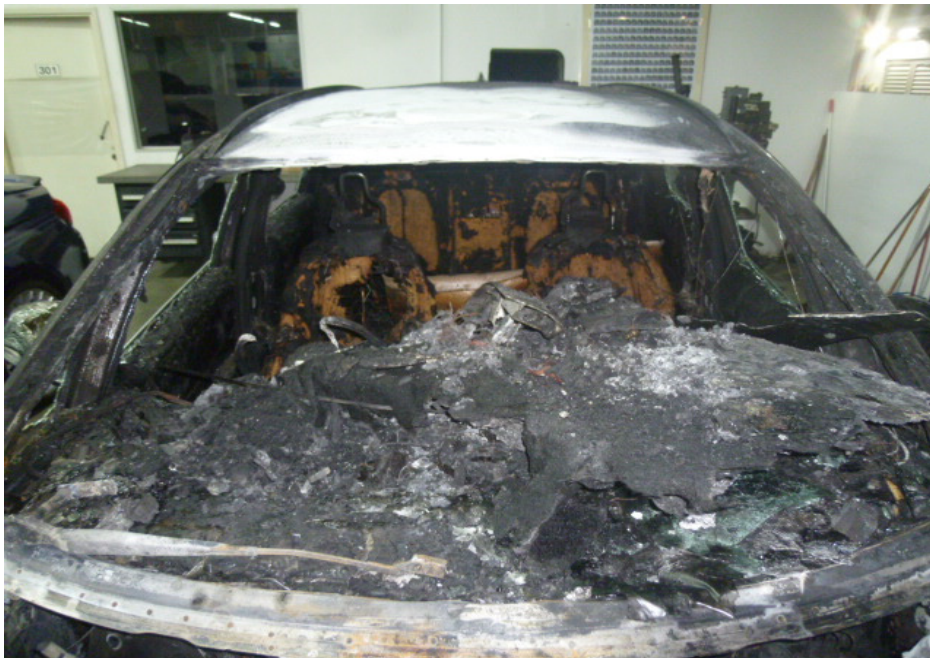
**Photo 4** shows the general view of the front windscreen of the Insured Vehicle at the time of our inspection. The fire damage to the windscreen was extensive.

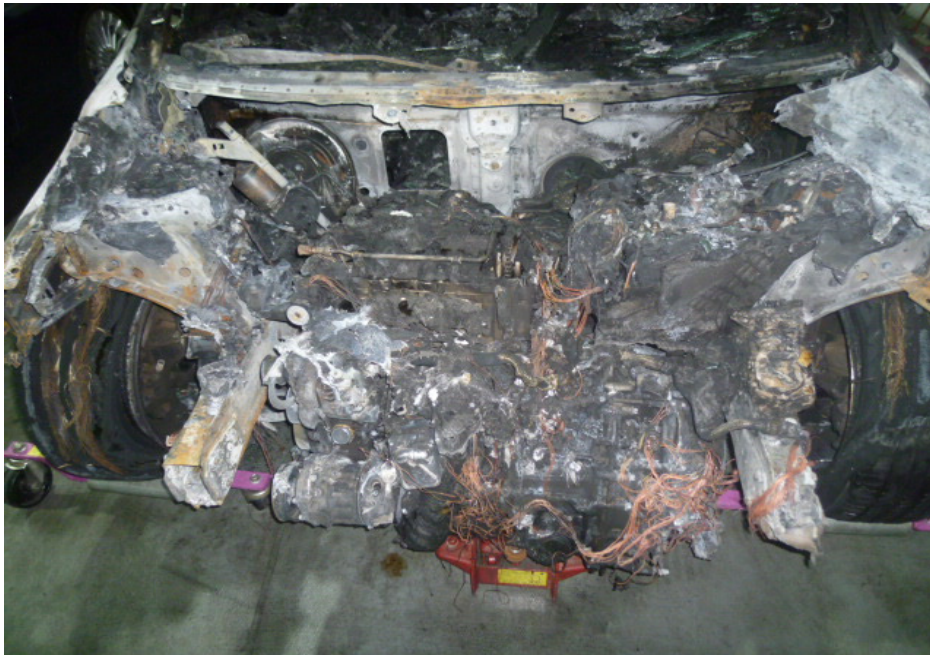
**Photo 5** shows the engine compartment of the Insured Vehicle at the time of our inspection. The entire engine compartment of the Insured Vehicle was observed to be severely burnt. Most of the parts inside the engine compartment were found to be burnt and/or melted as a result of the fire.

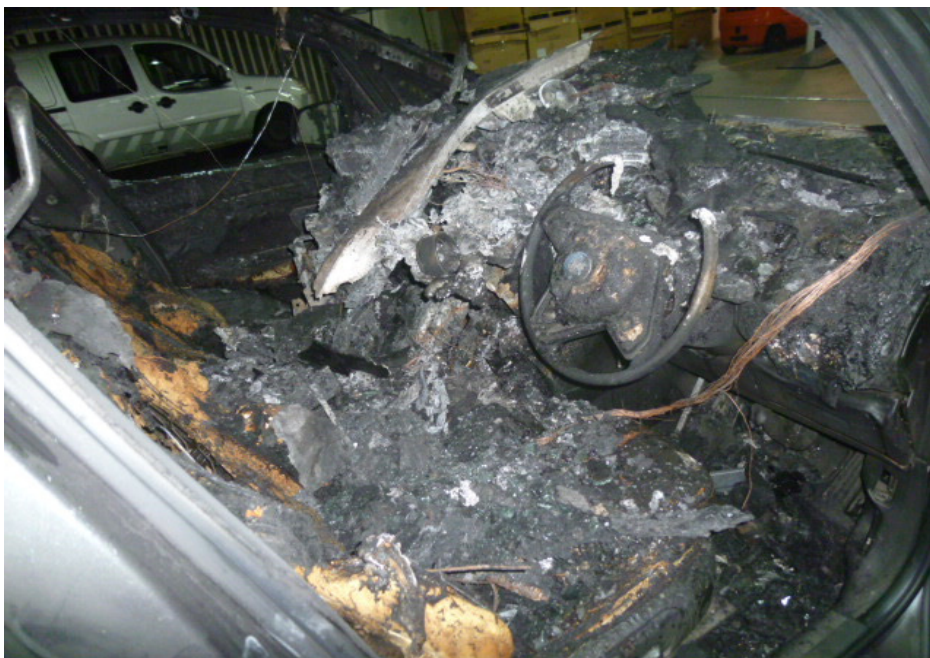
**Photo 6** shows the interior compartment of the Insured Vehicle, which was severely affected by the fire.

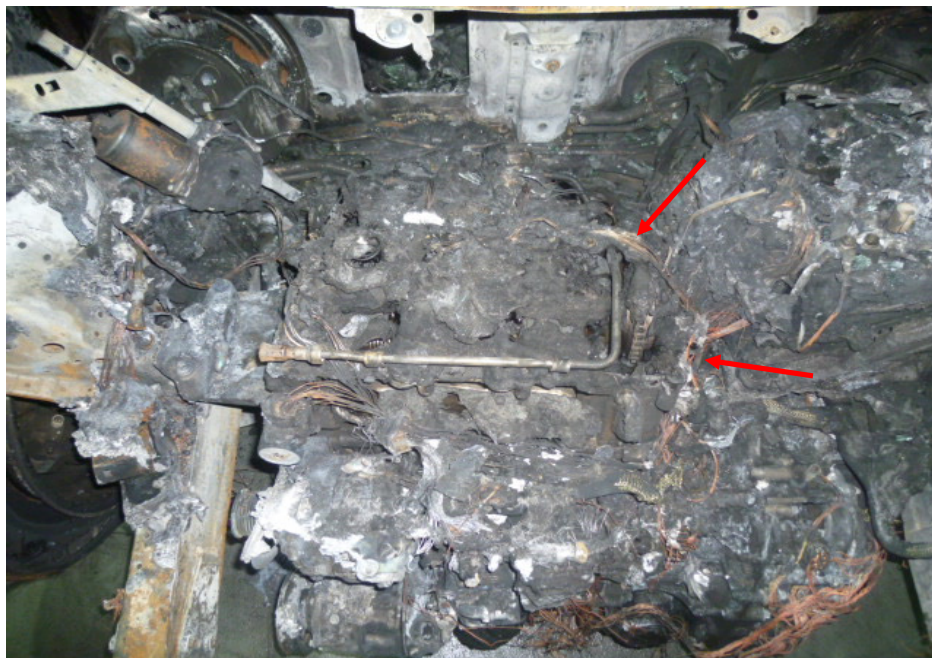
8. For this particular case, the fire appears to have originated within the engine compartment of the Insured Vehicle as this was the area where the damage of fire nature was most severe.
9. Upon closer examination of the engine compartment, which was where the fire to the Insured Vehicle had likely started, we had found several stretches of wiring burnt internally to its bare copper state. Such condition normally indicates internal heating of copper wires which is a sign of an electrical short circuit occurring. This would then appear to suggest that the cause of fire to the Insured Vehicle could have possibly been due to electrical in nature. See photos 7 - 9 below.

**Photo 7** shows the wirings around the engine compartment, which is in the immediate vicinity where the fire to the Insured Vehicle had likely started. The wirings (red arrows) were found to have been burnt internally to its bare copper state, suggesting occurrence of an electrical short circuit.

23. The possibility of the fire being due to electrical in nature would then seem more likely given that engine overheating and external factors would both seem unlikely. The fire being due to electrical nature is also supported by the condition of the wirings that were found in the engine compartment of the Insured Vehicle, which was earlier discussed in paragraph 9 above.

25. Having investigated and technically analysed the damages to the Insured Vehicle, we are of the view that the cause of fire to the Insured Vehicle was of electrical in nature. For this particular case, the fire had originated along the wirings inside the engine compartment. The wirings were original factory wirings of the Insured Vehicle.

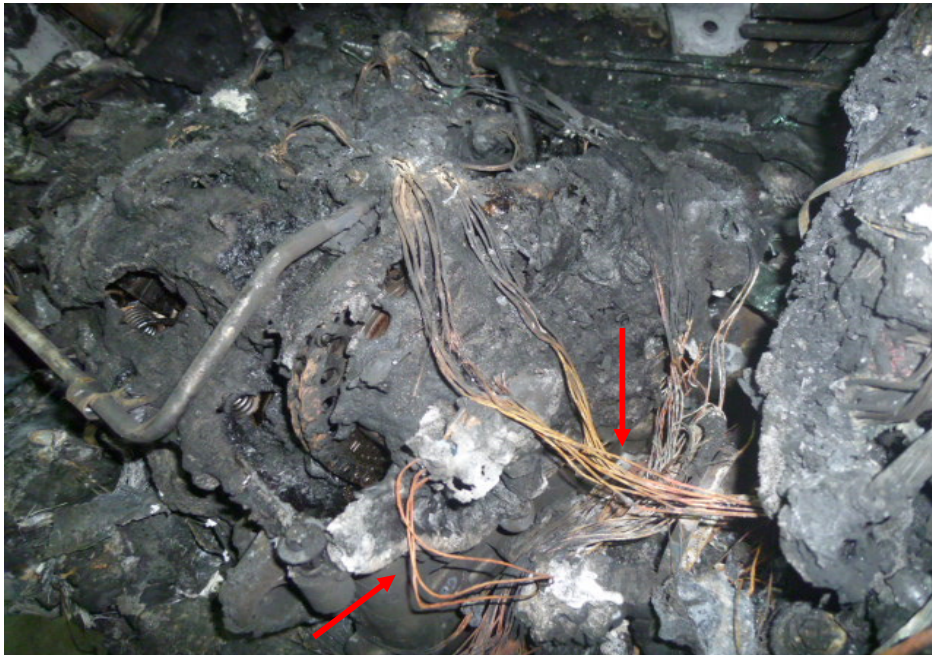
**Photo 8** shows a closer view of the wirings (red arrows) which were found to have been burnt internally to its bare copper state, suggesting occurrence of an electrical short circuit.

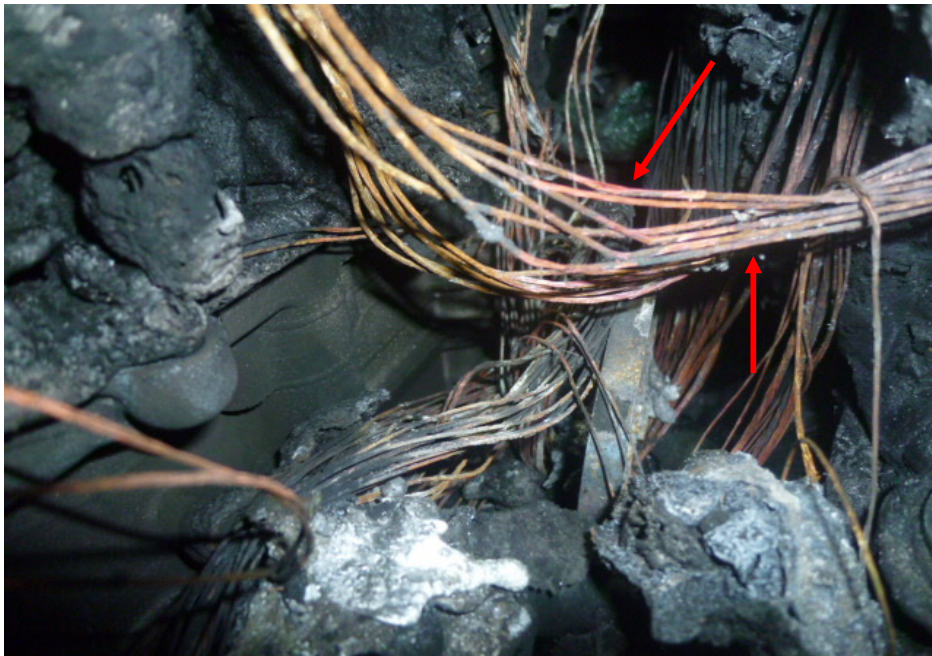
**Photo 9** shows a close up view of the wirings (red arrows) which were found to have been burnt internally to its bare copper state, suggesting occurrence of an electrical short circuit.

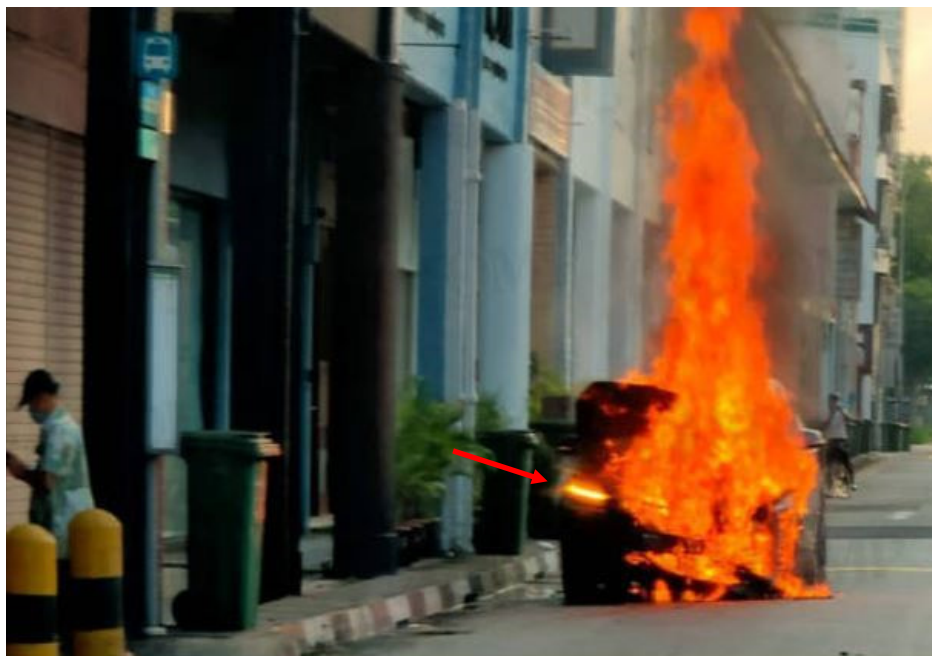
**Photo 10** shows the Insured Vehicle on fire before the arrival of the SCDF. In general, the information that could be gathered from this photograph had corresponded to the events that were related to us by Ms Goh and Mr Lee which is the fire had started from the engine compartment of the Insured Vehicle (arrowed).

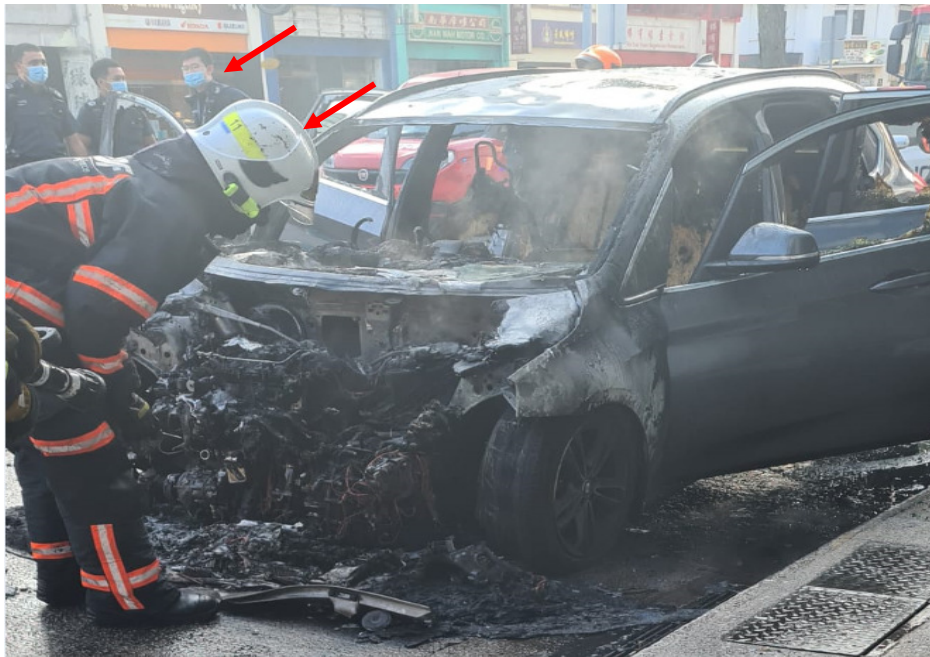
**Photo 11** shows the SCDF conducting preliminary investigations after putting out the fire on the Insured Vehicle. In general, the information that could be gathered from this photograph had corresponded to the events that were related to us by Ms Goh and Mr Lee which is the SCDF and police were present at the incident scene (arrowed).
