## LKK Auto Consultants Pte Ltd

Vehicle No. SHB 5561J  
Insured Veh. SJU 9400R  
Claim No. SNM21D206537/C02  
Policy No. DMPCSNW00197592000  
Accident Date 13/11/2021  
Inspection Date 16/11/2021

## ADJUSTMENT ON REPAIR COST FOR VEHICLE NO. SHB 5561J

### PHOTOGRAPHS FOR VEHICLE NO. SHB 5561J

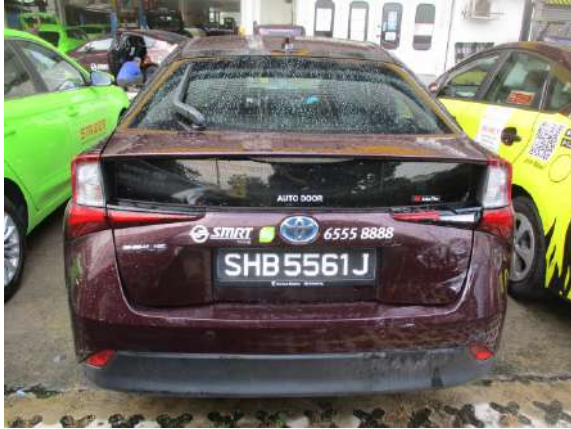
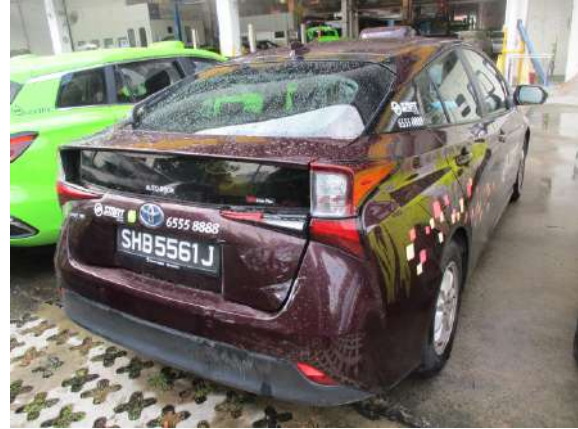
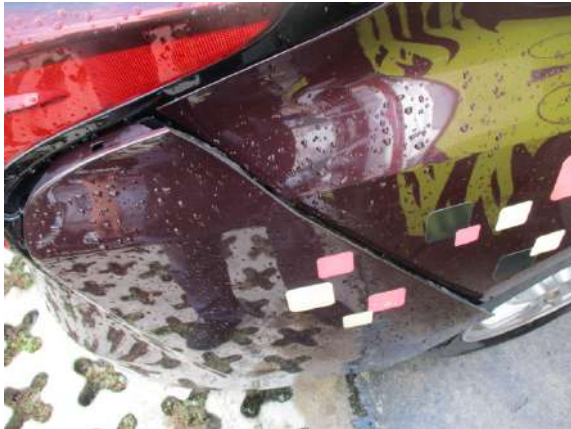
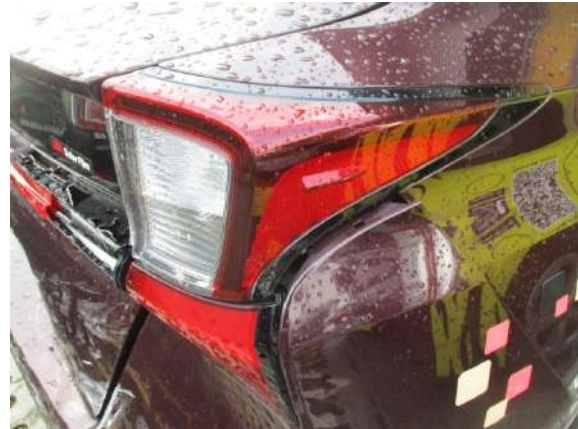
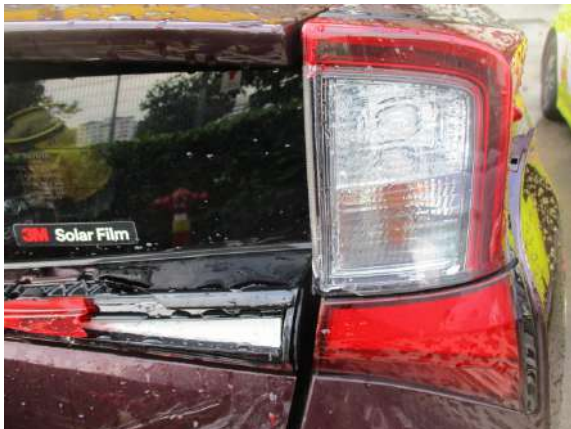
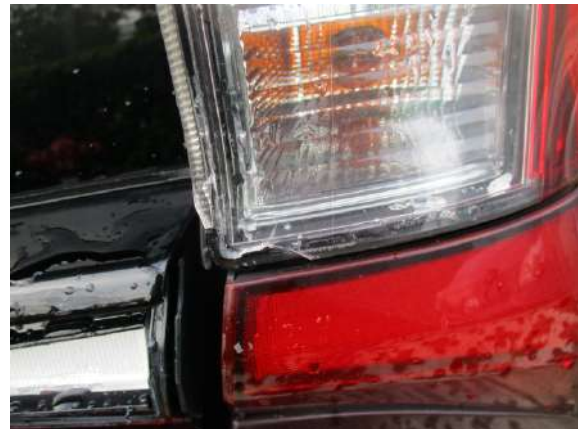
### INSPECTION

| Affiliated to Federation Internationale Des Experts En Automobile | | | | |
|---|---|---|---|--|
| | THE VEHICLE SUSTAINED DAMAGES AT THE REAR PORTION.<br>DAMAGES SEE DETAILS. | | | |
