Your Ref: BMW M4 Coupe  
(chassis number WBS4Y92000AH86089)  
Our Ref : CI/TP21011810/D

19 November 2021

**Star Auto Performance Pte Ltd**

**INSPECTION REPORT OF AN UNREGISTERED BMW M4 COUPE MOTOR CAR WITH CHASSIS NUMBER WBS4Y92000AH86089**

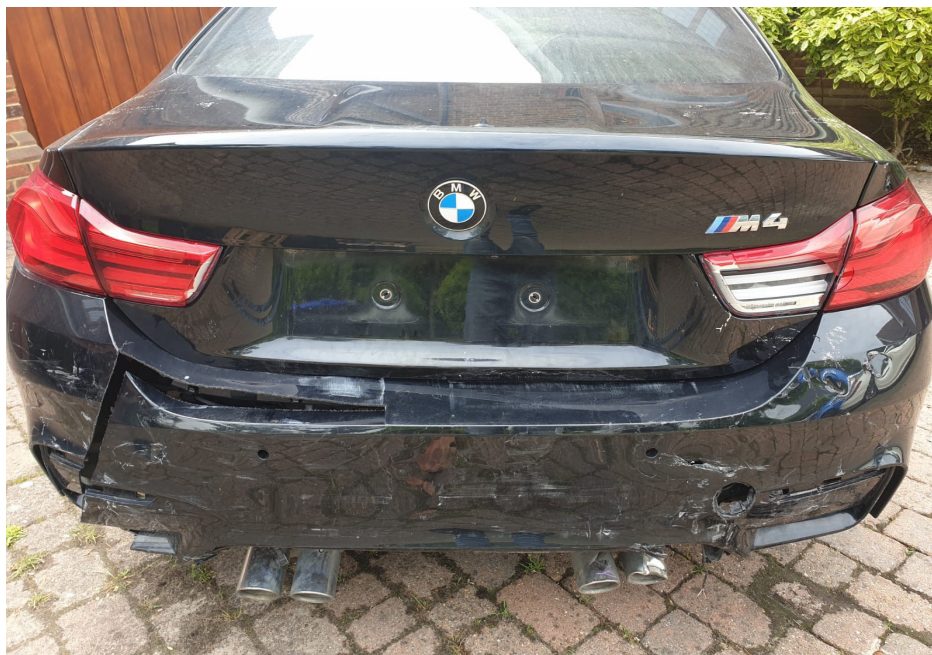
**Photo 1** shows the rear body of the Motor Car (photograph provided to me). The Motor Car was observed to have sustained damage at its rear portion. The rear bumper, rear bumper centre under cover, rear bumper reflectors, rear bumper sensors, rear bumper tow hook cover, rear exhaust muffler, rear bootlid, rear bootlid lamps and rear right taillamp were amongst the body parts that were observed to be damaged.

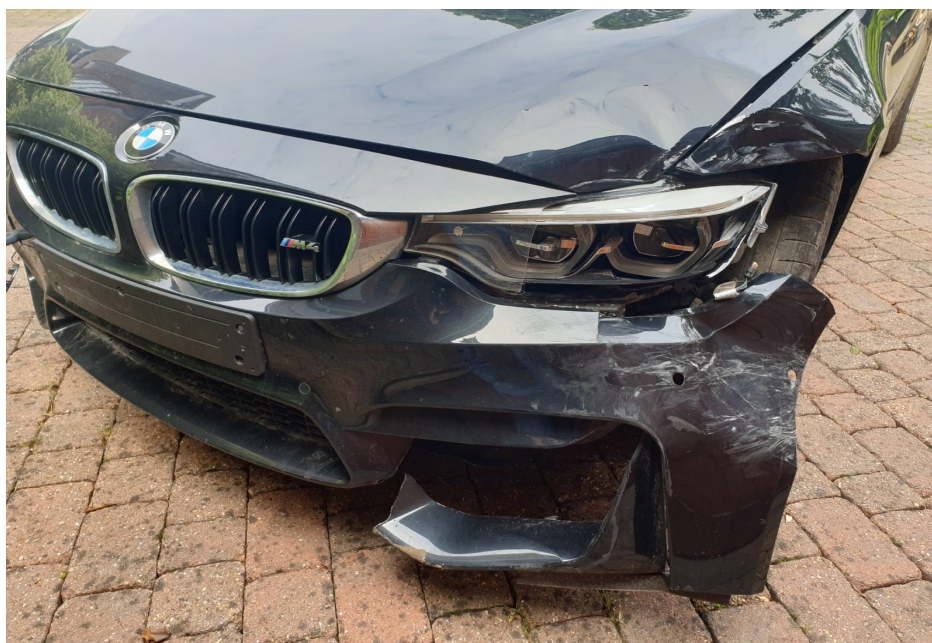
**Photo 2** shows the front left body of the Motor Car (photograph provided to me). Apart for the rear portion, I had also observed damage to the front left portion of the Motor Car. The front bumper, front bumper sensors, front bumper left lower grille, front bonnet, front left headlamp, front left fender and front left fender inner shield were amongst the body parts that were observed to be damaged.

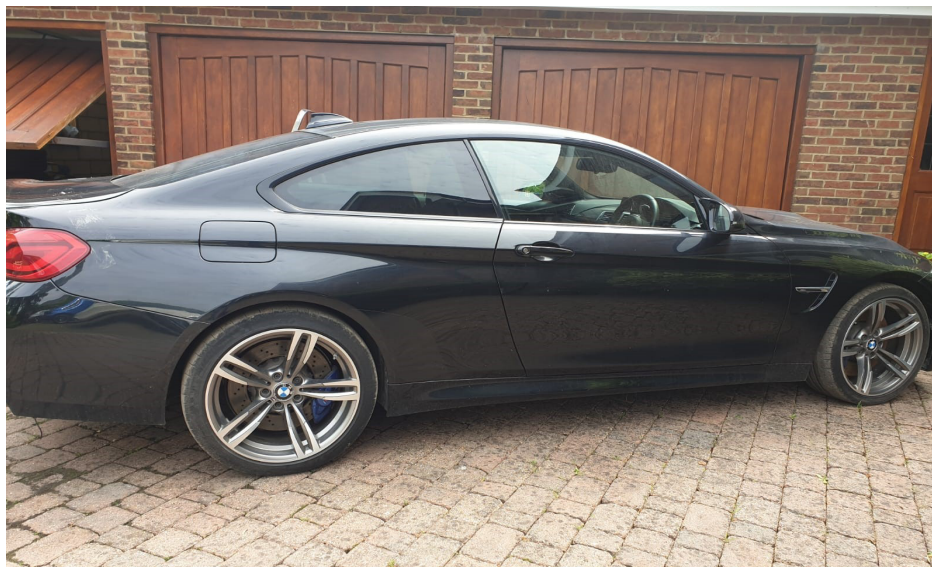
**Photo 3** shows the right side body of the Motor Car (photograph provided to me). Apart for the rear portion and front left portion, there was no physical damage observed to other areas of the Motor Car. The airbags of the Motor Car were also not deployed as seen from the photographs that were provided to me.

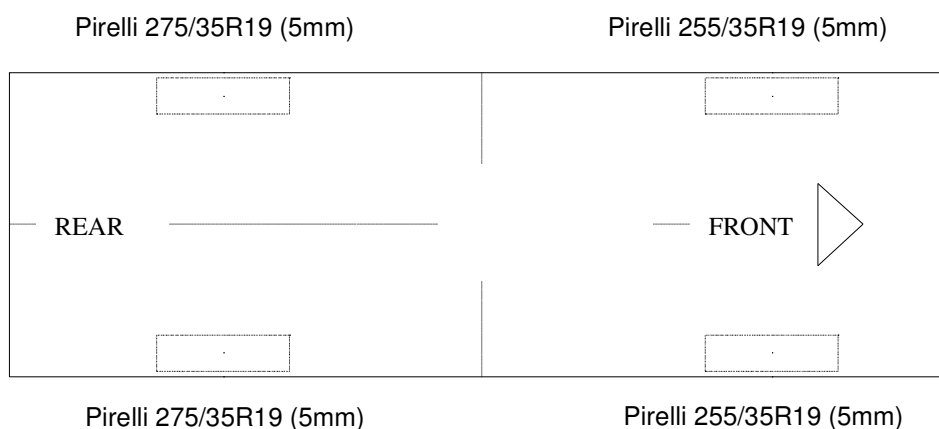
9. It was fitted with 19inch sport wheel rims that were wrapped with tyres that were observed to be of serviceable condition. The tyres were also sufficiently inflated for vehicular operation. The tyre brand, tyre size and approximate remaining tread depth of the 4 tyres of the Motor Car were recorded as follows: -

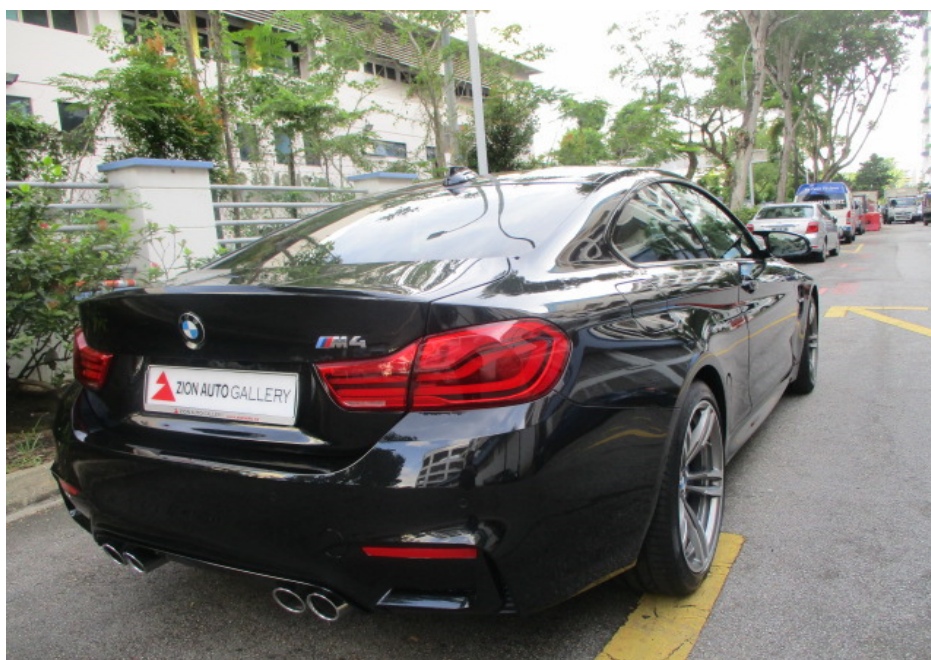
**Photo 4** shows a general view of the rear right body of the Motor Car at the time of my inspection. The Motor Car was observed to be in a relatively good general condition with no loose exterior fittings observed. The body parts at the rear portion of the Motor Car were visually examined, and it was observed that the repair/restoration works carried out to the damaged area of the Motor Car (refer to photograph 1 above) were reasonably adequate and in order.

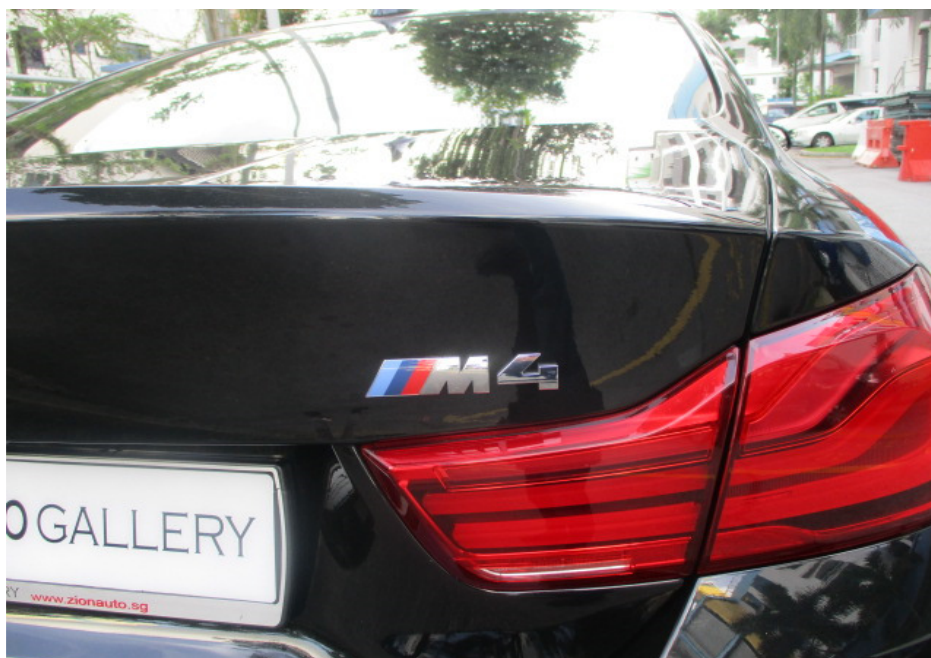
**Photo 5** shows a closer view of the Motor Car's rear bootlid, rear right bootlid lamp and rear right taillamp at the time of my inspection. The body parts at the rear portion of the Motor Car were visually examined, and it was observed that the repair/restoration works carried out to the damaged area of the Motor Car (refer to photograph 1 above) were reasonably adequate and in order.

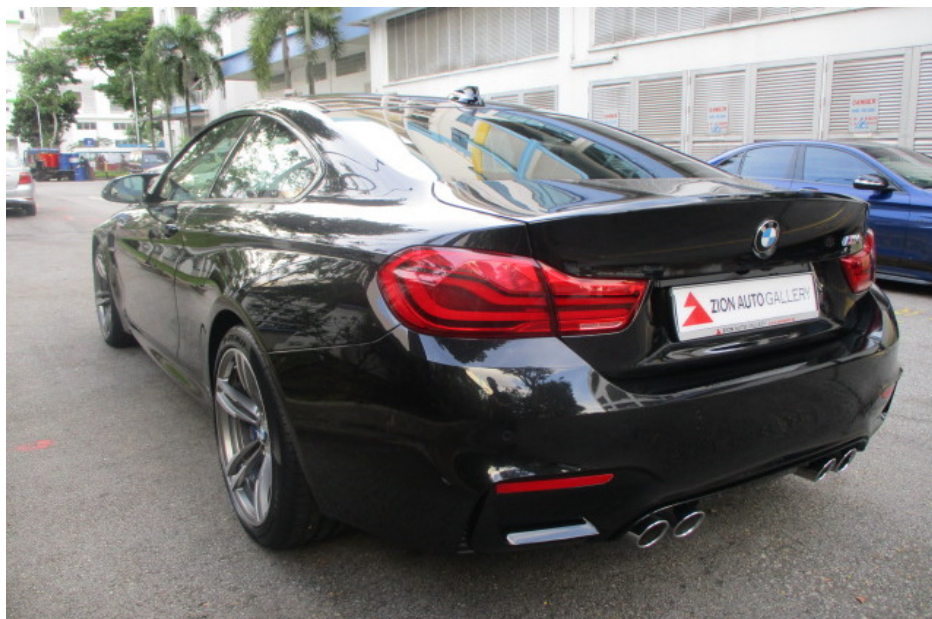
**Photo 6** shows a general view of the rear left body of the Motor Car at the time of my inspection. The Motor Car was observed to be in a relatively good general condition with no loose exterior fittings observed. The body parts at the rear portion of the Motor Car were visually examined, and it was observed that the repair/restoration works carried out to the damaged area of the Motor Car (refer to photograph 1 above) were reasonably adequate and in order.

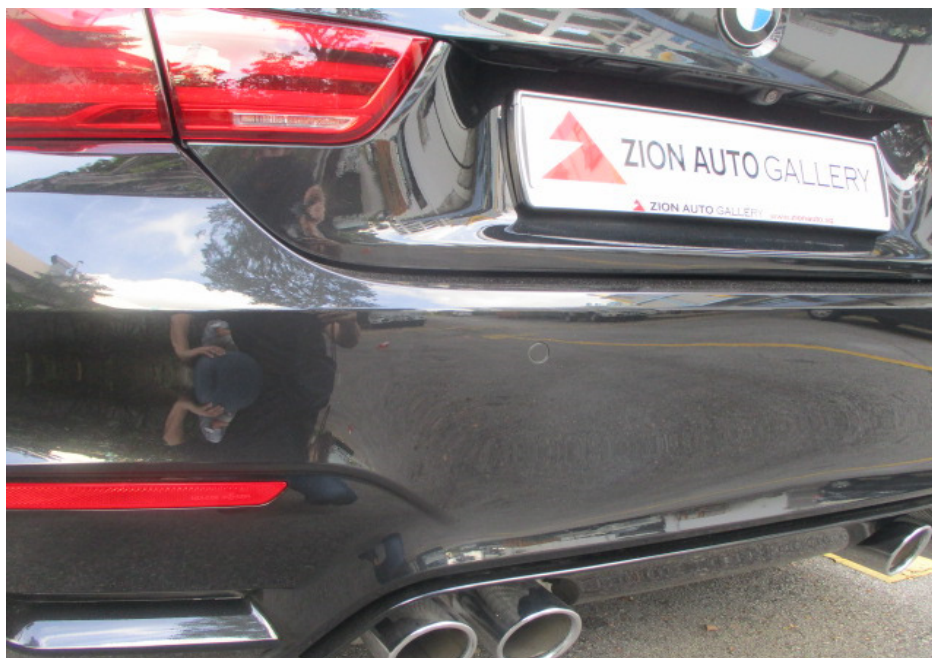
**Photo 7** shows a closer view of the Motor Car's rear bumper, rear bumper centre under cover, rear bumper left reflector, rear exhaust muffler, rear bootlid and rear left bootlid lamp at the time of my inspection. The body parts at the rear portion of the Motor Car were visually examined, and it was observed that the repair/restoration works carried out to the damaged area of the Motor Car (refer to photograph 1 above) were reasonably adequate and in order.

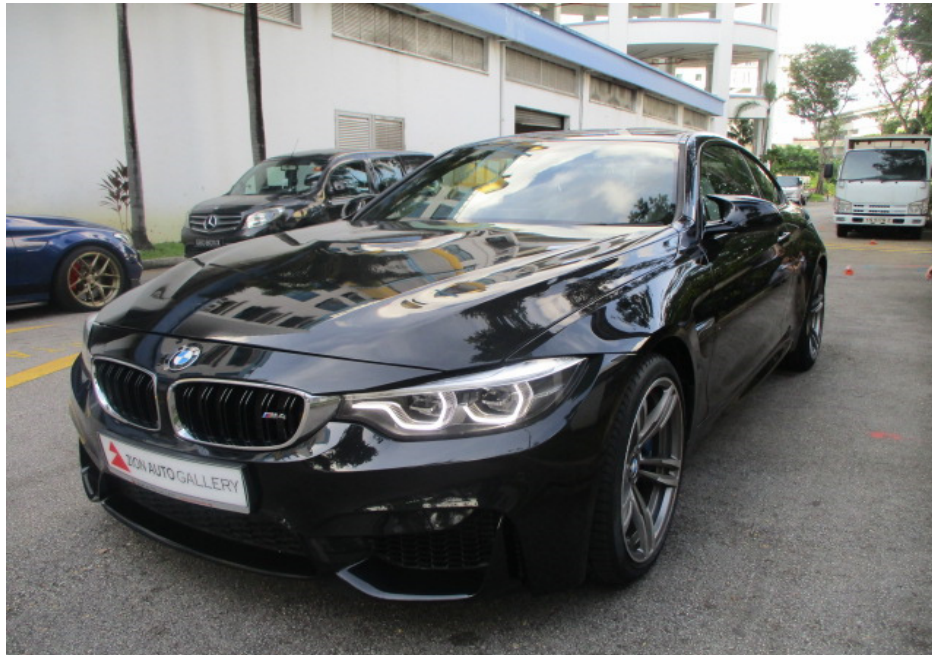
**Photo 8** shows a general view of the front left body of the Motor Car at the time of my inspection. The Motor Car was observed to be in a relatively good general condition with no loose exterior fittings observed. The body parts at the front left portion of the Motor Car were visually examined, and it was observed that the repair/restoration works carried out to the damaged area of the Motor Car (refer to photograph 2 above) were reasonably adequate and in order.

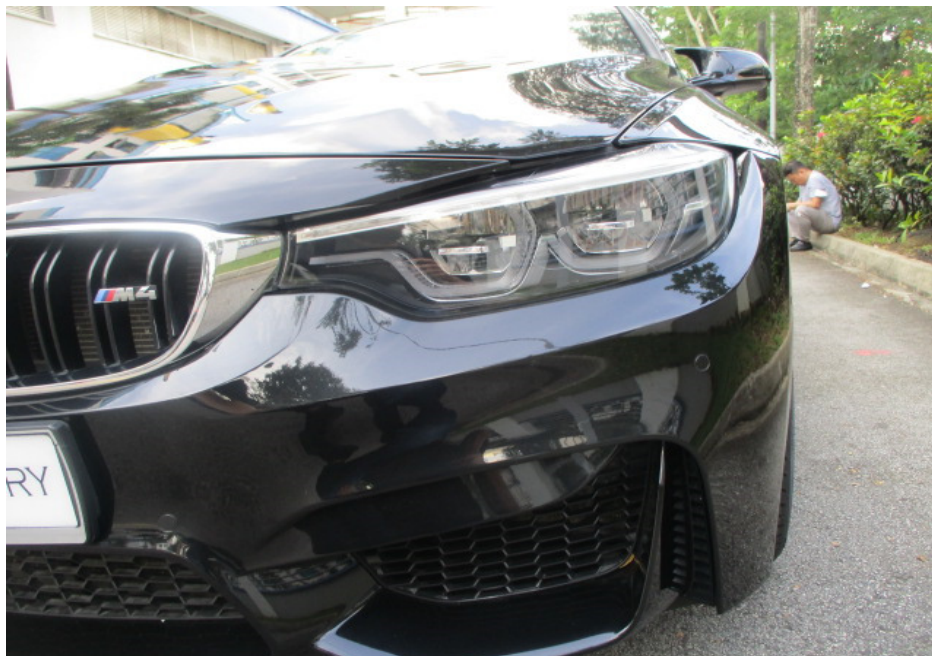
**Photo 9** shows a closer view of the Motor Car's front bumper, front bumper left lower grille, front left headlamp and front bonnet at the time of my inspection. The body parts at the front left portion of the Motor Car were visually examined, and it was observed that the repair/restoration works carried out to the damaged area of the Motor Car (refer to photograph 2 above) were reasonably adequate and in order.

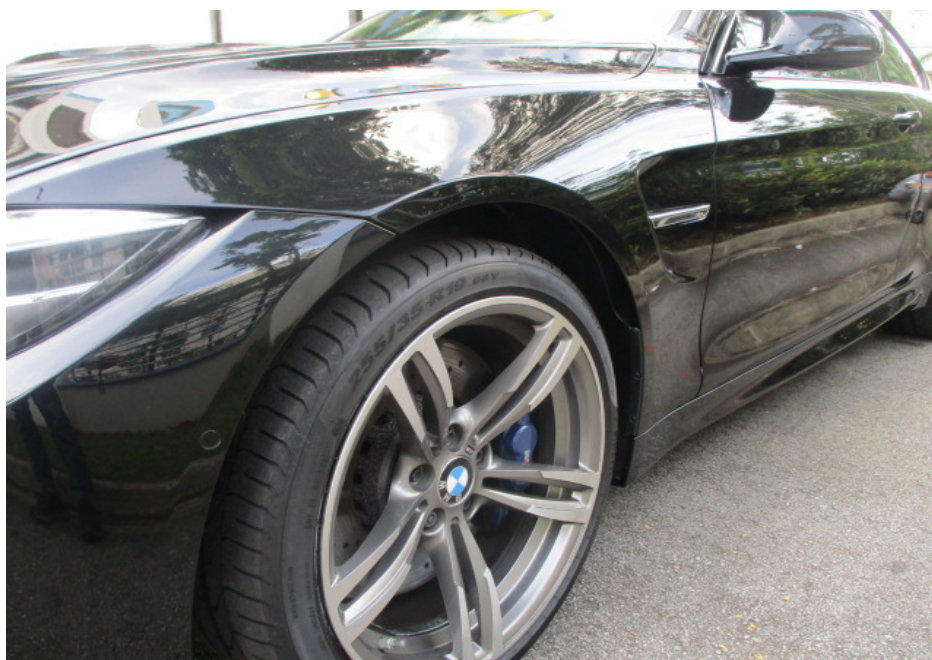
**Photo 10** shows a closer view of the Motor Car's front bumper, front bonnet, front left headlamp and front left fender at the time of my inspection. The body parts at the front left portion of the Motor Car were visually examined, and it was observed that the repair/restoration works carried out to the damaged area of the Motor Car (refer to photograph 2 above) were reasonably adequate and in order.

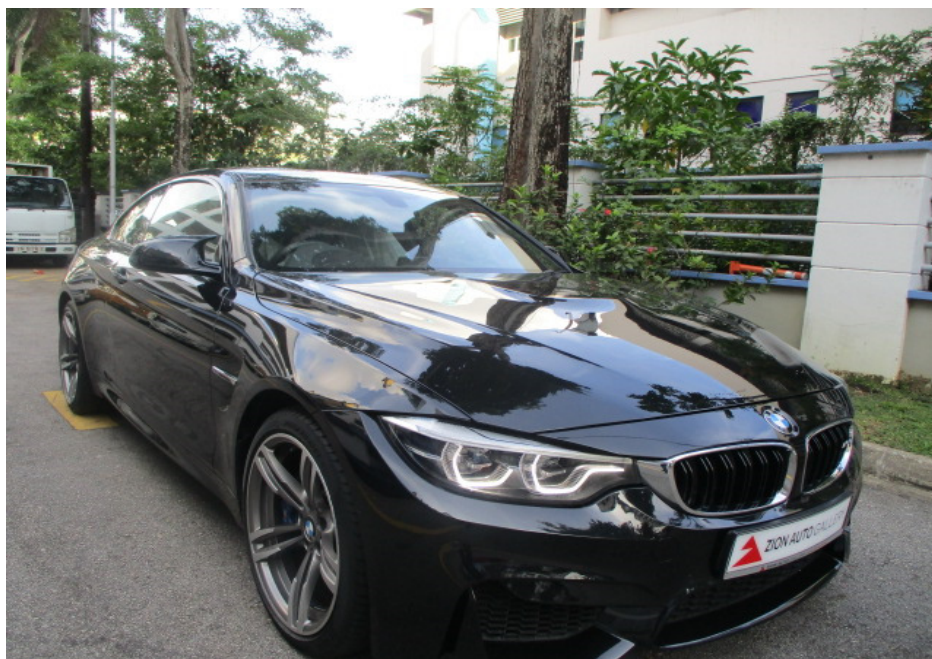
**Photo 11** shows a general view of the front right body of the Motor Car at the time of my inspection. The Motor Car was observed to be in a relatively good general condition with no loose exterior fittings observed. The mileage of the Motor Car recorded at the time of my inspection was 23,588km.

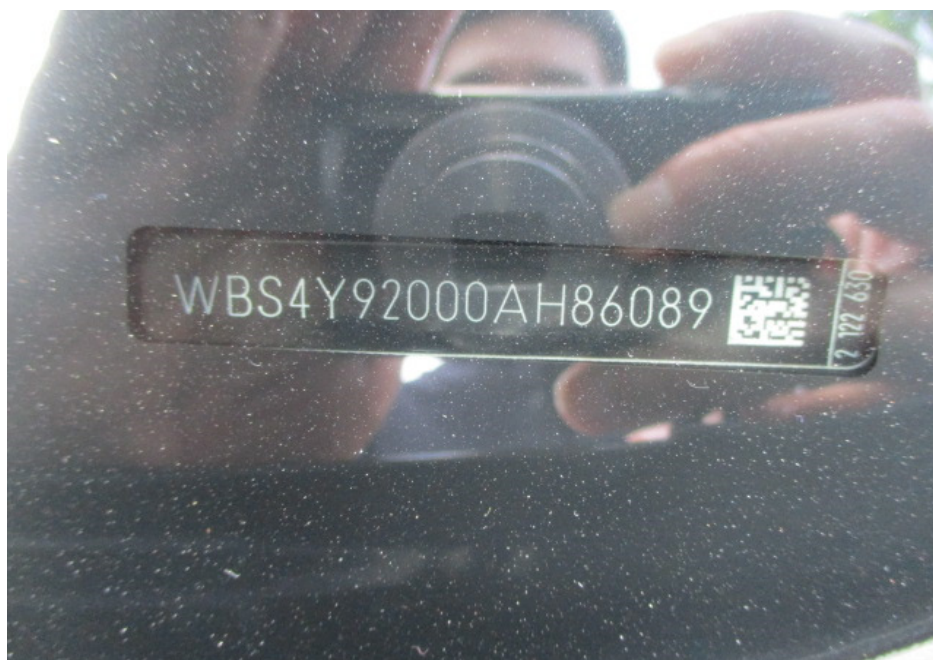
**Photo 12** shows the chassis number of the Motor Car. The chassis number recorded was WBS4Y92000AH86089.

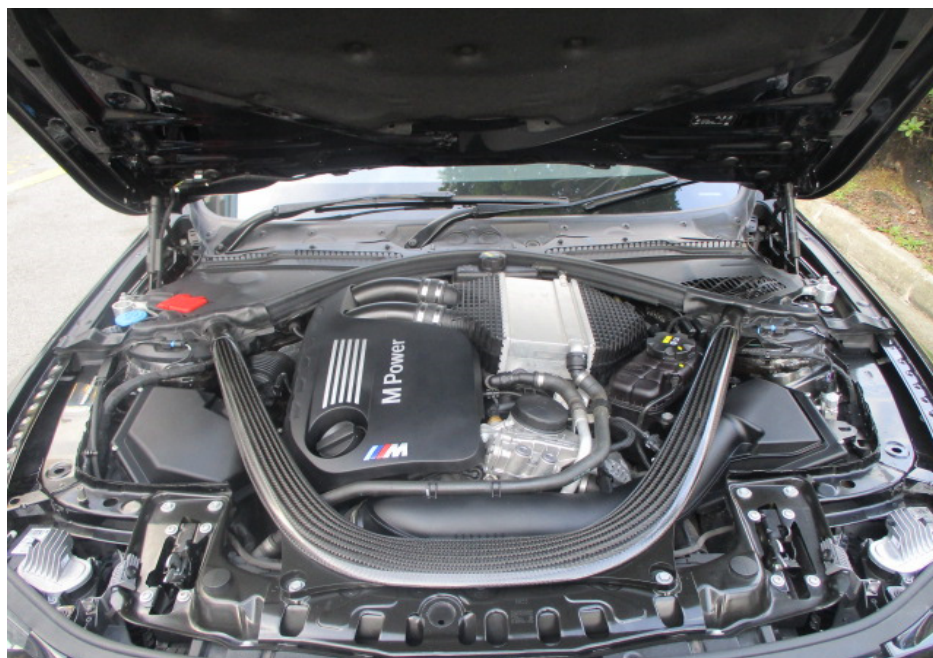
**Photo 13** shows a general view of the engine compartment of the Motor Car at the time of my inspection. The various parts and components inside the engine compartment were all observed to be intact and properly fitted. There was also no sign(s) or indication(s) of fluid leak and/or fluid stain found inside the engine compartment.

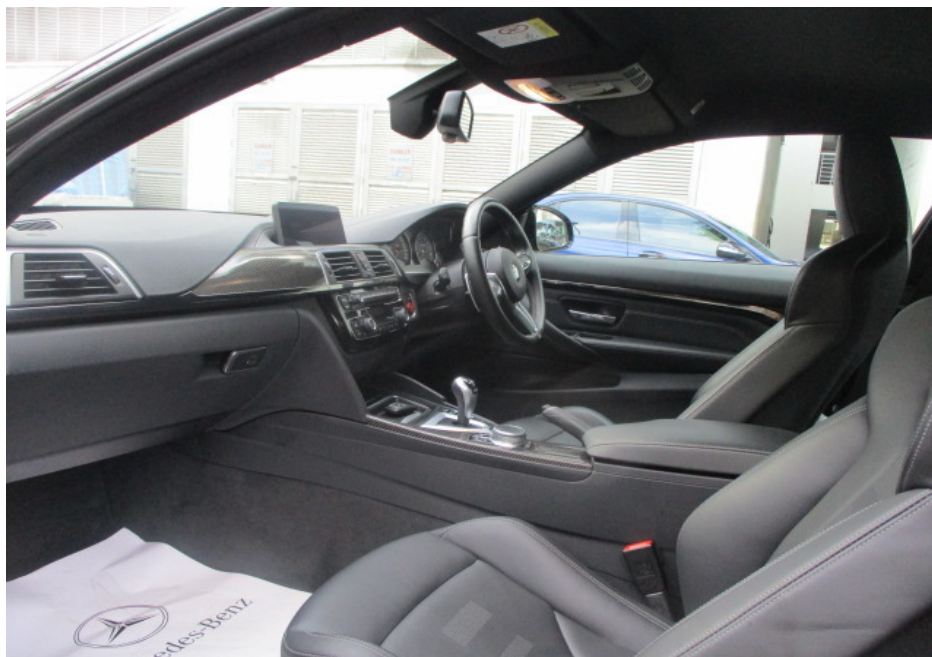
**Photo 14** shows the interior compartment of the Motor Car at the time of my inspection. The various parts and components, trims, carpet and upholstery inside the interior compartment were all observed to be intact and properly fitted.

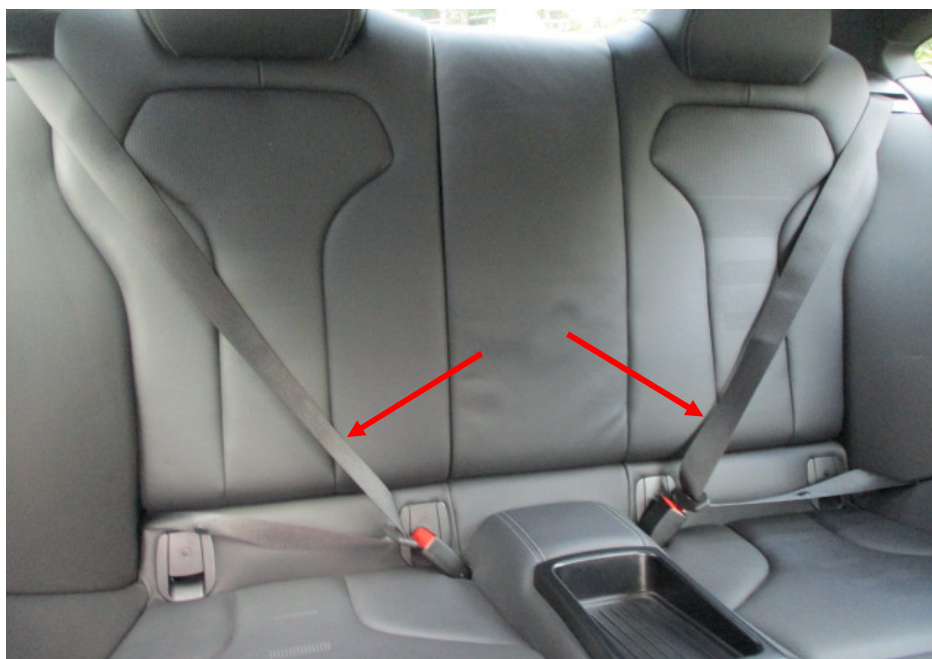
**Photo 15** shows the rear seats of the Motor Car. All the seats of the Motor Car were secured via seat rails to the floorboard. They were also fitted with a retractable seat belt reel and a pre-tensioner. The seat belts (arrowed) were tested and were able to be fastened into the respective pre-tensions that were fitted on the side of each individual seat.

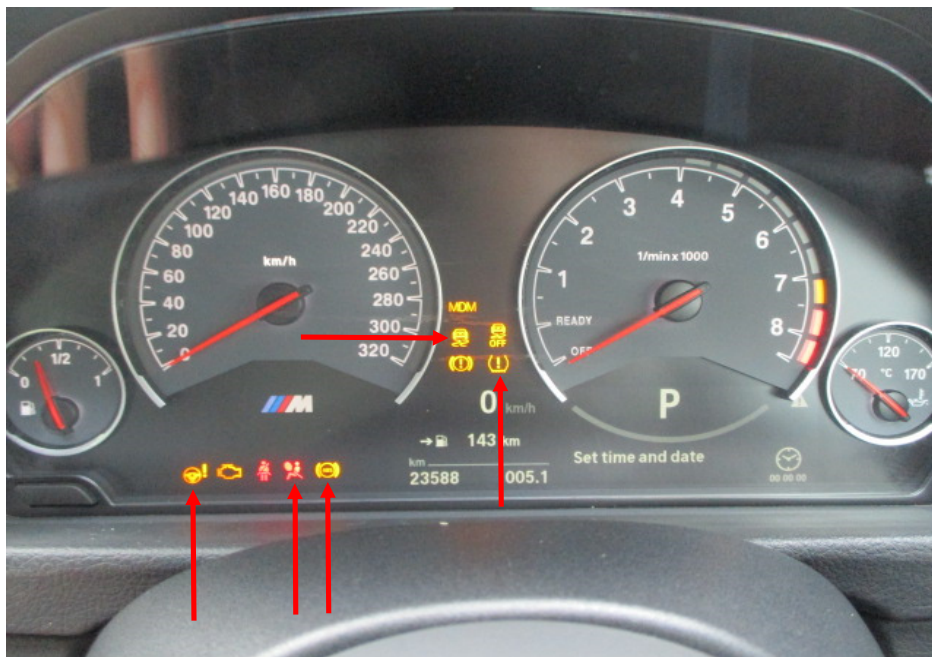
**Photo 16** shows the warning lights for the various electronic safety features appearing on the instrument panel of the Motor Car during its self-test when the engine is cranked, in particular the ABS, SRS, IAS, TPM and DSC lights (arrowed).

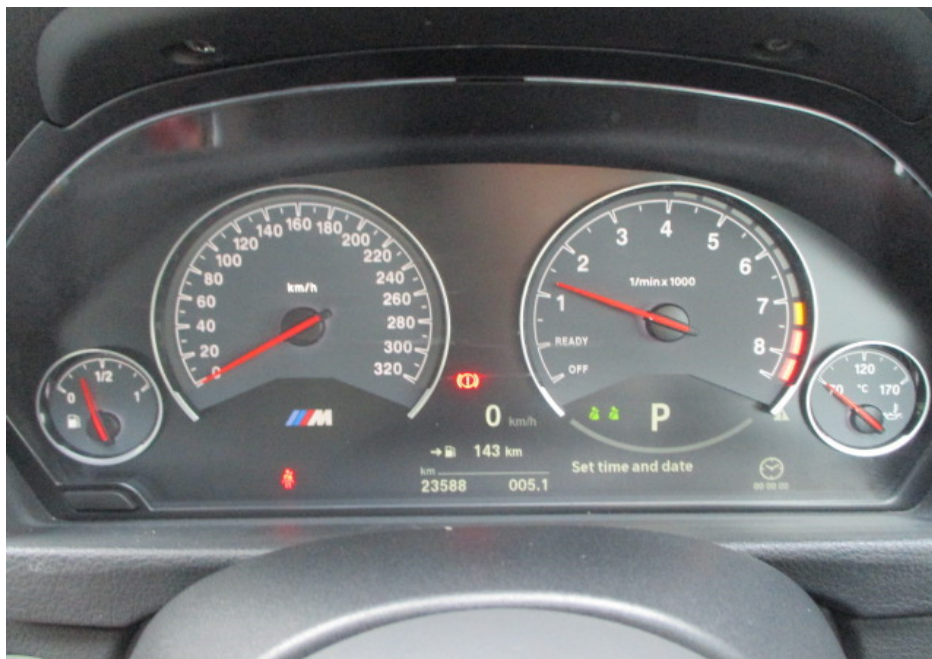
**Photo 17** shows the respective warning lights no longer illuminated, indicating that there is no fault detected to the ABS, SRS, IAS, TPM and DSC systems of the Motor Car during the self-test. These electronic systems were hence in working condition at the time of my inspection.

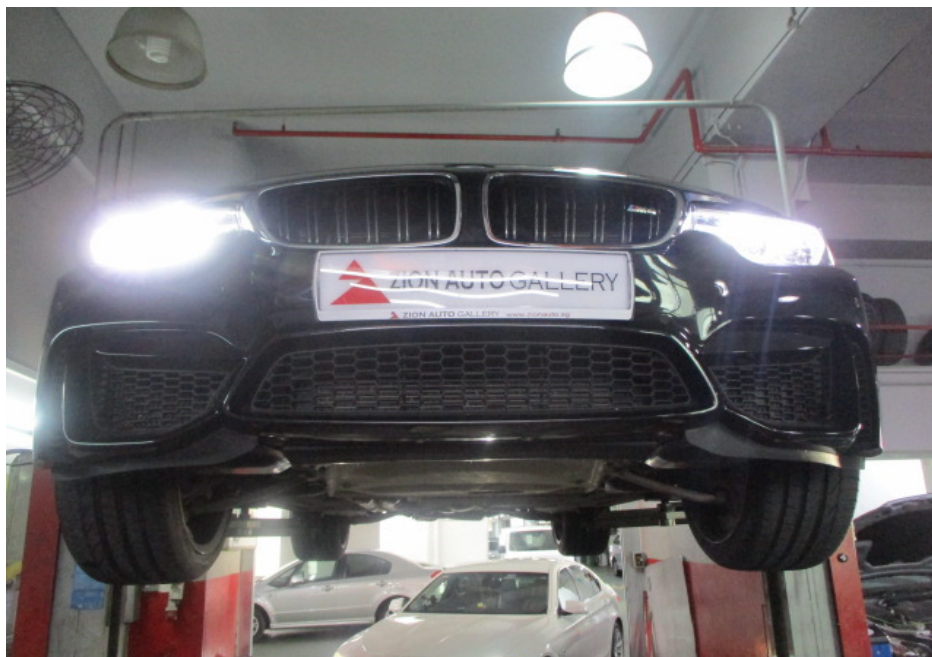
**Photo 18** shows the Motor Car hoisted up for checks on its undercarriage. There was no sign(s) or indication(s) of fluid leakage and/or fluid stain(s) on the underside of the Motor Car. The undercarriage components of the Motor Car were also all observed to be intact and secured in an appropriate manner.

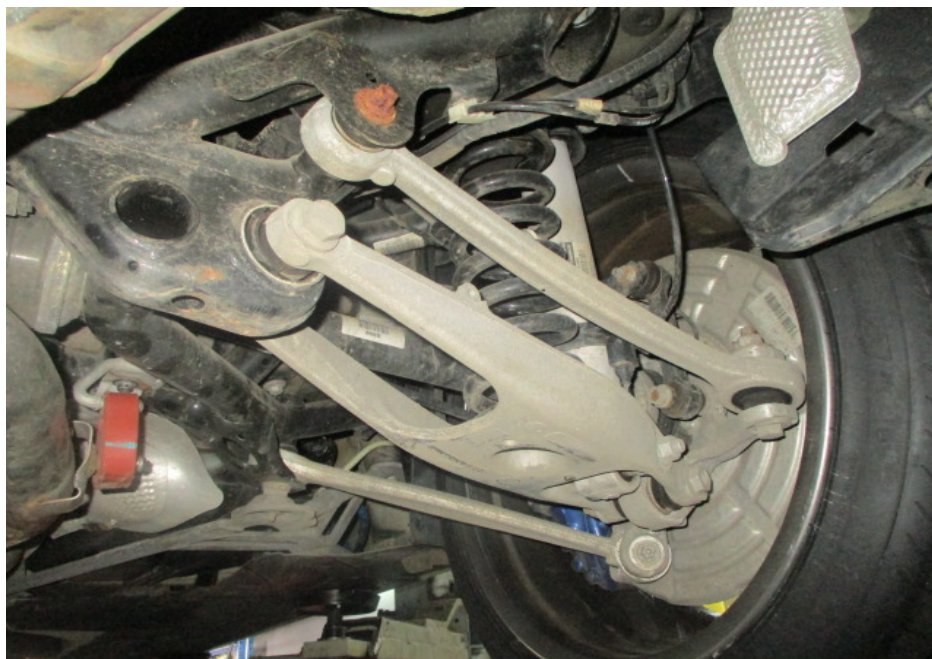
**Photo 19** shows a general view of the control arms and linkages at the rear right wheel of the Motor Car. I did not observe any fluid leak and/or fluid stain on the underside of the Motor Car. All of the Motor Car's undercarriage components were observed to be intact and secured in an appropriate manner.

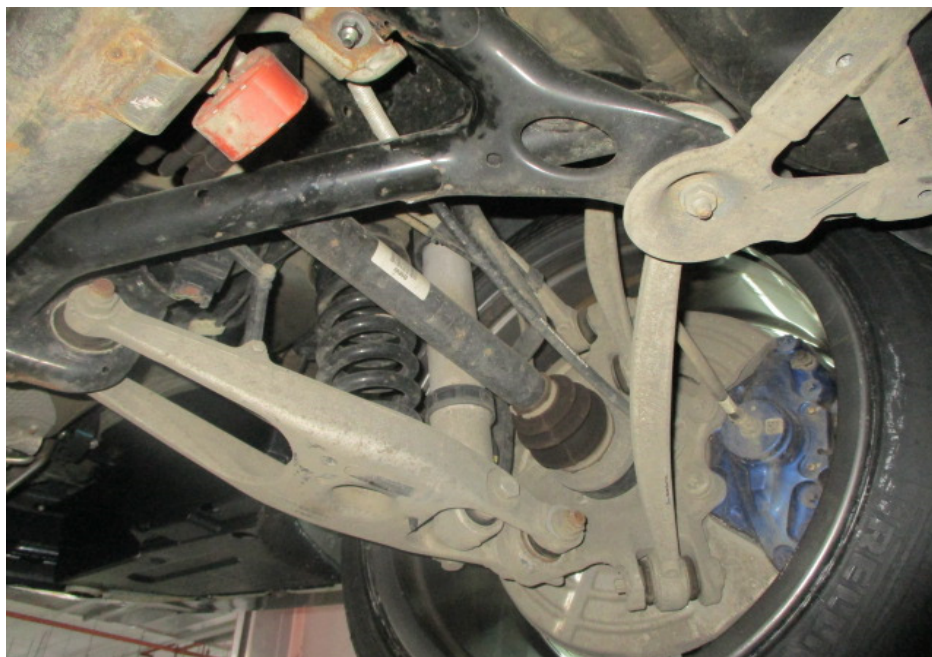
**Photo 20** shows a general view of the control arms and linkages at the rear left wheel of the Motor Car. I did not observe any fluid leak and/or fluid stain on the underside of the Motor Car. All of the Motor Car's undercarriage components were observed to be intact and secured in an appropriate manner.

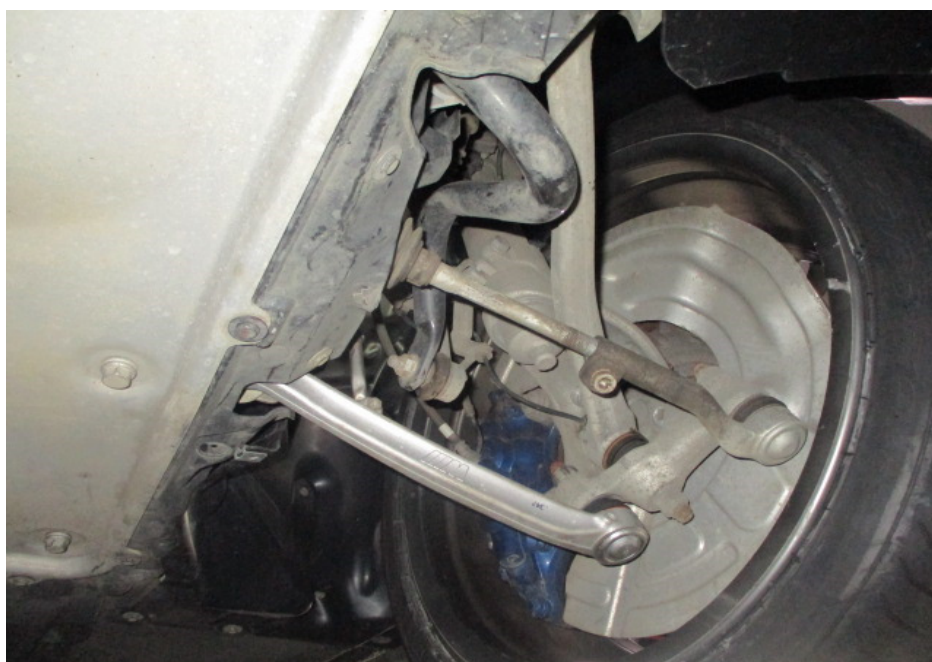
**Photo 21** shows the various undercarriage components at the front left wheel of the Motor Car. The mechanical components, control arms and linkages were all found to be intact and secured in an appropriate manner.

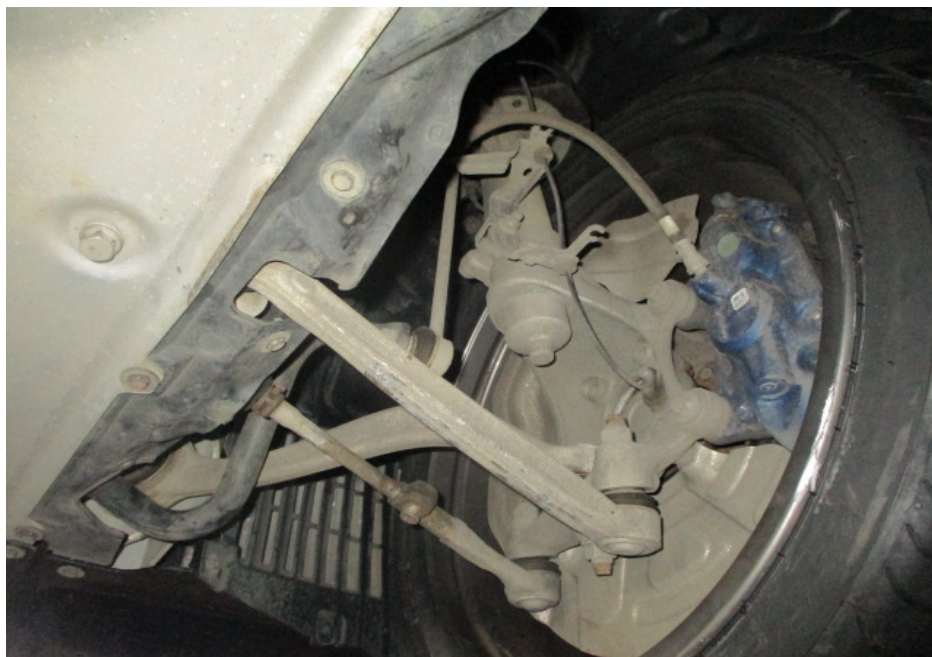
**Photo 22** shows the various undercarriage components at the front right wheel of the Motor Car. The mechanical components, control arms and linkages were all found to be intact and secured in an appropriate manner. I also did not observe any fluid leak and/or fluid stain on the underside of the Motor Car.

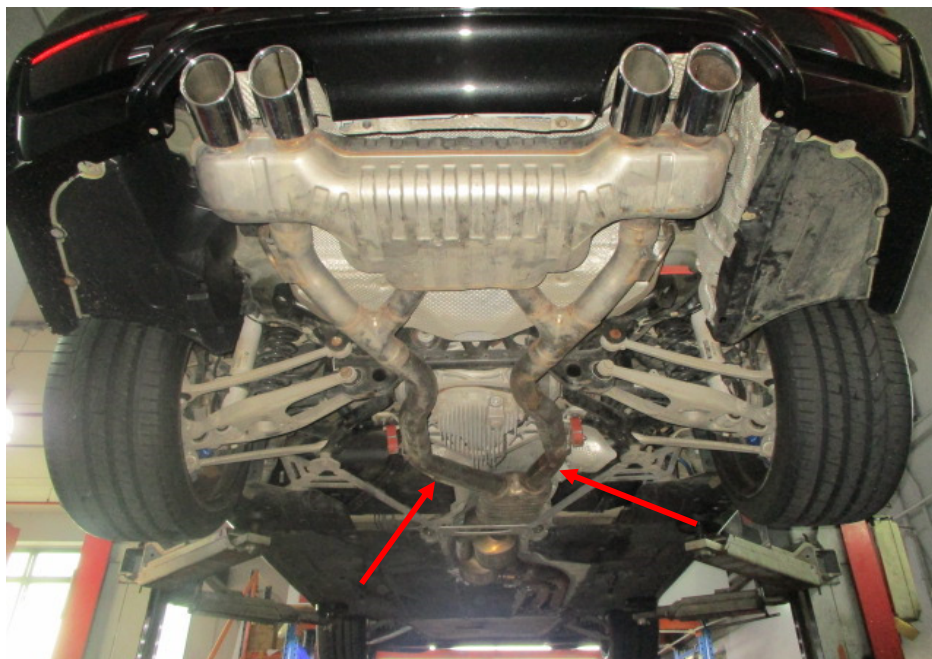
**Photo 23** shows a general view of the rear section of the Motor Car's exhaust system. My examination of the Motor Car's exhaust system revealed no sign(s) or indication(s) of any cut or weld marks along its exhaust pipes (arrowed), on its centre resonator boxes, on its catalytic converters and on its rear muffler.

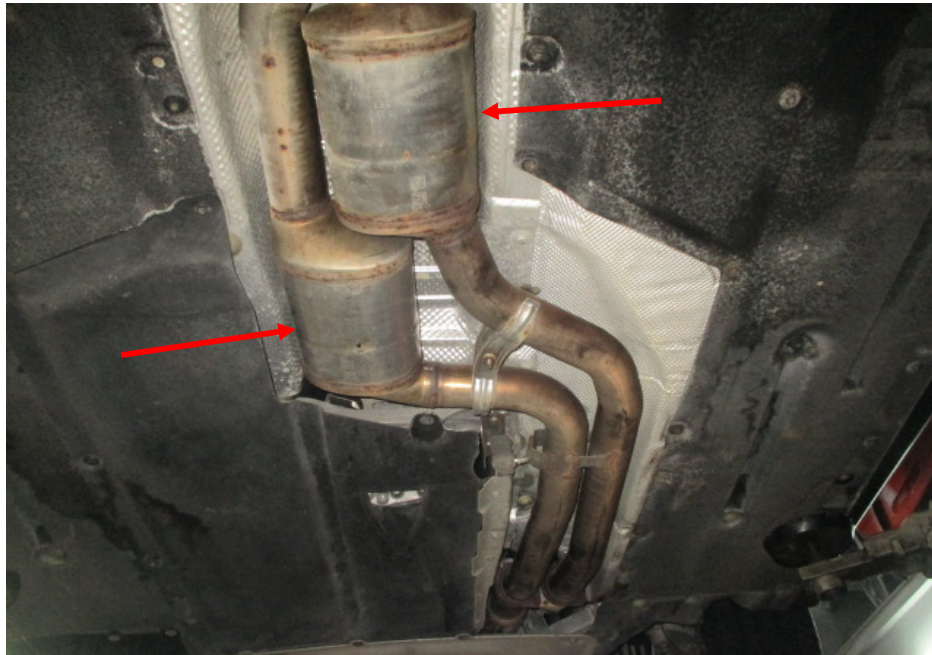
**Photo 24** shows a general view of the front section of the Motor Car's exhaust system. My examination of the Motor Car's exhaust system revealed no sign(s) or indication(s) of any cut or weld marks along its exhaust pipes, on its centre resonator boxes, on its catalytic converters (arrowed) and on its rear muffler.

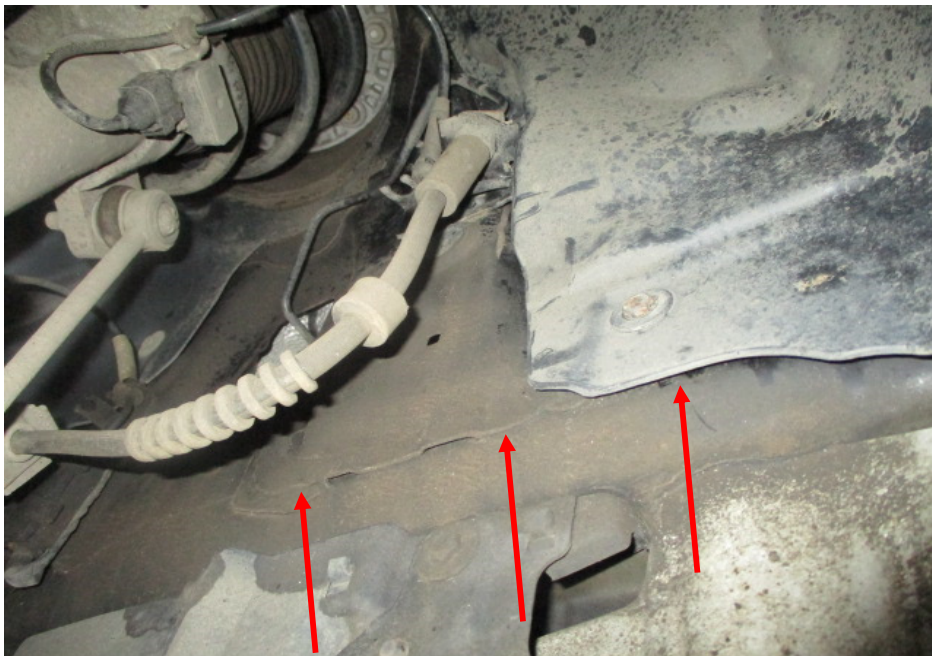
**Photo 25** shows the chassis/structural body at the underside front right of the Motor Car. I did not find any weld marks other than original spot weld marks on the chassis/structural body of the Motor Car. The original factory sealant (arrowed) at the joints along the chassis/structural body was untouched, indicating no work was done on the chassis/structural body of the Motor Car and that the chassis/structural body was originally fitted.

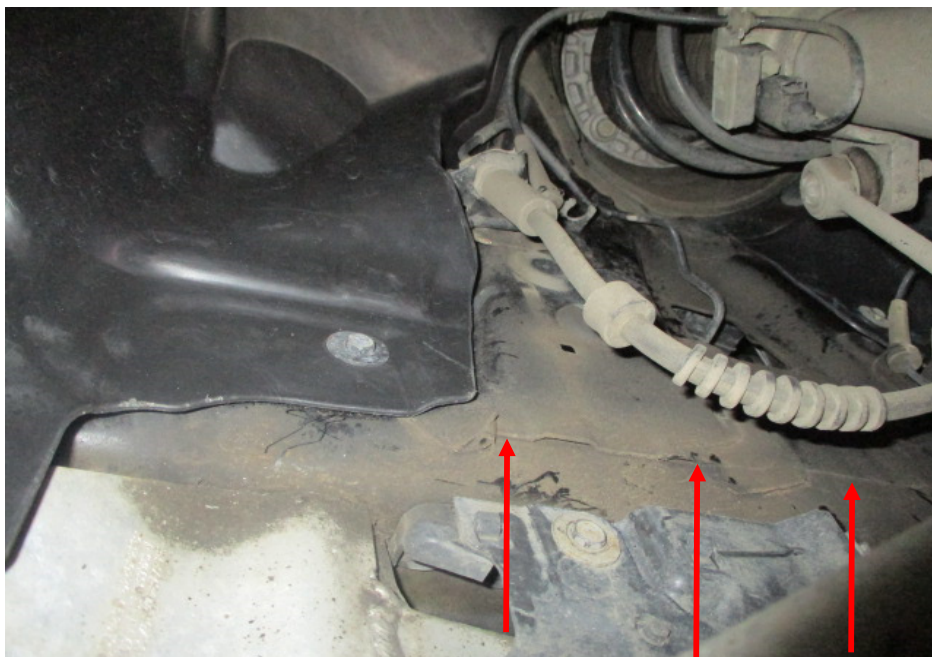
**Photo 26** shows the chassis/structural body at the underside front left of the Motor Car. The original factory sealant (arrowed) at the joints along the chassis/structural body was observed to be untouched. In general, I had found no work was carried out on the chassis/structural body of the Motor Car. The chassis/structural body of the Motor Car was originally fitted.

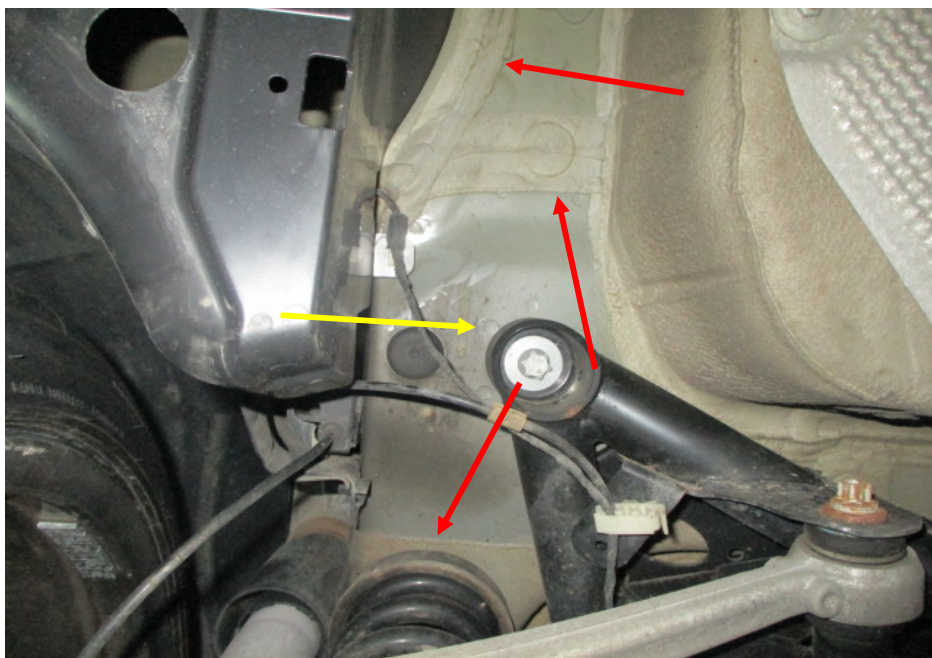
**Photo 27** shows the chassis/structural body at the underside rear left of the Motor Car. I did not find any weld marks other than original spot weld marks (yellow arrow) on the chassis/structural body of the Motor Car. The original factory sealant (red arrow) at the joints along the chassis/structural body was untouched, indicating no work was done on the chassis/structural body of the Motor Car and that the chassis/structural body was originally fitted.

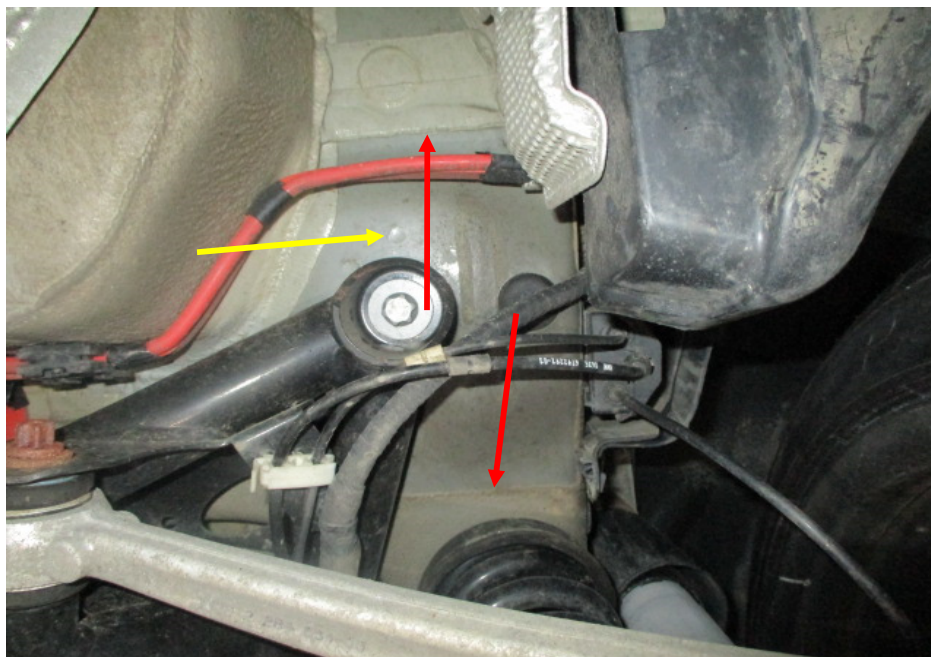
**Photo 28** shows the chassis/structural body at the underside rear right of the Motor Car. I did not find any weld marks other than original spot weld marks (yellow arrow) on the chassis/structural body of the Motor Car. The original factory sealant (red arrow) at the joints along the chassis/structural body was untouched, indicating no work was done on the chassis/structural body of the Motor Car and that the chassis/structural body was originally fitted.

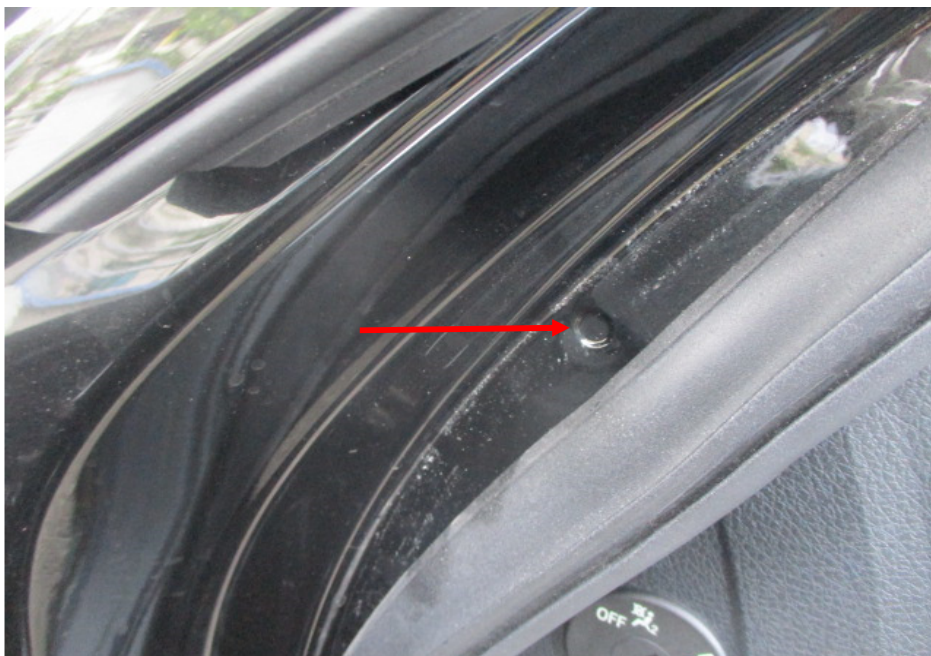
**Photo 29** shows the left side "A" pillar of the Motor Car. I did not find any weld marks other than original spot weld marks (arrowed) on the left side "A" pillar of the Motor Car which, indicates that there was no re-welding works carried out. In general, I had found all the non-detachable body panels of the Motor Car to be originally fitted at the time of my inspection.

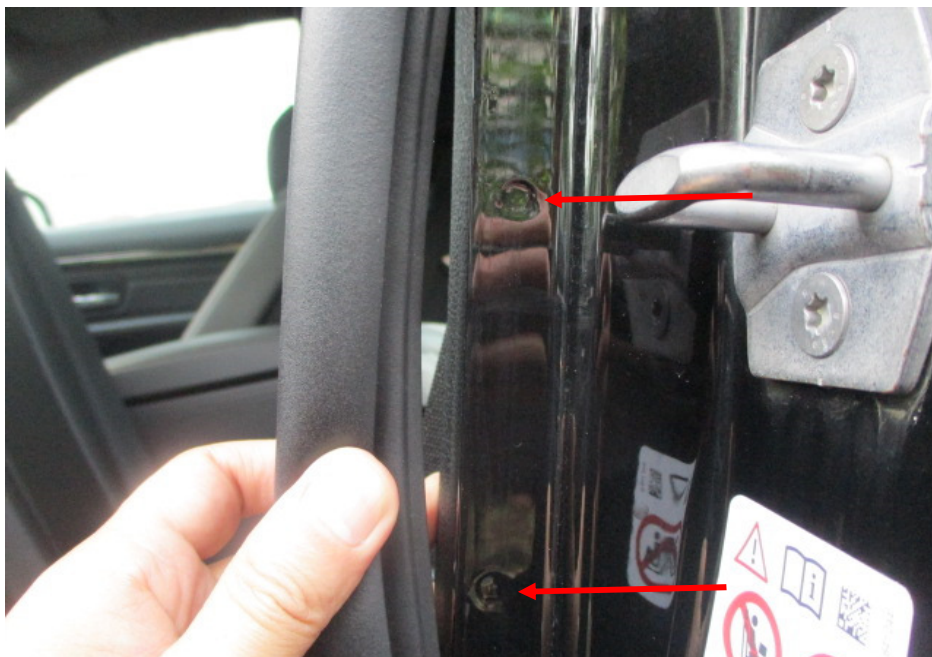
**Photo 30** shows the left side rear body panel of the Motor Car. I did not find any weld marks other than original spot weld marks (arrowed) on the left side rear body panel of the Motor Car which, indicates that there was no re-welding works carried out. In general, I had found all the non-detachable body panels of the Motor Car to be originally fitted at the time of my inspection.

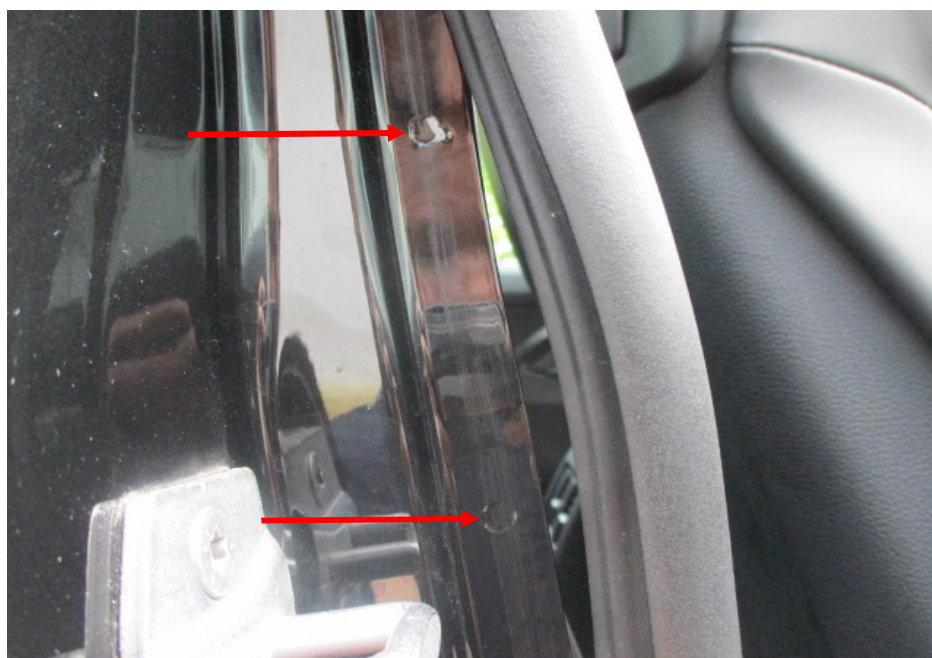
**Photo 31** shows the right side rear body panel of the Motor Car. I did not find any weld marks other than original spot weld marks (arrowed) on the right side rear body panel of the Motor Car which, indicates that there was no re-welding works carried out. In general, I had found all the non-detachable body panels of the Motor Car to be originally fitted at the time of my inspection.
