Your Ref: BMW M4 Coupe  
(chassis number WBS4Y92000AH86089)  
Our Ref : CI/TP21011810/D

19 November 2021

**Star Auto Performance Pte Ltd**

**INSPECTION REPORT OF AN UNREGISTERED BMW M4 COUPE MOTOR CAR WITH CHASSIS NUMBER WBS4Y92000AH86089**

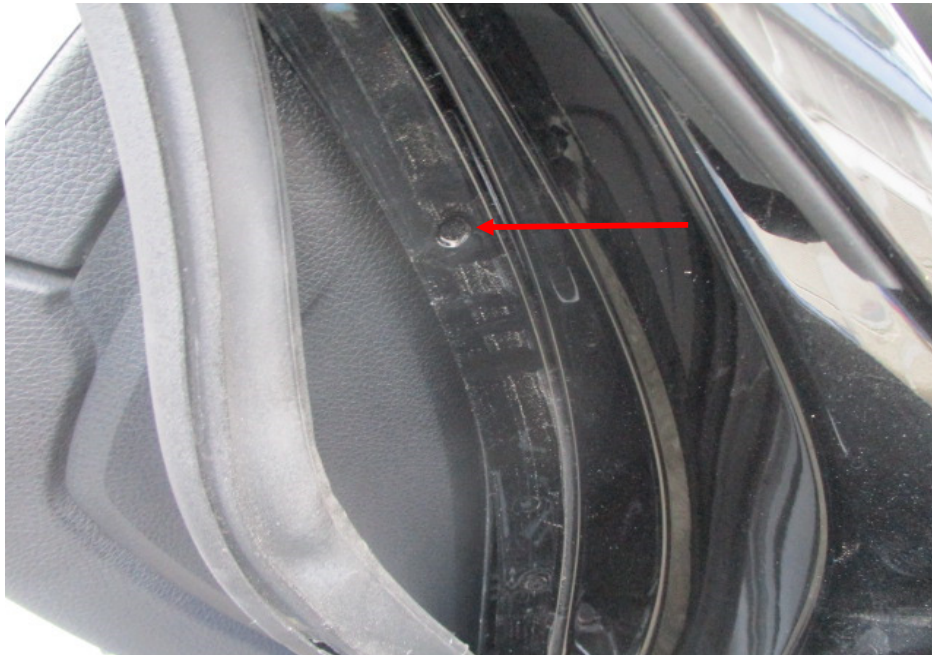
**Photo 32** shows the right side "A" pillar of the Motor Car. I did not find any weld marks other than original spot weld marks (arrowed) on the right side "A" pillar of the Motor Car which, indicates that there was no re-welding works carried out. In general, I had found all the non-detachable body panels of the Motor Car to be originally fitted at the time of my inspection.
