Your Ref: BMW M5  
(chassis number WBSJF02040CE30222)  
Our Ref : CI/TP21011812/D

**INSPECTION REPORT OF AN UNREGISTERED BMW M5 MOTOR CAR WITH CHASSIS NUMBER WBSJF02040CE30222**

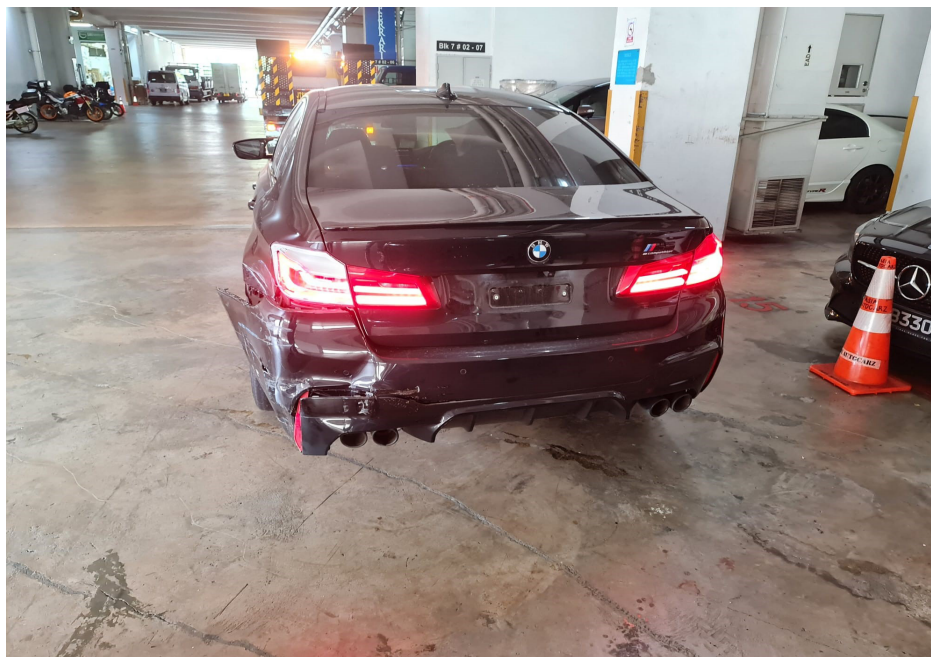
**Photo 1** shows the rear body of the Motor Car (photograph provided to me). The Motor Car was observed to have sustained damage at its rear left portion. The rear bumper, rear bumper lower diffuser, rear bumper left reflector and rear left taillamp were amongst the body parts that were observed to be damaged.

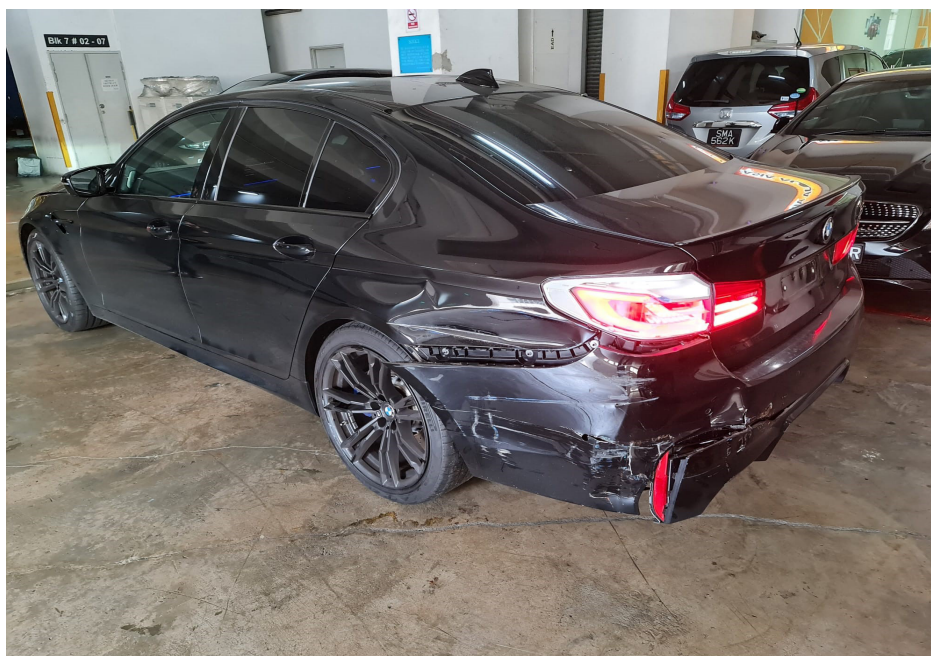
**Photo 2** shows the rear left body of the Motor Car (photograph provided to me). The Motor Car was observed to have sustained damage at its rear left portion. The rear bumper, rear bumper lower diffuser, rear bumper left reflector, rear bumper sensor, rear left taillamp and rear left fender were amongst the body parts that were observed to be damaged.

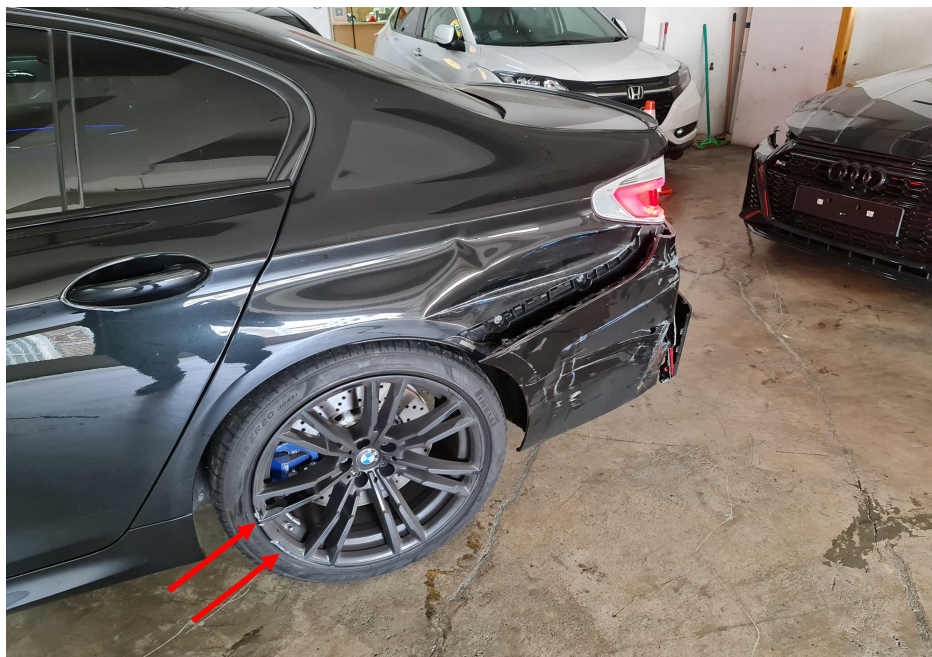
**Photo 3** shows another view of the rear left body of the Motor Car (photograph provided to me). The Motor Car was observed to have sustained damage at its rear left portion. The rear bumper, rear bumper lower diffuser, rear bumper left reflector, rear left taillamp, rear left fender and rear left wheel rim (arrowed) were amongst the body parts that were observed to be damaged.

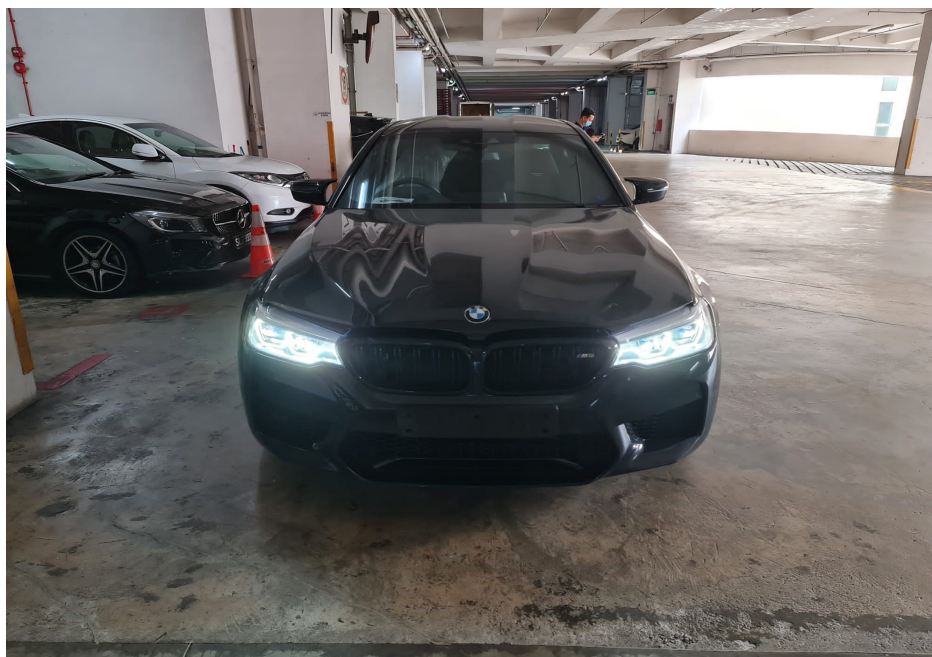
**Photo 4** shows the frontal body of the Motor Car (photograph provided to me). Apart for the rear left portion, there was no physical damage seen to other areas of the Motor Car. The airbags of the Motor Car were also not deployed as seen from the photographs that were provided to me.

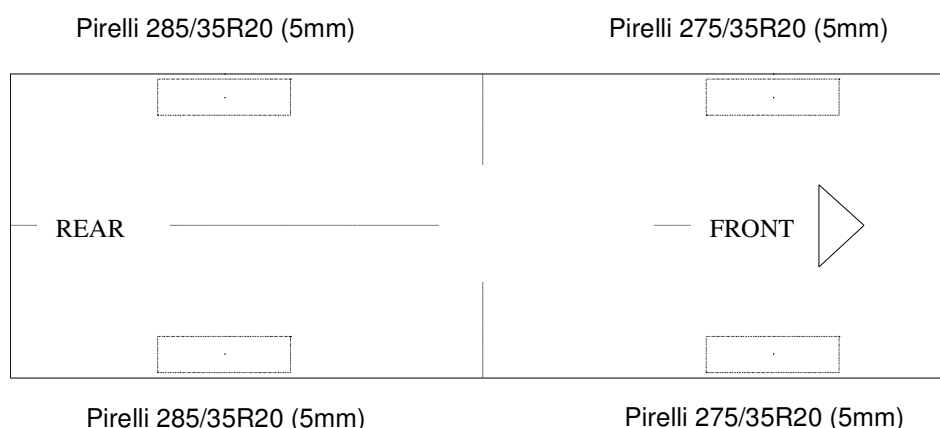
8. It was fitted with 20inch sport wheel rims that were wrapped with tyres that were observed to be of serviceable condition. The tyres were also sufficiently inflated for vehicular operation. The tyre brand, tyre size and approximate remaining tread depth of the 4 tyres of the Motor Car were recorded as follows: -

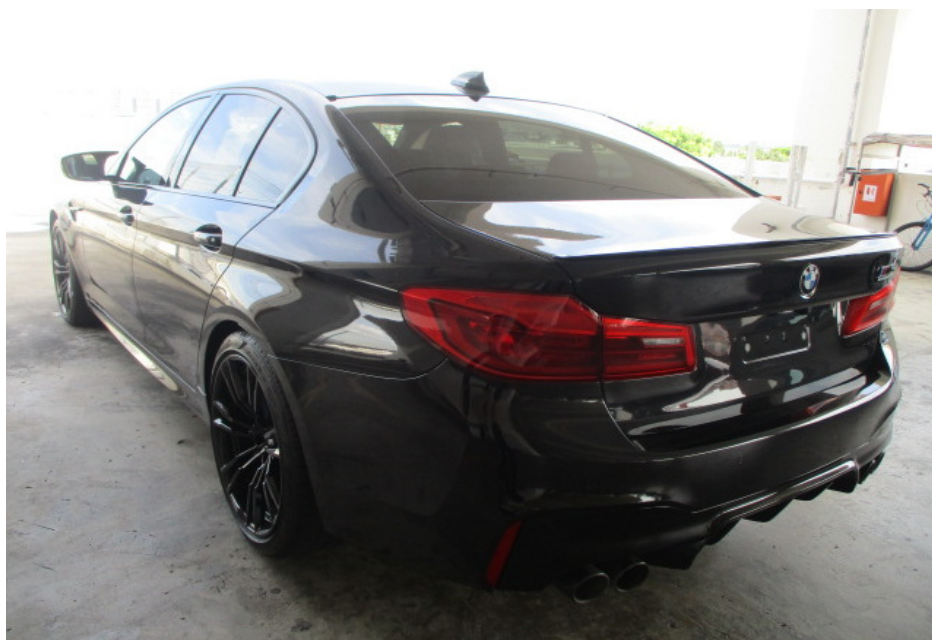
**Photo 5** shows a general view of the rear left body of the Motor Car at the time of my inspection. The Motor Car was observed to be in a relatively good general condition with no loose exterior fittings observed. The body parts at the rear left portion of the Motor Car were visually examined, and it was observed that the repair/restoration works carried out to the damaged area of the Motor Car (refer to photograph 1 – 3) were reasonably adequate and in order.

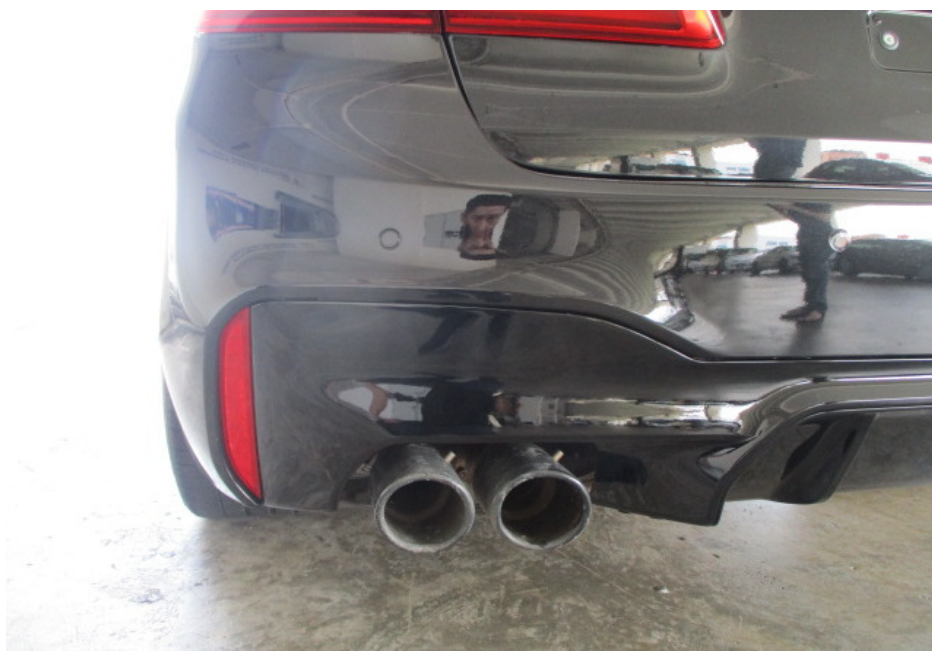
**Photo 6** shows a closer view of the Motor Car's rear bumper, rear bumper lower diffuser, rear bumper left reflector and rear left exhaust. The body parts at the rear left portion of the Motor Car were visually examined, and it was observed that the repair/restoration works carried out to the damaged area of the Motor Car (refer to photograph 1 – 3) were reasonably adequate and in order.

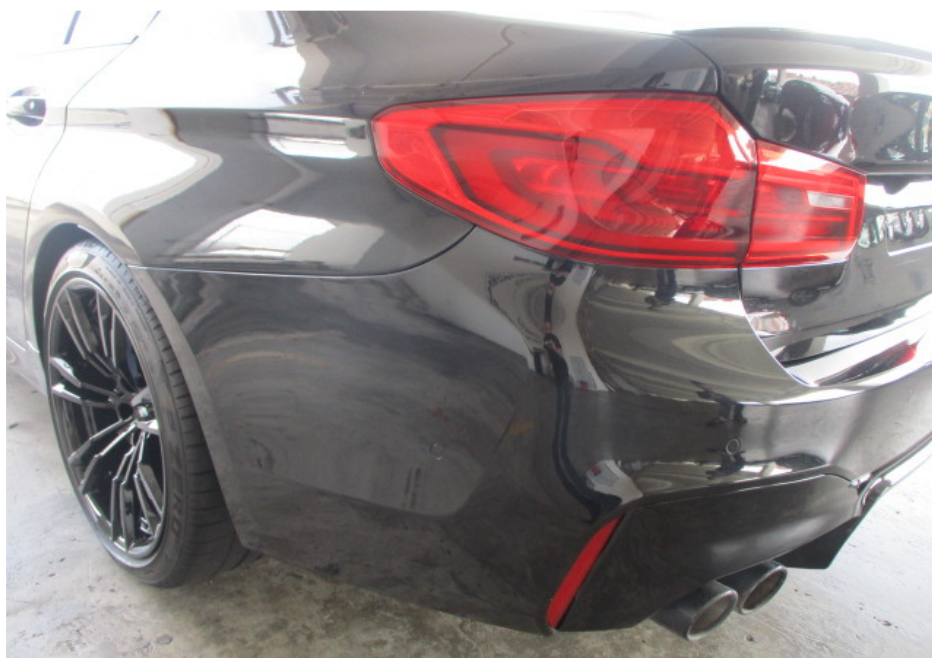
**Photo 7** shows a closer view of the Motor Car's rear bumper, rear bumper lower diffuser, rear bumper left reflector, rear left taillamp, rear left fender and rear left wheel rim at the time of my inspection. The body parts at the rear left portion of the Motor Car were visually examined, and it was observed that the repair/restoration works carried out to the damaged area of the Motor Car (refer to photograph 1 – 3) were reasonably adequate and in order.

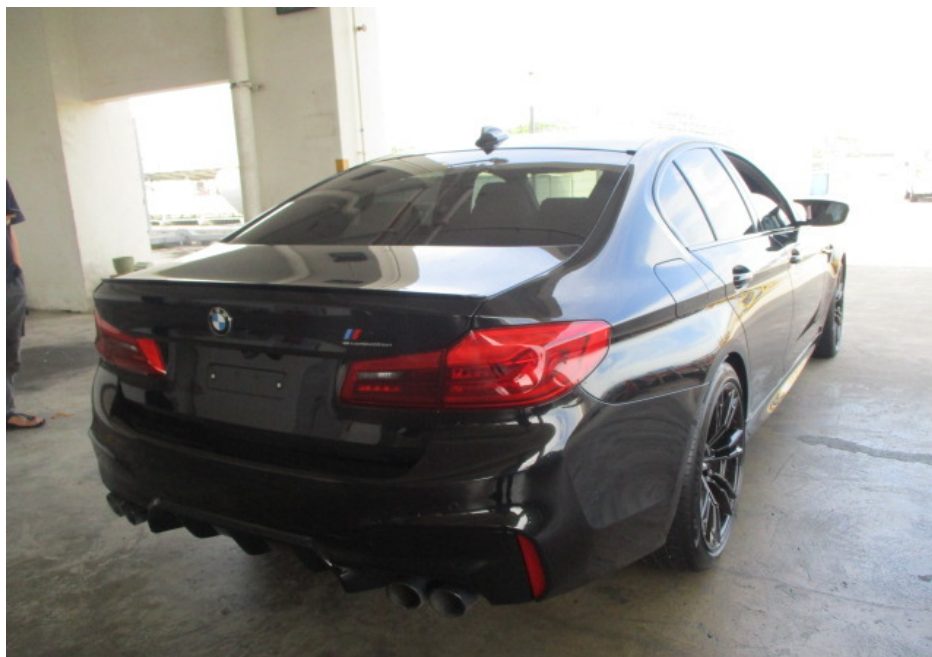
**Photo 8** shows a general view of the rear right body of the Motor Car at the time of my inspection. The Motor Car was observed to be in a relatively good general condition with no loose exterior fittings observed. The body parts at the rear left portion of the Motor Car were visually examined, and it was observed that the repair/restoration works carried out to the damaged area of the Motor Car (refer to photograph 1 – 3) were reasonably adequate and in order.

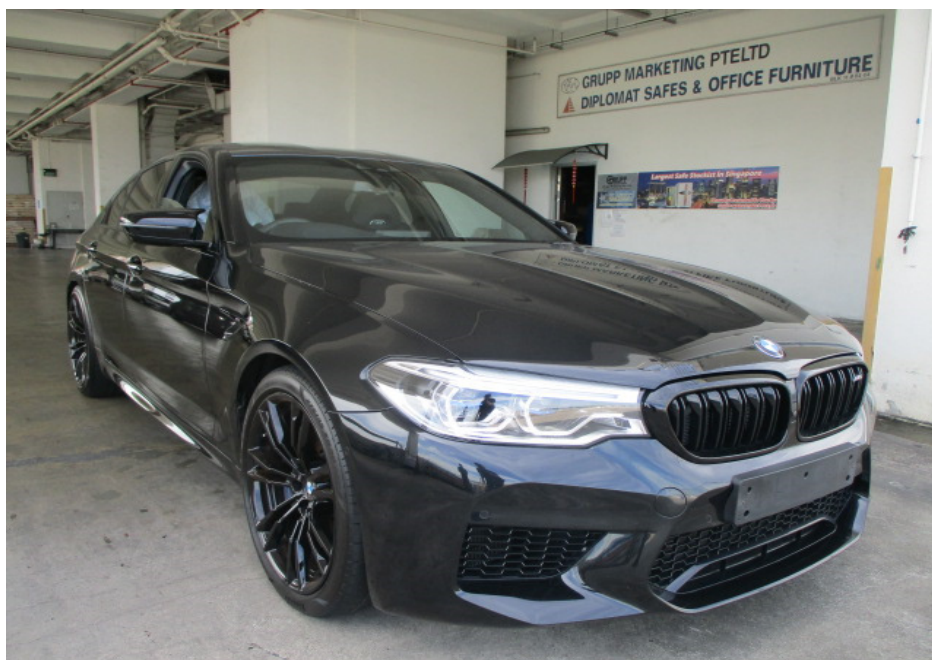
**Photo 9** shows a general view of the front right body of the Motor Car at the time of my inspection. The Motor Car was observed to be in a relatively good general condition with no loose exterior fittings observed. The mileage of the Motor Car recorded at the time of my inspection was 2,737km.

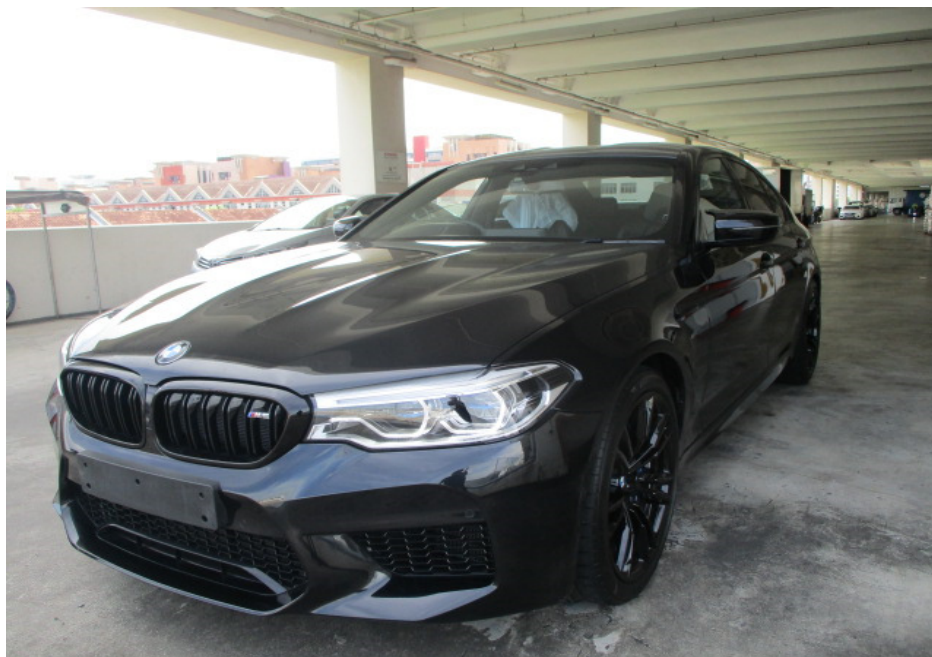
**Photo 10** shows a general view of the front left body of the Motor Car at the time of my inspection. The Motor Car was observed to be in a relatively good general condition with no loose exterior fittings observed. The mileage of the Motor Car recorded at the time of my inspection was 2,737km.

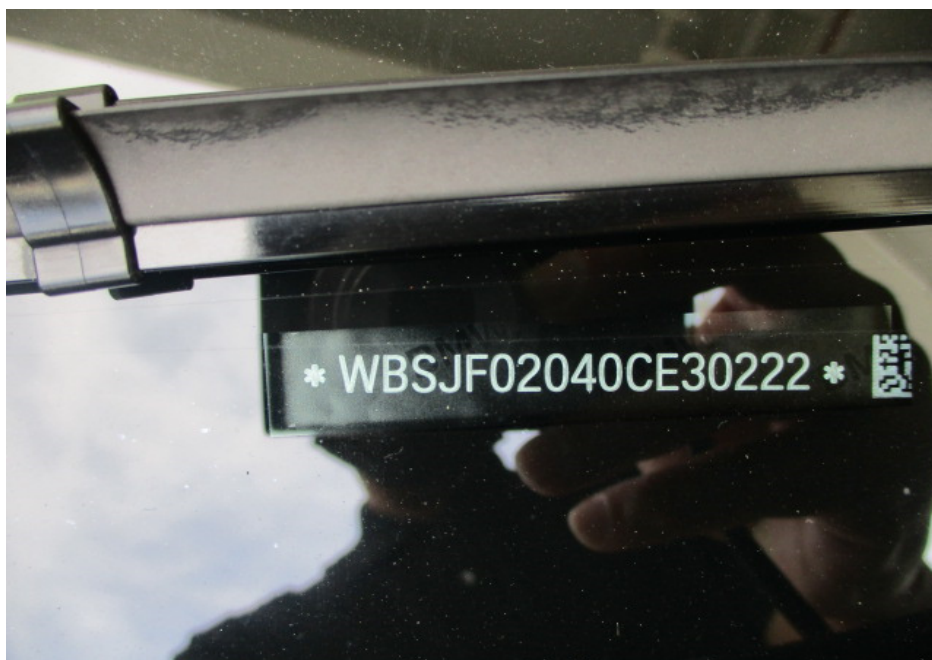
**Photo 11** shows the chassis number of the Motor Car. The chassis number recorded was WBSJF02040CE30222.

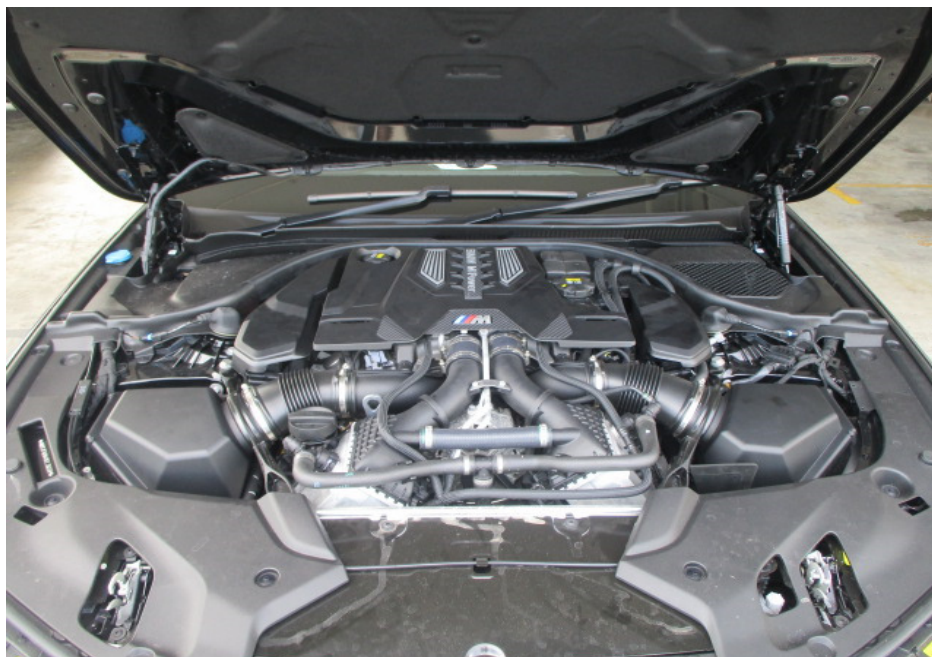
**Photo 12** shows a general view of the engine compartment of the Motor Car at the time of my inspection. The various parts and components inside the engine compartment were all observed to be intact and properly fitted. There was also no sign(s) or indication(s) of fluid leak and/or fluid stain found inside the engine compartment.

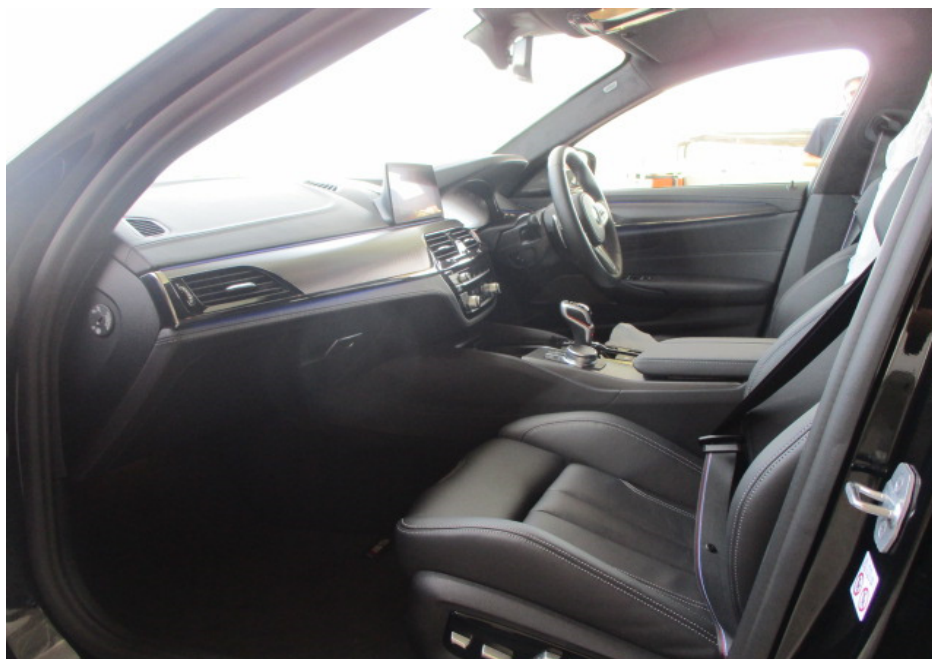
**Photo 13** shows the interior compartment of the Motor Car at the time of my inspection. The various parts and components, trims, carpet and upholstery inside the interior compartment were all observed to be intact and properly fitted.

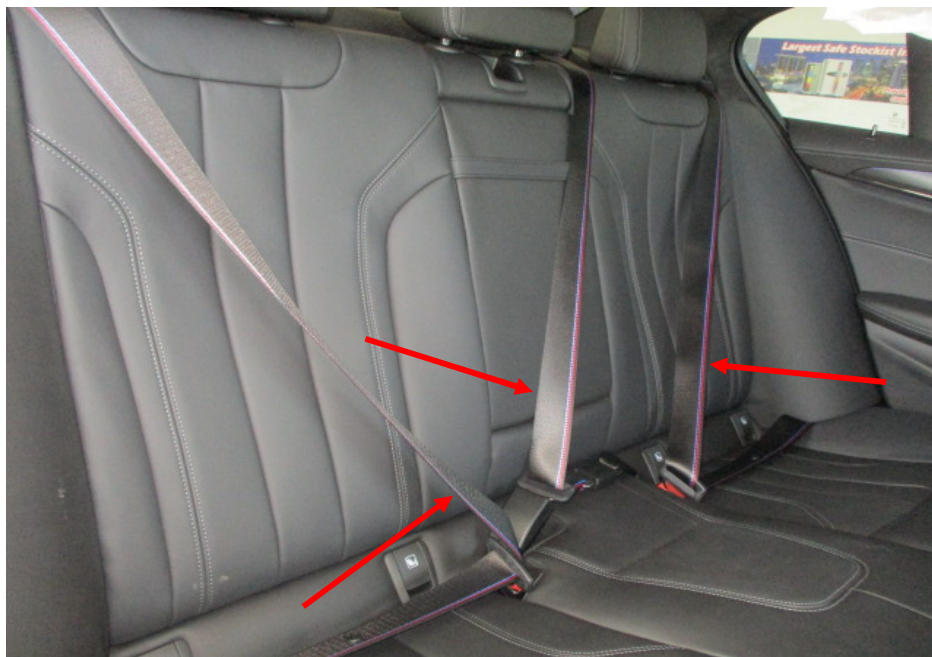
**Photo 14** shows the rear seats of the Motor Car. All the seats of the Motor Car were secured via seat rails to the floorboard. They were also fitted with a retractable seat belt reel and a pre-tensioner. The seat belts (arrowed) were tested and were able to be fastened into the respective pre-tensions that were fitted on the side of each individual seat.

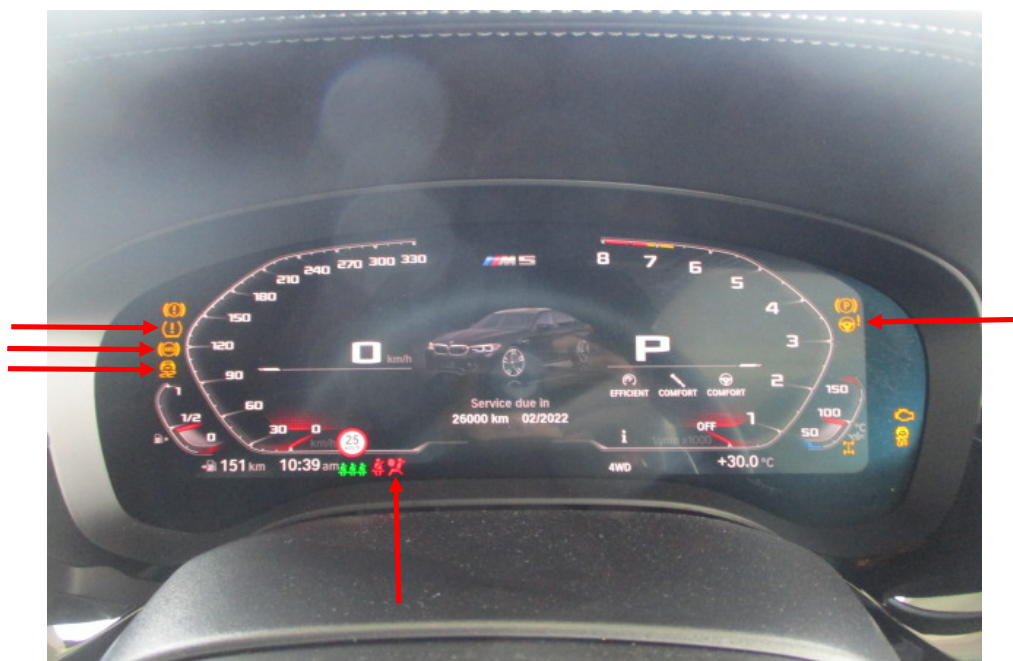
**Photo 15** shows the warning lights for the various electronic safety features appearing on the instrument panel of the Motor Car during its self-test when the engine is cranked, in particular the ABS, SRS, IAS, TPM and DSC lights (arrowed).

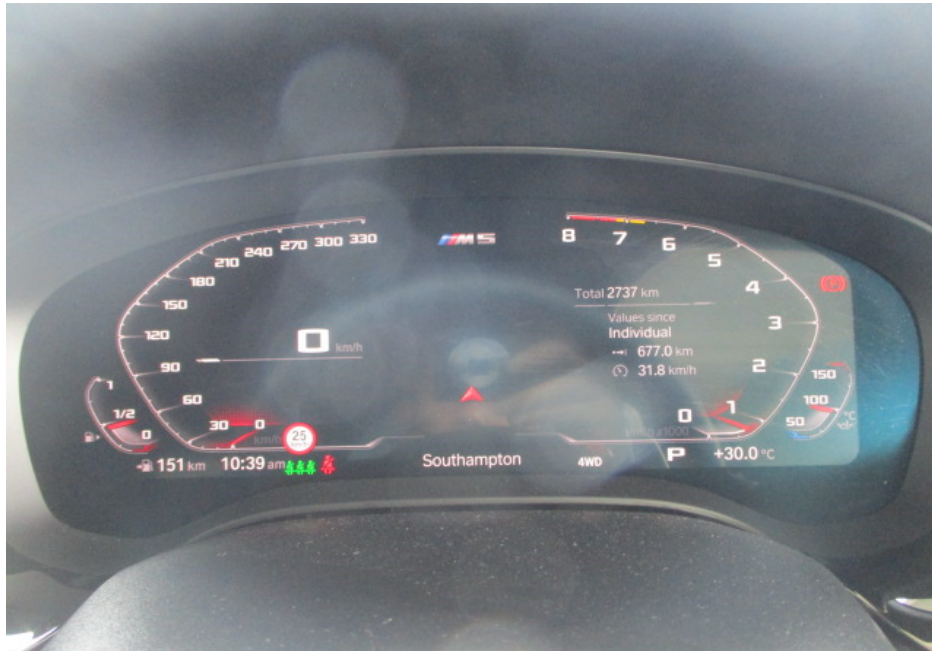
**Photo 16** shows the respective warning lights no longer illuminated, indicating that there is no fault detected to the ABS, SRS, IAS, TPM and DSC systems of the Motor Car during the self-test. These electronic systems were hence in working condition at the time of my inspection.

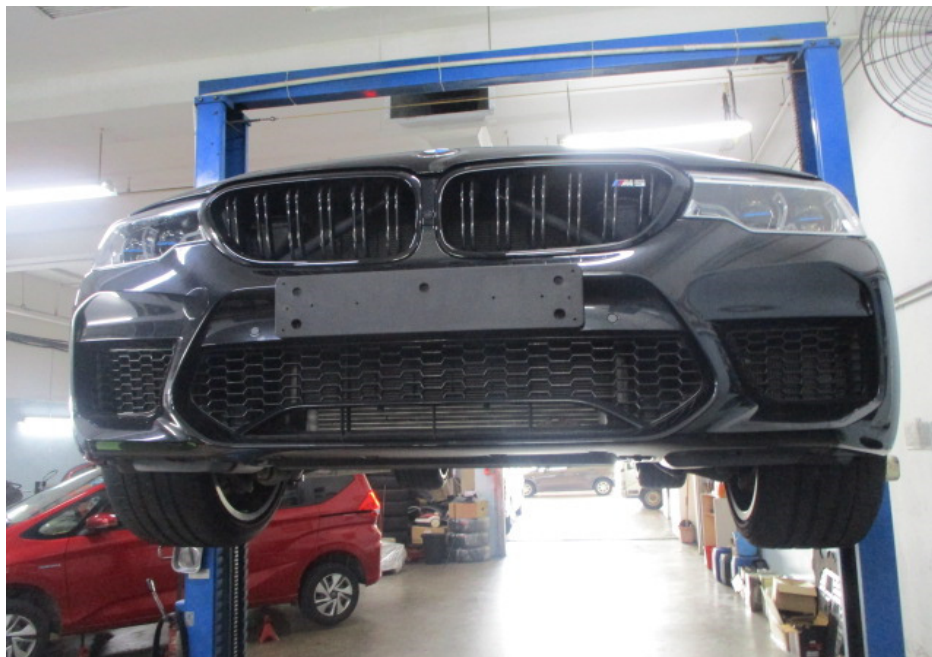
**Photo 17** shows the Motor Car hoisted up for checks on its undercarriage. There was no sign(s) or indication(s) of fluid leakage and/or fluid stain(s) on the underside of the Motor Car. The undercarriage components of the Motor Car were also all observed to be intact and secured in an appropriate manner.

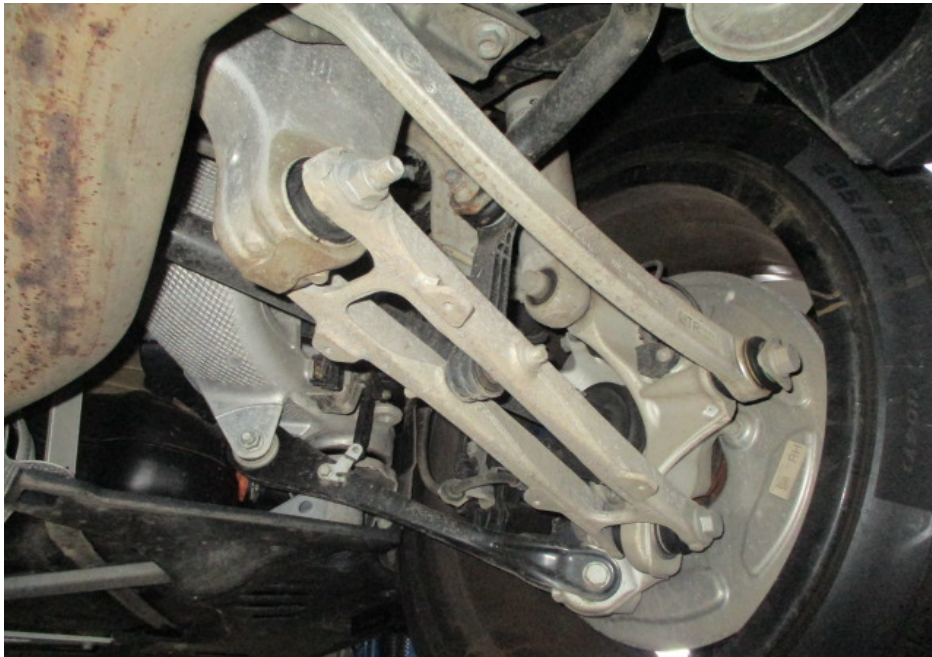
**Photo 18** shows a general view of the control arms and linkages at the rear right wheel of the Motor Car. I did not observe any fluid leak and/or fluid stain on the underside of the Motor Car. All of the Motor Car's undercarriage components were observed to be intact and secured in an appropriate manner.

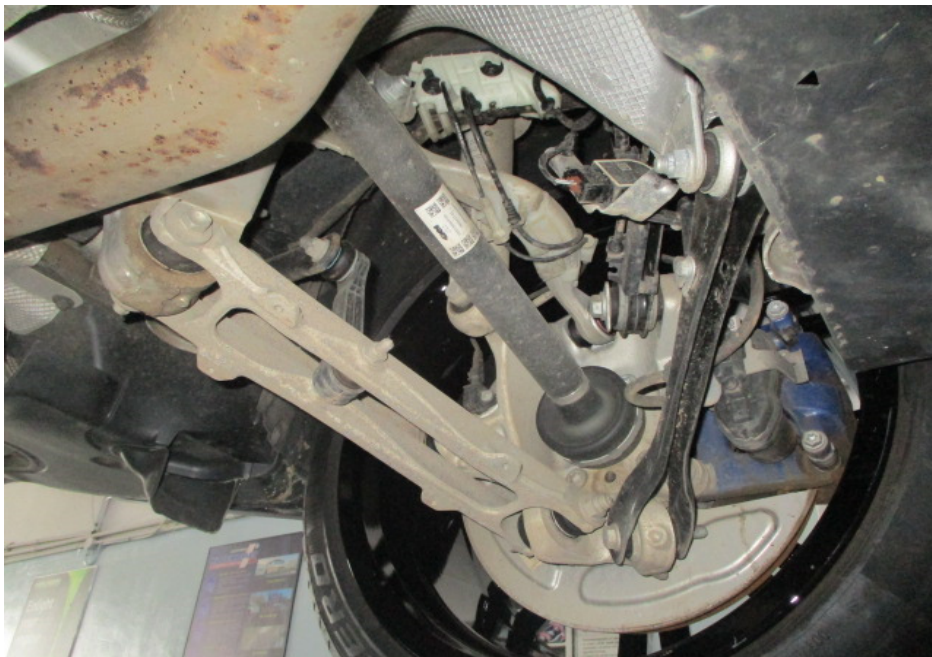
**Photo 19** shows a general view of the control arms and linkages at the rear left wheel of the Motor Car. I did not observe any fluid leak and/or fluid stain on the underside of the Motor Car. All of the Motor Car's undercarriage components were observed to be intact and secured in an appropriate manner.

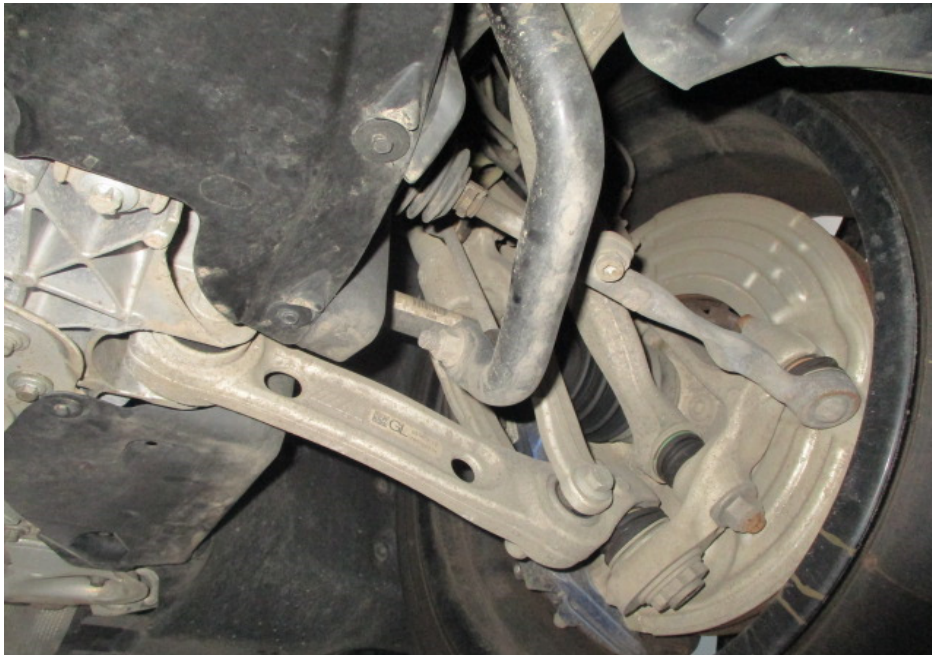
**Photo 20** shows the various undercarriage components at the front left wheel of the Motor Car. The mechanical components, control arms and linkages were all found to be intact and secured in an appropriate manner.

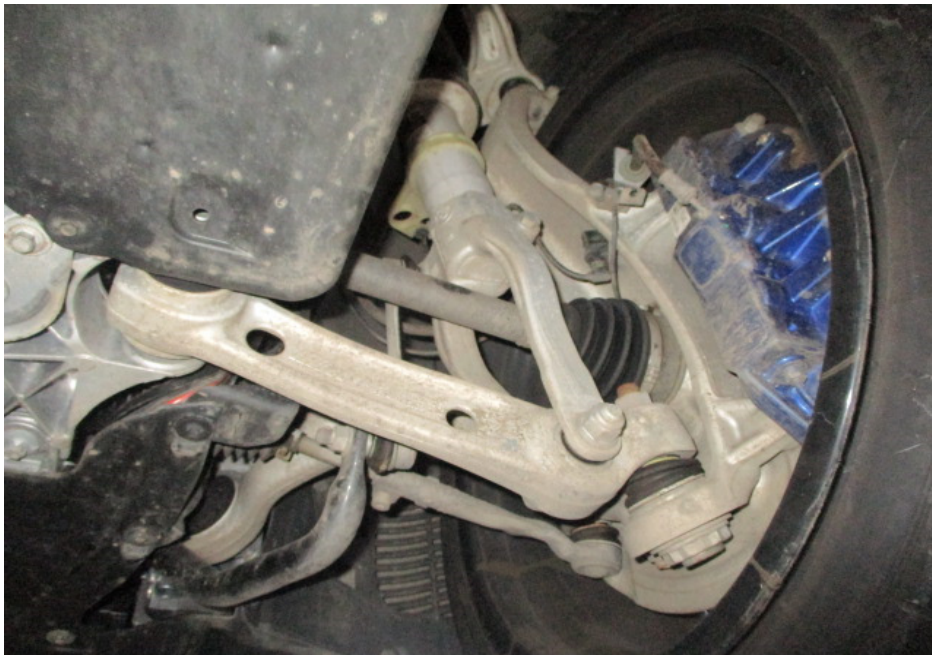
**Photo 21** shows the various undercarriage components at the front right wheel of the Motor Car. The mechanical components, control arms and linkages were all found to be intact and secured in an appropriate manner. I also did not observe any fluid leak and/or fluid stain on the underside of the Motor Car.

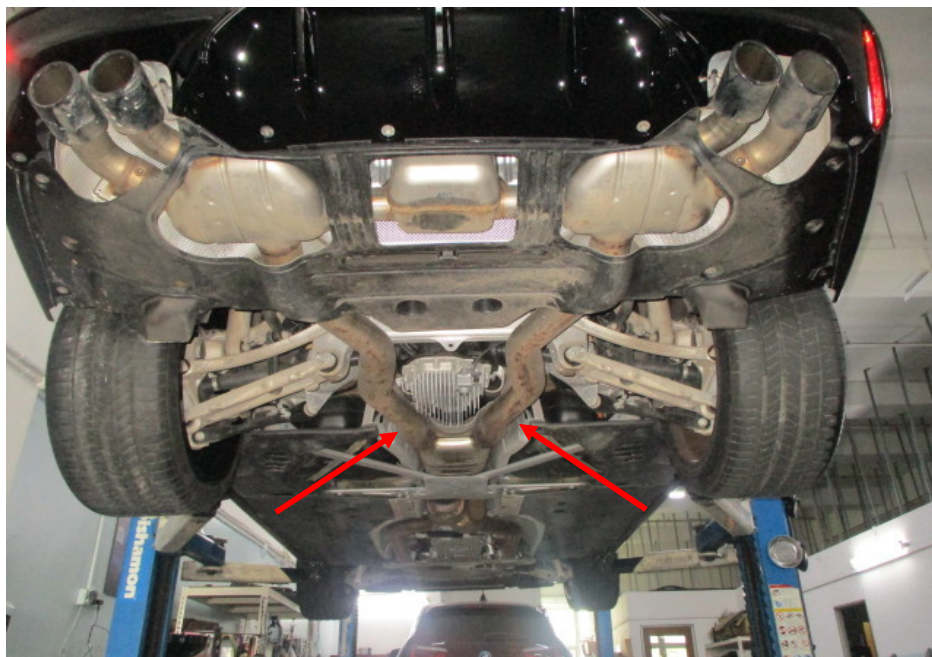
**Photo 22** shows a general view of the rear section of the Motor Car's exhaust system. My examination of the Motor Car's exhaust system revealed no sign(s) or indication(s) of any cut or weld marks along its exhaust pipes (arrowed), on its centre resonators boxes, on its catalytic converters and on its rear mufflers.

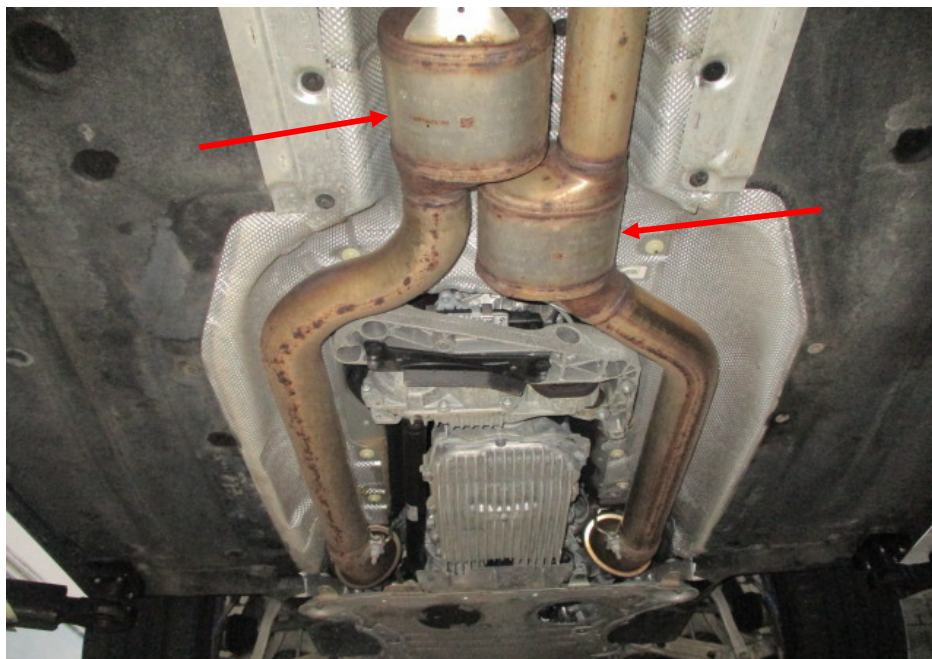
**Photo 23** shows a general view of the front section of the Motor Car's exhaust system. My examination of the Motor Car's exhaust system revealed no sign(s) or indication(s) of any cut or weld marks along its exhaust pipes, on its centre resonators boxes (arrowed), on its catalytic converters and on its rear mufflers.

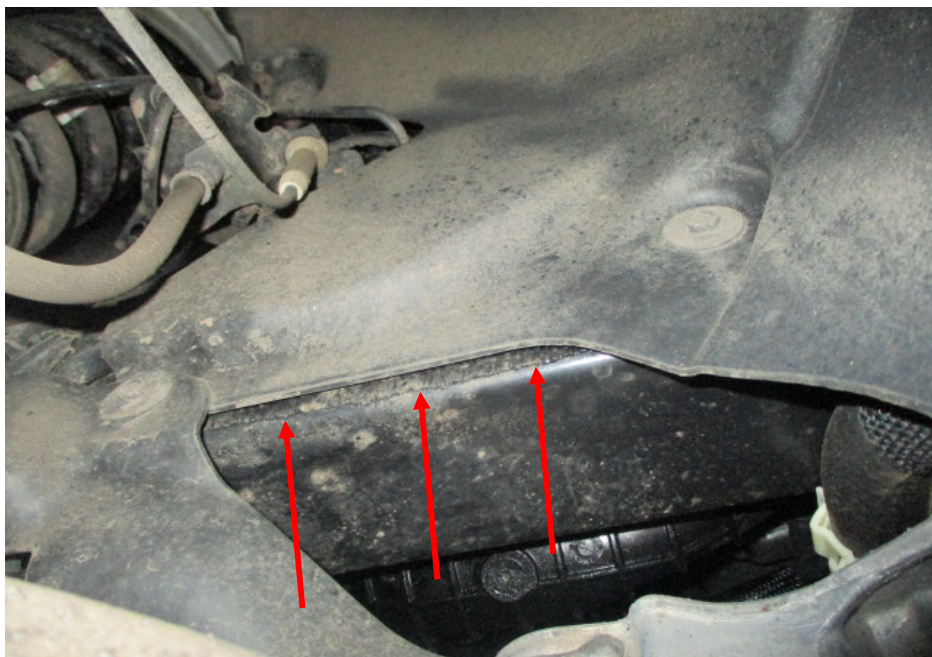
**Photo 24** shows the chassis/structural body at the underside front right of the Motor Car. I did not find any weld marks other than original spot weld marks on the chassis/structural body of the Motor Car. The original factory sealant (arrowed) at the joints along the chassis/structural body was untouched, indicating no work was done on the chassis/structural body of the Motor Car and that the chassis/structural body was originally fitted.

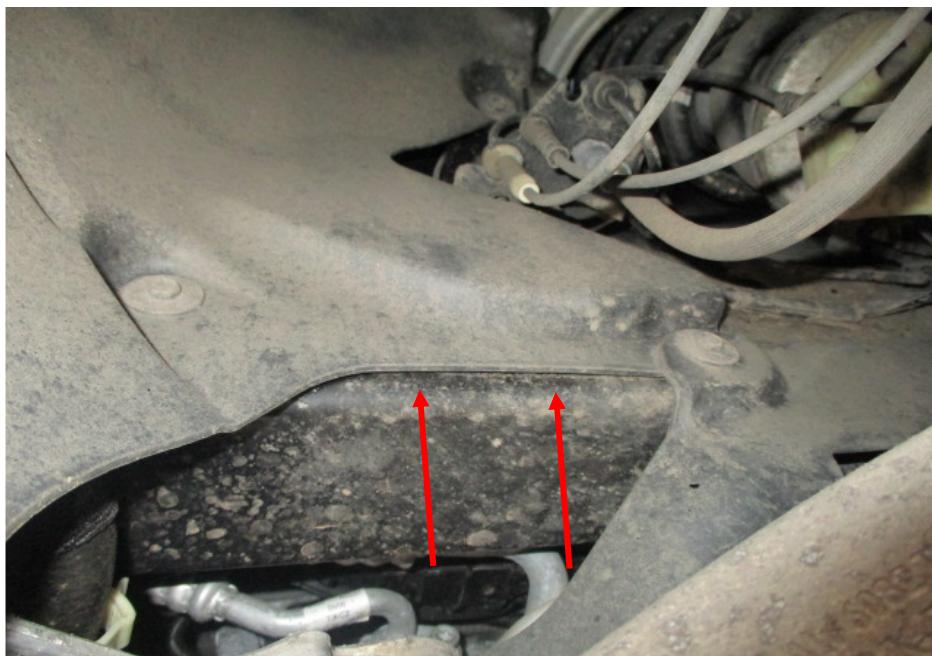
**Photo 25** shows the chassis/structural body at the underside front left of the Motor Car. The original factory sealant (arrowed) at the joints along the chassis/structural body was observed to be untouched. In general, I had found no work was carried out on the chassis/structural body of the Motor Car. The chassis/structural body of the Motor Car was originally fitted.

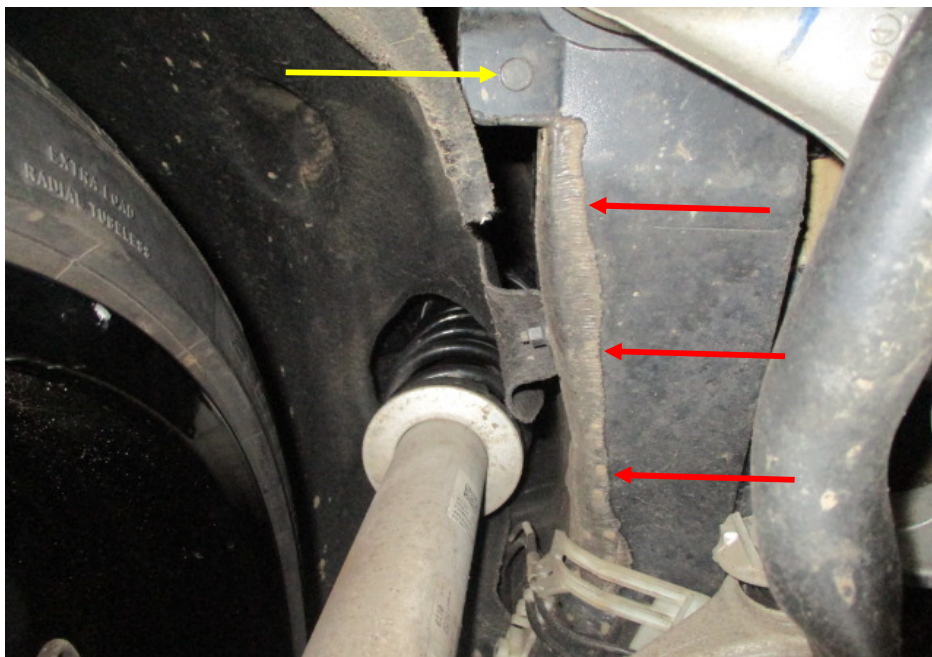
**Photo 26** shows the chassis/structural body at the underside rear left of the Motor Car. I did not find any weld marks other than original spot weld marks (yellow arrow) on the chassis/structural body of the Motor Car. The original factory sealant (red arrow) at the joints along the chassis/structural body was untouched, indicating no work was done on the chassis/structural body of the Motor Car and that the chassis/structural body was originally fitted.

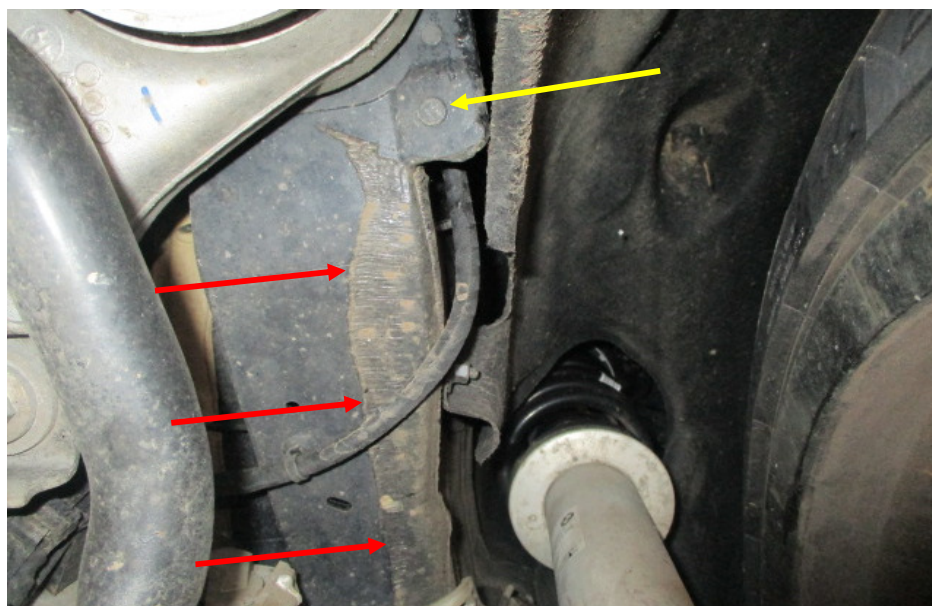
**Photo 27** shows the chassis/structural body at the underside rear right of the Motor Car. I did not find any weld marks other than original spot weld marks (yellow arrow) on the chassis/structural body of the Motor Car. The original factory sealant (red arrow) at the joints along the chassis/structural body was untouched, indicating no work was done on the chassis/structural body of the Motor Car and that the chassis/structural body was originally fitted.

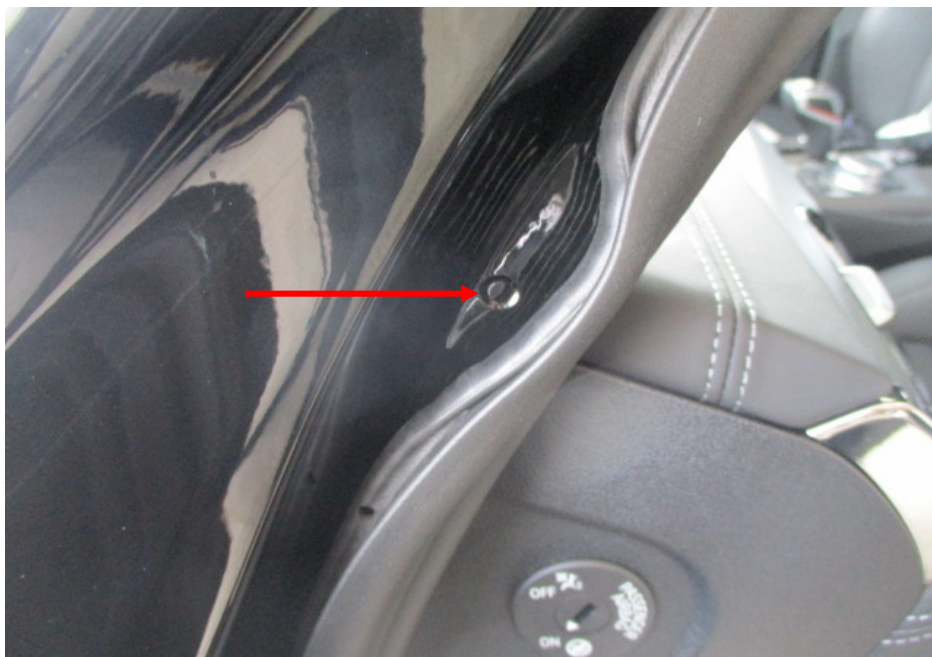
**Photo 28** shows the left side "A" pillar of the Motor Car. I did not find any weld marks other than original spot weld marks (arrowed) on the left side "A" pillar of the Motor Car which, indicates that there was no re-welding works carried out. In general, I had found all the non-detachable body panels of the Motor Car to be originally fitted at the time of my inspection.

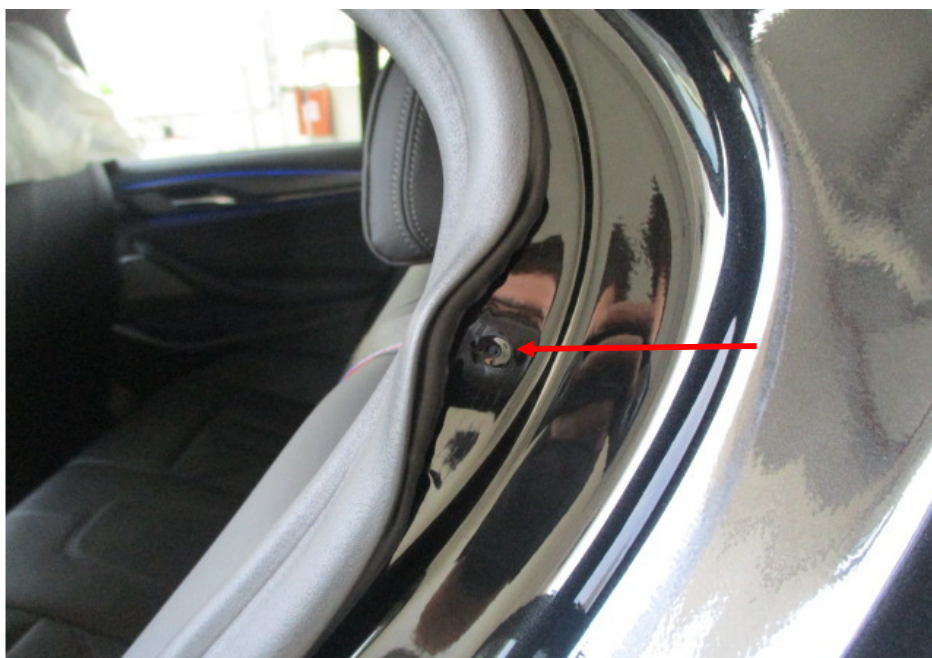
**Photo 29** shows the left side "C" pillar of the Motor Car. I did not find any weld marks other than original spot weld marks (arrowed) on the left side "C" pillar of the Motor Car which, indicates that there was no re-welding works carried out. In general, I had found all the non-detachable body panels of the Motor Car to be originally fitted at the time of my inspection.

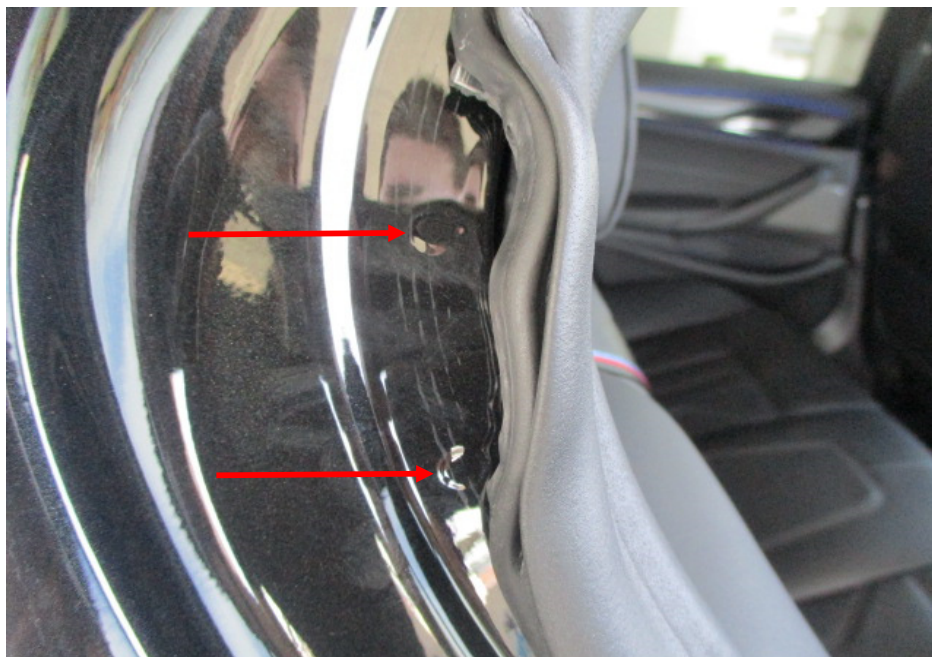
**Photo 30** shows the right side "C" pillar of the Motor Car. I did not find any weld marks other than original spot weld marks (arrowed) on the right side "C" pillar of the Motor Car which, indicates that there was no re-welding works carried out. In general, I had found all the non-detachable body panels of the Motor Car to be originally fitted at the time of my inspection.
