Your Ref: BMW 850i  
(chassis number WBAGV82010BU60300)  
Our Ref : CI/TP21011841/D

22 November 2021

**INSPECTION REPORT OF AN UNREGISTERED BMW 850i MOTOR CAR  
WITH CHASSIS NUMBER WBAGV82010BU60300**

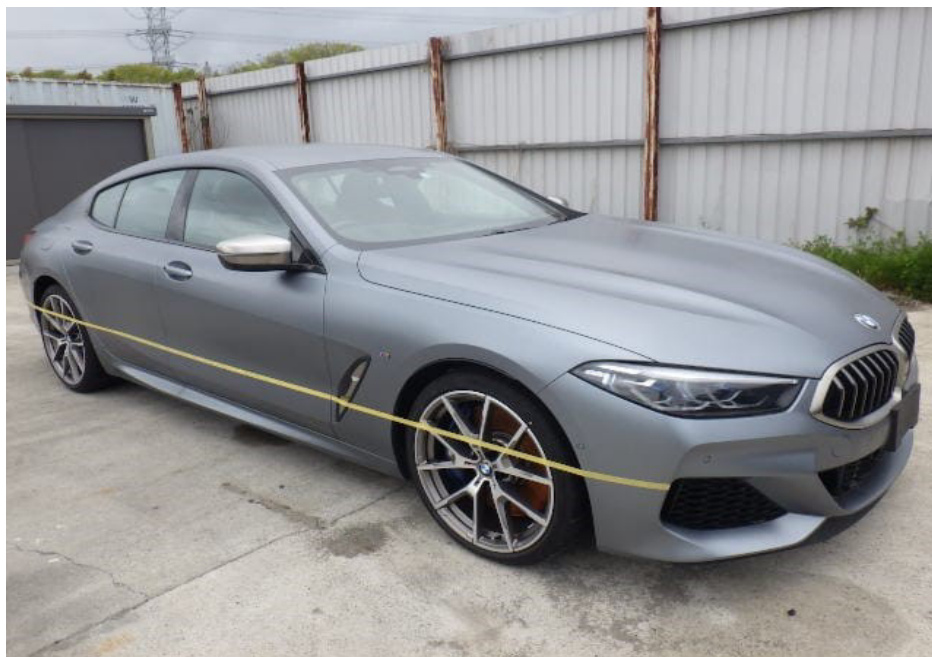
**Photo 1** shows the front right body of the Motor Car (photograph provided to me). The Motor Car was observed to be without any physical damage. The airbags were also not deployed.

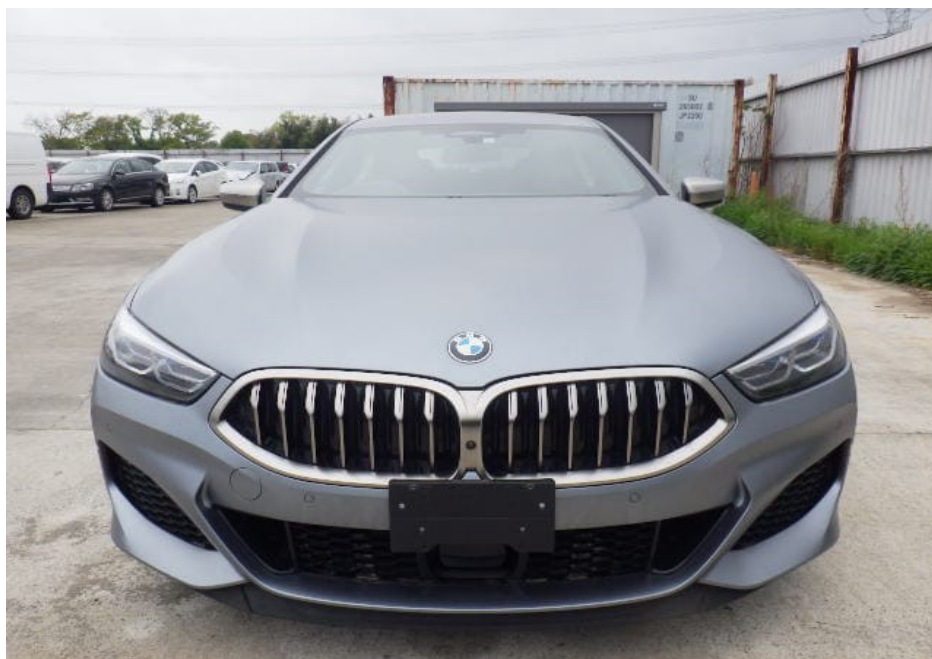
**Photo 2** shows the frontal body of the Motor Car (photograph provided to me). The Motor Car was observed to be without any physical damage. The airbags were also not deployed.

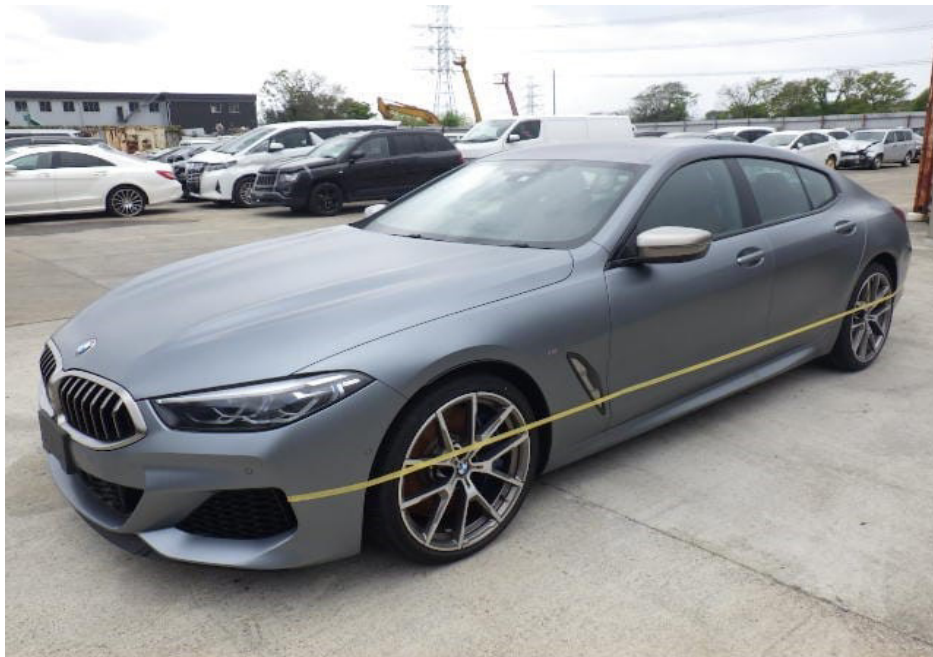
**Photo 3** shows the front left body of the Motor Car (photograph provided to me). The Motor Car was observed to be without any physical damage. The airbags were also not deployed.

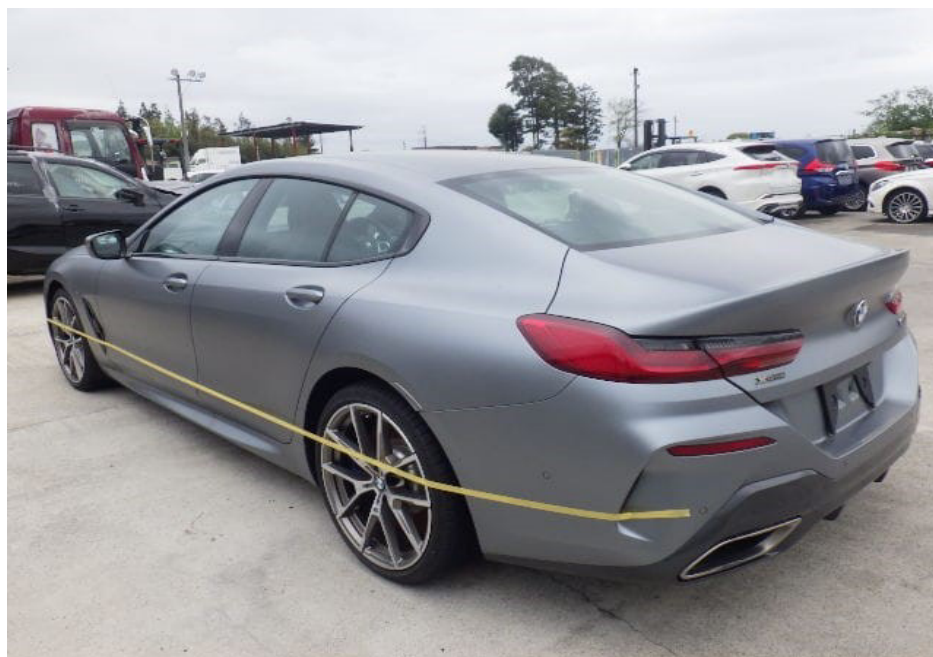
**Photo 4** shows the rear left body of the Motor Car (photograph provided to me). The Motor Car was observed to be without any physical damage. The airbags were also not deployed.

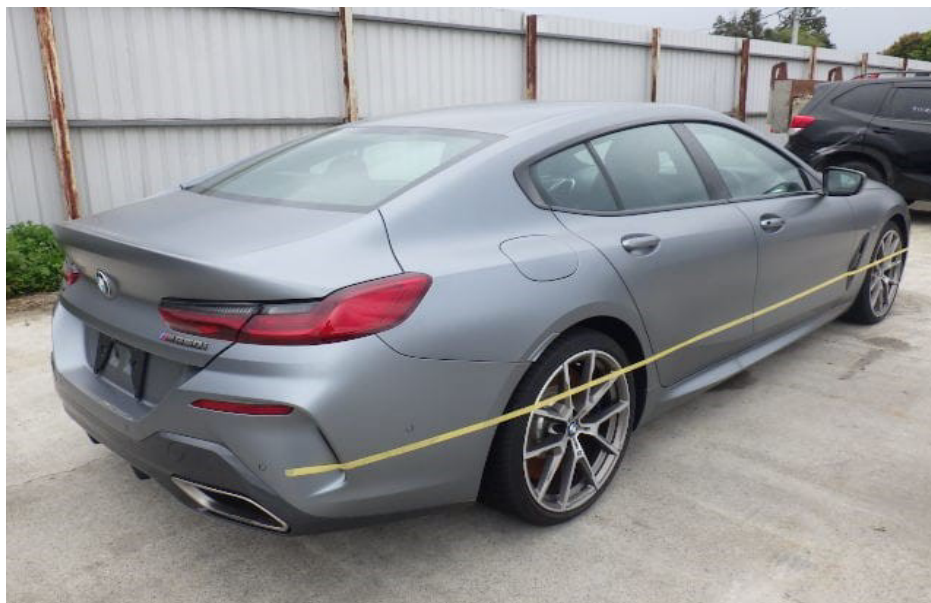
**Photo 5** shows the rear right body of the Motor Car (photograph provided to me). The Motor Car was observed to be without any physical damage. The airbags were also not deployed.

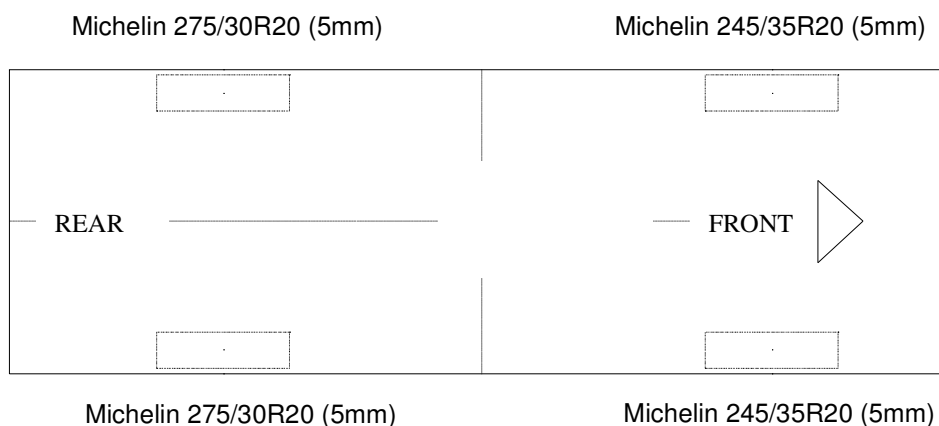
7. It was fitted with 20inch sport wheel rims that were wrapped with tyres that were observed to be of serviceable condition. The tyres were also sufficiently inflated for vehicular operation. The tyre brand, tyre size and approximate remaining tread depth of the 4 tyres of the Motor Car were recorded as follows: -

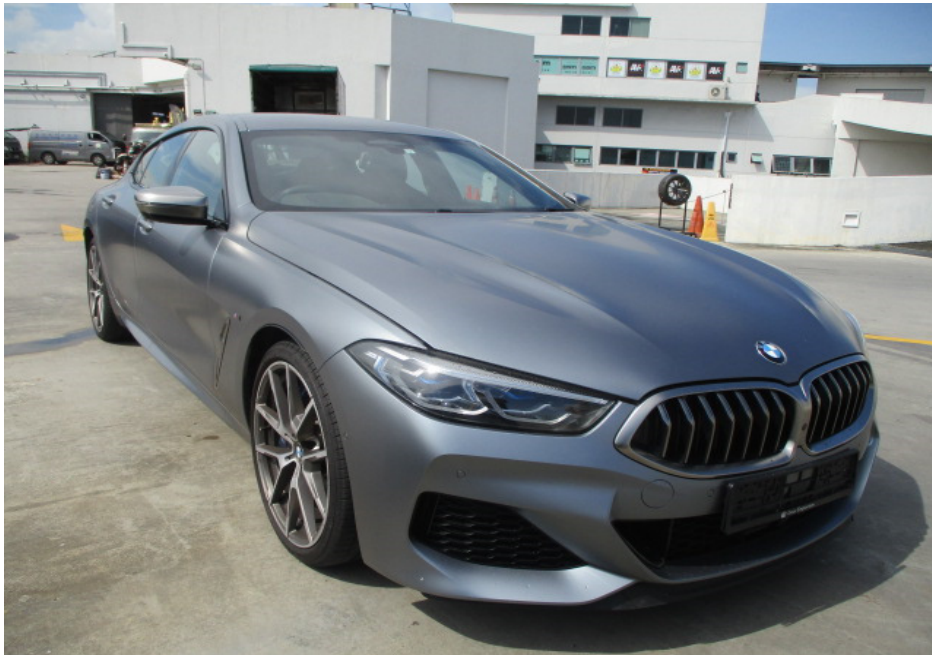
**Photo 6** shows a general view of the front right body of the Motor Car at the time of my inspection. The Motor Car was observed to be in a relatively good general condition with no loose exterior fittings observed. The mileage of the Motor Car recorded at the time of my inspection was 3,663km.

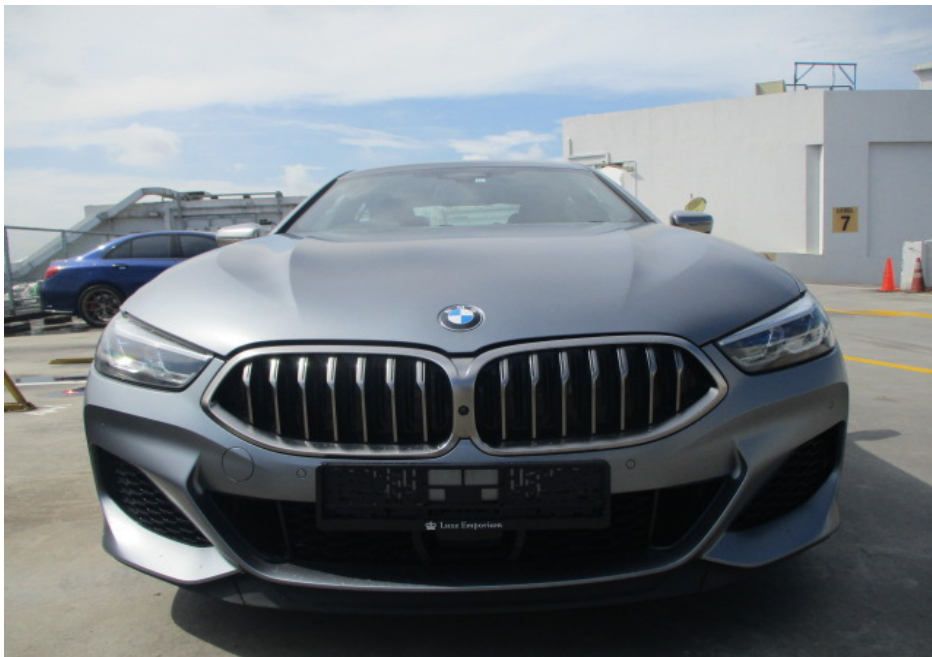
**Photo 7** shows a general view of the frontal body of the Motor Car at the time of my inspection. The Motor Car was observed to be in a relatively good general condition with no loose exterior fittings observed. The mileage of the Motor Car recorded at the time of my inspection was 3,663km.

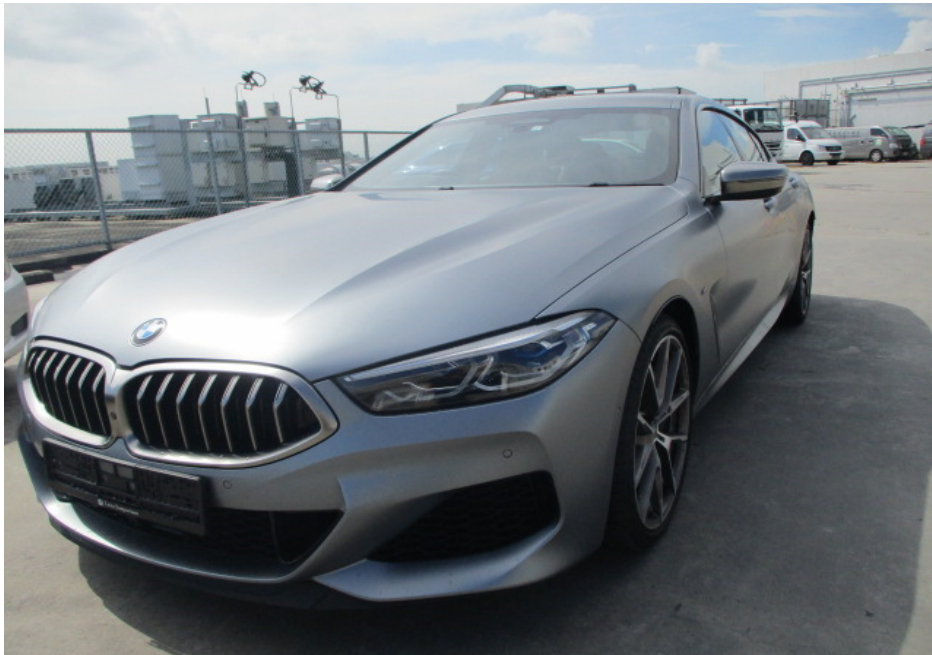
**Photo 8** shows a general view of the front left body of the Motor Car at the time of my inspection. The Motor Car was observed to be in a relatively good general condition with no loose exterior fittings observed.

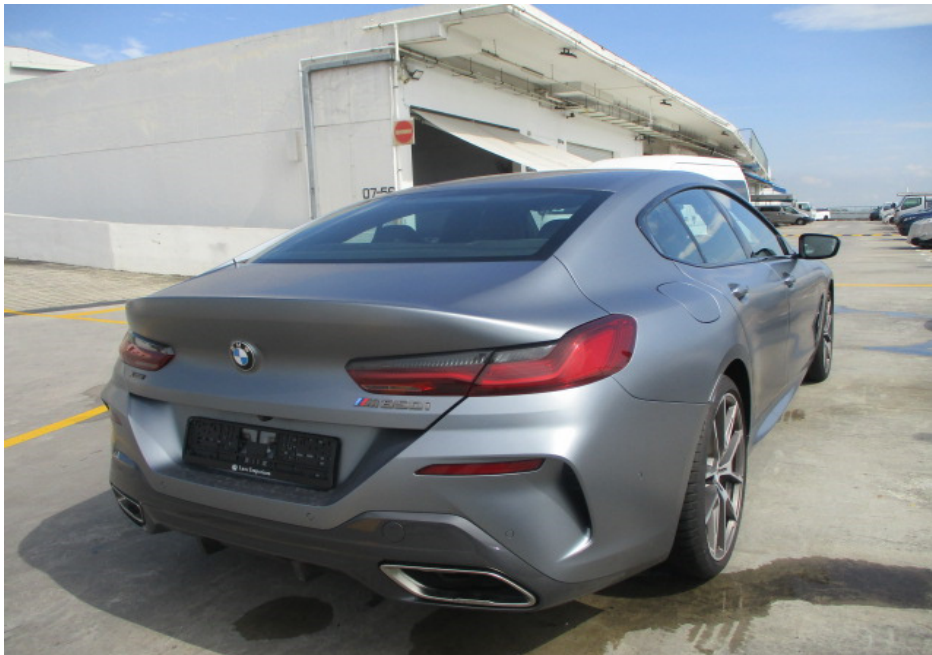
**Photo 9** shows a general view of the rear right body of the Motor Car at the time of my inspection. The Motor Car was observed to be in a relatively good general condition with no loose exterior fittings observed. The mileage of the Motor Car recorded at the time of my inspection was 3,663km.

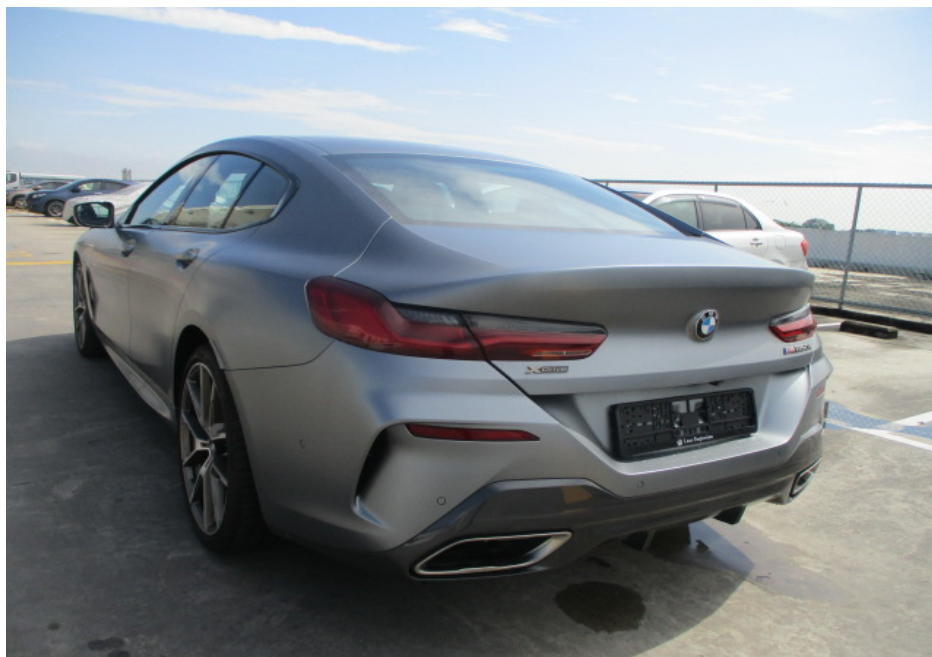
**Photo 10** shows a general view of the rear left body of the Motor Car at the time of my inspection. The Motor Car was observed to be in a relatively good general condition with no loose exterior fittings observed. The mileage of the Motor Car recorded at the time of my inspection was 3,663km.

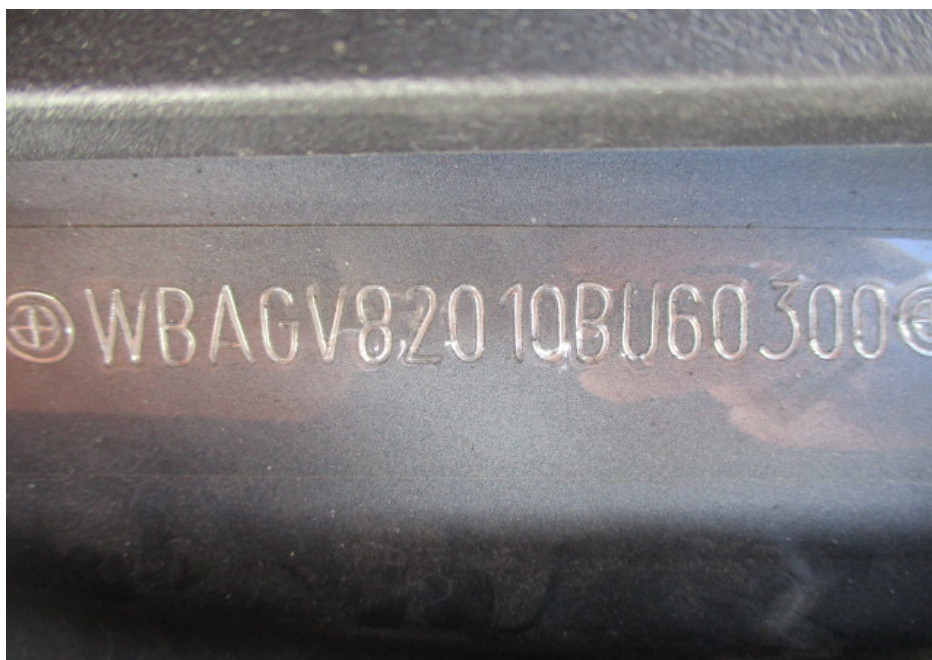
**Photo 11** shows the chassis number of the Motor Car. The chassis number recorded was WBAGV82010BU60300.

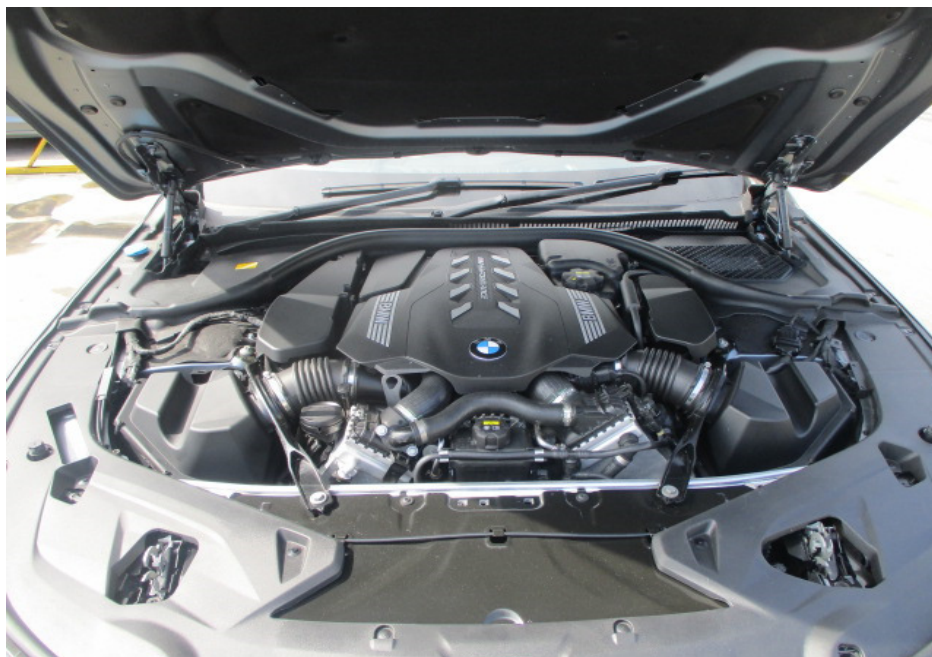
13. My examination of the engine compartment of the Motor Car revealed that the various parts and components inside the engine compartment were all intact and properly fitted. The engine oil, brake fluid and engine coolant were all found to be of sufficient level for operating purposes. Visually, there was also no contamination found to these fluids.
14. My checks on the underside of the Motor Car revealed no sign(s) or indication(s) of fluid leakage and/or fluid stain(s). The engine block and automatic transmission assembly were both secured properly. All undercarriage components of the Motor Car were also observed to be intact and secured in an appropriate manner.

**Photo 12** shows a general view of the engine compartment of the Motor Car at the time of my inspection. The various parts and components inside the engine compartment were all observed to be intact and properly fitted. There was also no sign(s) or indication(s) of fluid leak and/or fluid stain found inside the engine compartment.

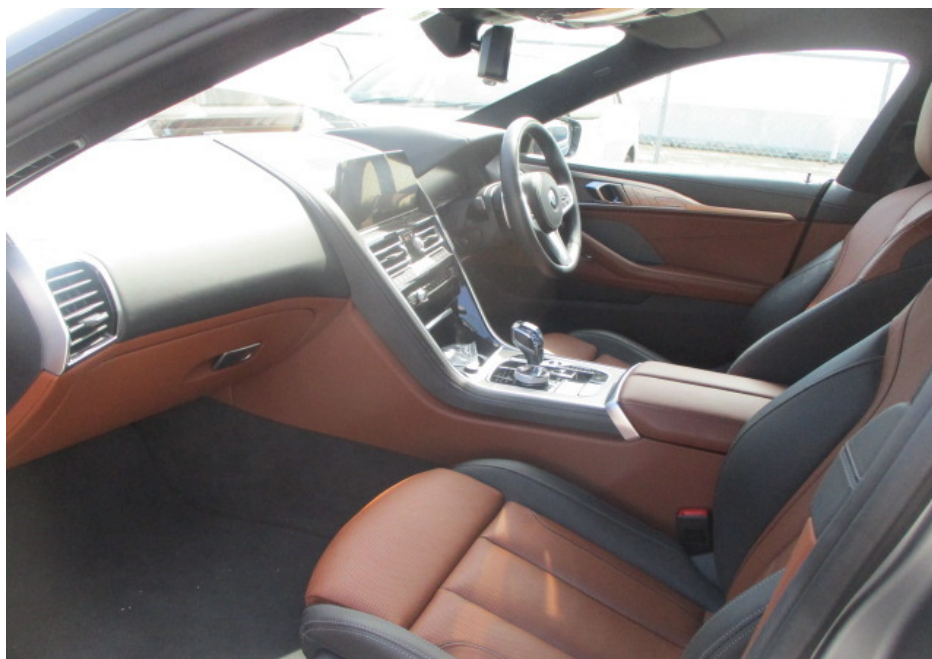
**Photo 13** shows the interior compartment of the Motor Car at the time of my inspection. The various parts and components, trims, carpet and upholstery inside the interior compartment were all observed to be intact and properly fitted.

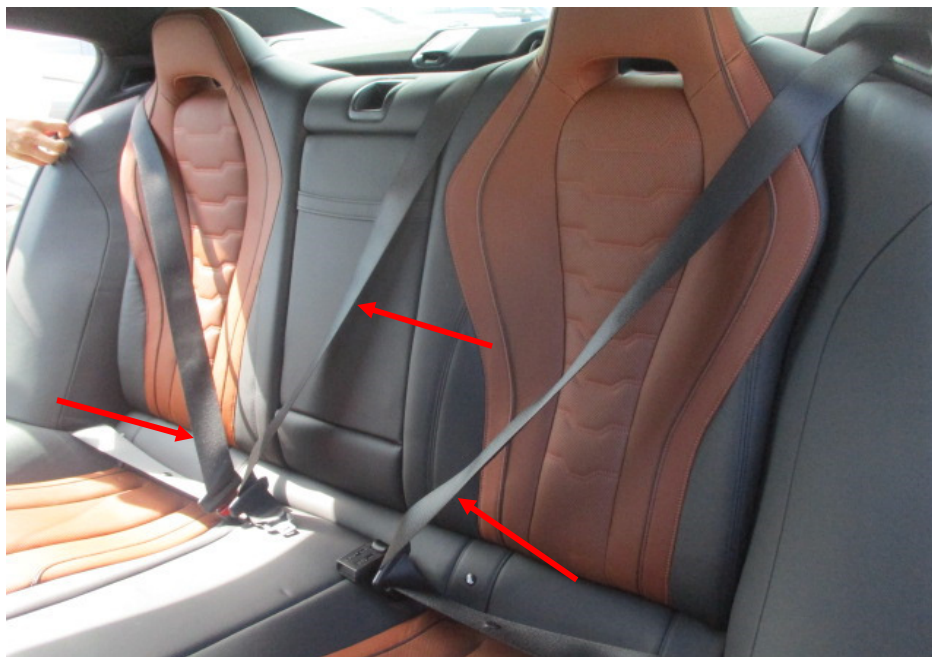
11. The seats of the Motor Car were found to be secured to the floorboard of the Motor Car via seat rails bolted onto the floorboard. Retractable seat belt reels and pre-tensioners were fitted on all seats of the Motor Car. The seat belts were tested and were able to be fastened securely into the respective pre-tensioners that were fixed to the side of all the seats.

**Photo 14** shows the rear seats of the Motor Car. All the seats of the Motor Car were secured via seat rails to the floorboard. They were also fitted with a retractable seat belt reel and a pre-tensioner. The seat belts (arrowed) were tested and were able to be fastened into the respective pre-tensions that were fitted on the side of each individual seat.

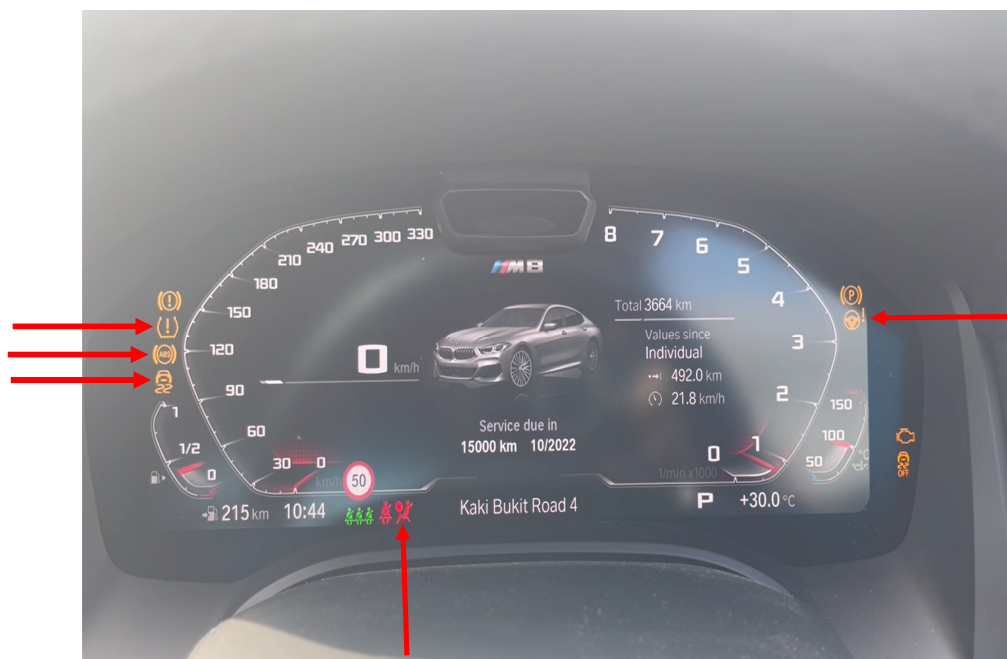
**Photo 15** shows the warning lights for the various electronic safety features appearing on the instrument panel of the Motor Car during its self-test when the engine is cranked, in particular the ABS, SRS, IAS, TPM and DSC lights (arrowed).

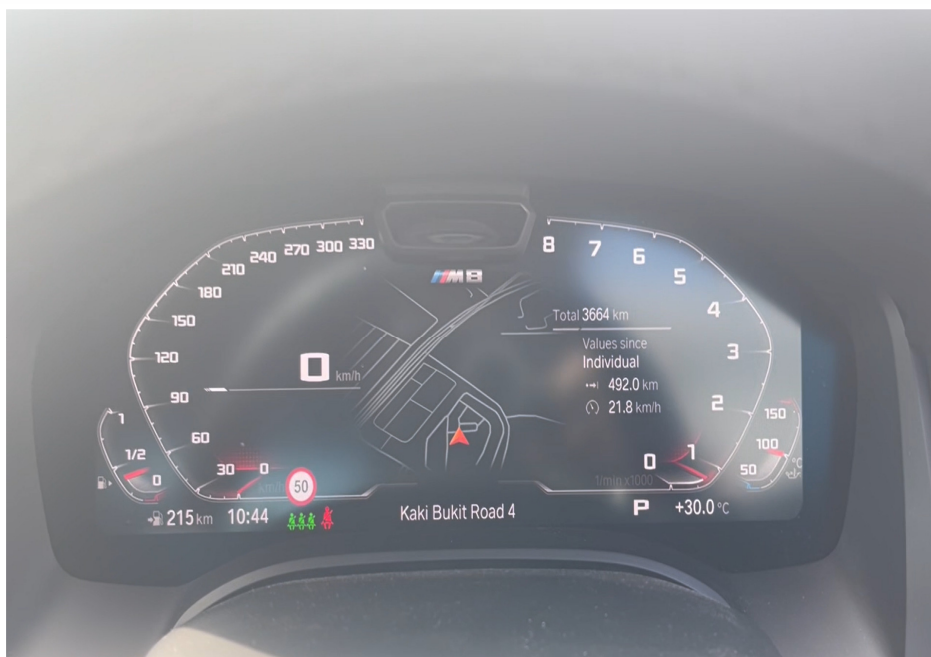
12. The Motor Car's automatic self-test of the functionality of its various electronic safety features like the Anti-Lock Brake System (ABS), Supplemental Restraint System (SRS), Integral Active Steering (IAS), Tyre Pressure Monitor (TPM) and Dynamic Stability Control (DSC) during cranking of the engine had indicated that these electronic systems were in working condition. This was determined from the respective warning lights disappearing from the instrument panel after the self-test.

**Photo 16** shows the respective warning lights no longer illuminated, indicating that there is no fault detected to the ABS, SRS, IAS, TPM and DSC systems of the Motor Car during the self-test. These electronic systems were hence in working condition at the time of my inspection.

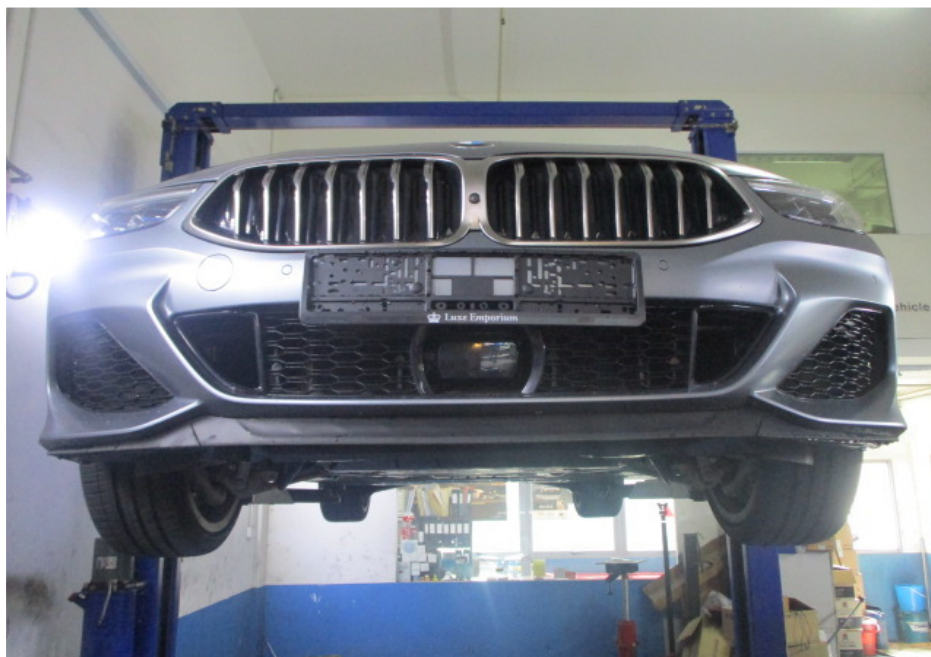
**Photo 17** shows the Motor Car hoisted up for checks on its undercarriage. There was no sign(s) or indication(s) of fluid leakage and/or fluid stain(s) on the underside of the Motor Car. The undercarriage components of the Motor Car were also all observed to be intact and secured in an appropriate manner.

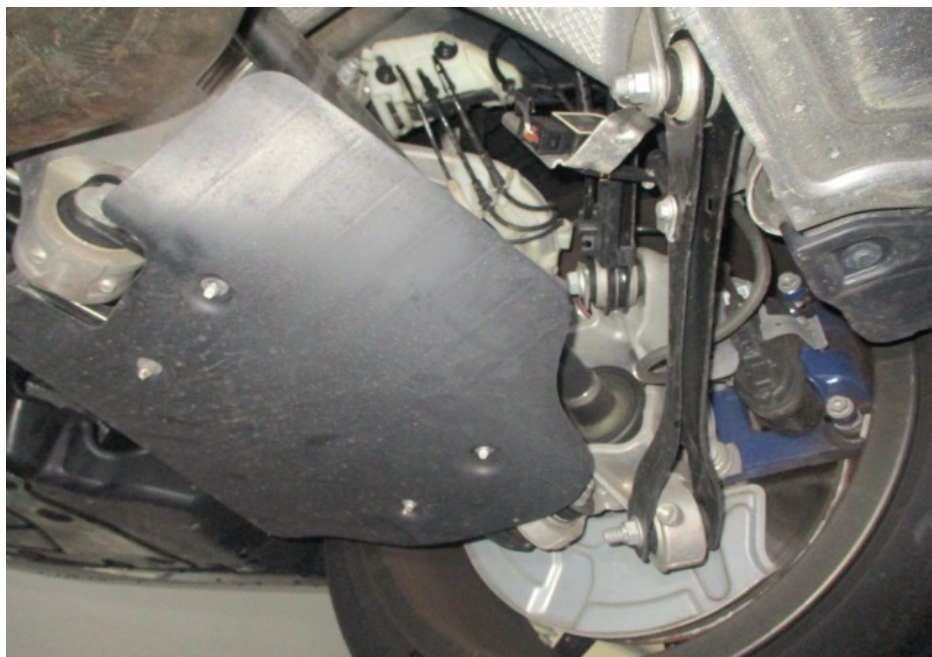
**Photo 18** shows a general view of the control arms and linkages at the rear left wheel of the Motor Car. I did not observe any fluid leak and/or fluid stain on the underside of the Motor Car. All of the Motor Car's undercarriage components were observed to be intact and secured in an appropriate manner.

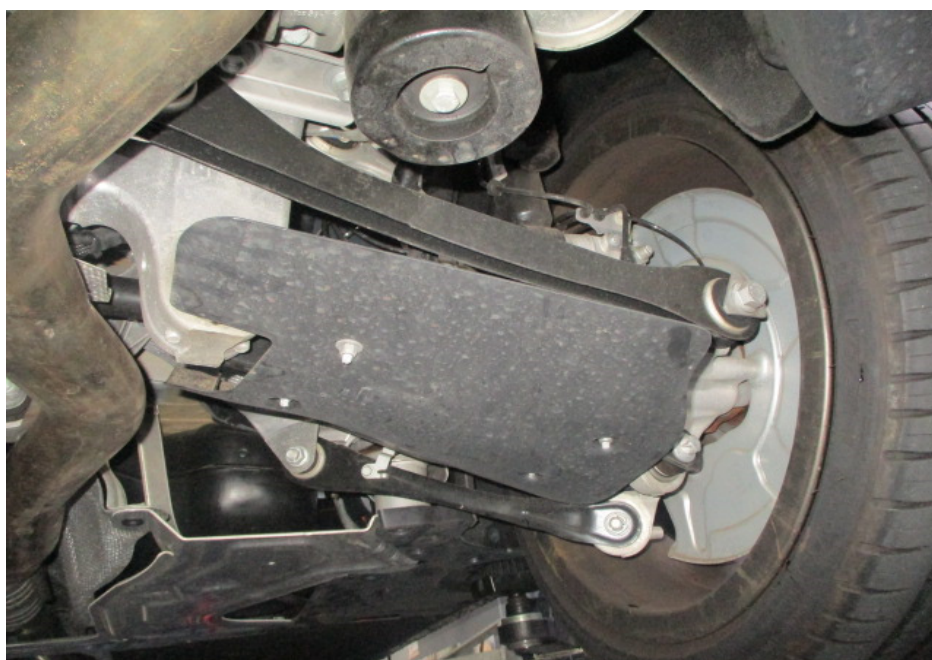
**Photo 19** shows the various undercarriage components at the rear right wheel of the Motor Car. The mechanical components, control arms and linkages were all found to be intact and secured in an appropriate manner.

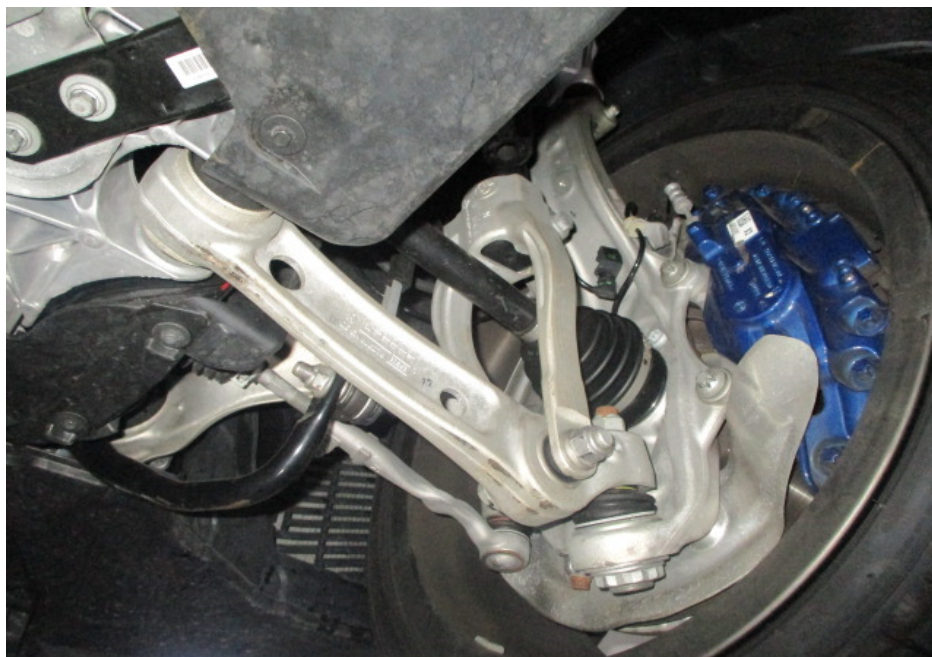
**Photo 20** shows the various undercarriage components at the front right wheel of the Motor Car. I did not observe any fluid leak and/or fluid stain on the underside of the Motor Car. All of the Motor Car's undercarriage components were observed to be intact and secured in an appropriate manner.

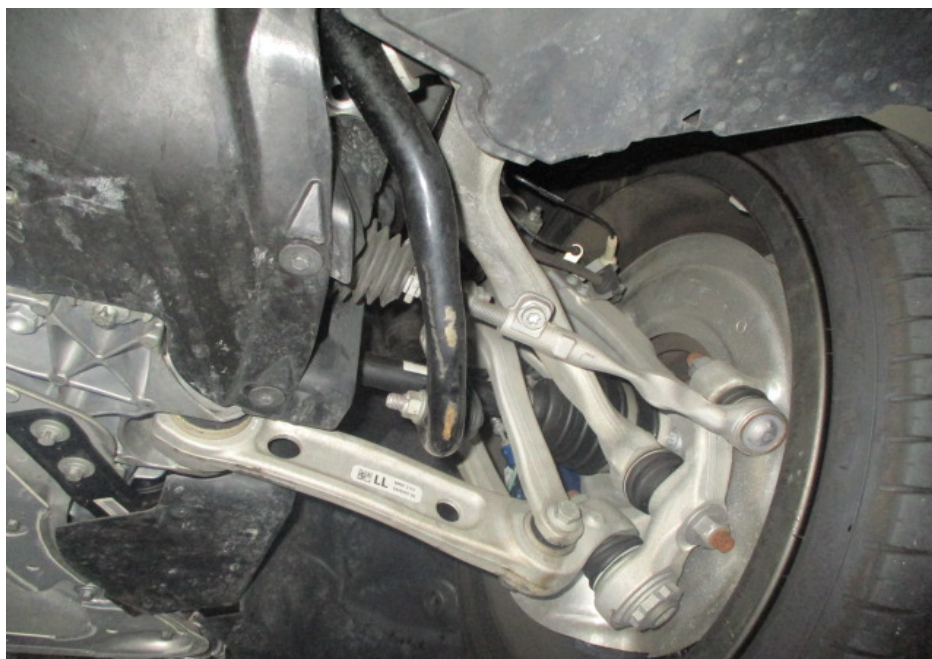
**Photo 21** shows the various undercarriage components at the front left wheel of the Motor Car. The mechanical components, control arms and linkages were all found to be intact and secured in an appropriate manner. I also did not observe any fluid leak and/or fluid stain on the underside of the Motor Car.

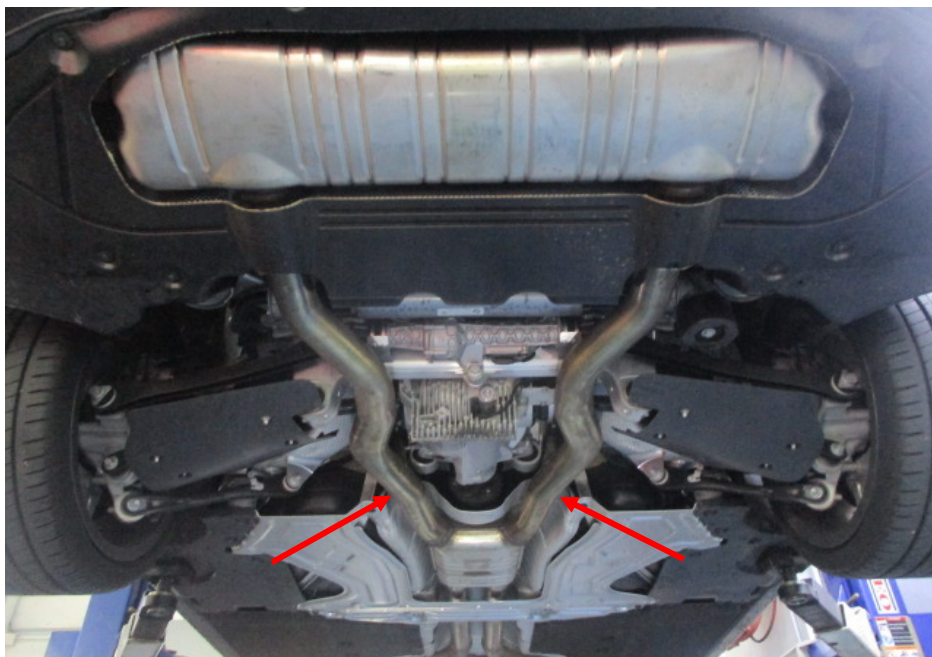
**Photo 22** shows the rear section of the Motor Car's exhaust system. My examination of the Motor Car's exhaust system revealed no sign(s) or indication(s) of any cut or weld marks along its exhaust pipes (arrowed), on its centre resonator box, on its rear muffler and on its catalytic converters.

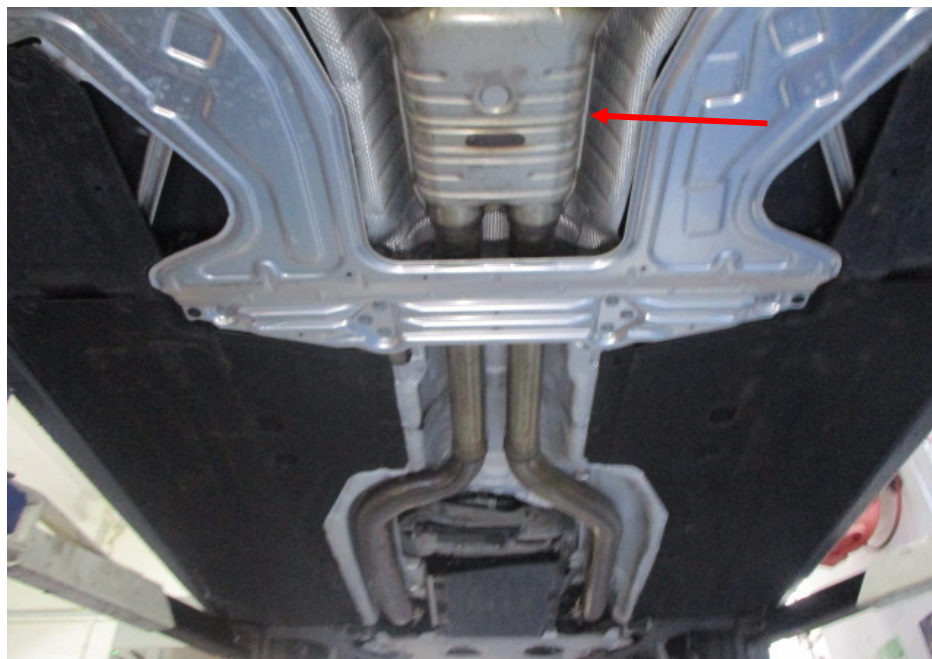
**Photo 23** shows the front section of the Motor Car's exhaust system. My examination of the Motor Car's exhaust system revealed no sign(s) or indication(s) of any cut or weld marks along its exhaust pipes, on its centre resonator box (arrowed), on its rear muffler and on its catalytic converters.

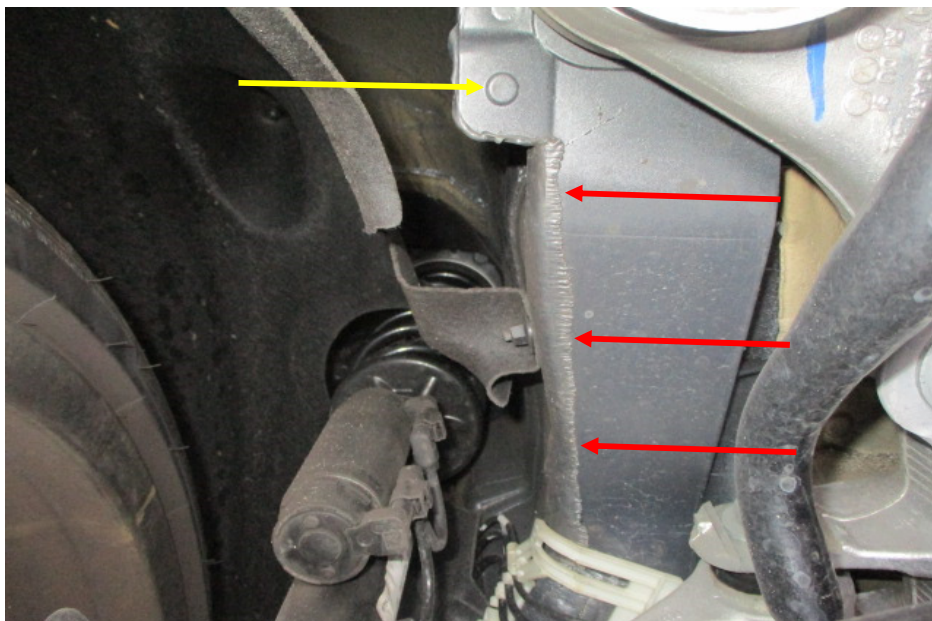
**Photo 24** shows the chassis/structural body at the underside rear left of the Motor Car. I did not find any weld marks other than original spot weld marks (yellow arrow) on the chassis/structural body of the Motor Car. The original factory sealant (red arrow) at the joints along the chassis/structural body was untouched, indicating no work was done on the chassis/structural body of the Motor Car and that the chassis/structural body was originally fitted.

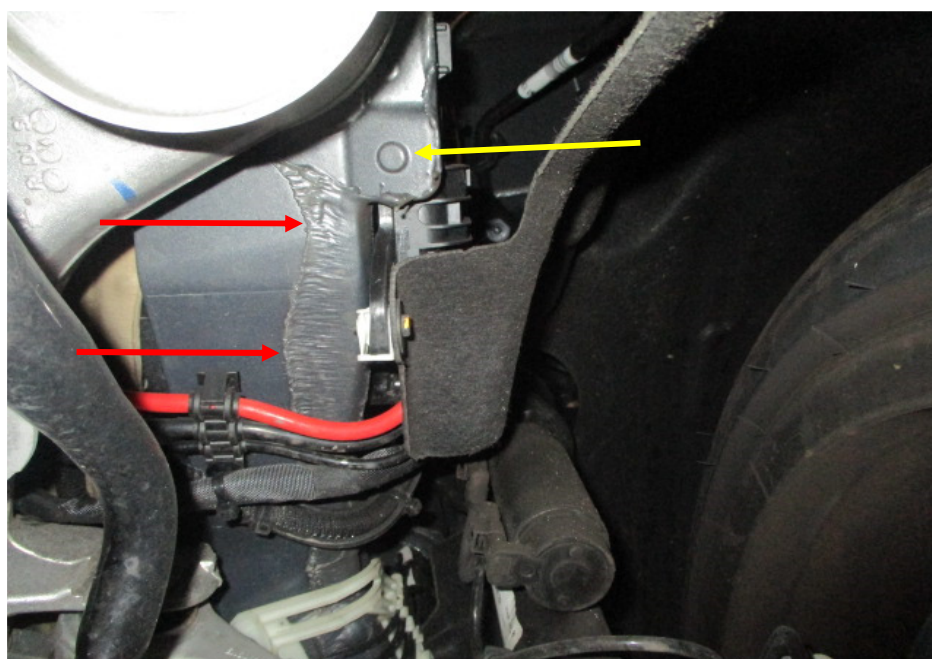
**Photo 25** shows the chassis/structural body at the underside rear right of the Motor Car. I did not find any weld marks other than original spot weld marks (yellow arrow) on the chassis/structural body of the Motor Car. The original factory sealant (red arrow) at the joints along the chassis/structural body was untouched, indicating no work was done on the chassis/structural body of the Motor Car and that the chassis/structural body was originally fitted.

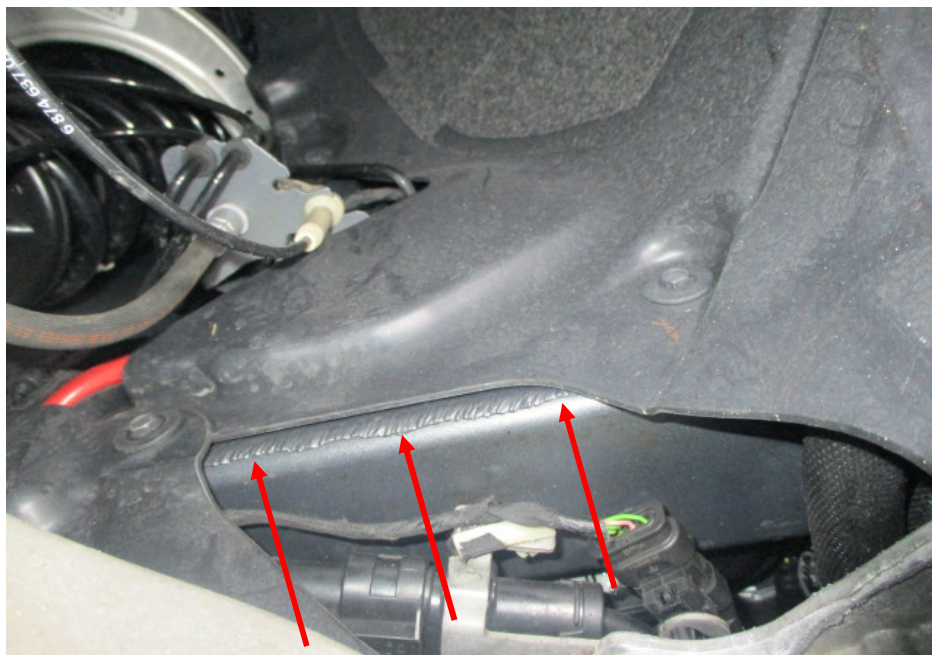
**Photo 26** shows the chassis/structural body at the underside front right of the Motor Car. I did not find any weld marks other than original spot weld marks on the chassis/structural body of the Motor Car. The original factory sealant (arrowed) at the joints along the chassis/structural body was untouched, indicating no work was done on the chassis/structural body of the Motor Car and that the chassis/structural body was originally fitted.

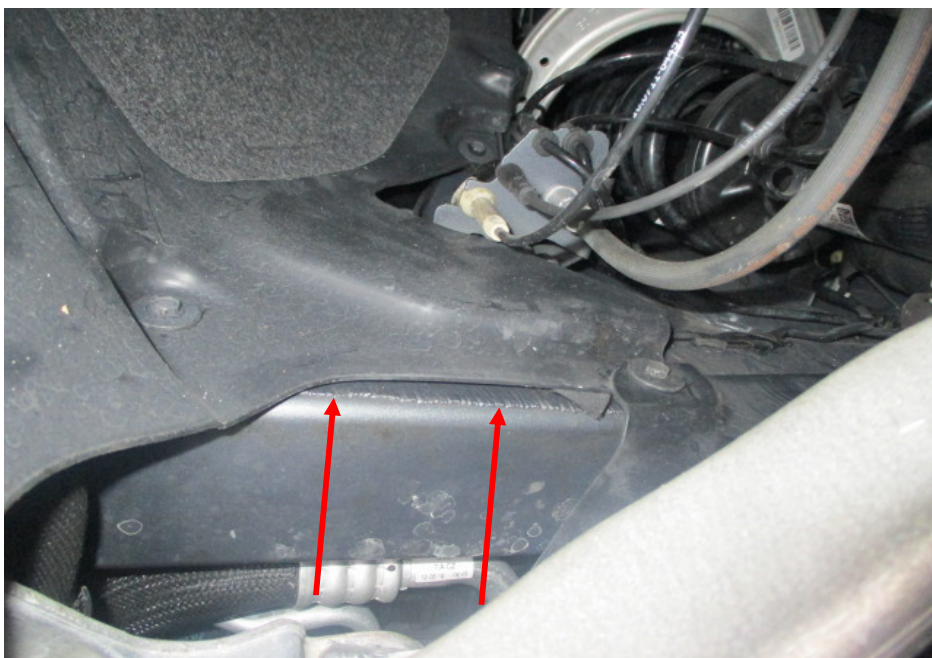
**Photo 27** shows the chassis/structural body at the underside front left of the Motor Car. The original factory sealant (arrowed) at the joints along the chassis/structural body was observed to be untouched. In general, I had found no work was carried out on the chassis/structural body of the Motor Car. The chassis/structural body of the Motor Car was originally fitted.

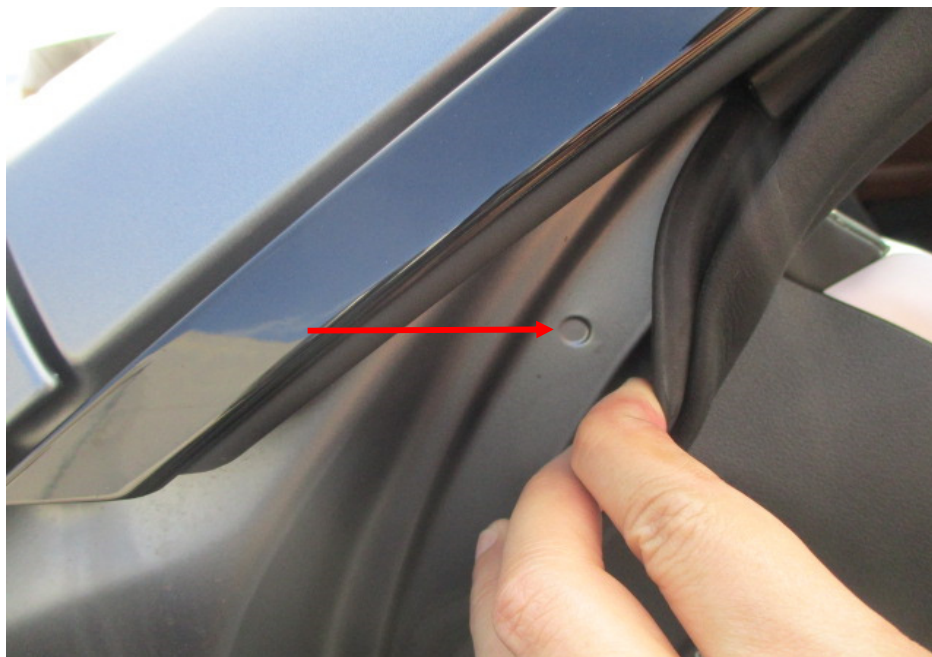
**Photo 28** shows the left side "A" pillar of the Motor Car. I did not find any weld marks other than original spot weld marks (arrowed) on the left side "A" pillar of the Motor Car which, indicates that there was no re-welding works carried out. In general, I had found all the non-detachable body panels of the Motor Car to be originally fitted at the time of my inspection.

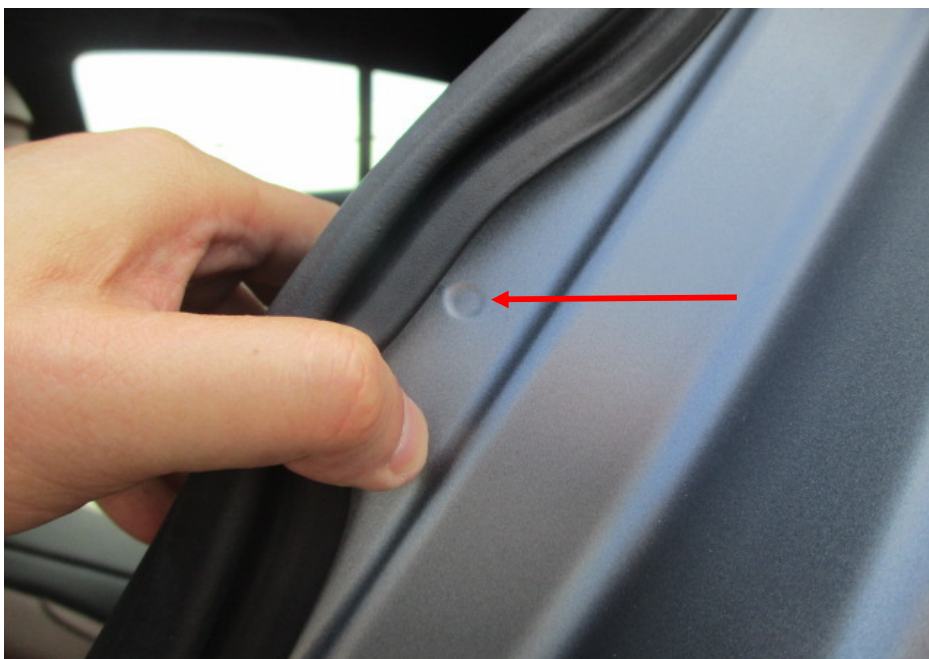
**Photo 29** shows the left side "C" pillar of the Motor Car. I did not find any weld marks other than original spot weld marks (arrowed) on the left side "C" pillar of the Motor Car which, indicates that there was no re-welding works carried out. In general, I had found all the non-detachable body panels of the Motor Car to be originally fitted at the time of my inspection.

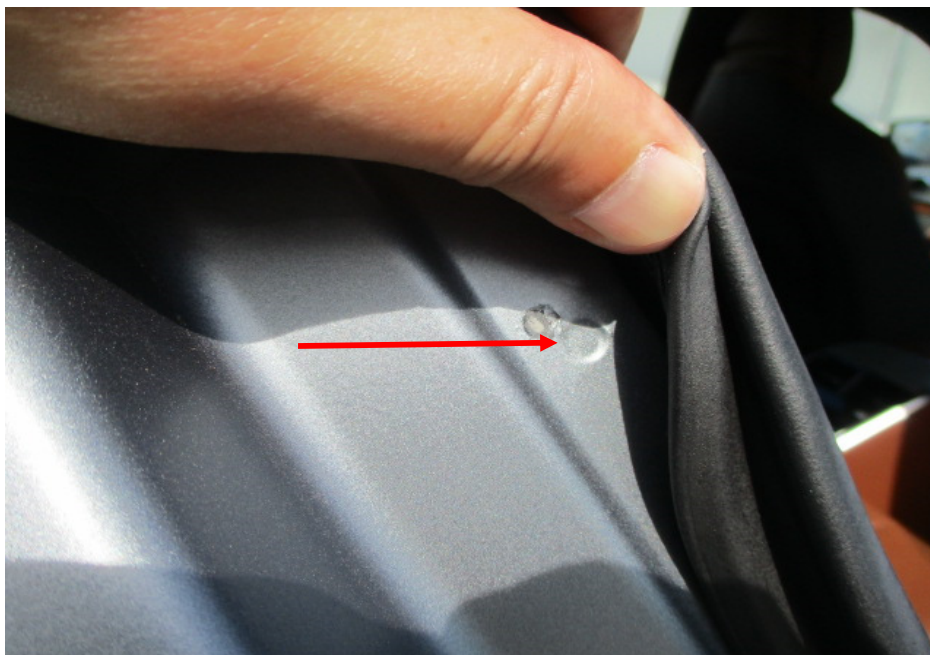
**Photo 30** shows the right side “C” pillar of the Motor Car. I did not find any weld marks other than original spot weld marks (arrowed) on the right side “C” pillar of the Motor Car which, indicates that there was no re-welding works carried out. In general, I had found all the non-detachable body panels of the Motor Car to be originally fitted at the time of my inspection.
